Document Number S24129_LTR_001 Existing Stone Retaining Wall

**Re: Project: 22-32 Junction Street, Forest Lodge NSW 2037
Structural Letter - Existing Stone Retaining Wall**

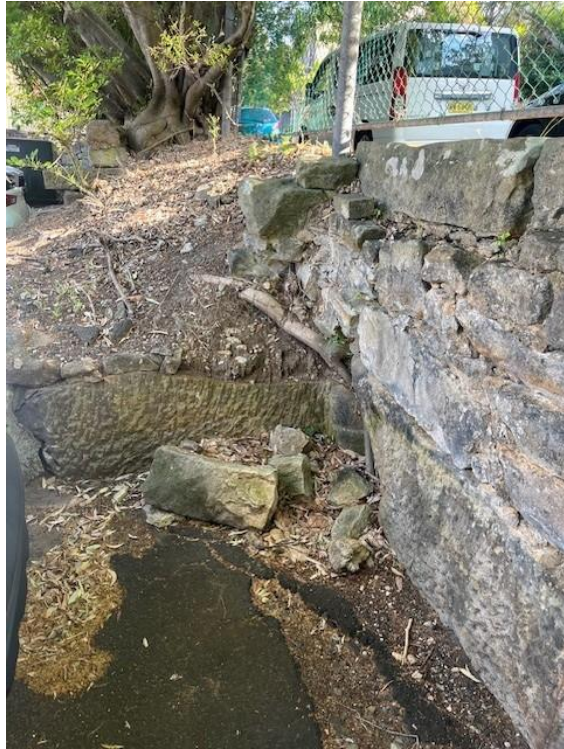
Photo 1

As per the provided photos, there are portions of the stone wall that appear to be in poor condition, with vertical cracking, loose stone and locations where stones have been removed.

Based on the condition of the wall and structural review, BG&E believe that the existing stone retaining wall is not suitable to be conserved in situ for the proposed development.
