Design for the proposed upgrade of Bankstown North Public School, in Bankstown, NSW

Stage 3 (Detailed design) Road Safety Audit

February 2021

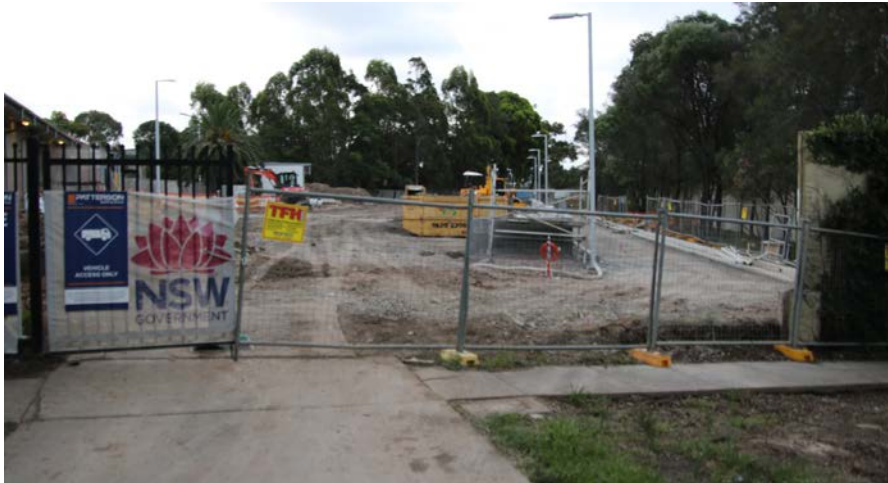
Photo 3.1
[Photo: Traffic Engineering Centre Pty Ltd]

In order to check the feasibility of implementing the proposed design, the daylight site inspection was undertaken on 8 February 2020, in dry weather and road condition.

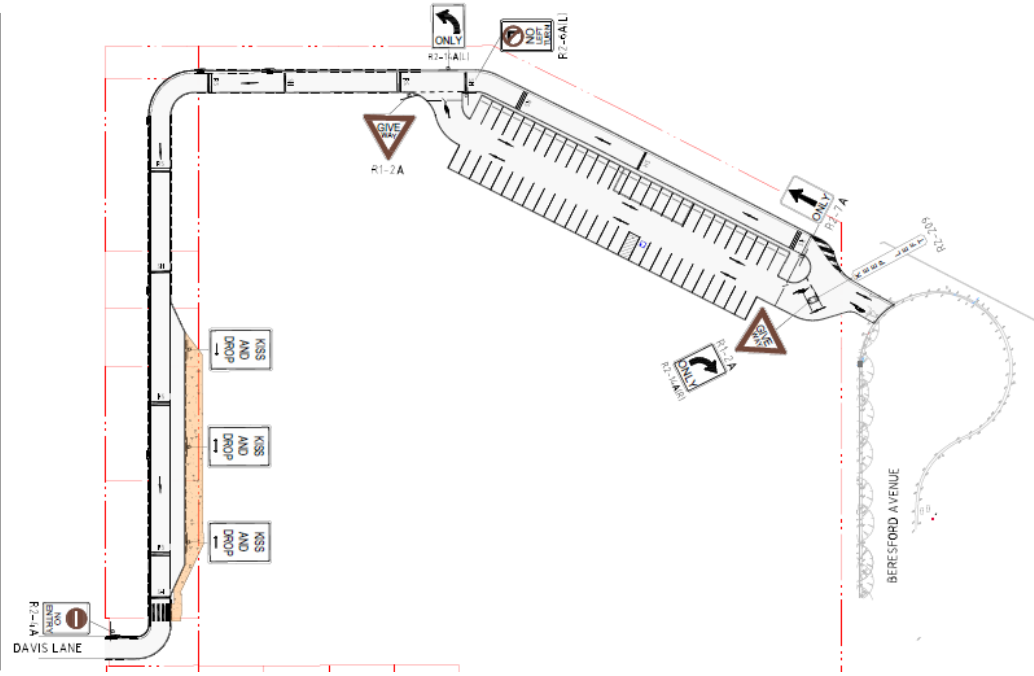
<p>Figure 4.1</p>	Intolrable (Probable / Serious)

No.	Drawings / Approximate Location	Description of findings	Risk rating (likelihood/severity)
1	C10.01 / Zebra crossing on the circulation roadway	<p>'Pedestrian Crossing' (R3-1) signs are missing at both sides of the proposed Zebra crossing, so to face and alert egress drivers about the presence of Zebra crossing and pedestrians on it, as it is required in accordance with AS 1742.10-2009 (refer to Figure 4.1).</p> <p>Without the signs in place, some drivers could easily overlook the Zebra crossing, thus increasing the chance for a pedestrian to be struck by a vehicle on it.</p>

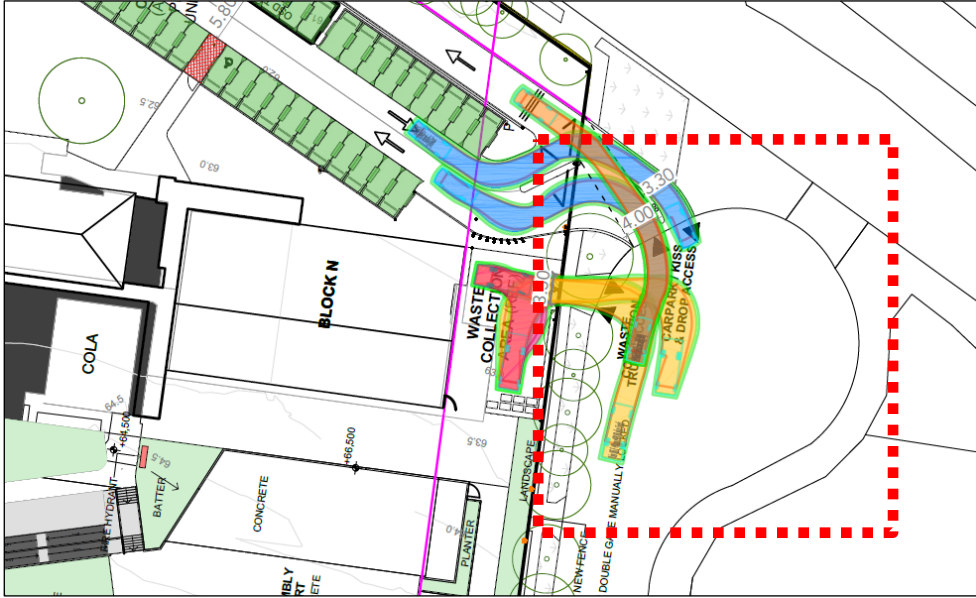
<p>Figure 4.2</p>	<p>Medium (Probable / Limited)</p>

No.	Drawings / Approximate Location	Description of findings	Risk rating (likelihood/severity)
2	ptc-003 / Cul-de-sac on Beresford Avenue	<p>'No Stopping' zone is <u>not</u> proposed in the cul-de-sac on Beresford Avenue (refer to Figure 4.2).</p> <p>Therefore, there is nothing in place to prevent vehicles from stopping and/or parking within the cul-de-sac, thus obstructing access and/or exit from the car park, and mutual visibility between vehicles which are exiting the car park and vehicles traveling on Beresford Avenue toward the car park.</p> <p>Currently, 'No Stopping' zone is signposted, but limited only to school days and only between 2.30pm and 4.00pm (refer to Photo 4.1), while the car park would be used in the morning, too, as well as during the rest of a weekday, and, perhaps, on [some] weekends.</p>
