## Field Soil Observations/Testing

### 5.3 Slope

## 5.14 BSAL Sites within the Gateway Certificate Application Area

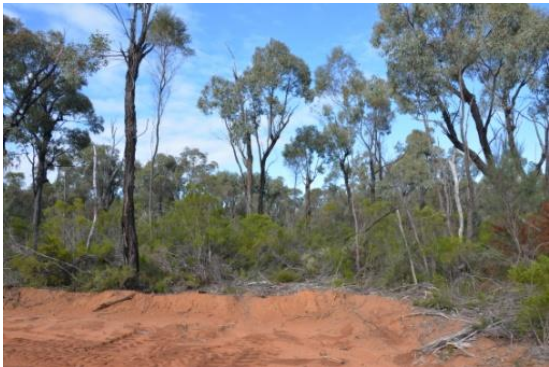
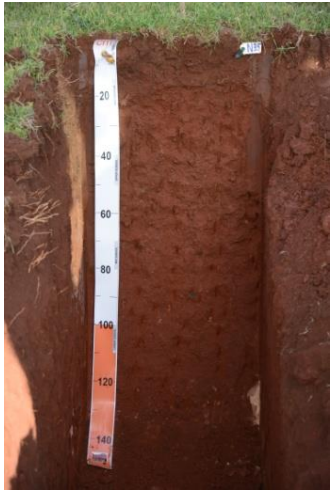
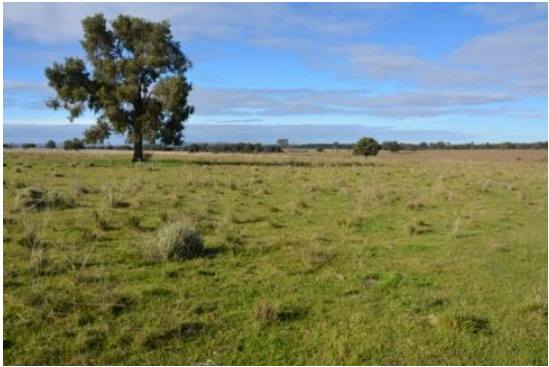
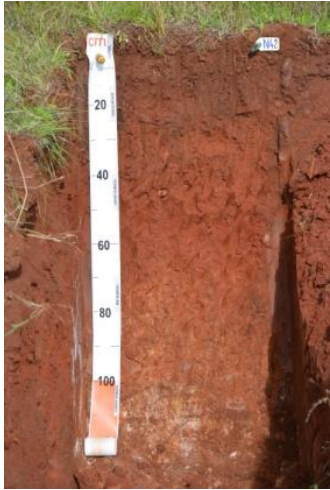
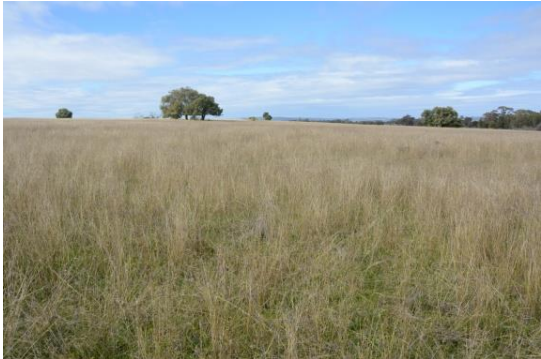
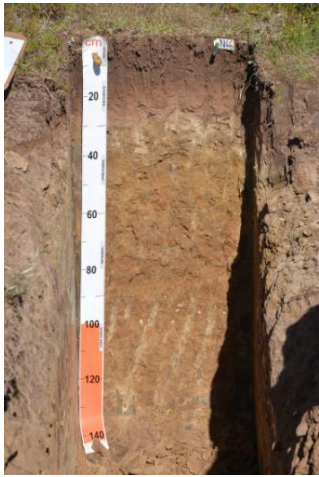
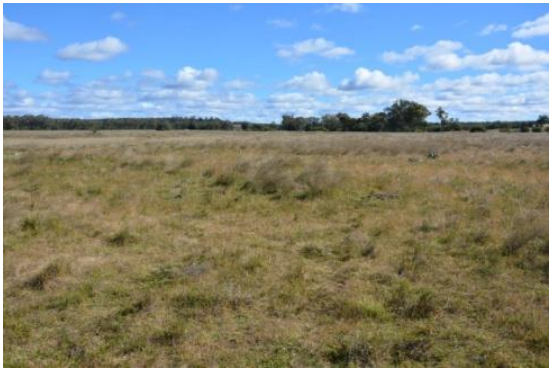
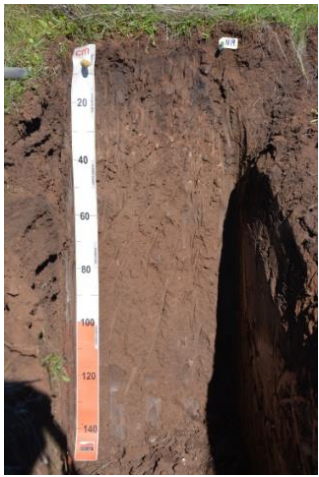
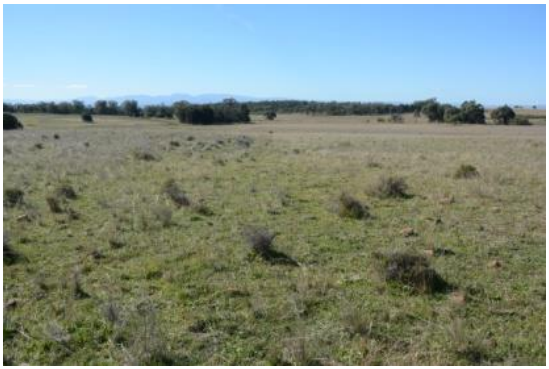
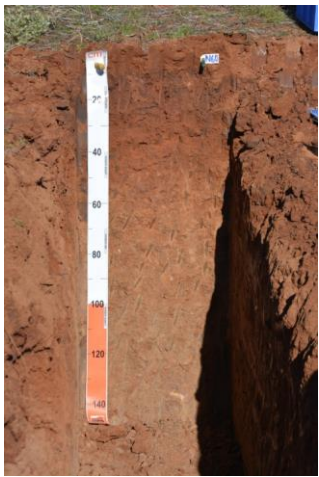
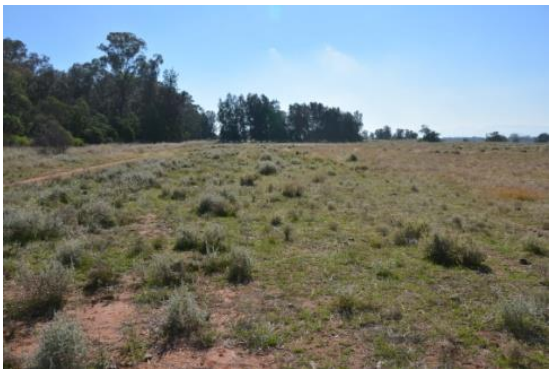
**Figure 11. Photographs of Representative Soil Types for each Soil Landscape Unit**

| Soil Landscape Unit | Dominant Soil Types | Landscape View |
|---|---|---|
| Pilliga Sandstone | Pit 22: Orthic Tenosol<br> | Site 22<br> |
| Garawilla Volcanics - Calcic | Pit 36: Vertosol<br> | Site 36<br> |
| Garawilla Volcanics - Intermediate | Pit 43: Dermosol<br> | Site 43<br> |

| <p>Garawilla<br/>Volcanics -<br/>Sodic</p> | <p>Pit 47: Sodosol</p> | <p>Site 47</p> |
| <p>Garawilla<br/>Volcanics –<br/>Sodic/<br/>Vertosols</p> | <p>Pit 19: Vertosol</p> | <p>Site 19</p> |
| <p>Napperby<br/>Siltstone</p> | <p>Pit 61: Sodosol</p> | <p>Site 61</p> |

The ASC (Isbell, 2002) has been used to determine soil types at each of the 69 observation sites (Map 2). Photographs of representative soil profiles identified during the survey are presented in Figure 11 (for each Soil Landscape Unit and ASC soil type described below). All the sites have three photographs that record the following: a) Landscape view, b) Trimmed soil profile, and c) Close-up view of soil surface and associated vegetation where required. The Landscape view and Trimmed soil profile photographs for all sites are shown in Attachment E.
