# WILPINJONG COAL PROJECT

### Land Contamination Assessment

*LAND CONTAMINATION ASSESSMENT*

*Project Number G1245*  
*April 2005*

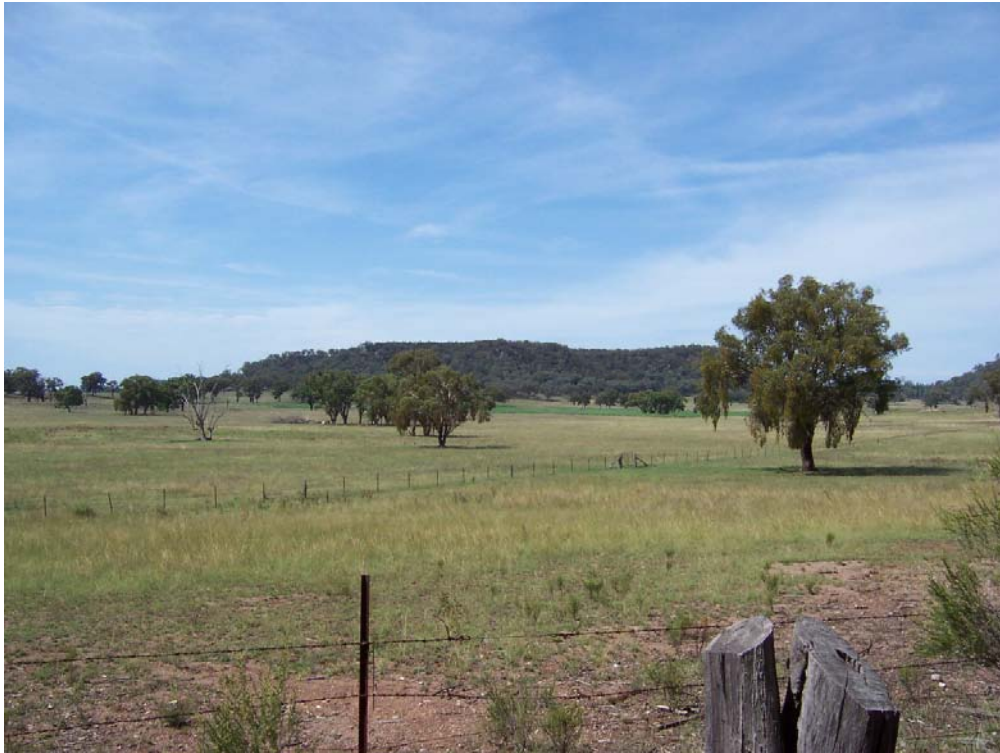
Photograph A: Typical current land use in the study area (Munghorn Gap Nature Reserve is in the background).

The study area is sparsely populated with some 6 inhabited dwellings. The majority of land within the study area is freehold agricultural land used for grazing, cropping and small farming (Attachment OA, Photograph A).

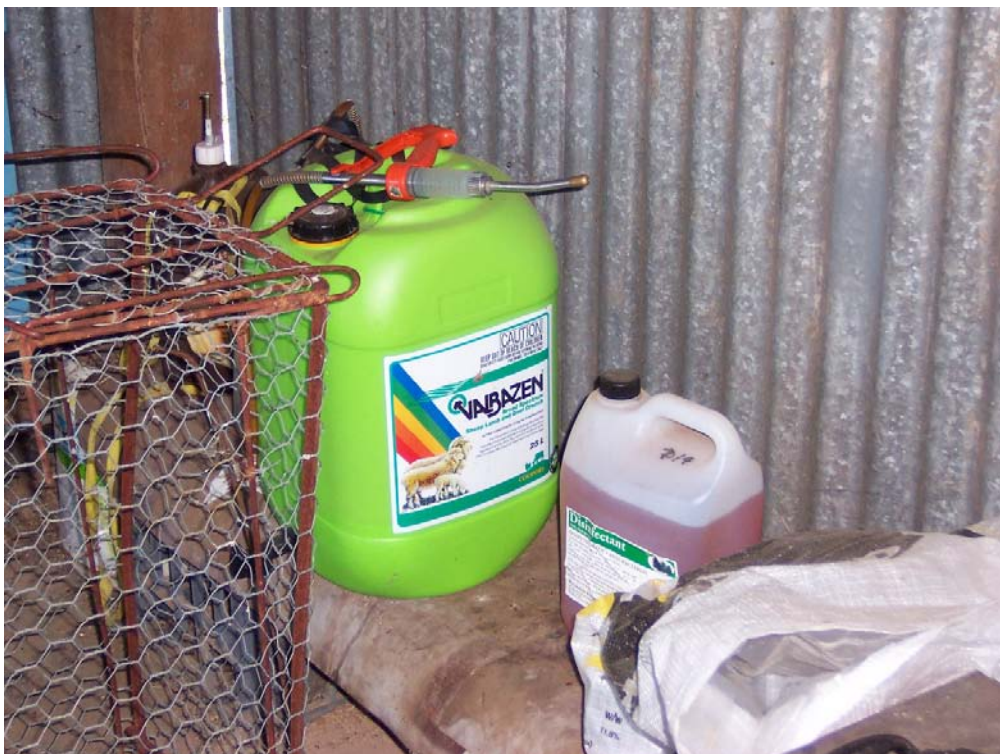
Photograph B: Portable sheep drench at Spring Flat.

As land was predominantly used for sheep grazing, there are several sheep dips present within the study area that were used until about the mid 1970s (pers. comm., Lloyd Coleman and Kevin Dorahy). Sheep dipping was replaced in the mid 1970s by pour on sheep drenches which are generally regarded as easier to use, more effective and more environmentally 'friendly' (refer Attachment OA, Photograph B).

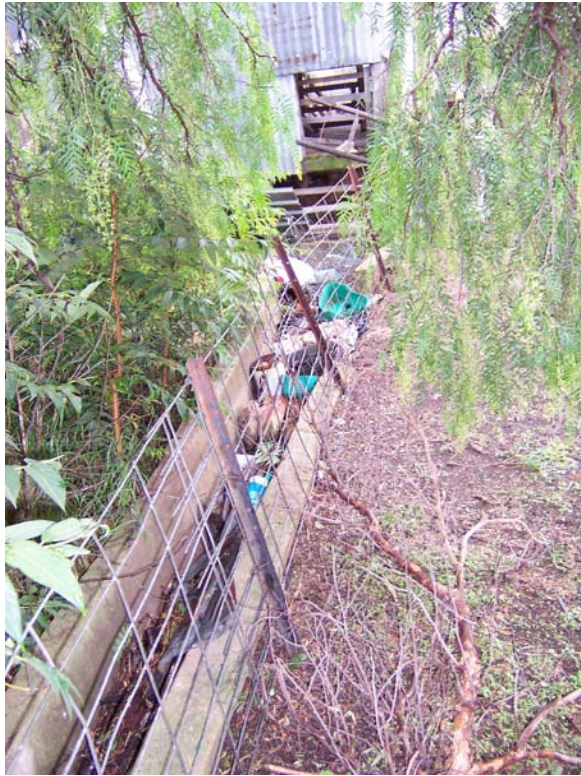
Photograph C: Disused sheep dip at Pine Park.

The three disused sheep dips are located at the woolsheds of the *Pine Park*, *Wyangle* and *Hillview* properties. The locations of the sheep dips are shown in Figure O-2. The sheep dips are constructed from concrete and are now abandoned and, possibly collapsed. Some of the sheep dips have been used for general waste disposal and are now filled to ground level and are barely evident (refer Attachment OA, Photographs C and D).

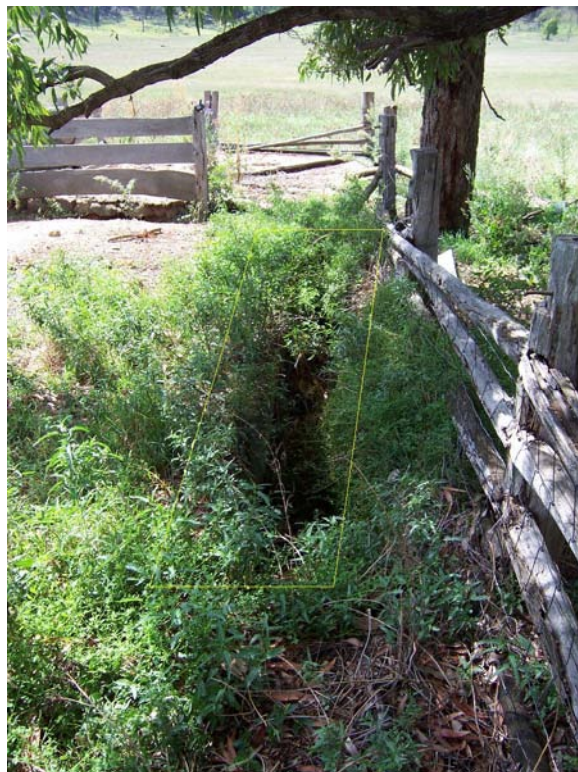
Photograph D: Disused sheep dip at Wyangle (outlined in yellow), dip exit and drainage slab in background.

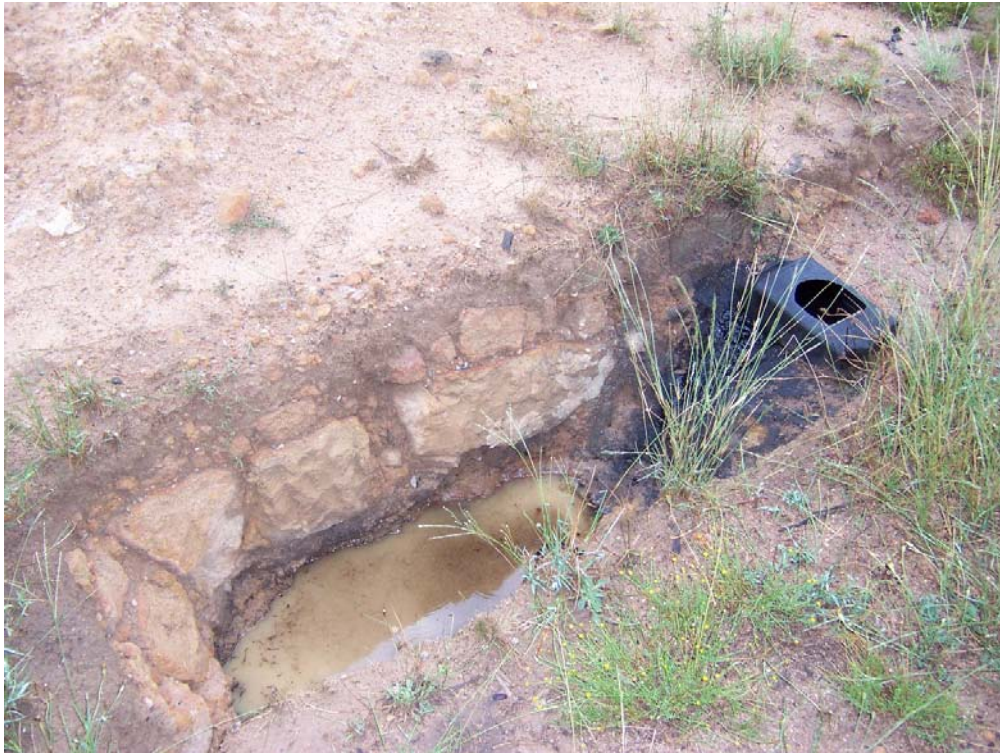
A small pit for changing oil that has been excavated into silty sandstone is present at *Pine Park*. There was only minor evidence of oil staining in the pit (refer Attachment OA, Photograph E). At the time of the site inspection the oil changing pit was full of water from storm rain two days prior. The accumulation rather than infiltration of water from the pit indicates the low permeability nature of the silty sandstone.

Photograph E: Oil change pit at Pine Park, note presence of fractured rock at surface.

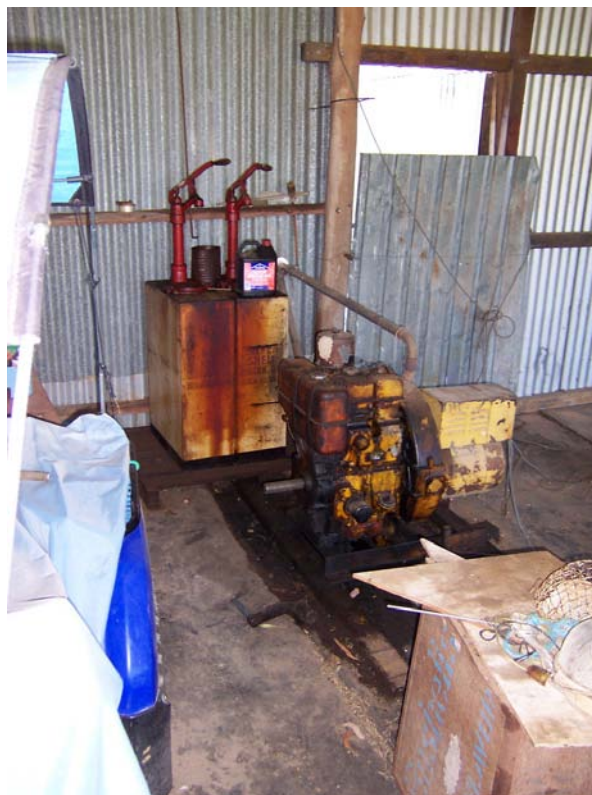
A small diesel generator is present at *Spring Flat* with minor oil staining observed on the concrete floor (refer Attachment OA, Photograph F).

Photograph F: Diesel power generator at Spring Flat, with oil staining on ground.

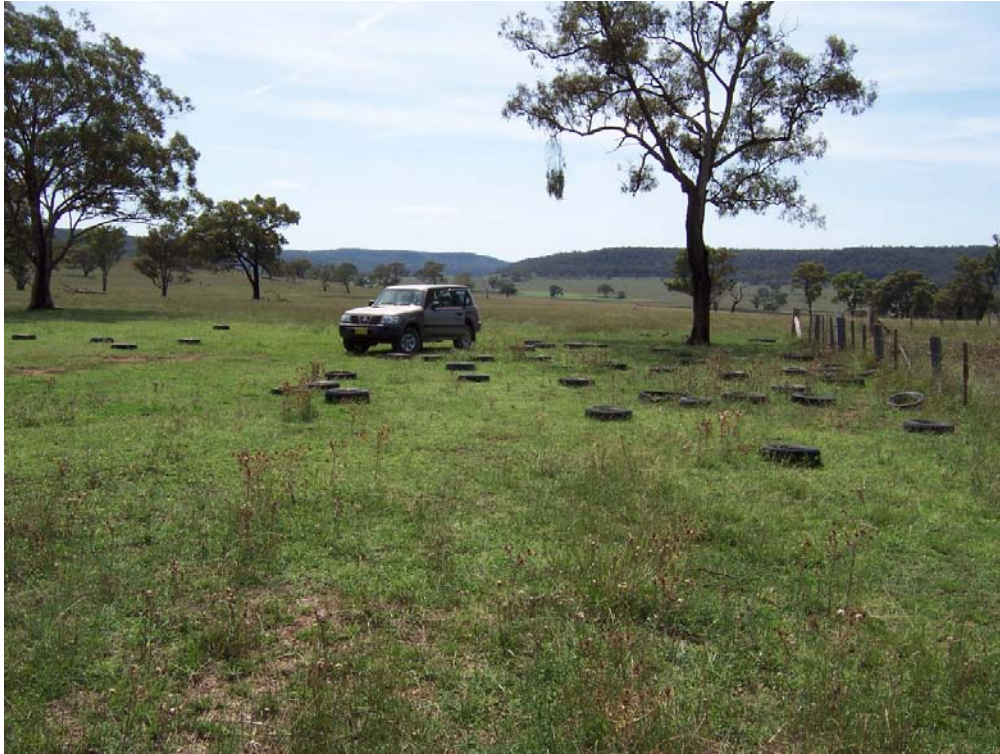
In the 1970s and 1980s two bush airstrips were used for the aerial spreading of superphosphate. These airstrips were located on *Castle View* and *Cumbo Creek*. Superphosphate was stored on-site and picked up by aircraft for subsequent spreading. There is no longer any evidence of the airstrip on *Castle View*. The airstrip on *Cumbo Creek* is still visible (refer Attachment OA, Photograph G).

Photograph G: Former superphosphate storage area at head of airstrip (looking northeast).

The soil sampling undertaken during the preliminary investigation did not detect the presence of contaminated soils within the study area. However, it is recommended that during the construction stage when earthmoving equipment is available on-site that a Stage 2 investigation be undertaken at the *Pine Park*, *Wyangle* and *Hillview* sheep dips. As part of this investigation the general waste should be removed from the dips and additional soil samples be collected. If contaminated soils are detected, appropriate management measures for the soils should be developed, which may include disposal with Coal Handling and Preparation Plant (CHPP) tailings
