# moira station cattle feedlot

## Moira Station Cattle Feedlot Environmental Assessment

### Volume 2

December 2005

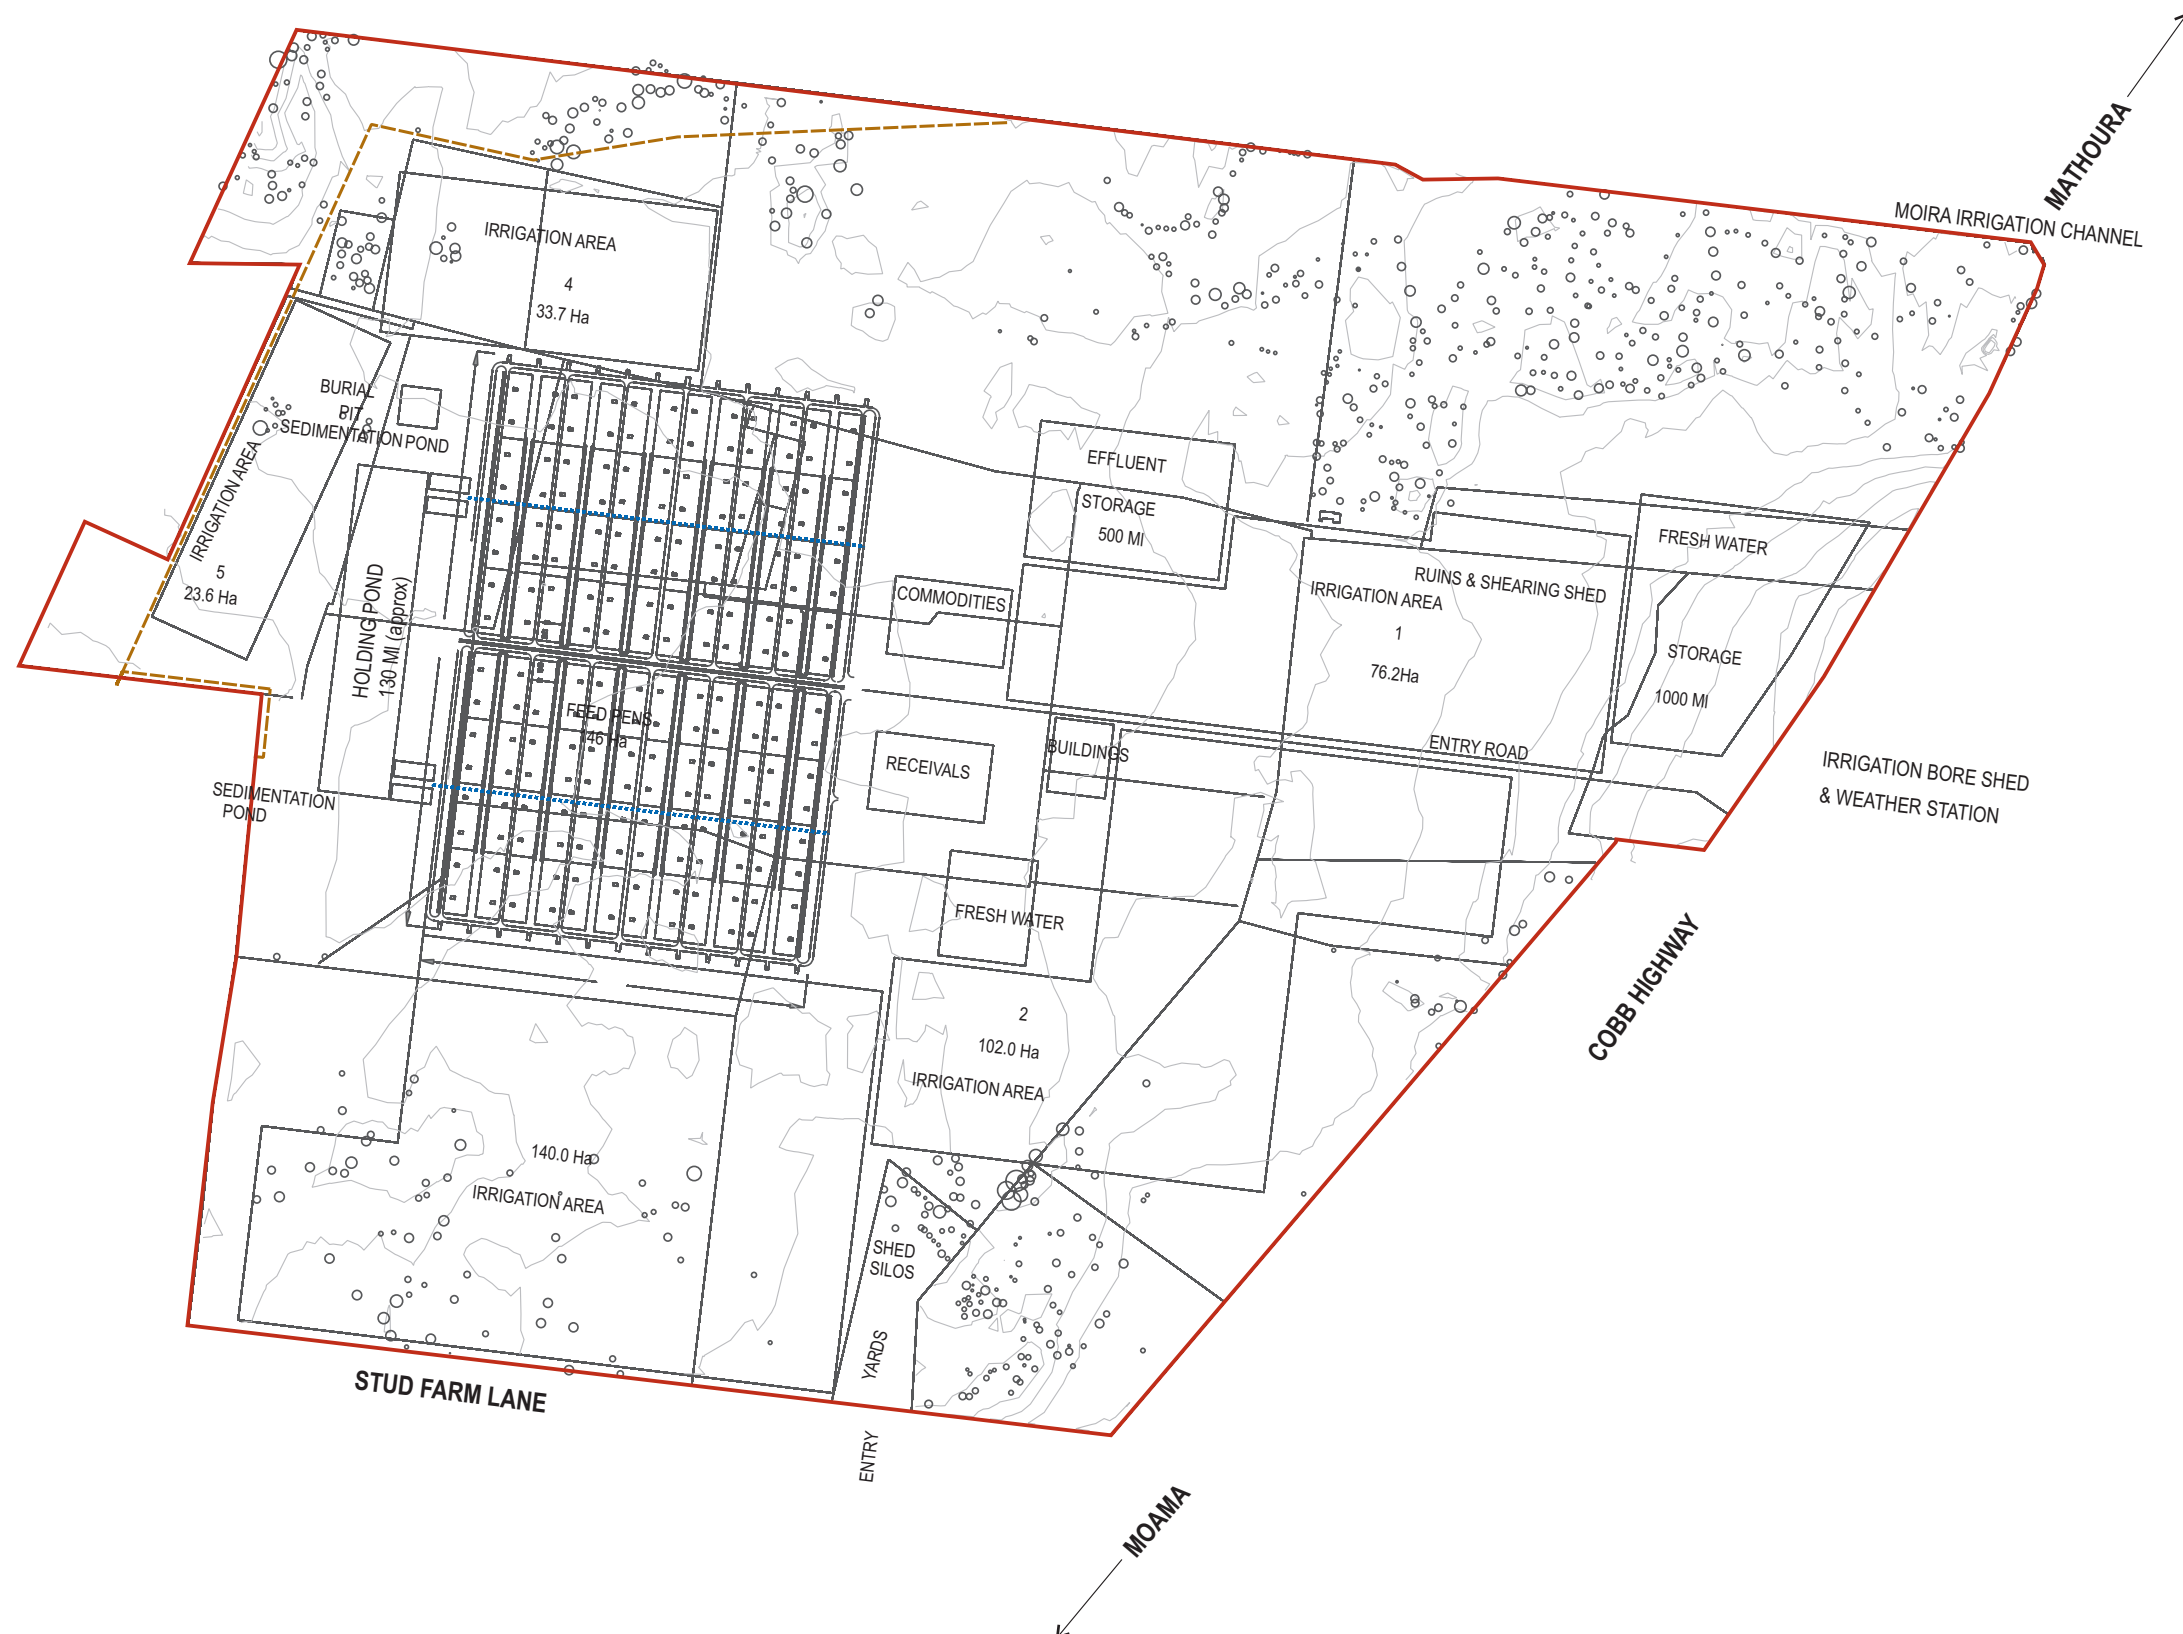
- Site boundary
- ..... Drainage pipeline
- - - - - Moira channel relocation

**Proposed Site Layout**  
**Agricultural Equity Investments Pty Ltd**  
 Moira Station Cattle Feedlot  
 Environmental Impact Statement  
 Mathoura NSW

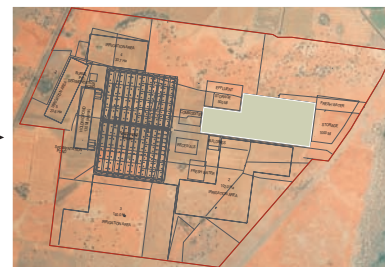
Irrigation area no. 1 (76.2ha)

## **Appendix B - Effluent Treatment and Irrigation Schematic**

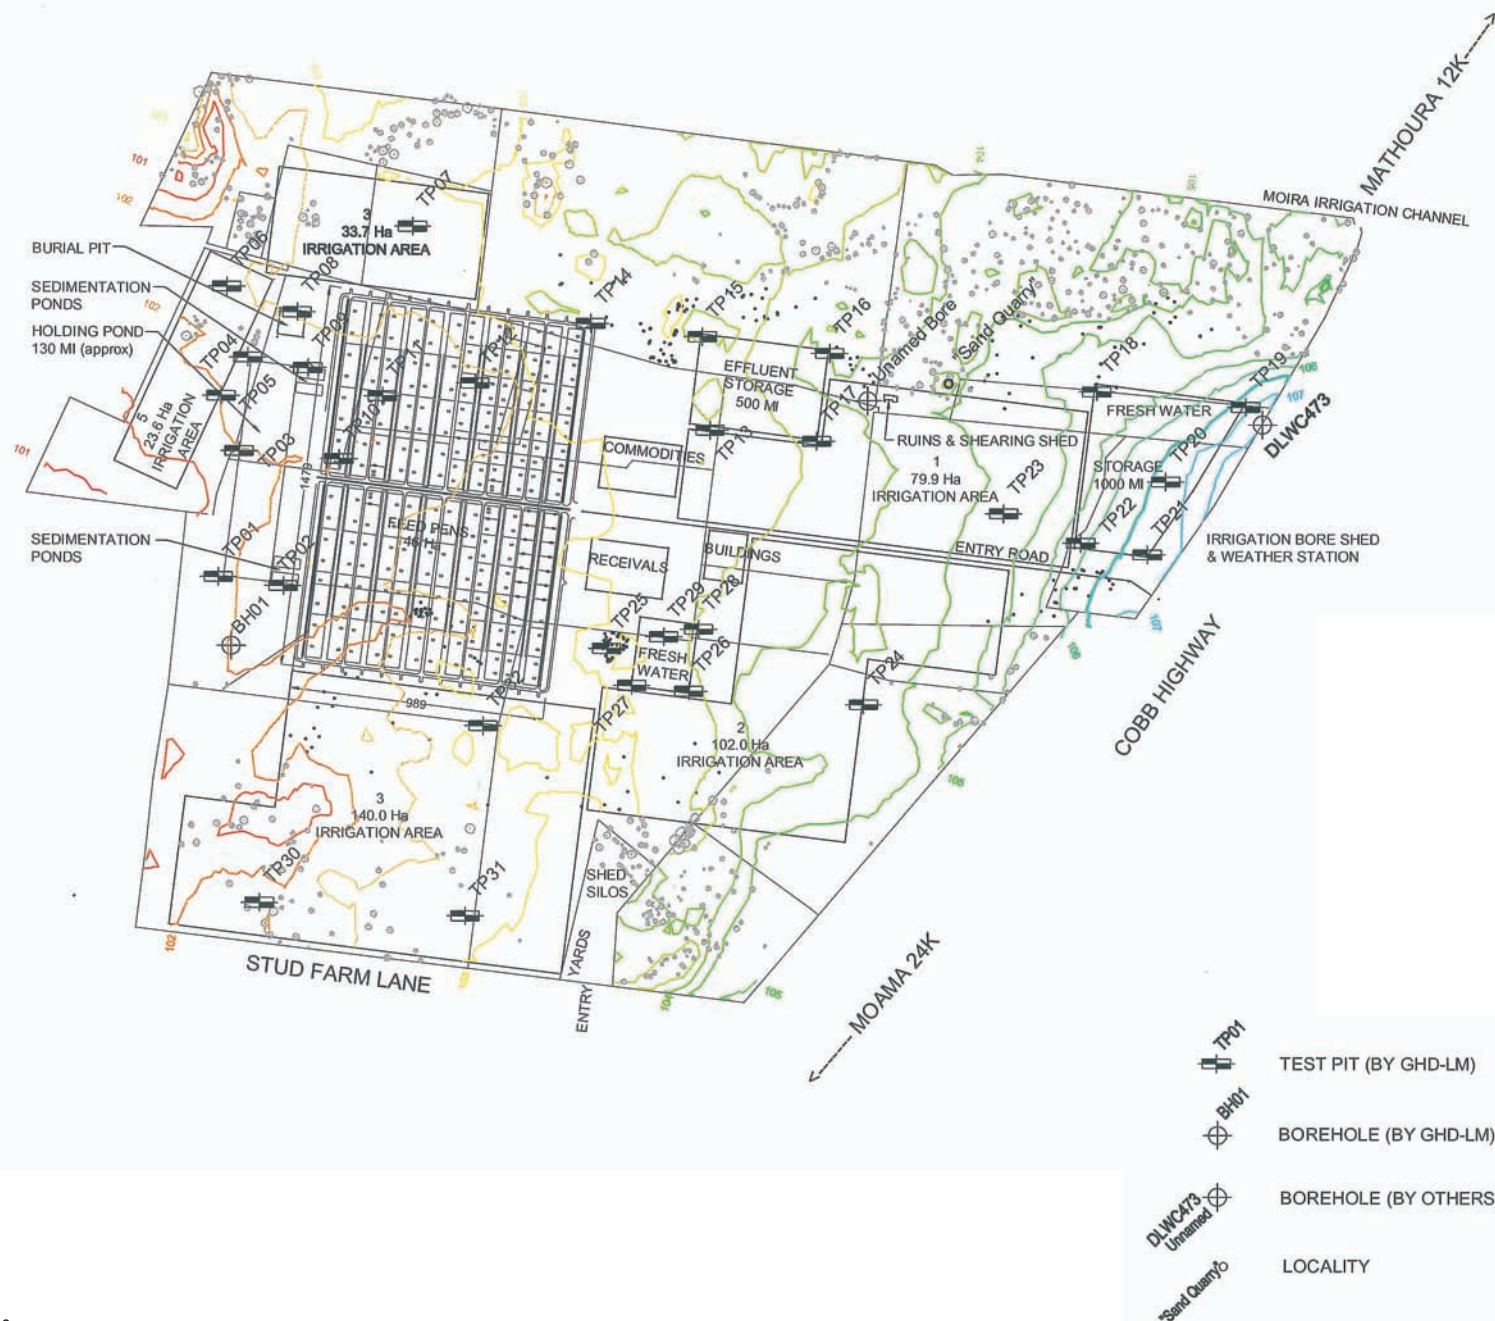
Location of Geotechnical Test Pit and Borehole Locations (After GHD) Agricultural Equity Investments Aboriginal Heritage Assessment of the Proposed 80,000 Head Cattle Feedlot at Moira Station Mathoura, NSW

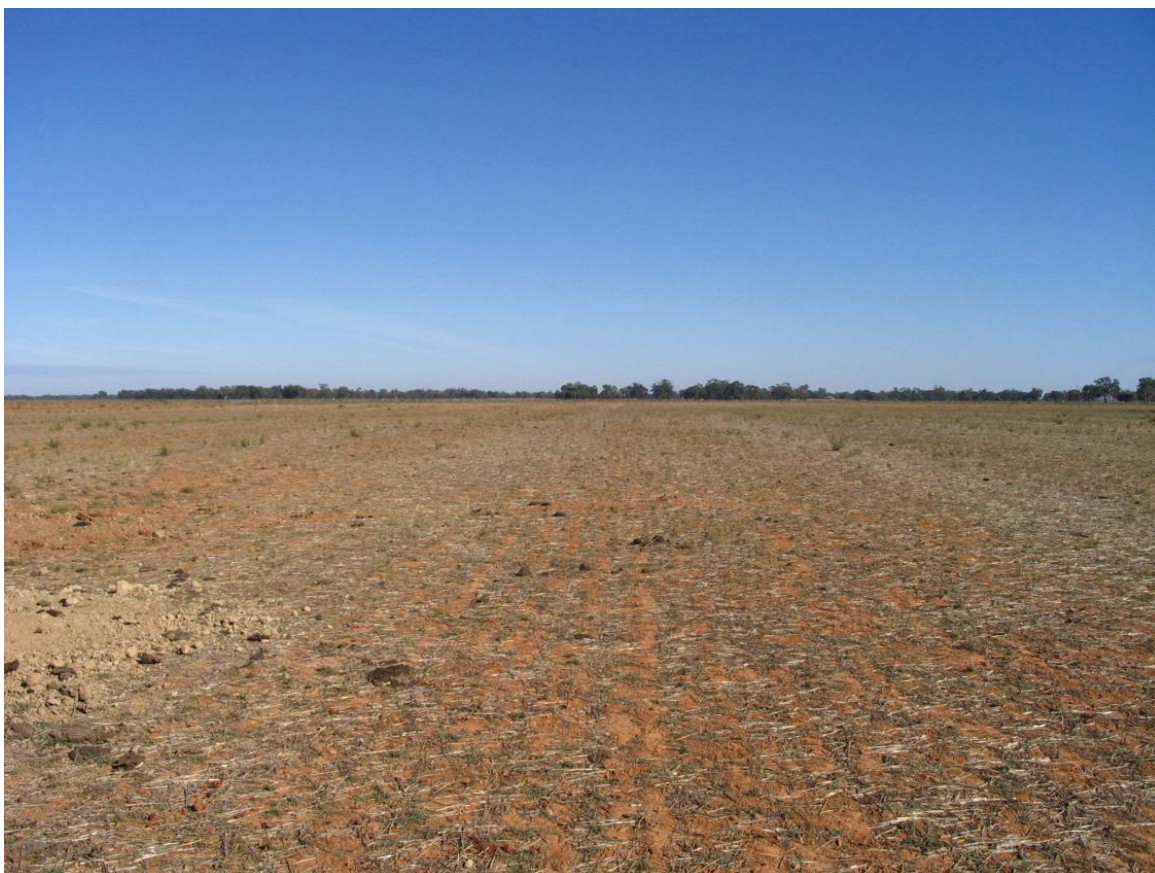
### **PLATE 6**

*Transect 7 looking north across the alluvial plain. Note the parallel lines indicating ploughing*

Transect 7 (**Plate 6**) was situated within a ploughed field in the north east corner of the proposed feedlot pens. The boundaries of the transect were fence lines on all cardinal points. A red brown clayey loam to clay was present on the plain as disturbed topsoil. Vegetation on the surface was thistles and straw, meaning visibility was around 30 % of the ground surface. No Aboriginal sites were located.

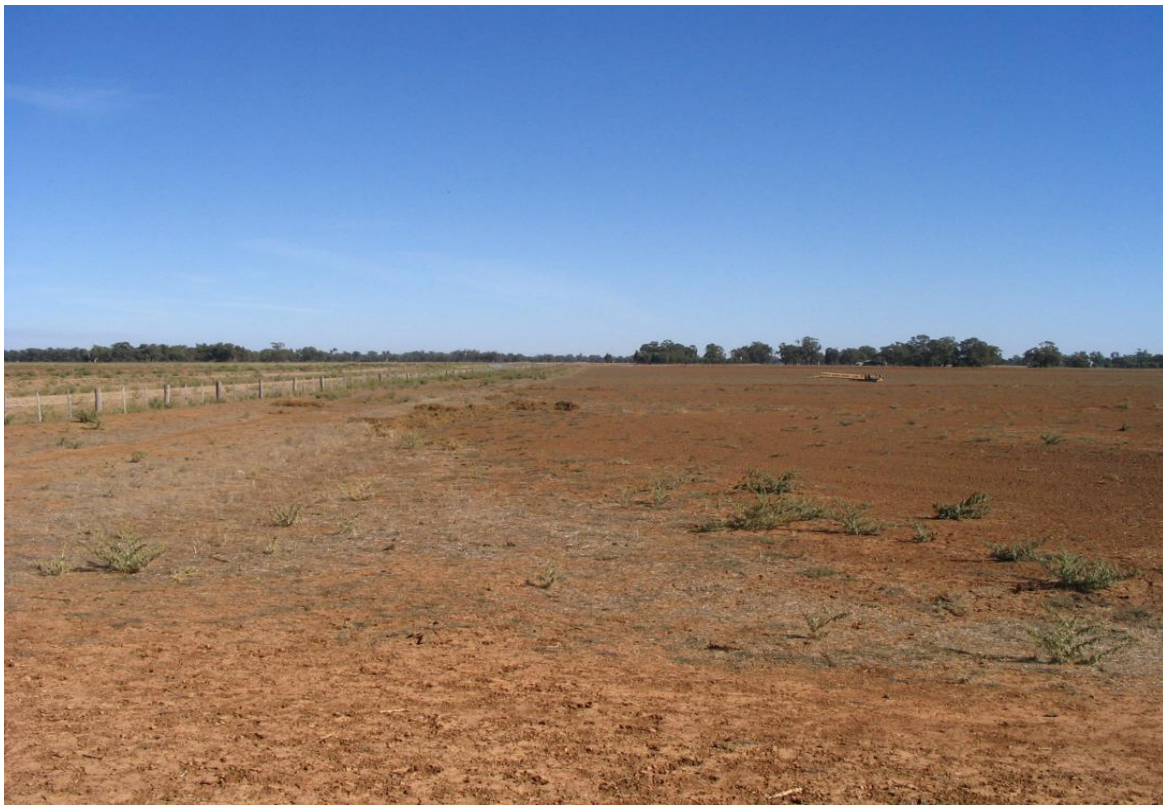
**PLATE 7**  
*Transect 8 looking westwards*

Transect 8 was located in the north west quarter of the proposed feeding pens (**Plate 7**, the area being a ploughed field. A red brown clayey loam to clay was present as disturbed topsoil.

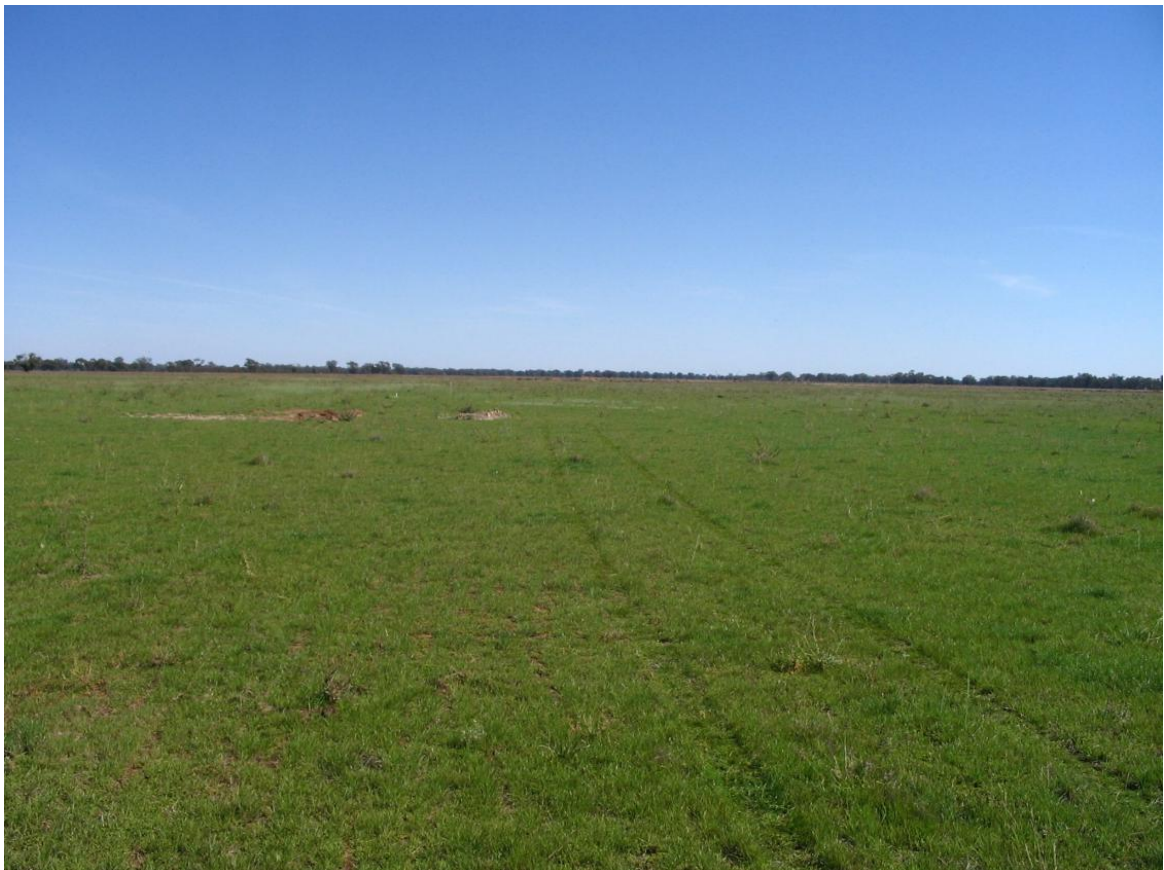
**PLATE 8**  
*Transect 11 looking westwards – note the dense grass cover*

Transect 11 was located across the areas marked as two sedimentation ponds immediately west of the southern half of the proposed feed pen. Grass cover was very dense here (95 %), the area obviously lying fallow from cultivation (probably seeded) for some time (**Plate 8**). Where visible, the ground surface indicated a brownish red clay / clayey loam, representing a disturbed topsoil. No Aboriginal sites were located.

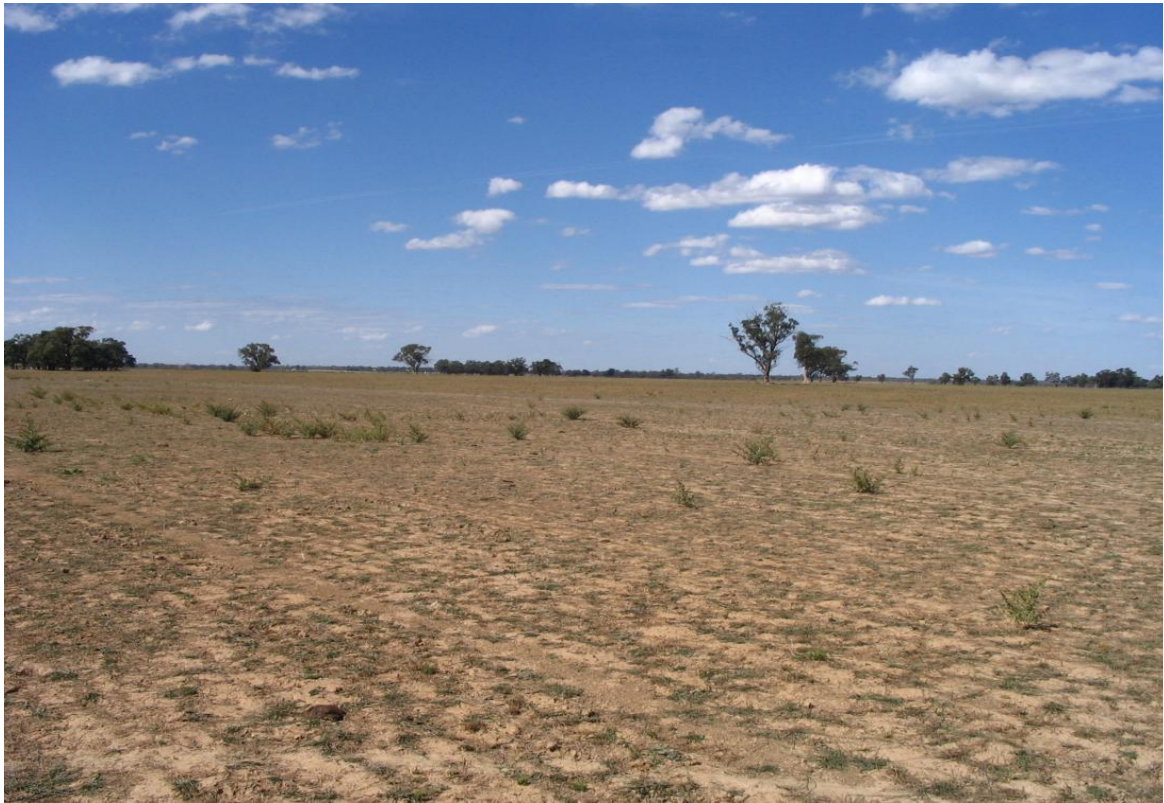
**PLATE 9**

*Transect 13 looking east. Note the plough lines and weeds*

Transect 13 (**Plate 9**) was located within the south west corner of the area earmarked for the proposed feeding pens. Vegetation cover within this part of the study area was around 70 %, the visible ground surface indicating that the soil was a disturbed brown loam topsoil. No Aboriginal sites were located.

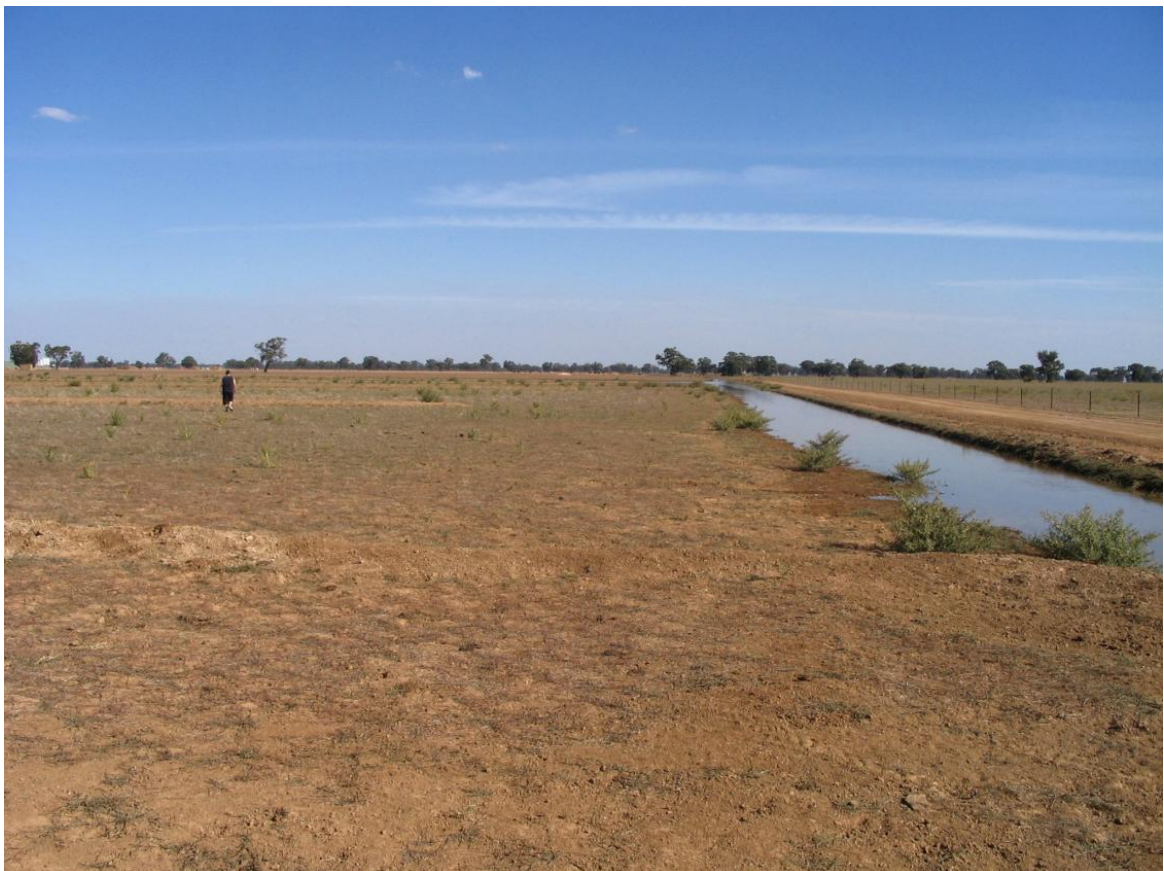
**PLATE 10**

*Transect 14 looking south. Note the irrigation channel is flooded*

Transect 14 was located within to the east of transect 13 over the area near the south eastern corner of the proposed feeding pens (**Plate 10**). Vegetation cover within this part of the study area was around 70 %, the visible ground surface indicating that the soil was a disturbed brown loam topsoil. No Aboriginal sites were located.

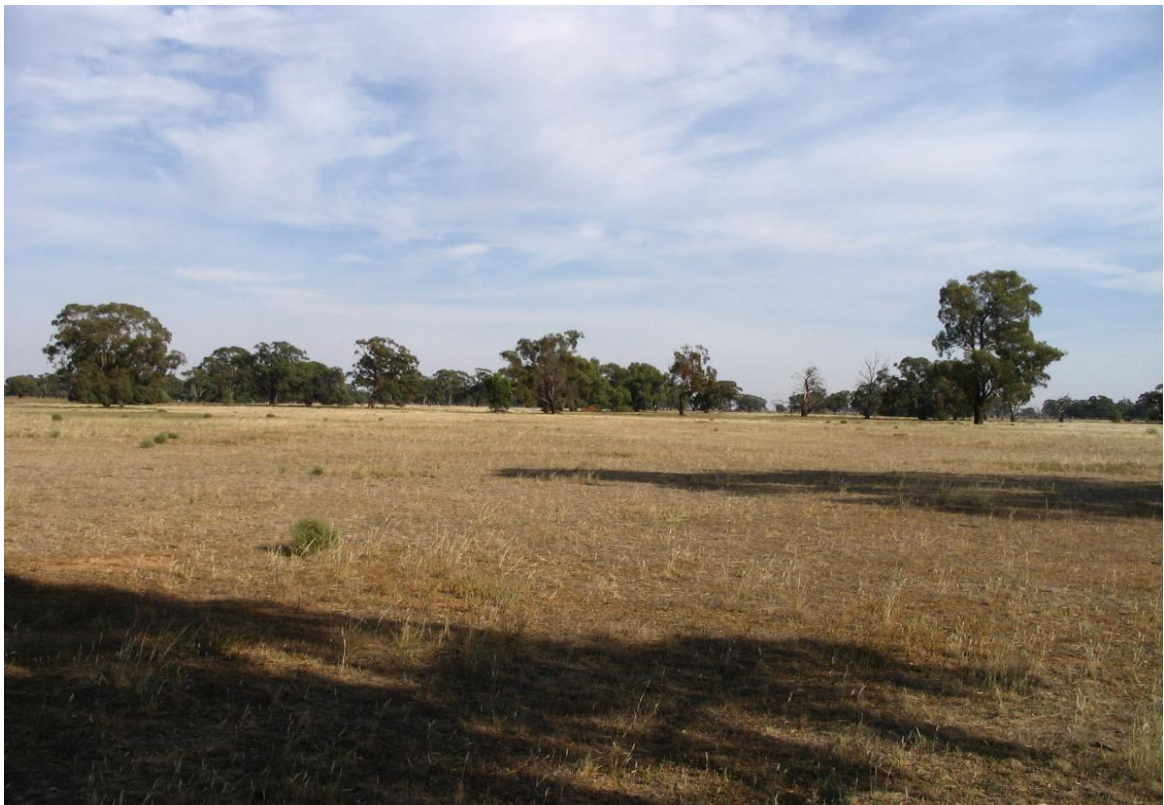
**PLATE 11**  
*Transect 15 looking west*

Transect 15, from near the historic ruins to the Cobb Highway, is flat and level. (**Plate 11**). The route follows the southernmost tree line of the northern wooded area, and contains a dam with exposed soils present at the northeast corner of the transect. Further to this there are some dry earthworks located in the southwest of the transect. Both earthworks display exposed A / B horizon – a red brown loam. Approximately 10% of the total transect area was exposed in places to 90% visibility due to erosion scouring. Exposure in the area is middling, with visibility hindered by coverage of grasses and some low weeds. The area is scattered with pockets of tall trees and sapling regrowth. A total of three archaeological sites were recorded in this transect, which was the total number of sites recorded in the study area as a whole. This is not surprising considering that this area has the least impacted landscape at the site, and has not been as intensively cleared, irrigated and tilled – at least in the recent past.

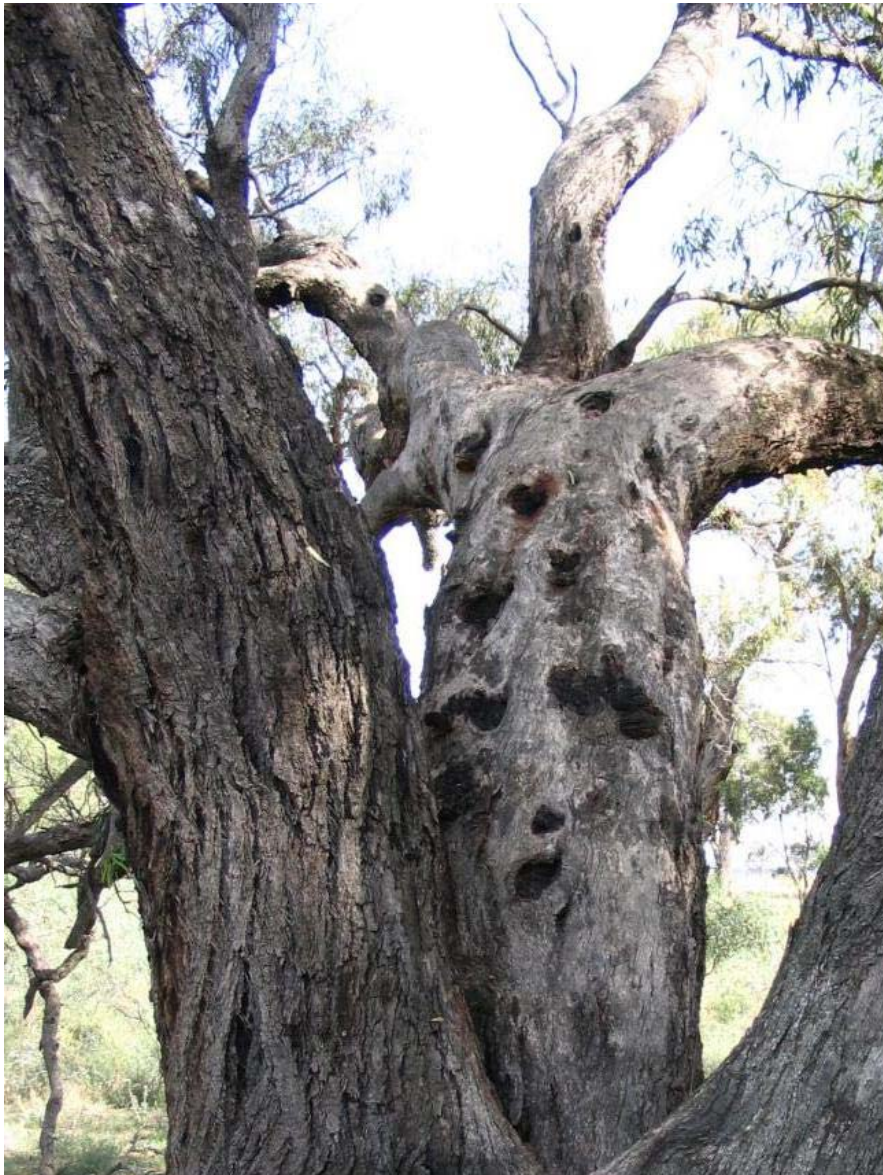
**PLATE 20**

*General shot of site MF1 looking north. Note the cut footholds located in the central trunk*

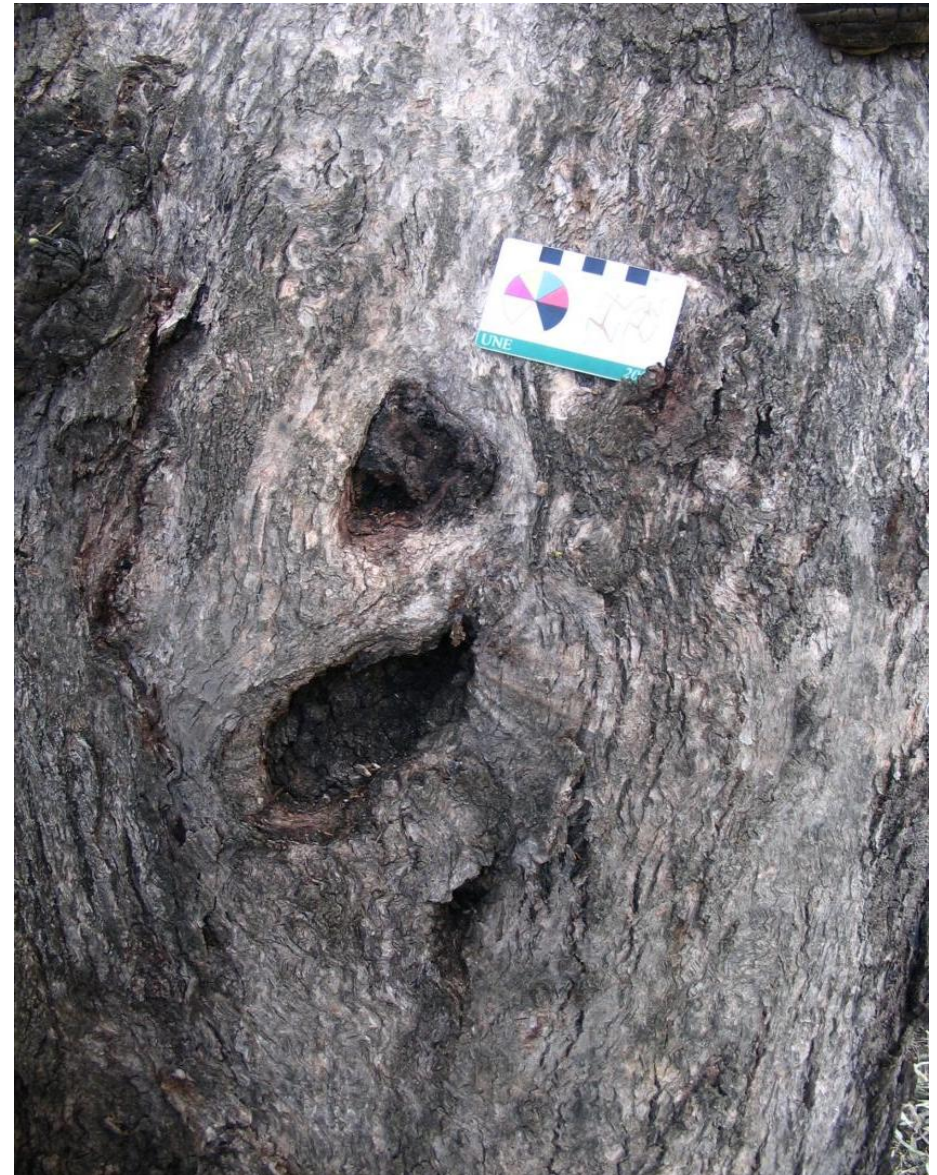
**PLATE 21**

*Close-up of MF1 footholds. Scale is in centimetres*

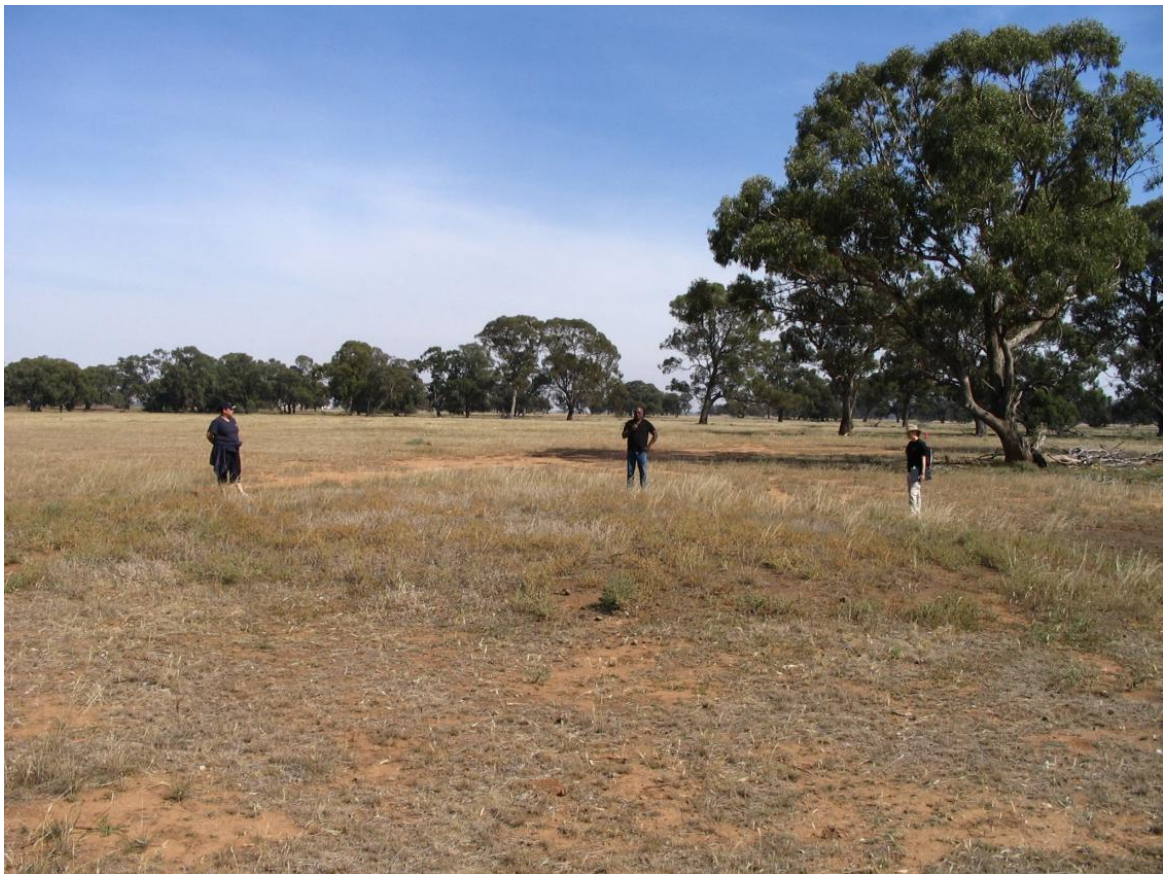
**PLATE 22**

*Oven Mound MF2 looking westwards. The three people are standing at the western, northern and southern boundaries of the mound*

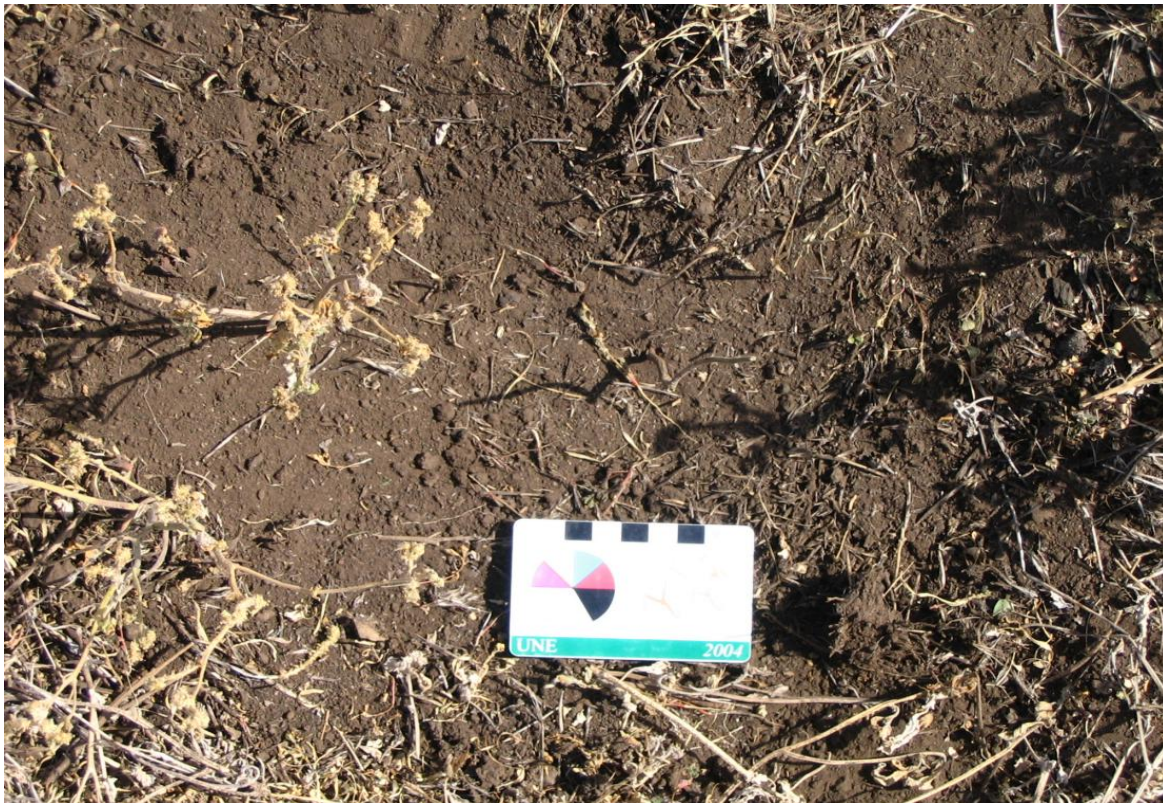
**PLATE 23**

*Close up of the surface of MF2: reveals an ashy dark grey loam*

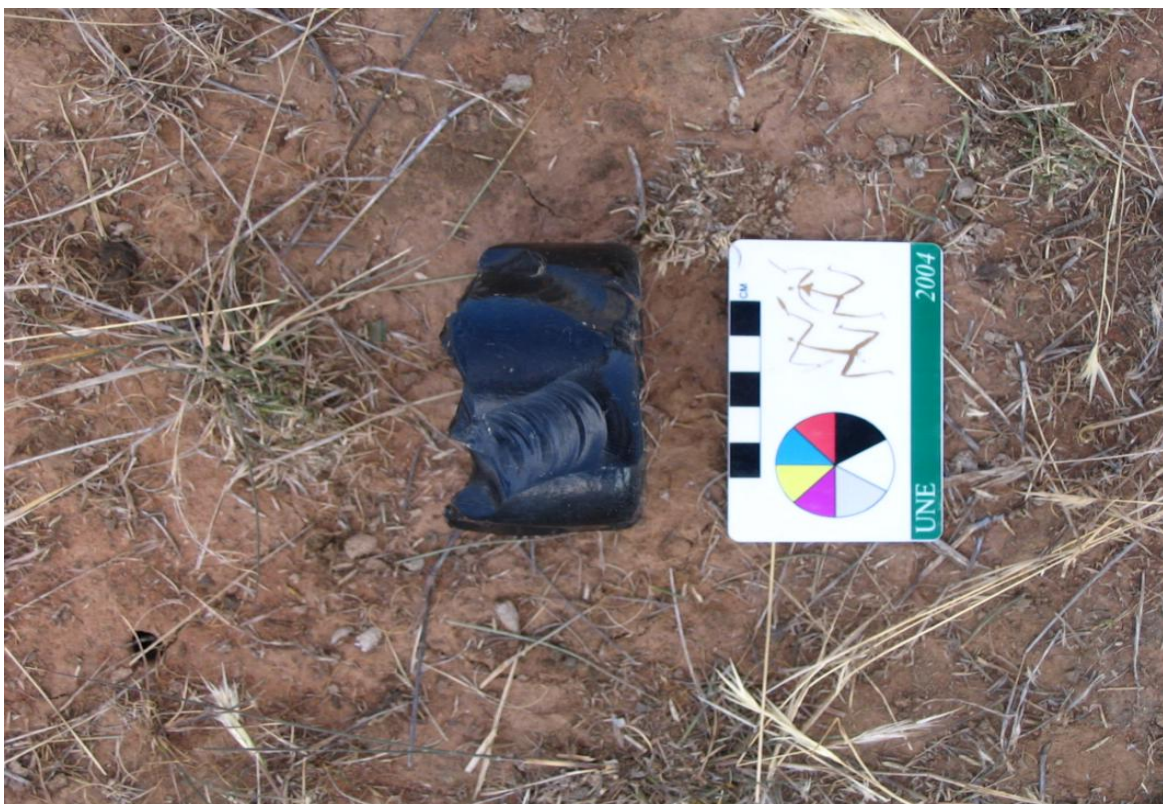
**PLATE 25**  
*Close up of glass bottle base core – MF3*
