B7 Reel Store Demolition verification noise report

Project B7 Reel Store Demolition
Client Opal ANZ Pty Ltd, Matraville

16002-NV-TN-9-0

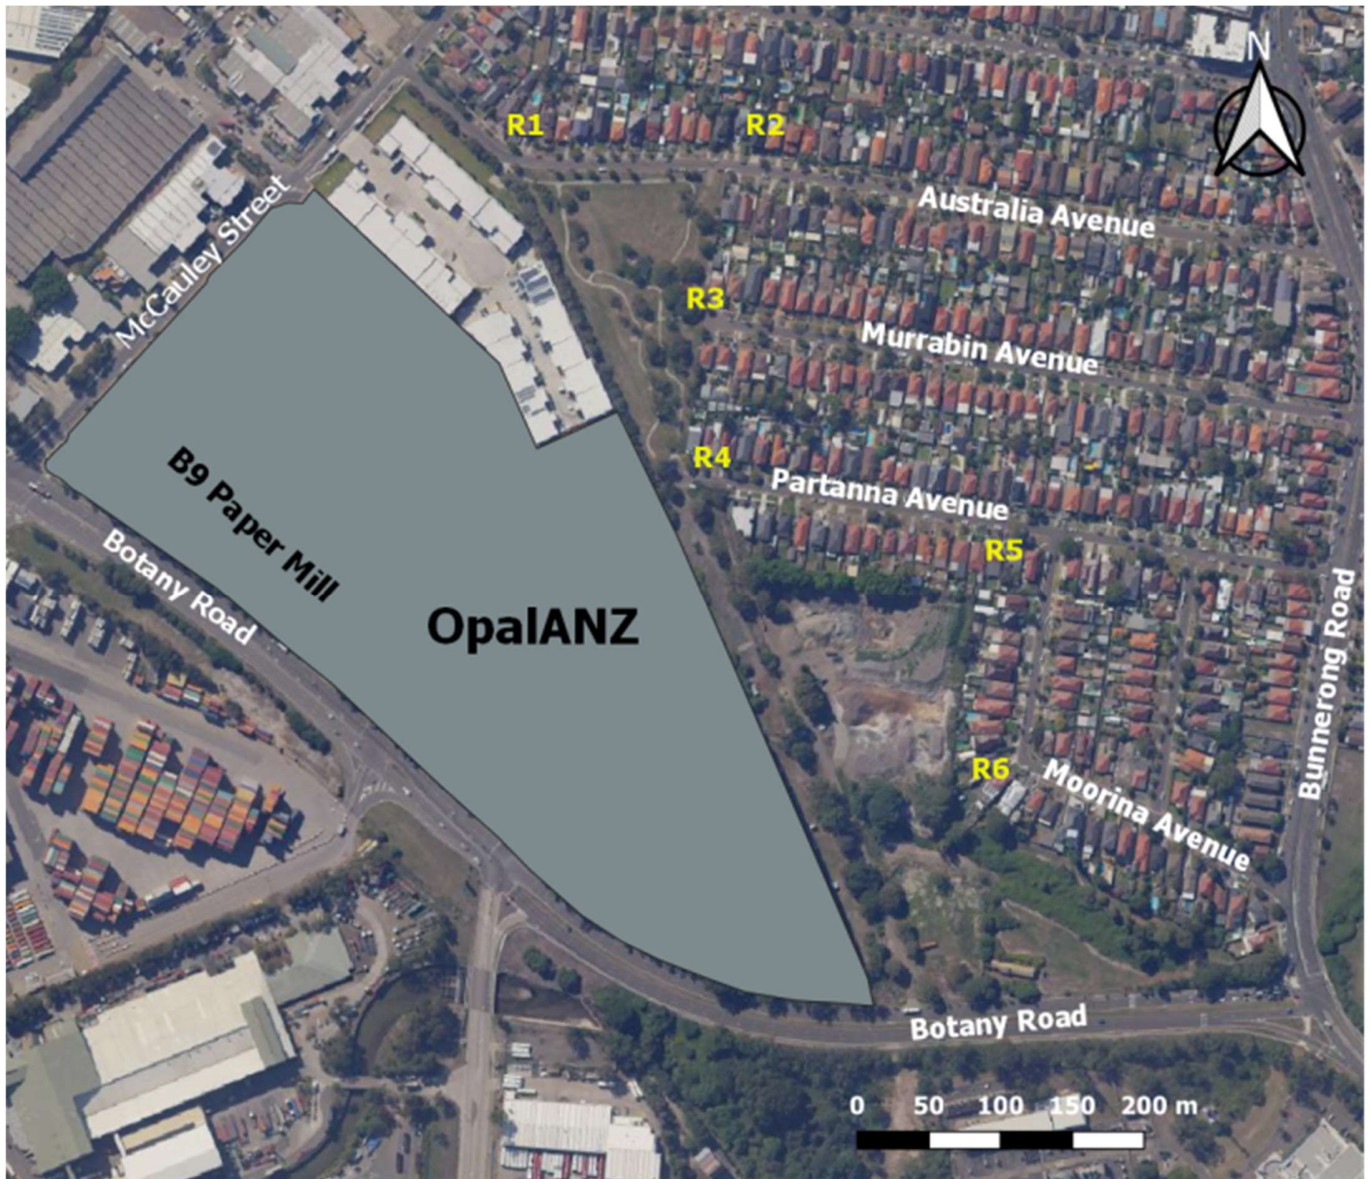
Figure 1 Site location and compliance monitoring locations

The monitoring locations and references are presented in Table 1 and shown in Figure 1. Recent changes to access at R3 means that this location is no longer available as a monitoring site.

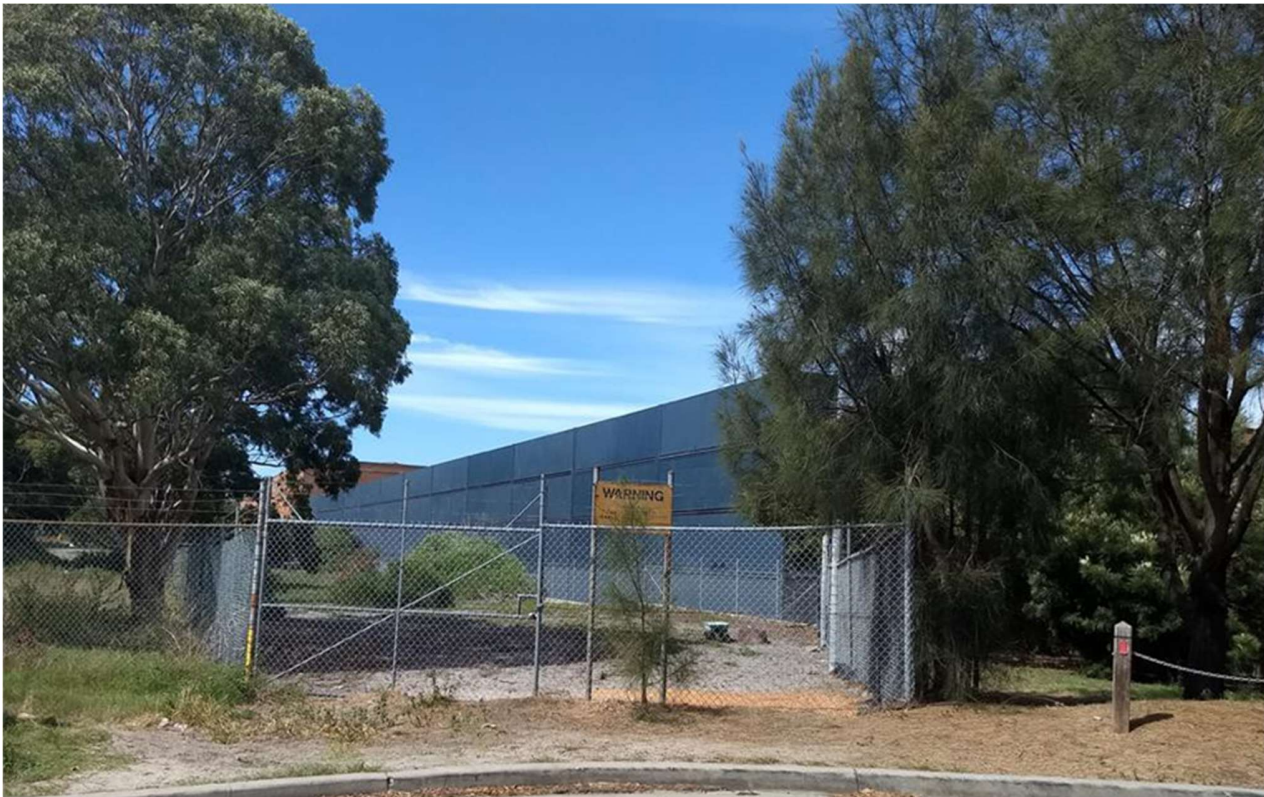
Figure 2 Paper mill (southern section) container noise wall - March 2018

Changes to the configuration of the boundary noise walls at the B7 paper machine and reel store buildings after each round of demolition are presented in Figure 2 to Figure 4 showing the scale and extents of the shielding at Partanna Avenue.

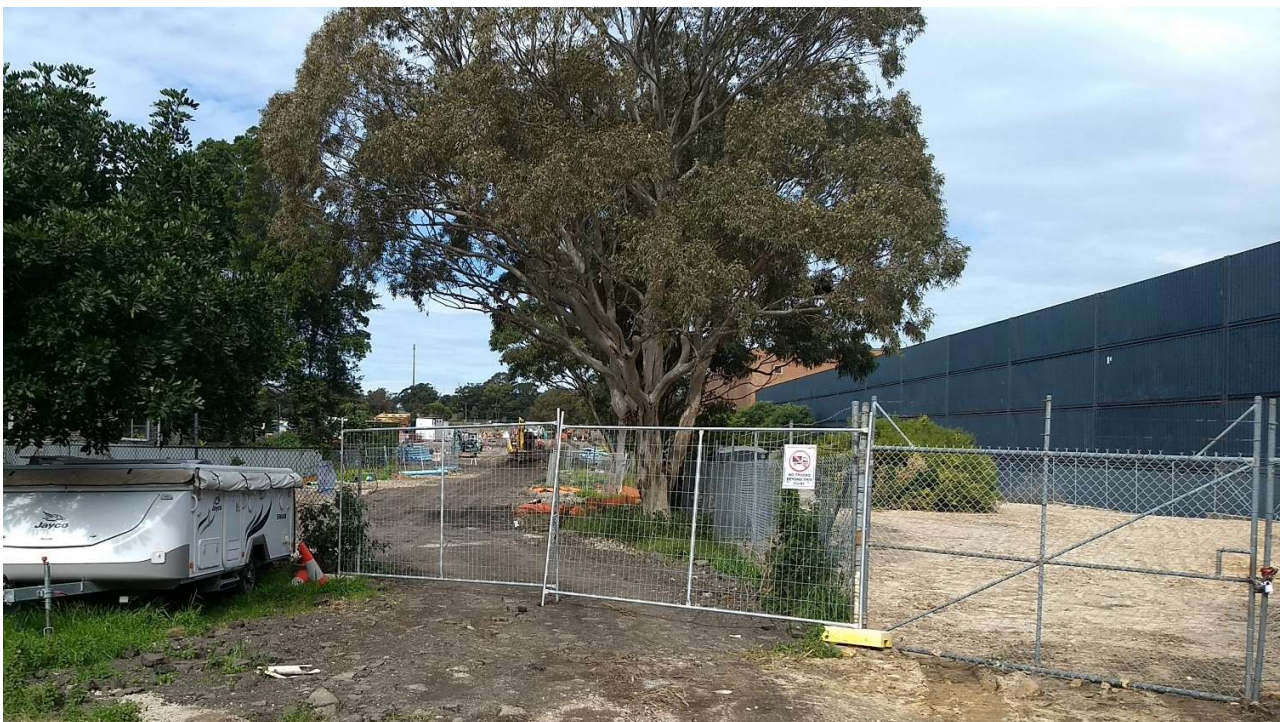
Figure 3 View of southern section of container noise wall following demolition of the B7 reel store - May 2020

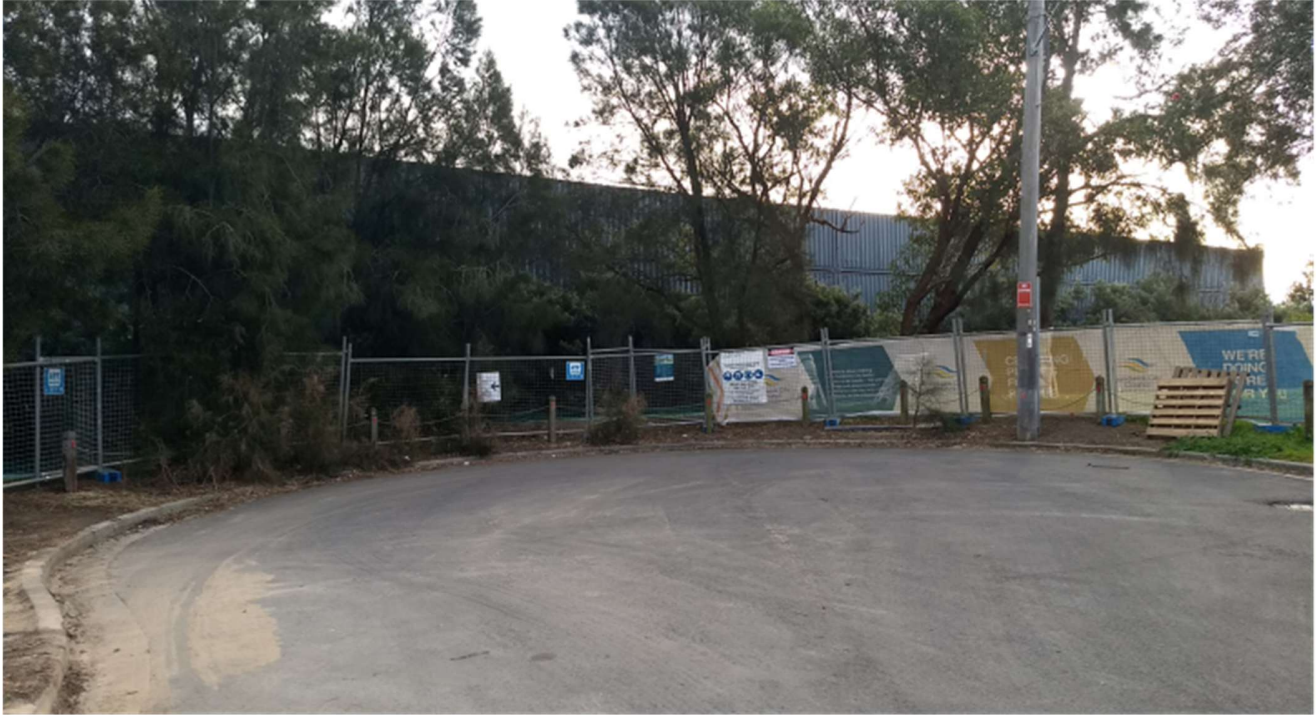
Figure 4 View of northern section of container noise wall following demolition of the B7 reel store - May 2020

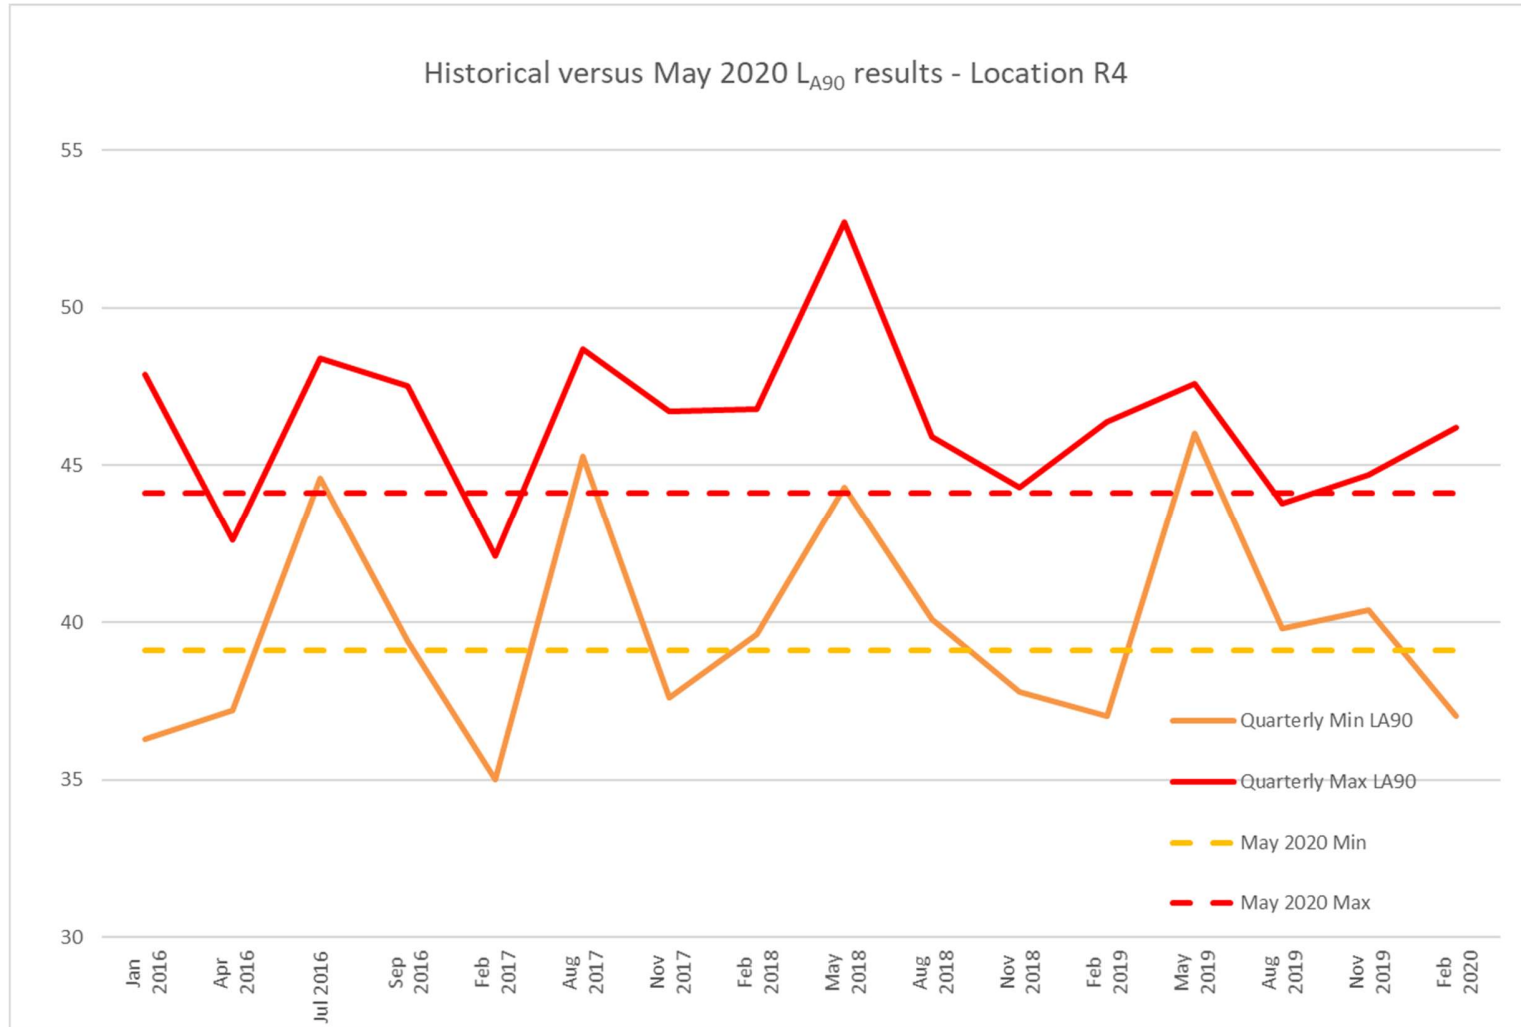
Appendix A1 Receiver R4 results

A summary of noise monitoring results for the receiver at R4 was completed in May 2020 and is presented in Table 3 for the day, evening and night time assessment periods. Data from Table 3 have been graphed to show the range of noise level measurements and are presented in Appendix A.
