Aquatic Monitoring Report: Autumn 2019 and Spring 2019

Tasman Coal Aquatic Monitoring Report Autumn 2019

Prepared for Donaldson Coal Pty Ltd

Spring 2019

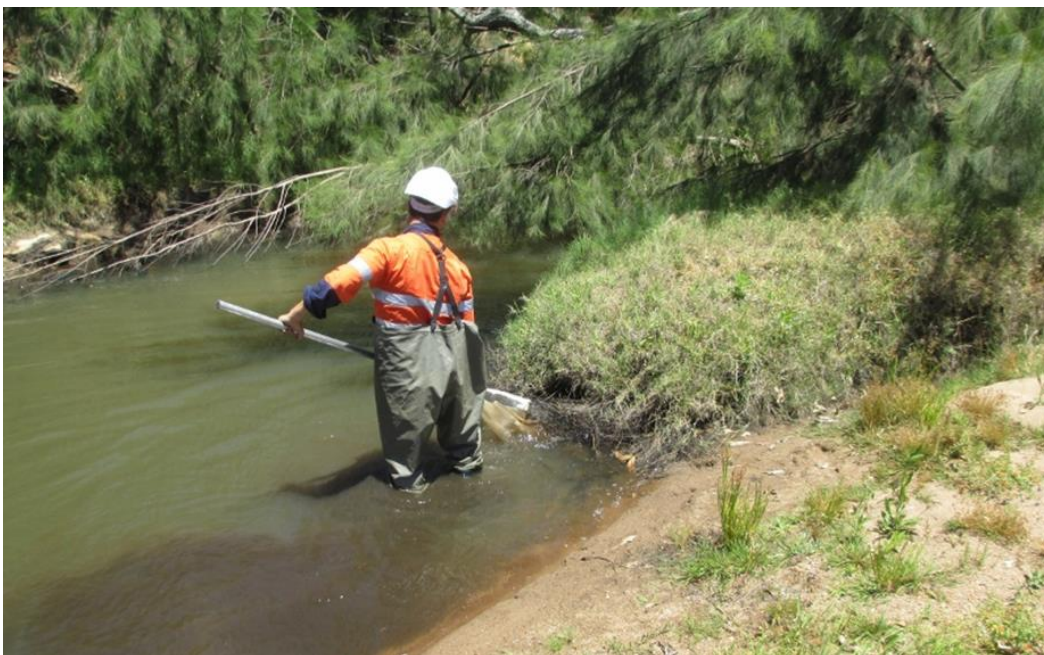
Plate 1: Sampling method – dip netting

Samples were collected from pool edges for a length of 10 metres, either as a continuous line or in disconnected segments. Sampling in segments was often undertaken to ensure the sampling of sub-habitats such as macrophyte beds, bank overhangs, submerged branches and root mats. Segmented sampling was also employed where pool length was short and it was logistically difficult to sample in a continuous line (e.g. in-stream logs). A 250 µm dip net was drawn through the water with short sweeps towards the bank to dislodge benthic fauna while scraping submerged rocks and debris, sides of the stream bank and the bed substrate (Plate 1). Further sweeps in the water column targeted the suspended fauna.

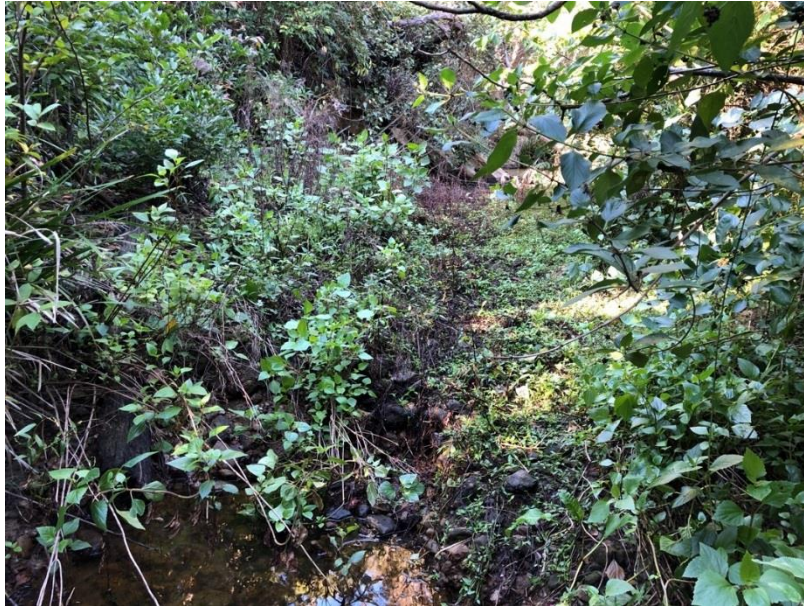
Plate 2. Blue Gum Creek at Stockrington Road.

The aquatic habitat of Blue Gum Creek at Stockrington Road (BGC@SR) (Plate 2) at the time of the Autumn 2019 monitoring surveys is detailed in Table 5.

Comments		Similar to previous sampling conditions, although water quality appears to have deteriorated and appears soupy.

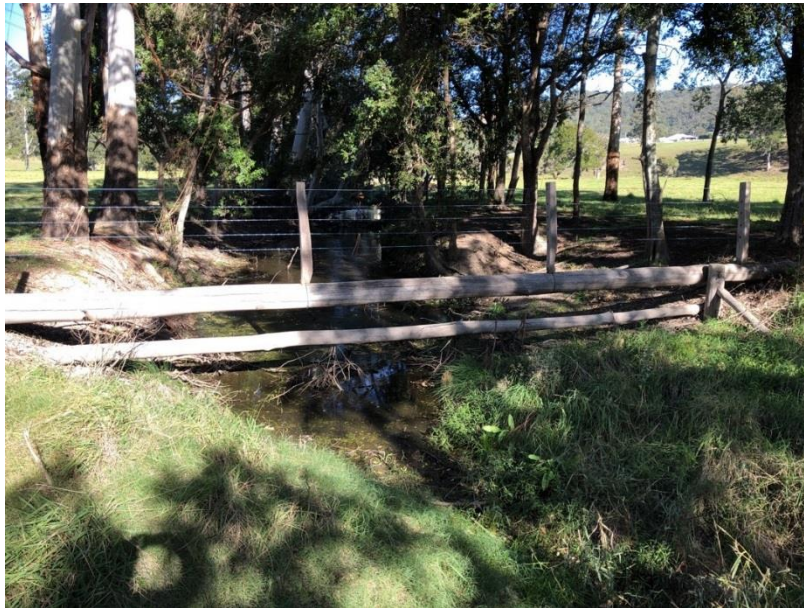
Plate 3. Blue Gum Creek at Dog Hole Bridge

The aquatic habitat of Blue Gum Creek at Dog Hole Bridge (BGC@DHB) (Plate 3) at the time of the Autumn 2019 monitoring surveys is detailed in Table 6.

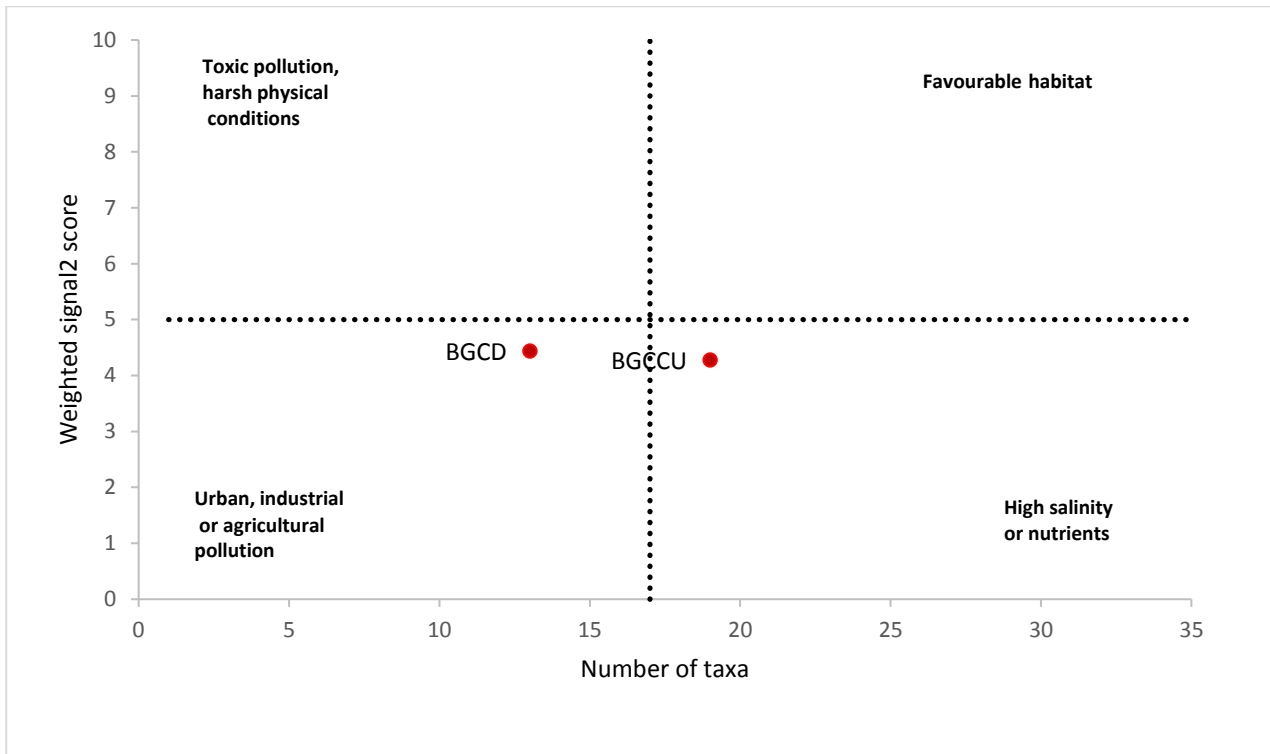
Figure 4. SIGNAL 2 Bi-plot

The sampling sites had a low- moderate diversity of macroinvertebrate families (13-19) (Table 8). SIGNAL2 and weighted SIGNAL 2 scores indicated that the sites had moderate pollution (~4 SIGNAL), with a dominance of pollution tolerant macroinvertebrate families. However, pollution sensitive mayflies Leptophlebiidae (SIGNAL 8) and caddis flies Leptoceridae (SIGNAL 6) were recorded at both sampling sites. Other sensitive species include beetle larvae Elmidae (SIGNAL 8) at Blue Gum Creek upstream site and Scirtidae (SIGNAL 6) at Blue Gum Creek downstream site. There has been an increase in SIGNAL 2 score since sampling in Spring 2018 (Table 9). The SIGNAL bi-plot (Figure 4) indicates that the downstream sites are potentially suffering from urban, industrial or agricultural pollution and upstream high nutrients or salinity.

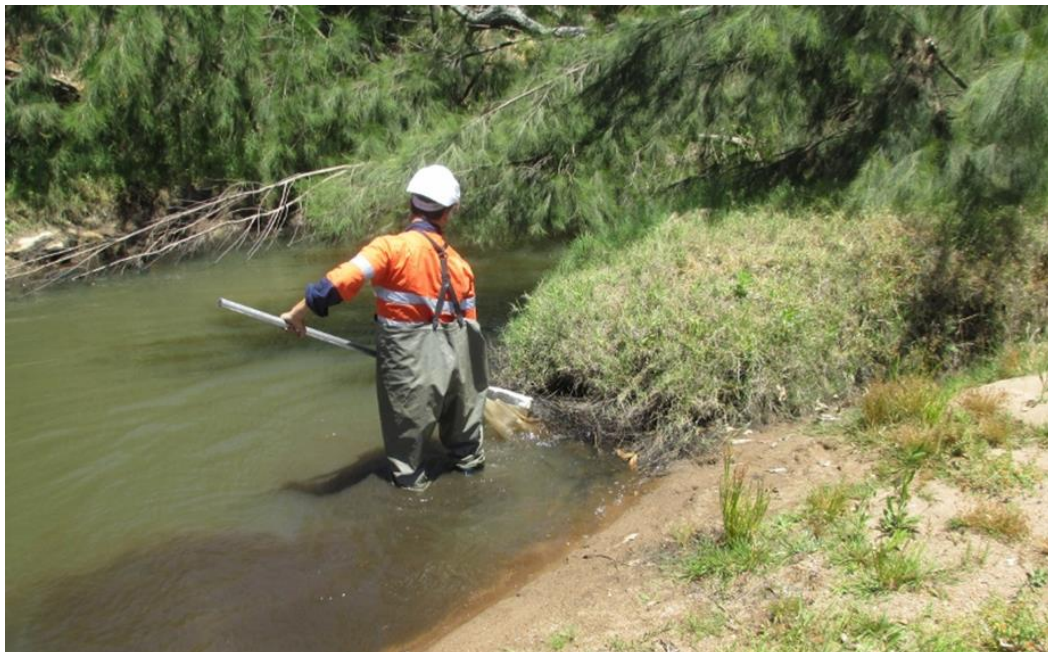
Plate 1: Sampling method

Samples of macroinvertebrates were collected from pool edges for a length of 10 metres, either as a continuous line or in disconnected segments. Sampling in segments was often undertaken to ensure the sampling of sub-habitats such as macrophyte beds, bank overhangs, submerged branches and root mats. Segmented sampling was also employed where pool length was short and it was logistically difficult to sample in a continuous line (e.g. in-stream logs). A 250 μm dip net was drawn through the water with short sweeps towards the bank to dislodge benthic fauna while scraping submerged rocks and debris, sides of the stream bank and the bed substrate (Plate 1). Further sweeps in the water column targeted the suspended fauna.

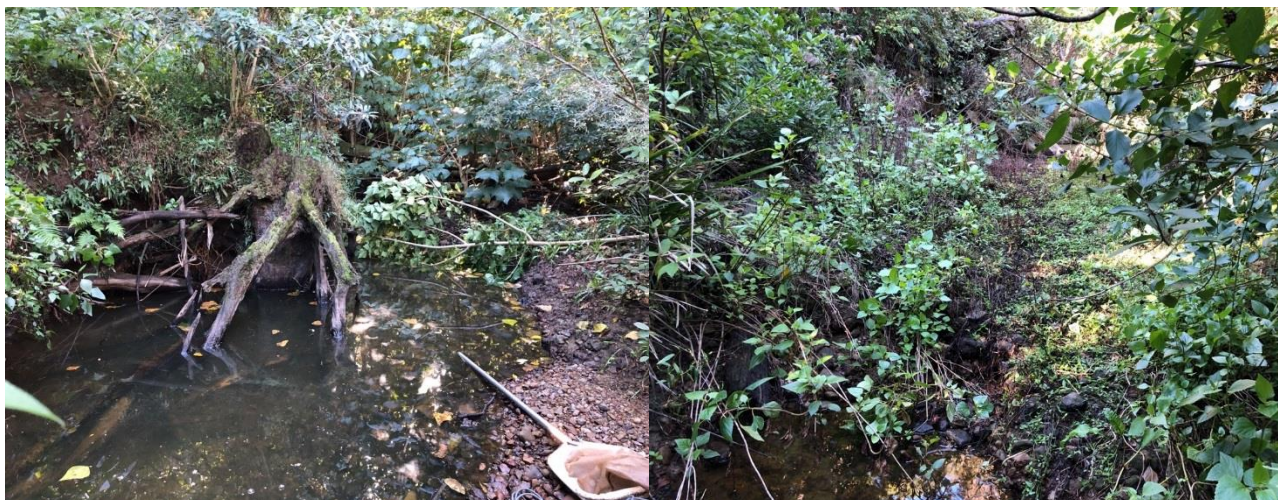
The aquatic habitat at Blue Gum Creek at Stockrington Road (Plate 2) at the time of the spring 2019 monitoring surveys is detailed in Table 5.

Blue Gum Creek at Stockrington (Downstream)

Blue Gum Creek at Stockrington (Upstream)

Comments		Similar to previous sampling conditions; although water quality seems to have improved slightly with clearer water and less algae. Evidence of sedimentation on dry banks and vegetation. Less algal growth than Autumn 2019 survey.

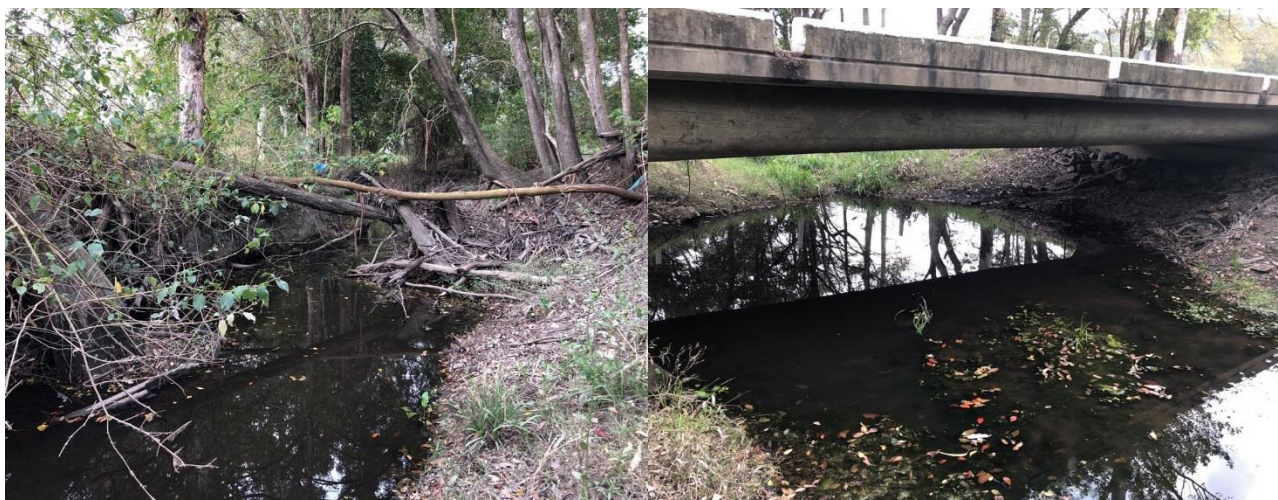
The aquatic habitat at Blue Gum Creek at Dog Hole Bridge (Plate 3) at the time of the spring 2019 monitoring surveys is detailed in Table 6.

Blue Gum Creek at Dog Hole Bridge (Downstream)

Blue Gum Creek at Dog Hole Bridge (Upstream)
