**DRAFT BEACH MANAGEMENT PLAN
FORESHORE RESERVE, KIOLOA BEACH**

**KIOLOA BEACH HOLIDAY PARK
LOT 128 DP 40869
MURRAMARANG ROAD
KIOLOA**

SEPTEMBER 2007

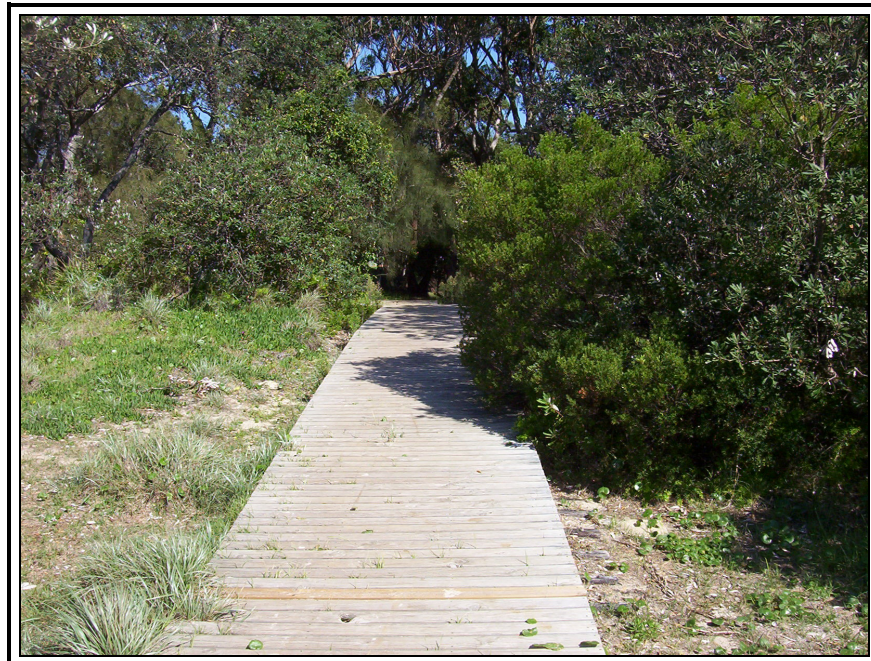
Area A is the most south-easterly site situated within the foreshore reserve. Two old walking tracks to the beach within this area have already been closed and revegetation has taken place. This area contains two existing boardwalks (one situated on the southern periphery of the area). (Refer **Plate 1**.)

Plate 1: View of existing timber boardwalk providing access to beach through dune area.

The main issue with this portion of the foreshore reserve is the spread / infestation of grass (kikuyu) as an understorey plant. As a result the native dune understorey vegetation has diminished.

- In order to minimise disturbance to a large section of the dunal system, it is proposed that the kikuyu infestation should be removed and revegetation should be undertaken. Small discrete areas within this area should be treated at any one time to prevent excessive disturbance to the dune system.

- Each area infested by kikuyu to be revegetated should be fenced off to preclude access prior to revegetation works commencing. Fencing should consist of 1200 mm high treated pine and rail / wire.

- The existing kikuyu grass cover is to be removed. A cover of either mulch or jute matting is to be placed over the area to be revegetated.
- The affected area is to be revegetated using a combination of colonising plants such as *Isolepis Nodosa*, *Juncus spp.* or *Lomandra longifolia* *Acacia sophorae*, *Leptospermum laevigatum*, *Banksia integrifolia* and *Leuopogon parviflorus*. Plants are to be planted on a one (1) metre centre grid basis.

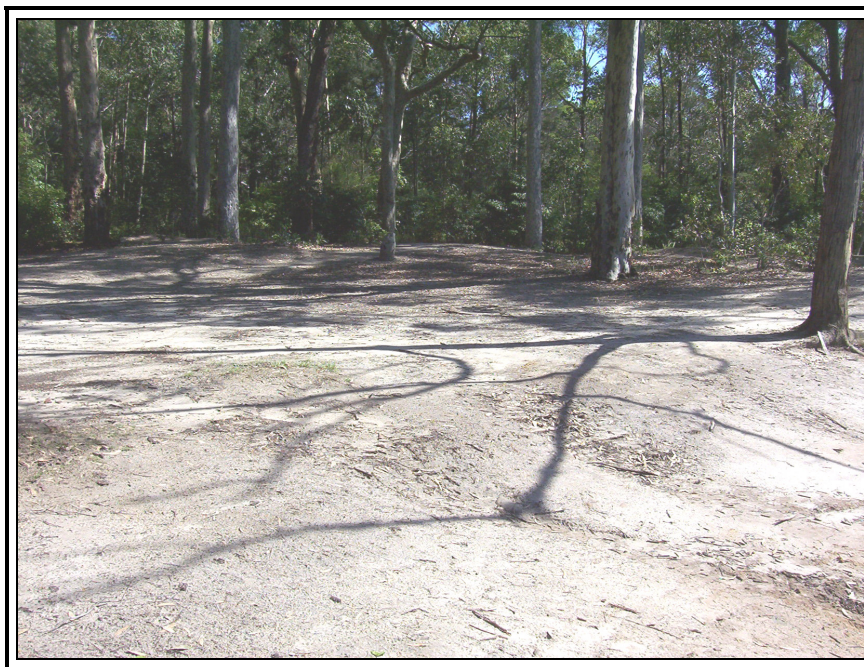
This is the area between the northern boundary of the Kioloa Beach Holiday Park and Butlers Creek. During summer, the area is heavily used as a car park and pedestrian access way for people going to Kioloa Beach. The area is also used for parking by some patrons of the Kioloa Beach Holiday Park.

There are many dirt vehicle tracks near the creek, and it appears that people use the area for wheel spins and other unsafe and damaging driver behaviour. It should be noted that this area is used by the broader general public; and not solely patrons of the Holiday Park. Uncontrolled vehicle and pedestrian access has lead to vegetation damage, soil compaction and soil erosion (refer **Plate 2**). There is poor access for pedestrians with low levels of mobility and those with children in strollers.

Plate 2: View of “Northern Car Park” area adjacent to Kioloa Beach Holiday Park. Note compacted ground denuded of vegetation.

This area has become largely denuded of vegetation, compacted and is experiencing soil erosion.

- In order to rationalise vehicle tracks through this area it is proposed that treated pine bollards and rail / wire fencing (1200 mm) high) be placed directly across the reserve in the location shown of **Figure 1**. This would preclude vehicle access to that portion of this reserve which has suffered from uncontrolled vehicle access.

- Once the area has been fenced off, the denuded compacted areas should be lightly tilled to break up the compacted top soil without mixing the lower clay soils into the topsoil.

- This area is then to be mulched, and left for natural vegetation regeneration of this area to occur.
- On-going monitoring is to be undertaken to eradicate weed growth as it occurs.

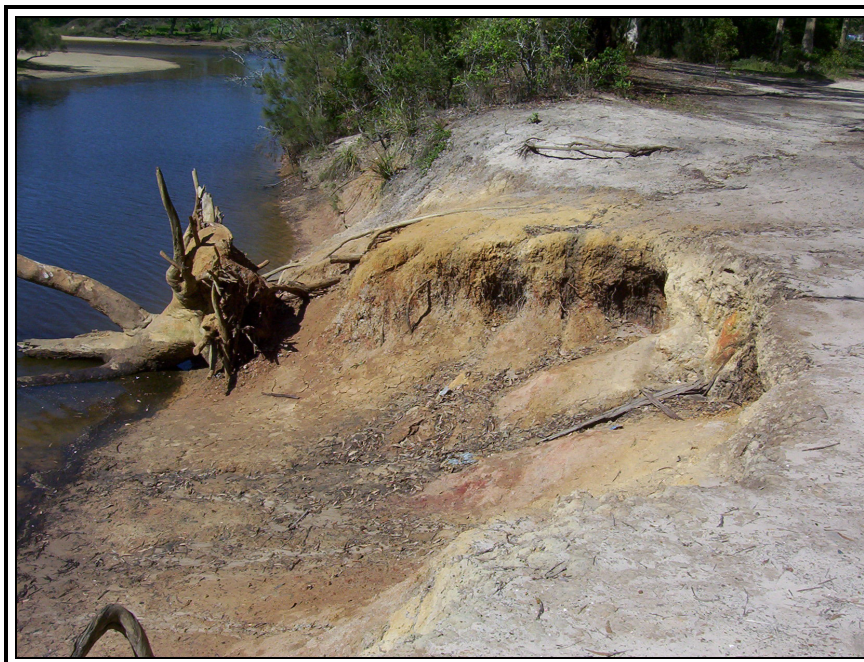
In the northern part of the reserve there is a section of the bank of Butlers Creek that is undergoing unnatural erosion (refer **Plate 3**). This has been caused by swimmers climbing up the bank from the creek. A rope swing was attached to a dead tree at this location but it has been removed. The tree has now collapsed into the creek

Plate 3: View of eroded bank along Butler Creek.

- The eroded portion of the bank is to be fenced off to prevent access to the public. Fencing should consist of 1200 mm high treated pine and rail / wire.

- A small earth berm is to be placed above this section of the bank to redirect surface runoff away from the eroded site.
- The tree that has collapsed into the creek is to be retained to provide a marine habitat.

- The eroded bank of the creek is to be re-shaped to create a gentle batter (3 horizontal: 1 vertical). This batter slope is to be topsoiled and mulched.

- The area is to be revegetated using a combination of colonising plants such as *Lomandra longifolia*, *Acacia sophorae*, *Leptospermum laevigatum*, *Banksia integrifolia* and *Leuopogon parviflorus*. Plants are to be planted on a one (1) metre grid basis.

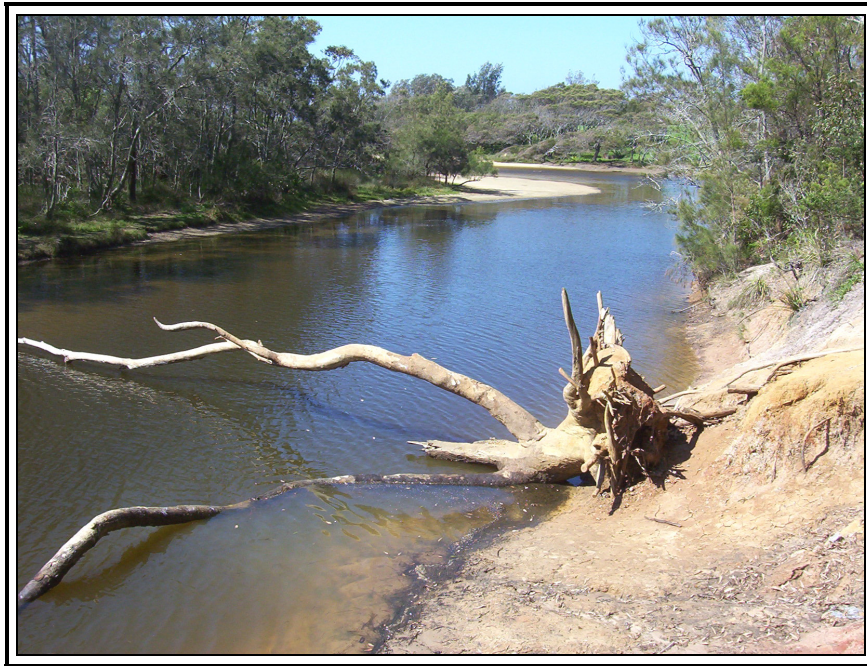
(refer **Plate 4**). Revegetation of creek bank and diversion of storm water away from eroding area would be appropriate.

Plate 4: View of tree that has collapsed into creek.
