**REPORT ON  
GEOTECHNICAL  
AND ACID SULFATE  
CONDITIONS**

**HEXHAM SWAMP**

**ROBERT CARR  
& ASSOCIATES  
PTY. LTD.**

**Report No. 928**

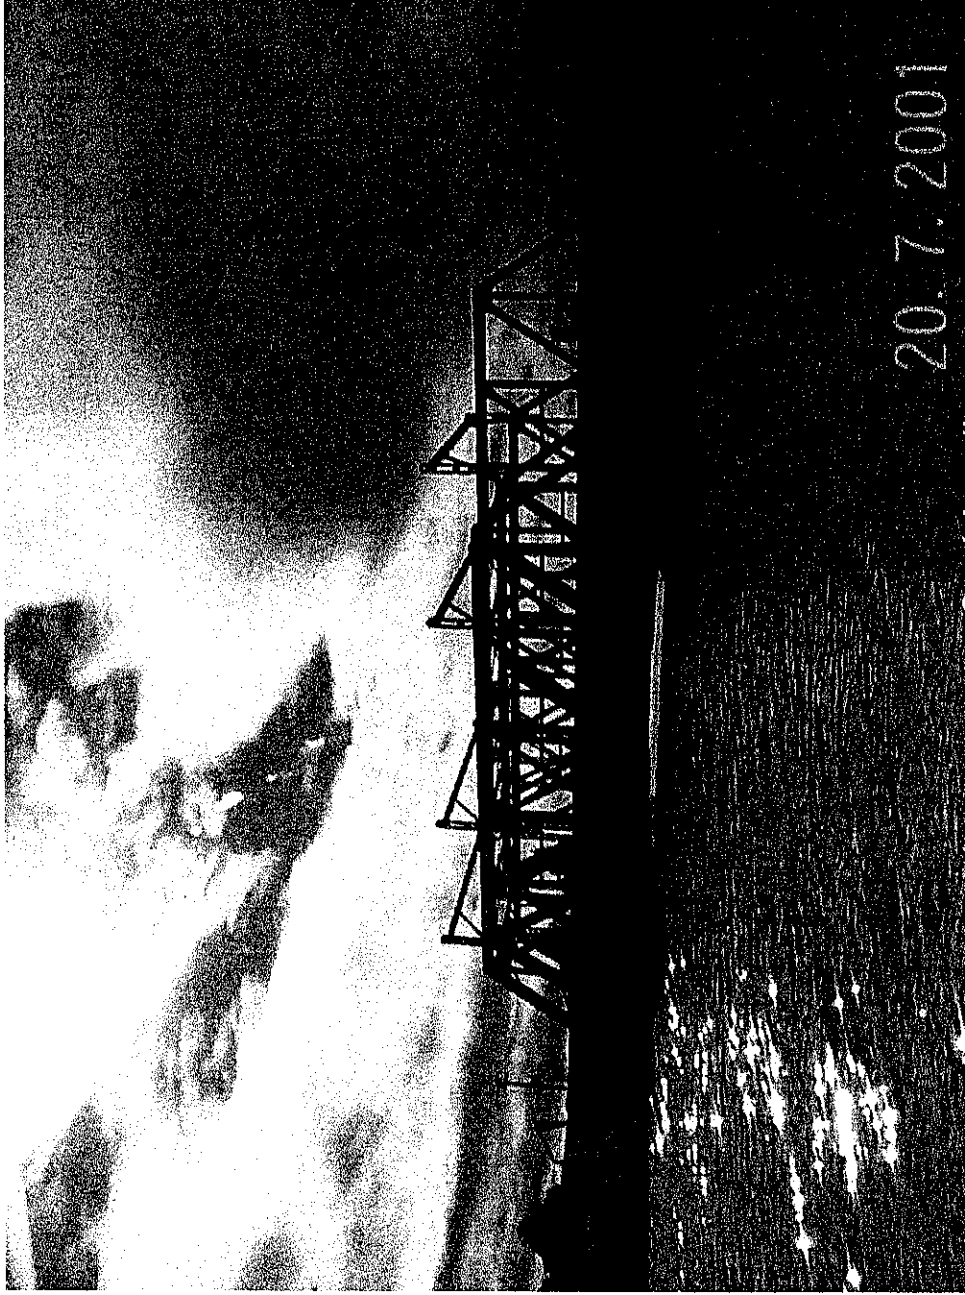
**PHOTOGRAPH – No. 1. Upstream view of coal line rail bridge.**
