# **Aboriginal Cultural Heritage and Archaeological Assessment – Proposed Relocation of 500 kV Electricity Transmission Line, Mangoola Coal**

**Umwelt (Australia) Pty Limited**

**Xstrata Mangoola and TransGrid**

| Report No. | 2497/R13/Final | Date: | December 2010 |

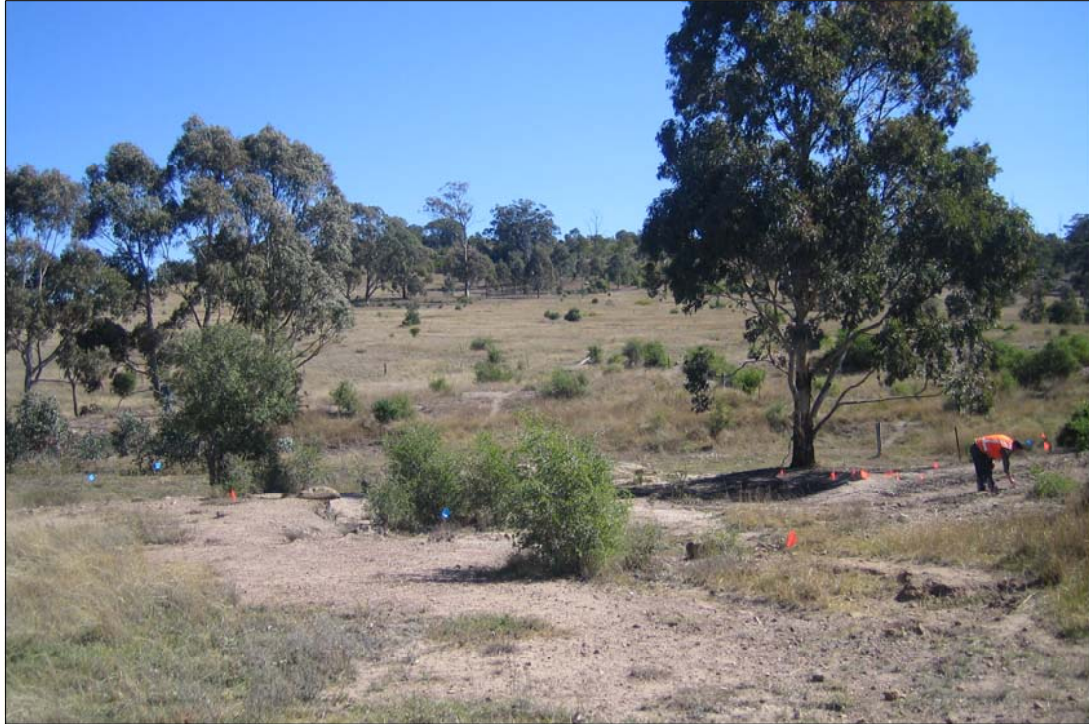
PLATE 1  
SC56 northern perspective over site

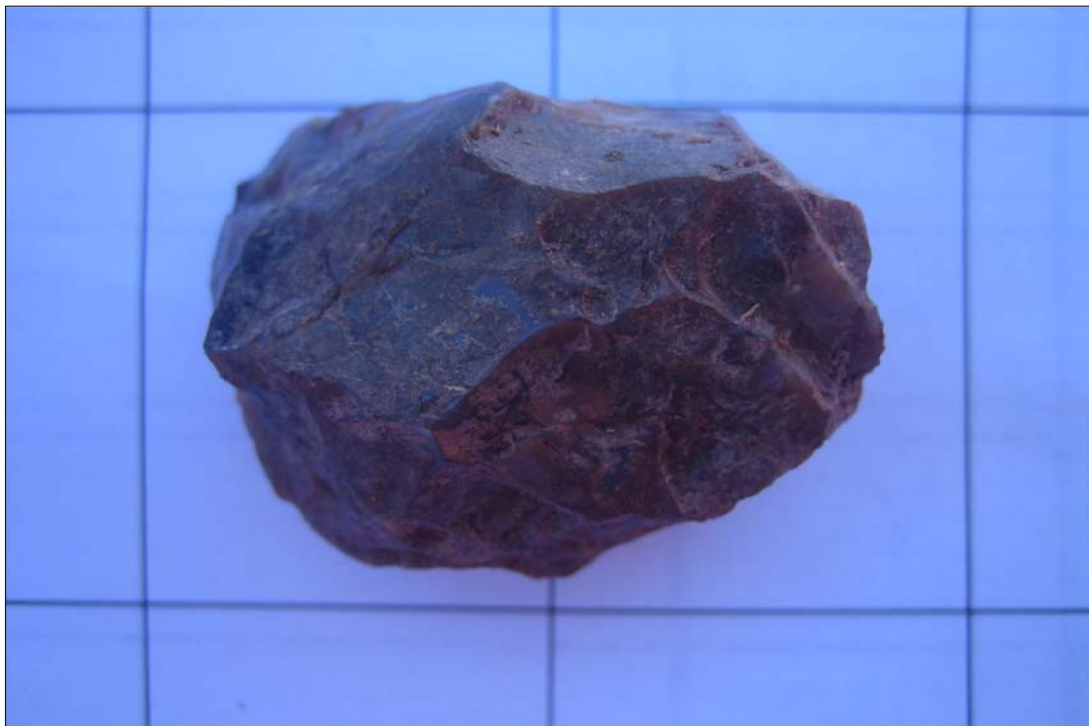
PLATE 2  
SC56 silcrete core

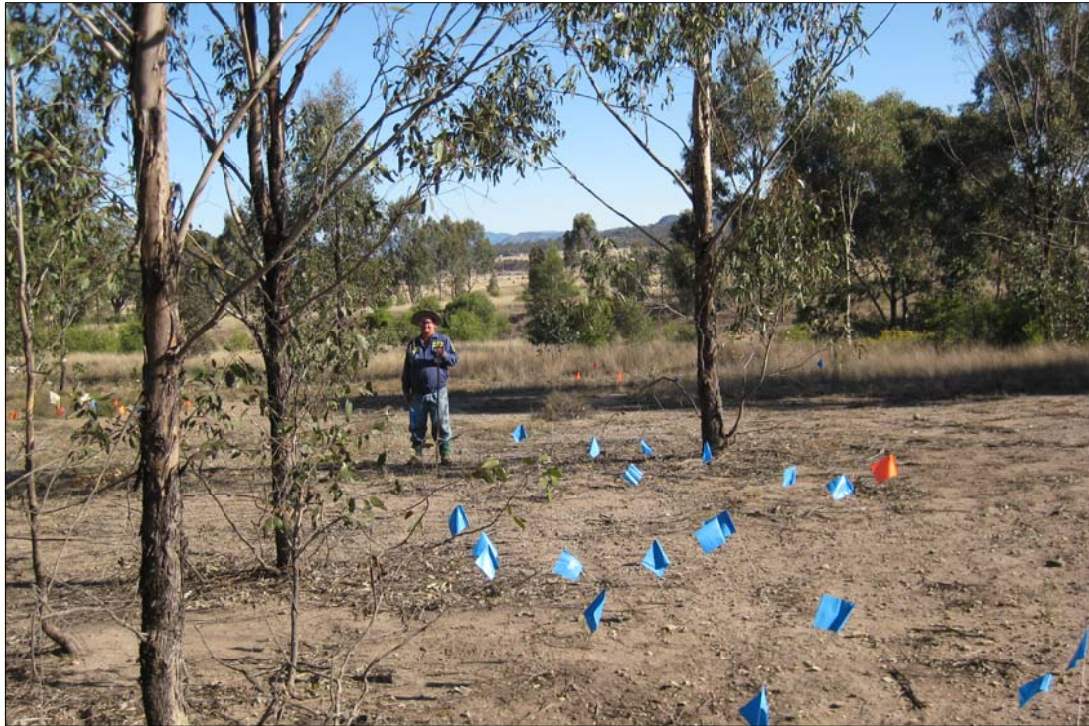
PLATE 3  
SC57 artefact scatter indicated by flags  
Eastern perspective

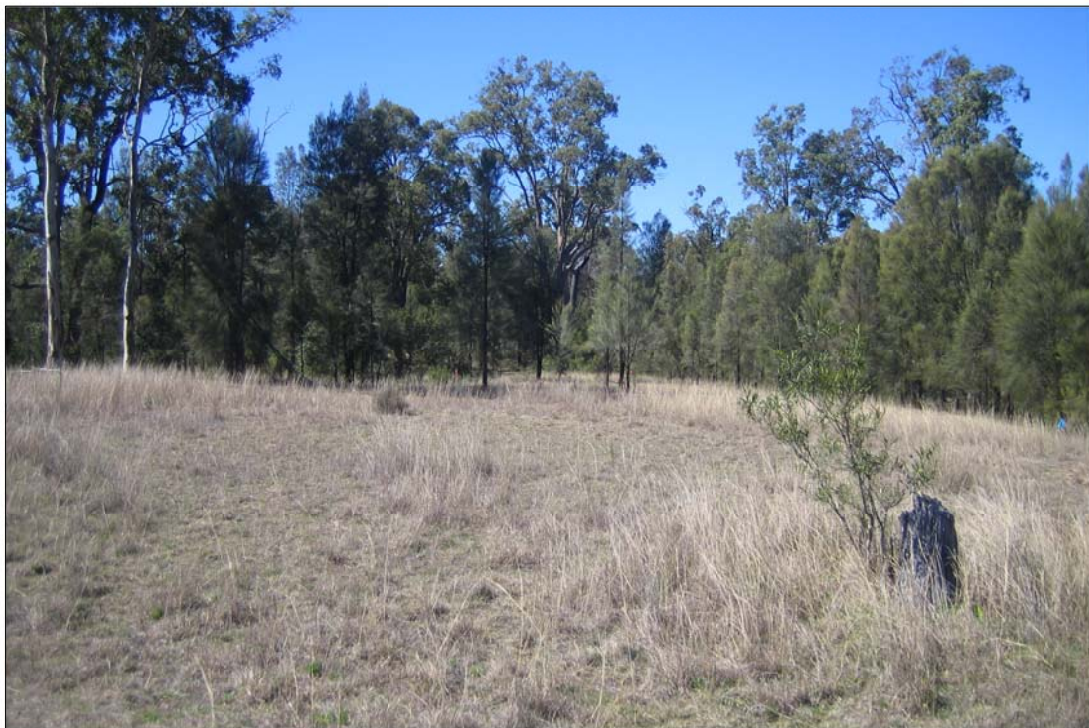
PLATE 4  
BFC72 eastern perspective over site

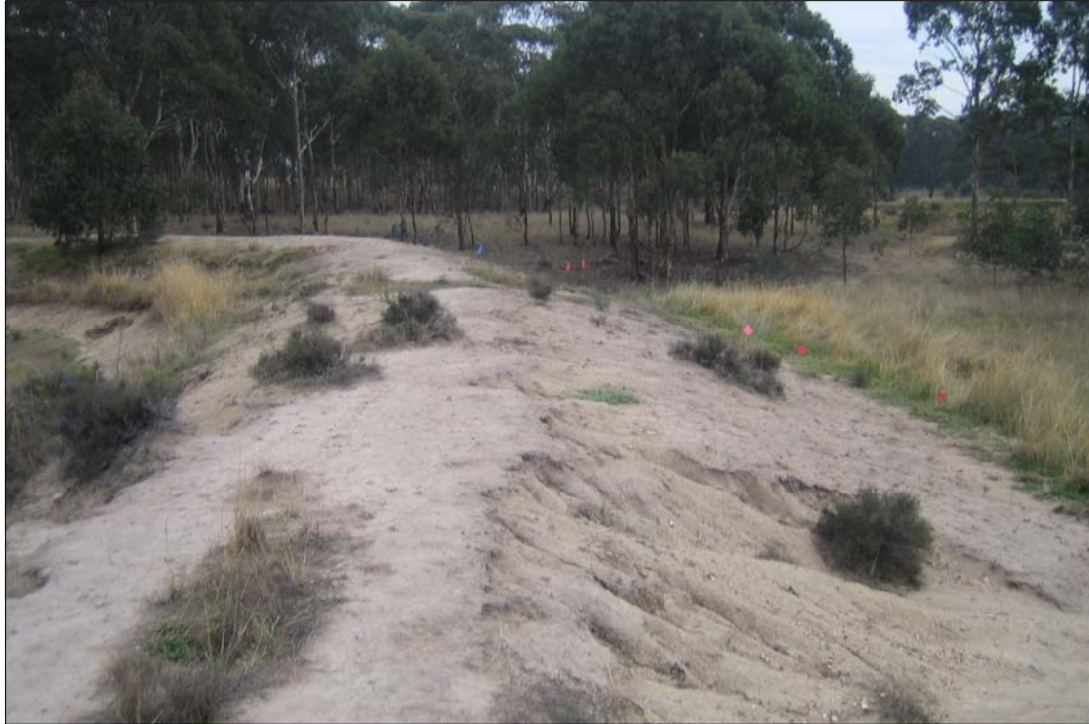
PLATE 5  
BFC75 site on bank of dam

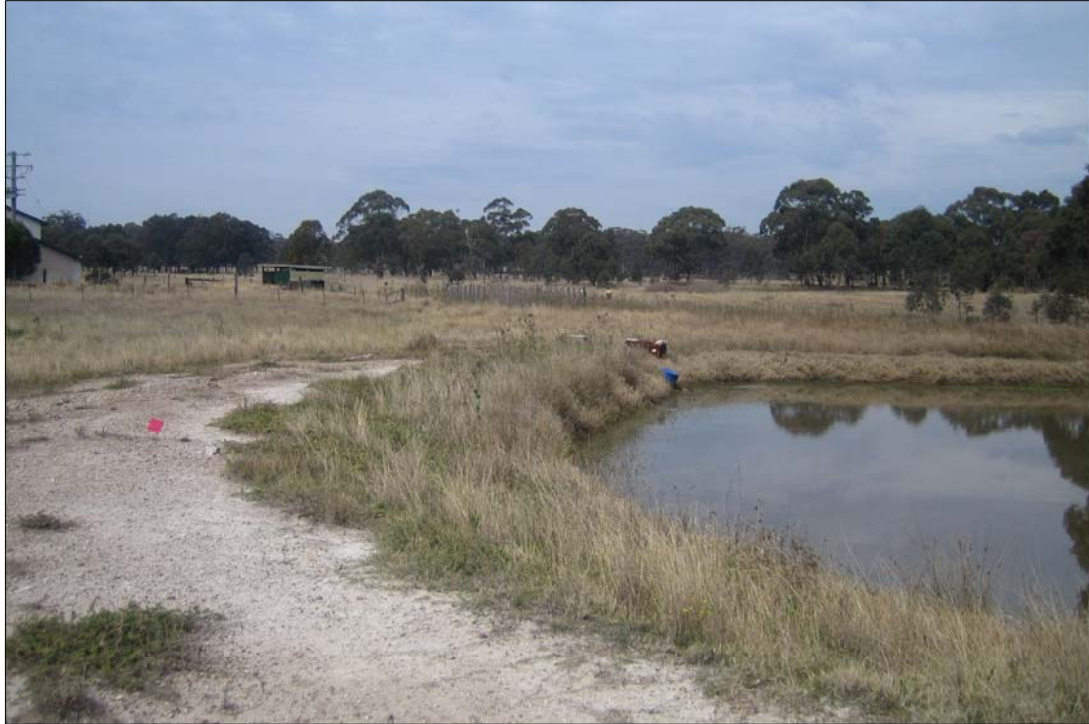
PLATE 7  
BFC79 site on bank of dam

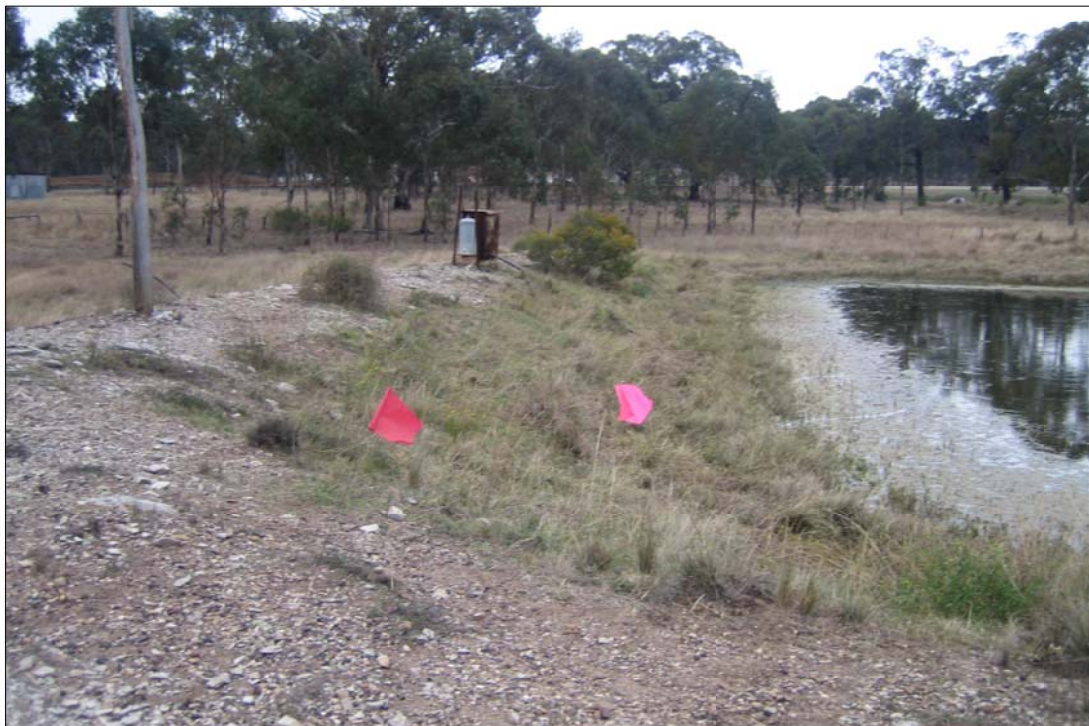
PLATE 8  
BFC85 site on bank of dam

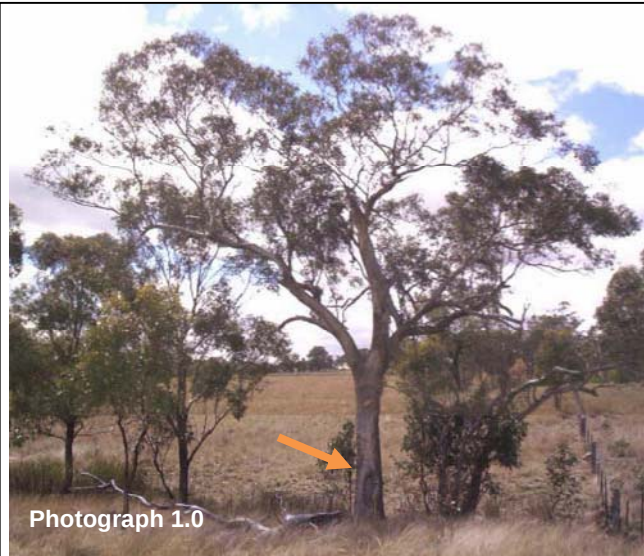
Photograph 1.0

**Photograph 1.0** View to east of Tree 1 / BFC88 *Eucalyptus moluccana* Roxb. – Grey Box, with wound on lower trunk from surveyor's blaze indicated by arrow.

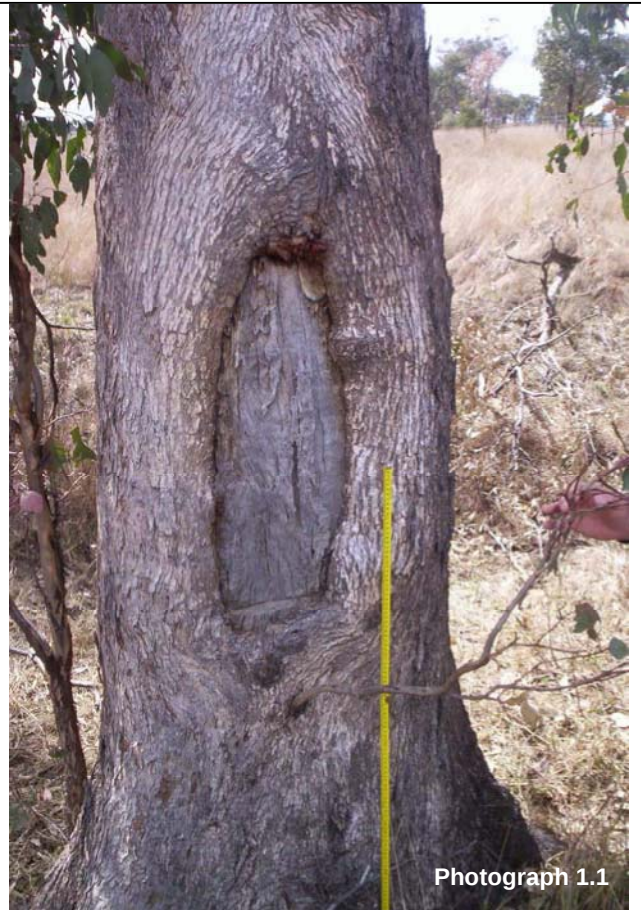
Photograph 1.1

**Photograph 1.1** View to east of Tree 1 with surveyor's blaze on west side of lower trunk shown with folding ruler extended to 1 m.

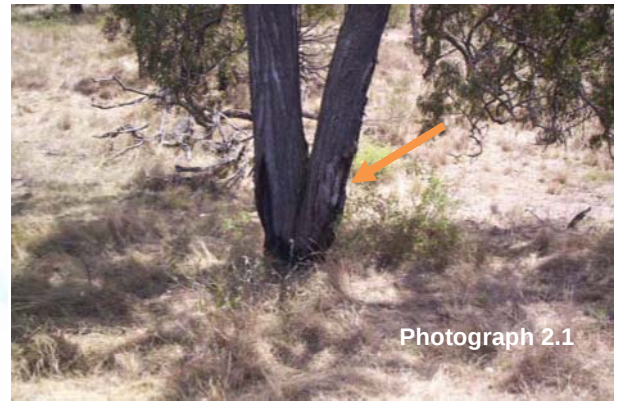
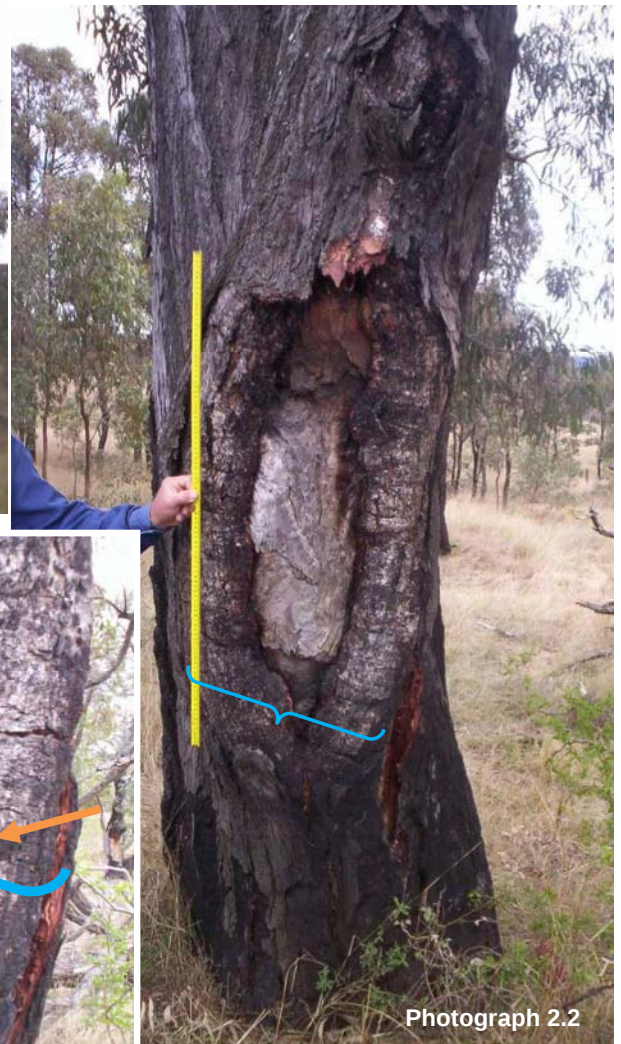
**Photograph 2.0** View to southwest of Tree 2 / BFC86 *Eucalyptus crebra* F. Muell. – **Narrow-leaved Red Ironbark**, arrow indicated location of Wound 1 at base of an inferior first order structural branch.

**Photograph 2.1** View to northwest of Tree 2, showing the 2 first order structural branches, 1 inferior (right) with arrow showing location of Wound 1 at base of an inferior first order structural branch.

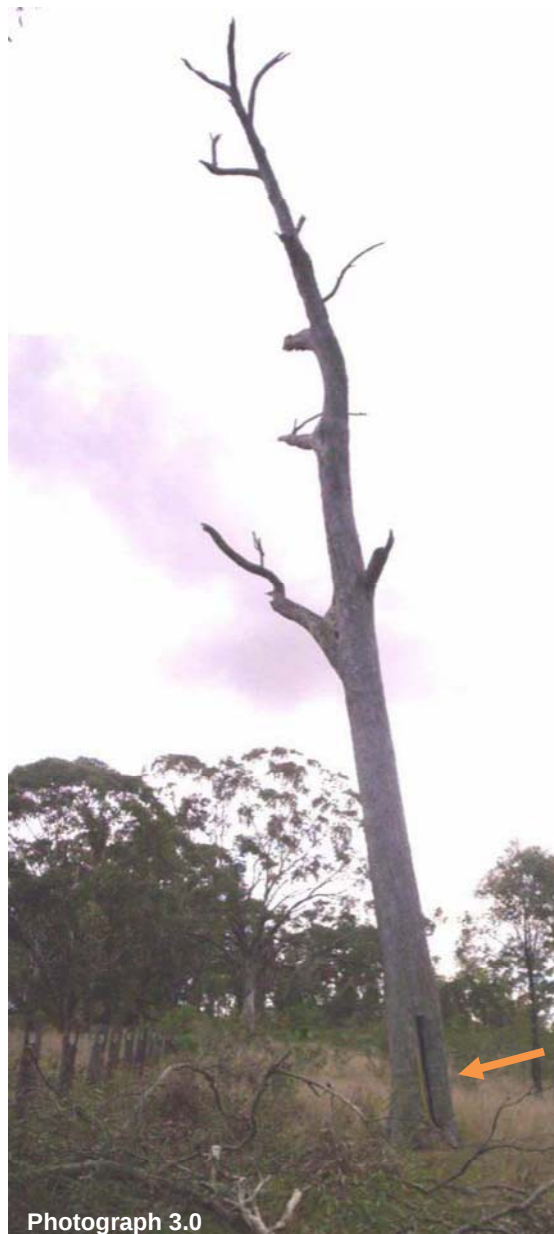
Photograph 3.0

**Photograph 3.0** View to north of Tree 3 / SC59 *Eucalyptus crebra* F. Muell. - **Narrow-leaved Red Ironbark**, arrow showing location of Wound 1 with retractable ruler (left of wound) extended to 1 m.

The mass of the trunk above the wound will continue to have loading impact and could be reduced to a stump to 2 m above the wound preserving that wood and reducing the loading on the tension side where the wound provides weakness as a notch. The area of soil around the wound could be treated for termites and the wood protected within a shelter and treated with fungicide to assist in its preservation.

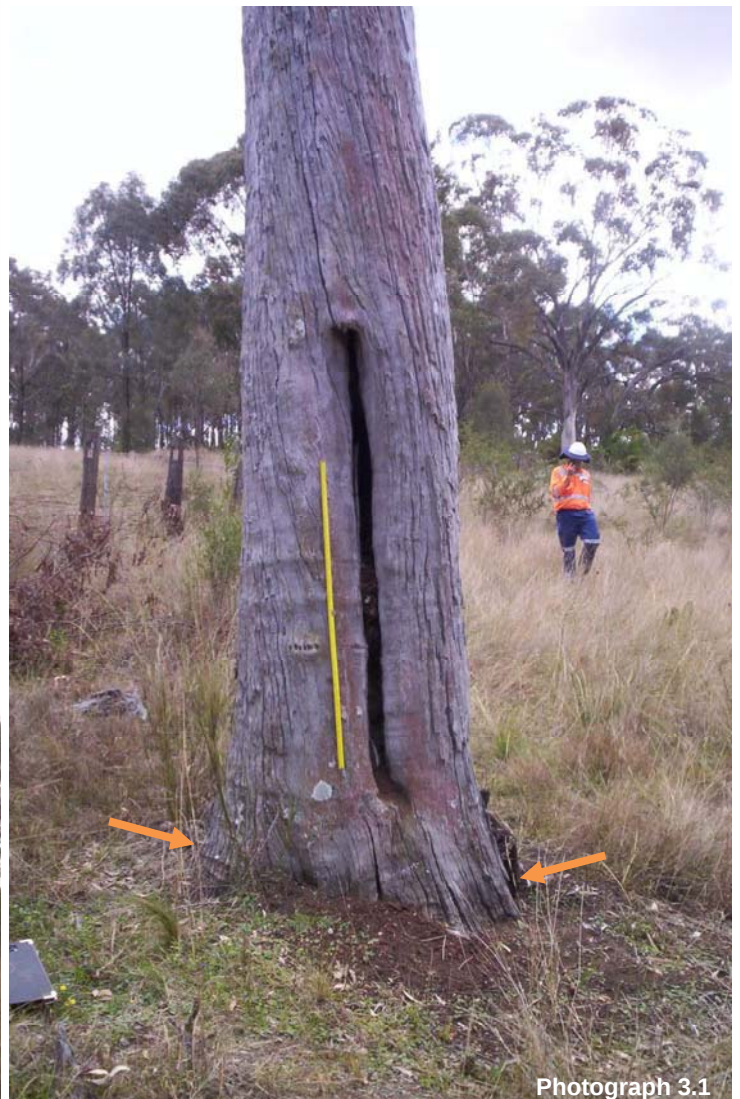
Photograph 3.1

Narrow linear, symmetrical, lower trunk to S, extending from 280 – 1900 mm and 70 mm at widest at 14000 mm (see Photograph 3.1). Wound face absent extending to hollow with humic mud evident at wound base. Margins entire, apex and base acute. Depth of margins: right 290 mm and left 170 mm. Width of margins: right 100 mm and left 130 mm. Trunk is slightly leaning to N and the wood on the side of the wound subject to tension with the fibres stretched and the bark generally thin and the area flat in its location between two root buttresses (Photograph 3.1).

**Photograph 3.1** View to north of Tree 3 / SC59 showing Wound 1 with retractable ruler extended to 1 m. Arrows indicate location of root buttresses.
