CENTENNIAL COAL
Angus Place
2024 ANNUAL REVIEW

March 2025

Name of Operation	Angus Place Colliery
Name of Operator	Centennial Angus Place Pty Limited
Development Consent/ Project Approval #	MP06_0021
Name of holder of Development Consent/ Project Approval	Centennial Angus Place Pty Limited
Mining Lease #	CCL704, ML1424, ML1699, ML1720, ML1853, ML1326, (part - Springvale) EL6856, EL6293, EL7415, EL8188.
Name of Holder of Mining Lease	Centennial Springvale Pty Limited and Boulder Mining Pty Ltd
Water License #	WAL36445; WAL36449; WAL37340; WAL37343; WAL41881
Name of Holder of Water License	Centennial Angus Place Pty Limited
RMP Start Date	July 2022
RMP End Date	NA
Annual Review Start Date	1 January 2024
Annual Review End Date	31 December 2024

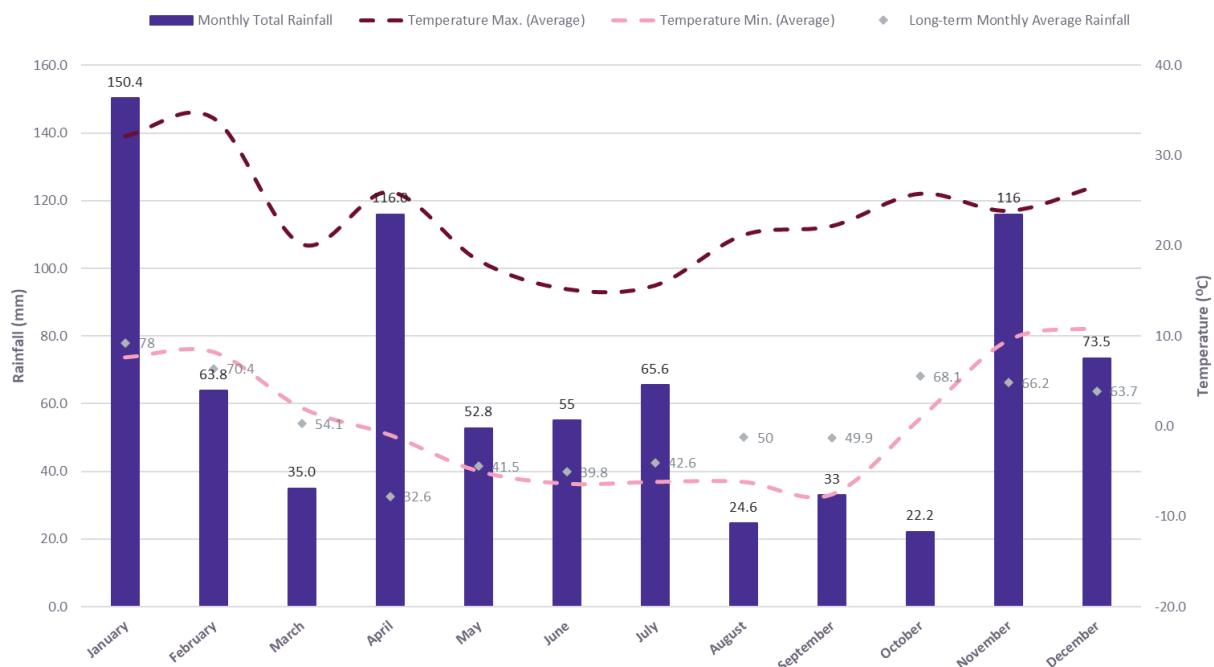
Figure 6-1: Summary of Meteorological Conditions

Figure 6-1 summarises meteorological conditions at Angus Place during the reporting period.

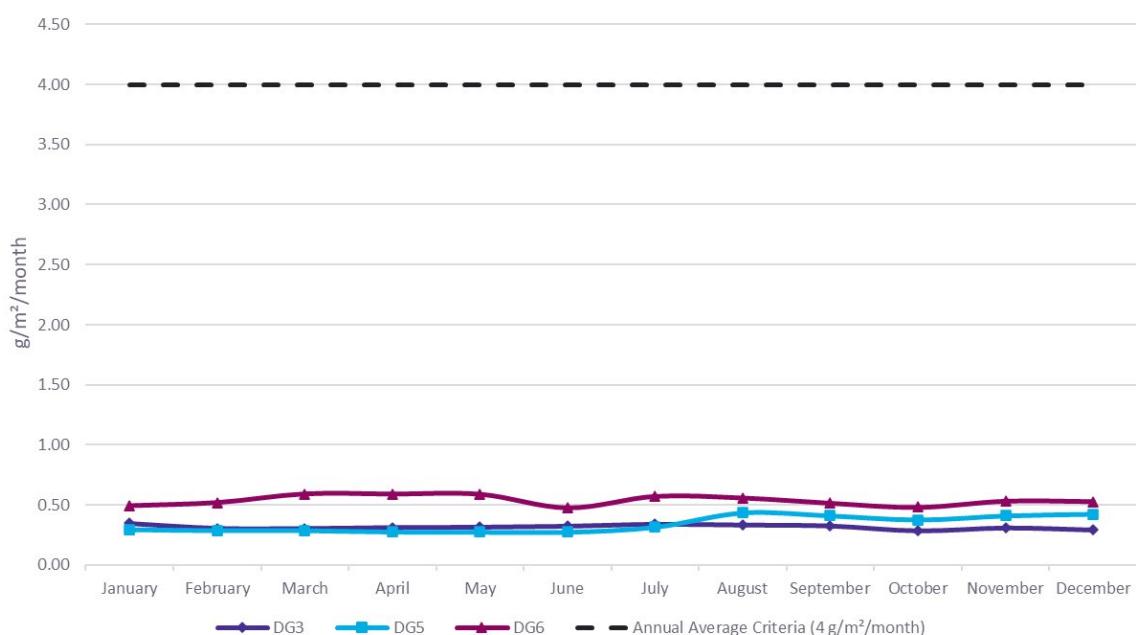
Figure 6-3: Dust Deposition Summary for 2024 (Rolling 12 Month Average)

Monitoring Point Reference	Description	Insoluble Solids (g/m ² /month)		
		2024 Annual Average	Criteria ^{1,2} Max Increase in Deposited Dust	Criteria ¹ Max Total Deposited Dust (Annual Average)
DG3 (onsite)	Dust Deposition Gauge ³	0.29		
DG5	Dust Deposition Gauge ⁴	0.43	2.00	4.00
DG6	Dust Deposition Gauge ⁵	0.53

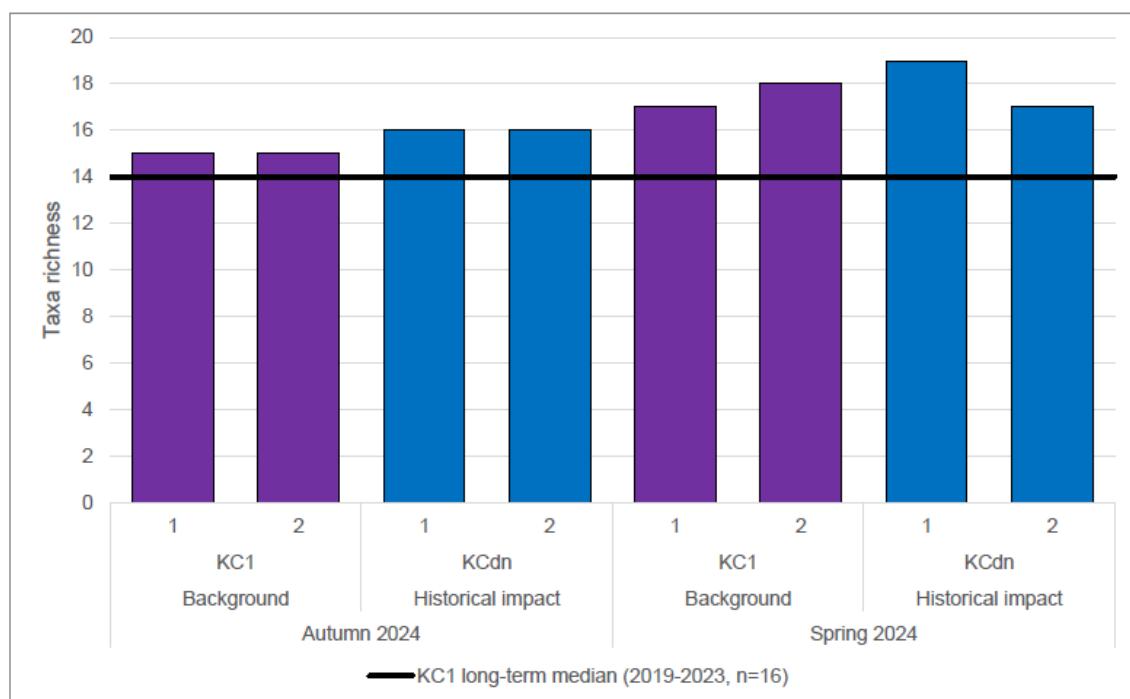
Figure 6-6: Taxa richness in Kangaroo Creek samples (2024)

Overall, the results of 2024 aquatic ecology monitoring indicate that the macroinvertebrate community of Kangaroo Creek (and the decommissioned LDP1) and the Coxs River downstream of LDP2 were in a generally good condition, with similar results for all metrics observed between the historical impact (KCdn) and impact sites (CR2) compared to the background sites (KC1 and CR1). Given the high sensitivity of the macroinvertebrate community (as indicated by the high EPT richness and SIGNAL-2 results) at CR7 relative to the background sites, there is no evidence of cumulative impacts from the Centennial operations on aquatic ecosystem health of the UCRC.

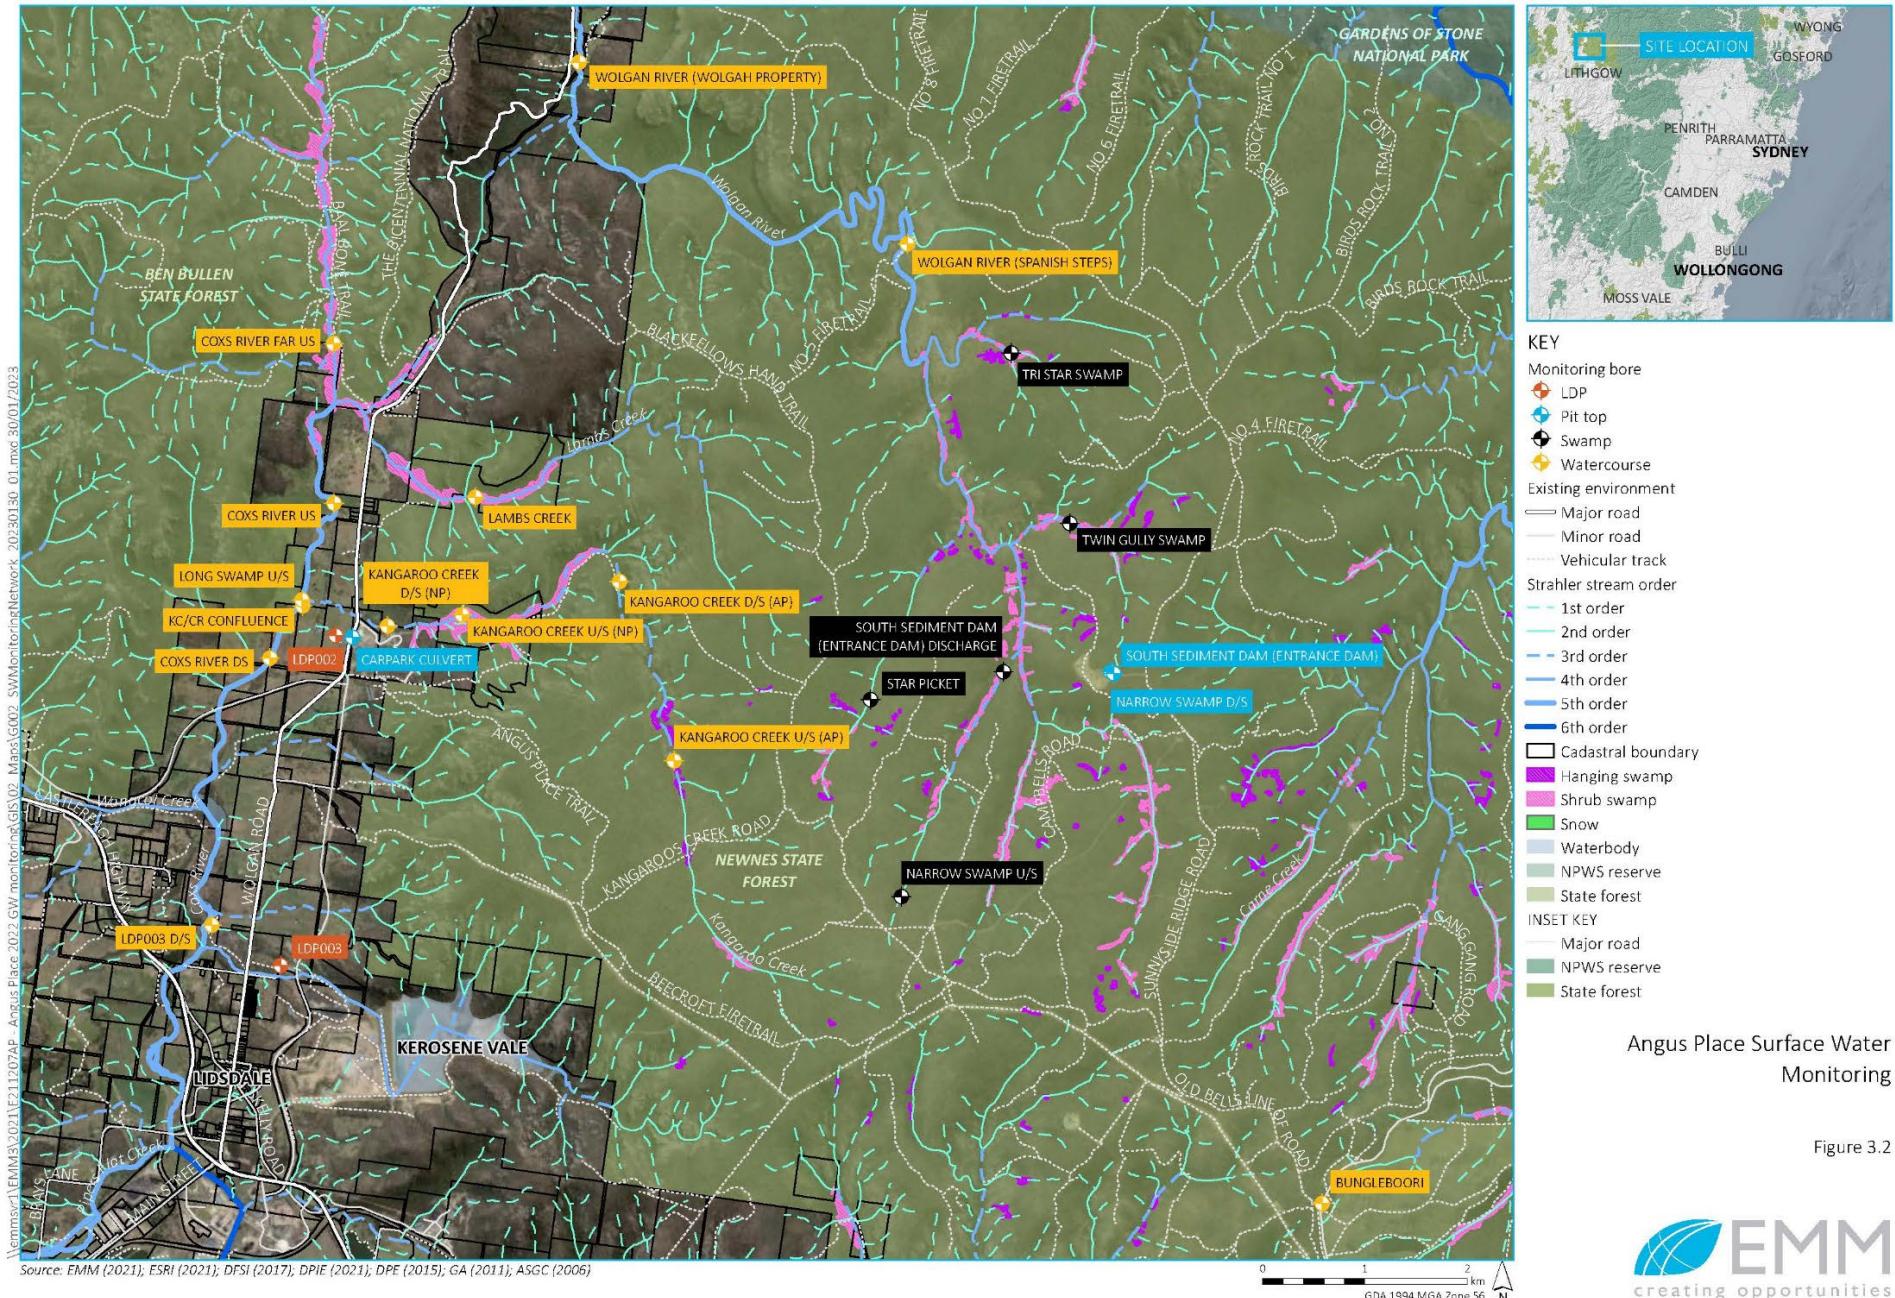
Figure 7-1: Surface Water Monitoring Locations

Monitoring Point	Description
	with Kangaroo Creek.
Kangaroo Creek U/S (AP)	Kangaroo Creek located approximately 500 m upstream of discharges from former LDP001.
Kangaroo Creek D/S (AP)	Kangaroo Creek located approximately 200 m downstream of discharges from former LDP001.
Kangaroo Creek U/S (NP)	Located in the upper reaches of Kangaroo Creek on the Newnes Plateau.
Kangaroo Creek D/S (NP)	Kangaroo Creek located on Newnes Plateau approximately 2 km downstream of Kangaroo Creek U/S (NP).
KC/CR Confluence	Located at the confluence of the Coxs River and Kangaroo Creek.
Wolgan River (Spanish Steps)	Located on the Wolgan River upstream of any potential seepage from the 800 District.
Wolgan River (Wolgan Property)	Located on the Wolgan River downstream of any potential seepage from the 800 District.
Swamps	
Narrow Swamp U/S	Upper reaches of Narrow Swamp.
Narrow Swamp D/S	Lower reaches of Narrow Swamp.
Star Picket	Swamp monitoring.

Tri Star Swamp	Swamp monitoring.
Twin Gully Swamp	Swamp monitoring.
Other	
LDP005	Pond 4 of Sewage Treatment Ponds (STP) feeding to the irrigation area (discharge to utilisation area)

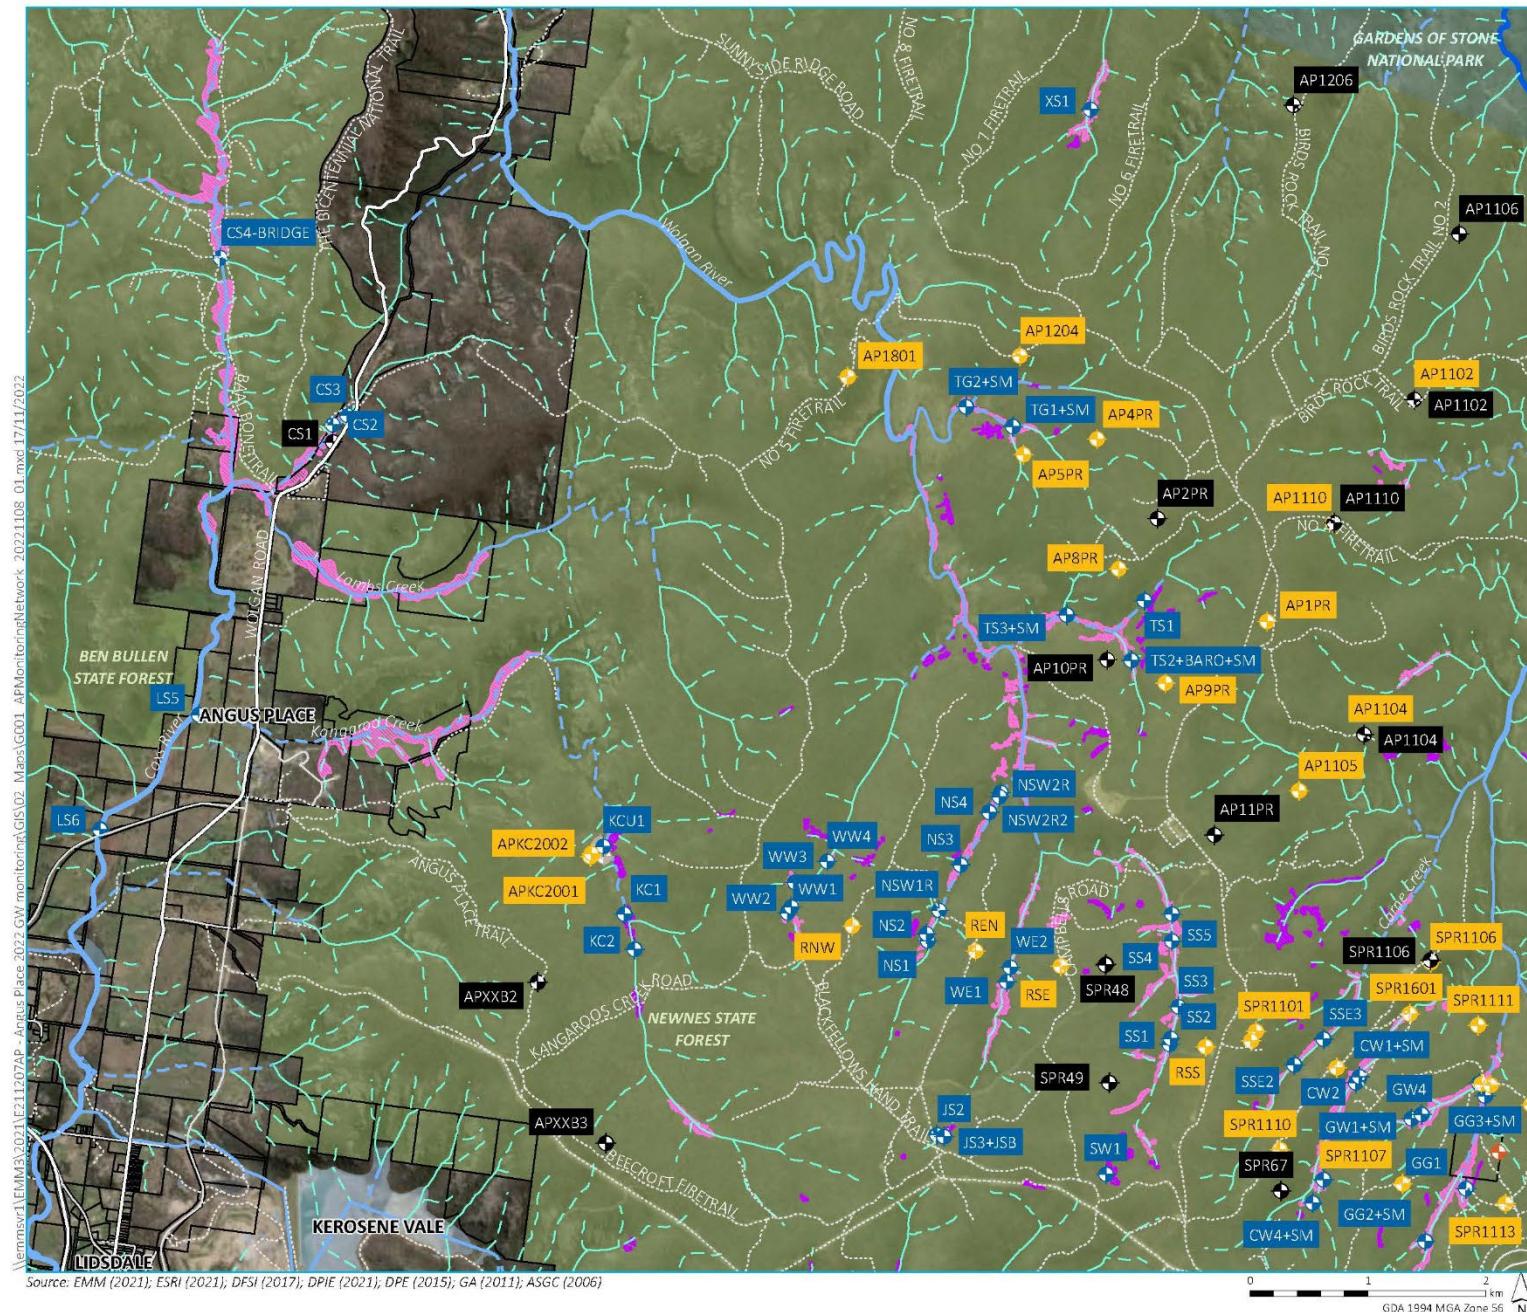
Figure 7-2: Groundwater Monitoring Locations

Swamp	Location	Monitoring Commenced	Depth (mbgl)
Swamp Monitoring Bores			
Kangaroo Creek Swamp	KC1	May 2005	1.10
	KC2	November 2008	1.56
	KCU1	October 2020	0.90
Tri Star Swamp	TS1	October 2011	3.98
	TS2	October 2011	2.06
	TS3	November 2011	1.77
West Wolgan Swamp	WW1	May 2005	1.90
	WW2	May 2005	2.30
	WW3	December 2005	2.40
	WW4	February 2006	2.08
East Wolgan Swamp	WE1	May 2005	2.51
	WE2	May 2005	1.20
Trail Six Swamp	XS1	October 2011	1.44
Twin Gully Swamp	TG1	October 2011	1.16
	TG2	April 2018	0.85
Narrow Swamp	NS1	May 2005	2.53
	NS2	May 2005	2.60
	NS3	February 2008	2.80
	NS4	April 2008	2.40
	NSW1R	November 2021	NA
	NSW2R	November 2021	NA
Long Swamp	LS5	February 2019	1.71
	LS6	February 2019	1.86
	CS4	February 2019	2.58
Coxs River Swamp	CS2	February 2019	2.23
	CS3	February 2019	1.92

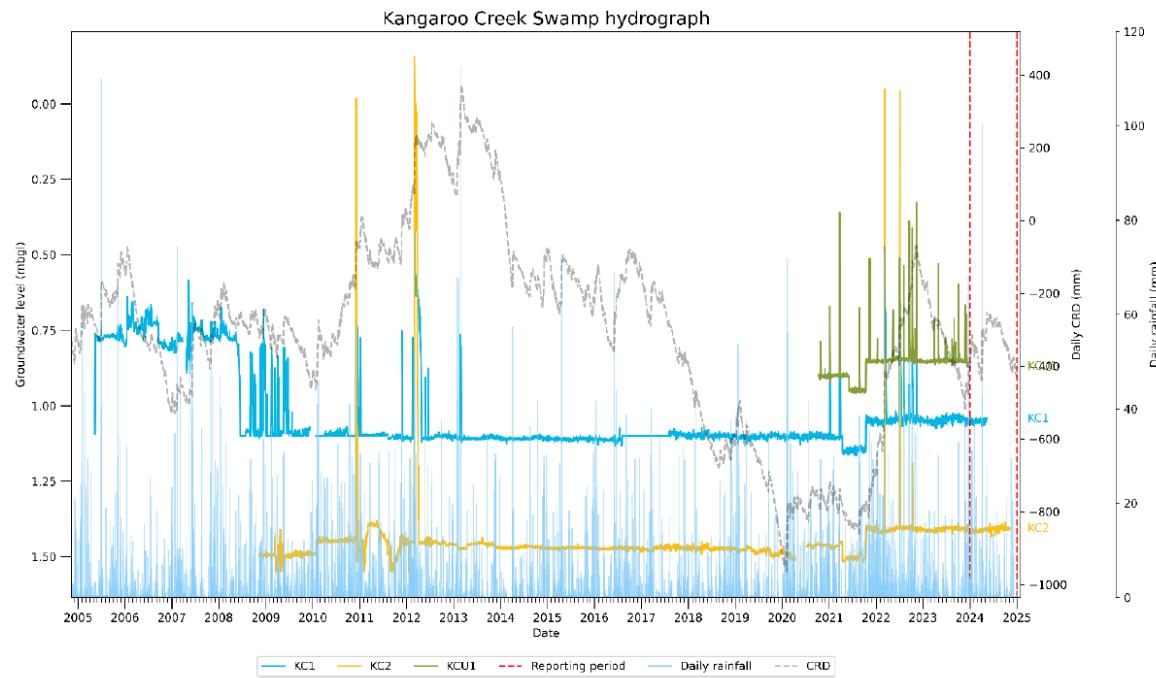
Figure 7-4: Kangaroo Creek Groundwater Levels

Following undermining in 2008, groundwater levels at KC1 and KC2 were typically dry and have shown minimal response to rainfall events. Since installation, KCU1 has typically been dry, however, it is slightly more responsive to rainfall than KC1 and KC2.

During the reporting period, groundwater levels at KC1 and KC2 were dry despite an increasing CRD trend and large rainfall events in early-April. The KCU1 logger is broken, and a new logger will be installed in the near future. KC1 logger was experiencing issues and was fixed in the November maintenance event.

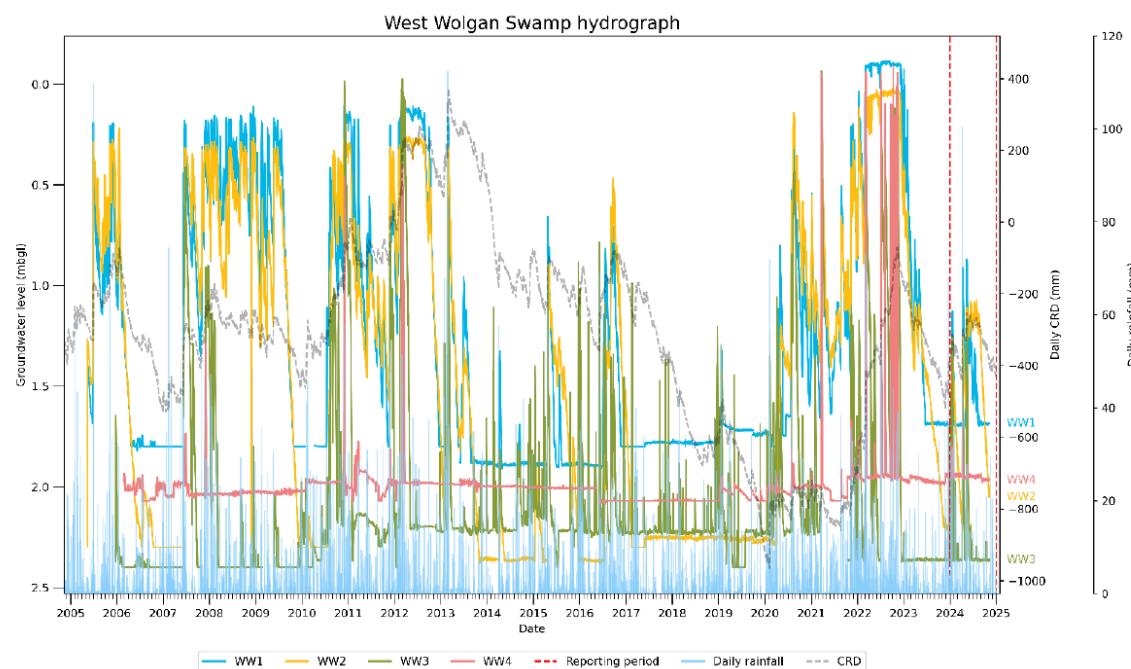
Figure 7-6: West Wolgan Groundwater Levels

The hydrograph for West Wolgan Swamp is presented as **Figure 7-6**. West Wolgan Swamp is currently monitored at four locations: WW1, WW2, WW3 and WW4 (all installed in 2005), which were undermined by longwalls LW930, LW940 and LW960 between May 2007 and July 2009.

Historically, groundwater levels at WW1 and WW2 have mirrored the daily CRD trend. WW3 responds quickly to rainfall recharge, followed by rapid drainage. WW4 has remained predominantly dry since 2012, with water levels only rising in response to significant rainfall events and draining shortly afterward. It is common for piezometers to remain dry between monitoring events. During the reporting period, groundwater levels at WW1 to WW4 remained predominately dry, apart from an increase in April and the following months due to rainfall events, before gradually decreasing due to drier conditions.

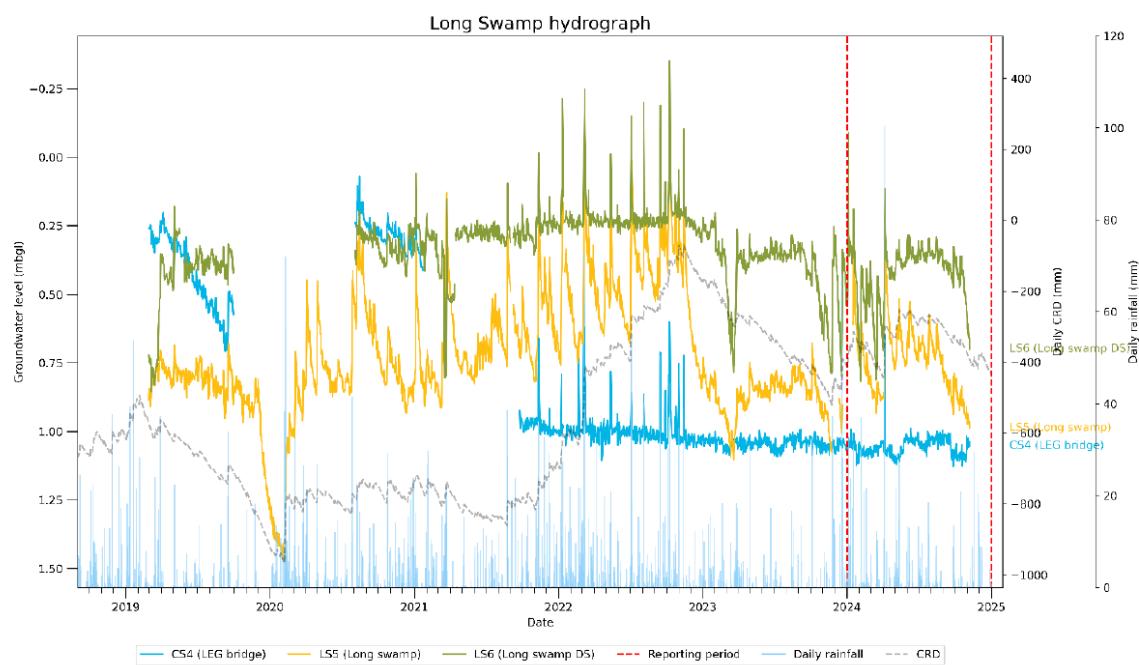
Figure 7-11: Long Swamp Groundwater Levels

Groundwater levels across all monitoring sites generally fluctuated in direct response to rainfall recharge. LS5 demonstrated greater fluctuations in base groundwater levels compared to CS4 and LS6, suggesting a higher sensitivity to recharge events or variations in local hydrogeological conditions.

During the reporting period, CS4 groundwater levels remained relatively stable, but fluctuated in response to daily CRD trends. LS6 and LS5 also fluctuated in response to daily CRD trends.

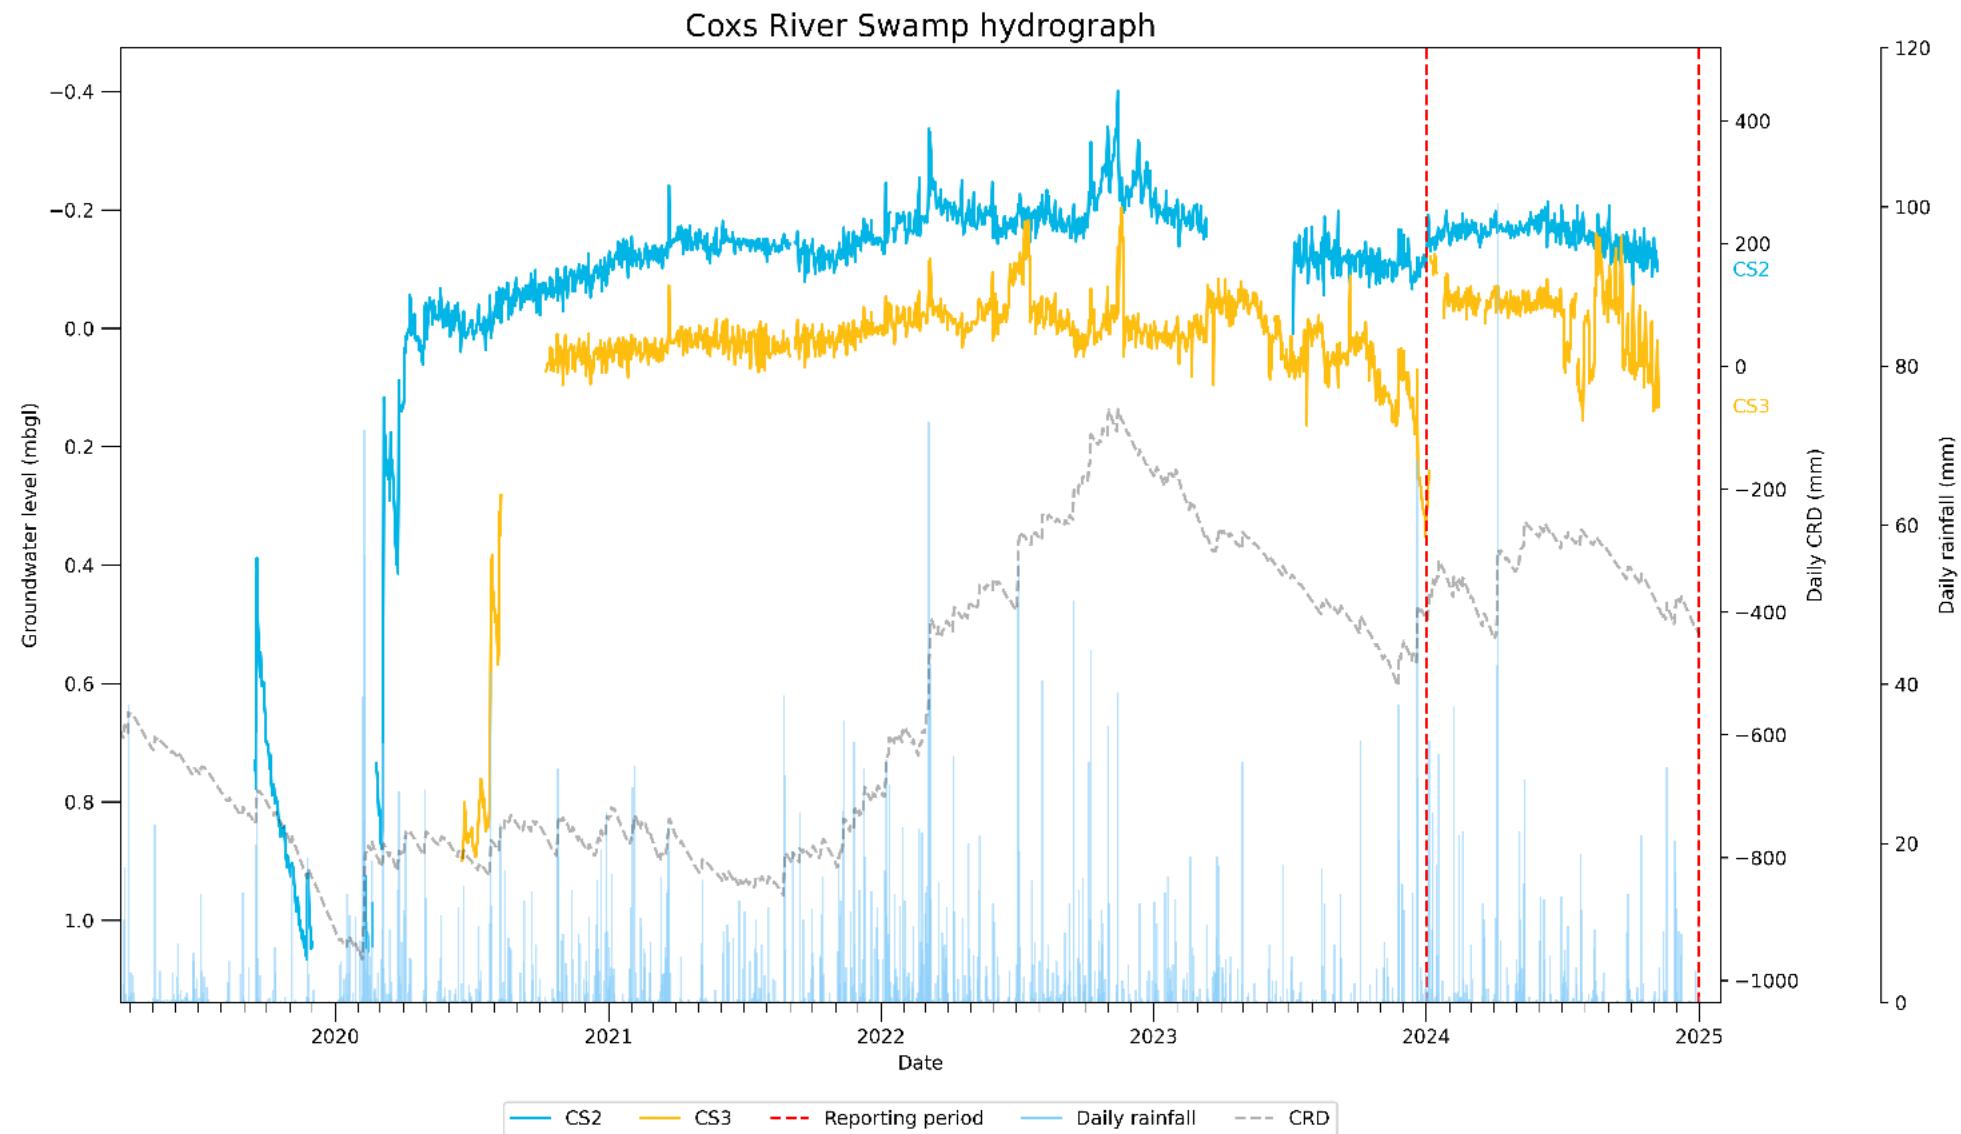
Figure 4.9 Coxs River Swamp hydrograph

Swamp ID	Piezometer ID	Comments
Coxs River	• CS2 • CS3	<p>The hydrograph for Coxs River Swamp is presented in Figure 4.9. Monitoring at Coxs River Swamp is conducted through piezometers CS2 and CS3, both installed in September 2019.</p> <p>Historically, CS2 and CS3 remained dry until February 2020 and July 2020, respectively, after which they maintained stable groundwater levels due to above-average rainfall between February 2020 and November 2022. A data gap is present for CS2 from March to June 2023 because the logger was not reinstalled correctly.</p> <p>During the reporting period, groundwater levels at CS2 and CS3 remained relatively stable, fluctuating in response to daily CRD trends. CS3 exhibited more pronounced responses to these trends compared to CS2.</p>

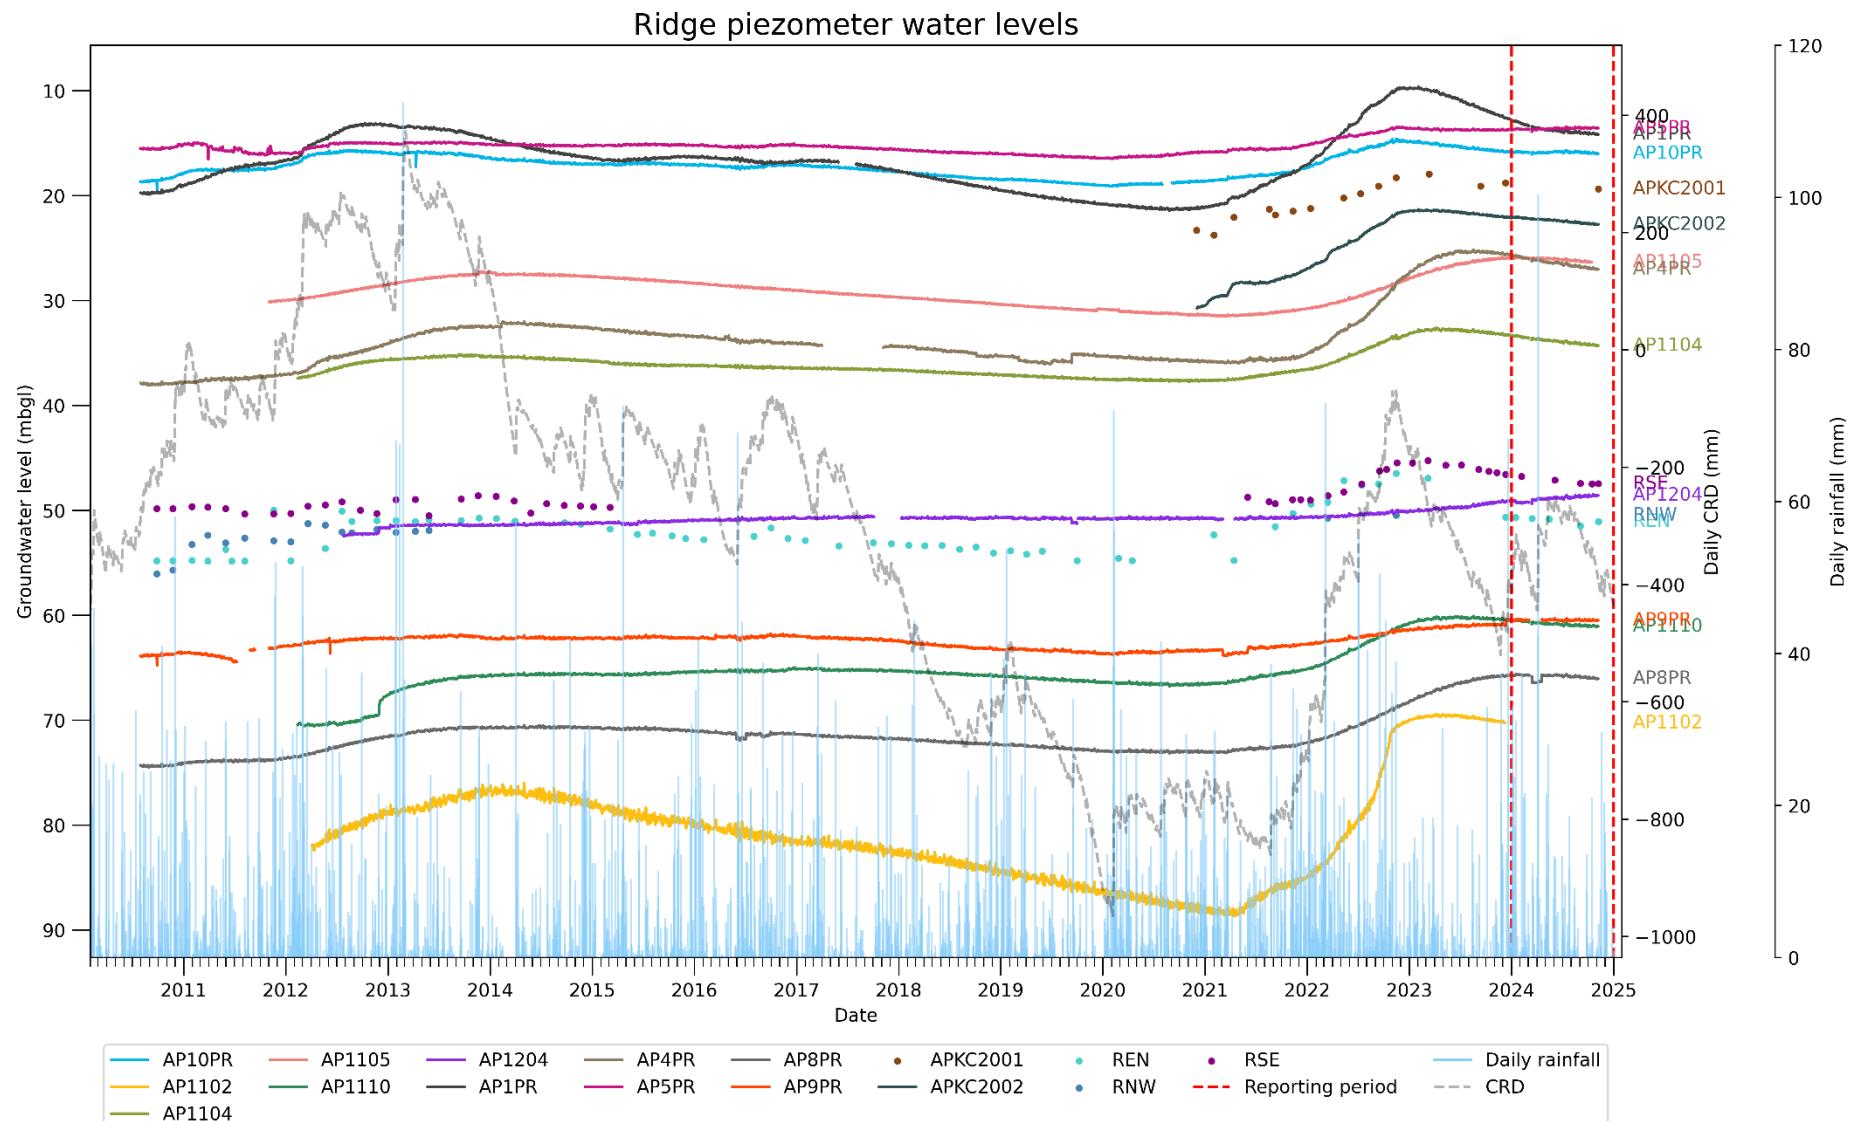
Figure 4.10 Ridge piezometer hydrograph

AP1104	Shows a delayed and subdued correlation with daily CRD. A declining trend was observed during the reporting period, corresponding to the overall long-term decreasing trend in daily CRD since November 2022.
AP1105	Shows a delayed and subdued correlation with daily CRD. Groundwater level peaked around May and gradually decreased for the remainder of the reporting period.
AP1110	Shows a delayed and subdued correlation with daily CRD. A slightly declining trend was observed during the reporting period, corresponding to the overall long-term decreasing trend in daily CRD since November 2022.
AP1102	Logger battery has expired. Logger needs to be replaced.
AP1204	Groundwater level increased through the reporting period.
APKC2001	Monitoring point is manually measured. Decreasing trend during the reporting period.
APKC2002	Shows a subdued correlation with daily CRD. Groundwater level decreasing during the reporting period.

REN	Monitoring point is manually measured. Shows a subdued correlation with daily CRD. Groundwater level decreasing during the reporting period.
RSE	Monitoring point is manually measured. Shows a subdued correlation with daily CRD with the groundwater level decreasing during the reporting period.
RNW	Monitoring point is manually measured and was dry during the reporting period.

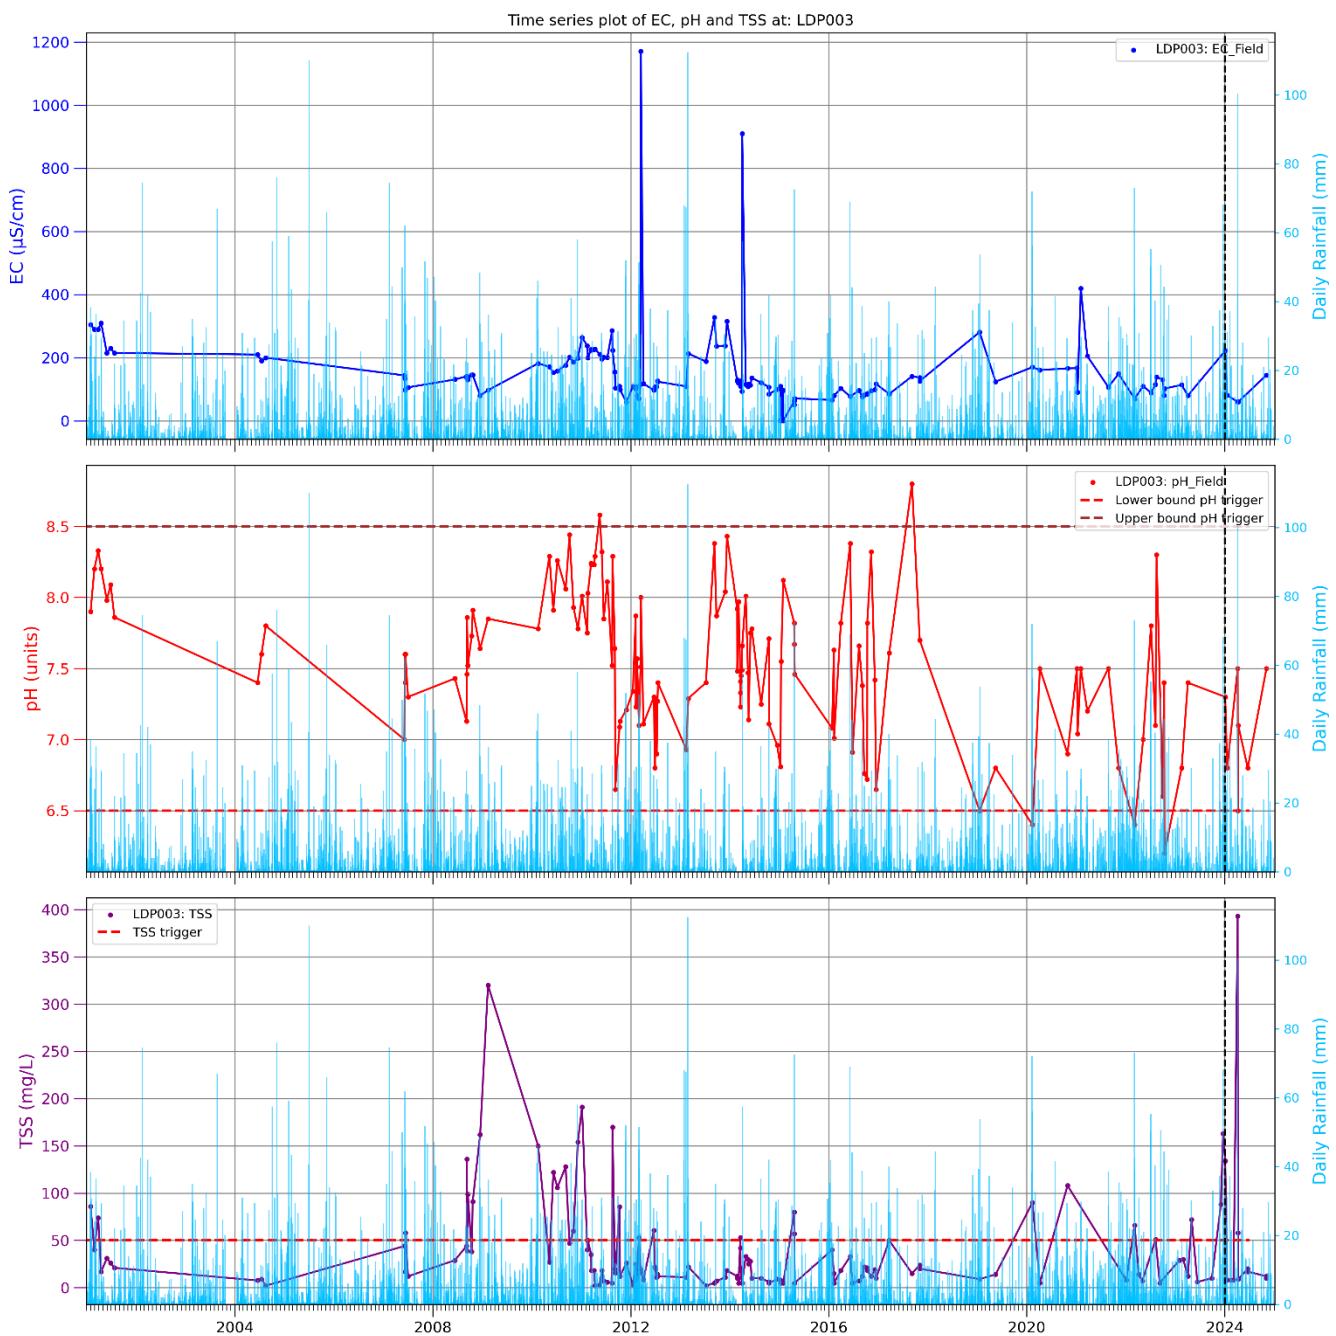
Figure 5.2 LDP003 water quality time series

Water quality time series for electrical conductivity (EC), pH and total suspended solids (TSS) at LDP002 and LDP003 are presented in Figure 5.1 and Figure 5.2, respectively. Dashed horizontal lines indicate water quality trigger criteria, while the dashed vertical line indicates the beginning of the reporting period.
