RE: Vincentia, Woolworths, NSW  
LANDSCAPE ARCHITECTURAL DESIGN STATEMENT

*Re: to the NSW Government, Planning and Environment letter signed by Kirsty Ruddock, Director Compliance and Investigations dated 30<sup>th</sup> May 2017 and titled: Vincentia District Town Centre – Stage 1 (MP\_06\_0025\_ - Show Cause. Addressed to: Mr Dose.*

Elke Haege, registered landscape architect and AQF Level 5 arborist inspected the site on the 2<sup>nd</sup> November 2017 in respect of items 1 and 2 in the above referenced letter (the letter).

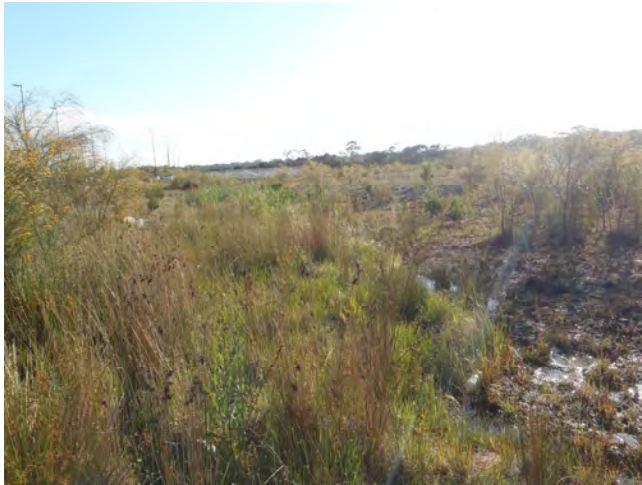
**Figure 1.** Recolonisation of the overland flow to the southeast of the site has occurred. the area in the background is proposed for new additional landscape. refer to plan L\_102

In relation to item 2: Landscaping along the overland flow corridor.  
Native trees in understorey are proposed in an area that has not revegetated as effectively as the surrounding overland swale banks. The plant species described in the letter are proposed as shown on plan L\_102. In addition, tree species are proposed along the access path on the southeastern side of the access bridge. The size of plants has been determined by the proposed use of kangaroo/wallaby and rabbit deterrent items that are proposed for establishment and protection of the proposed landscape. Site derived mulch is proposed. The other areas of the overland swale outside of the proposed additional landscape have revegetated and in my opinion the natural revegetation of native plants that have naturally colonized the area well are best left in situ rather than creating mounded landforms.

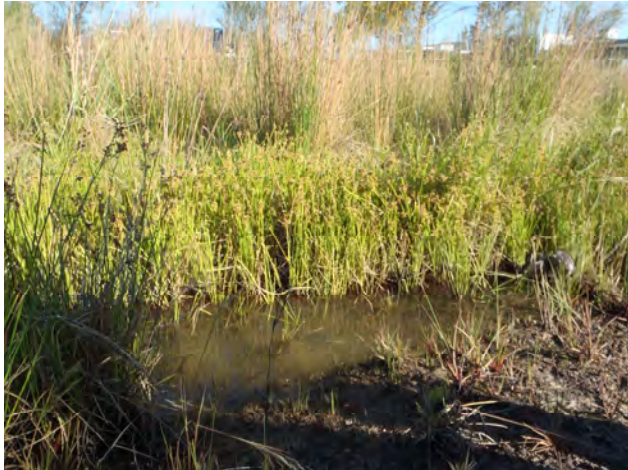
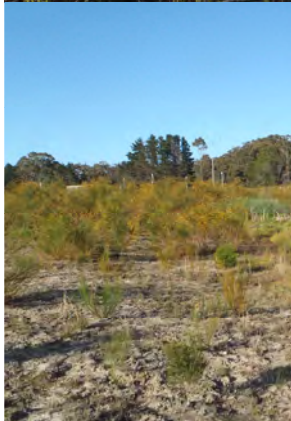
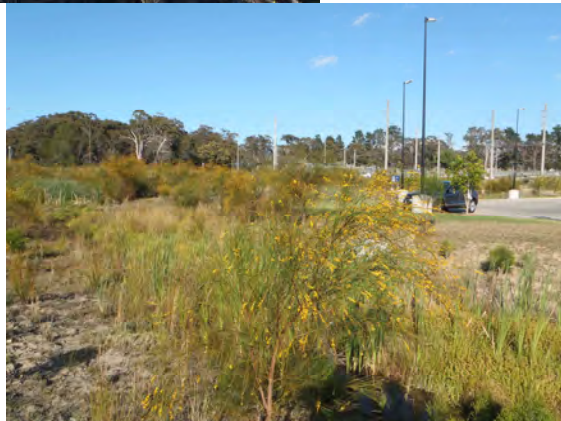
**Figure 2.** Southern corner of car park visible in the background for reference. The native vegetation has largely regrown in the overland swale.

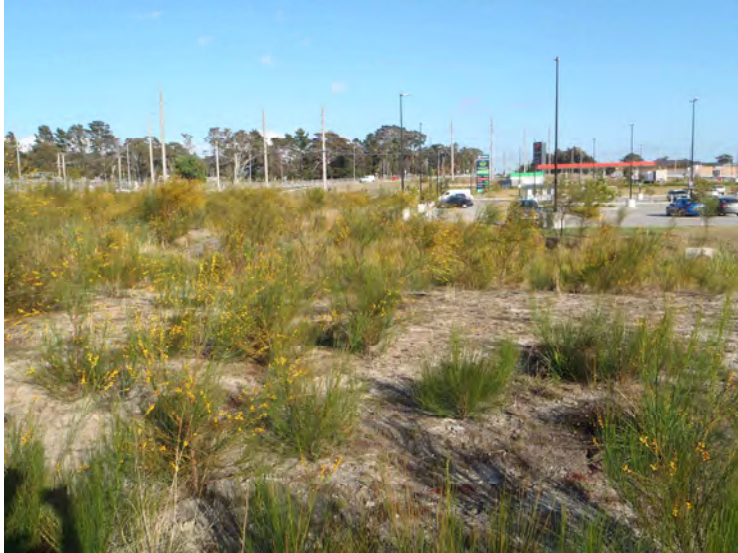
*Figure 3. View looking north towards car park from the overland flow swale.*

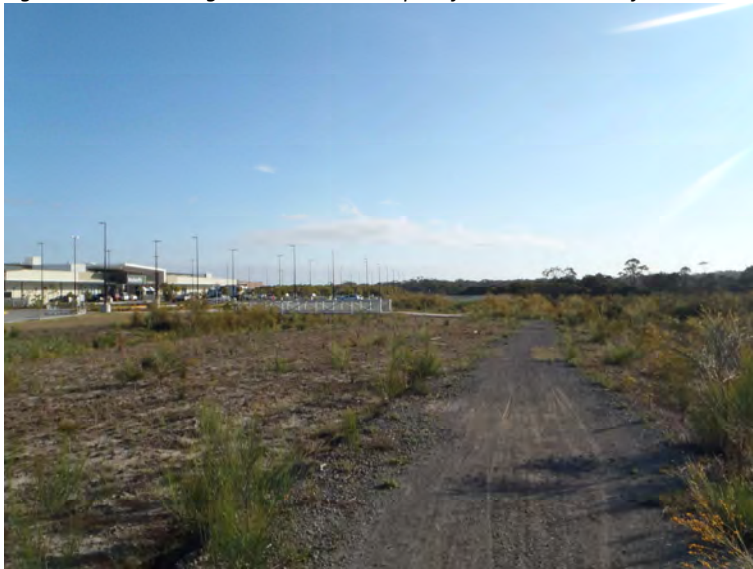
*Figure 4. Photo looking north from the overland flow to the southern most bridge (standing on access path). the area left of the path is proposed for new, additional landscape as shown on plan L\_102*

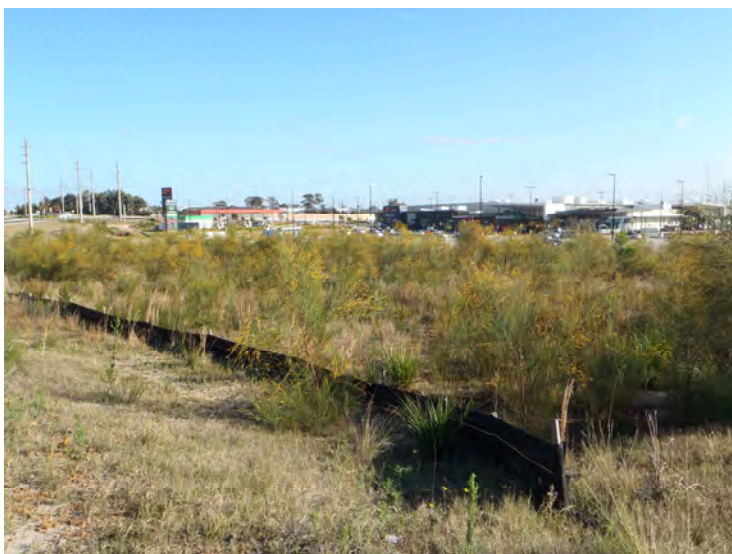
*Figure 5. Photo looking north toward the car park and Woolworths building showing the revegetation. Photo from Naval College Road*

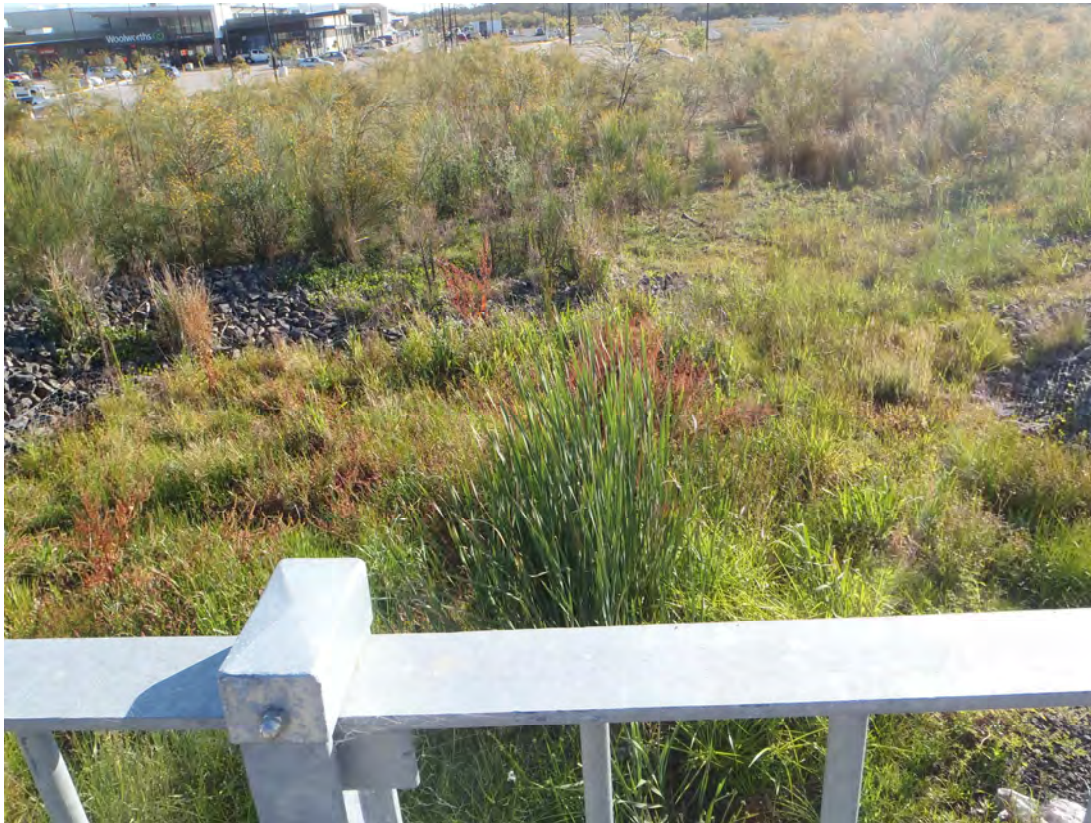
Figure 6. View from stormwater outlet at Naval Head Road. View looking north along overland flow corridor.

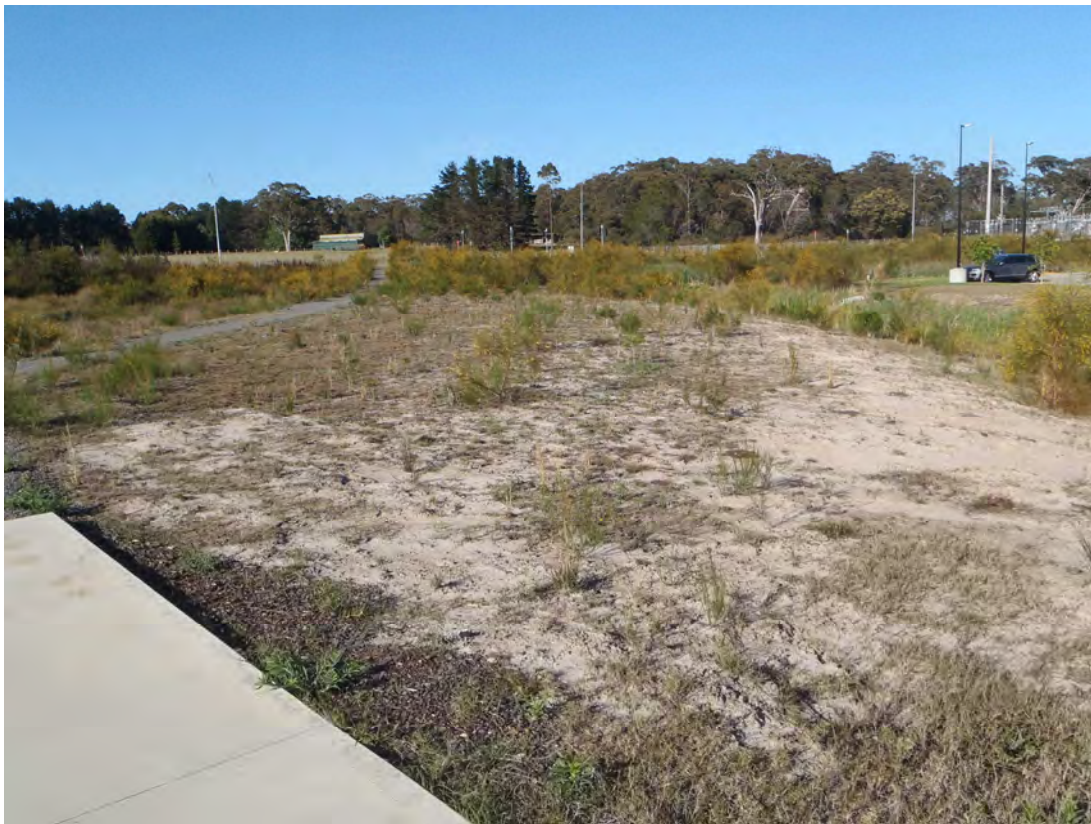
Figure 7. Photo from first bridge looking south out at the area proposed for new additional landscape in the overland flow corridor where plants have not yet colonised the area.

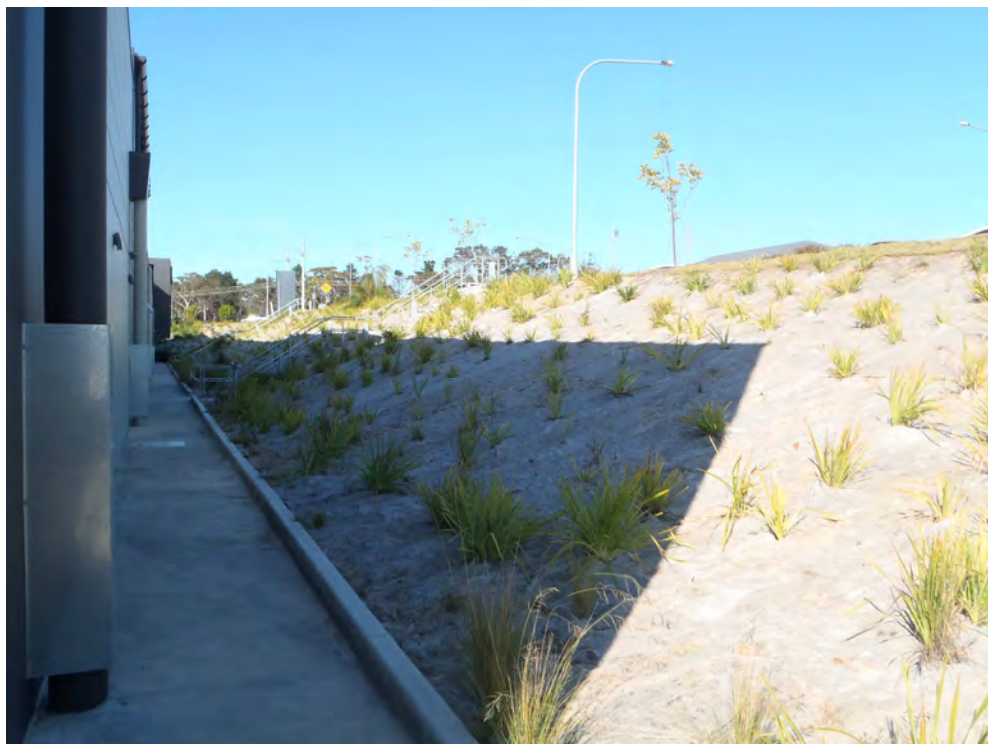
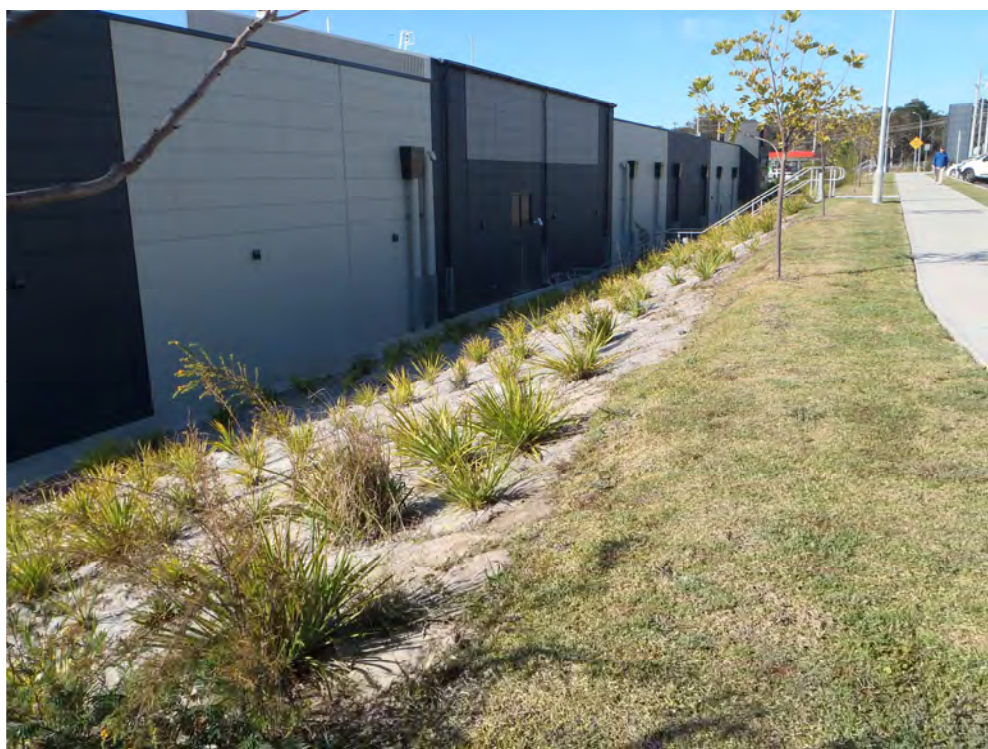
*Figure 8. The Moona Creek Road embankment (above and below – both photos looking southwest), proposed for additional tree, shrub and plants along with topsoil and bank stabilisation coir logs as proposed on plan L\_101*

In relation to item 1: Moona Creek Road elevation, an increase of the plant species denoted in the letter, including tree species described in the letter is proposed and shown on plan L\_101. The planting sizes are proposed to suit the proposed additional topsoil 300mm deep and coir log bank stabilization to support the additional plants as shown on the cross section on L\_101.
