# Supplementary Contamination Assessment

TH & TH Chung

191 Miller Road,  
Chester Hill, NSW

October 2007  
JBS 40414 - 11915 (Rev 0)  
JBS Environmental Pty Ltd

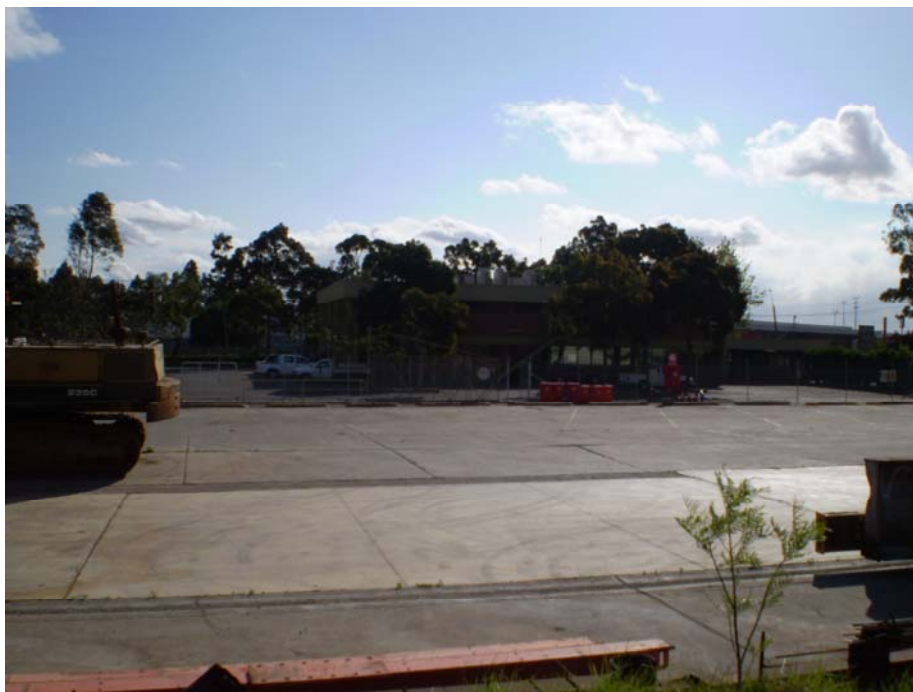
**Photo 1-** View of two storey office and administration building looking west with office car park immediately to the south and truck parking hardstand area in the foreground.

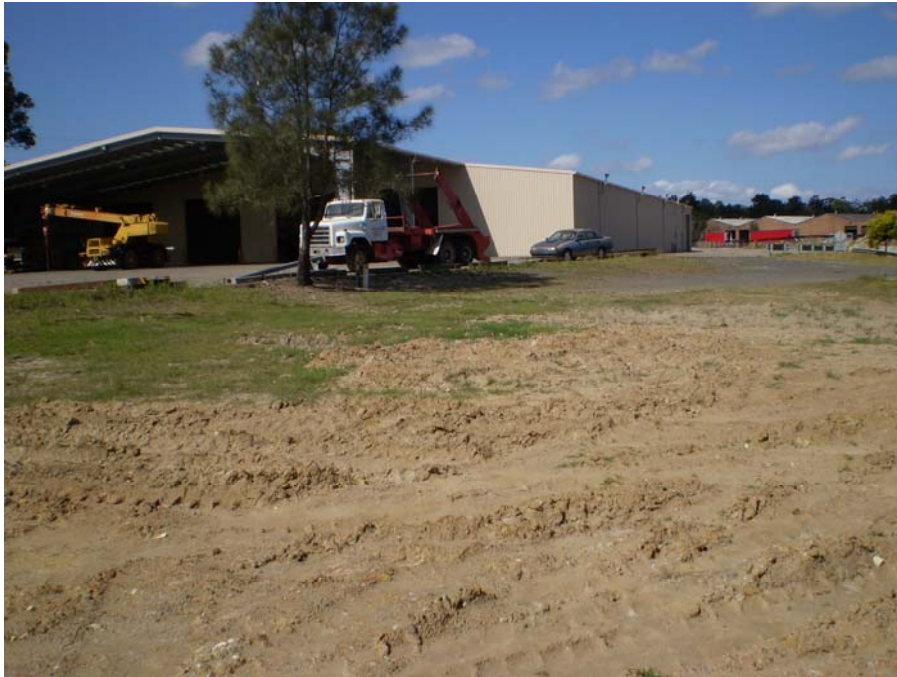
**Photo 2-** Looking east towards the transport store warehouse located in the central northern portion of the site with the former location of the diesel UST in the foreground.

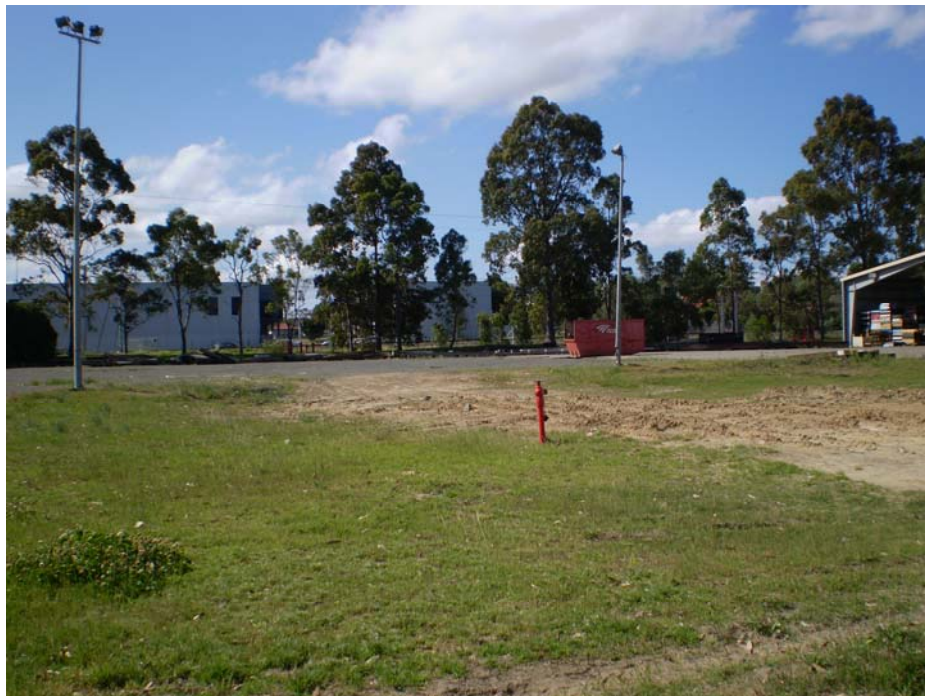
**Photo 3-** Looking north towards the hardstand truck parking area extending west from the transport store warehouse.

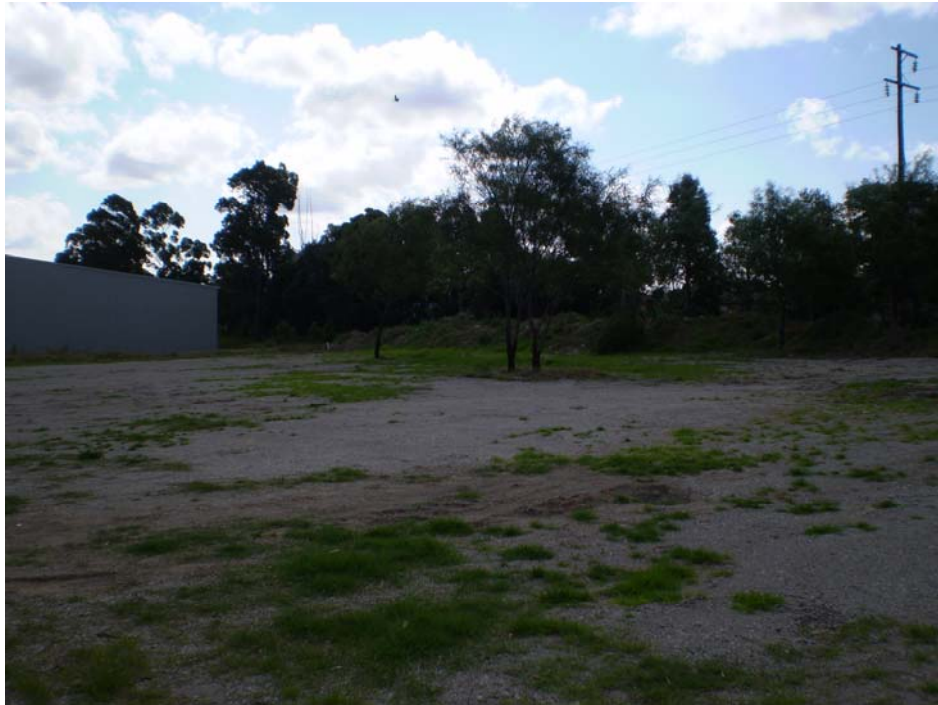
**Photo 4-** Looking north west towards sparsely vegetated region at the eastern end of transport store warehouse.

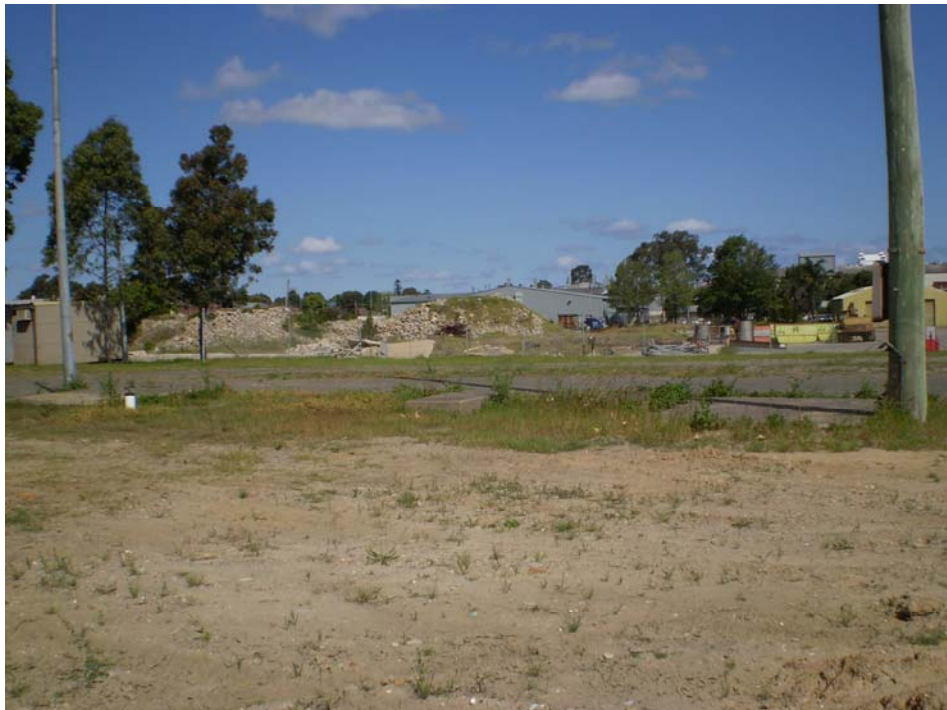
Several disturbed areas are present at the site, particularly in the area immediately south west of the transport store warehouse in proximity to the former diesel underground storage tank (UST) which was decommissioned and removed in 2002 (HLA 2002d)<sup>6</sup> and former fuel loading point (**Photo 2 & 5**).

**Photo 5-** Looking south-east from the location of the removed diesel UST excavation towards the former fuel loading point (sample location TP3).

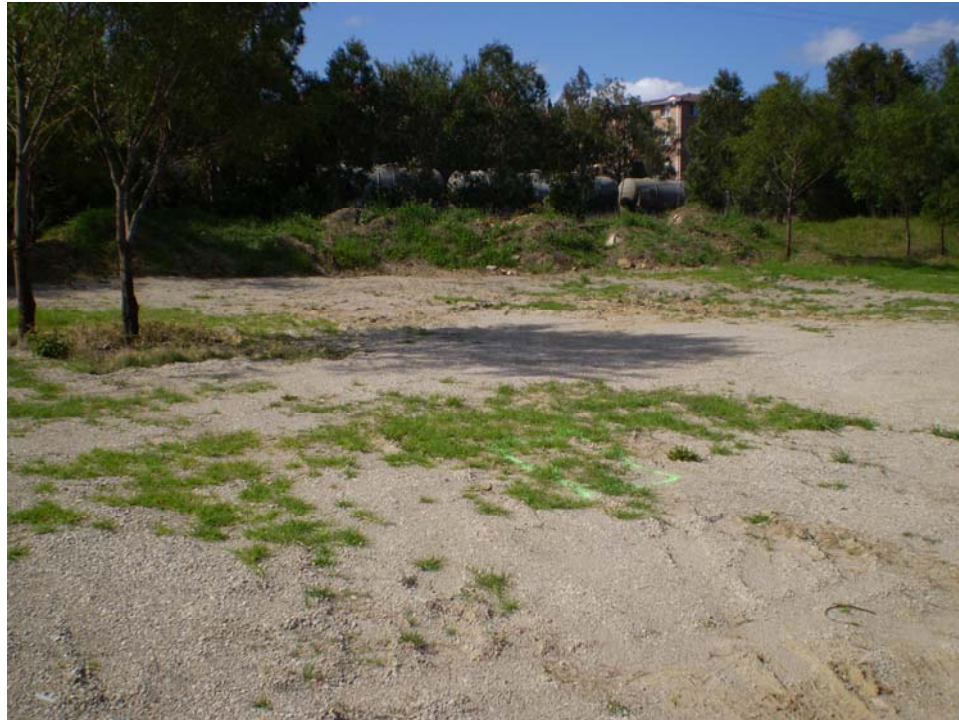
Several elevated areas are present across the site, believed to have been raised through the importation of fill material. The northern boundary of the site possesses a 1m to 3m embankment, beyond which lied the Southern Railway (**Photo 6** and **7**).

**Photo 6-** Looking north towards the embankment traversing the northern site boundary with the railway line beyond.

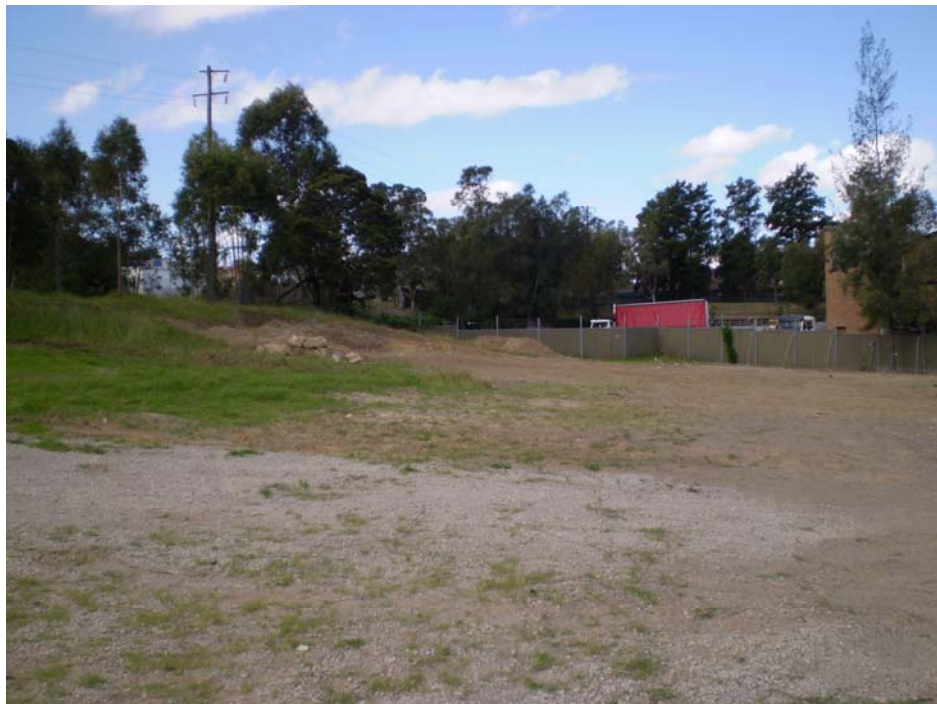
**Photo 7-** Looking north east following the embankment along the northern boundary towards the eastern site boundary.

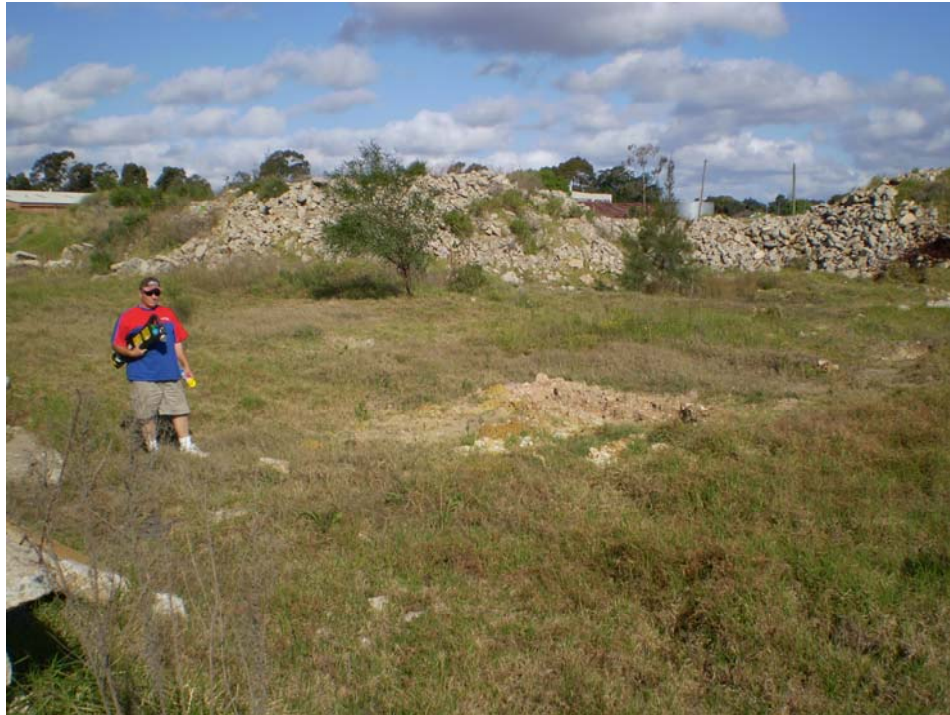
Two stockpiles, derived predominantly from soil and crushed concrete are present in the central portion of the site, extending towards the eastern site boundary (**Photos 8 and 9**).

**Photo 8-** Looking east towards a portion of the stockpile located in the central portion of the site.

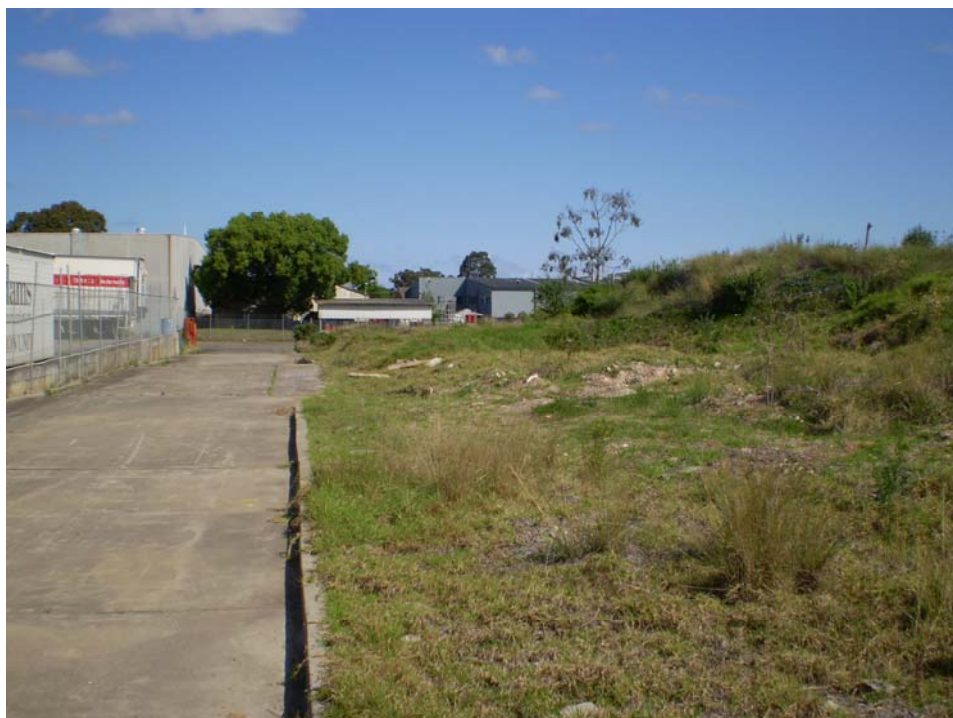
**Photo 9-** Looking south along the eastern site boundary and extent of the stockpile extending from the centre of the site.

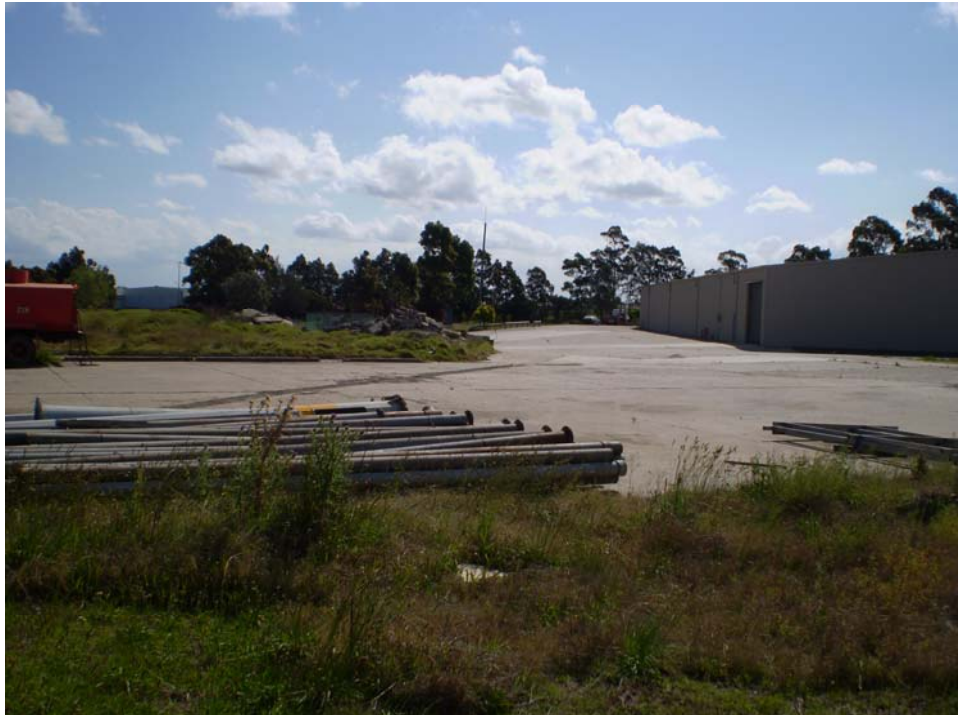
Roadways have been retained following previous occupation of the site and are found to dissect the site extending from the eastern entrance off Miller Road and running laterally along the eastern and southern site boundaries (**Photos 9 to 11**).

**Photo 10-** View to the west of the roadway that extends from the site entrance, past the warehouse and to the eastern site boundary.

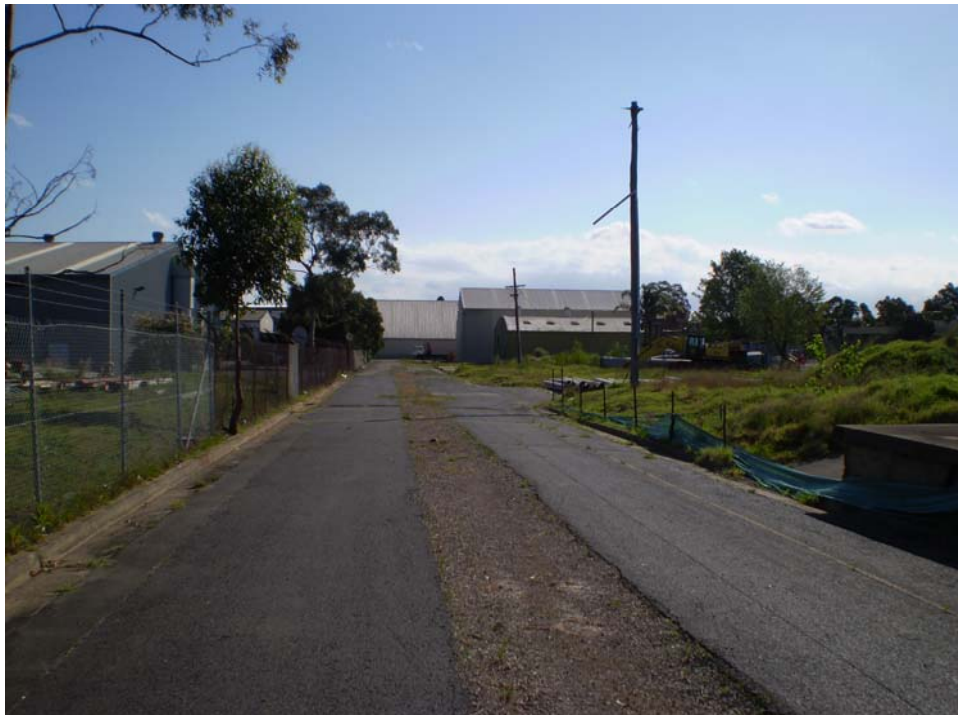
**Photo 11-** View to the west of the roadway that extends along the southern site boundary towards the workshop area.

Two large buildings utilised as workshops are located in the south western portion of the site (**Photo 11**).

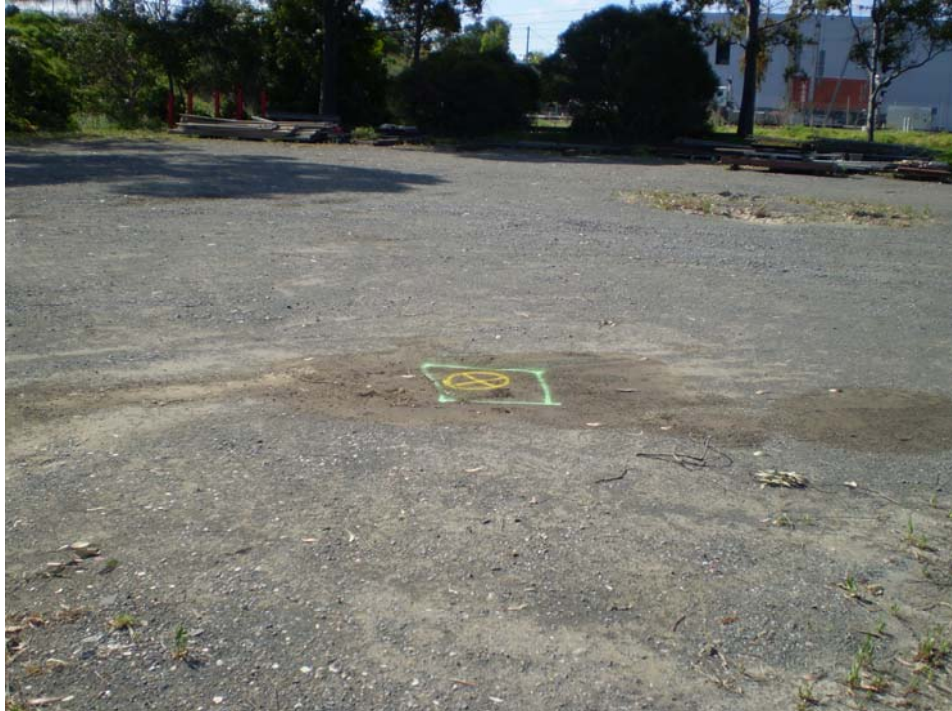
- The gravel/roadbase area extending west of the truck parking hardstand area near the warehouse (**Photo 12**);

**Photo 12-** Localised staining noted in the unsealed gravel/roadbase area west of the warehouse (sample location TP1).

Four locations were identified to contain localised concentrations of TPH (as TPH C<sub>10</sub>-C<sub>36</sub>) within the surface soils exceeding the adopted threshold concentration of 1000 mg/kg. Samples TP1/0.1, TP6/0.1, TP6/0.5, TP7/0.1 and TP17/0.1 reported concentrations of 8500 mg/kg, 7600 mg/kg, 4280 mg/kg, 5600 mg/kg and 2500 mg/kg respectively. Sample locations TP1, TP6, TP7 and TP17 are presented in **Figure 2** and were targeted during the current investigation due to observed surface staining during the site visit. Sample location TP1 and TP17 are located in the north western and north eastern regions of the site respectively, whilst sample locations TP6 and TP7 are located in the southern portion of the site, with TP6 located directly adjacent to the workshop area.

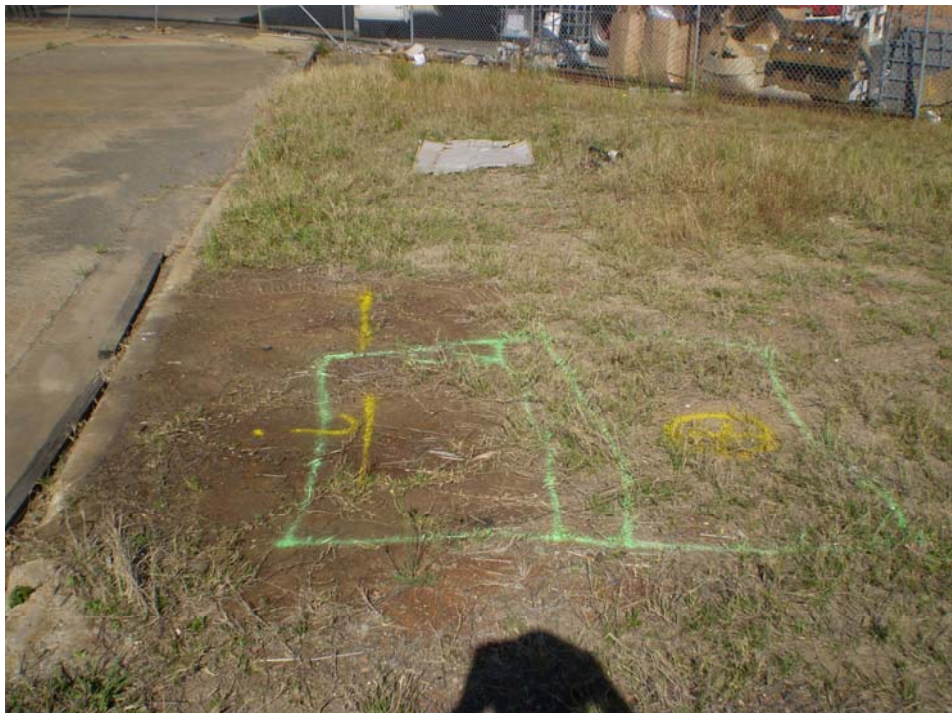
- Localised staining in the area near the eastern site boundary;

**Photo 13-** Localised staining observed in the vegetated area within proximity to the eastern site boundary (sample location TP17).

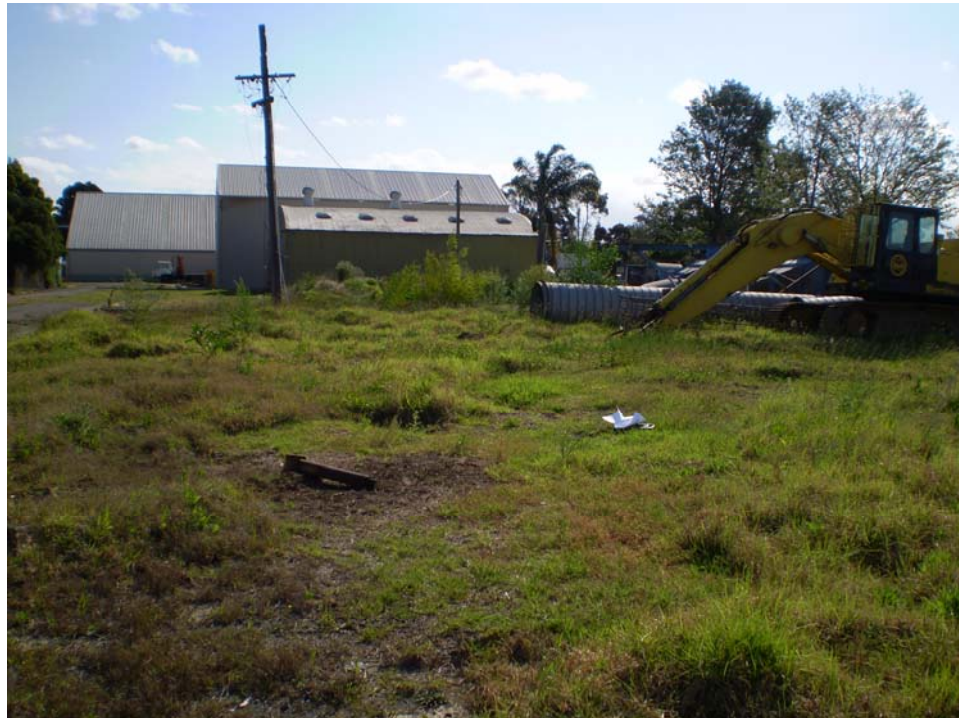
- Localised staining in the southern portion of the site, to the east of the workshop area; and

**Photo 14-** Localised staining observed in the grass vegetated area adjacent to the southern site boundary and east of the workshop area (sample location TP7).

Additional analysis of soil from sample location TP7 reported TPH C<sub>10</sub>-C<sub>36</sub> concentrations above adopted commercial/industrial (HIL-F) health based criteria. Given that the reported concentration was found to have decreased with depth from 5600 mg/kg at 0.1m bgs to 2010 mg/kg, it is unlikely that TPH C<sub>10</sub>-C<sub>36</sub> concentrations exceeding the adopted site criteria would extend beyond 1.0m bgs.

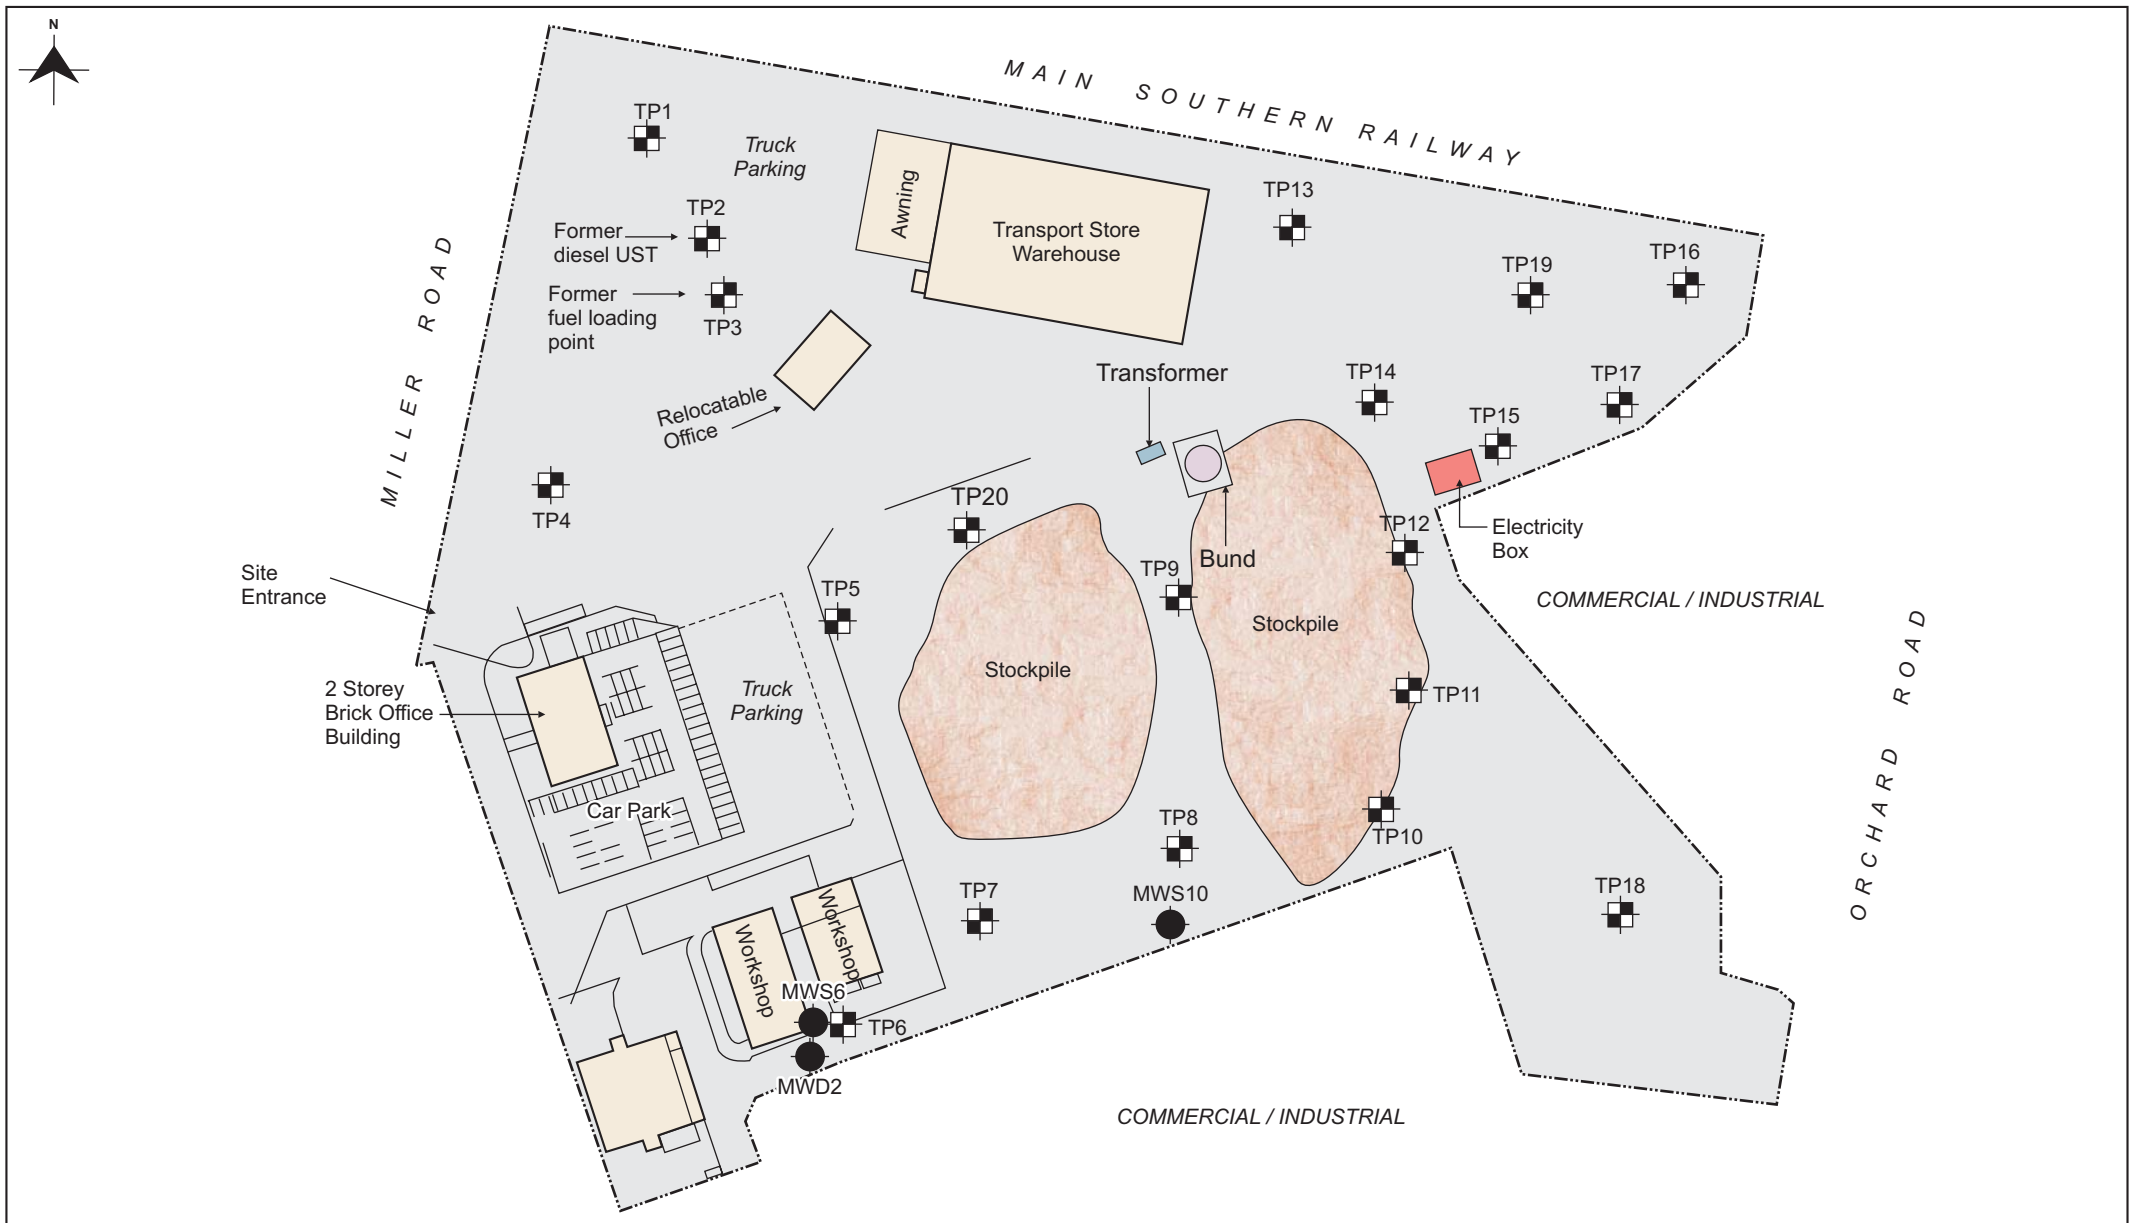
TP6	Conc (mg/kg)	Depth (m)
TPH C <sub>10</sub> -C <sub>14</sub>	1,600	0.1
TPH C <sub>15</sub> -C <sub>28</sub>	6,000	0.1
TPH C <sub>10</sub> -C <sub>36</sub>	7,600	0.1
TPH C <sub>15</sub> -C <sub>28</sub>	3,300	0.5
TPH C <sub>10</sub> -C <sub>36</sub>	4,280	0.5

TP7	Conc (mg/kg)	Depth (m)
TPH C <sub>15</sub> -C <sub>28</sub>	1,000	0.1
TPH C <sub>29</sub> -C <sub>36</sub>	4,600	0.1
TPH C <sub>10</sub> -C <sub>36</sub>	5,600	0.1
TPH C <sub>29</sub> -C <sub>36</sub>	1,600	0.5
TPH C <sub>10</sub> -C <sub>36</sub>	2,010	0.5

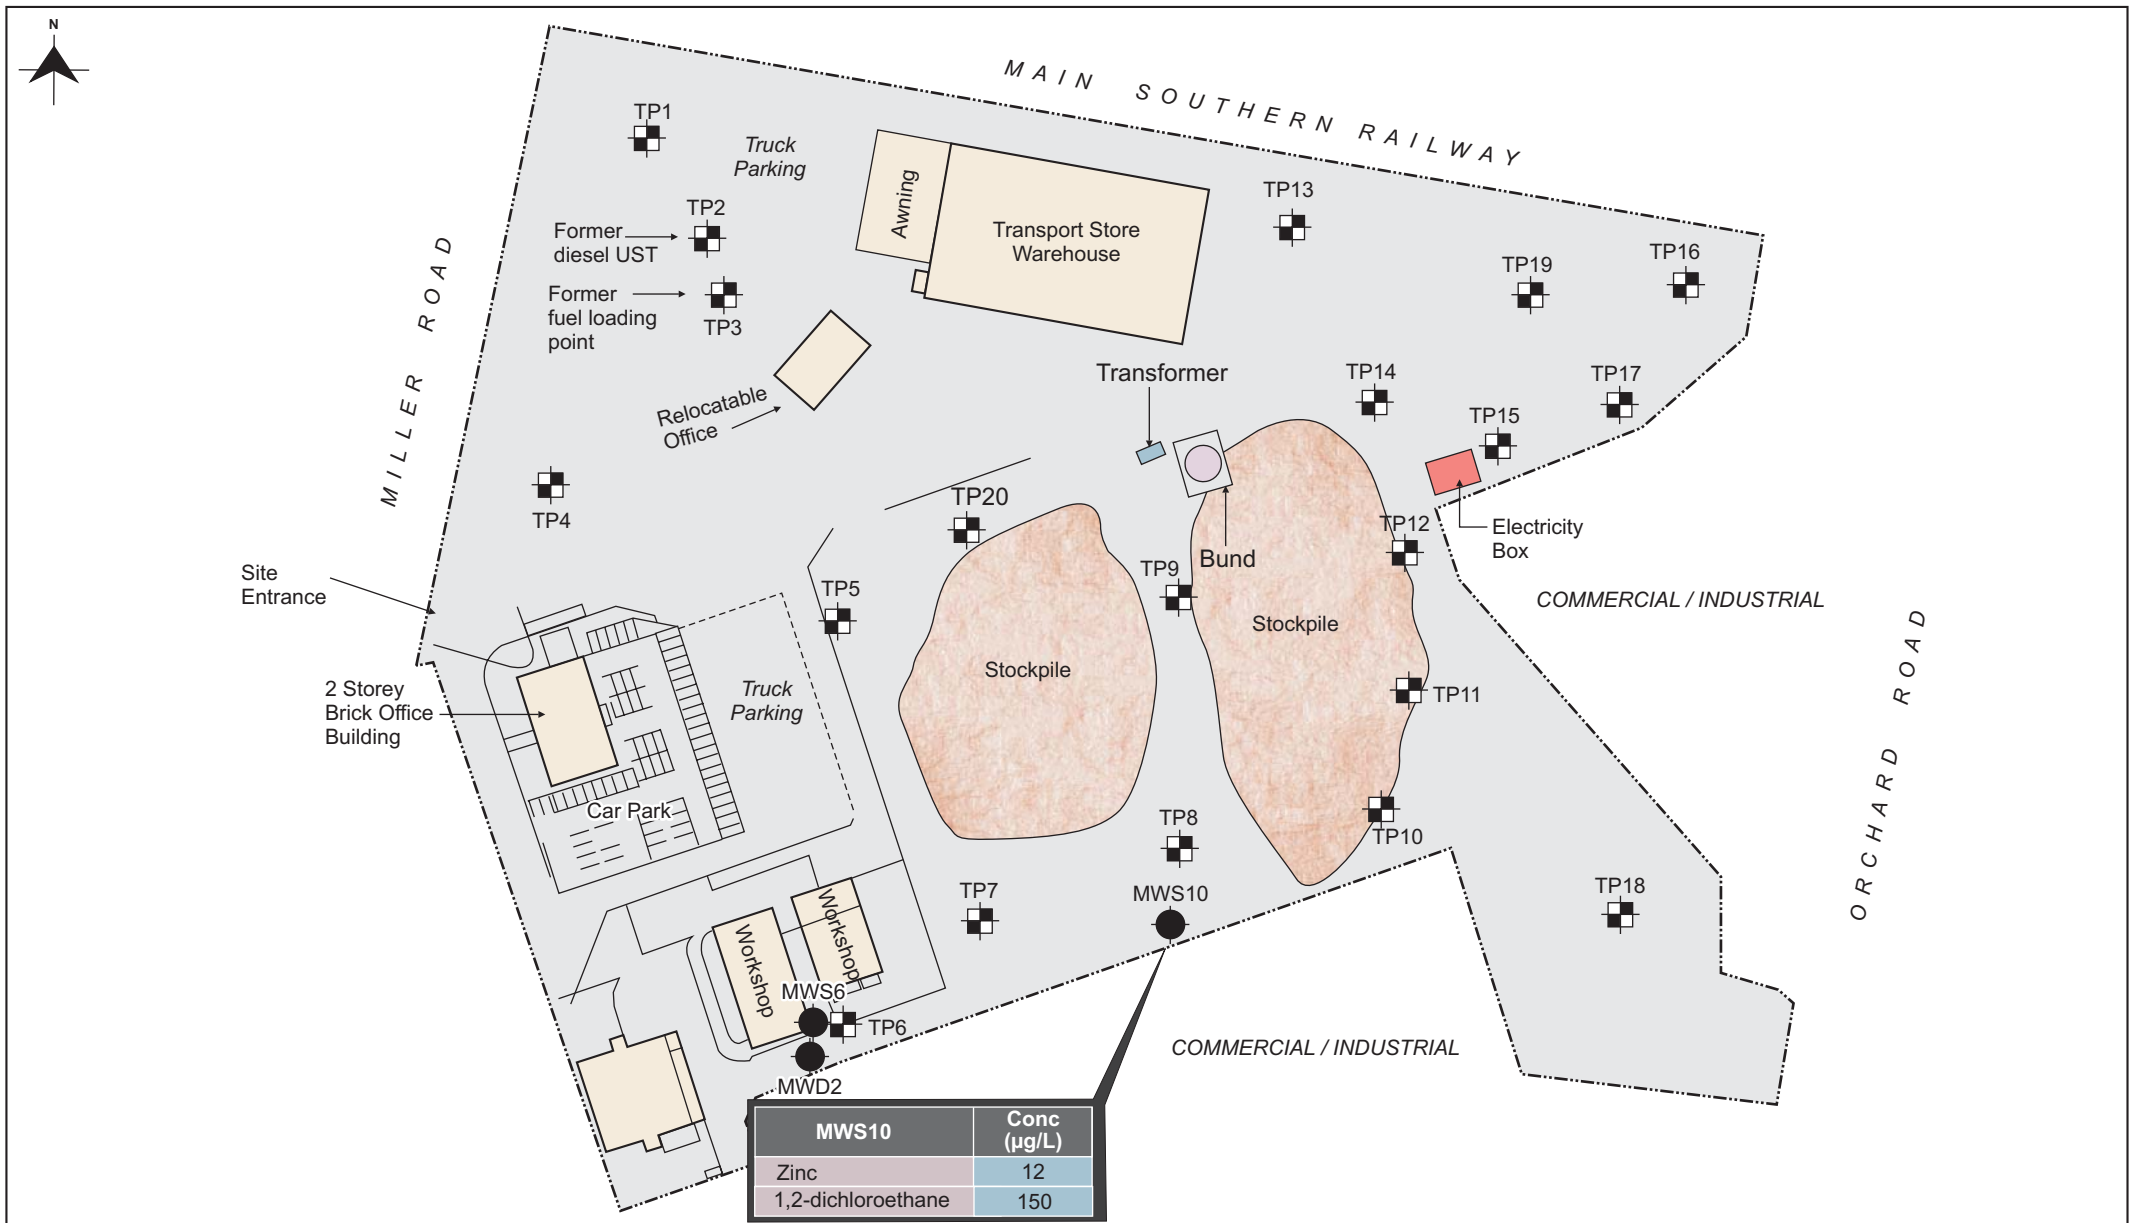
MWS10	Conc (µg/L)
Zinc	12
1,2-dichloroethane	150
