## **5. Land Systems and Environmental Effects**

*This chapter describes the existing environment that will be potentially impacted by the proposed transmission line. Detailed impact assessments and mitigation strategies are also described.*

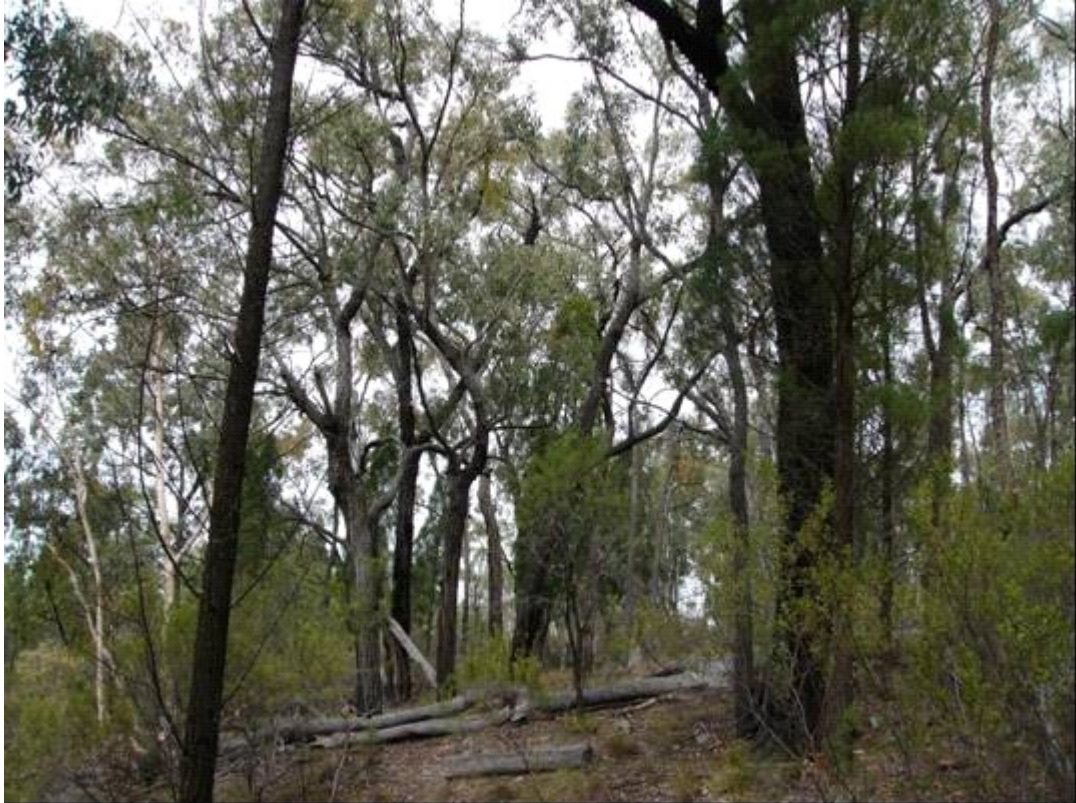
Three tower sites (56, 57 and 58) contained undisturbed open forest dominated by *Callitris endlicheri* and *Eucalyptus fibrosa*. Other canopy trees occurred locally, including *Eucalyptus rossii* (Inland Scribbly Gum), *Eucalyptus dwyeri* (Dwyer's Red Gum), *Eucalyptus agglomerata* (Bluetop Stringybark) and *Eucalyptus crebra* (Narrow-leaved Ironbark).

**Photograph**            Black Cypress Pine – Broad-leaved Ironbark Open Forest on a sandstone ridge top in the eastern portion of the route

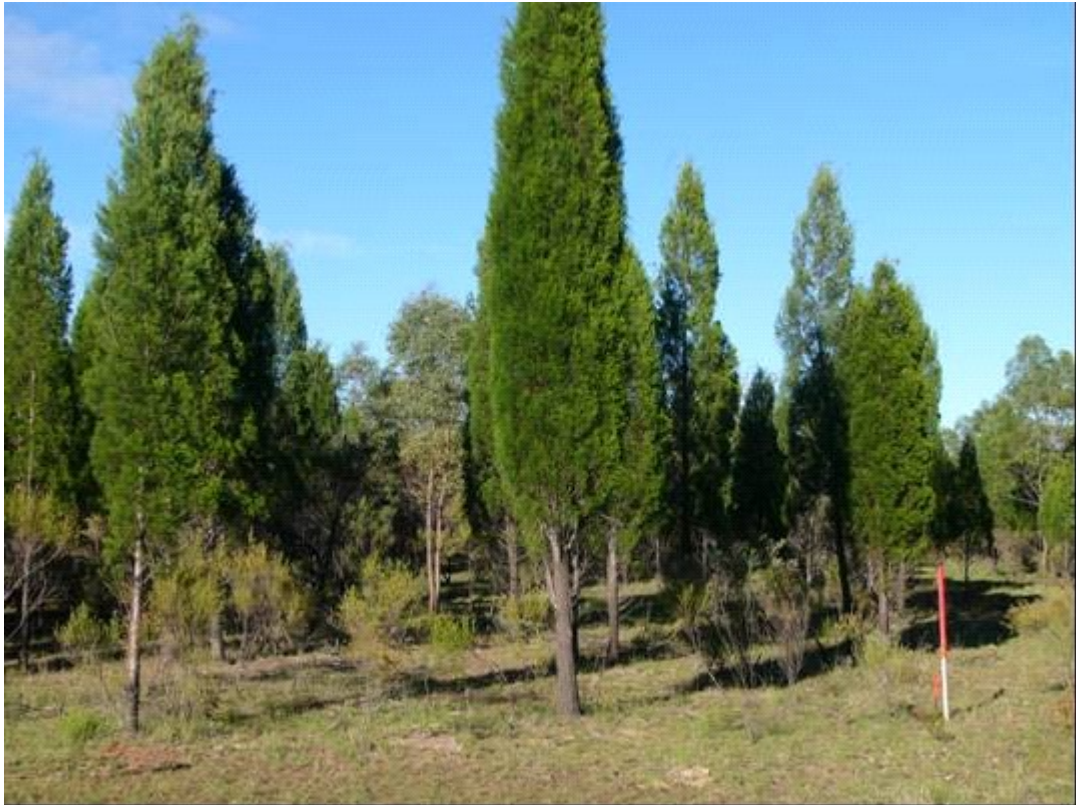
Adjacent to tower 16 an individual stand of early Black Cypress Pine regrowth occurred next to a cleared area.

**Photograph**                      Black Cypress Pine Woodland regrowth

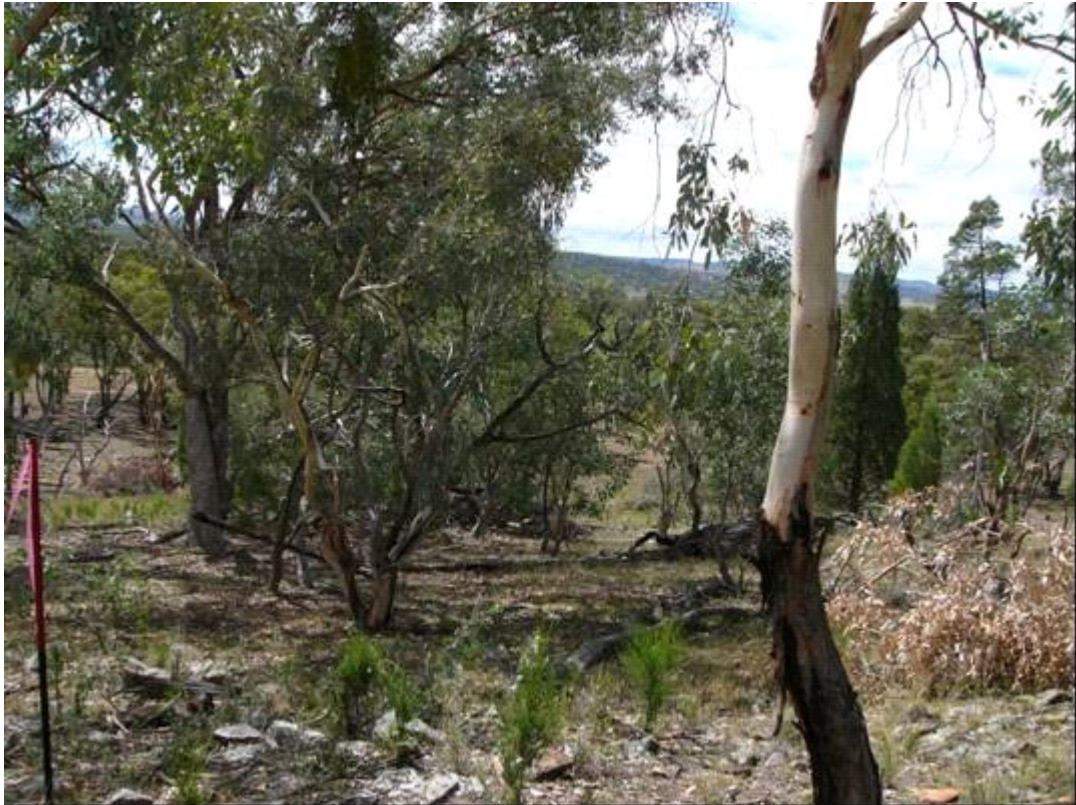
**Photograph** Black Cypress Pine – White Box Woodland in the western portion of the route.

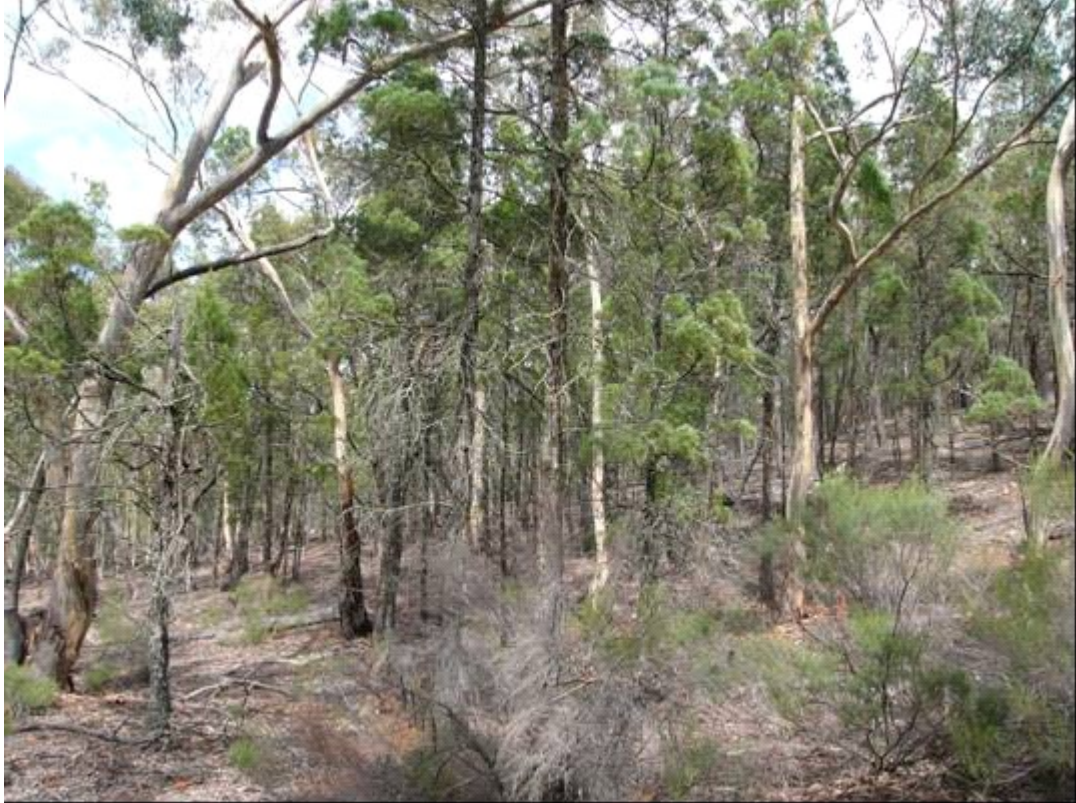
**Photograph**                      Black Cypress Pine – Red Box Woodland

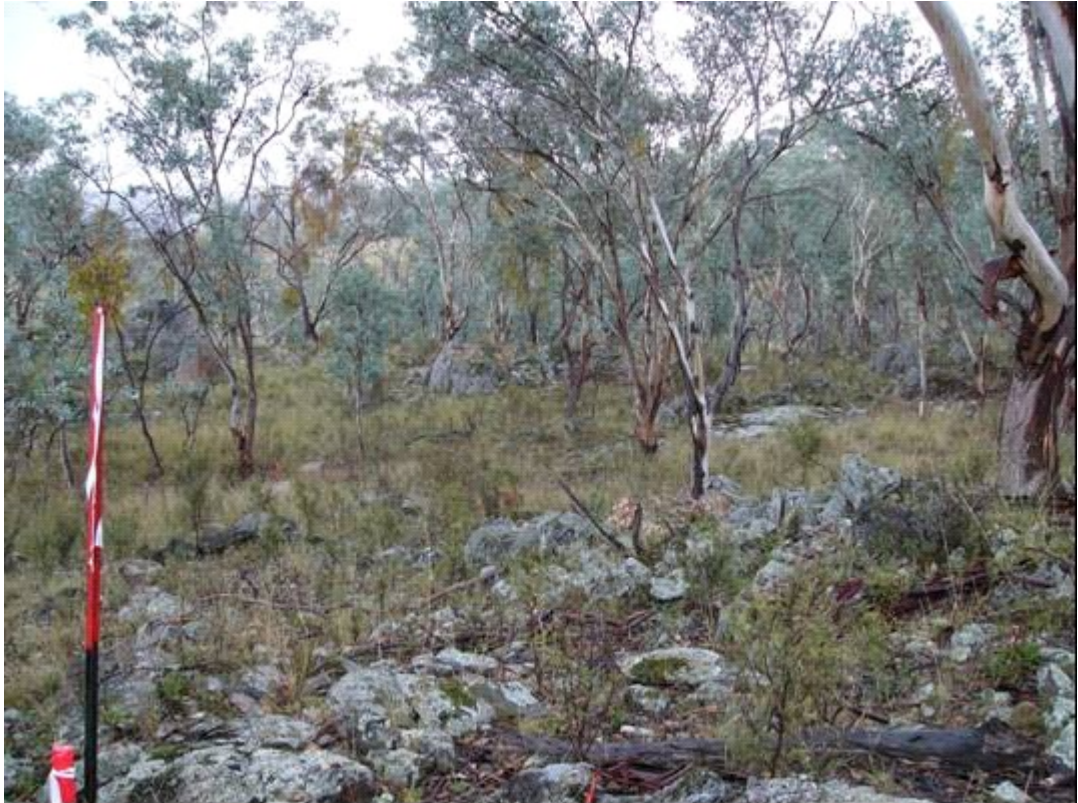
**Photograph**                      Black Cypress Pine – Tumble-down Red Gum Woodland

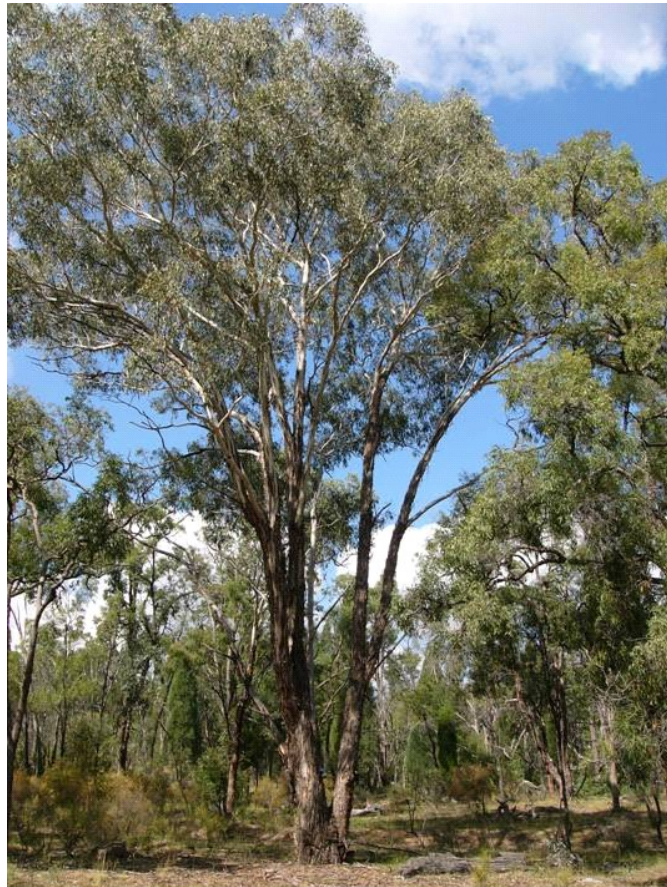
**Photograph**

Yellow Box – Blakely's Red Gum Woodland

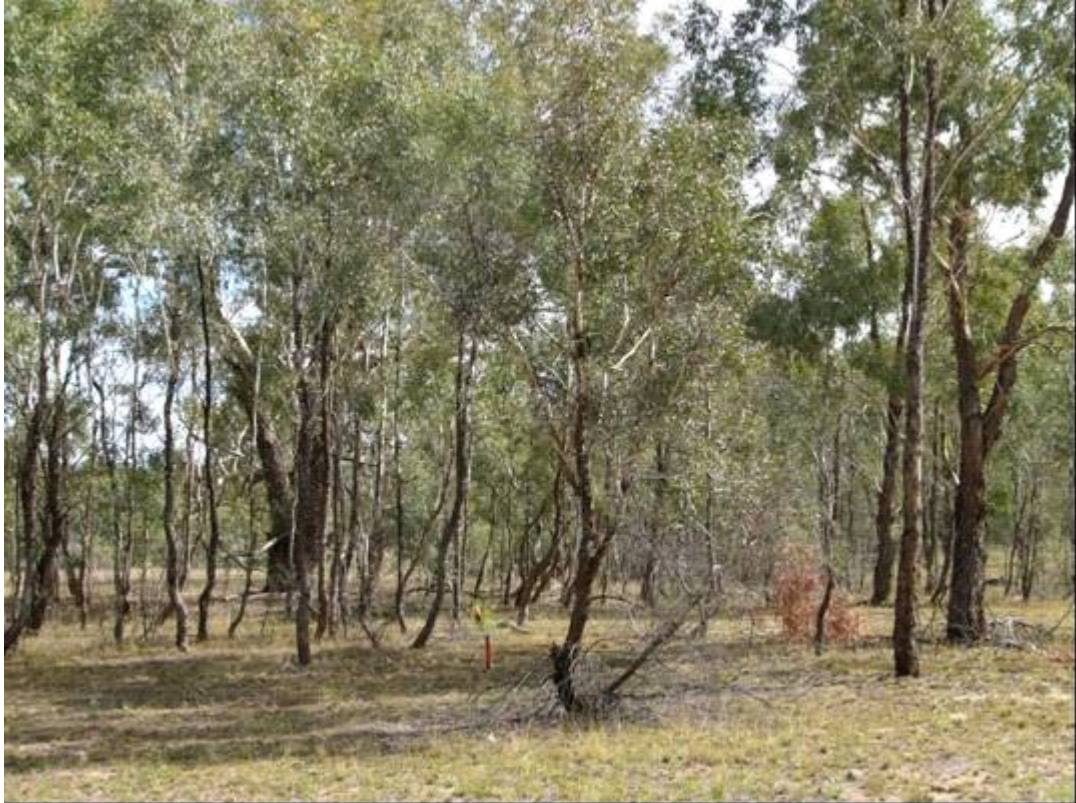
**Photograph**                      Yellow Box – White Box Woodland

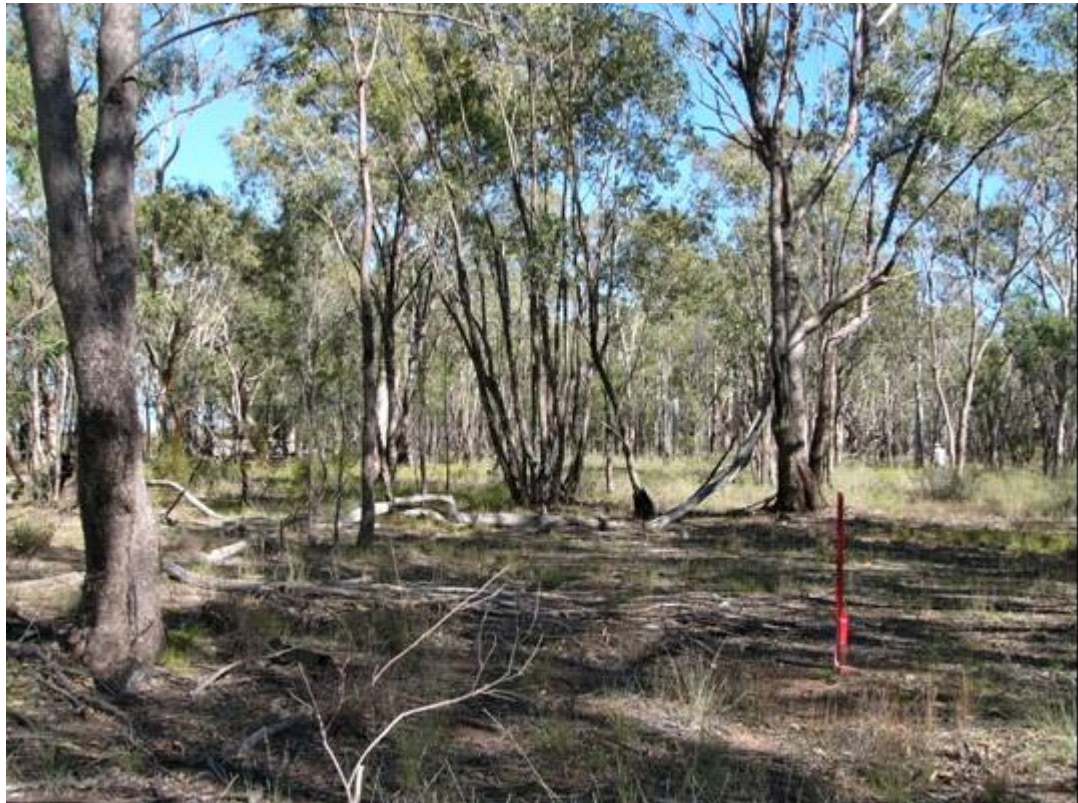
**Photograph** White Box – Inland Grey Box Woodland

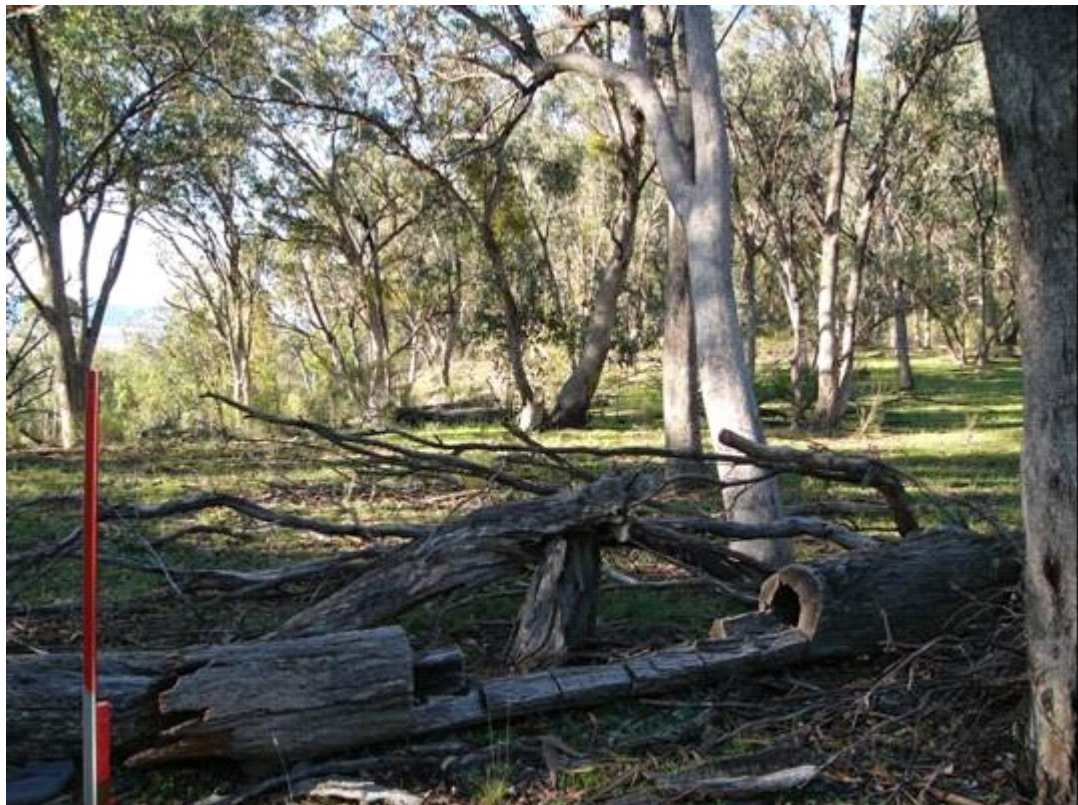
**Photograph**                      White Box Woodland

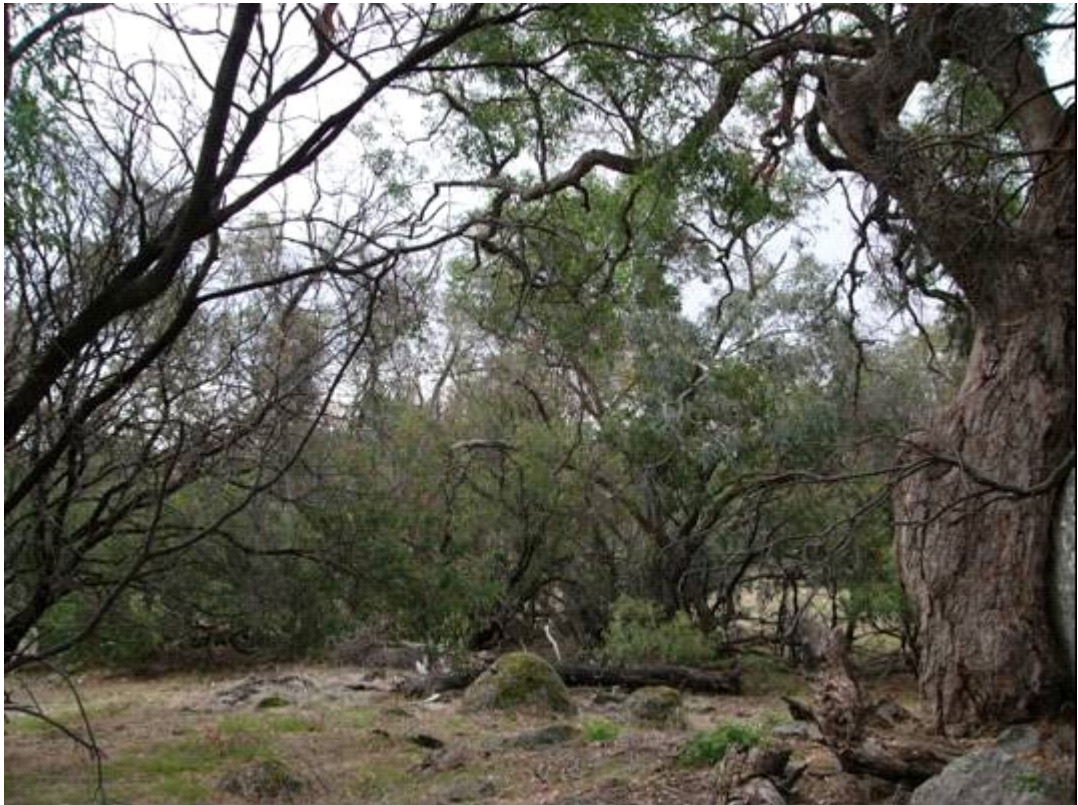
**Photograph**

In the study area this community occurs at one tower site (225) in the western portion of the route and is dominated by White Box (*Eucalyptus albens*) and Red Stringybark (*Eucalyptus macrohyncha*) in association with Roughbarked Apple (*Angophora floribunda*) and Black Cypress Pine (*Callitris endlicheri*).

White Box – Red Stringybark Woodland

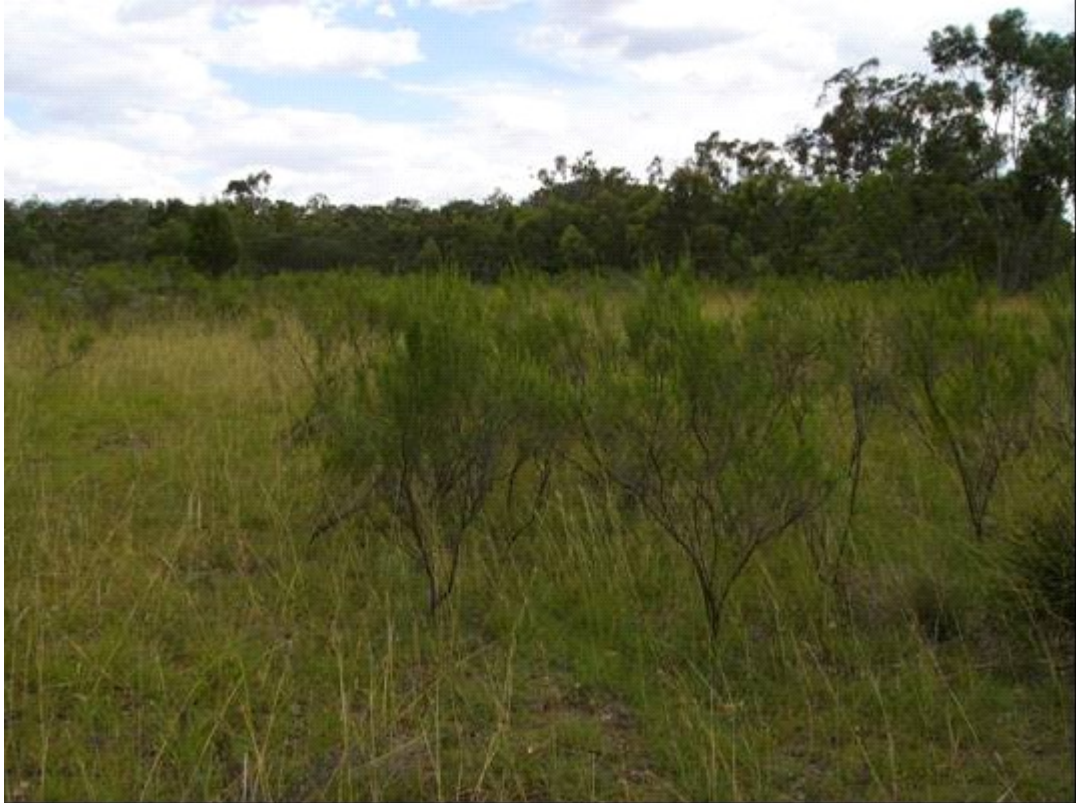
**Photograph**            Partially cleared woodland showing native grasses and regenerating shrubs in the foreground.

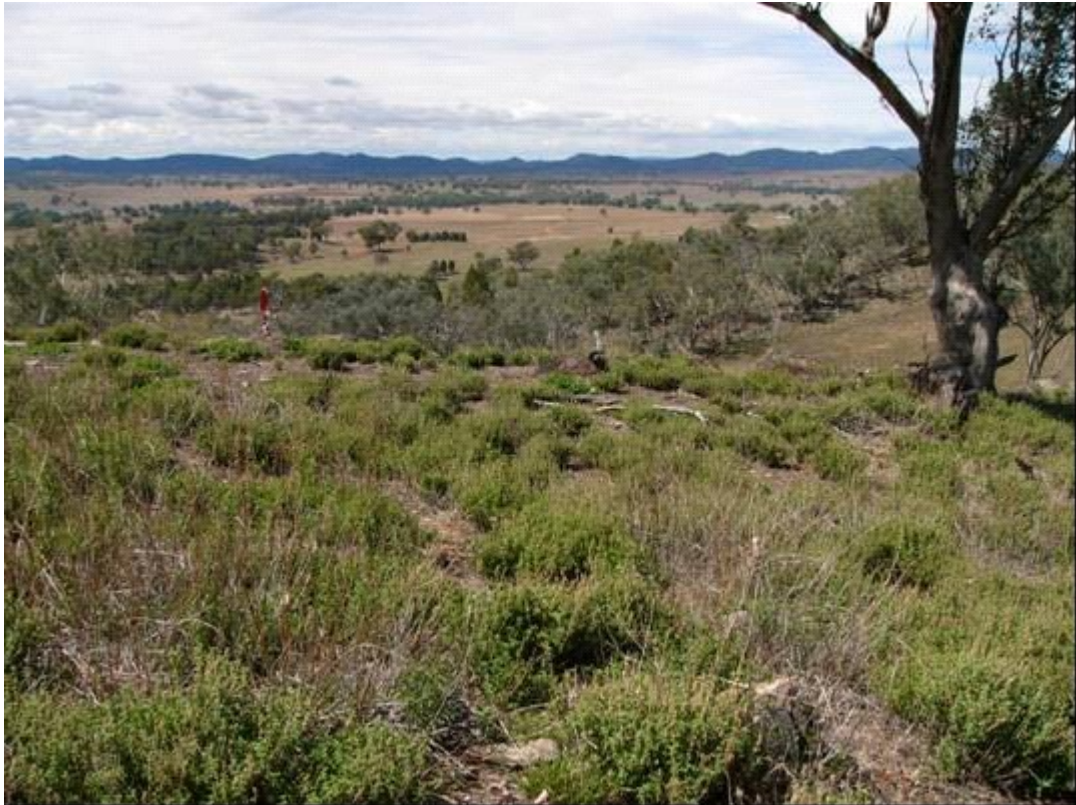
**Photograph** Exotic Pasture with broad leaved weeds including Fieldcress, Horehound and Saffron Thistle.
