## INDIGENOUS AND NON-INDIGENOUS HERITAGE ASSESSMENT:

### WOLLAR - WELLINGTON 330KV ELECTRICITY TRANSMISSION LINE

August 2005

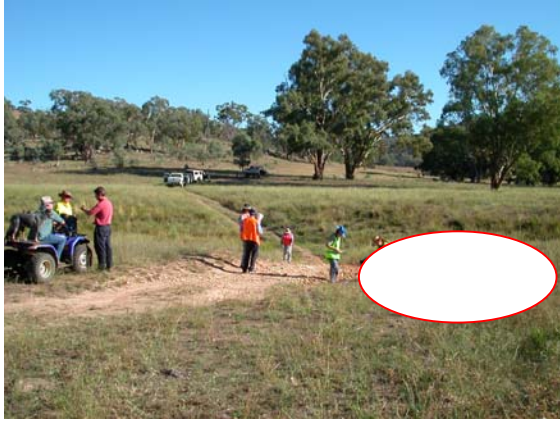
Plate 1:

UC-OS1 with PAD. View Nth. The red circle indicates the general location of the site on the eastern bank of Uamby Creek. Artefacts were observed eroding out of the cutting in the embankment.

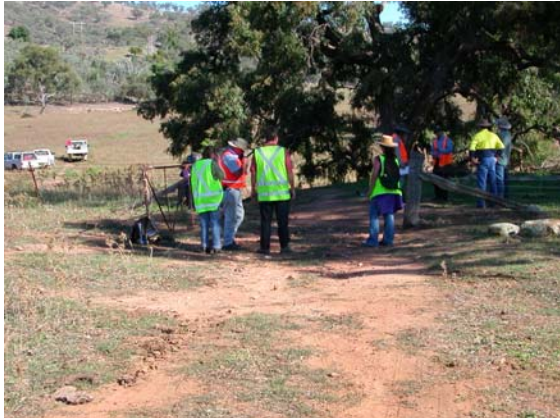
Plate 3:

UC-OS2. View W. Artefacts were observed within the exposure associated with the gate. A tributary of Uamby Creek is immediately after the gates.

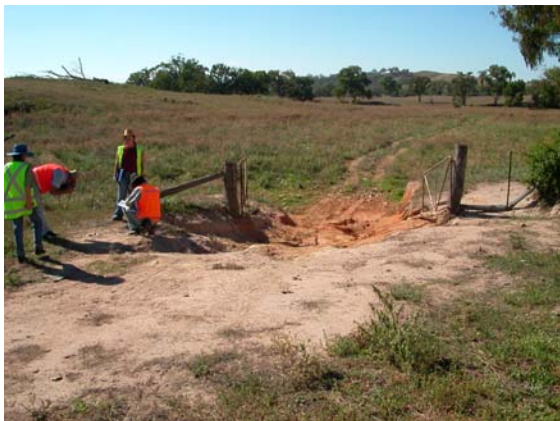
Plate 5:

UC-OS3 with PAD. View SE. The exposed soil indicates the general location of the artefacts observed on the western bank of the tributary to Uamby Creek.

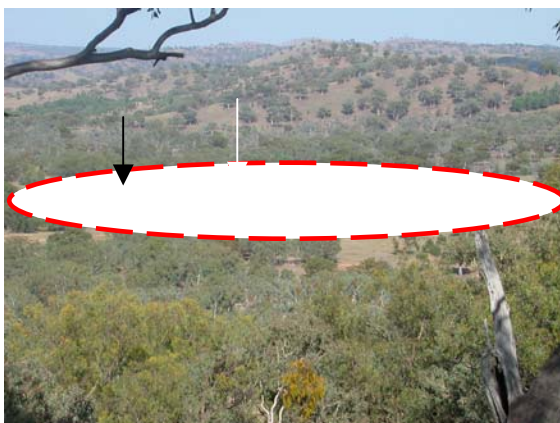
Plate 7:

View S over CR-OS1 with PAD from an adjoining hill top. The red circle gives a rough indication of the potential extent of the site. Several quartz reefs were located in the general vicinity of the black arrow. The white arrow marks the position of Uamby Creek Road.

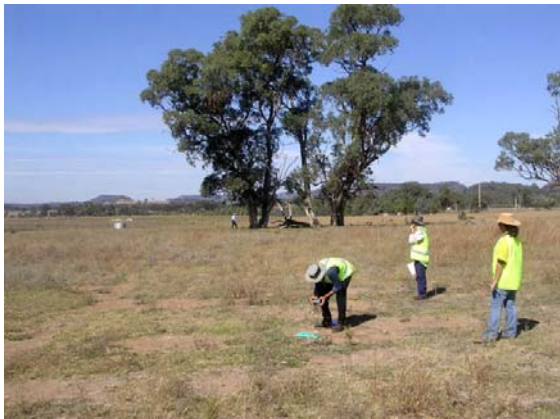
Plate 35:

Open site Wilpinjong Creek WC-OS13 with PAD. View southeast. Surveyor with folder marks the location of the site. Grindstone fragment was found near the surveyor in the background.

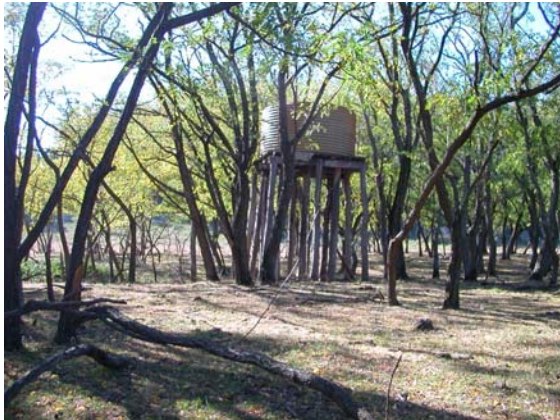
Plate 66:

Standing water tower found in association with a former cottage site. The area is surrounded by a remnant house yard fence and the well is located within 5 m south west of the water tank (in a drainage line).

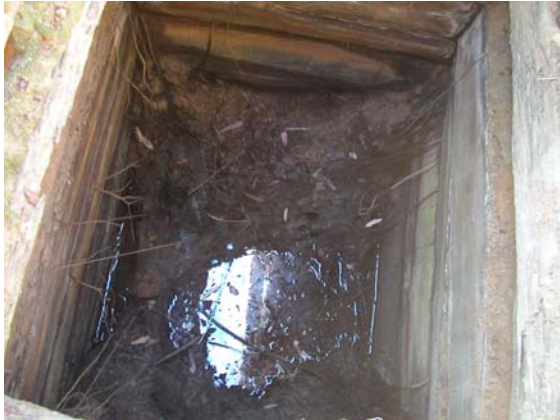
Plate 67:

The well is in reasonable conditions however it poses a hazard to workers.

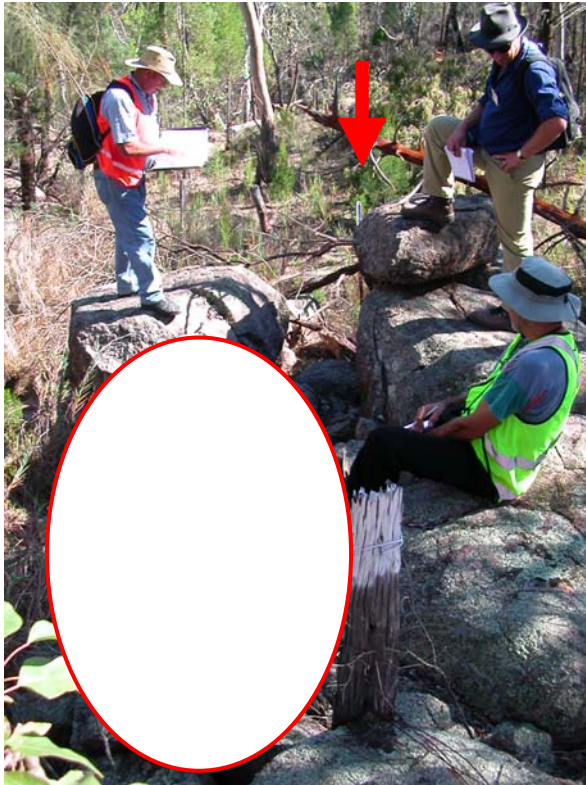
Plate 71:

The rock shelter / wall (?) is located at tower 87 (survey peg defined with an arrow). No explanation can be given as to its origins. The man made part of the structure is delineated within the red circle the other portions (where people are sitting and standing) are naturally occurring. .

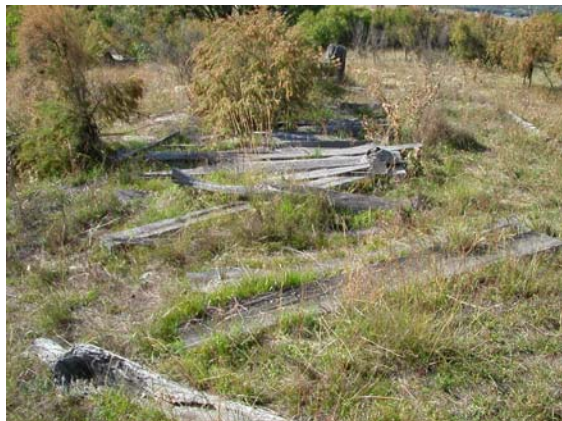
Plate 72:

This former wood cutters site showed marks similar to those made by a hand held chain saw. Chainsaws have not been commercially and widely available for 50 years therefore this area is not a relict as defined by the relevant guidelines.
