HITCHCOCK ROAD SAND EXTRACTION AND REHABILITATION PROJECT, MAROOTA

ANNUAL ENVIRONMENTAL MANAGEMENT REVIEW
2018 - 2019

Sand Extraction and Rehabilitation Project

ANNUAL ENVIRONMENTAL MANAGEMENT REVIEW 2018-2019

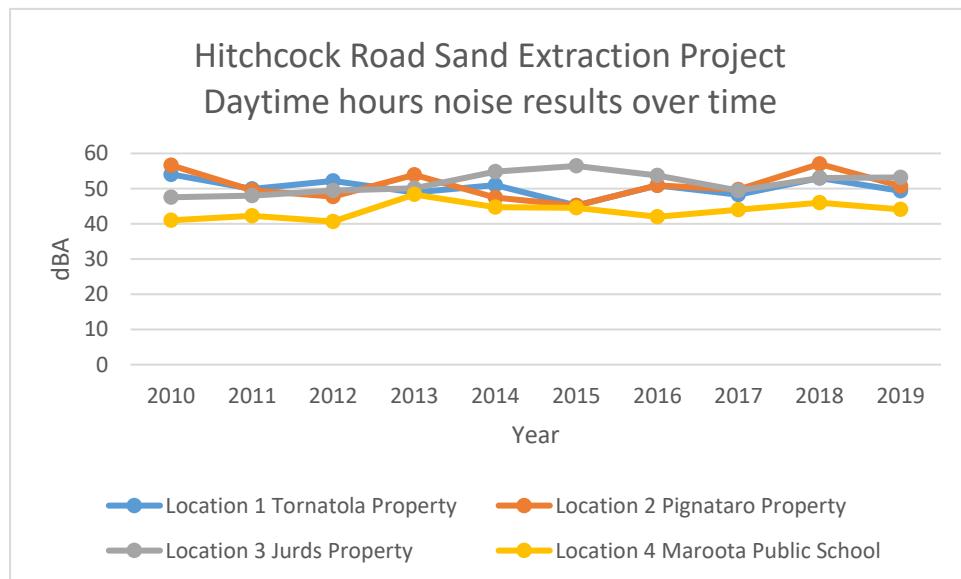
Chart 1. Daytime noise result trends over time

Koikas Acoustics concluded that noise results at all sites had been dominated by traffic or environmental noises during acoustic surveys over the past 12 month period and that quarry noise was either barely audible or inaudible. The site therefore complies with the nominated noise criteria.

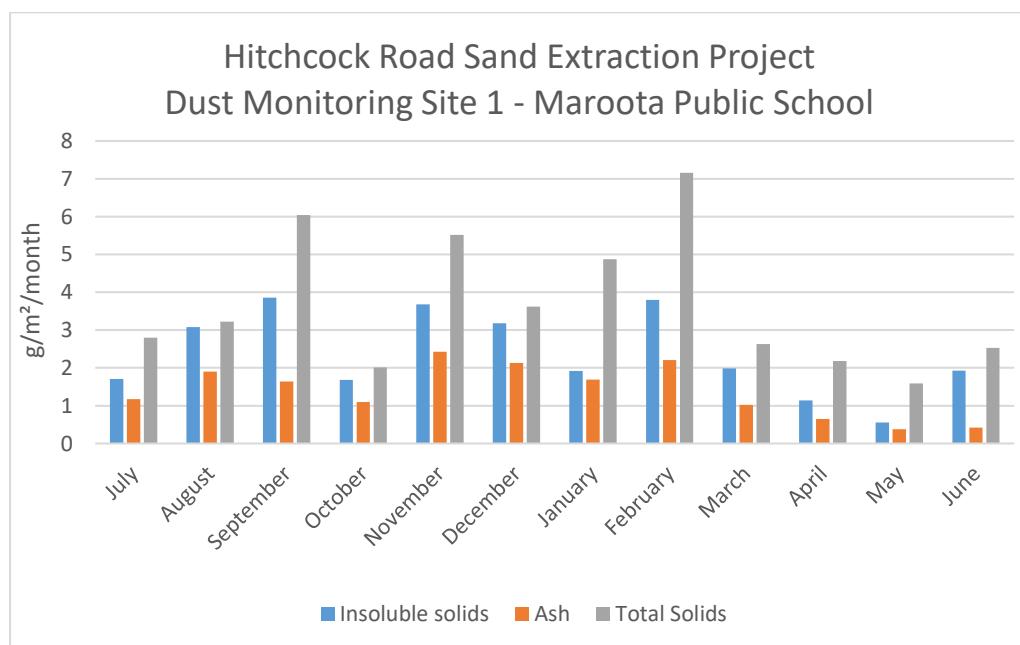
Chart 3. Dust monitoring results at Site 1 – Maroota Public School

- The annual average ambient dust deposition rate (insoluble solids) considered a nuisance criterion is $4 \text{ g/m}^2/\text{month}$. All sites monitored had annual averages below this level. Location 1 – Maroota School average was $2.3 \text{ g/m}^2/\text{month}$ while Location 2 – Hitchcock Road was $2.6 \text{ g/m}^2/\text{month}$.

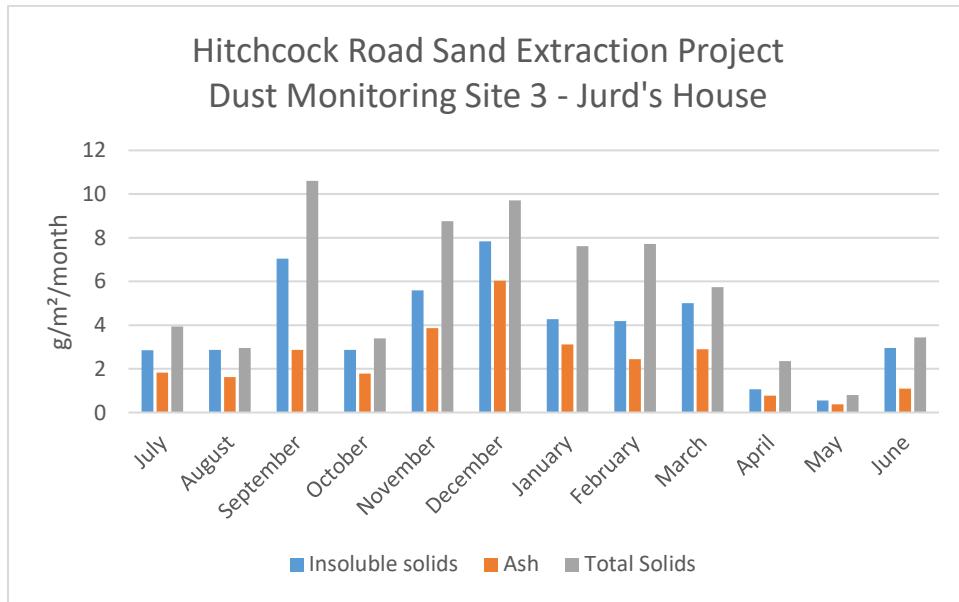
Chart 5. Dust monitoring results at Site 3 – Jurd's House

- The annual average ambient dust deposit rate (insoluble solids) at Location 3 – Jurd's House was $3.9 \text{ g/m}^2/\text{month}$. This is less than the dust nuisance criterion of $4 \text{ g/m}^2/\text{month}$ but higher than it has been in past years. This may be attributed to the location of the monitoring station in the front yard of a dwelling which has no sealed driveway. The extreme dry conditions throughout the monitoring period may have increased the amount of dust generated by the traffic generated by the occupant of the dwelling. The dwelling has since become permanently vacated and the dust monitoring station has been moved across Old Northern Road to the next nearest sensitive receiver. Monthly monitoring results have decreased since this move occurred.

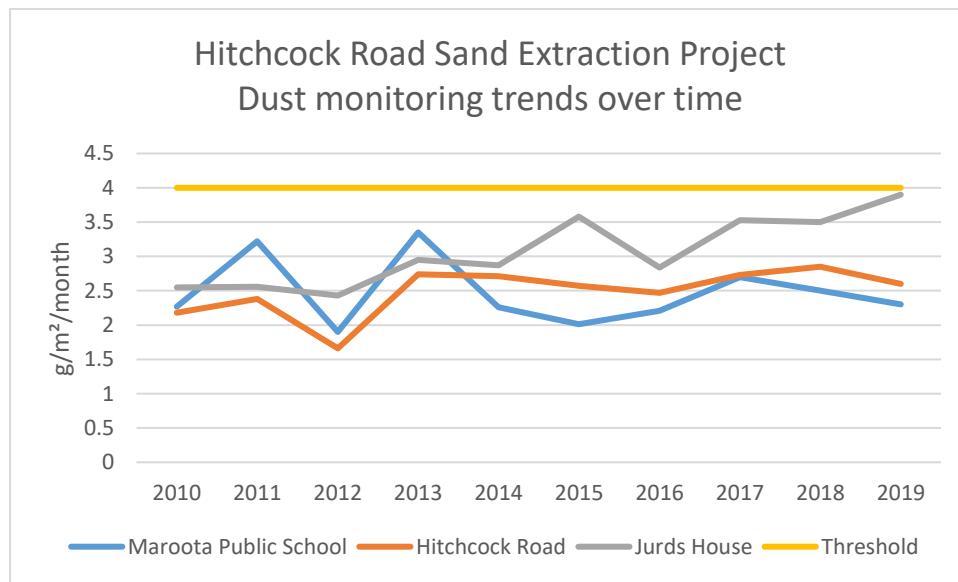
Chart 6. Dust monitoring trends over time – Insoluble Solids

- The insoluble solids portion of deposited dust is expected to be mineral matter with the ash content indicating the level of solid dust particles of inorganic origin such as soil/dust that could be derived from a source such as sand extraction and processing operations.

- The monitoring results are characterised by generally low average levels over extended periods with an occasional spike when high levels are experienced. As the operations from the site are very consistent, the dust generated from the site is consistent subject to weather impacts. Spikes are usually caused by factors unrelated to the quarry such as mowing or horticultural activities near the monitoring station or regional issues such as bush fires and dust storms.

- During the summer months of the reporting period several dust storms were recorded by the Bureau Of Meteorology within the Sydney region which were a result of the drought conditions in Western NSW and strong westerly winds.
