## 8 Appendices

### 8.1 Specific Site Descriptions <sup>[13]</sup>

## 8.2 Appendix 2: Universal MUSIC Calibration

### 8.3 Appendix 3 - Nutrient and Hydraulic Balances for Effluent Management Areas

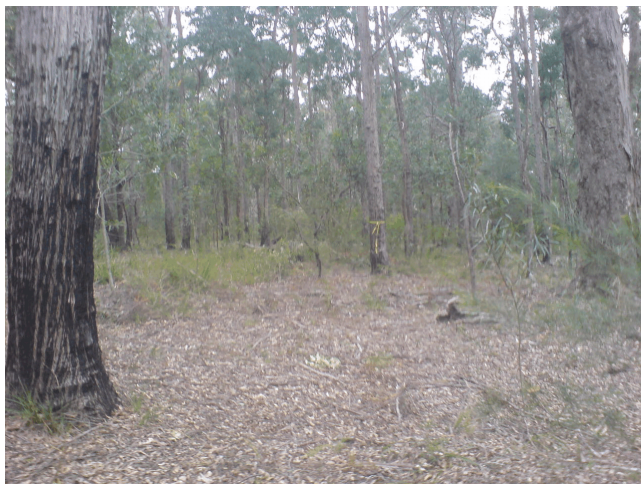
| <b>Lot number represented:</b> | Lot 1 | <b>GPS reference:</b> | 0759610 | 5874920 |

| <b>Slope position:</b> | Gentle side slope | | <b>Slope:</b> | <b>8 %</b> |
| <b>Proximity to watercourses etc:</b> | Wonboyn Lake approx 75 m to east | | | |
| <b>Soil profile:</b> | <b>Depth</b> | <b>Colour, texture, pedality, mottles, fragments</b> | | |
| Layer 1 | 0 - 250 | Grey sandy loam to clay loam, massive | | |
| Layer 2 | 250 - 800 | Orange brown sandy light clay, strongly pedal<br>800+ Bedrock | | |

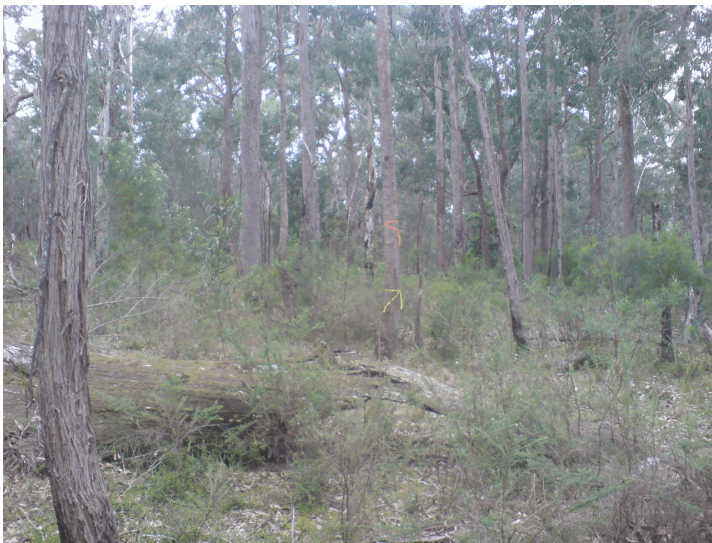
| <b>Lot number represented:</b> | Lots 1 and 2 | <b>GPS reference:</b> | 0759611 | 5874973 |

| <b>Slope position:</b> | mid slope | | <b>Slope:</b> | 8 % |
| <b>Soil profile:</b> | <b>Depth</b> | <b>Colour, texture, pedality, mottles, fragments</b> | | |
| Layer 1 | 0 - 250 | Grey sandy loam to clay loam, massive | | |
| Layer 2 | 250 - 800 | Orange brown sandy light clay, strongly pedal | | |
| Layer 3 | 800+ | Bedrock | | |

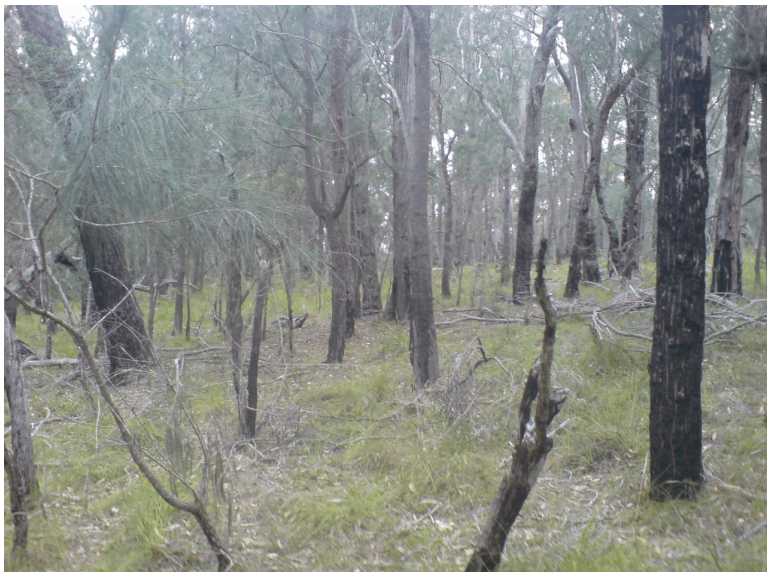
| <b>Lot number represented:</b> | Lots 3 and 4 | <b>GPS reference:</b> | 0759746 | 5875235 |

| <b>Slope position:</b> | Gentle side slope | | <b>Slope:</b> | 5-6 % |
| <b>Soil profile:</b> | <b>Depth</b> | <b>Colour, texture, pedality, mottles, fragments</b> | | |
| Layer 1 | 0 - 250 | Grey sandy loam to clay loam, massive | | |
| Layer 2 | 250 - 400 | Yellow sandy loam, massive | | |
| Layer 3 | 400 - 600+ | Yellow sandy clay loam, moderately pedal | | |

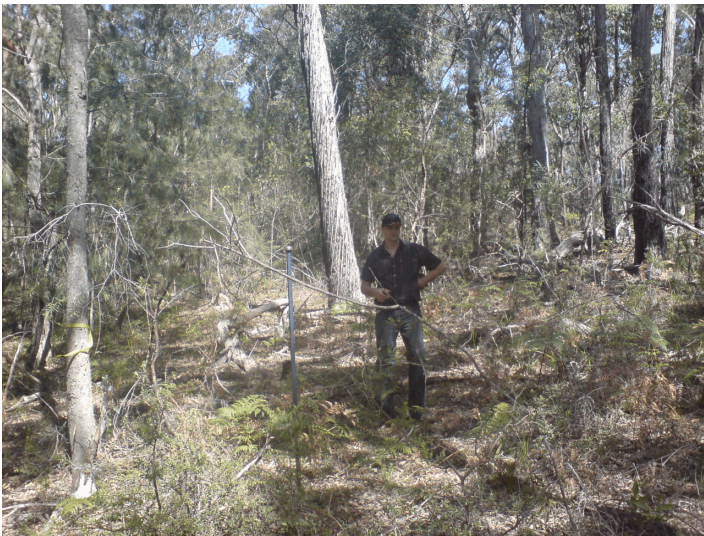
| <b>Slope position:</b> | Mid to lower side slope | <b>Slope:</b> | 20 % | |
| <b>Proximity to watercourses etc:</b> | Wonboyn Lake approx 75 m to east. Propose that EMA be on higher lands near to entrance. | | | |
| Layer 1 | 0 - 250 | Grey sandy loam to clay loam, massive | | |
| Layer 2 | 250 - 800 | Orange brown sandy light clay, strongly pedal | | |
| Layer 3 | | Rock | | |
| <p>Photo, comments</p> <p>EMA will be on higher lands where less steep.</p> | | | | |

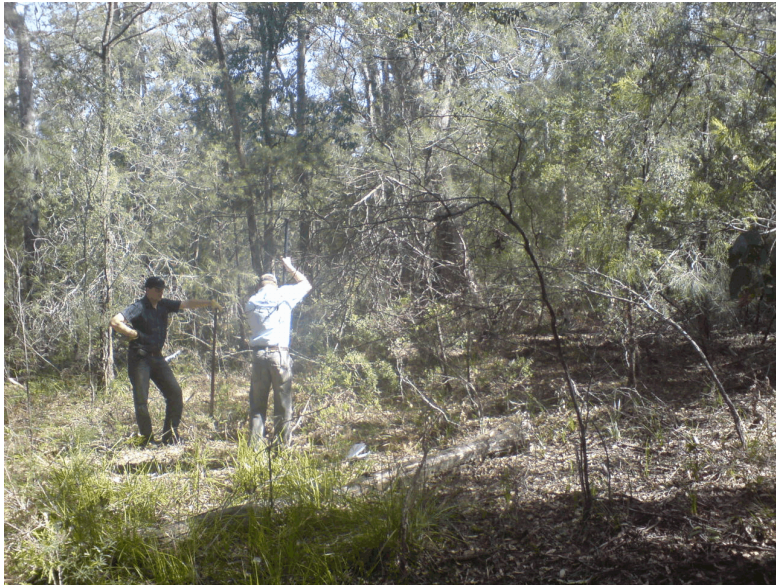
| <b>Lot number:</b> | Lot 7 | <b>GPS reference:</b> | 0759875 | 5875495 |

| <b>Slope position:</b> | Gentle upper side slope | <b>Slope:</b> | 8 % | |
| <b>Soil profile:</b> | <b>Depth</b> | <b>Colour, texture, pedality, mottles, fragments</b> | | |
| Layer 1 | 0 - 300 | Grey sandy loam, massive | | |
| Layer 2 | 300 - 700 | yellow brown sandy clay loam, moderately pedal | | |
| Layer 3 | 700 -800+ | yellow brown sandy light clay | | |
