Visy Pulp & Paper Tumut Mill

Environmental Compliance and Monitoring Report 2021

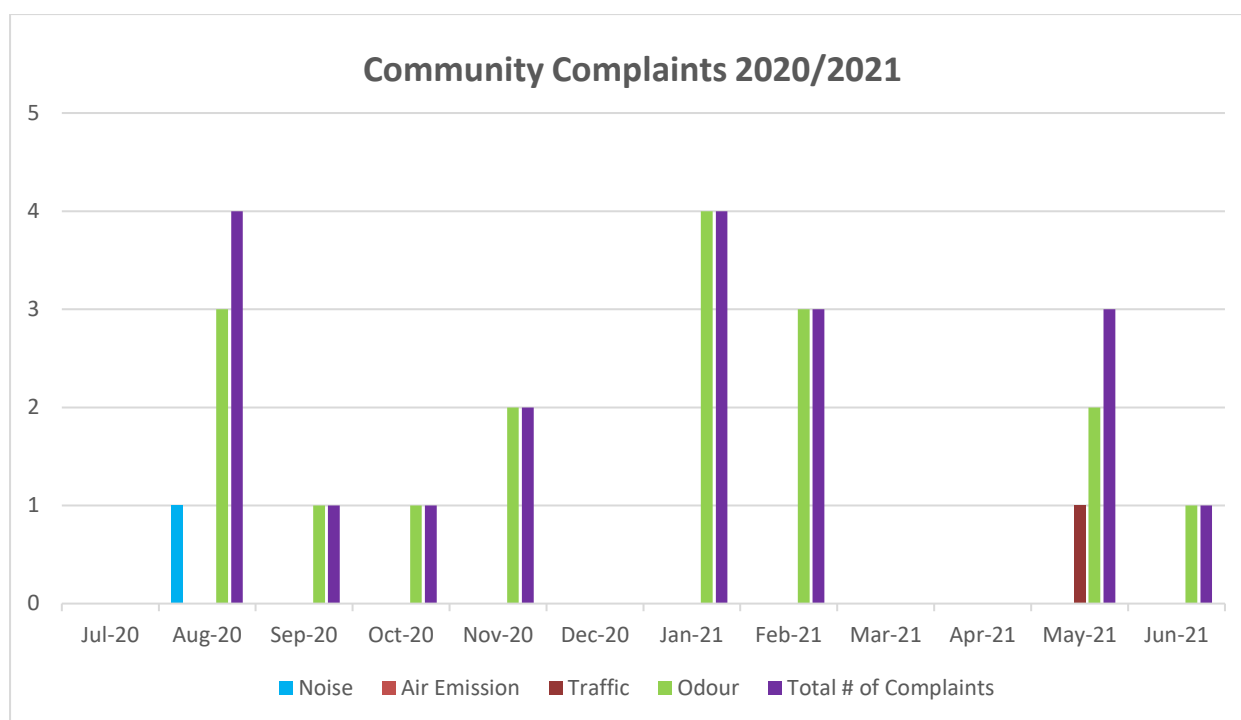
Figure 4: Community complaints for 2020 – 2021

The total complaints received during the reporting period have been tabulated and are presented below, Figure 4. Comparisons with historical monthly complaints are illustrated in Table 5.

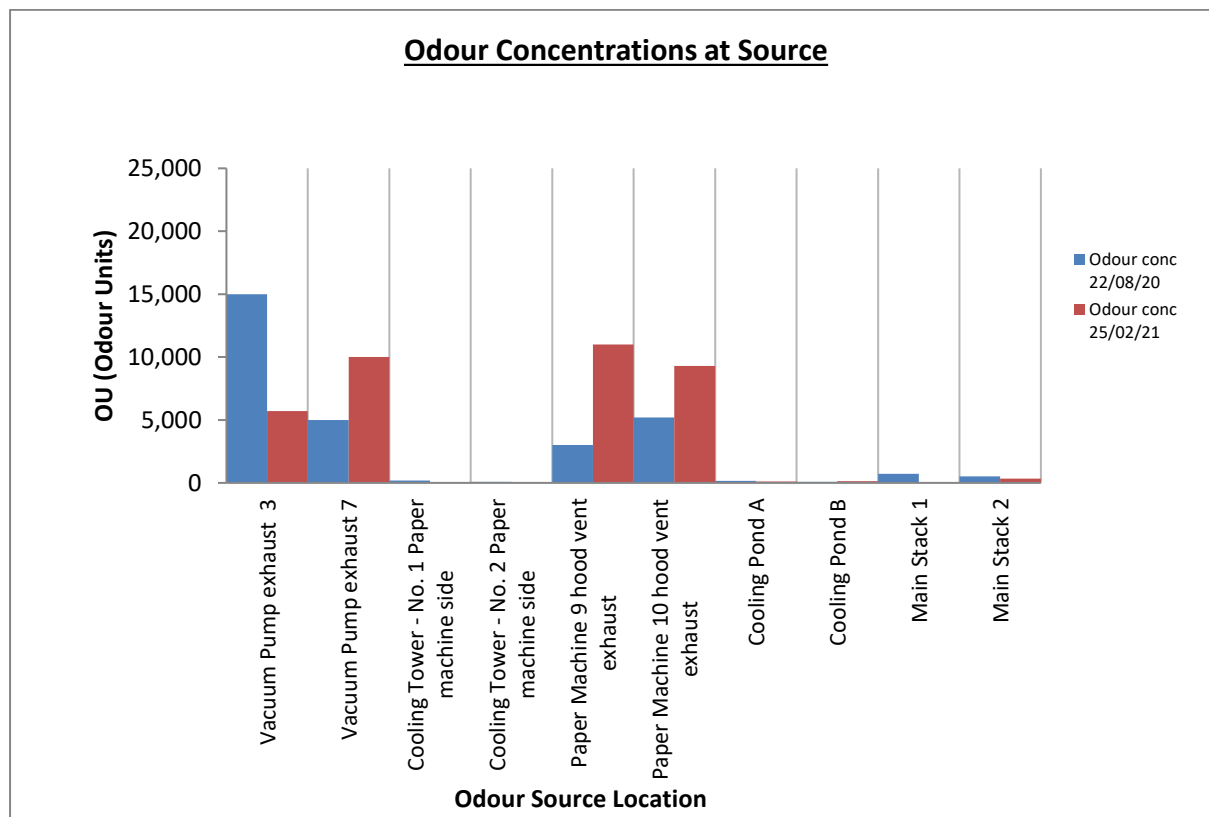
Figure 5: Odour concentrations at source

The odour concentrations at each source and sampling date are shown below in Figure 5.
