Visual Assessment of Proposed Cell Structure

Pasminco Cockle Creek Smelter Site, Boolaroo

June 2006

VISUAL ASSESSMENT OF PROPOSED CELL STRUCTURE ON PASMINCO COCKLE CREEK SMELTER SITE, BOOLAROO

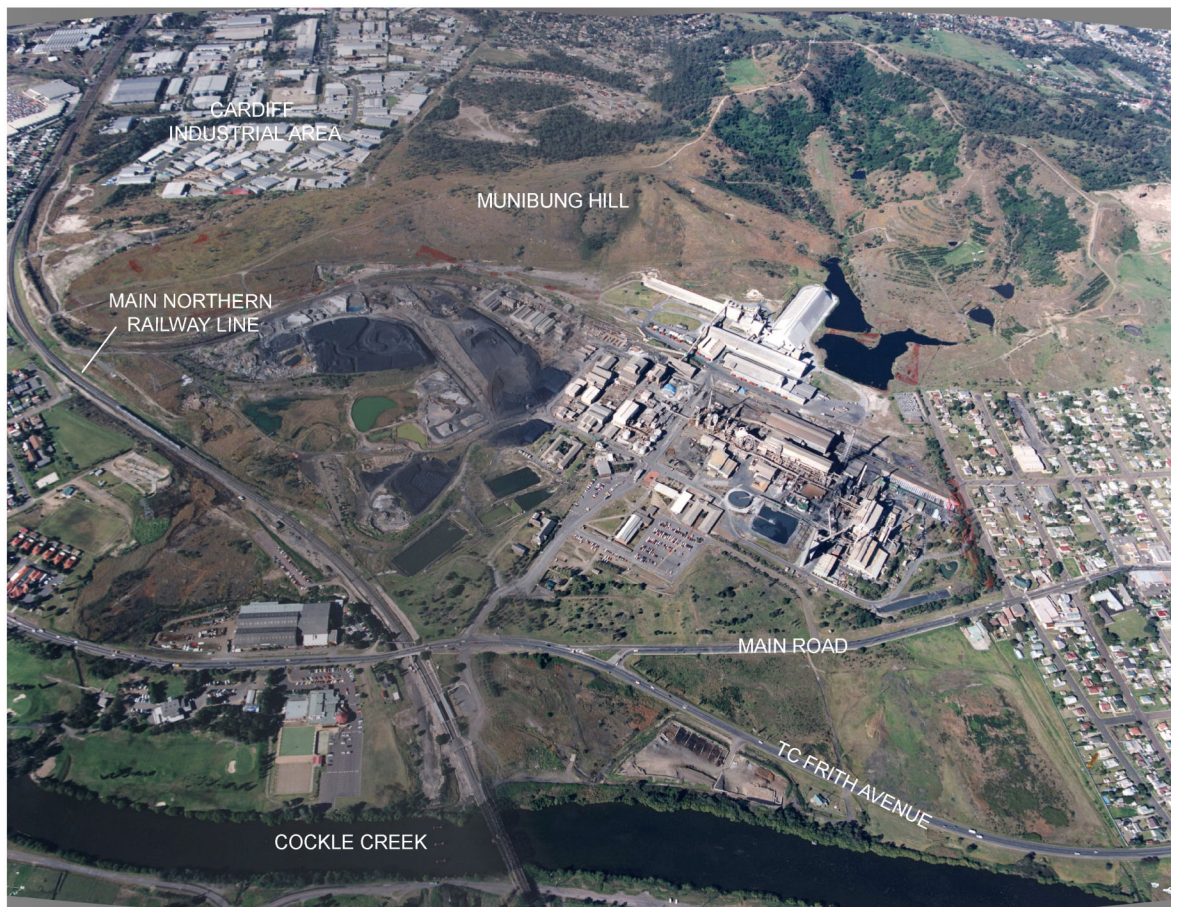
Figure 1: Aerial view of the PCCS site, Boolaroo (1998) with industrial buildings, viewed to the east

The PCCS and Incitec-Pivot sites are located at the base of the north and north-western slopes of Munibung Hill, north of the township of Boolaroo and east of Cockle Creek as shown on Figure 1.

The PCCS operations on the site ceased in September 2003. Figures 1 and 2 show the extent of the buildings and structures existing at closure. Since its closure and as a precursor to the proposed site remediation, most of the main structures have been demolished. A small number of buildings will remain on-site for the present including the STS building (currently used as the site office), the Old Laboratory Building on Fotheringham Road, the Effluent Treatment Plant (ETP), the Gatehouse and a few small work sheds/switch rooms.

Figures 1 and 2 also show that there are two large existing slag stockpiles within the PCCS site which are covered in high density black plastic (HDPE). The eastern stockpile is to remain on site in its present location and the western stockpile is to be relocated to join into the eastern stockpile as part of the ultimate cell configuration. Both of the existing stockpiles are visually prominent at present due to their size and the black colour of the HDPE covers which contrasts strongly with the background views. Since the stockpiles are to be centrally located with the containment cell, this visual assessment focuses on how they may be viewed now and in the future.

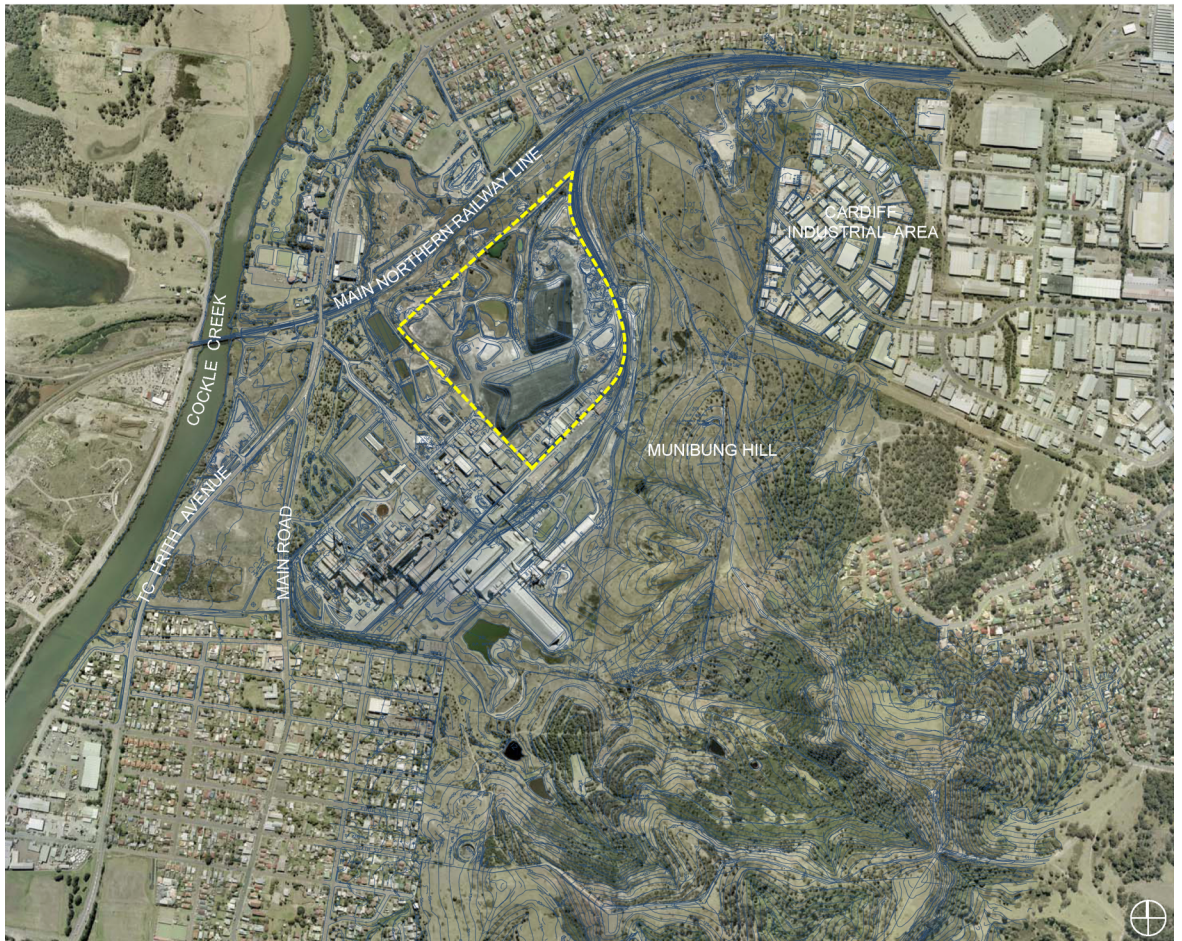
Figure 2: Direct aerial view of the PCCS site with outline of the site and future cell structure (shown dotted)

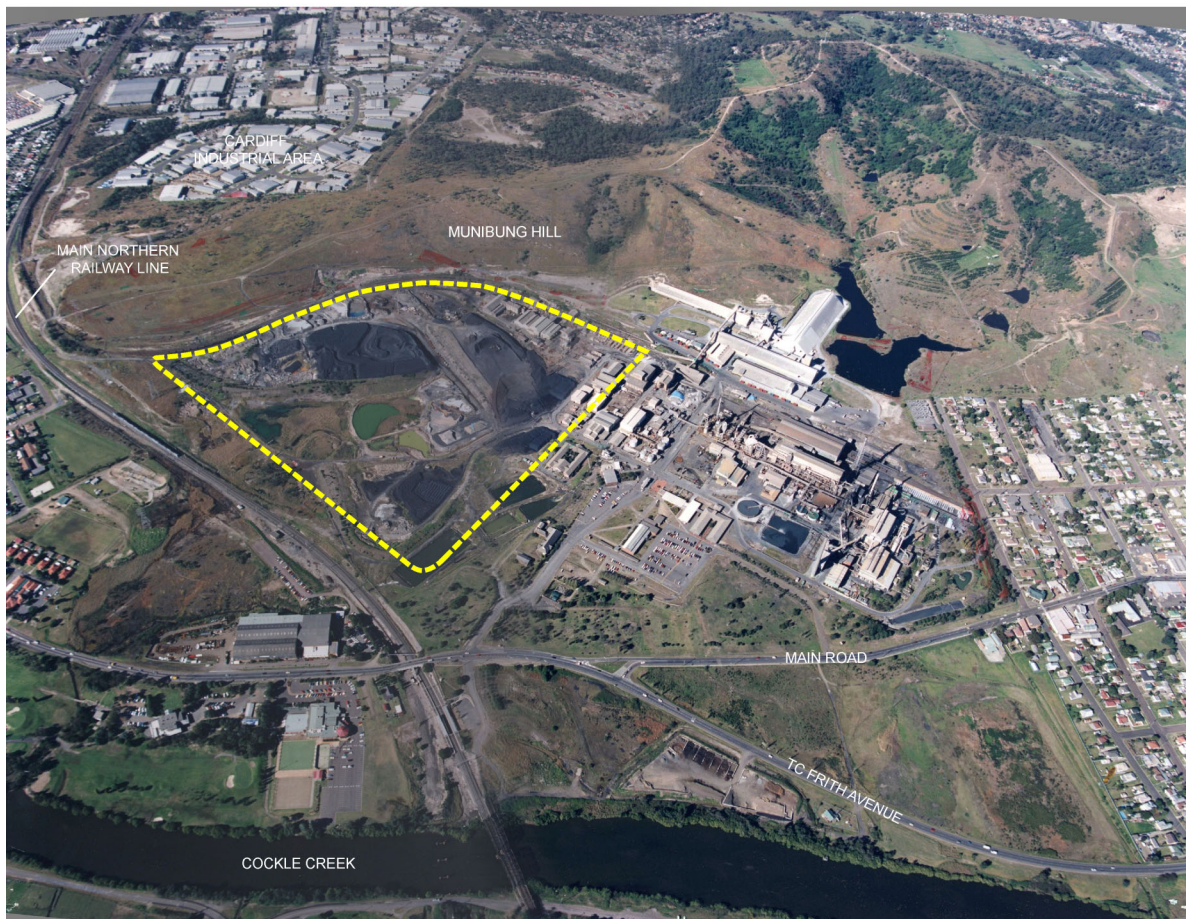
Figure 3: Aerial view of the PCCS site illustrating proposed footprint of future cell (shown dotted)

The existing western slag stockpile will be merged with the eastern stockpile and together with the other contaminated materials they will be formed (by being compacted in layers) into one large containment cell. Figure 3 shows the approximate location of the final cell as currently envisaged. While the exact cell size and location is yet to be finalised, the configuration shown in this report is considered to be generally representative of the ultimate cell configuration.

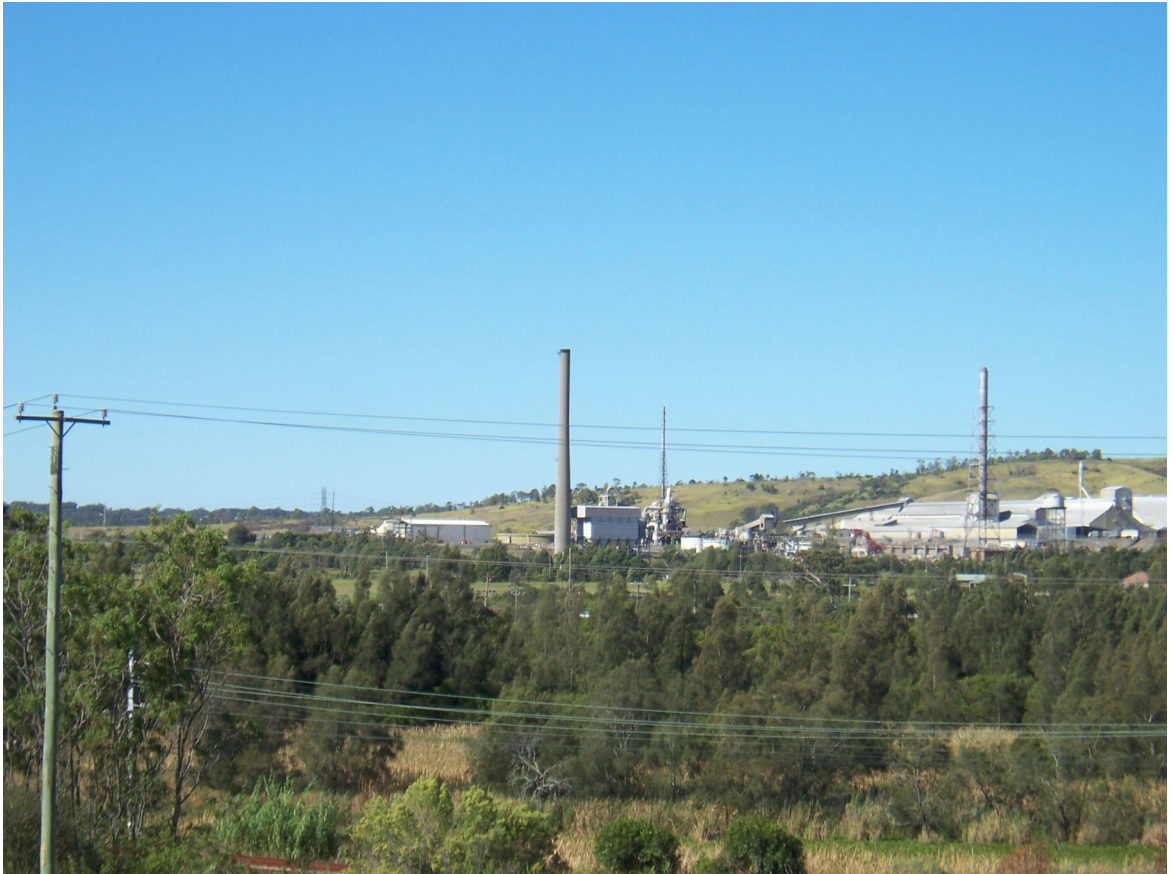
Photo 1: View of the PCCS site from Powerhouse Road, south-west of the site, west of Cockle Creek and Main Northern Railway line prior to demolition.

From Powerhouse Road, south-west of the site, west of Cockle Creek and the Main Northern Railway Line. This is a long distance view about 1.7km from the proposed cell as shown in Photo 1. The cell is not noticeably visible from this vantage point due to the distance, topography and the vegetation.

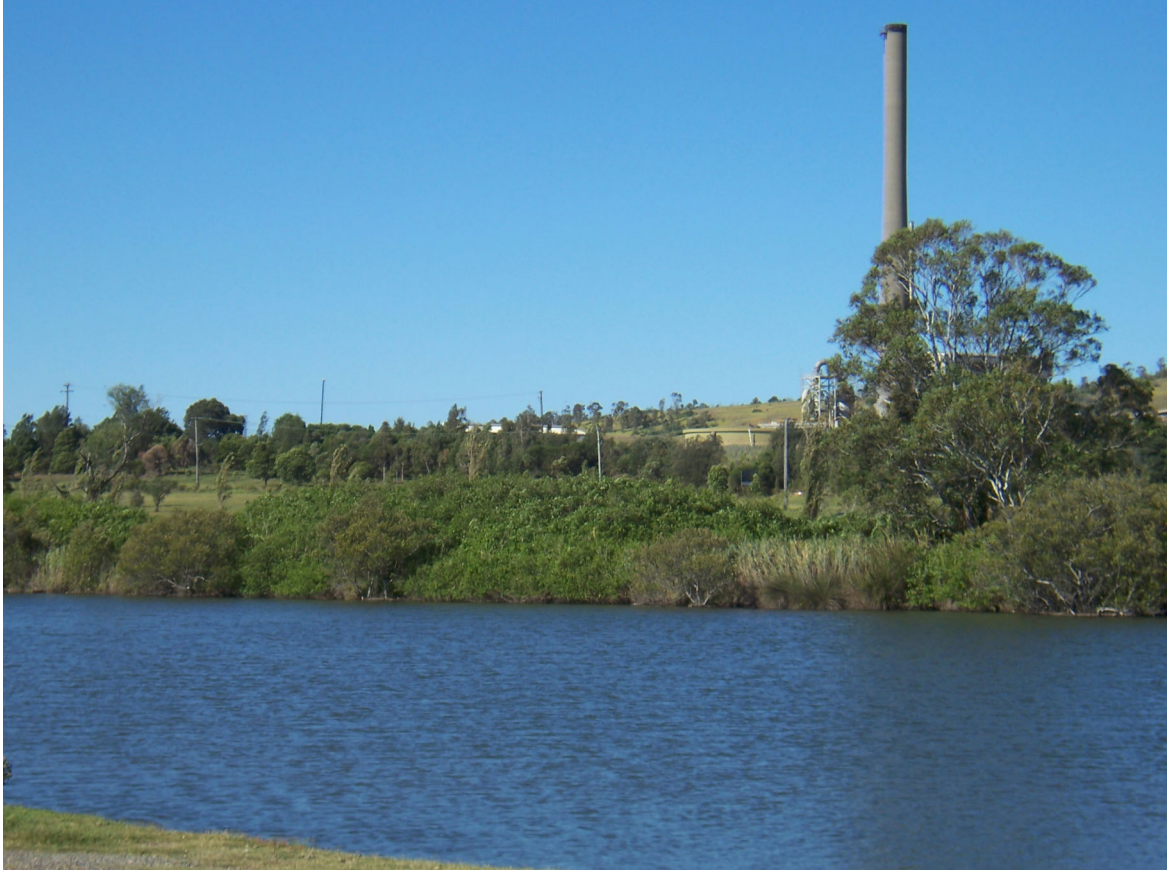
Photo 2: View of the site from Racecourse Road, south-west of the site directly west of Cockle Creek.

From Racecourse Road, south-west of the site directly west of Cockle Creek. This is a long distance view about 1.1km from the proposed cell as shown in Photo 2. The cell is not visible from this vantage point due to trees and shrubs along the eastern foreshore of the creek.

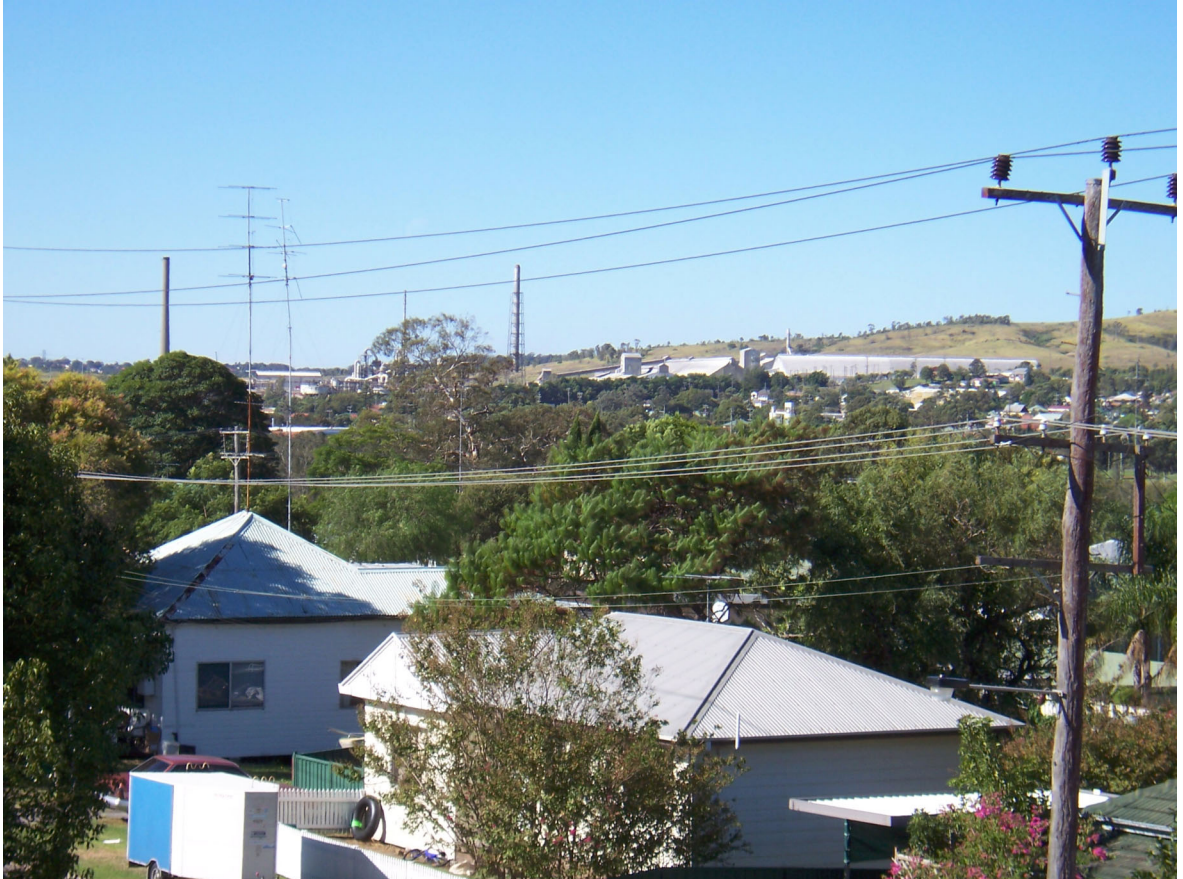
Photo 3: View to the south-west of the site from Teralba railway bridge.

From Teralba railway bridge to the south-west of the site. This is a long distance view about 2.2km from the proposed cell as shown in Photo 3. The cell is not visible from this vantage point due to distance, topography and tree cover.

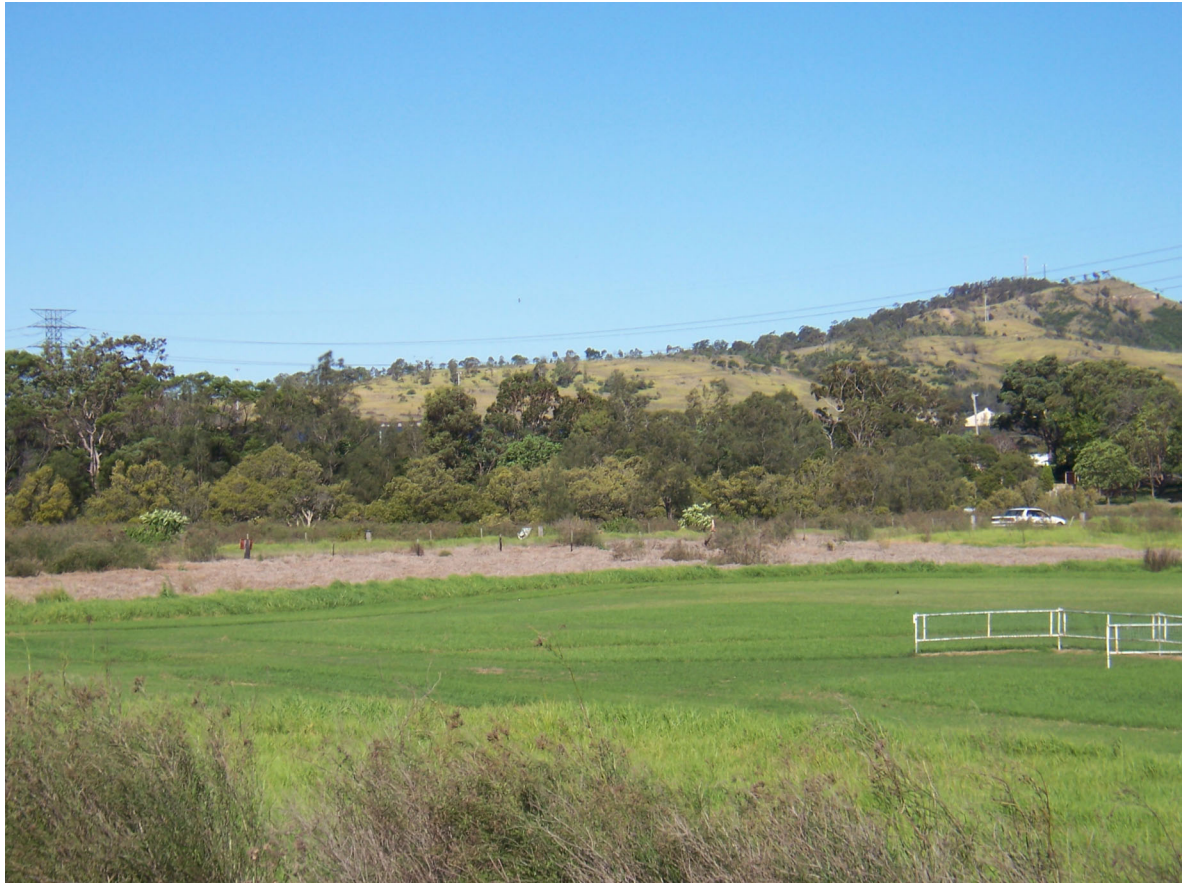
Photo 4: View of the site from Griffen Road, north-west of the site.

From Griffen Road, north-west from the site. This is a medium distance view about 0.75km from the proposed cell as shown in Photo 4. View of the cell is screened by existing mature trees and shrubs planted along the site's northern boundary.

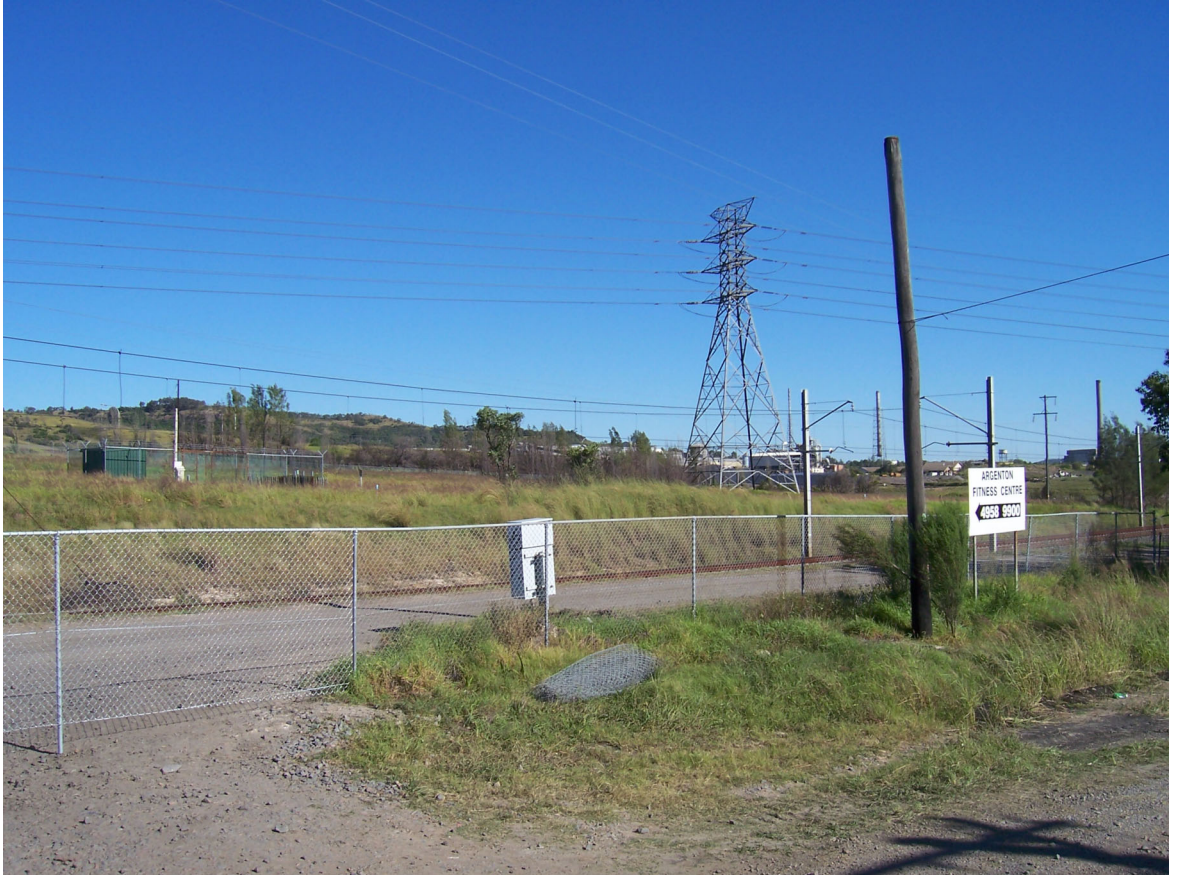
Photo 5: View of the site from Victoria Street, Argenton, north of the site.

From Victoria Street Argenton, north of the site. This is a near distance view about 0.15km from the proposed cell as shown in Photo 5. The cell view will be screened by the railway embankment and by existing trees and shrubs along the site boundary.

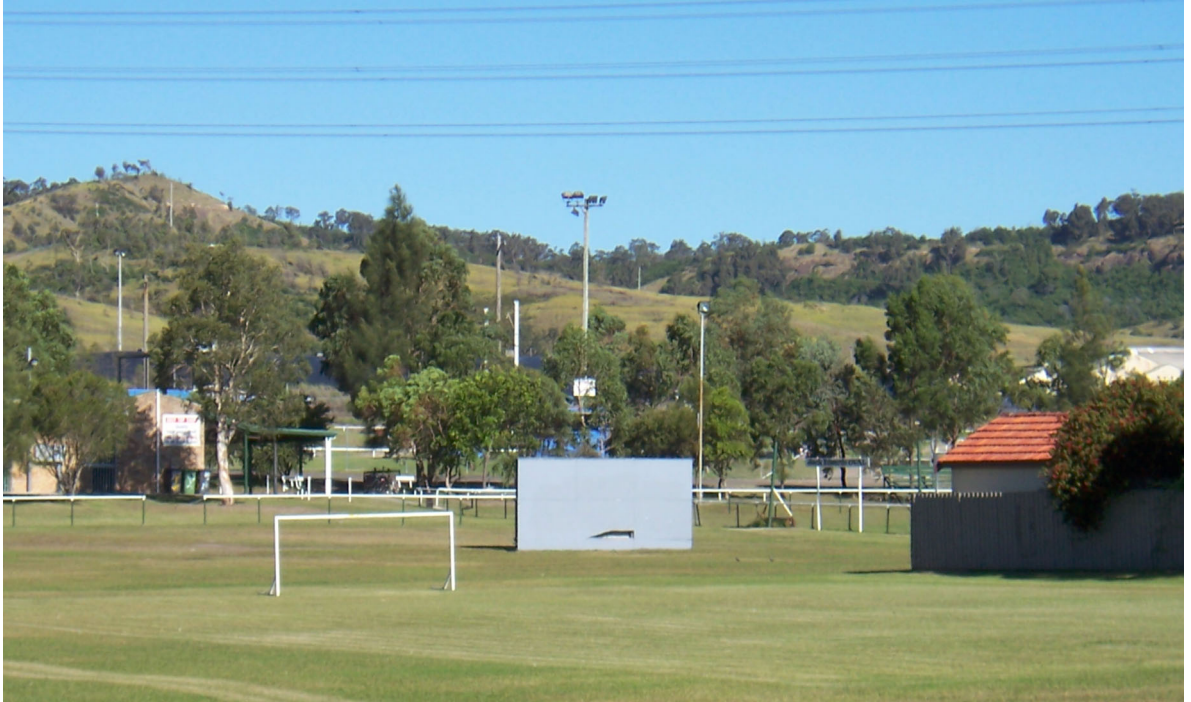
Photo 6A: View of the site and existing cell structure (slag stockpile) from corner of Mary Street and Lake Road.

From the corner of Mary Street and Lake Road north-west of the site. This is a near view about 0.45km from the proposed cell as shown in Photo 6. The cell will be directly visible from this location.

The locations as shown on Photos 6A, 7A, 8A and 9A are representative of viewpoints which will be available to the community. Photos 10A and 11A show view of the proposed cell structure from within the site. The corresponding photos 6B, 7B, 8B, 9B, 10B and 11B are montages which show how the proposed site landscaping will greatly diminish the visual impact of the cell from these locations. It is considered that despite the cell representing a major change in the local landform, that its visual impact will be relatively low from viewpoints external to and within the site.

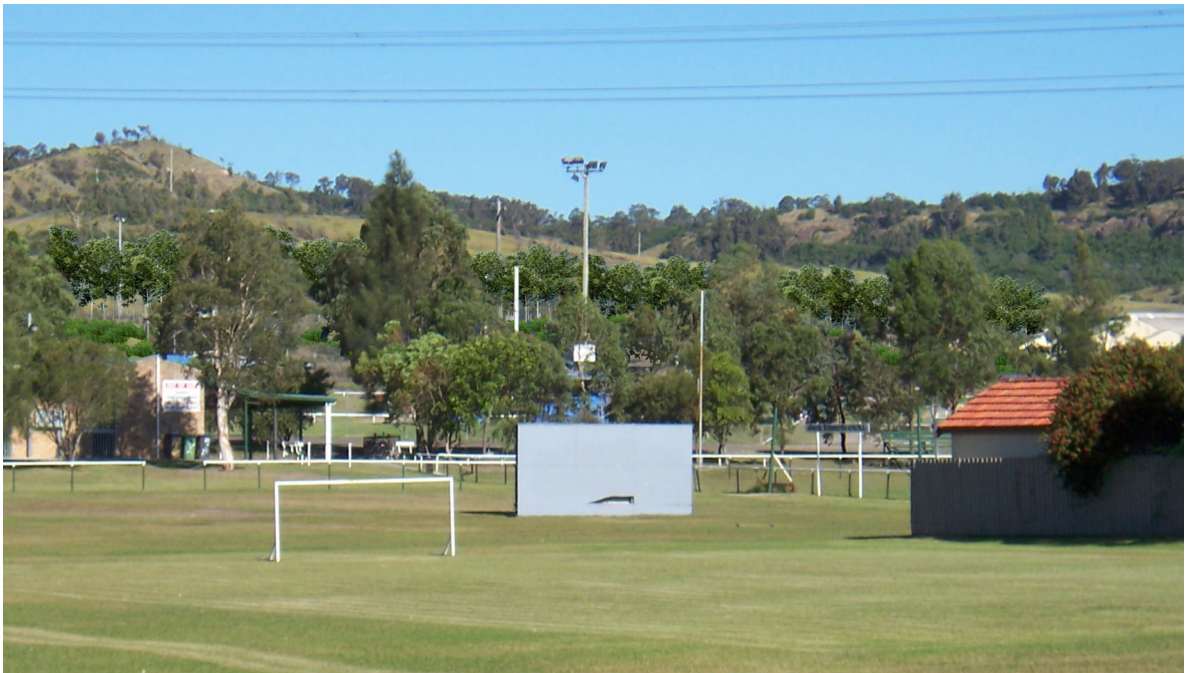
Photo 6B: View of the site and proposed cell as above, with vegetation cover.

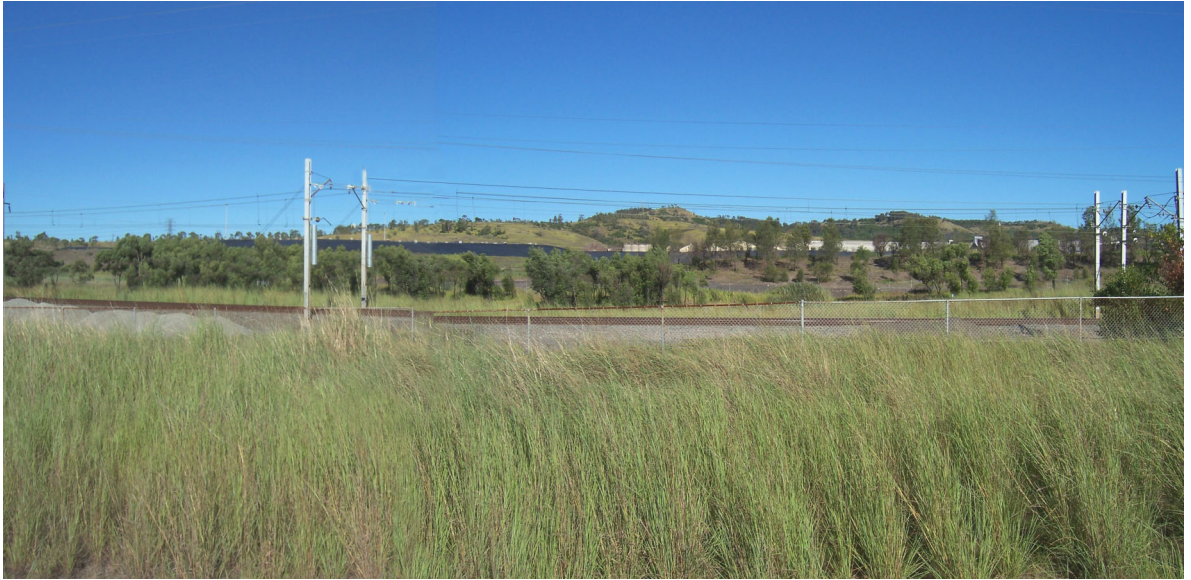
Photo 7A: View of the site and existing cell from Kindyerra Park, west of the site.

From Kindyerra Park, west of the site. This is a near view about 0.2km from the proposed cell. The upper part of the cell will be clearly visible from this location as seen in Photo 7.

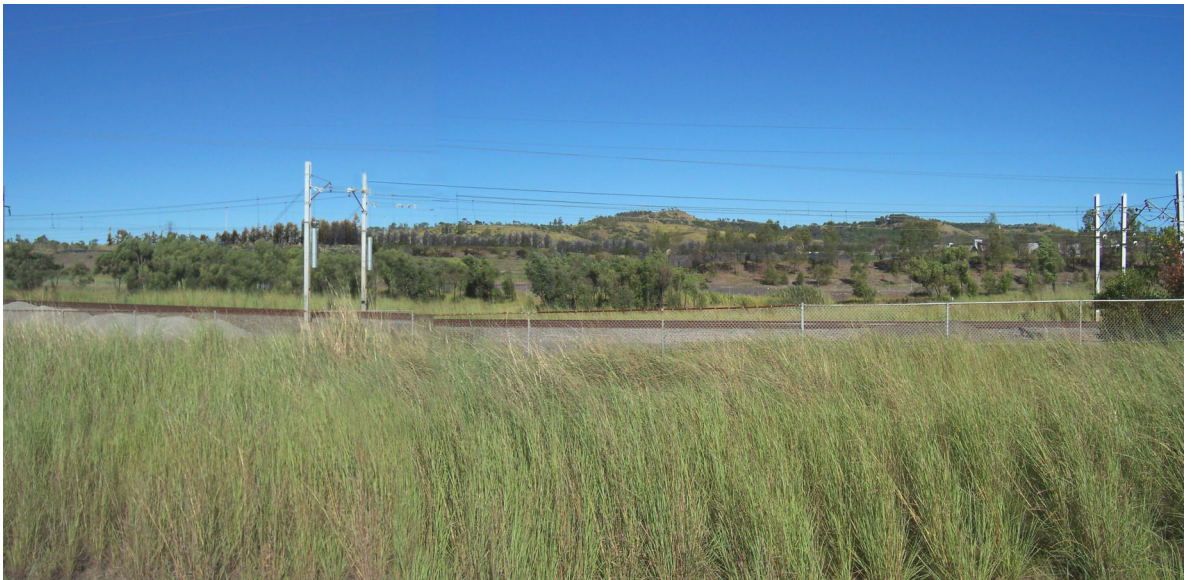
Photo 7B: Same view of the cell structure as above, from Kindyerra Park west of the site, with vegetation cover.

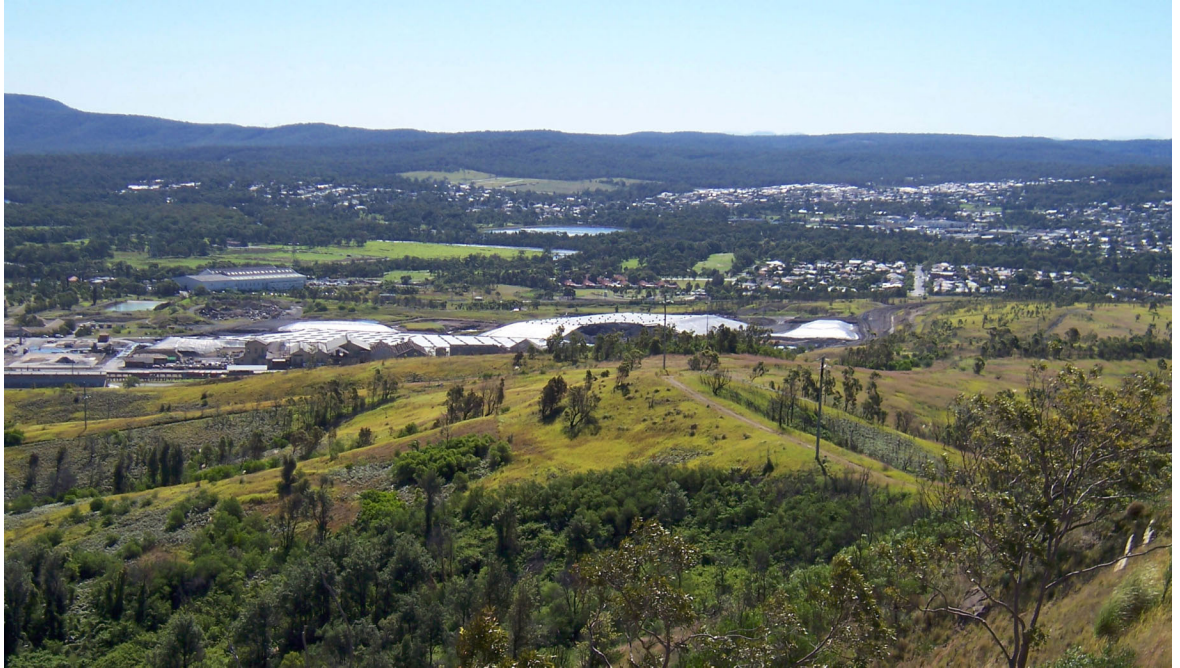
Photo 8A: View of the site and existing cell structures from the upper ridges of Munibung Hill, to the east. Buildings in the cell foreground will be demolished.

From Munibung Hill, south-east of the site. These are near views of 0.48km and 0.2km respectively. The whole cell is clearly seen from these locations as shown in the Photos 8 and 9.

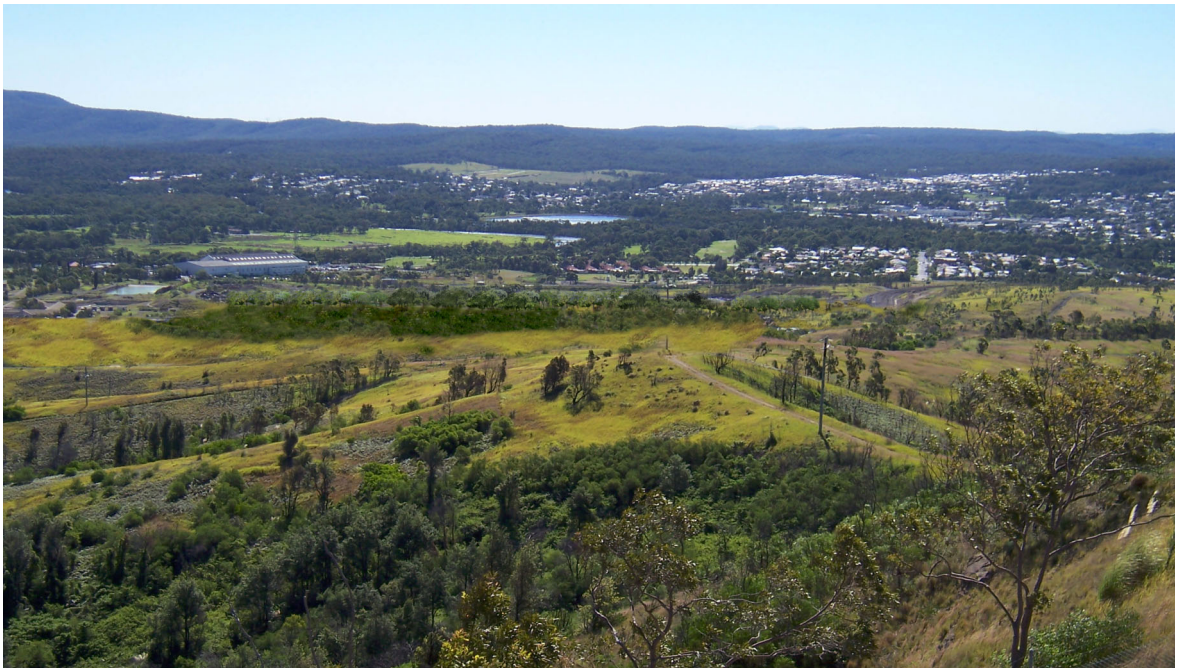
Photo 8B: Same view of the proposed cell structure.

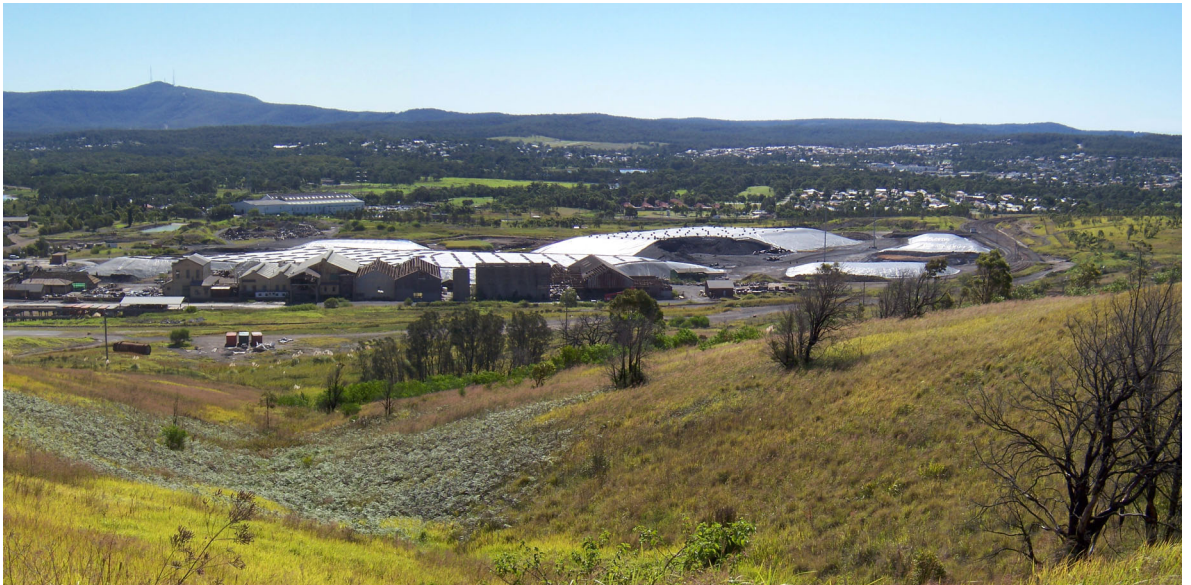
Photo 9A: View of the site and existing cell structures from the lower slopes of Munibung Hill, to the east. Buildings in the foreground of the cell will be demolished.

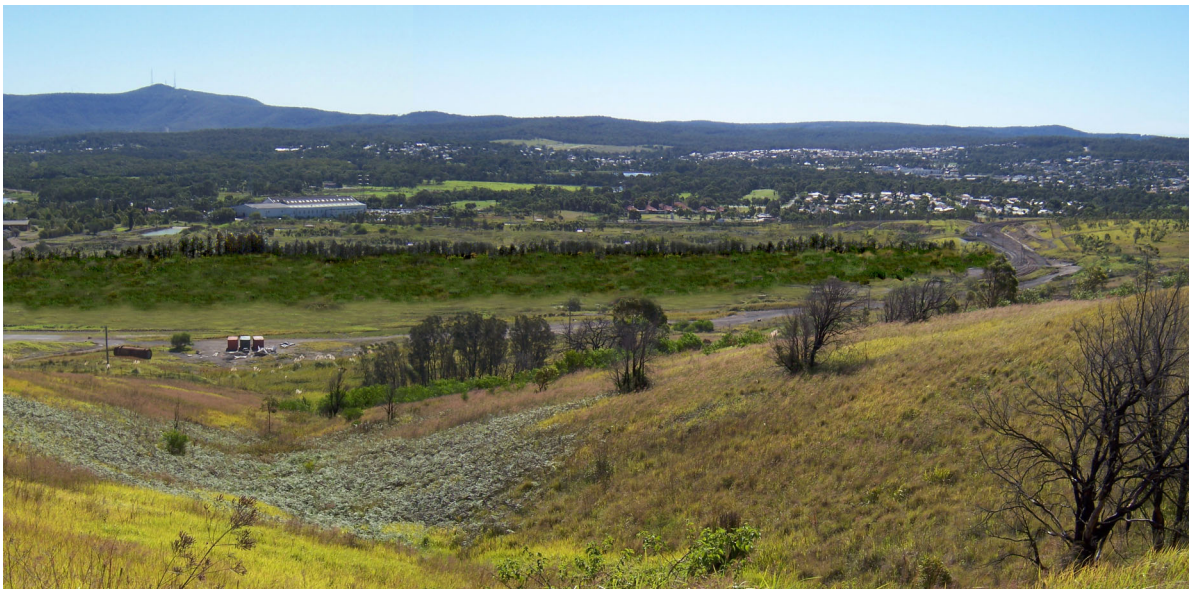
Photo 9B: Same view of the site with proposed cell structure.

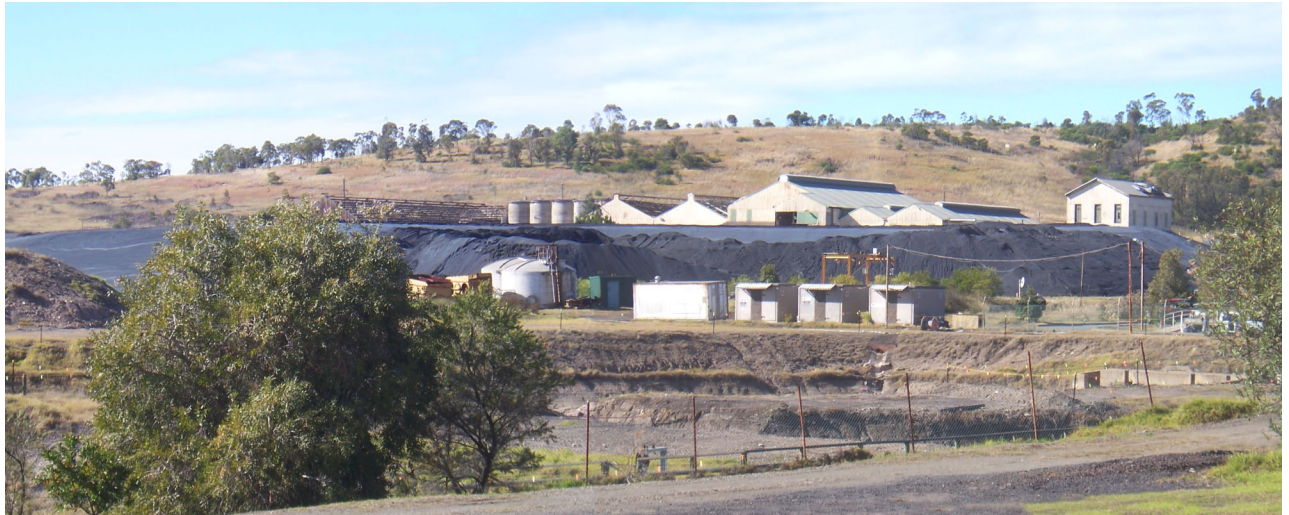
Photo 10A: View within the PCCS site behind the former Laboratory building, northwards towards the cell structure with existing buildings to be demolished.

From within the PCCS site, behind the former Laboratory building (to be retained for heritage purposes), located on the main internal access roadway. The cell structure is clearly seen from this location as shown in Photo 10.

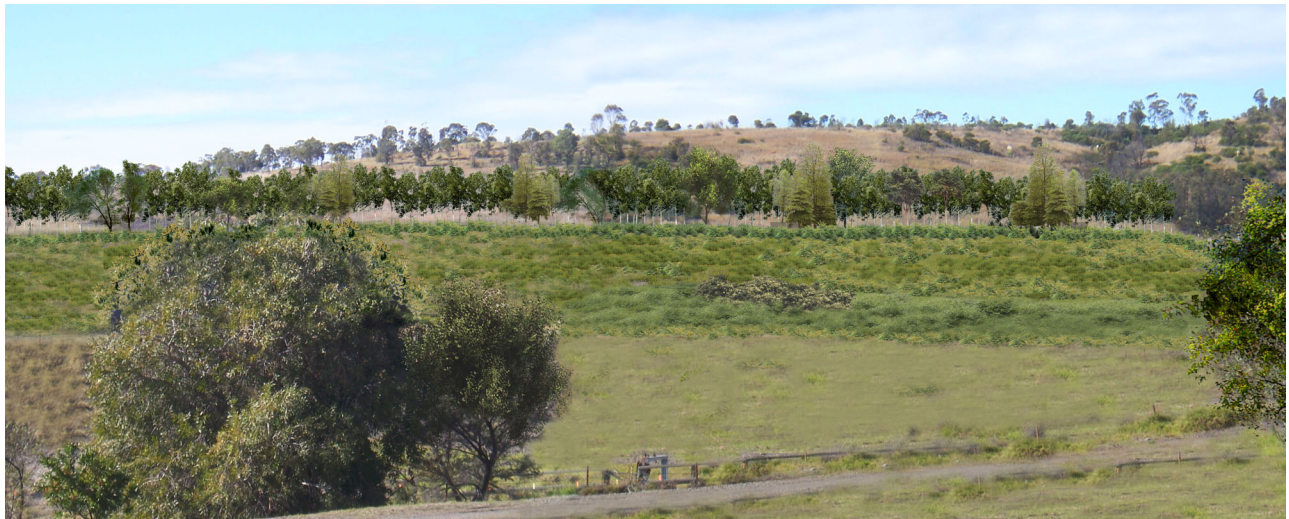
Photo 10B: Same view of the site and proposed cell structure with vegetation over.

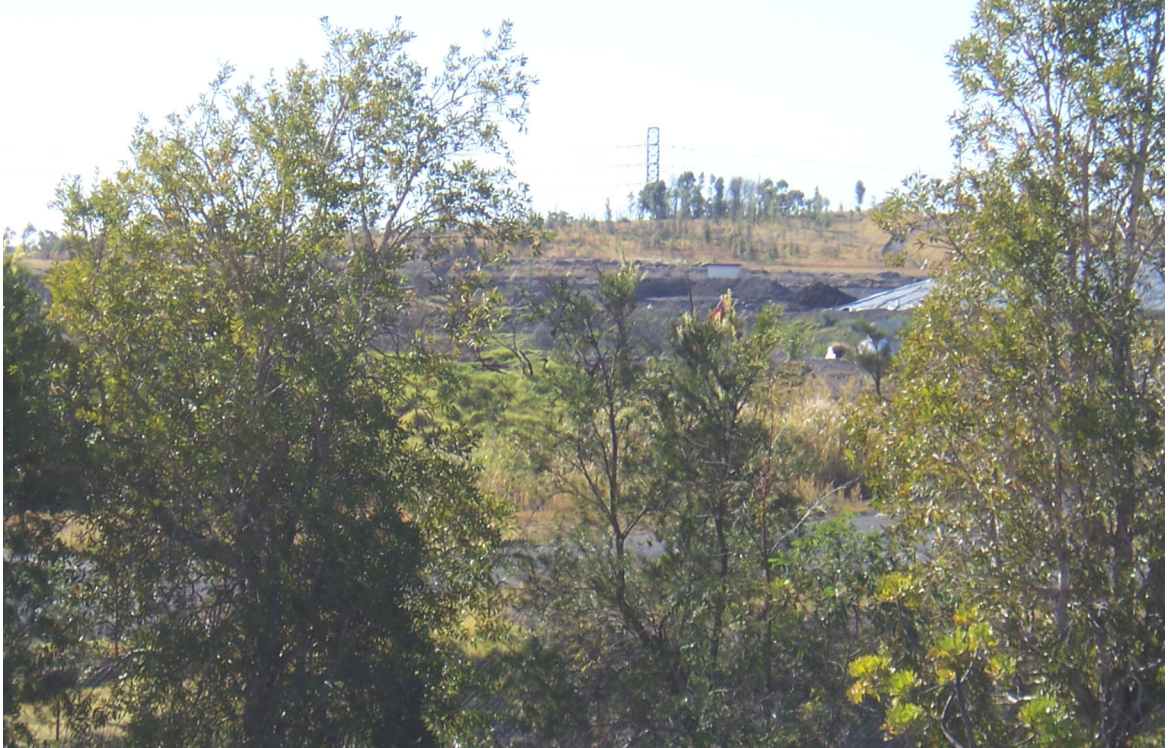
Photo 11A: View from PCCS site, towards the existing cell structure

From within the PCCS site, view of the cell structure from among the trees from a similar vantage point as in Photo 10, but looking to the left of the photo. The proposed cell structure is seen screened from the foliage of trees located within the site as shown in Photo 11.

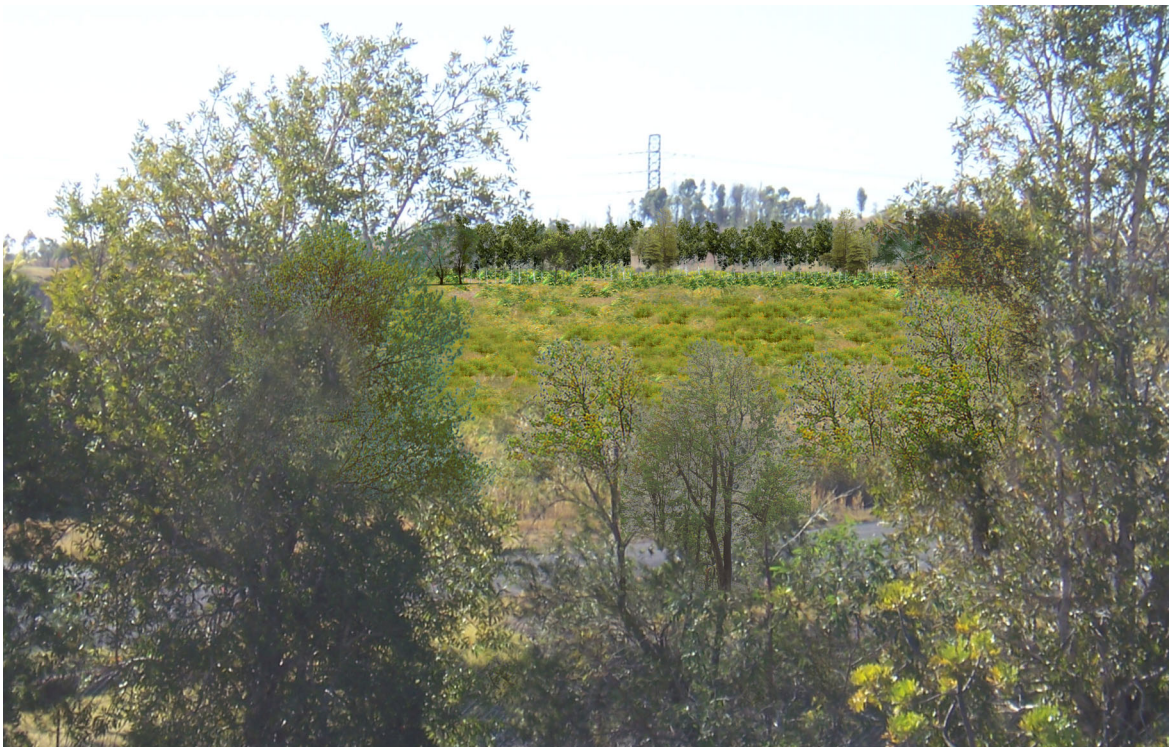
Photo 11B: Same view from the site towards the proposed cell structure with vegetation over.

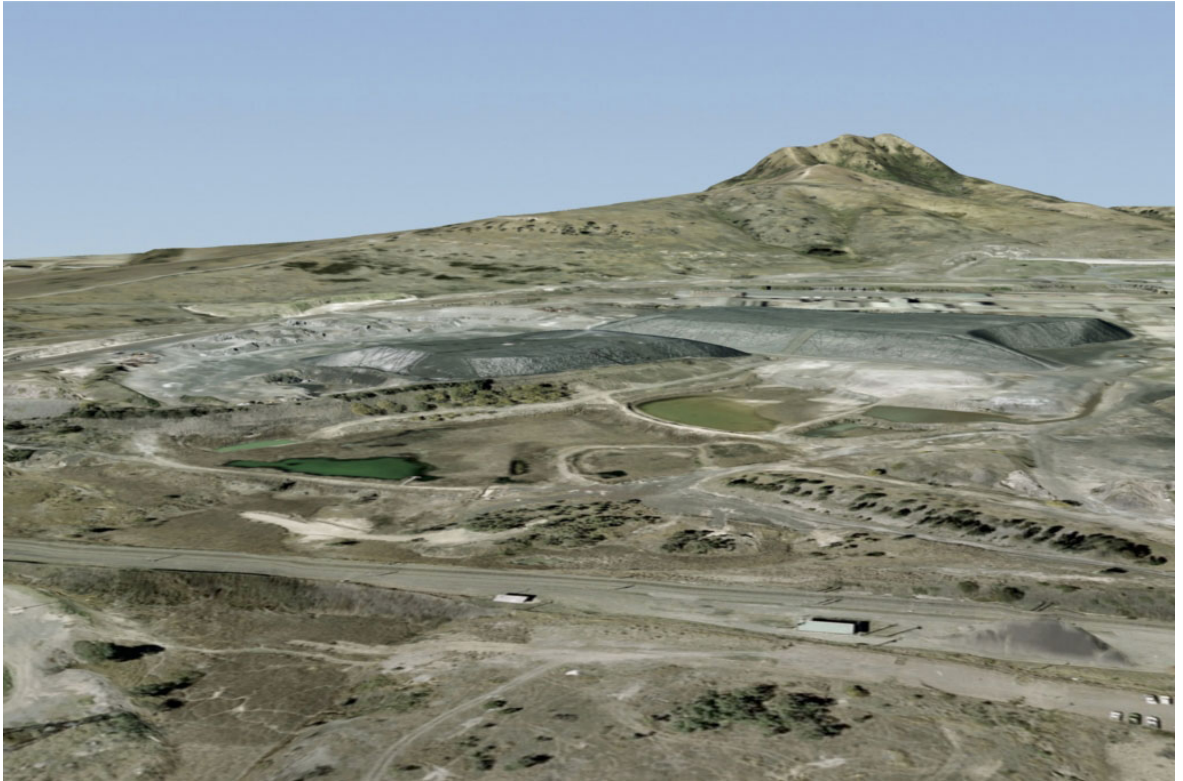
Photo 12A: 3D image of the site with existing cell structures, viewed from the west with Munibung Hill in the distance to the east.

This point is further demonstrated by the series of Photos 12A, 12B, 13A and 13B. Photos 12A and 13A show aerial photos of the existing slag stockpiles. Photo 12A is from the south-west and shows Munibung Hill in the background. Photo 12B is a montage showing the proposed cell, but without any landscaping on the front batters. From the aerial view, the montage clearly shows the rise in elevation of the cell with a valley behind and at the foothills of Munibung Hill. This change in elevation would not be very apparent from lower elevations such as in Argenton, on the Main Road or on the railway.

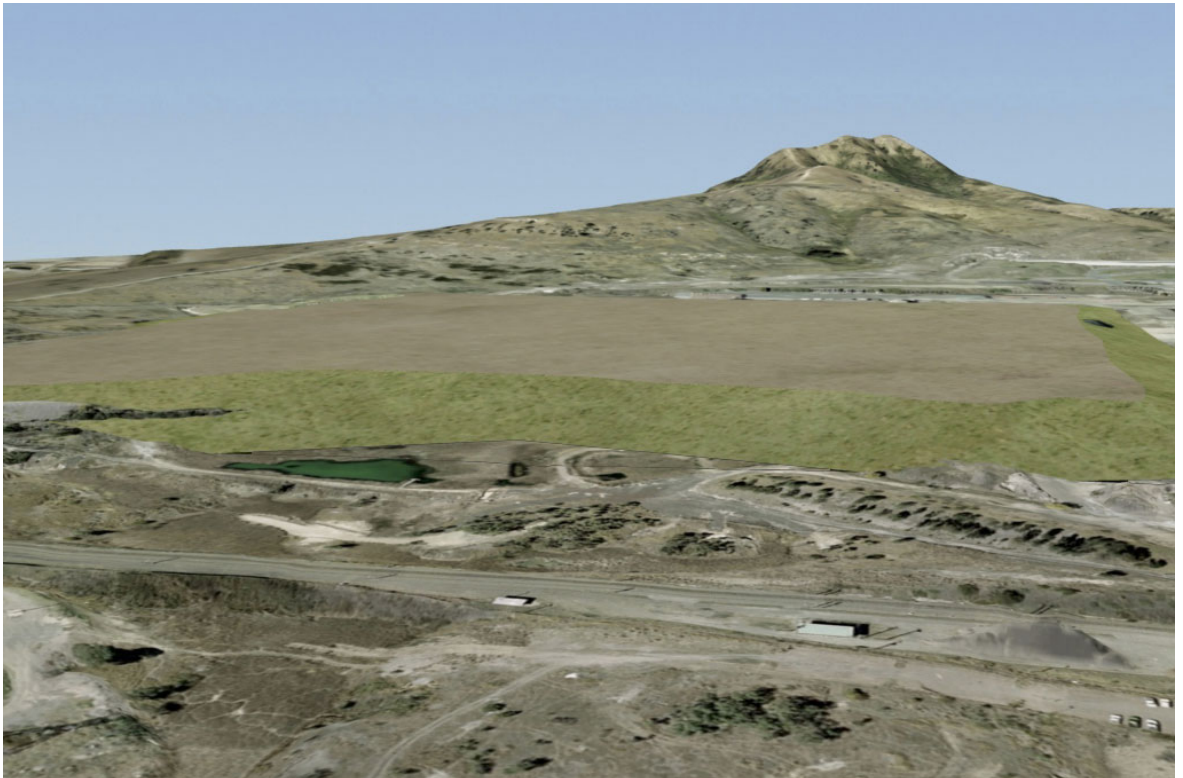
Photo 12B: Same view of the site with proposed cell structure with vegetation cover.

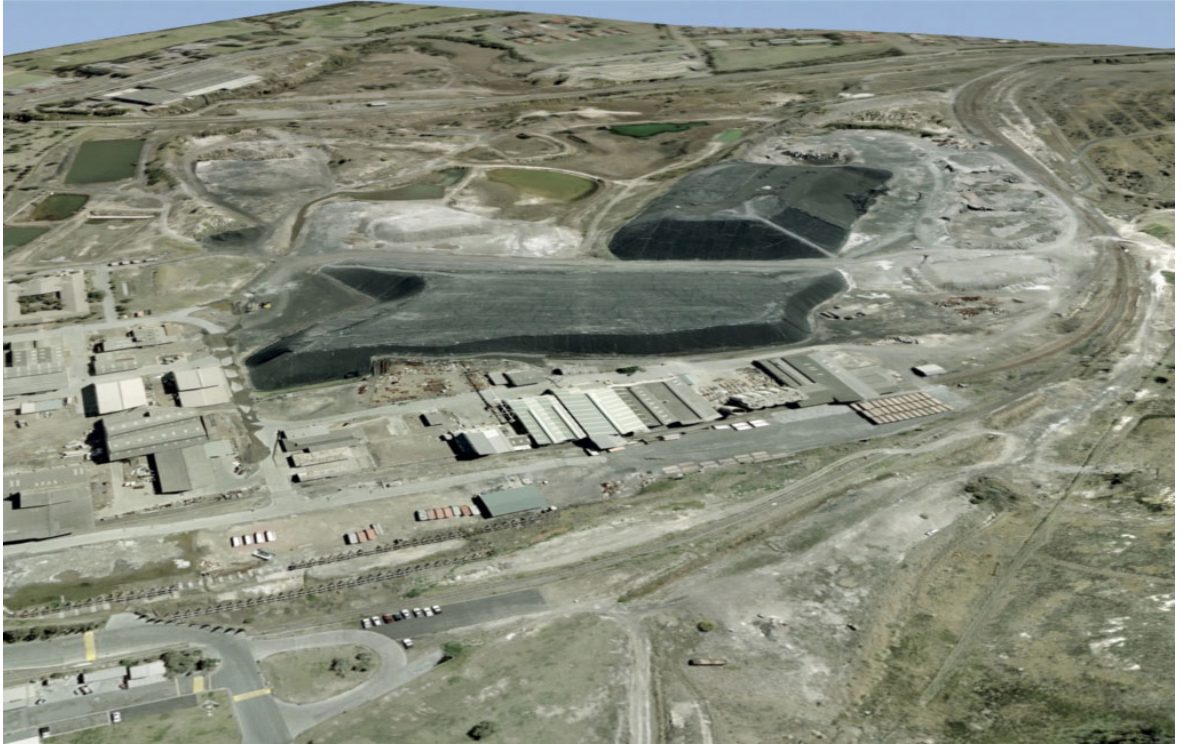
Photo 13A: 3D image of the site with existing cell structures, viewed from Munibung Hill.

Photo 13A shows how visible the slag stockpiles are from the top of Munibung Hill. Their high visibility arises not only from their size, but also from the highly visible and contrasting black colour of the plastic (HDPE) covering. Photo 13B is a montage that shows the finished and grassed cell (without any landscaping). This montage demonstrates that even though the cell size will be very apparent, because of the grass cover that matches the surrounding landscape colour, the visual impact of the cell is much diminished. Note that the buildings shown at the foot of the cell have been left in the montage to give perspective, but would not be there after the site remediation.
