Visual Assessment of Proposed Cell Structure

Pasminco Cockle Creek Smelter Site, Boolaroo

June 2006

VISUAL ASSESSMENT OF PROPOSED CELL STRUCTURE ON PASMINCO COCKLE CREEK SMELTER SITE, BOOLAROO

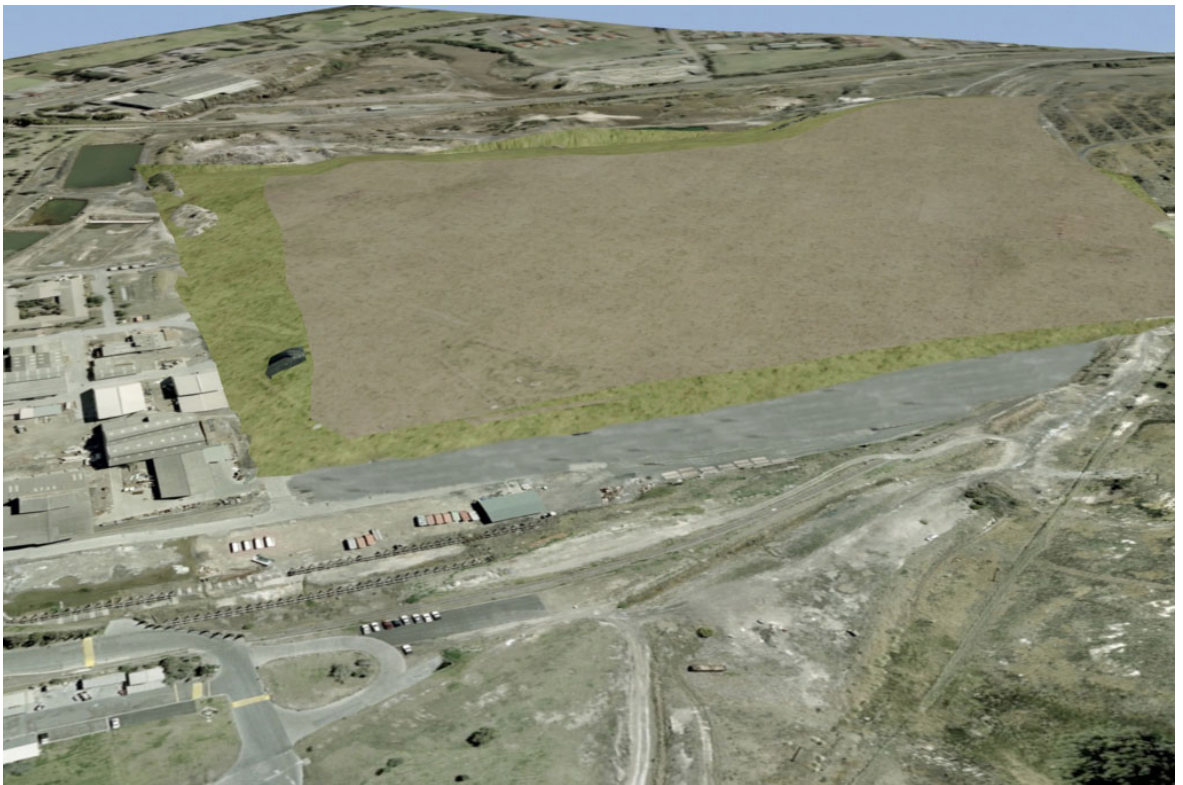
Photo 13B: Same view of the site with proposed cell structure with vegetation cover.

Photo 13A shows how visible the slag stockpiles are from the top of Munibung Hill. Their high visibility arises not only from their size, but also from the highly visible and contrasting black colour of the plastic (HDPE) covering. Photo 13B is a montage that shows the finished and grassed cell (without any landscaping). This montage demonstrates that even though the cell size will be very apparent, because of the grass cover that matches the surrounding landscape colour, the visual impact of the cell is much diminished. Note that the buildings shown at the foot of the cell have been left in the montage to give perspective, but would not be there after the site remediation.
