5.0 Bio-physical Environment Assessment of Impacts

Advanced Waste Treatment Facility
Elizabeth Drive
FIGURE 5.1: Elizabeth Drive Site Elevation

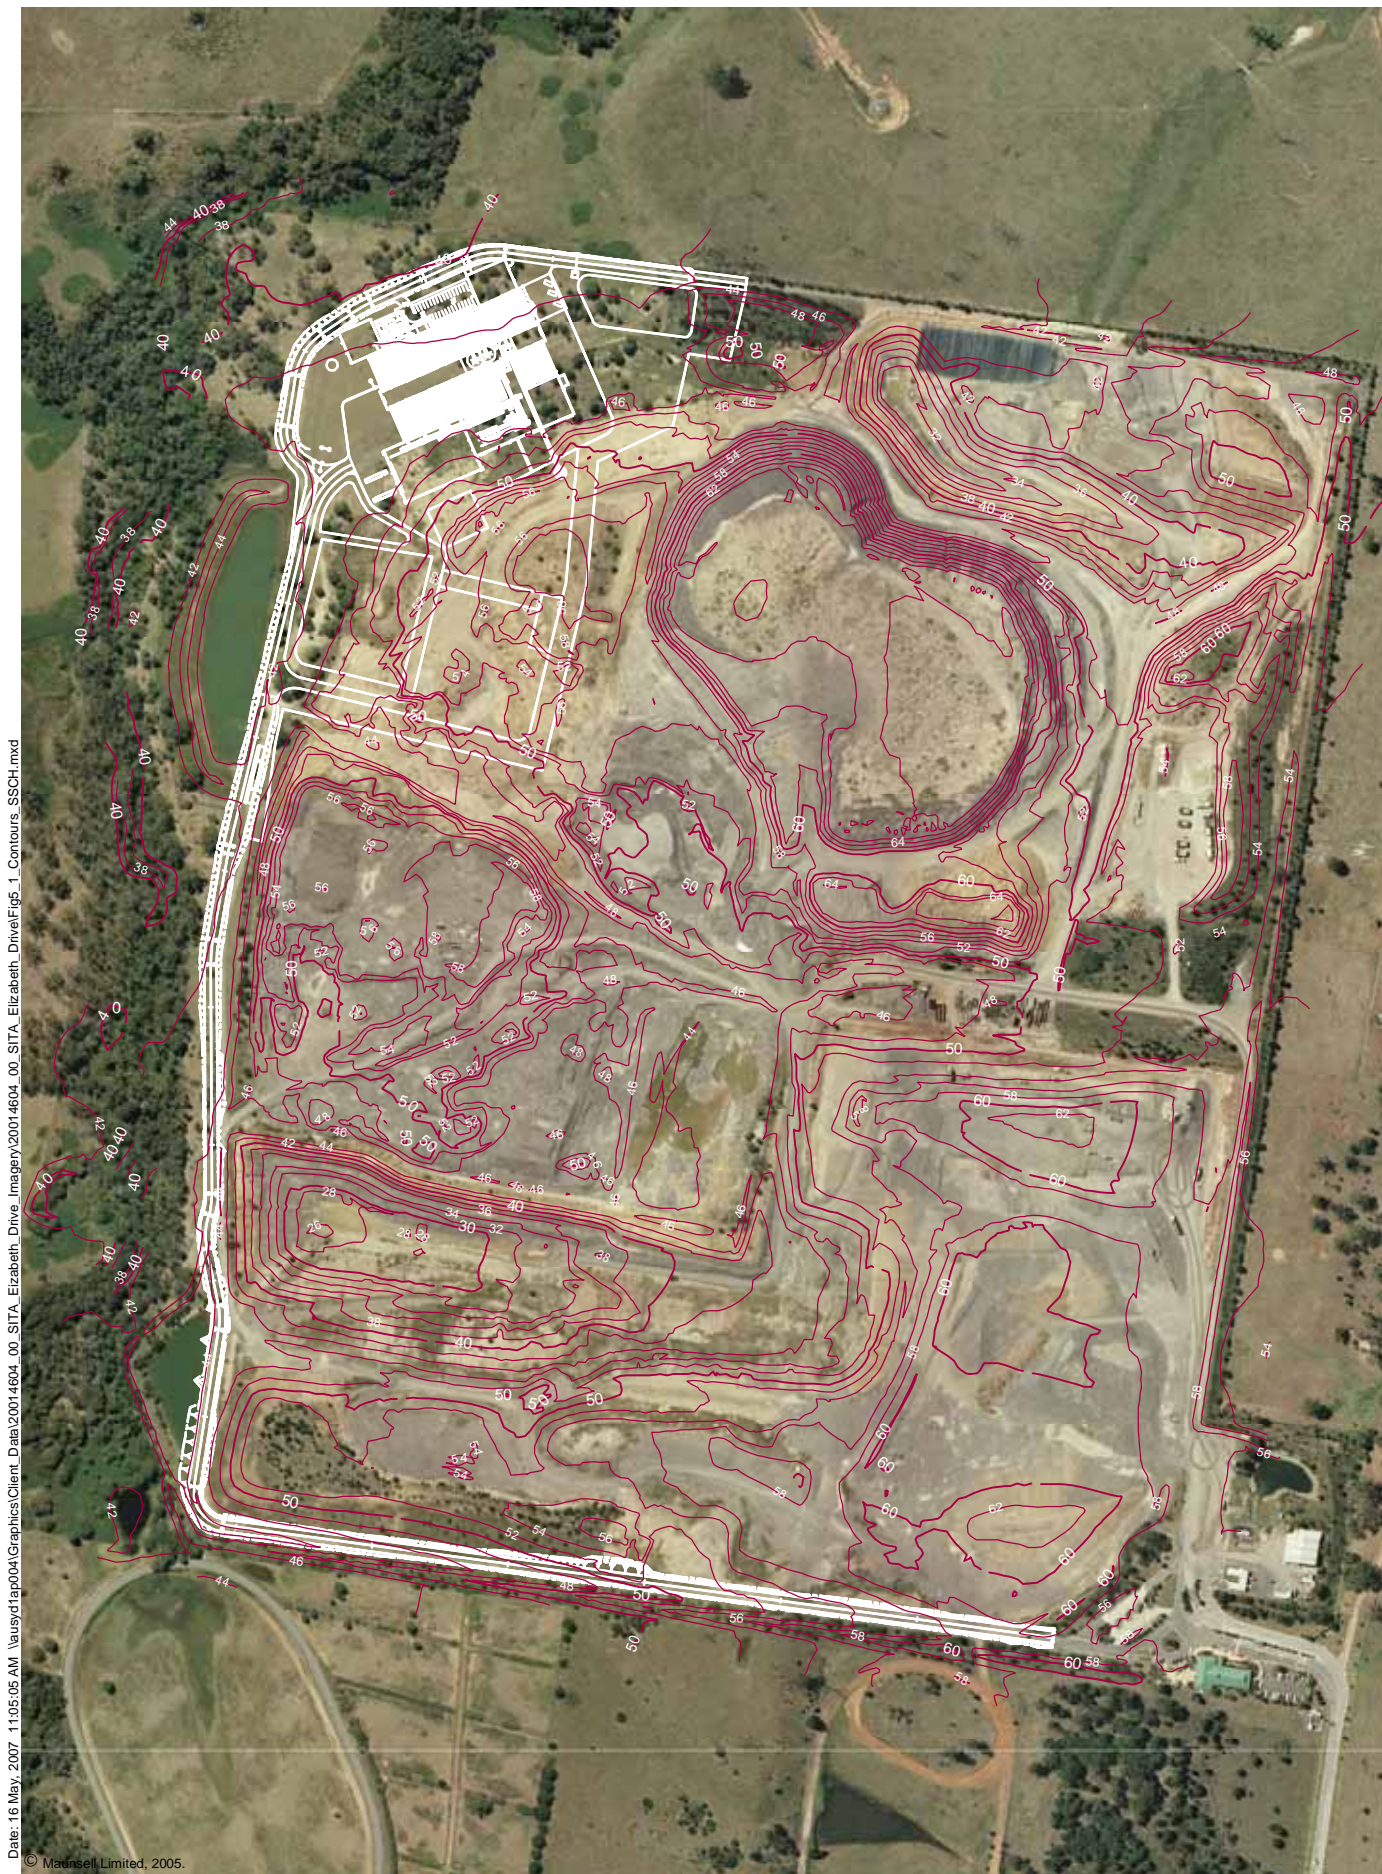
Most of the site lies above Reduced Level (RL) 44m AHD. On the western site boundary, near Badgerys Creek, the ground surface drops 2 to 3m to approximately RL 40m AHD. The lowest point is RL 26m AHD at the base of a waste cell to the south-west (**Figure 5.1**).

The proposed SAWT-BIOWISE facility will be located on generally undisturbed soil on the north-west of the site. Because of its elevation, the Elizabeth Drive Site has extremely low potential for Acid Sulphate Soils (ASS). No potential ASS or evidence of activities that may be associated with contamination, have been identified during excavations connected with the existing Landfill. Consequently, the presence of ASS or contamination is considered unlikely on the proposed SAWT-BIOWISE footprint.

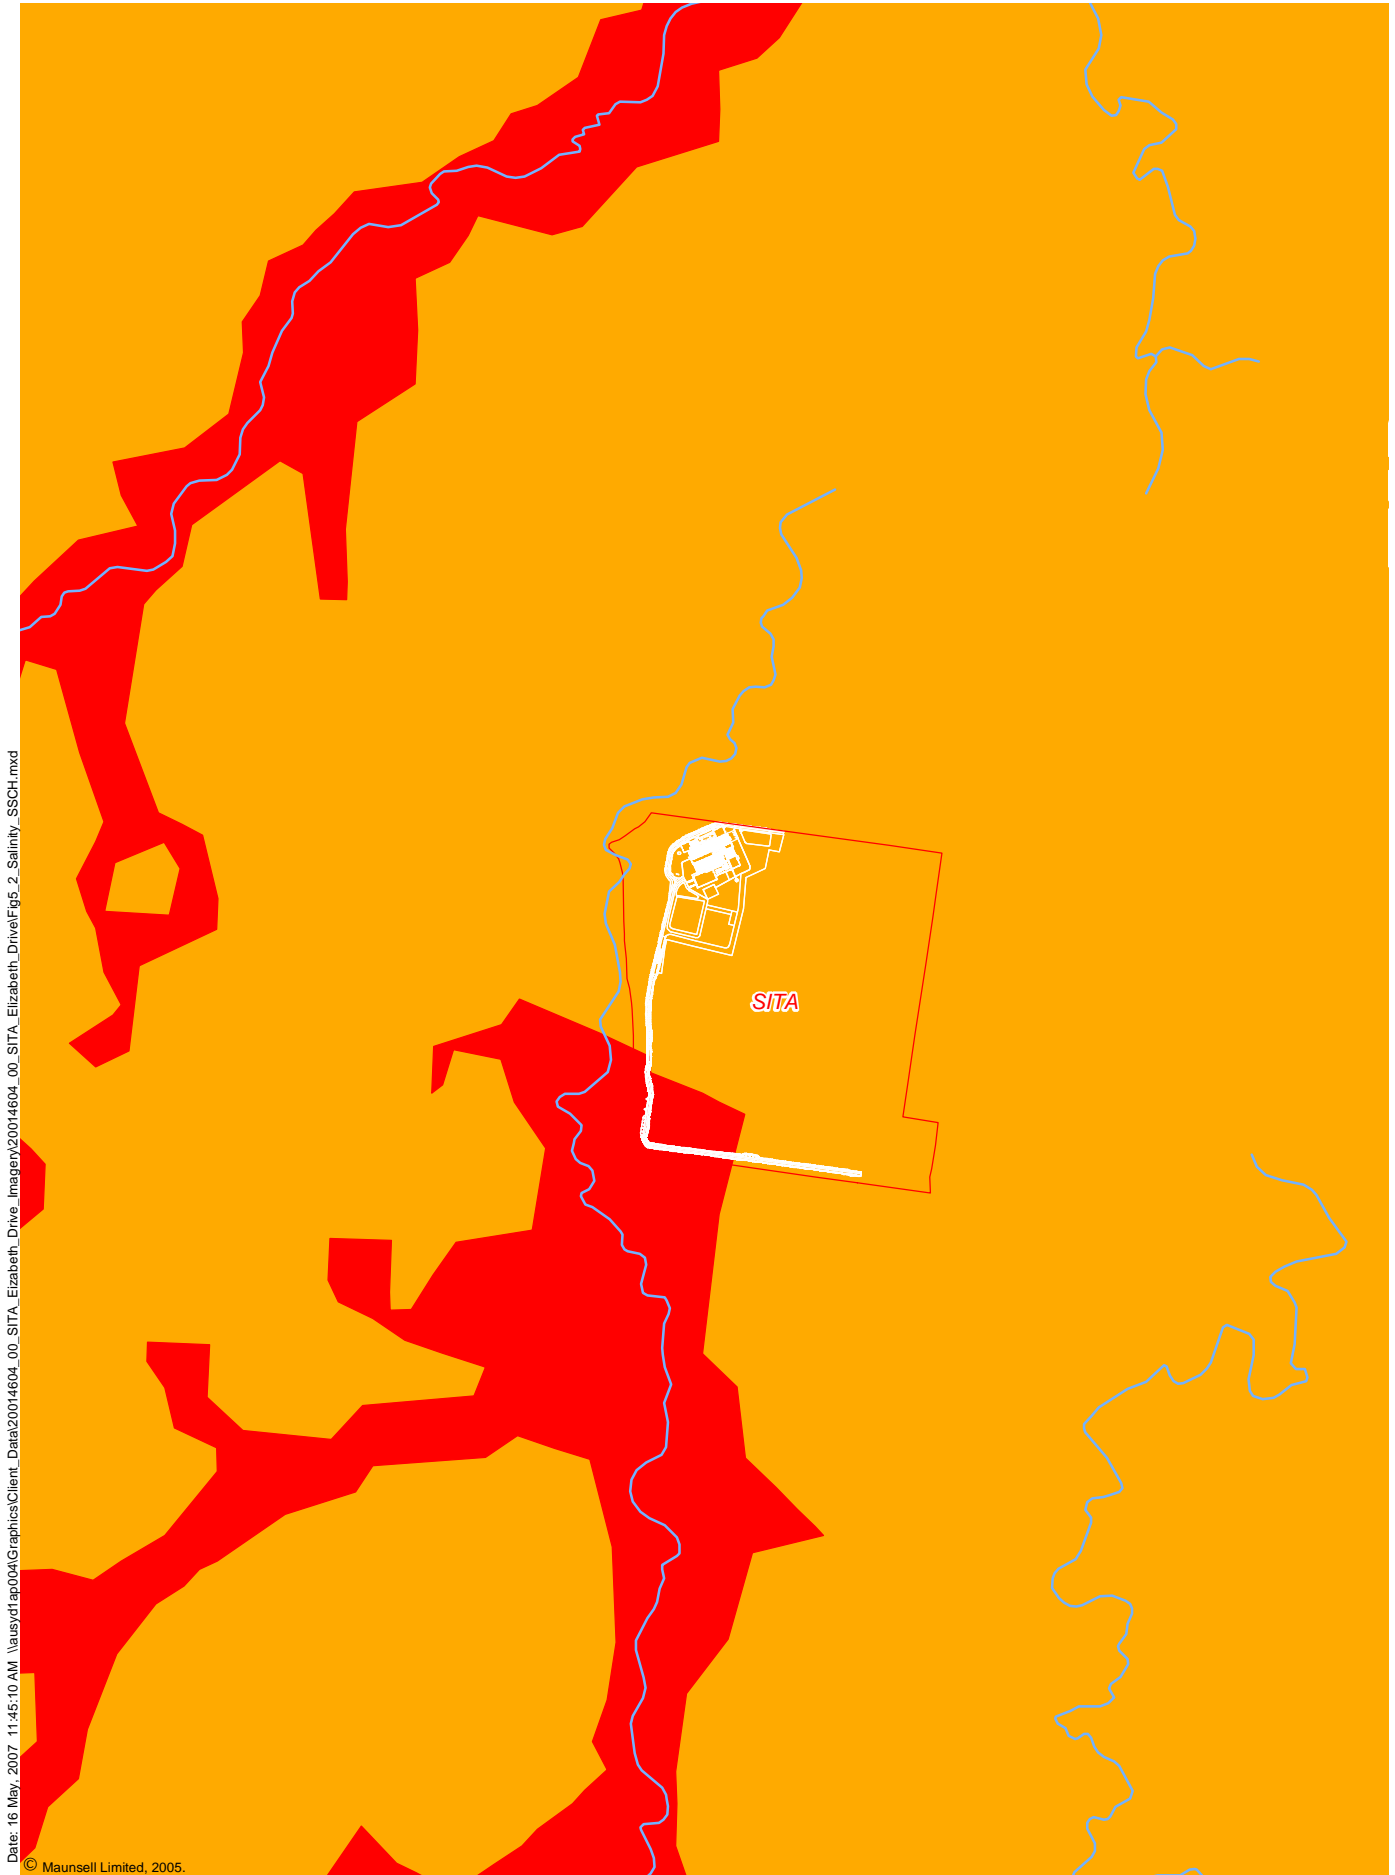
Advanced Waste Treatment Facility
Elizabeth Drive
FIGURE 5.2: Salinity Hazard

Previous NSW reports have documented that groundwater under the Elizabeth Drive Site has moderate to high salinity. **Figure 5.2** shows salinity potential in the vicinity of the Elizabeth Drive Site based on data previously supplied by DIPNR and indicates high potential for salinity in the extreme south-west corner of the site. This is a natural occurrence caused by the presence of saline Wianamatta Shales.

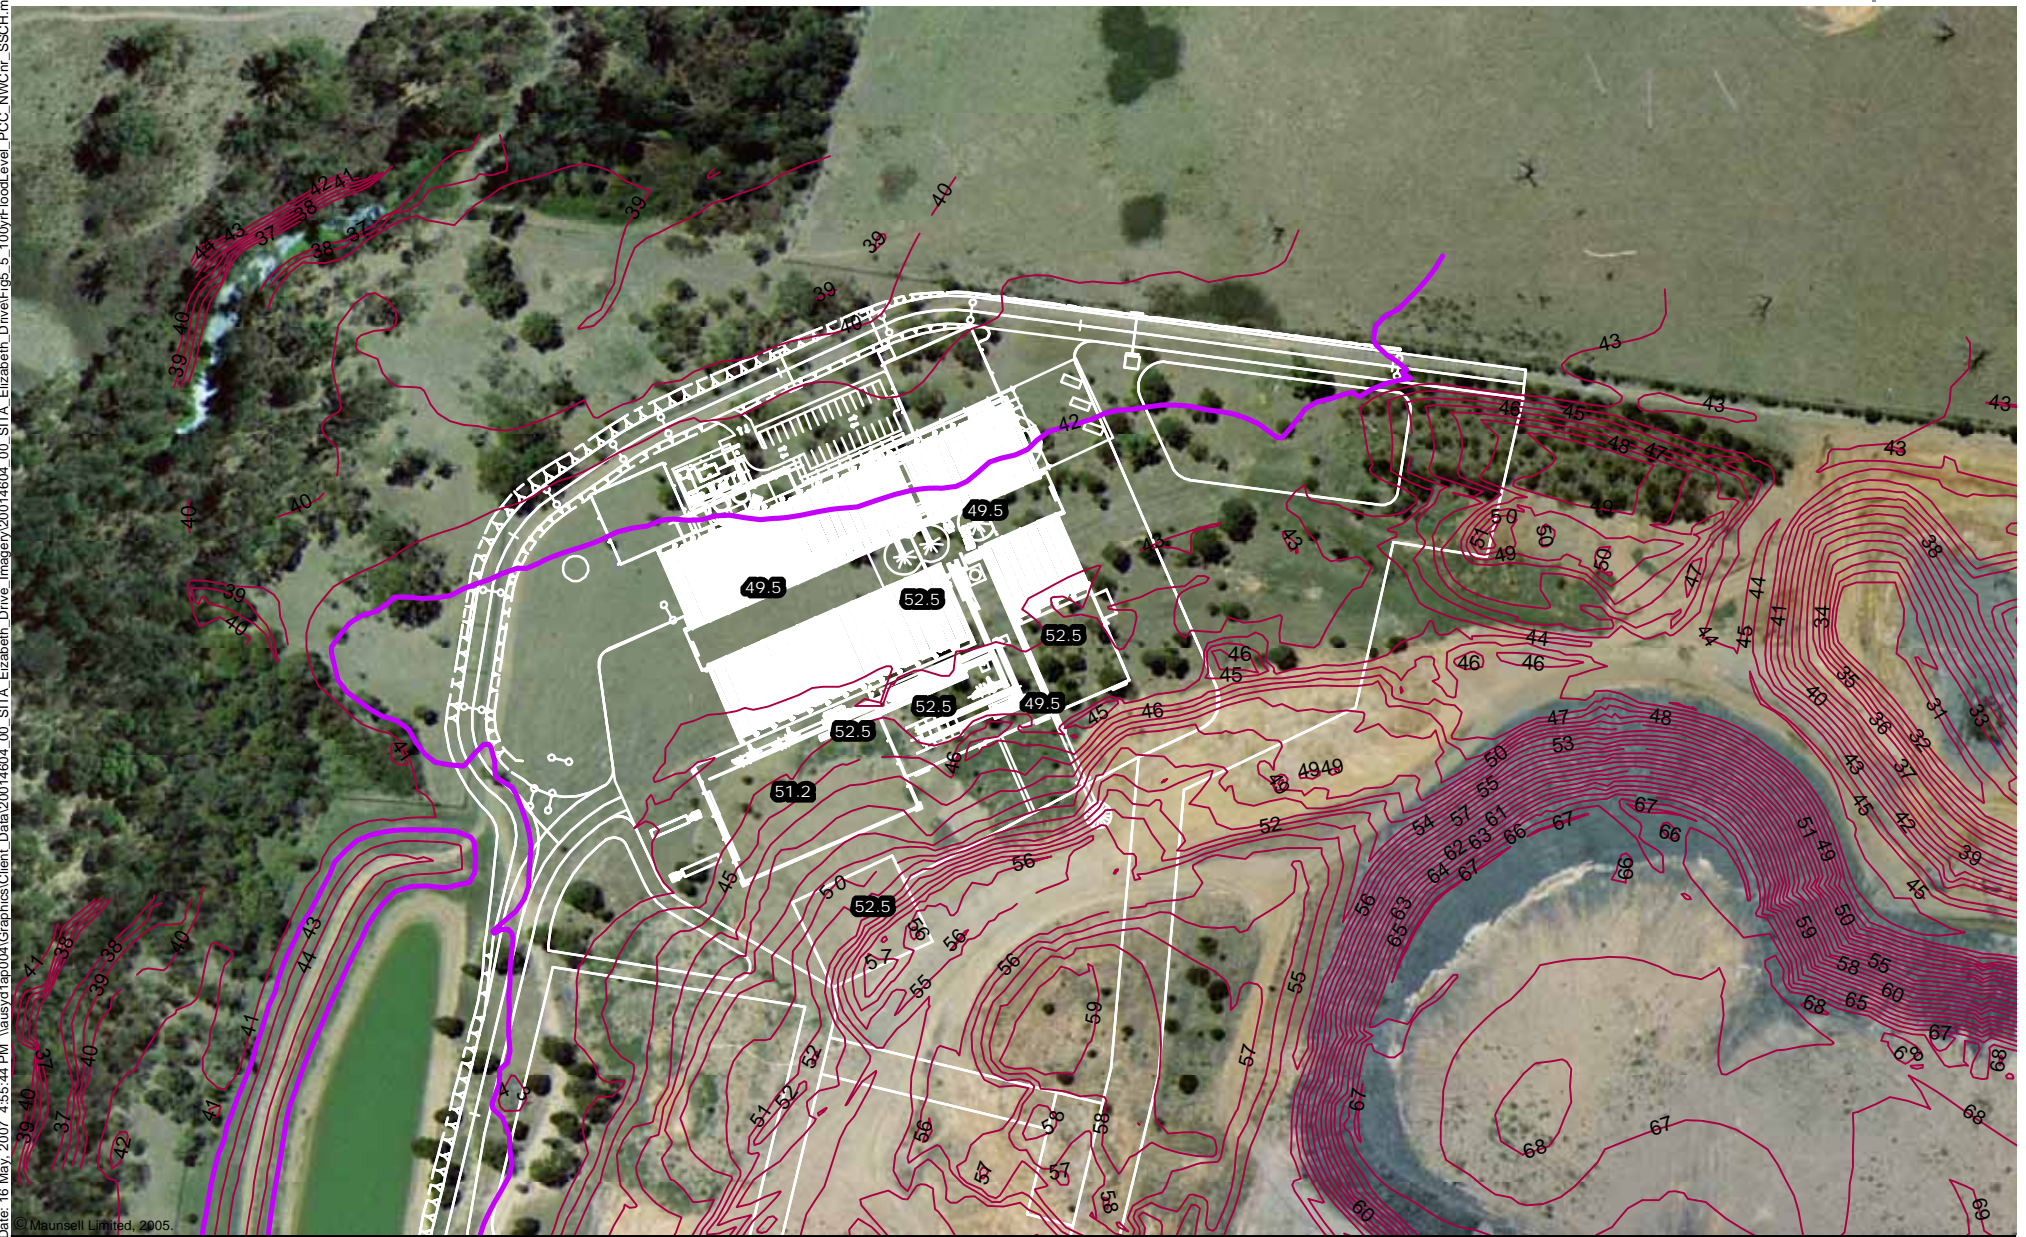
FIGURE 5.5: 1 in 100 Year AEP Flood Level and Elevations - Detailed View

Figure 5.4 and **Figure 5.5** display the concept SAWT-BIOWISE facility layout and the Relative Levels (RL) of all major items. As shown, the SAWT-BIOWISE Site will be on the north-western corner. The majority of the existing SAWT-BIOWISE Site area is located above the 1 in 100 year AEP flood level as calculated by the Department of Water Resources. The entire SAWT-BIOWISE facility layout is located above the 1 in 100 year AEP flood line. Hence the SAWT-BIOWISE facility, including ponds, will be above the flood level and will not be subject to inundation during a 1 in 100 year AEP flood.

- 42m - Approx 100y flood level
 - 1m Contours
 - ! SAWT Design Roof Heights (m AHD)
- Contour Interval 1m

However, based upon realistic conditions that occur during a flooding event, such a flood level is unlikely to remain at a single RL contour, as water will rise and fall according to the land contours. It is therefore more likely that the relevant RL of this flood level will vary across the site. Table 5.5 of the NSW for the Elizabeth Drive Landfill (PPK Consultants, 1993) includes information from the former NSW Department of Water Resources, now NSW Department of Natural Resources. The Department had noted in a 1990 report that the 1 in 100 AEP flood level at the northern boundary of the Elizabeth Drive site is 39.86m AHD. This information means that the land for the proposed SAWT-BIOWISE facility, the RL of which is generally between 40m and 42m, is outside this flood level.

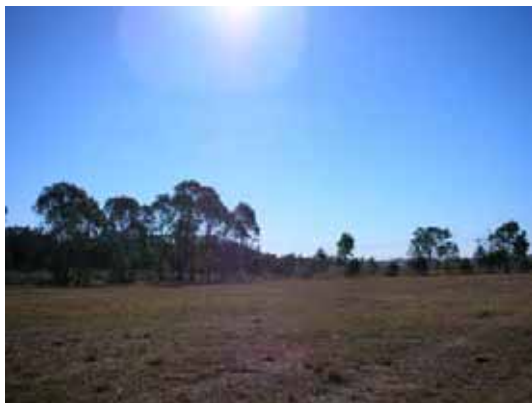
Plate 1: SAWT-BIOWISE Site

The SAWT-BIOWISE Site has been extensively disturbed and modified as part of the existing landfill operations. There only remains small pockets of highly degraded Eucalyptus species and virtually no natural understorey remains today although isolated individual blackthorn *Bursaria spinosa* and paperbark *Melaleuca nodosa* were observed (a full species list is presented in **Appendix B**). Introduced pasture grasses have regenerated on the cleared land, and a large topsoil stockpile (for landfill coverage) to the north-eastern side of site is covered with regenerating black wattle *Acacia parramattaensis*. A large rough-barked angophora *Angophora floribunda* occurs near this stockpile, however this will be retained. An access road around the perimeter of the site is another source of human disturbance.

A total of 0.81 ha of Cumberland Plain Woodland will be removed as a result of the proposal. This is primarily comprised of degraded *E.tereticornis* and *E. eugenioides* over *Melaleuca woodland* adjacent to the Access Track to site (refer to **Plate 2** and **Plate 3**). In addition some clearing of scattered *E.tereticornis*, *E. amplifolia* and *E. moluccana* may occur along the perimeter of the site (Refer to **Plate 1** and **Plate 2**).

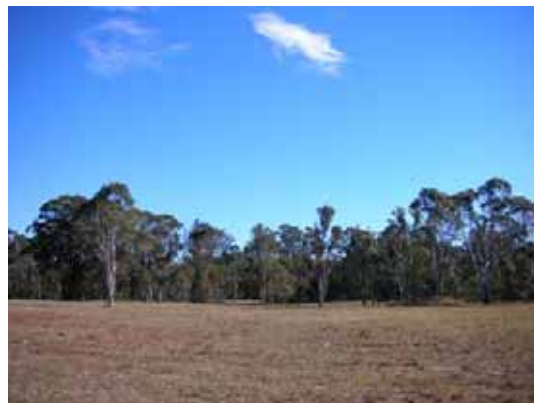
Plate 2: SAWT-BIOWISE Site with Badgerys Creek Riparian Vegetation in Background

The north-western area adjacent to the SAWT-BIOWISE Site leads to Badgery's Creek and the riparian vegetation community supported along the creek consists of 'River Flat Eucalypt Forest' which is listed as an endangered ecological community (EEC). This community was found to be in good condition near the SAWT-BIOWISE Site, although evidence of tree mortality was observed further south. None of this vegetation type will be cleared as part of this proposal, and existing revegetation works in conjunction with the local eofabri group occurring outside the SAWT-BIOWISE Site will continue.

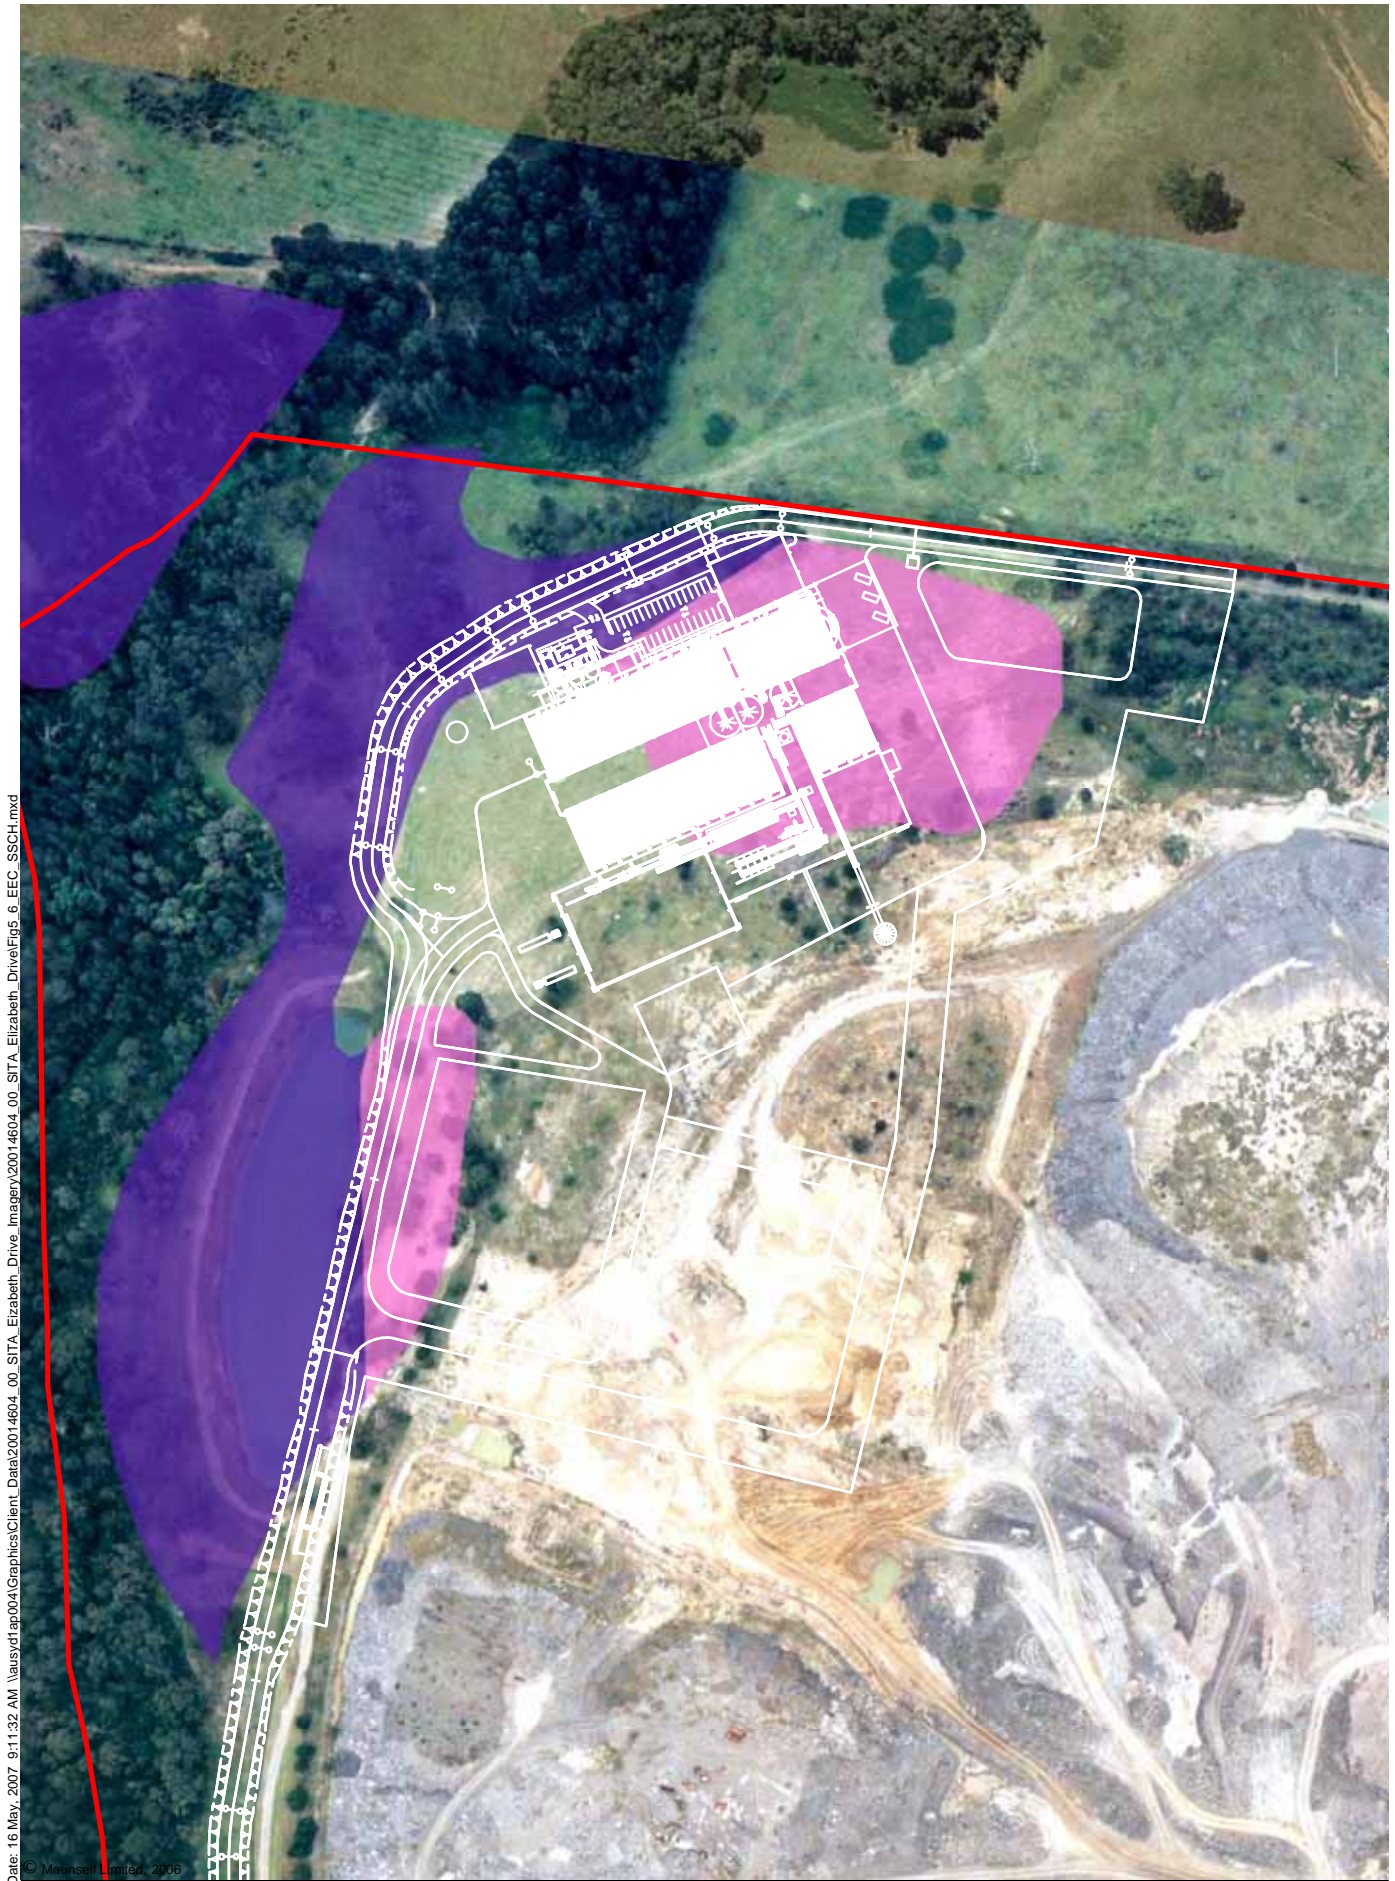
FIGURE 5.6: Endangered Ecological Communities

- Cumberland Plain Woodland
- River Flat Eucalypt Forest

*Note: Vegetation visible as CPW has been cleared since this photograph was taken under previous approvals.
Source: Maunsel, 2006; NPWS, 2002a*

Moderate-to-good condition River Flat Eucalypt Forest occurs immediately adjacent to the SAWT-BIOWISE Site (listed as Endangered under the TSC Act). This area of riparian vegetation (to the north/northwest of the existing access track) is currently fenced off from existing operations and no impacts are expected to occur to this community if mitigation measures outlined in **Section 5.3.2** are implemented.

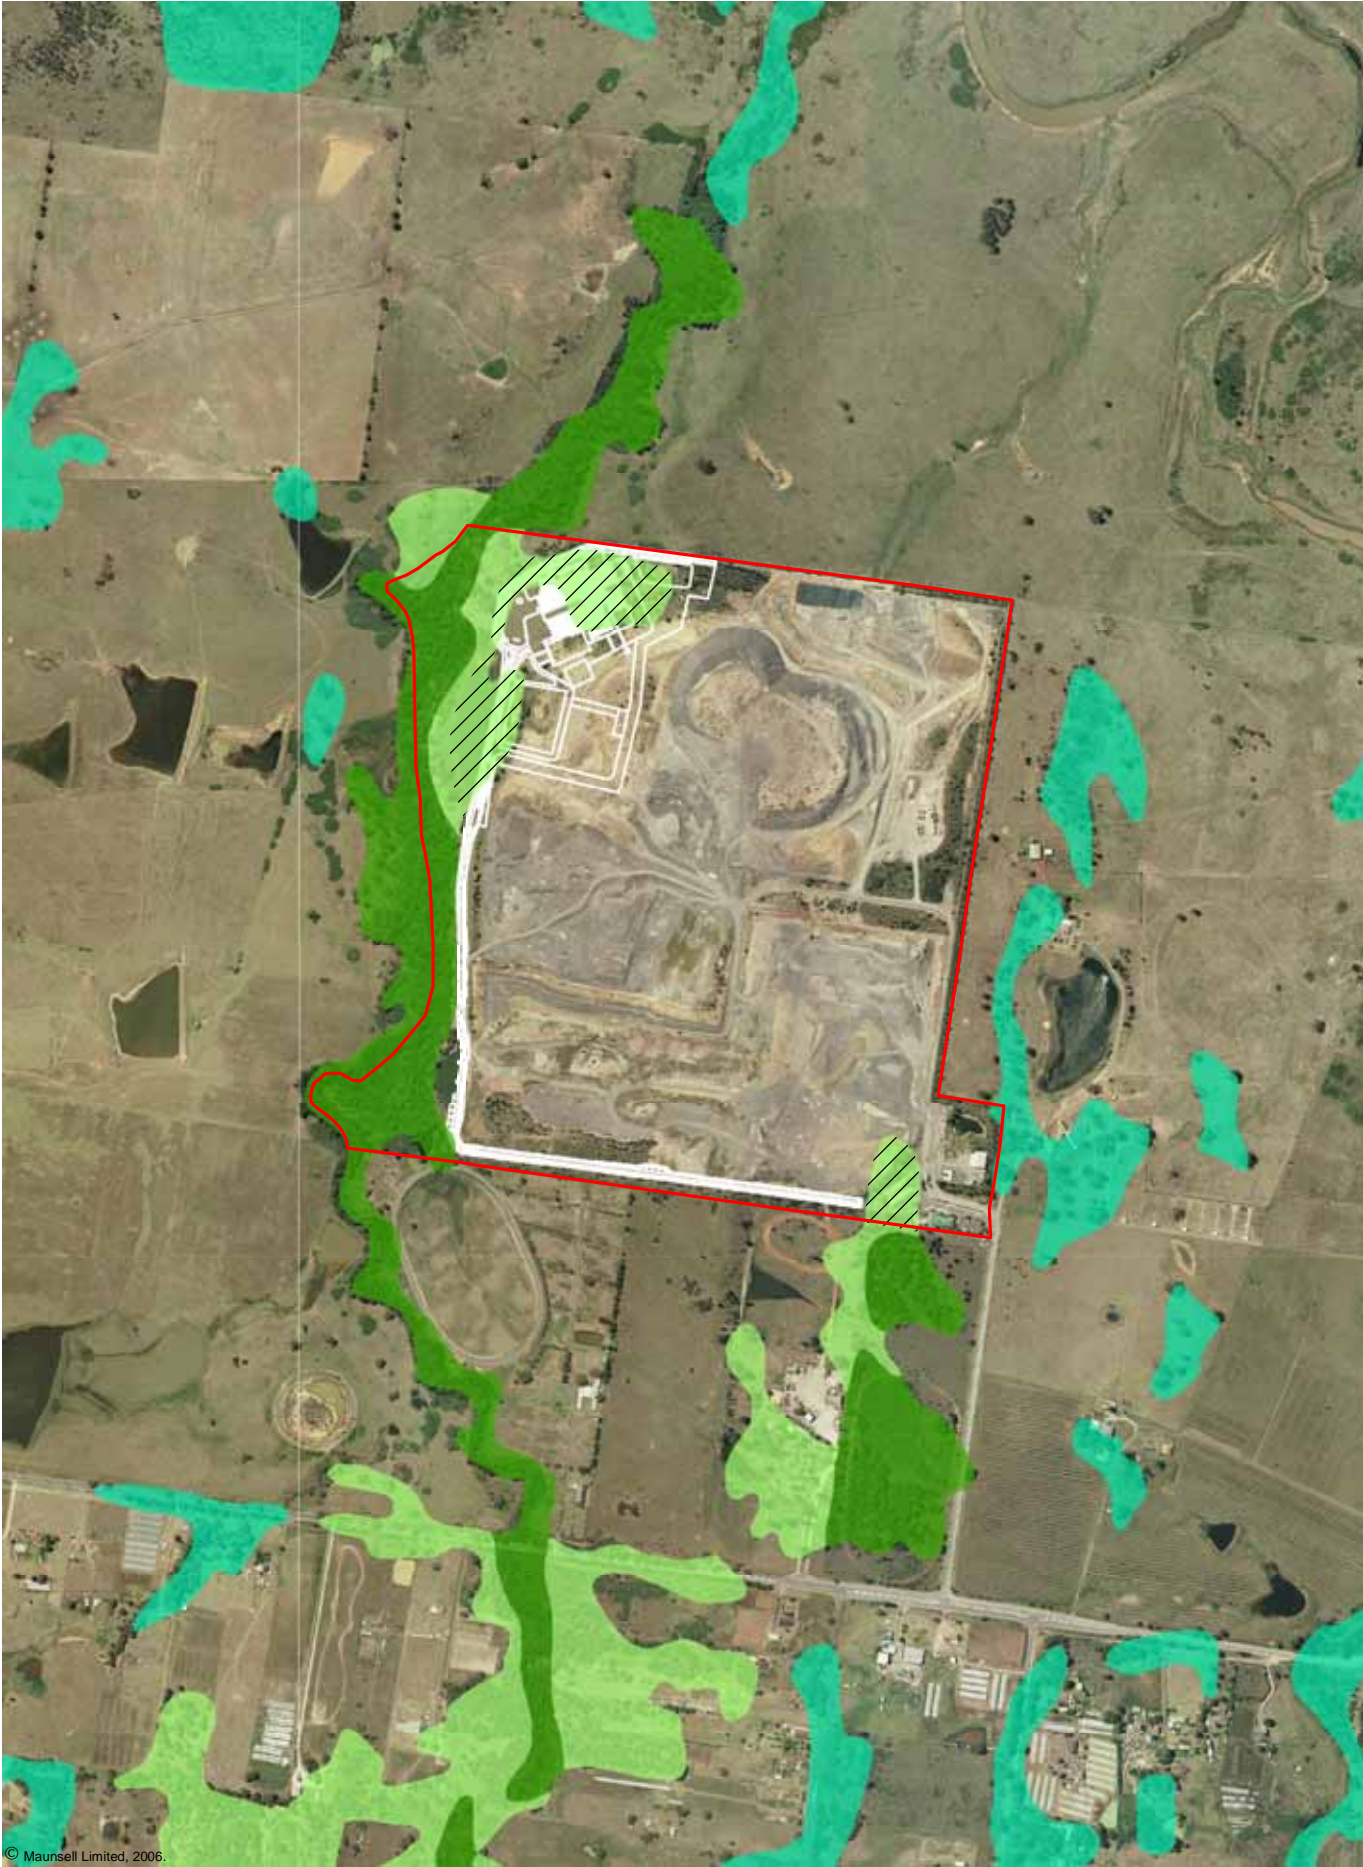
FIGURE 5.8: Fauna Habitat and Movement Corridors

- Core Habitat
- Support to Core Habitat
- Other Remnant Vegetation
- Highly Disturbed

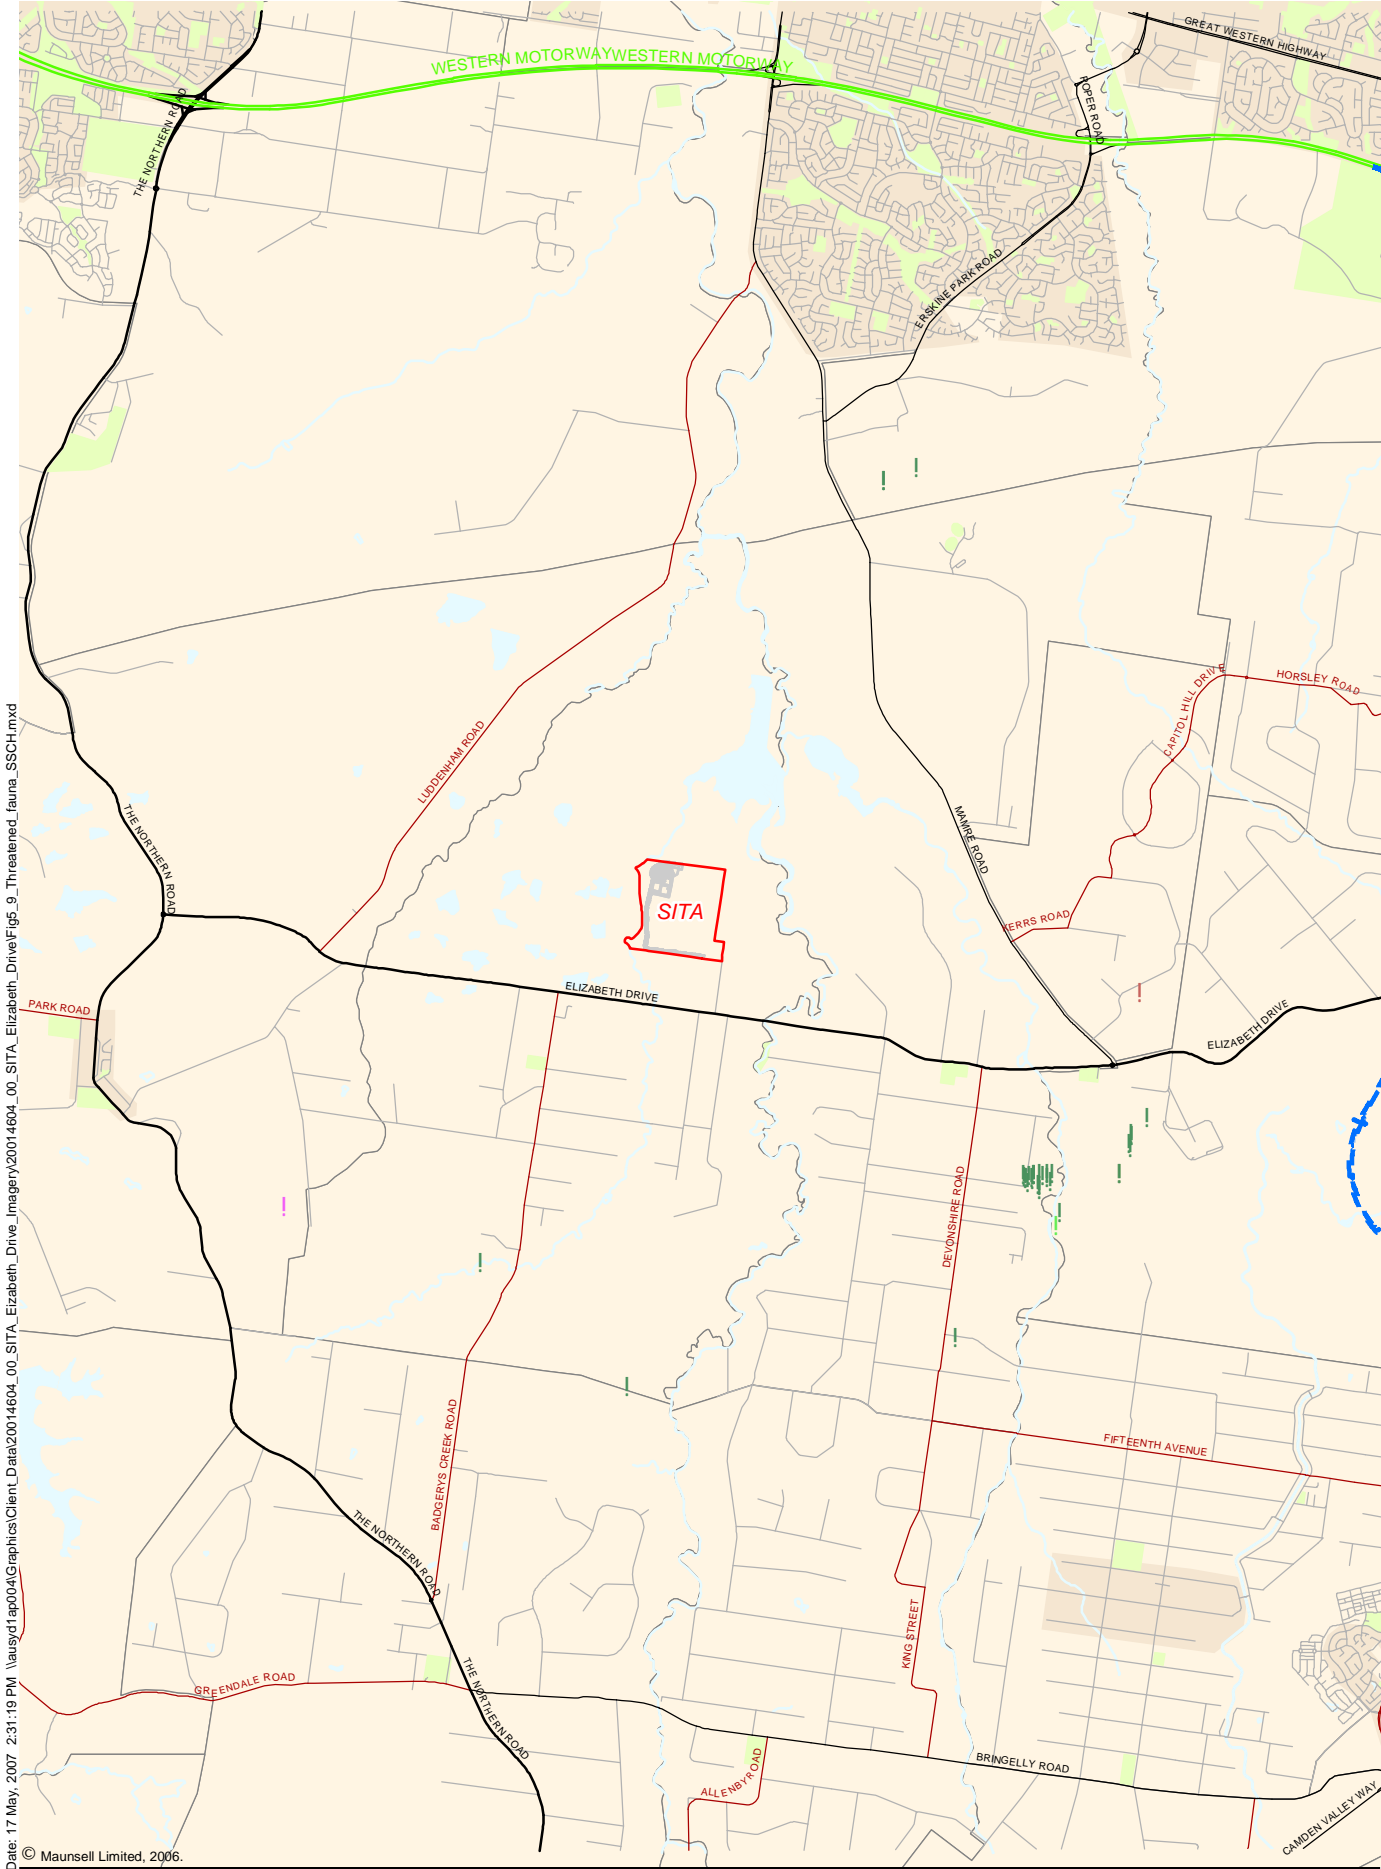
A comprehensive fauna survey was not undertaken, however, potential fauna composition in relation to threatened species and their habitat requirements has been assessed and is reported in **Table 5.2**. Threatened fauna known to occur within a 5 km radius are presented in **Figure 5.9**.

- ! Cumberland Plain Land Snail
- ! Eastern Bentwing-bat
- ! Eastern Freetail-bat
- ! Grey-headed Flying-fox
- ! Large-footed Myotis
- ! Speckled Warbler
