**Badgerys Creek Riparian Corridor | SUEZ SAWT Facility at Elizabeth Drive Landfill**

# VEGETATION MANAGEMENT PLAN

Prepared for SUEZ | 15 April 2021

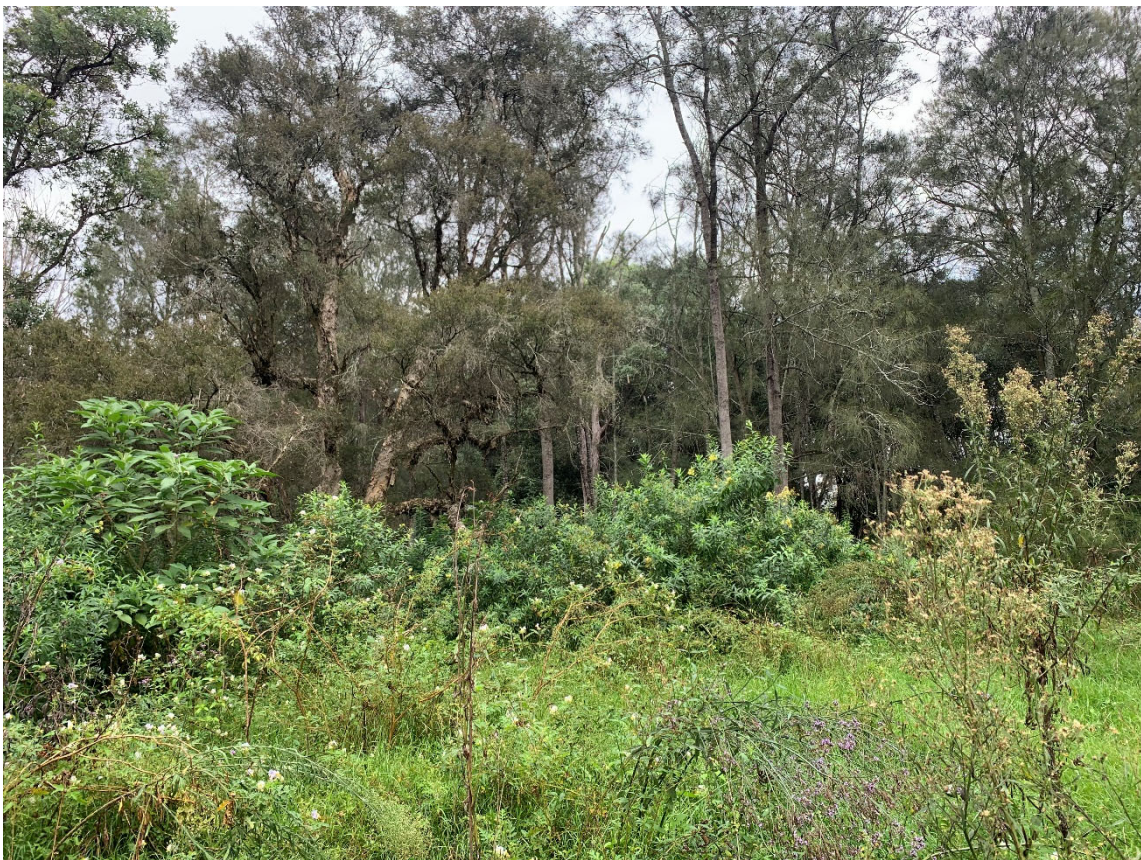
**Plate 1 Zone 1 regeneration only area. Typical vegetation supports structurally complete native canopy shrub layer with dense weed Infestation in the understorey and ground layer**

The groundcover stratum is comprised of native and exotic grasses and forbs. The native grass *Microlaena stipoides* is the dominant groundcover species through much of this management zone but is replaced in places by exotic grasses such as *Paspalum dilatatum*, *Pennistenum clandestinus*, *Chloris gayana* and *Setaria pumila* with dense patches of Trad.

A variety of native forbs are also found in the groundcover stratum throughout this management zone, most common are *Plectranthus parviflorus*, *Dichondra repens*, and *Geranium solanderi*. Several species of vine occur in this management zone and can be found creeping through the groundcover and climbing through the shrub layers of the vegetation. Native vines include *Clematis aristata*, *Desmodium varians*, *Glycine microphylla*, *Convolvulus erubescens* and *Parsonsia straminea*. Moth Vine is the most abundant vine weed and requires a targeted approach to management.

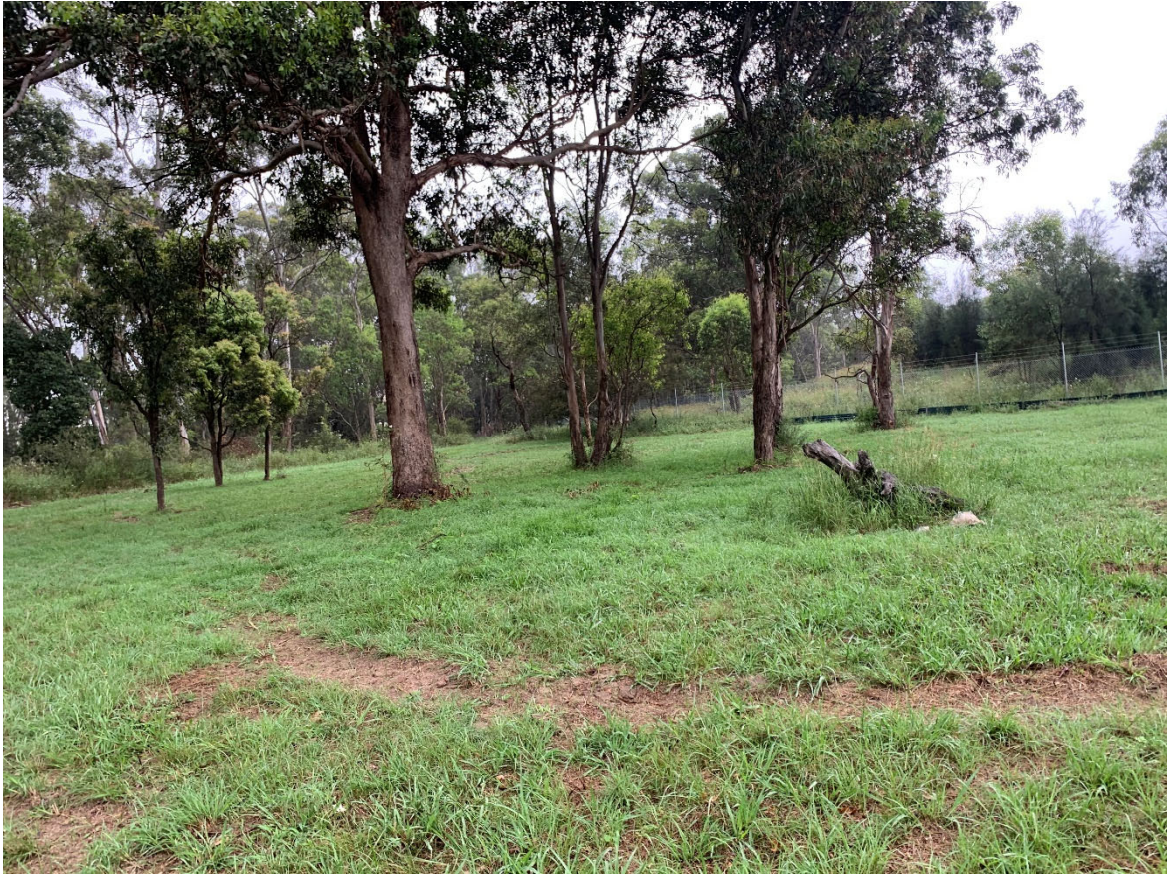
**Plate 2 Zone 2 regeneration area. Showing slashed understorey and minimum structural complexity.**

Current vegetation management approach in this zone consists of the control of noxious weeds and mowing of grassed areas to minimise bushfire hazard.

Considering the level of weed infestation and low density of natives in some areas of this management zone, additional planting will be necessary, especially in areas of extensive weed removal.
