## Irrigation Management of Treated Water; MOD 16.

## **Executive Summary**

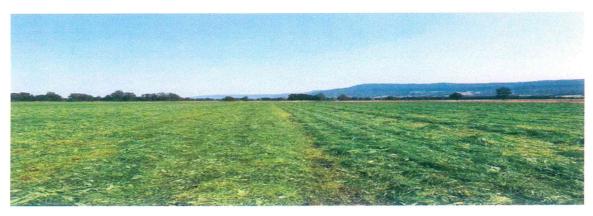
Photo 1 Freshly cut mixed pasture, ryegrass and kikuyu, to be sold to local dairy.

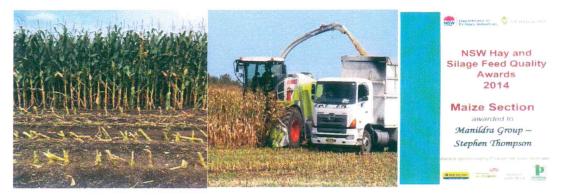
Photo 2, 3 and 4 Maize harvesting for silage. Certificate awarded to Manildra Group Farm as State winners for the NSW Silage Quality.

This shift in agriculture has been enabled by the reduction in irrigation volumes. Further changes are being implemented and trialed for the lower elevation areas of the Farm
