## Aquatic Survey

# Shoalhaven Starches Bomaderry Plant Modification Works Shoalhaven River, Bomaderry, NSW

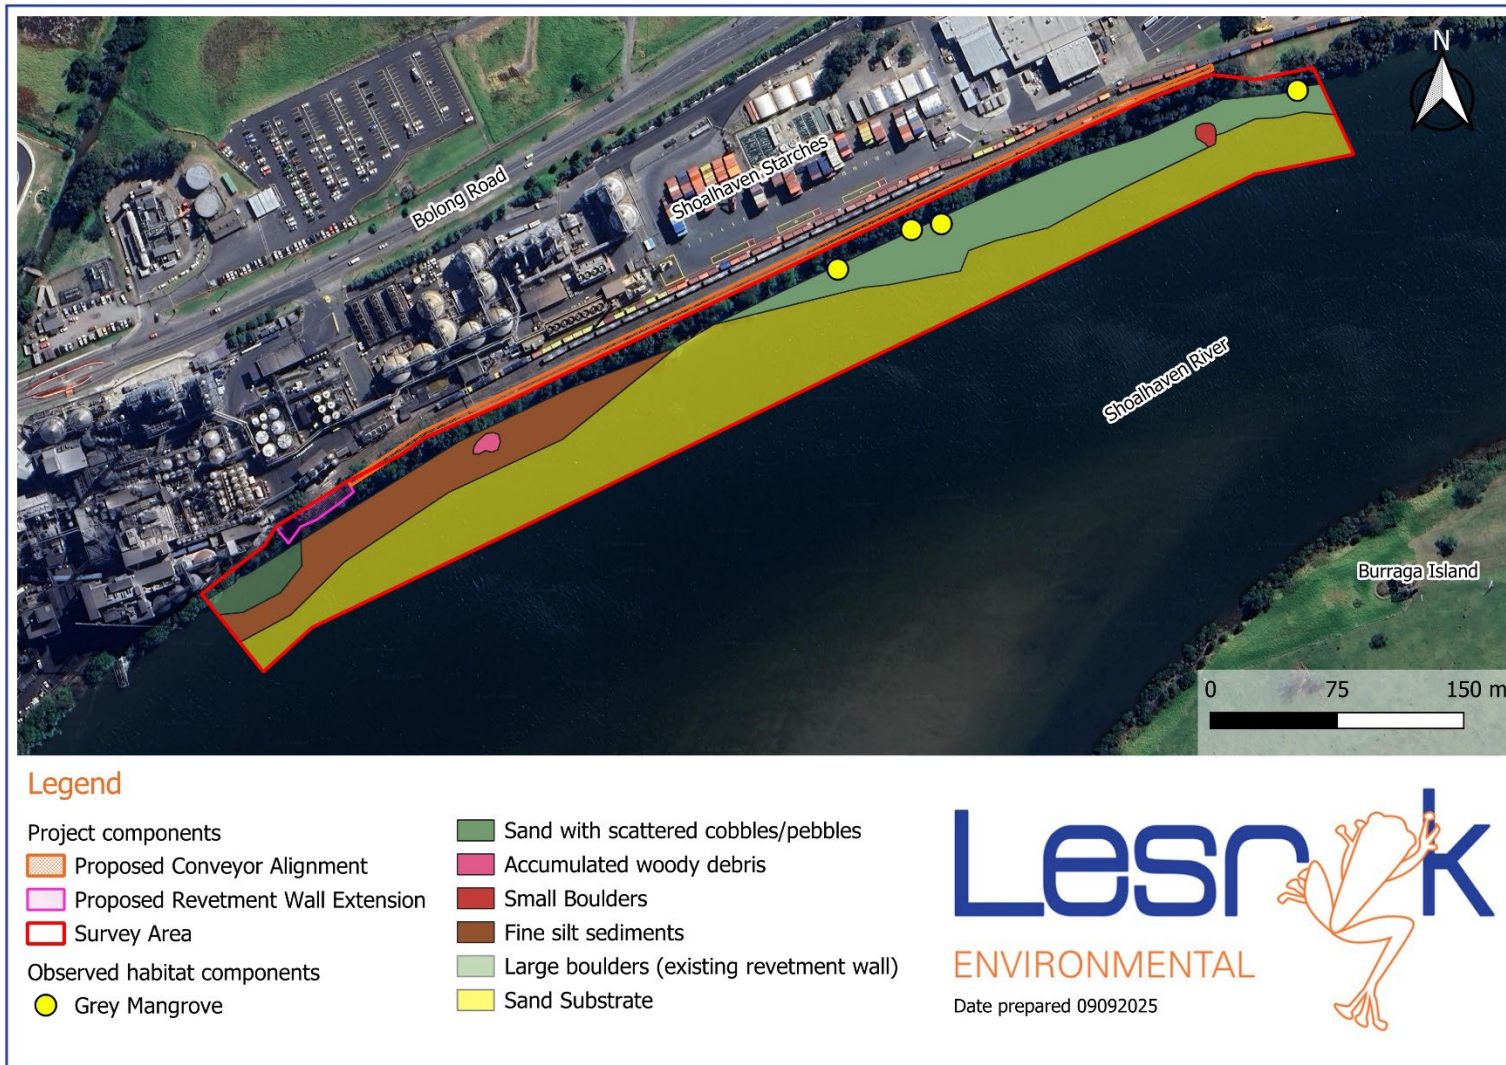
**Figure 4. Habitat composition identified during field investigation**

The field investigation confirmed that the aquatic environment present was variable across the study area. Tow-camera transects revealed the presence of sand flats, sand with scattered cobbles and pebbles, and areas of fine silt sediments. In addition, accumulations of large woody debris (snags) and isolated boulders were observed across sections of the riverbed, providing areas of structural complexity.

Four small patches of mangrove habitat were present along the riverbank. Each patch consisted of a single Grey Mangrove (*Avicennia marina* subsp. *australasica*) tree, with associated pneumatophore fields ranging in area from about 1.7 - 7 m<sup>2</sup>, totalling approximately 23 m<sup>2</sup>. The mangroves were positioned in the intertidal zone on the riverbank and their approximate locations are noted in Figure 4.

No seagrass beds were detected within the study area. Neither the tow-camera transects, nor the SCUBA-assisted dive identified the presence of *Zostera*, *Posidonia*, or any other seagrass taxa. Similarly, no extensive beds of other submerge aquatic macrophytes were observed. During the survey, no floating remnants of seagrass were noted and none were noted washed up on the shore near the proposal area.

It is noted that the spatial accuracy of the mapped features presented in Figure 4 is limited. This map is provided to illustrate the general location and relative extent of habitats observed, rather than to serve as precise habitat distribution data.

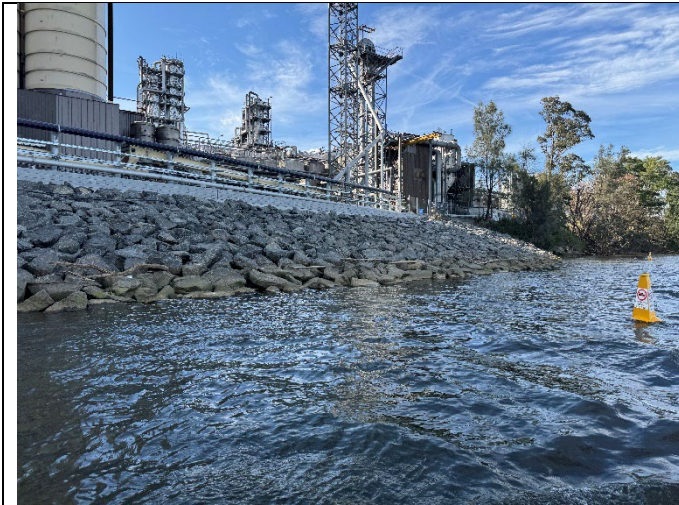
Character of the existing rock revetment.

Photograph taken facing north east.

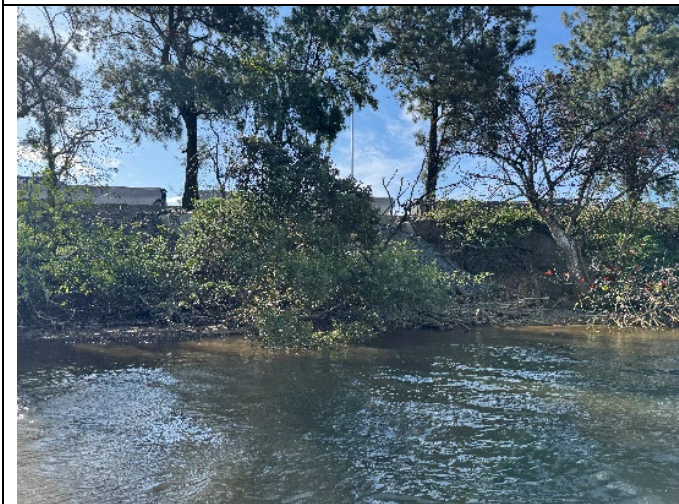
Character of vegetation present along the river bank

Grey mangrove present in centre of image

Photograph taken facing north.

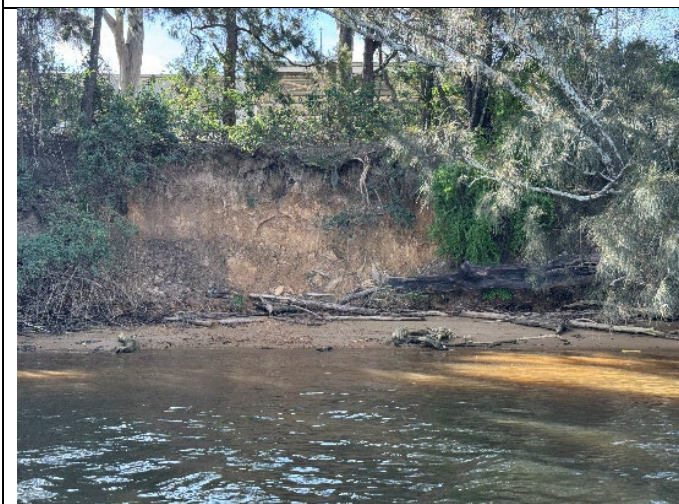
Character of areas along river bank that have existing amounts of heavy erosion

- Areas where bank erosion was observed near the proposed activity should be remediated and stabilised. In stabilising these areas, consultation with an ecological or bush regeneration firm should be entered into to ensure outcomes that benefit the localities terrestrial and aquatic flora and fauna communities are achieved.

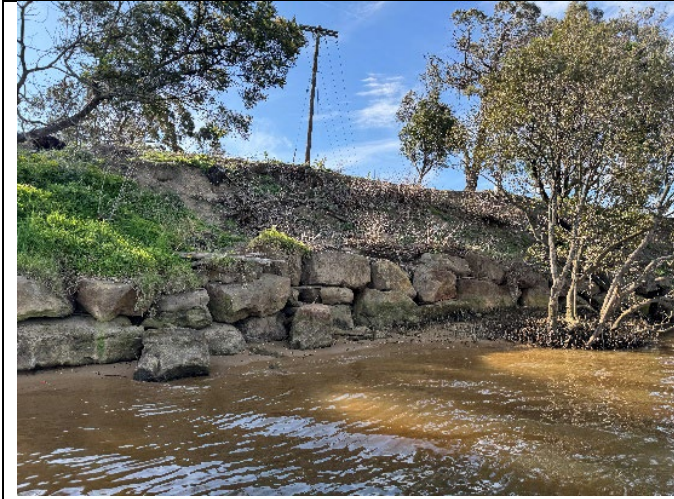
Character of historic bank  
stabilisation present along the river  
bank adjacent to the works area
