ARDGLEN QUARRY

2019 Annual Environmental Management Report (AEMR)

PROJECT APPROVAL MP 06_0264

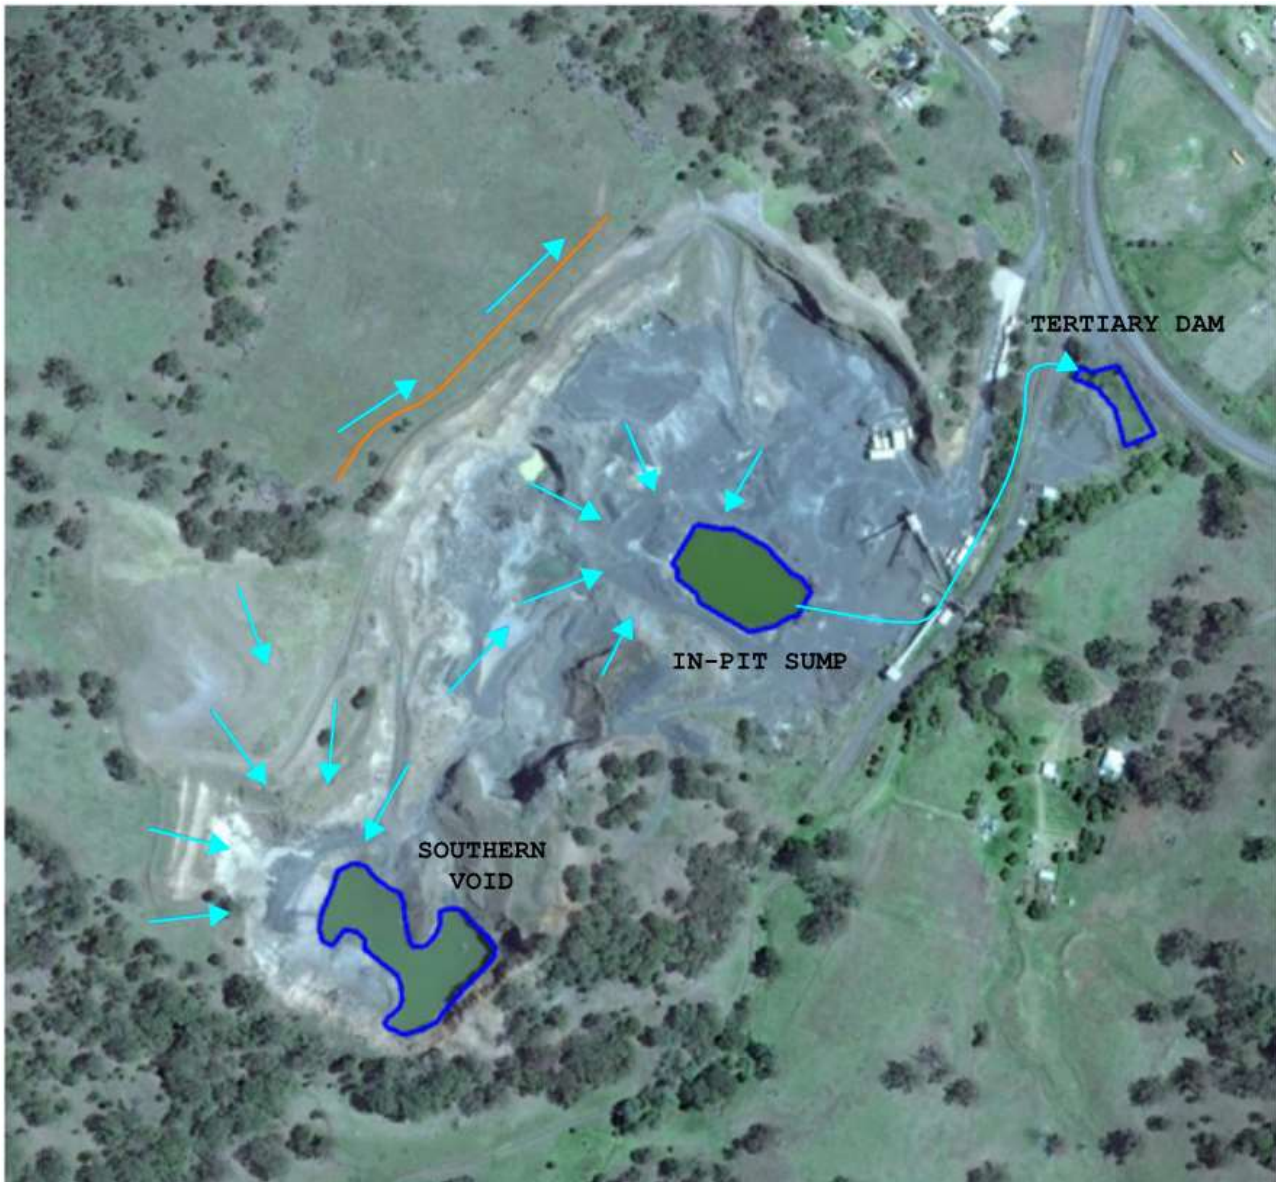
Figure 2: Water Management

- An assessment of basin volumes is included as part of the proposed consent modification;
- An assessment of the reliability of the water supply to the operation is included as part of the proposed consent modification;
- Operational and maintenance activities that could cause soil erosion and sediment generation will be identified and described;
- Procedures to manage unforeseen water quality impacts;
- Water treatment processes to enable discharge as required (subject to the approval of a variation to the site EPL);

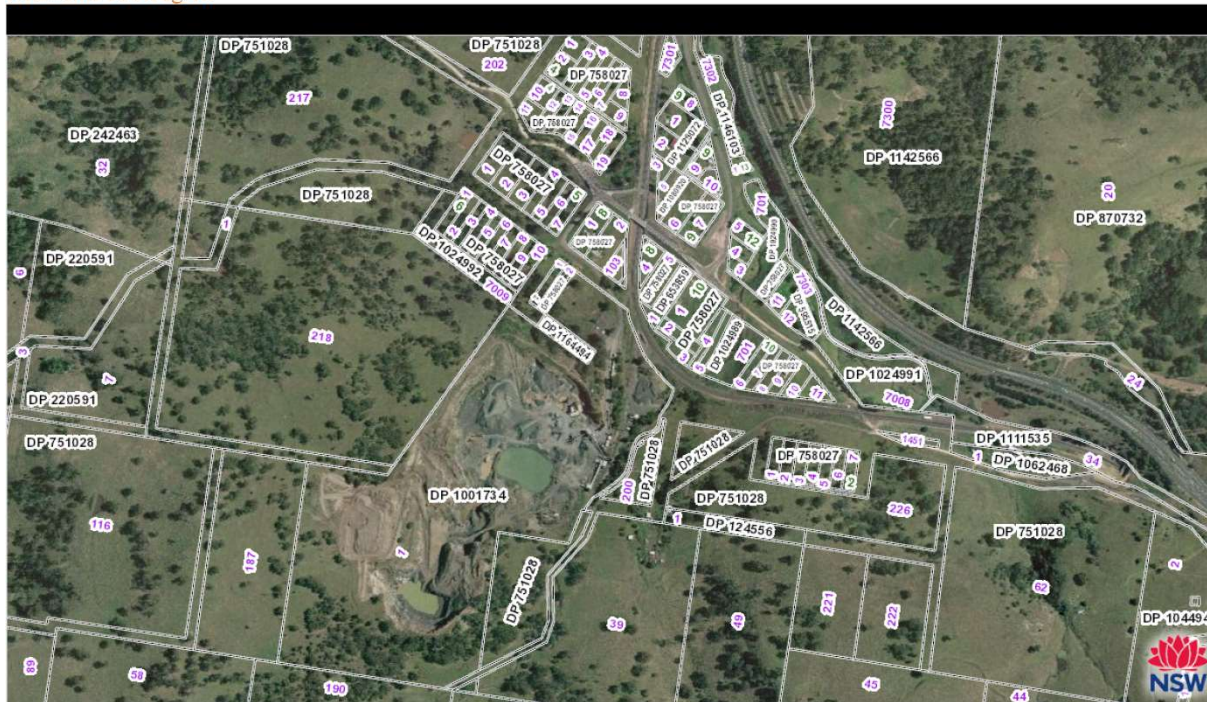
Figure 3: Land Ownership and Residents

Figure 3 displays the land ownership and residence surrounding the quarry. During the reporting period, it is understood that there were no changes to the land ownership within the area. Informal discussions have occurred with a number of residents in the area during the reporting period.

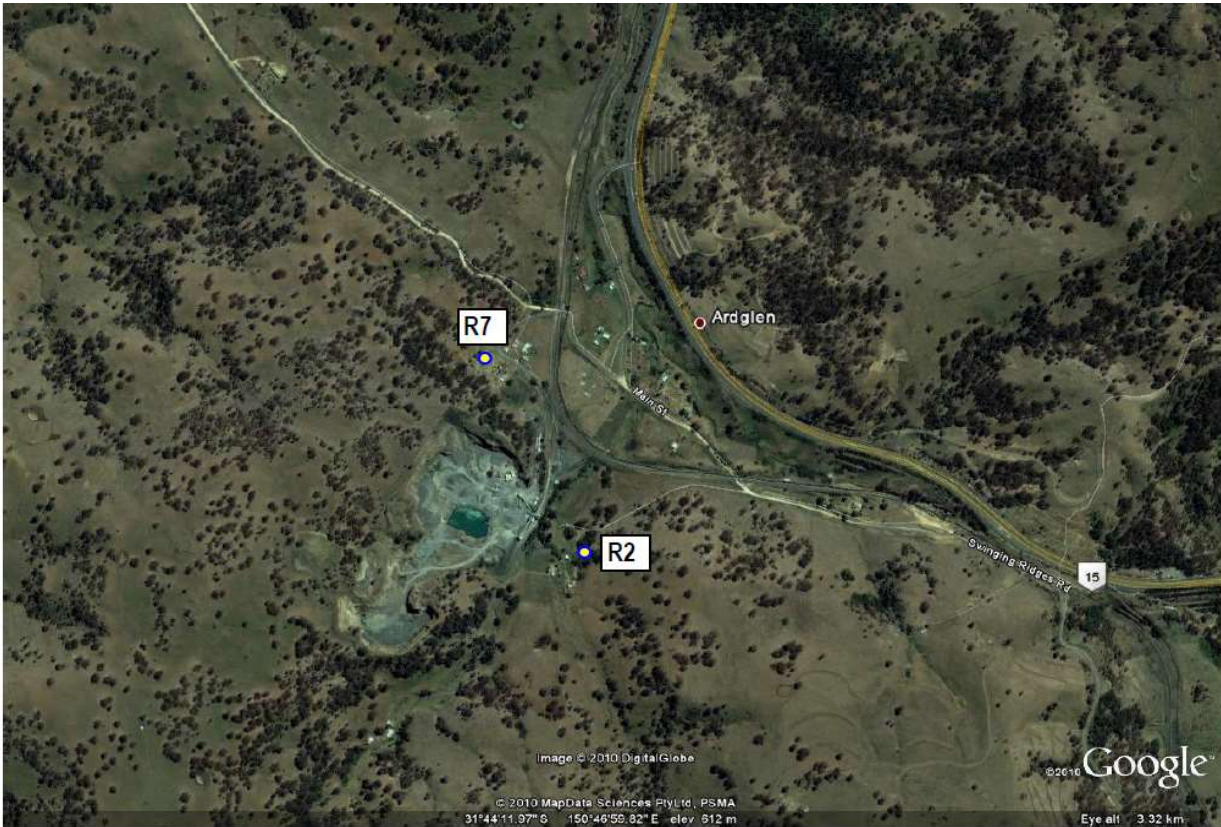
Figure 4: Blast Monitoring Locations

The Blast Monitoring program requires monitoring to take place at specified locations as shown in **Figure 4**. The Noise Monitoring Plan calls for quarterly attended noise monitoring to be completed and take place at specified noise monitoring locations as shown in **Figure 5**.

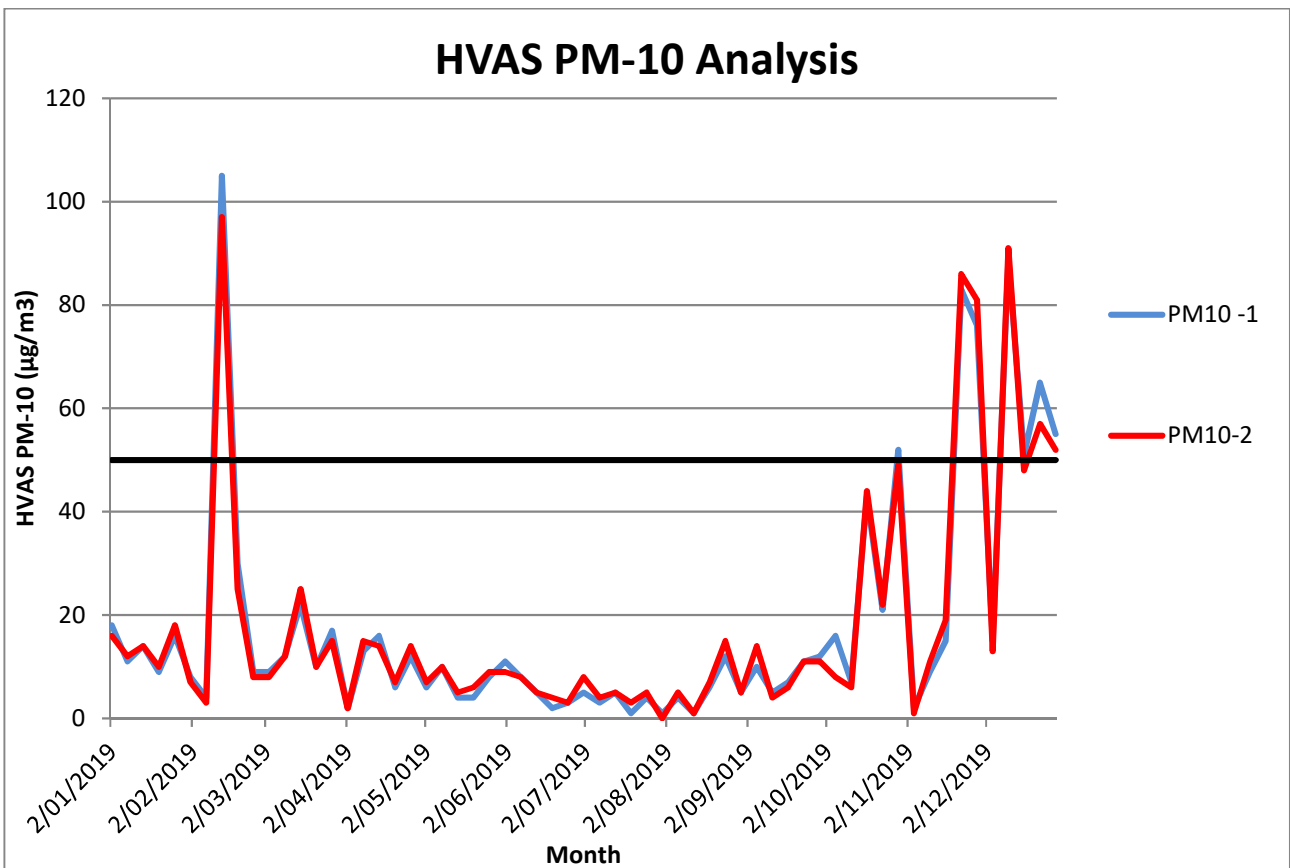
Figure 8: HVAS (PM-10) results for the reporting period

It is worth noting that although all of the annual average results obtained were compliant, there were a number of elevated "24 hour" results were caused by a number of factors as detailed below:

- A regional dust storm that passed through the region in February 2019;
- Intense drought conditions experienced throughout the region for the entire reporting period as described in more detail below in Section 4.6.3;

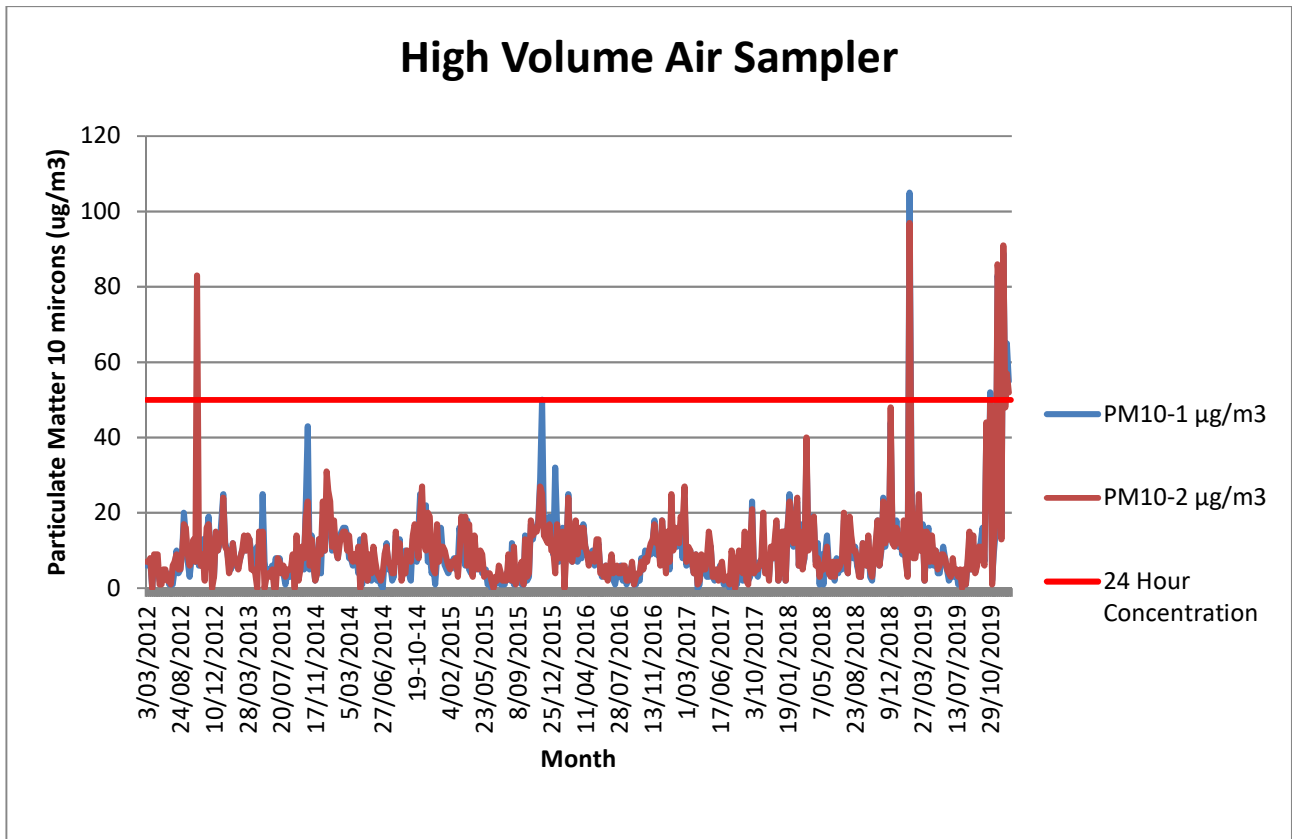
Figure 12: Twenty four hour concentration PM-10 results from 2012 to 2019

- Figure 12 – This shows the HVAS PM-10 “24 hour” monitoring results from 2012 to 2019. As seen in Figure 12, the annual average results are all below the criterion apart from the results obtained in 2012 and more recently during late 2018 and into 2019. For clarification regarding the prevailing weather conditions during late 2018 into 2019, please see also see below Figure 14 (taken from the biodiversity monitoring report) which demonstrates that the region surrounding Ardglen quarry was experiencing “intense drought” conditions which were a significant contributor to the elevated PM10 monitoring results obtained during this time;

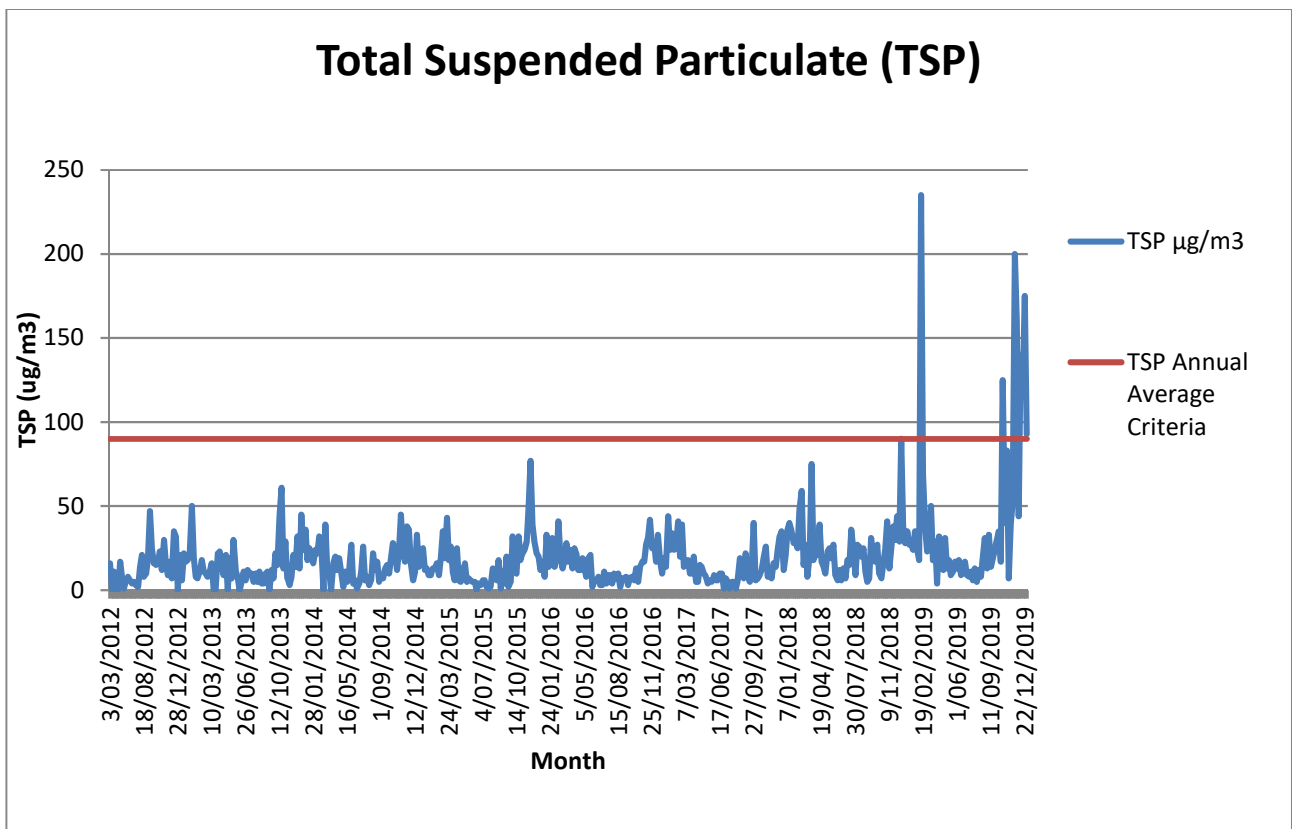
Figure 13: Annual average TSP results from 2012 to 2019

- Figure 13 – This shows the HVAS TSP monitoring results from 2012 to 2019. As seen in Figure 13, the TSP results are all below the criterion apart from the results obtained during late 2018 and into 2019. For clarification regarding the prevailing weather conditions during late 2018 into 2019, please see also see below Figure 14 (taken from the biodiversity monitoring report) which demonstrates that the region surrounding Ardglen quarry was experiencing “intense drought” conditions which were a significant contributor to the elevated PM10 monitoring results obtained during this time;

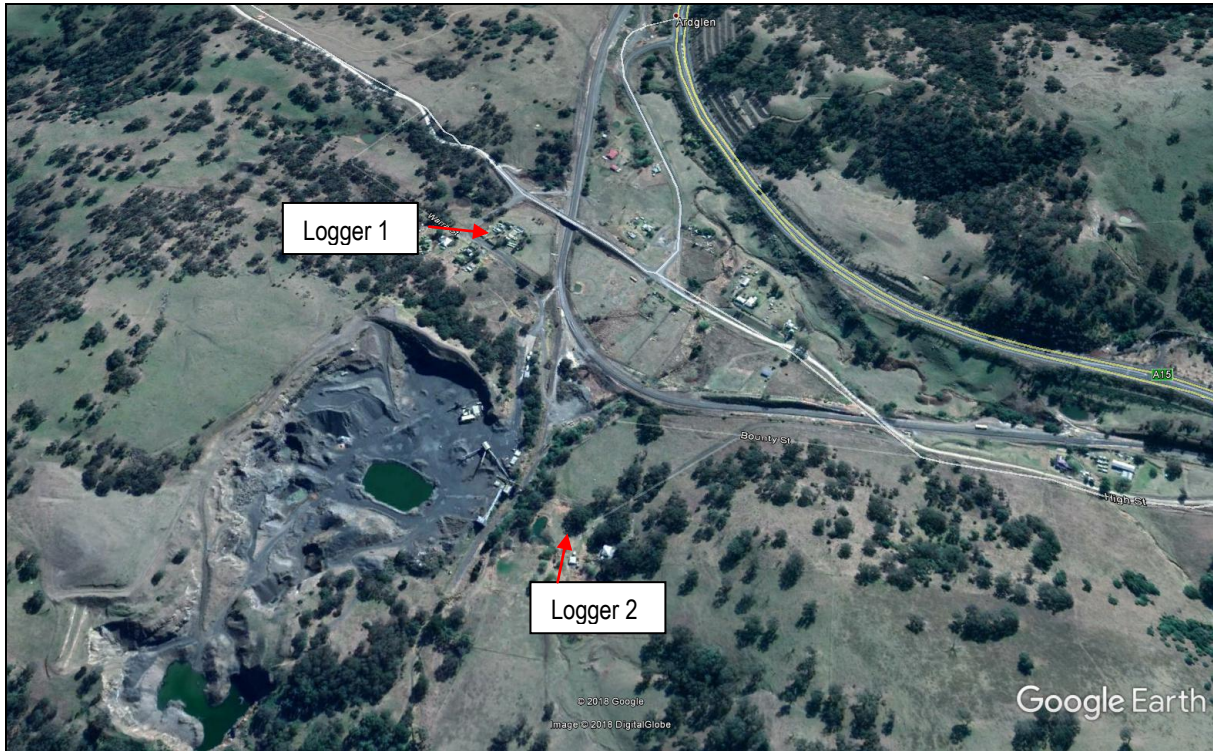
Figure 2 – Unattended Noise Monitoring Locations

The NMP requires that unattended noise logging be undertaken over a period of seven days, part of which coincides with the quarterly attended noise monitoring. To measure the acoustic environment Rion NL-42 sound level meters, set up as environmental noise loggers, were located as shown in Figure 2 from 5th to 12th February, 2019. **Table 3** shows a summary of the relevant measured data from the loggers which is also shown graphically in **Appendix I**.

The logger locations were chosen to be representative of the acoustic environment of the closest residences to the quarry and for security reasons.

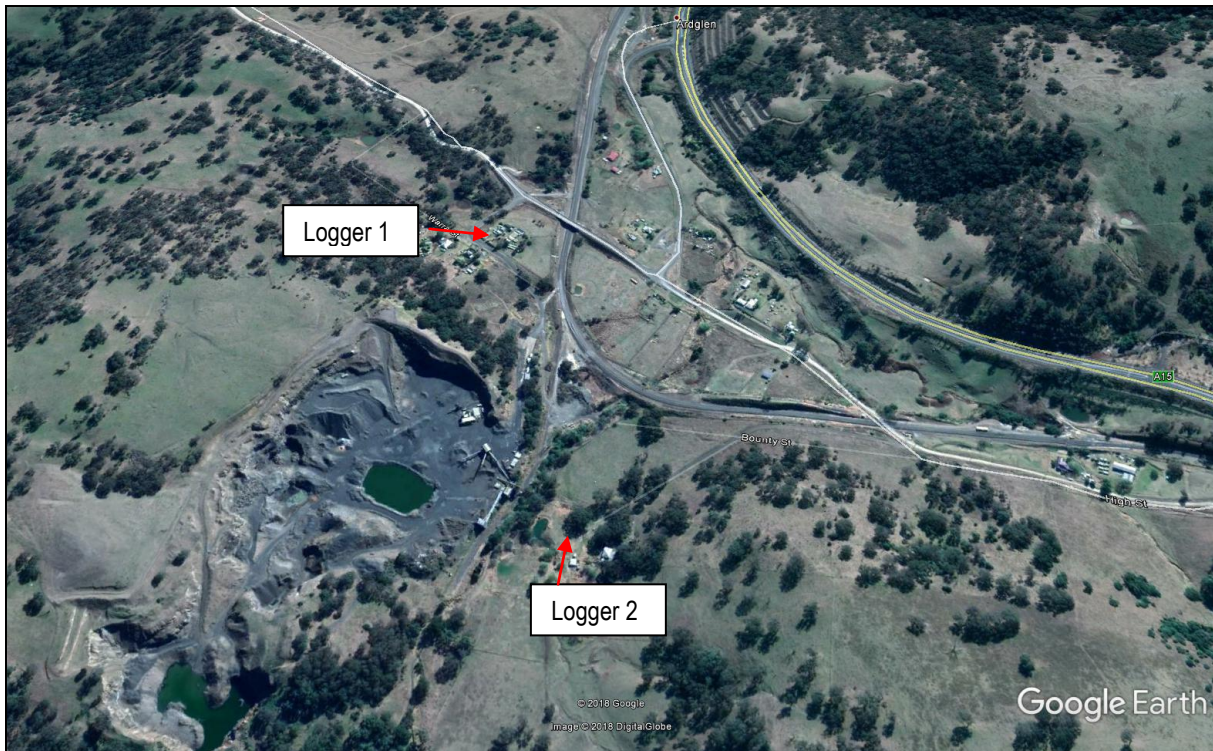
Figure 2 – Unattended Noise Monitoring Locations

To measure the acoustic environment Rion NL-42 sound level meters, set up as environmental noise loggers, were located as shown in Figure 2 from 8th to 15th May, 2019. **Table 3** shows a summary of the relevant measured data from the loggers which is also shown graphically in **Appendix I**.

The logger locations were chosen to be representative of the acoustic environment of the closest residences to the quarry and for security reasons.

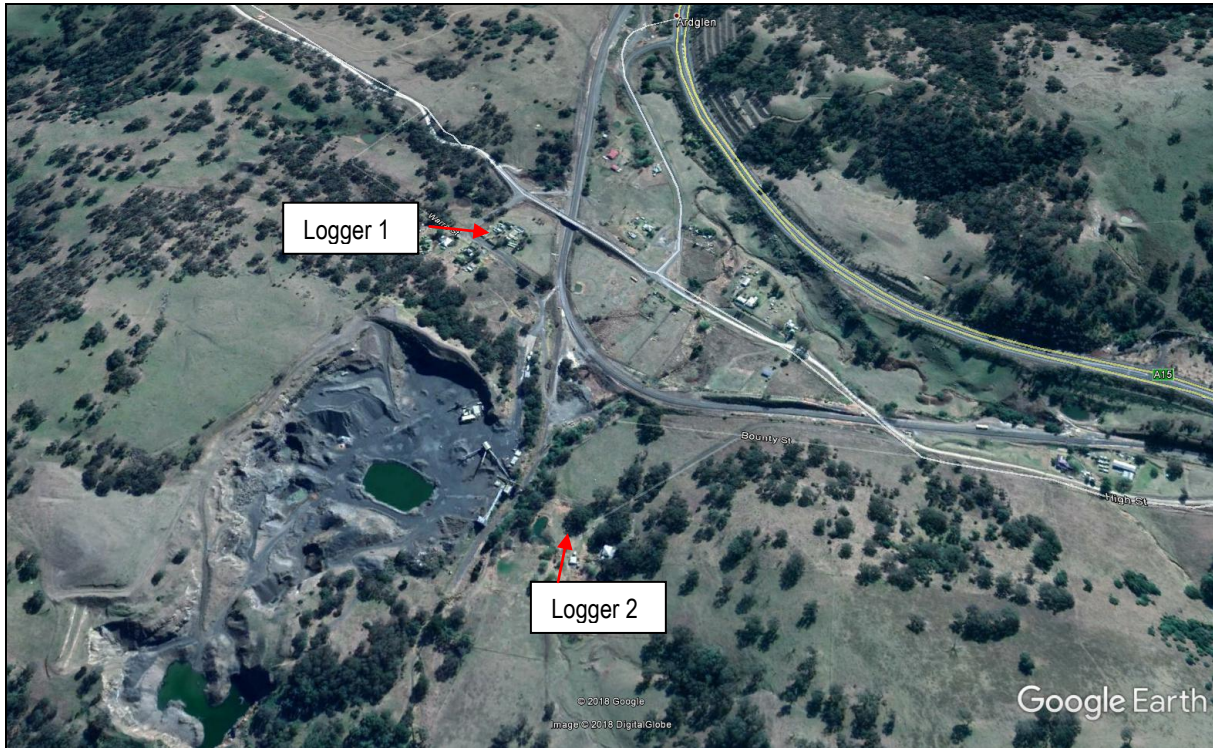
Figure 2 – Unattended Noise Monitoring Locations

To measure the acoustic environment Rion NL-42 sound level meters, set up as environmental noise loggers, were located as shown in Figure 2 from 23rd to 30th August, 2019. **Table 3** shows a summary of the relevant measured data from the loggers which is also shown graphically in **Appendix I**.

The logger locations were chosen to be representative of the acoustic environment of the closest residences to the quarry and for security reasons.

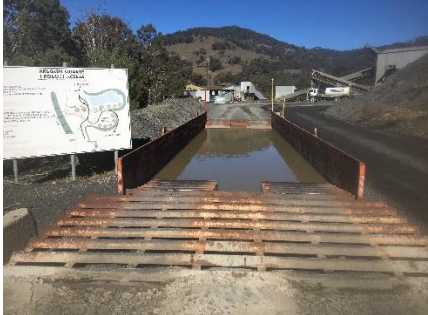
1.	Entrance road.	As noted above, a wheel wash for departing transport vehicles has been established in the period since the previous inspection.	Continue to implement control measures to reduce sediment tracking and dust emissions when the quarry is operating.

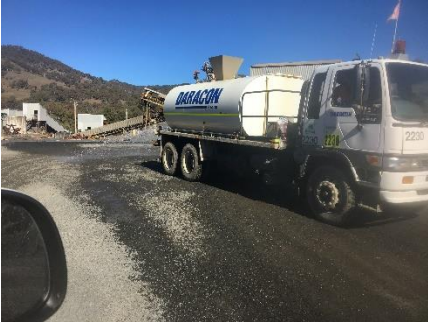
2.	Entrance road and haul roads.	A water cart was noted to be operating from the quarry entrance and around the internal haul roads.	Continue to implement control measures to reduce dust emissions when the quarry is operating.

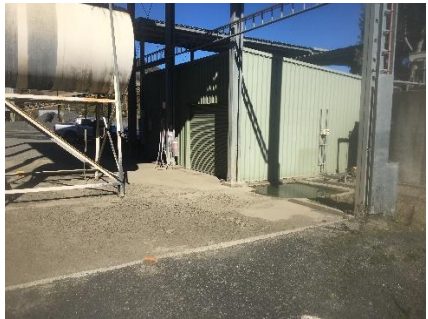
3.	Lube shed and fuel storage area.	The lube shed area remains secure and dormant with adequate bund storage and controls. Ponded water in the surrounding areas was clear and no oil sheens were present.	Continue maintain the area and visually monitor water quality in the surrounding areas.

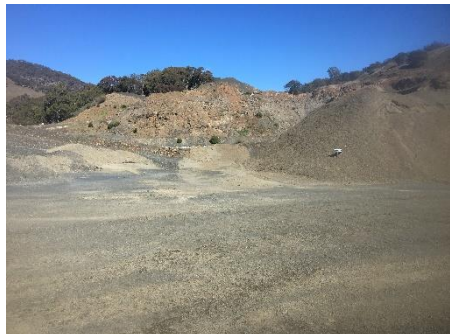
ISSUE NO.	LOCATION	ISSUE/MATTER	RECOMMENDATION/COMMENT	PHOTOGRAPH
4.	Central Dam	The recent destocking and material movement had resulted in accumulated materials being windrowed around the northern aspect of the dam which would impede flows draining to the dam, potentially bypassing the dam and flowing to downslope areas.	As discussed, we recommend excavating several 'notches' in the windrow at key locations to allow free drainage into the dam. Completed 31.07.19

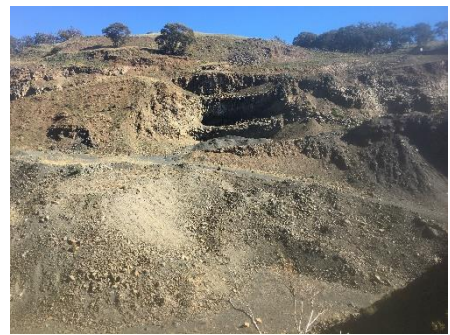
5.	Weed control – main quarry	As noted above, weed suppression has been effective across most areas, with no significant outbreaks noted in the main quarry floor and surrounds .	Continue to monitor the workings and perimeter areas and implement periodic weed control as required. Weed control ongoing for the remainder of 2019

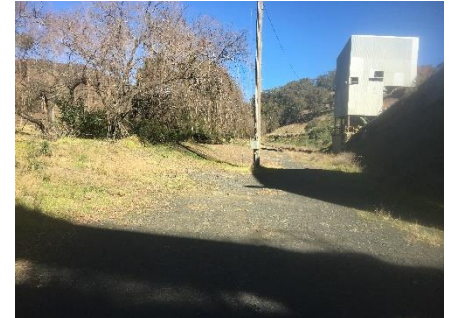
6.	Warra Street rail siding area.	As noted previously, stockpiles in the area had been reworked, and the control berm along the rail siding road had been trimmed and topsoiled. We recommended the control bund should be seeded to establish vegetative cover when suitable weather conditions returned.	As recommended, the control berm has revegetated and is now stabilised.

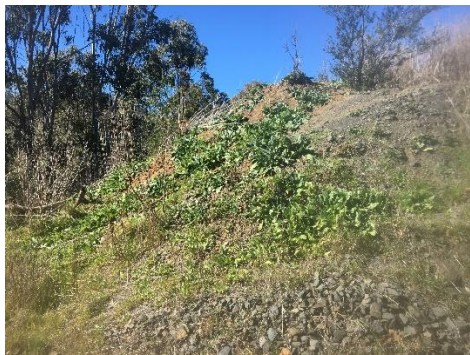
PROJECT:	Ardglen Quarry	INSPECTION REPORT NO.	3	INSPECTION DATE	17 July 2019
7.	Warra Street rail siding area – lower stockpile area..	On the previous inspection the stockpile area had been partially re-worked and destocked, and weed outbreaks had been controlled. We noted one area on the stockpile where an outbreak of what was believed to be 'Paterson's Curse' had established.	As discussed, we recommend the outbreak is treated as soon as practical as this species is a late winter flowering weed. We noted another minor outbreak on the batter between the weighbridge and rail siding access road. Weed control ongoing for the remainder of 2019

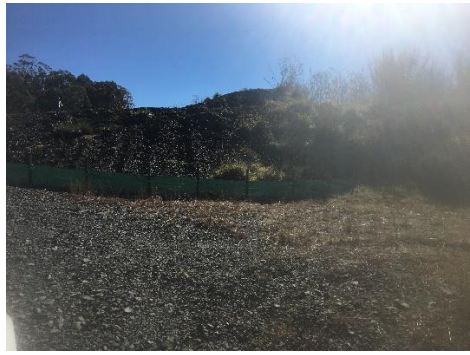
8.	Warra Street rail siding area.	As noted previously, the stockpile area had been reworked and a stand of sediment has been installed downslope from the stockpile area.	The sediment fence remains functional and the adjacent batter areas are being colonised with encroaching vegetation. No actions required.

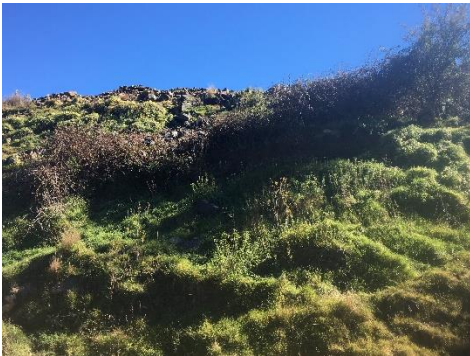
9.	Warra Street rail siding area embankment – west of the rail loader.	We noted a small outbreak of Blackberry Vine which has established on the upper portion of the rail siding area embankment.	As discussed, proceed to treat the area with an appropriate control measure to suppress the spread of the blackberry. Weed control ongoing for the remainder of 2019

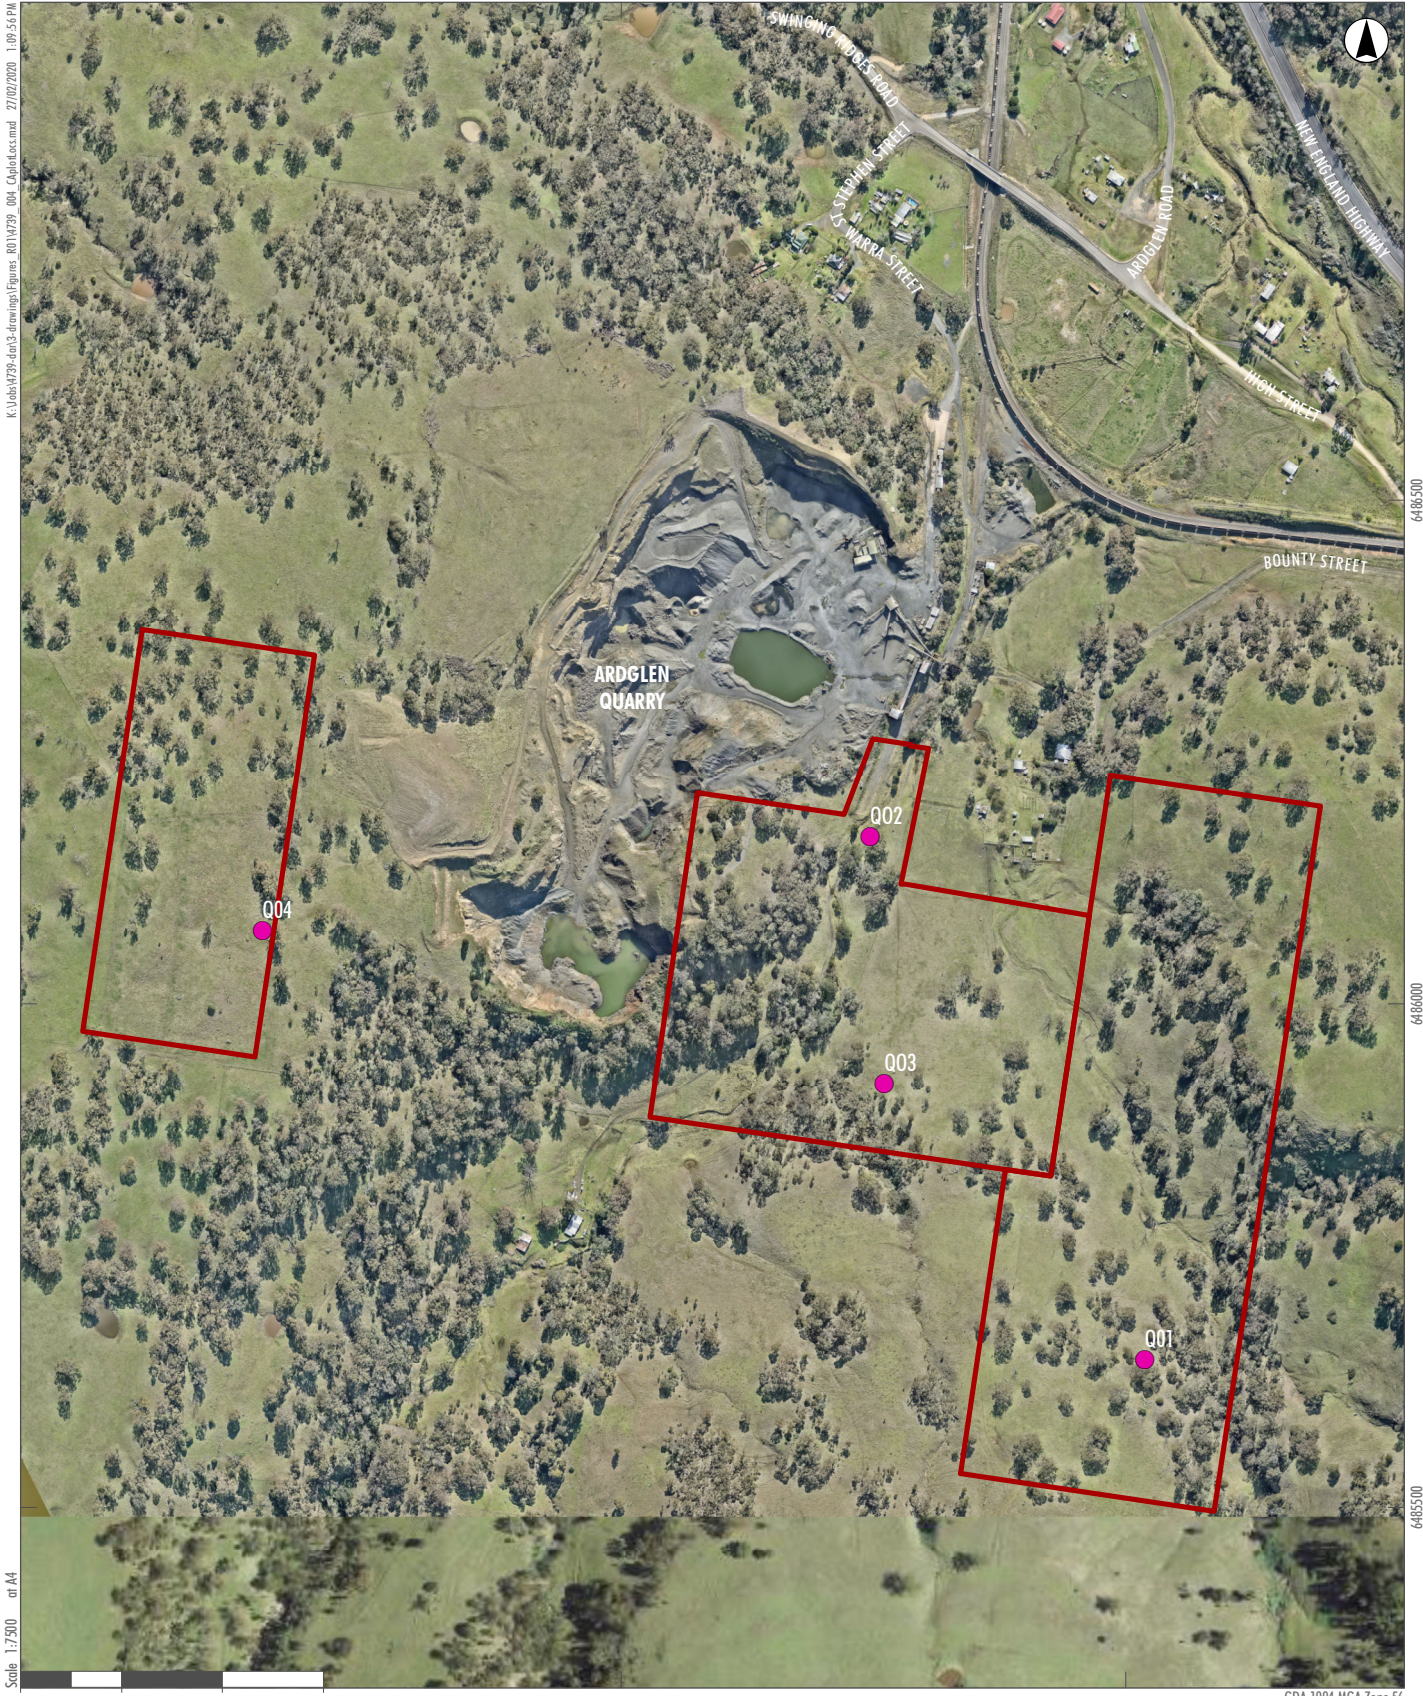
FIGURE 2.3
Conservation Agreement Plot Locations

Four permanent monitoring plots were established within each of the four vegetation zones in the BOAs identified by Orogen (2010). Each plot was marked in the north east corner (of the 20 m x 20 m subplot) with a steel picket and high visibility flagging tape. Plot locations are shown in Figure 2.3. Photo monitoring, floristic and biometric data collection and a walkover assessment were completed according to the BBAM methodology (OEH 2014) and are further described in the following sections.

Rubbish was noted at some locations in the BOAs (Figure 4.1). A significant dump site was found in Offset B, filled with tyres, tiles, glass (Plate 4.4). Large concrete pipes were also noted within permanent monitoring plot Q02 (Figure 2.3).

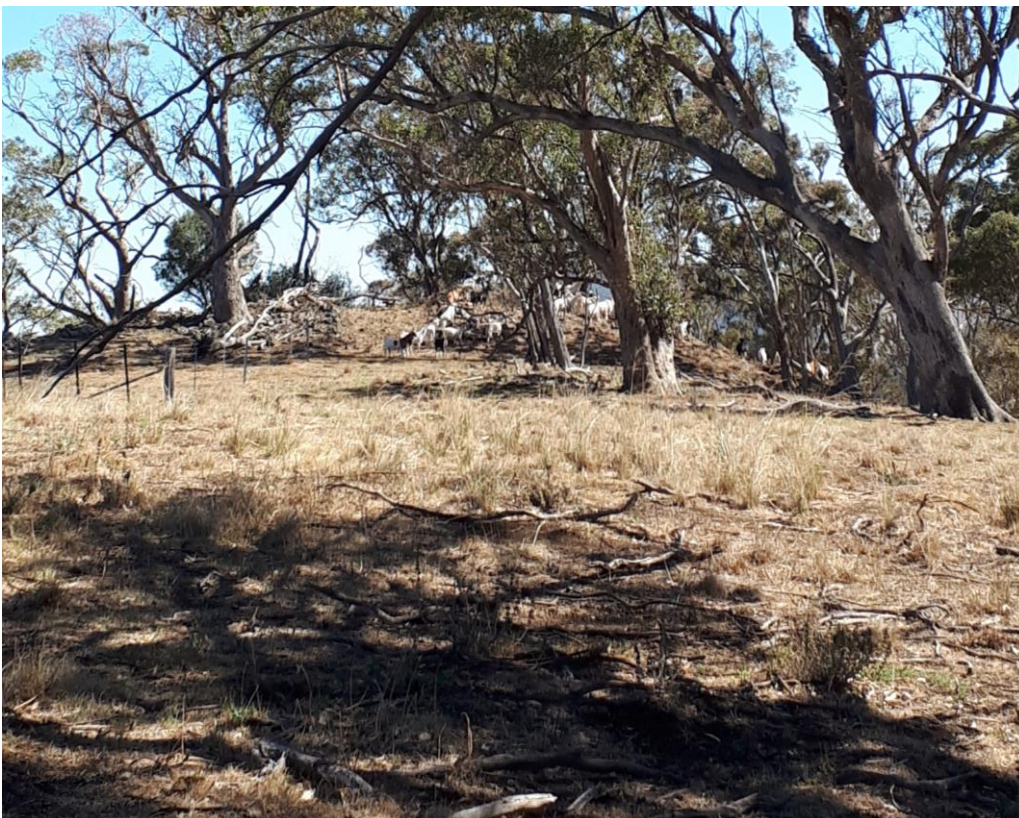
Plate 4.1 Feral goat mob observed on a hill in Offset A

Feral animals and livestock such as sheep, goats, and rabbits continue to remain an issue in the BOAs (see Plate 4.1). A horse has also managed to access Offset C; a problem which remains from 2018 (Conacher Consulting 2018). As a result, there are areas of intense grazing, trampling and digging that has had a noticeable and detrimental effect on the condition and quality of the ground cover (see Plate 4.2). It is noted that goat traps have been established in attempt to reduce numbers of the goat mobs that access the BOAs. Daracon have engaged the services of a feral animal shooter, and it is recommended that this practice continues in order to reduce the detrimental effects of feral animals on the condition of the BOAs.

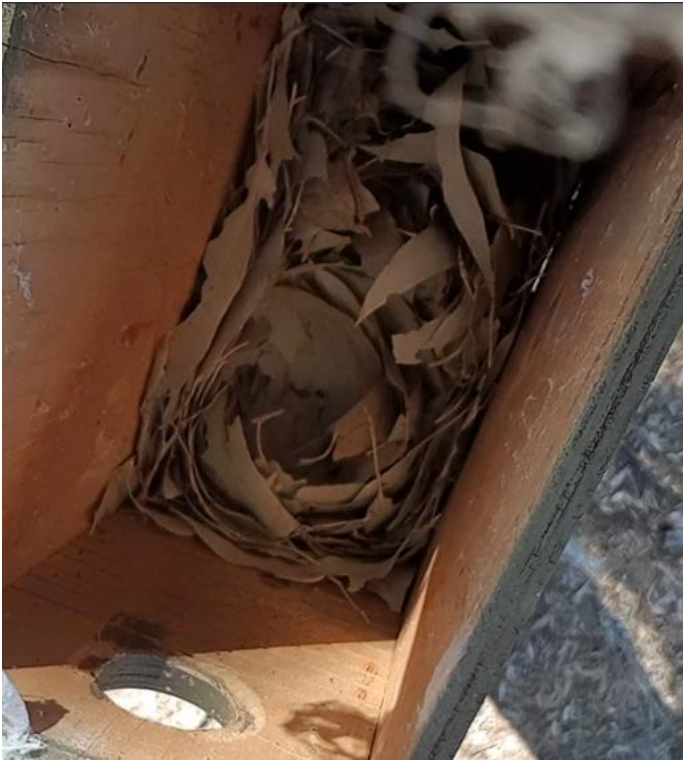
Plate 4.5 Glider nest in Nest Box 15/Tree Tag 161

This year's monitoring period showed greater usage of nest boxes by fauna, with target glider species utilising four nest boxes (14.5%) as shown in Plate 4.5. Aside from invertebrate species, no fauna species were directly identified using any of the boxes, however there were positive signs of use of a high percentage of boxes (92.5%). Pest species (ants and wasps) were present in 14.5% of boxes.

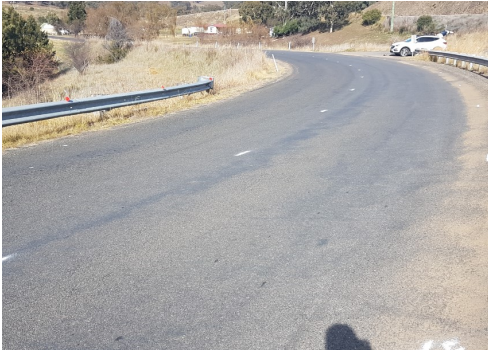
5	Main Street South of the Intersection on the outside of the curve Northbound Road pavement	At the Main Street / rail site compound access and in front of the existing w-beam safety barrier there is loose gravel on the outside of the horizontal curve. This may lead to reduced skid resistance for an errant vehicle. The likelihood of this risk may increase at night and / or adverse weather conditions. This may result in vehicle crashes and serious injury to occupants of a vehicle(s).	As agreed with LPSC representative, the loose gravel on the outside of the curve will be removed by appropriate means by Daracon.	Daracon completed this on the 3 rd April 2019 with street sweeper on site. Additional gravel removal on the 11 th July 2019 before the line marking was installed

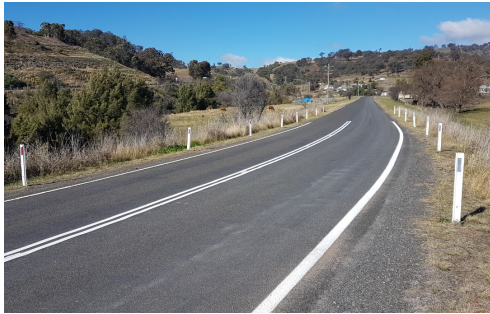
RSA report identification number	Location / category	Description of risk to road safety	Specific actions Daracon commit to undertake	Completion date (if complete) with comments	Evidence of completion	If not complete, status update as at 30 th March 2020 (provided by Daracon to DPIE)
6	Main Street – South of the intersection of New England Highway Northbound and Southbound Roadside hazards	200m along Main Street from the intersection of New England highway, there is an existing culvert with steep embankments within the clear zone. The combination of narrow shoulder widths, steep batters, culvert headwalls within the clear zone, may limit a driver's manoeuvrability to avoid striking an object or have a reduced ability to gain control of their vehicle and strike objects within the clear zone. Narrow shoulders may also limit the available road width for wide vehicle loads and restrict vehicles in the opposing direction. This may increase the likelihood of drivers encroaching into the opposing travel lane and / or vehicles driving within the road shoulder / verge area to avoid a stationary object on the road. This may result in drivers striking the object or another object within the clear zone and lead to rapid deceleration of the vehicle. This may result in serious injury (not limited to) to occupants of a vehicle(s).	As agreed with LPSC representative, Daracon proposes to install a temporary barrier (type F concrete or similar) to highlight the presence of the existing culvert and minimise the likelihood of interaction with the roadside hazard. Subject to the ongoing operation of the quarry, Daracon may choose to install a permanent barrier (guardrail or similar) at some time in the future.	Effectively complete with the self-imposed mandatory speed limit of 40kph from the New England Highway to the Quarry entrance for all trucks was imposed immediately. On the 11 th July 2019, additional controls were installed to highlight the presence of the culvert. These additional controls were the extension of the line marking and installation of extra guideposts as shown in the image.

As of the 30 th March 2020 and in consultation with LPSC, no issues or incidents have arisen at this location. This fact combined with the cessation of material export from Ardglen quarry (and the subsequent reduction in vehicular movements along Main St), combined with the fact that the additional guideposts are still present and operating effectively, means that this item remains unchanged at this time.

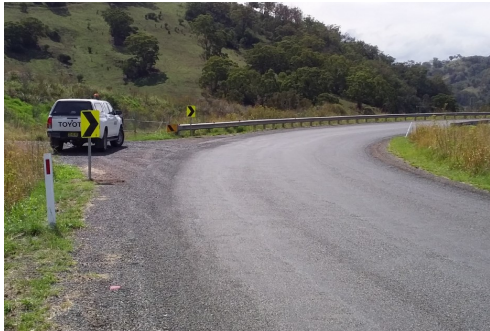
7	Main Street – Rail site compound access Northbound Road alignment and cross section and delineation	Approximately 150m from the intersection of New England Highway along Main Street there is an access track to a rail site compound. At the access there is a lack of delineation on the horizontal curve. This may give the oncoming driver the impression that the Main Street continues through rather than traveling to the right, especially at night. This may cause a driver to make a late change in direction. The combination of loose gravel on the outside of the curve and the late change in direction may result in crashes with other vehicles and result in injury to occupants of a vehicle(s).	As agreed with LPSC representative, Daracon proposes to install additional guide posts (or similar) to delineate the outside of the horizontal curve.	Completed on the 26 th March 2019.

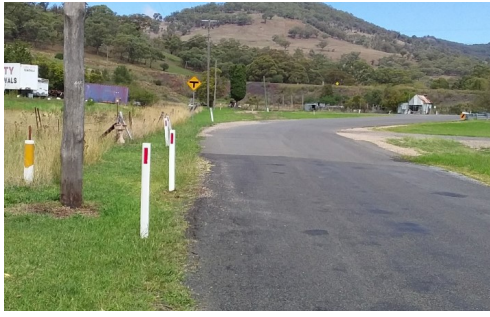
9	Main Street Intersection with Ardglen Road Northbound and Southbound Traffic signs	On Main Street approach to Ardglen Road, the existing speed zone repeater signage appears faded. This may increase the likelihood of readability issues for drivers, and increase the likelihood of a driver failing to travel to the sign posted speed limit. The likelihood of this risk may increase at night and / or adverse weather conditions. This may lead to vehicle crashes and injury to occupants of a vehicle(s).	As agreed with LPSC representative, Daracon proposes to install new speed limit signage as the existing sign is faded.	Completed on the 20 th March 2019.	 	N/A
10	Main Street Approaching the Intersection with Ardglen Road Northbound and Southbound Roadside hazards	On Main Road approach to Ardglen Road, there is an existing power pole and fence posts within the clear zone. Errant vehicles at these locations may have a reduced ability to gain control of their vehicle and strike the power pole or fence post within the clear zone which may lead to rapid deceleration of the vehicle. This may be due to the combination of horizontal and / or vertical alignment of the road and / or drivers swerving to avoid striking an animal (i.e. animal carcass). The likelihood of this risk may increase at night and / or adverse weather conditions. This may result in vehicle crashes and injury to occupants of a vehicle(s), not limited to.	As agreed with LPSC representative, Daracon proposes to install delineation in the form of additional guideposts adjacent to the roadway to highlight the presence of the existing power pole.	Completed on the 26 th March 2019.

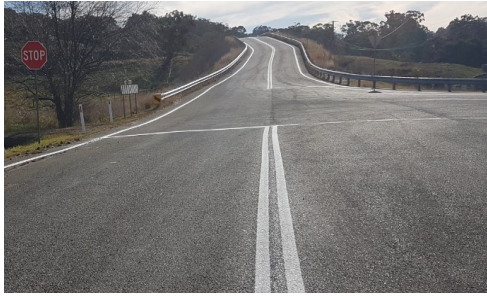
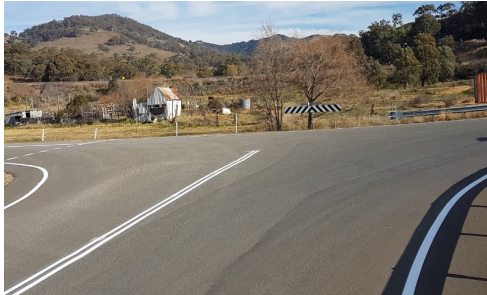
12	Main Street Intersection with High Street Delineation	At the intersection of Main Street and High Street, the existing delineation is faded. This may lead to readability issues for a driver and increase the likelihood of a vehicle failing to give way at the intersection. The likelihood of this risk may increase at night and / or adverse weather conditions. This may lead to vehicle crashes and injury to occupants of a vehicle(s).	As agreed with LPSC representative, Daracon proposes to refresh the existing line marking.	Completed on the 11 th July 2019.

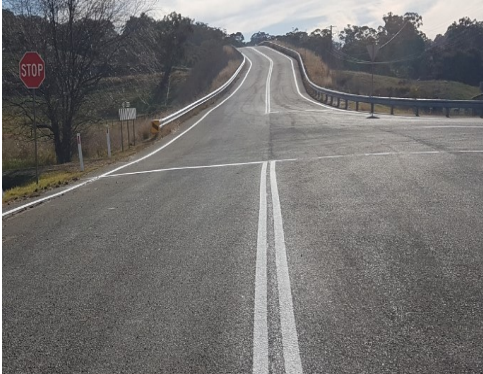
N/A
15	High street Rail overpass bridge Eastbound and Westbound Road alignment and cross section	Traveling west along High Street towards the rail overpass bridge, the travel lanes appear to narrow and there is a kink in the alignment of the road. The narrow travel lane widths may limit a driver's manoeuvrability and increase the likelihood of readability issues to oncoming vehicles. Narrow travel lane may also limit the available road width for wide vehicle loads and restrict vehicles in the opposing direction. This may result in drivers striking oncoming vehicles or safety barriers and lead to rapid deceleration of the vehicle. This may result in serious injury (not limited to) to occupants of a vehicle(s).	As agreed with LPSC representative, all existing line marking will be renewed if not completed recently by LPSC. An additional control that has been implemented is the self-imposed mandatory speed limit of 40kph from the New England Highway to the Quarry entrance for all trucks. Appropriate delineation already exists along the guardrail.	Self-imposed 40 kph speed limit imposed immediately. The line marking was completed on the 11 th July 2019.

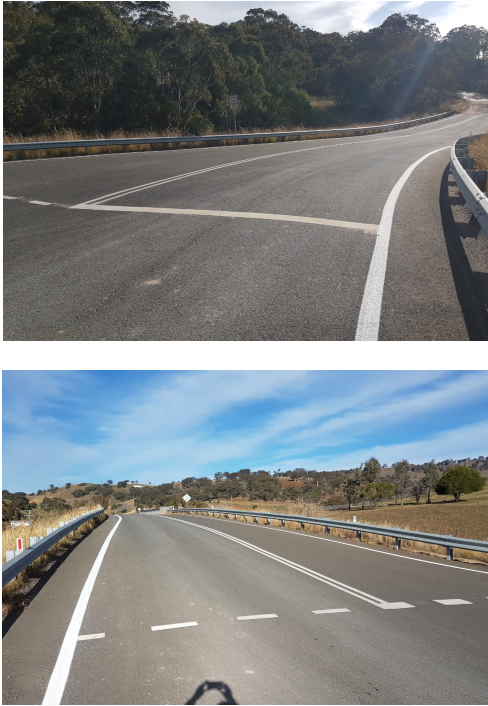
RSA report identification number	Location / category	Description of risk to road safety	Specific actions Daracon commit to undertake	Completion date (if complete) with comments	Evidence of completion	If not complete, status update as at 30 th March 2020 (provided by Daracon to DPIE)
16	High Street Approach to St Stephen Street Intersection Eastbound and Westbound Delineation	<p>At the intersection of High Street and St Stephen Street, the existing delineated is faded. This may lead to readability issues for a driver and increase the likelihood of a vehicle failing to give way / stop at the intersection. The likelihood of this risk may increase at night and / or adverse weather conditions. This may lead to vehicle crashes and injury to occupants of a vehicle(s).</p>	As agreed with LPSC representative, all existing line marking will be renewed by Daracon if not completed recently by LPSC.	Completed on the 11 th July 2019.

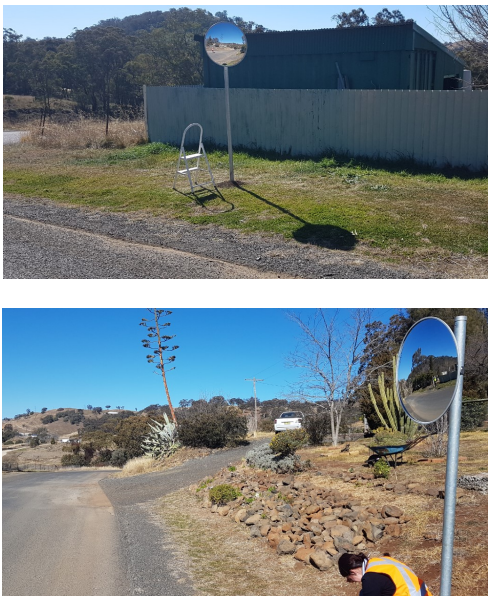
17	St Stephen Street Northbound and Southbound Road alignment and cross section	<p>The road carriageway width along St Stephens Street does not appear suitable for vehicles to pass (i.e. trucks passing other trucks and / or cars). The travel lane widths may limit a driver's manoeuvrability and increase the likelihood of readability issues to oncoming vehicles. Narrow travel lane may also limit the available road width for wide vehicle loads and restrict vehicles in the opposing direction. This may result in drivers striking oncoming vehicles or objects within the clear zone and lead to rapid deceleration of the vehicle. This may result in serious injury (not limited to) to occupants of a vehicle(s).</p>	As agreed with LPSC representative, Daracon will consult with the three residents along Warra and St Stephen Streets to discuss the potential installation of convex mirrors at strategic locations and will install as agreed. Daracon has also implemented a self-imposed mandatory speed limit of 40kph from the New England Highway to the Quarry entrance as well as a mandatory "call up" protocol for St Stephens and Warra St's as detailed in the TTMP.	<p>Complete with the self-imposed mandatory speed limit of 40kph from the New England Highway to the Quarry entrance for all trucks was imposed immediately. The call up protocol for St Stephens and Warra St's was also implemented immediately as detailed in the TTMP. The residents along Warra and St Stephens St were also consulted with and agreed that the installation of "convex mirrors" located in strategic locations would assist to mitigate the issues identified. The "convex mirrors" were installed on the 15th August 2019 as shown in the images.</p>

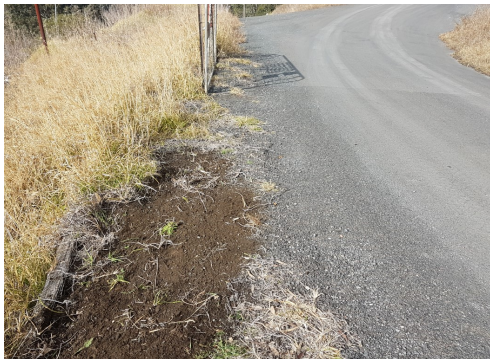
19	Warra Street Northbound and Southbound Road alignment and cross section	The road carriageway width along Warra Street does not appear suitable for vehicles to pass (i.e. trucks passing other trucks and / or cars). The travel lane widths may limit a driver's manoeuvrability and increase the likelihood of readability issues to oncoming vehicles. Narrow travel lane may also limit the available road width for wide vehicle loads and restrict vehicles in the opposing direction. This may result in drivers striking oncoming vehicles or objects within the clear zone and lead to rapid deceleration of the vehicle. This may result in serious injury (not limited to) to occupants of a vehicle(s).	Refer to RSA CAR #17.	Refer to RSA CAR #17.		N/A
20	Warra Street Near the quarry entrance Southbound Pavement And Road alignment And cross section	Near the entrance to the quarry and part of Warra Road the existing pavement is deteriorated and shoulder show evidence of erosion. This may lead to soft shoulders and may be unstable for heavy vehicle to use if divers need to move their vehicle to avoid oncoming traffic. This may result in injury to occupants of a vehicle(s), not limited to.	As agreed with LPSC representative, Daracon proposes to investigate and repair the shoulder as described in the RSA.	Completed 20 th March 2019.
