ARDGLEN QUARRY

2019 Annual Environmental Management Report (AEMR)

PROJECT APPROVAL MP 06_0264

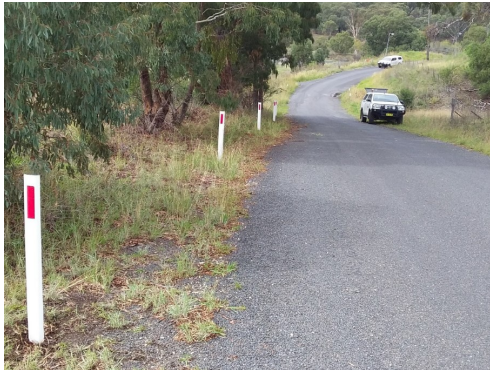
RSA report identification number	Location / category	Description of risk to road safety	Specific actions Daracon commit to undertake	Completion date (if complete) with comments	Evidence of completion	If not complete, status update as at 30 th March 2020 (provided by Daracon to DPIE)
21	Warra Street Northbound and Southbound Roadside hazards	<p>Along Warra Street the auditors observed trees within clear zone as well as narrow carriageway. Errant vehicles at these locations may have a reduced ability to gain control of their vehicle and strike the trees within the clear zone which may lead to rapid deceleration of the vehicle. This may be due to the narrow carriageway width of the road and / or drivers swerving to avoid striking oncoming vehicles. The likelihood of this risk may increase at night and / or adverse weather conditions. This may result in vehicle crashes and injury to occupants of a vehicle(s), not limited to.</p>	<p>As agreed with LPSC representative, Daracon proposes to install delineation in the form of additional guideposts adjacent to the roadway to highlight the presence of the trees. Daracon has implemented a self-imposed mandatory speed limit of 40kph from the New England Highway to the Quarry entrance as well as a mandatory “call up” protocol for St Stephens and Warra St’s as detailed in the TTMP.</p>	<p>Completed on the 26th March 2019.</p>

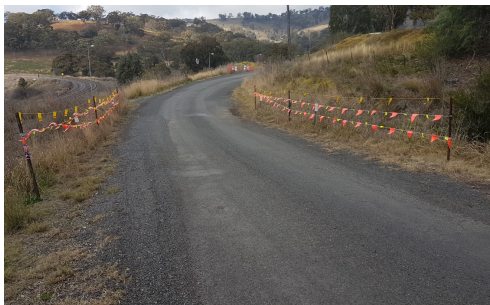
22	Warra Street Northbound and Southbound Roadside hazards	<p>Approximately 50m from the entrance of the quarry there is an existing culvert headwall with drop-off within the clear zone. Errant vehicles at these locations may have a reduced ability to gain control of their vehicle impact with the existing headwall and / or surrounding objects within the clear zone. This may be due to the narrow carriageway width of the road and / or drivers swerving to avoid striking oncoming vehicles. The likelihood of this risk may increase at night and / or adverse weather conditions. This may result in vehicle crashes and serious injury to occupants of a vehicle(s).</p>	<p>As agreed with LPSC representative, Daracon proposes to install a temporary barrier (type F concrete or similar) to highlight the presence of the existing culvert and minimise the likelihood of interaction with the roadside hazard. Additionally, LPSC have committed to investigating the option of extending the existing storm water pipe to permit widening of the formation thus eliminating the roadside hazard.</p>	<p>The self-imposed mandatory speed limit of 40kph from the New England Highway to the Quarry entrance for all trucks was imposed immediately. The call up protocol for St Stephens and Warra St’s was also implemented immediately as detailed in the TTMP. Temporary delineation was installed on the 1st April 2019 as shown in the image. These are considered appropriate short term rectification measures due to the fact that this location exists beyond the section of Warra St that requires private vehicular access and only quarry traffic utilises this section of road.</p>

<p>Longer term planning for additional works along Warra St are continuing in consultation with LPSC with final arrangements pending the proposed MOD #2 status. This matter was discussed and agreed with Warren Faulkner from LPSC on the 26th February 2020.</p>

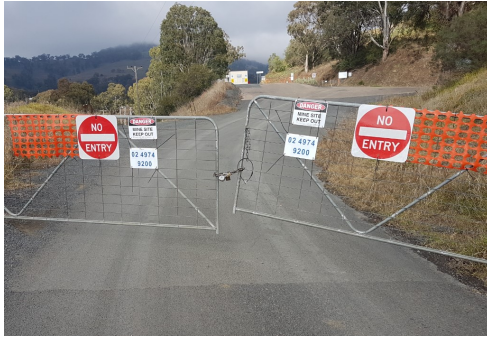
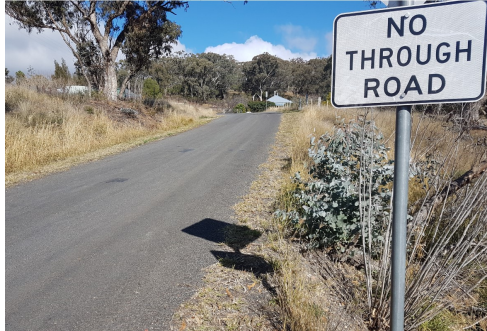
RSA report identification number	Location / category	Description of risk to road safety	Specific actions Daracon commit to undertake	Completion date (if complete) with comments	Evidence of completion	If not complete, status update as at 30 th March 2020 (provided by Daracon to DPIE)
23	Warra Street Quarry entrance Northbound and Southbound Road alignment and cross section	At the site entry of the quarry, the entry appears narrow, lack of carriageway width for drivers to turn around as well as lack of restriction signage / no through road. This may lead to driver frustration and confusion which may contribute to driver error. The likelihood of this risk may increase at night and / or adverse weather conditions. This may result in vehicle crashes and serious injury to occupants of a vehicle(s).	As agreed with LPSC representative, Daracon has implemented a self-imposed mandatory speed limit of 40kph from the New England Highway to the Quarry entrance as well as a mandatory “call up” protocol for St Stephens and Warra St’s as detailed in the TTMP.	The self-imposed mandatory speed limit of 40kph from the New England Highway to the Quarry entrance for all trucks was imposed immediately. The call up protocol for St Stephens and Warra St’s was also implemented immediately as detailed in the TTMP. Additional “no entry” and “no through road” signage was installed on the 11 th July 2019.

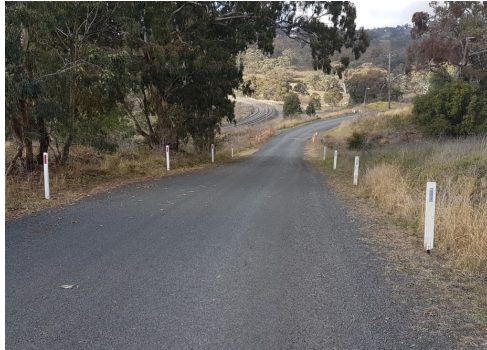
24	Warra Street Northbound and Southbound Delineation	It was noted that along Warra Street there is a lack of delineation. This may increase the likelihood of readability issues for drivers. The likelihood of this risk may increase at night and / or adverse weather conditions. This may result in vehicle crashes and injury to occupants of a vehicle(s).	As agreed with LPSC representative, Daracon proposes to install delineation in the form of additional guideposts adjacent to the roadway.	Completed on the 11 th July 2019.

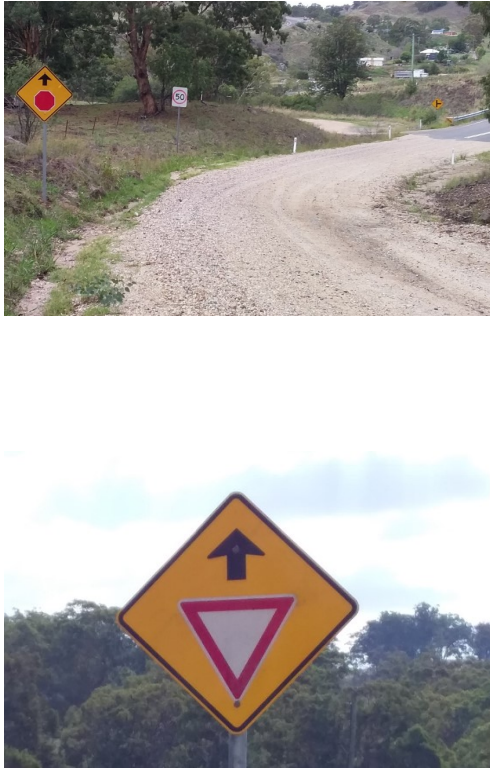
RSA report identification number	Location / category	Description of risk to road safety	Specific actions Daracon commit to undertake	Completion date (if complete) with comments	Evidence of completion	If not complete, status update as at 30 th March 2020 (provided by Daracon to DPIE)
LPSC #1	Either side of the rail overpass bridge	<p>The two 'T' intersections either side of the rail overpass bridge are not your normal 'T' intersections in that the approach roads to the top of the 'T' have right away, whereas the thru road normally has right of way. Whilst 'Give Way' and 'Stop Signs' along with line marking (that needs maintaining) exists, I think advance warning 'Give Way Sign Ahead' and 'Stop Sign Ahead' signs (W3-1B and W3-2B) should be considered to forewarn road users along High Street and Swinging Ridges Road as the thru road(s).</p>	<p>Daracon agree to install additional advance warning 'Give Way Sign Ahead' and 'Stop Sign Ahead' signs (W3-1B and W3-2B) to forewarn road users along High Street and Swinging Ridges Road as the thru road(s)</p>	<p>Completed on the 20th March 2019.</p>

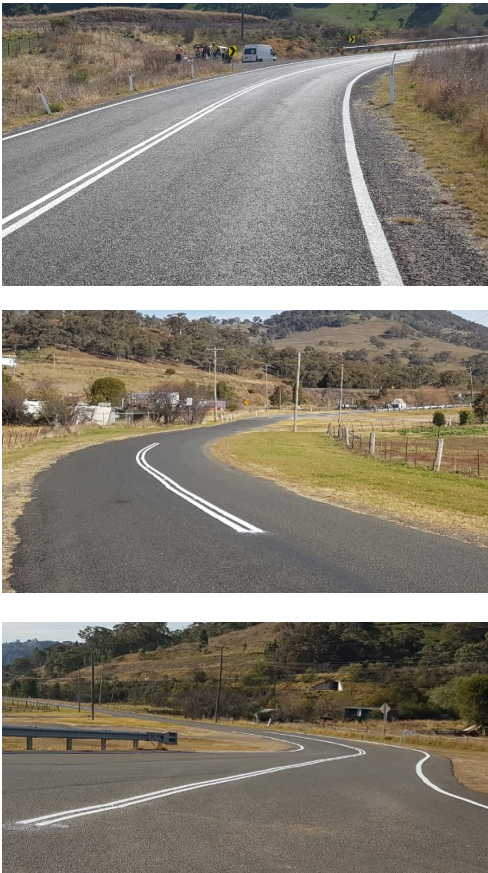
RSA report identification number	Location / category	Description of risk to road safety	Specific actions Daracon commit to undertake	Completion date (if complete) with comments	Evidence of completion	If not complete, status update as at 30 th March 2020 (provided by Daracon to DPIE)
LPSC #2	Main Street	<p>There is no centreline delineation along the Ardglan Road (it is being called Main Street in the RSA). High Street has centreline marking (albeit it is very faded and needs redoing). Given there are 2 curves along the Ardglan Road, the RSA should identify the lack of centreline marking along this road in greater detail.</p>	<p>Although the AADT would be less than 300 vehicles per day including the quarry operating at 500,000T by road per year as proposed (approximately 60 outbound and 60 inbound truck movements), it was agreed with LPSC to install additional line marking only at the curves either end of Main St. The straight section of Main St will remain with no line marking. All existing line marking will also be renewed if not completed recently by LPSC. An additional control that has been implemented is the self-imposed mandatory speed limit of 40kph from the New England Highway to the Quarry entrance for all trucks.</p>	<p>Completed on the 11th July 2019.</p>

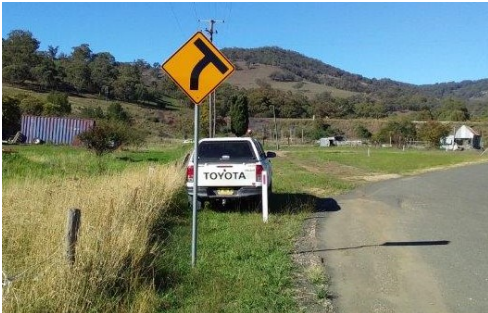
LPSC #3	Main Street	<p>The advance 'T' junction warning sign on Ardglan Road on approach to High Street does not depict the road alignment on approach to the intersection. The approach to the intersection has a horizontal curve between the Advanced intersection Warning Sign and the intersection. The sign should be changed to a Curved Intersection (W2-14B) sign.</p>	<p>Daracon agrees to change the advance 'T' junction warning sign on Ardglan Road on approach to High Street to a Curved Intersection (W2-14B) sign.</p>	<p>Completed on the 3rd April 2019.</p>

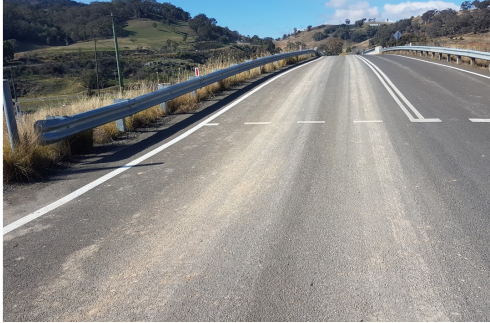
<p>Note – The dirt present on the road surface (as shown in the above image) was the result of LPSC unsealed road maintenance occurring along Swinging Ridges Rd and was in no way associated with truck movements to or from Ardglen Quarry.</p>	N/A
