# ARDGLEN QUARRY

## 2020 Annual Environmental Management Report (AEMR)

PROJECT APPROVAL MP 06\_0264

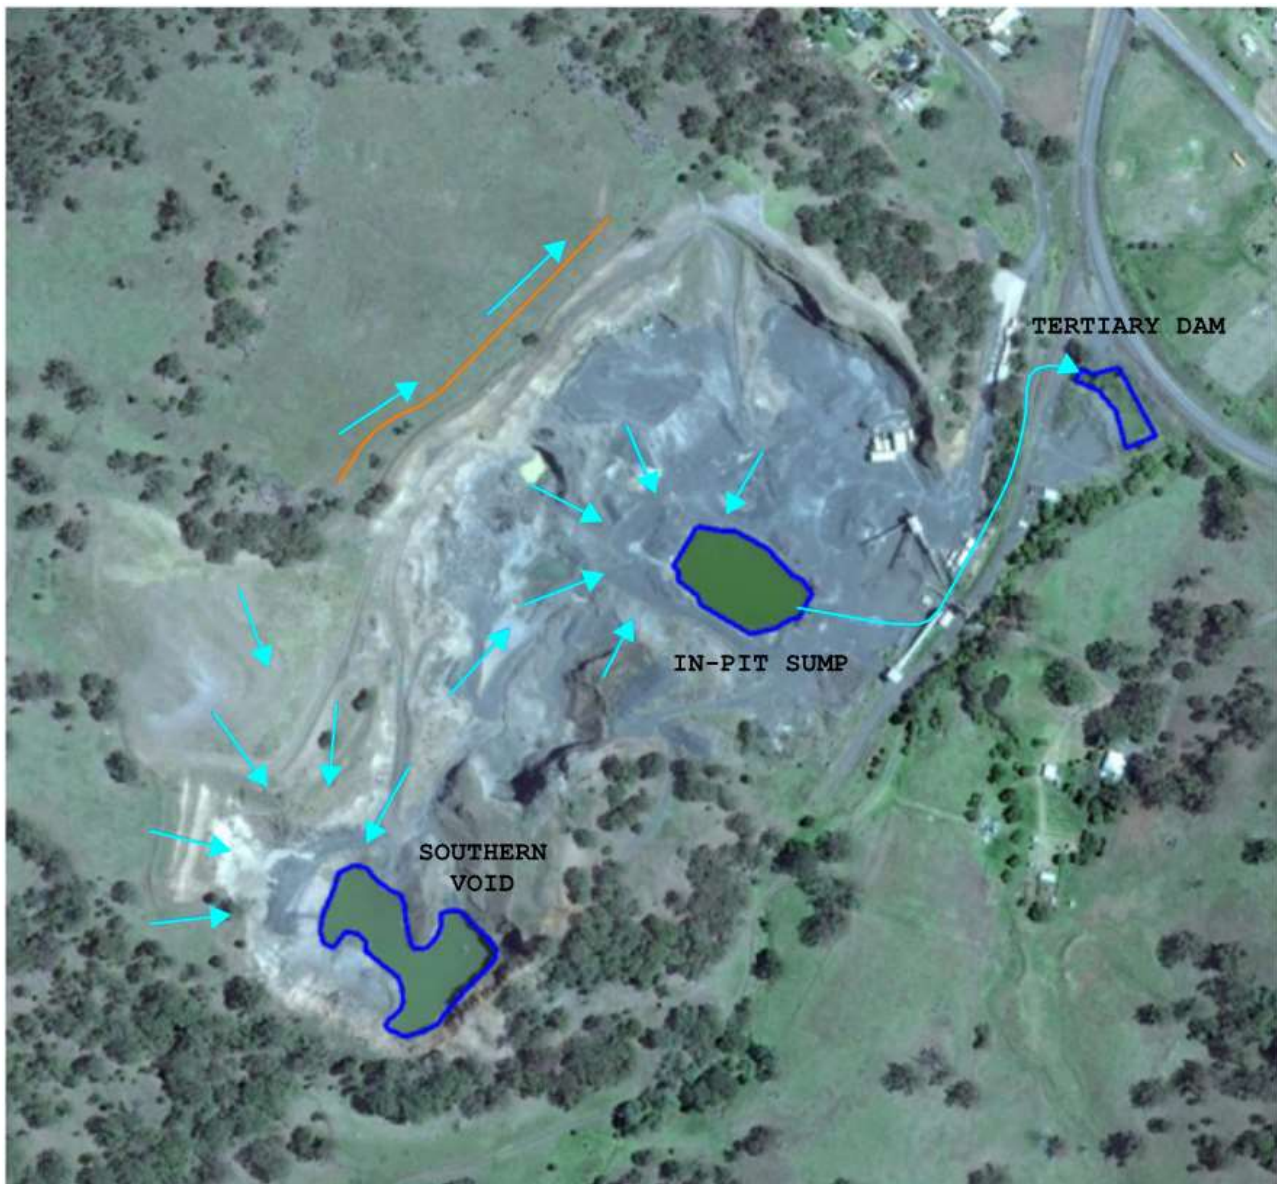
Figure 2: Water Management

- An assessment of basin volumes is included as part of the proposed consent modification;
- An assessment of the reliability of the water supply to the operation is included as part of the proposed consent modification;
- Operational and maintenance activities that could cause soil erosion and sediment generation will be identified and described;
- Procedures to manage unforeseen water quality impacts;
- Water treatment processes to enable discharge as required (subject to the approval of a variation to the site EPL);

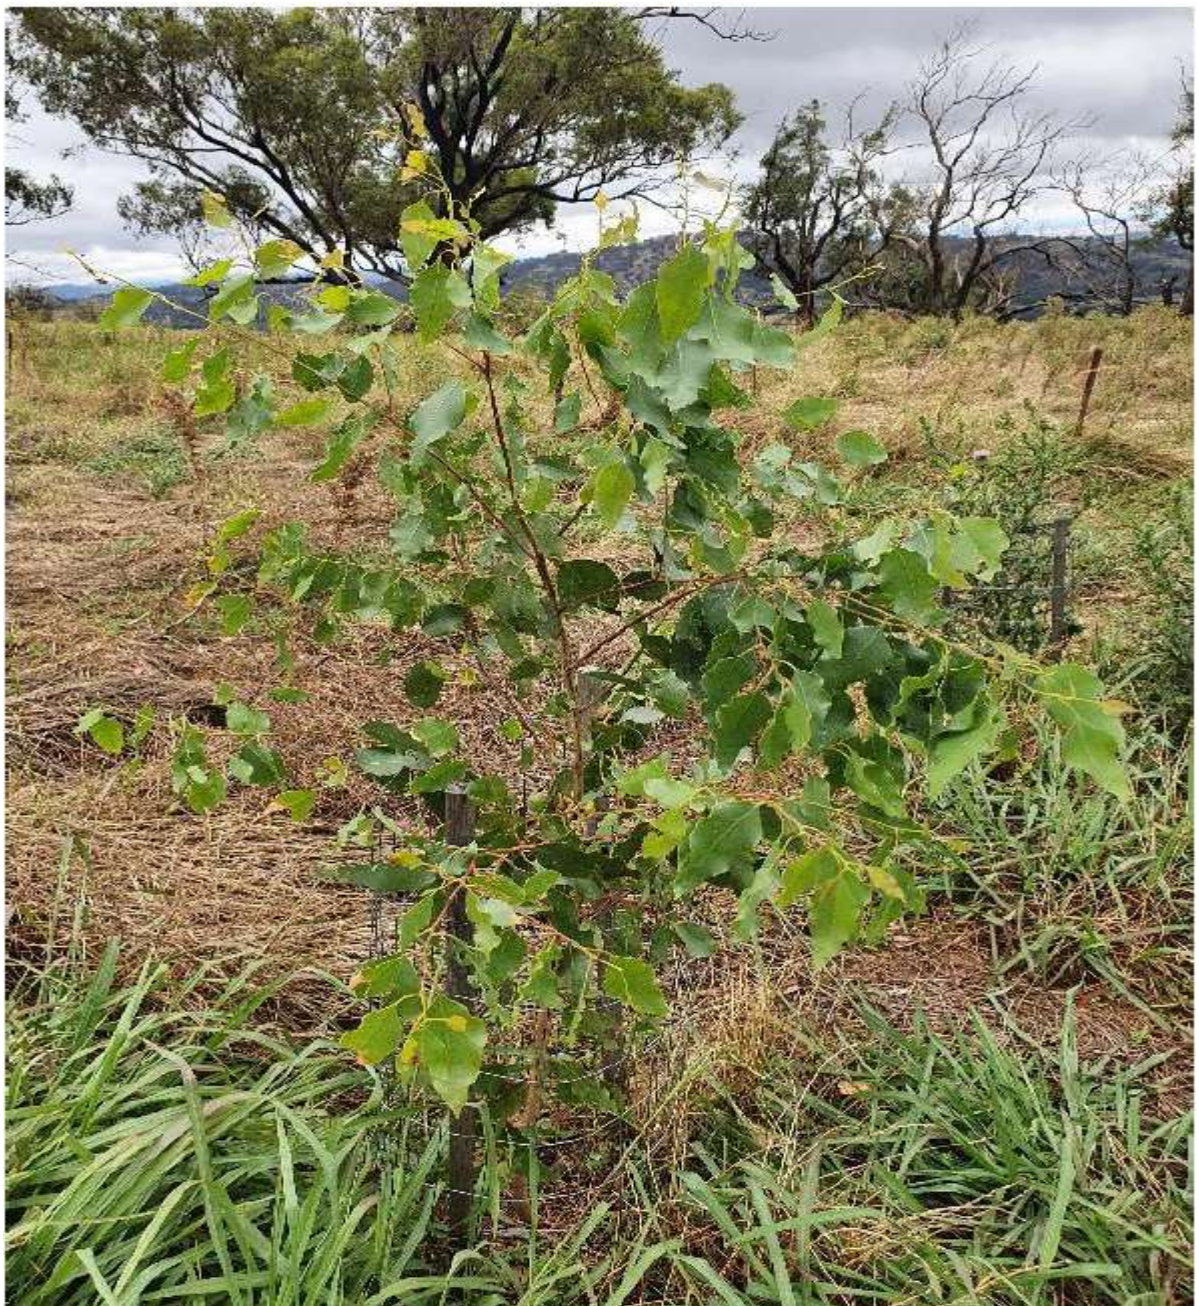
In the Western Boundary (Top of Pit plantings), a dense exotic understorey was present. Weed management is not recommended in this area as the thick groundcover is acting to shield the smaller saplings from herbivory, and provide shelter from the elements. The plant guards in this area seemed mostly intact, and plant heights ranged from 0.2 to 1.7 metres in height, the upper end of which is shown in Photo 1 below. Given the timing of plantings in this area in the height of intense drought, the survival rate and condition of these plantings is very high. The watering protocol undertaken for these plantings has resulted in successful outcomes for this rehabilitated area.

Photo 1: Rehabilitation planting on the western edge

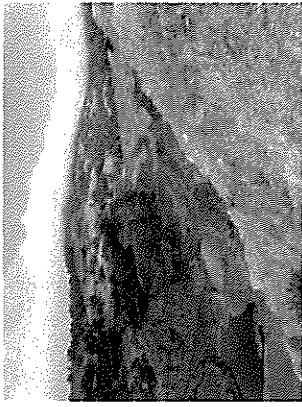
| 2. | Quarry slopes and floor. | The inspection around the quarry floor confirmed runoff was directed to the central dam. No significant outbreaks of weed have established, and in general terms, weed infestation control is good. | As recommended previously, ensure regular weed control continues with a focus on noxious weeds on boundary areas.<br><br>✓ Regular weed spraying continues to occur R. | | | | |

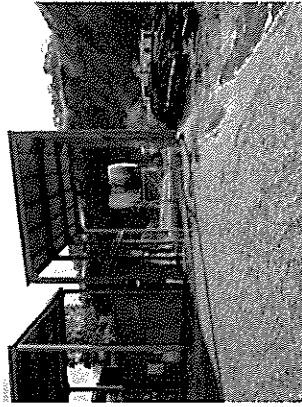
| 3. | Lube shed and fuel storage area. | As noted on the previous inspection, the lube shed area remains secure and dormant with adequate bund storage and controls. Pounded water in the surrounding areas was clear and no oil sheens were present. | Continue maintain the area and visually monitor water quality in the surrounding areas.<br><br>✓ Ongoing R | | | | |

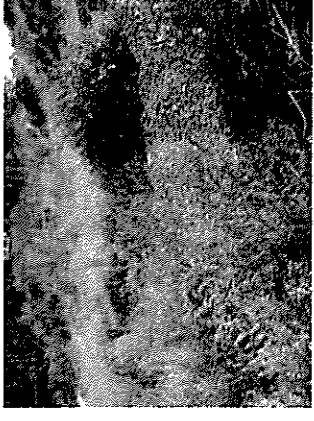
| PROJECT: | Ardglen Quarry | INSPECTION REPORT NO. | 4 | INSPECTION DATE | 29 <sup>th</sup> May 2020 |
|---|---|---|---|---|---|
| 5. | Weed control – main quarry | As noted above, weed suppression has been effective across most areas, with no significant outbreaks noted in the main quarry floor and surrounds. A small outbreak of 'Paterson's Curse' was noted around the quarry entrance and site sheds. Evidence of die back of previously treated areas was noted in several areas. | Continue to monitor the workings and perimeter areas and implement periodic weed control as required.<br><i>✓ Regular weed spraying occurring</i> | | |

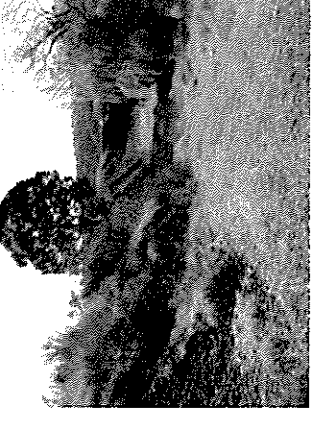
| PROJECT: | Ardglen Quarry | INSPECTION REPORT NO. | 4 | INSPECTION DATE | 29 <sup>th</sup> May 2020 |
|---|---|---|---|---|---|
| 6. | Warra Street rail siding area. | As noted previously, the stockpile area had been reworked and a stand of sediment has been installed downslope from the stockpile area. | The stockpile batter areas are now adequately colonised with vegetation and sediment controls are no longer required. No actions required beyond regular weed control.<br><i>✓ &amp; 12/6/20.</i> | | |

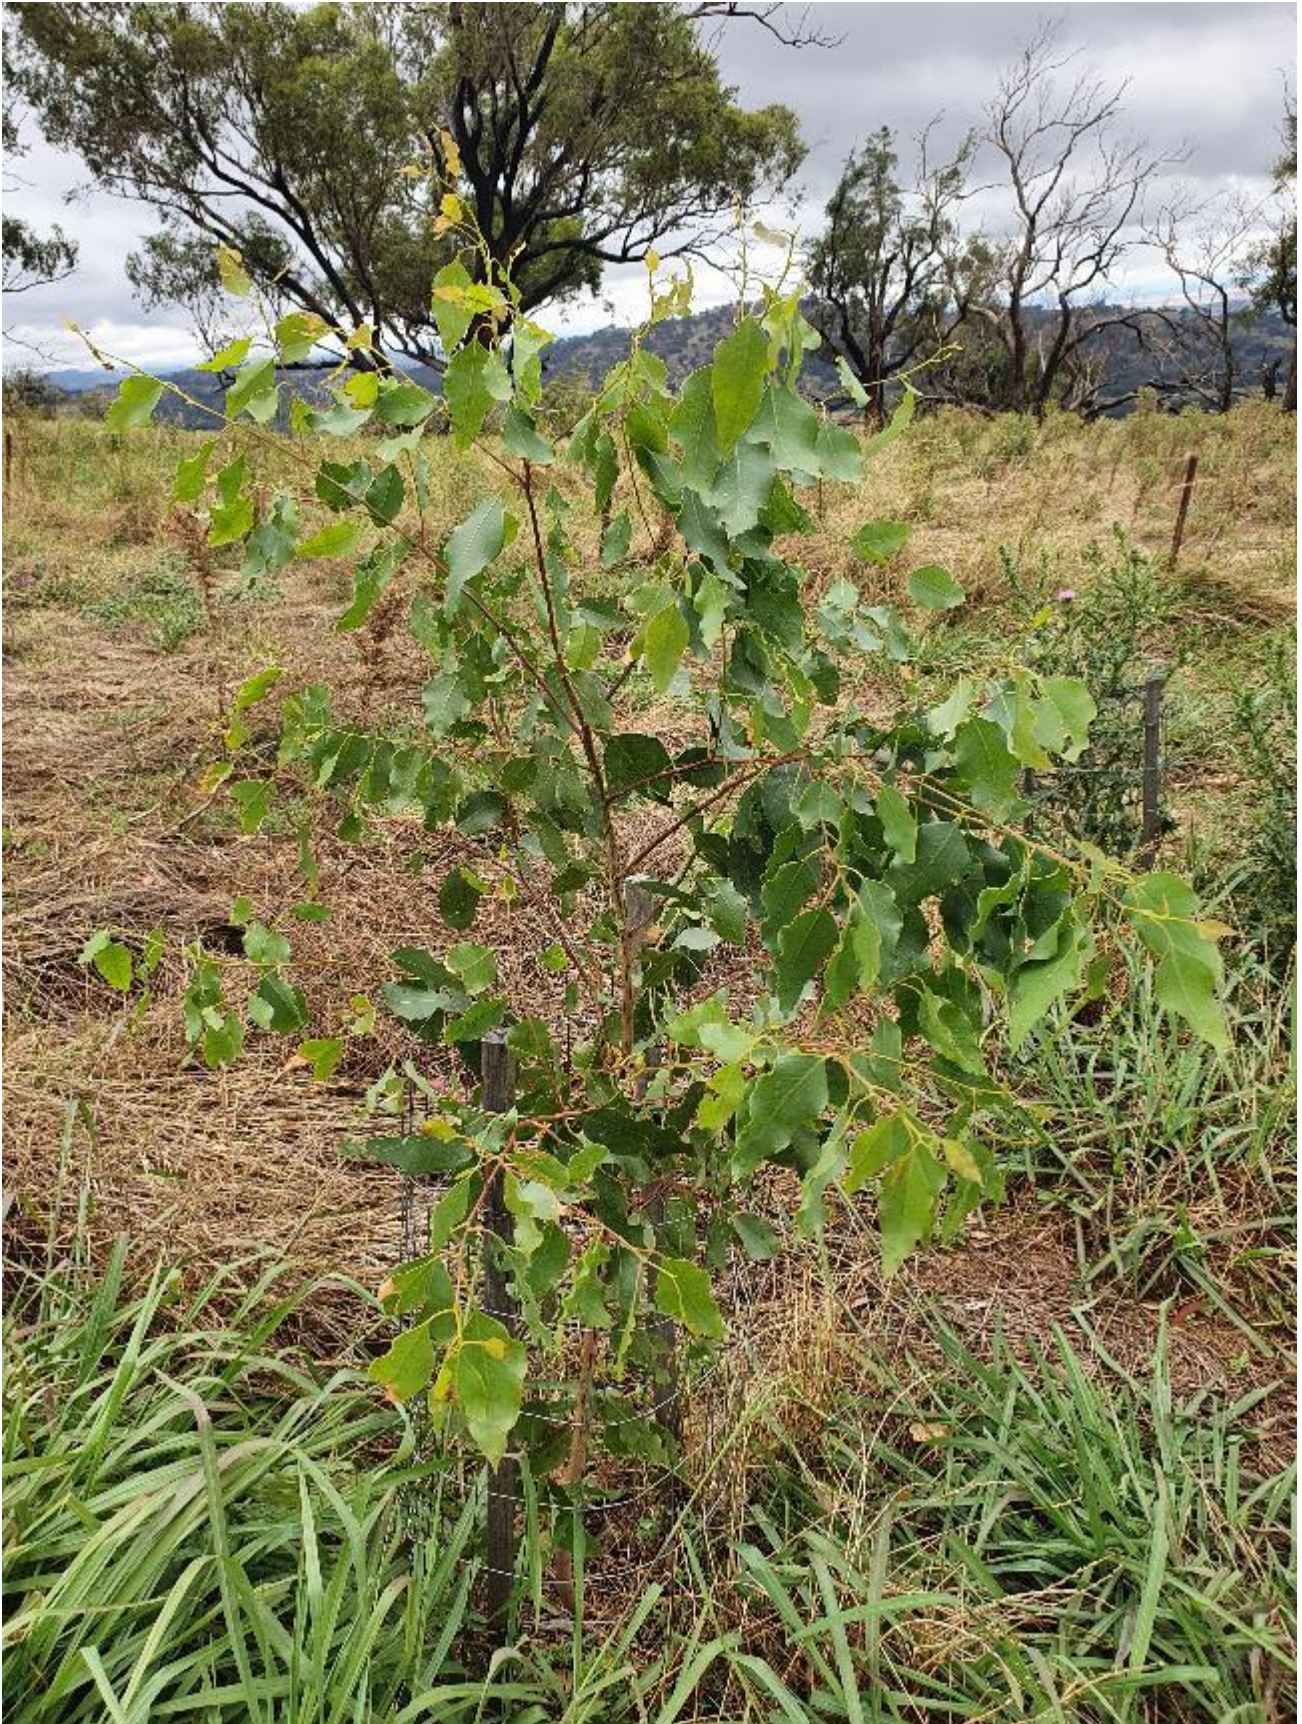
**Plate 4.4** Successful juvenile eucalypt planting in Western Rehabilitation

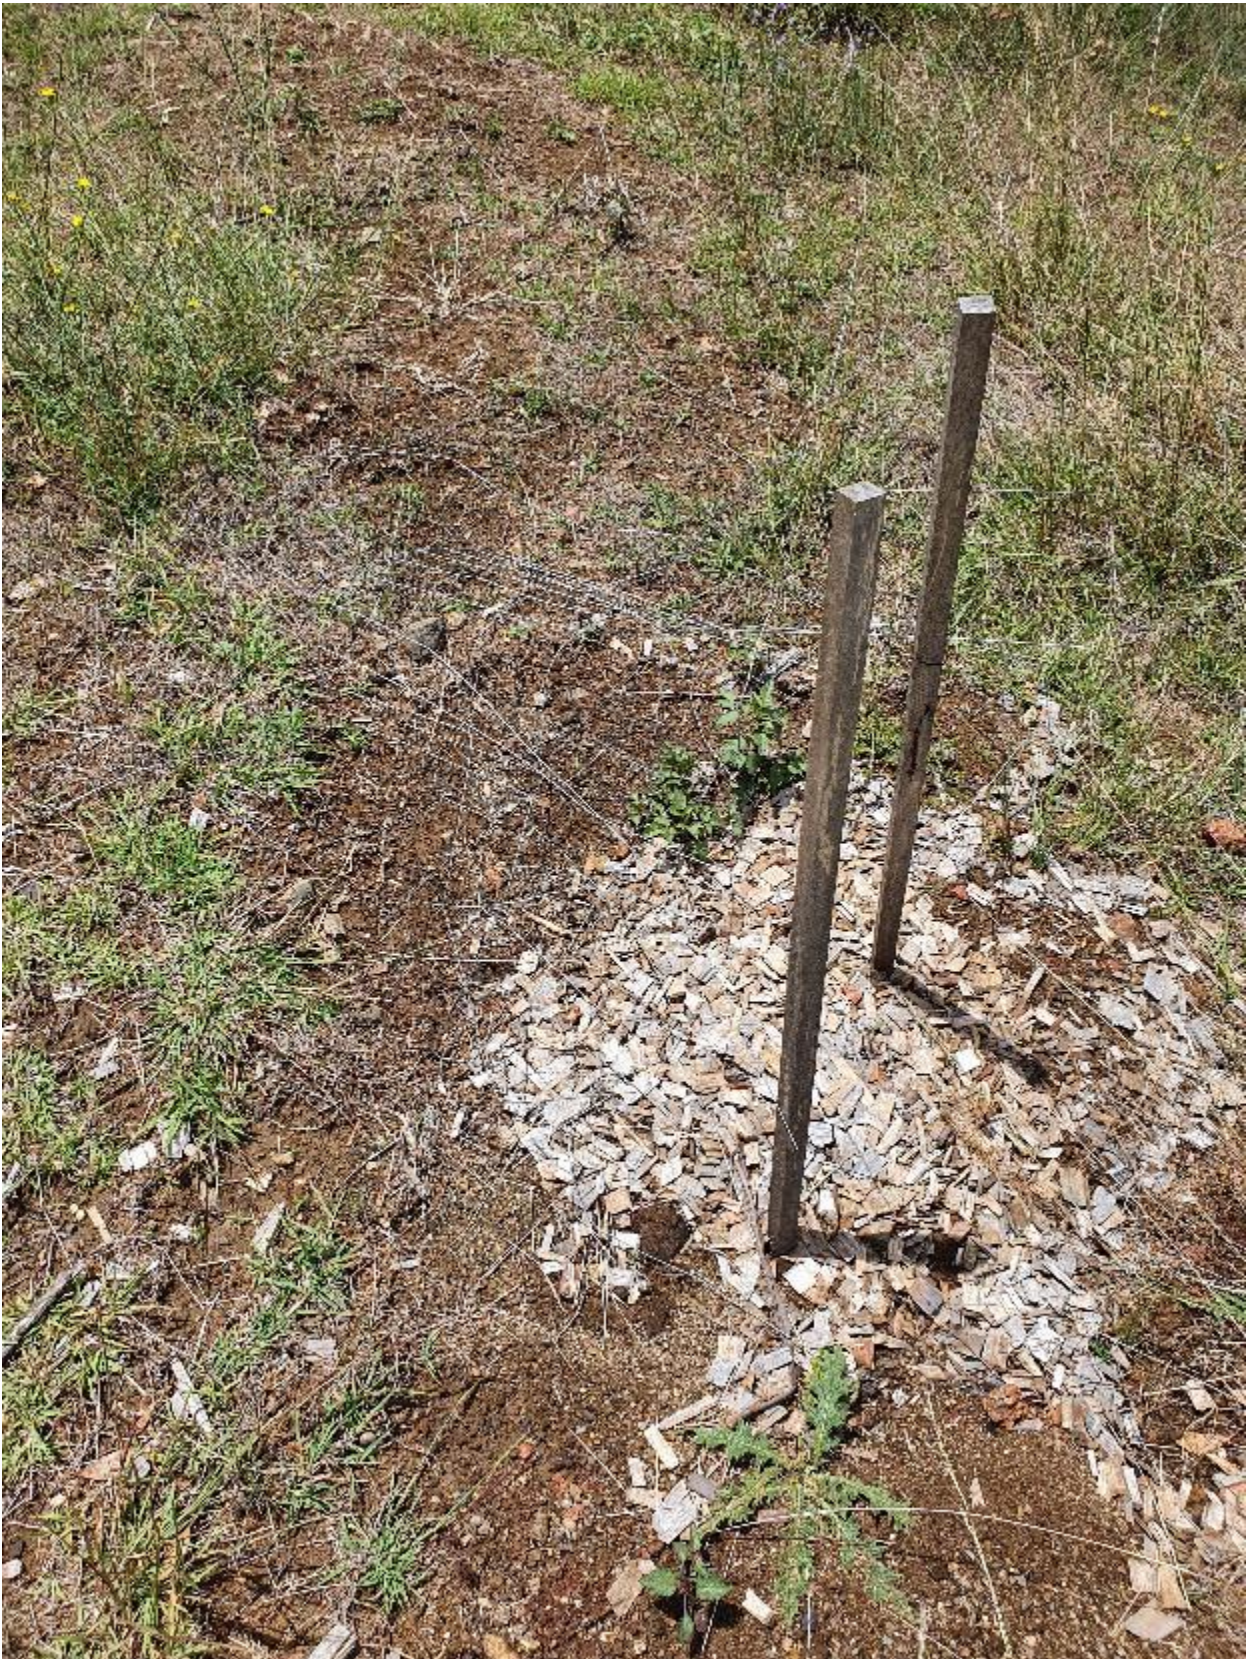
**Plate 4.5** Destroyed wire mesh guard and browsed plant in Southern Rehabilitation

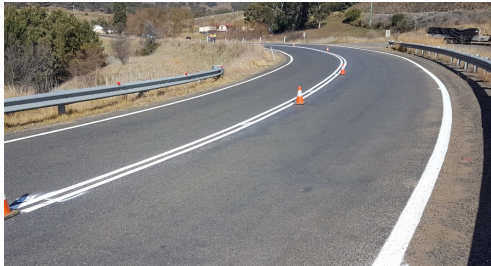
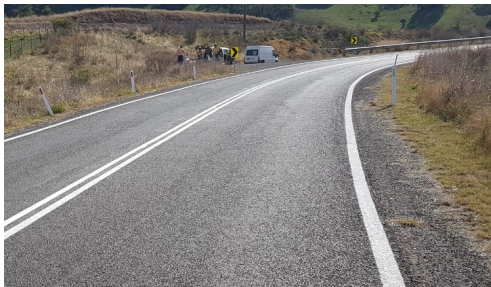
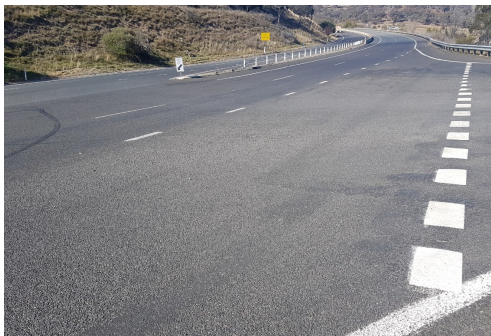
| RSA report identification number | Location / category | Description of risk to road safety | Specific actions Daracon commit to undertake | Completion date (if complete) with comments | Evidence of completion | If not complete, status update as at 30 <sup>th</sup> March 2020 (provided by Daracon to DPIE) |
|---|---|---|---|---|---|---|
| 1 | Intersection of Main Street and New England Highway Northbound and Southbound Delineation | The approach to the intersection of Main Street and New England Highway is missing delineation (i.e. RRPM's) and has faded line marking. This may increase the likelihood of readability issues for a driver. The likelihood of this risk may increase at night and / or adverse weather conditions. This may result in vehicle crashes and injury to occupants of a vehicle(s). | RMS Response – New England Highway (NEH) work will be addressed by works for Daracon | Mostly complete with essential delineation re-instated along New England Highway (NEH) by RMS prior to July 2019. Main Street Ardglan delineation installed on the 11 <sup>th</sup> July 2019 by Daracon. All as shown in the images. | | <p>Longer term planning for additional NEH intersection upgrade works continues with final arrangements pending the proposed MOD #2 status.</p> |

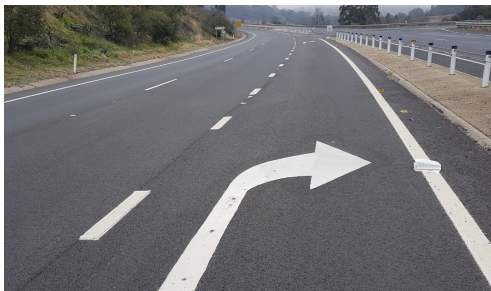
| RSA report identification number | Location / category | Description of risk to road safety | Specific actions Daracon commit to undertake | Completion date (if complete) with comments | Evidence of completion | If not complete, status update as at 30 <sup>th</sup> March 2020 (provided by Daracon to DPIE) |
|---|---|---|---|---|---|---|
| 2 | New England Highway Southbound Delineation | The existing right turn bay into Main Street is missing right turn pavement arrows, which may lead to readability issues for approaching vehicles. The likelihood of this risk may increase at night and / or adverse weather conditions. This may confuse oncoming drivers for the purpose of lane and cause late lane change decisions. This may result in vehicle crashes and injury to occupants of a vehicle(s). | RMS Response – <b>RMS to install missing Right Turn Arrows.</b> RMS to arrange to be included in this year's AC linemarking program. | Completed by RMS prior to July 2019. | | N/A |

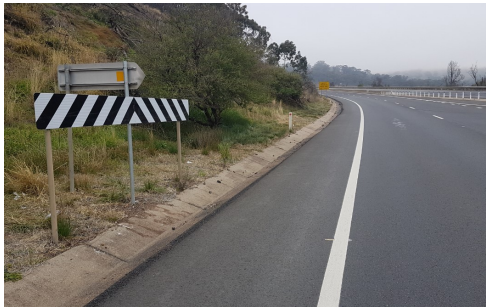
| RSA report identification number | Location / category | Description of risk to road safety | Specific actions Daracon commit to undertake | Completion date (if complete) with comments | Evidence of completion | If not complete, status update as at 30 <sup>th</sup> March 2020 (provided by Daracon to DPIE) |
|---|---|---|---|---|---|---|
| 3 | New England Highway Southbound Traffic signs | The advanced warning signage on approach to Main Street appears damaged, does not provide advanced warning to approaching vehicles, and has a reduced readability due to sightlines being obscured on the horizontal curve approach. This may lead to driver confusion and increase the likelihood of drivers slowing too early prior to the intersection and may result in vehicle crashes and serious injury to occupants of a vehicle(s). | RMS Response – <b>RMS to repair signs</b> from Routine Maintenance | Completed by RMS prior to July 2019. | | N/A |

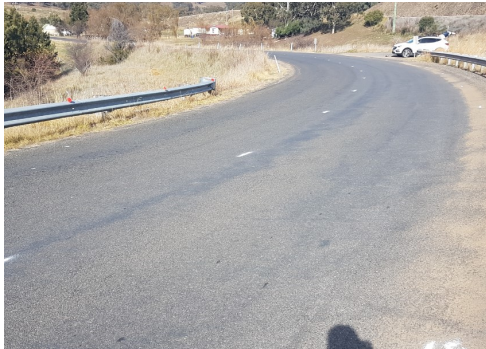
| RSA report identification number | Location / category | Description of risk to road safety | Specific actions Daracon commit to undertake | Completion date (if complete) with comments | Evidence of completion | If not complete, status update as at 30 <sup>th</sup> March 2020 (provided by Daracon to DPIE) |
|---|---|---|---|---|---|---|
| 5 | Main Street South of the Intersection on the outside of the curve Northbound Road pavement | At the Main Street / rail site compound access and in front of the existing w-beam safety barrier there is loose gravel on the outside of the horizontal curve. This may lead to reduced skid resistance for an errant vehicle. The likelihood of this risk may increase at night and / or adverse weather conditions. This may result in vehicle crashes and serious injury to occupants of a vehicle(s). | As agreed with LPSC representative, the loose gravel on the outside of the curve will be removed by appropriate means by Daracon. | Daracon completed this on the 3 <sup>rd</sup> April 2019 with street sweeper on site. Additional gravel removal on the 11 <sup>th</sup> July 2019 before the line marking was installed | | N/A |

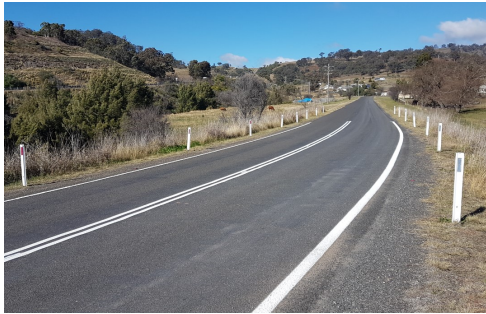
| RSA report identification number | Location / category | Description of risk to road safety | Specific actions Daracon commit to undertake | Completion date (if complete) with comments | Evidence of completion | If not complete, status update as at 30 <sup>th</sup> March 2020 (provided by Daracon to DPIE) |
|---|---|---|---|---|---|---|
| 6 | Main Street – South of the intersection of New England Highway Northbound and Southbound Roadside hazards | 200m along Main Street from the intersection of New England highway, there is an existing culvert with steep embankments within the clear zone. The combination of narrow shoulder widths, steep batters, culvert headwalls within the clear zone, may limit a driver's manoeuvrability to avoid striking an object or have a reduced ability to gain control of their vehicle and strike objects within the clear zone. Narrow shoulders may also limit the available road width for wide vehicle loads and restrict vehicles in the opposing direction. This may increase the likelihood of drivers encroaching into the opposing travel lane and / or vehicles driving within the road shoulder / verge area to avoid a stationary object on the road. This may result in drivers striking the object or another object within the clear zone and lead to rapid deceleration of the vehicle. This may result in serious injury (not limited to) to occupants of a vehicle(s). | As agreed with LPSC representative, Daracon proposes to install a temporary barrier (type F concrete or similar) to highlight the presence of the existing culvert and minimise the likelihood of interaction with the roadside hazard. Subject to the ongoing operation of the quarry, Daracon may choose to install a permanent barrier (guardrail or similar) at some time in the future. | Effectively complete with the self-imposed mandatory speed limit of 40kph from the New England Highway to the Quarry entrance for all trucks was imposed immediately. On the 11 <sup>th</sup> July 2019, additional controls were installed to highlight the presence of the culvert. These additional controls were the extension of the line marking and installation of extra guideposts as shown in the image. | | As of the 30 <sup>th</sup> March 2020 and in consultation with LPSC, no issues or incidents have arisen at this location. This fact combined with the cessation of material export from Ardglen quarry (and the subsequent reduction in vehicular movements along Main St), combined with the fact that the additional guideposts are still present and operating effectively, means that this item remains unchanged at this time. |

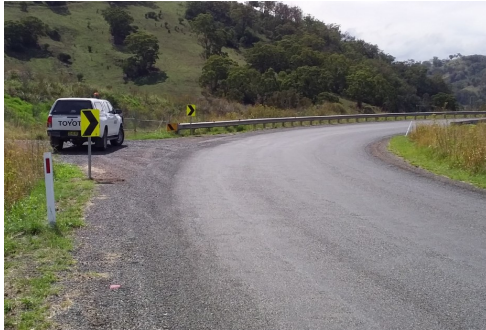
| RSA report identification number | Location / category | Description of risk to road safety | Specific actions Daracon commit to undertake | Completion date (if complete) with comments | Evidence of completion | If not complete, status update as at 30 <sup>th</sup> March 2020 (provided by Daracon to DPIE) |
|---|---|---|---|---|---|---|
| 7 | Main Street – Rail site compound access Northbound Road alignment and cross section and delineation | Approximately 150m from the intersection of New England Highway along Main Street there is an access track to a rail site compound. At the access there is a lack of delineation on the horizontal curve. This may give the oncoming driver the impression that the Main Street continues through rather than the traveling to the right, especially at night. This may cause a driver to make a late change in direction. The combination of loose gravel on the outside of the curve and the late change in direction may result in crashes with other vehicles and result in injury to occupants of a vehicle(s). | As agreed with LPSC representative, Daracon proposes to install additional guide posts (or similar) to delineate the outside of the horizontal curve. | Completed on the 26 <sup>th</sup> March 2019. | | N/A |

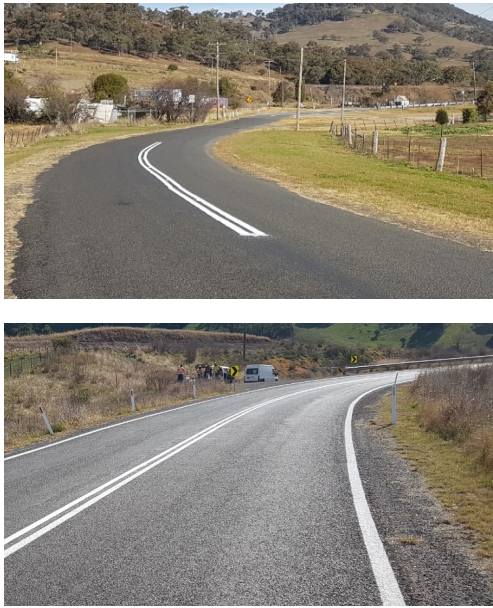
| RSA report identification number | Location / category | Description of risk to road safety | Specific actions Daracon commit to undertake | Completion date (if complete) with comments | Evidence of completion | If not complete, status update as at 30 <sup>th</sup> March 2020 (provided by Daracon to DPIE) |
|---|---|---|---|---|---|---|
| 8 | Main Street Northbound and Southbound Road pavement And Road alignment and cross section | The road carriageway width does not appear suitable for vehicles to pass (i.e. trucks passing other trucks and / or cars). The travel lane widths may limit a driver's manoeuvrability and increase the likelihood of readability issues to oncoming vehicles. Narrow travel lane may also limit the available road width for wide vehicle loads and restrict vehicles in the opposing direction. This may result in drivers striking oncoming objects or another object within the clear zone and lead to rapid deceleration of the vehicle. This may result in injury to occupants of a vehicle(s). | Please also refer to LPSC point #2 below. Although the AADT would be less than 300 vehicles per day including the quarry operating at 500,000T by road per year as proposed (approximately 60 outbound and 60 inbound truck movements), it was agreed with LPSC to install additional line marking only at the curves either end of Main St. The straight section of Main St will remain with no line marking. All existing line marking will also be renewed if not completed recently by LPSC. An additional control that has been implemented is the self-imposed mandatory speed limit of 40kph from the New England Highway to the Quarry entrance for all trucks. | Completed on the 11 <sup>th</sup> July 2019. | | N/A |

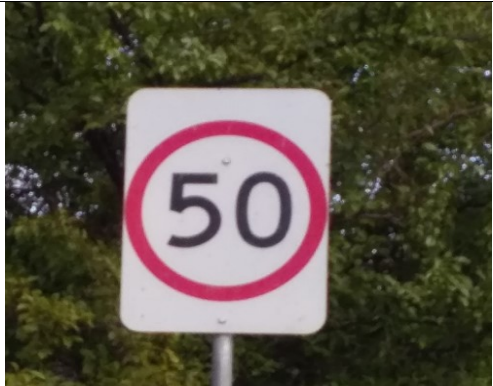
| RSA report identification number | Location / category | Description of risk to road safety | Specific actions Daracon commit to undertake | Completion date (if complete) with comments | Evidence of completion | If not complete, status update as at 30 <sup>th</sup> March 2020 (provided by Daracon to DPIE) |
|---|---|---|---|---|---|---|
| 9 | Main Street Intersection with Ardglen Road Northbound and Southbound Traffic signs | On Main Street approach to Ardglen Road, the existing speed zone repeater signage appears faded. This may increase the likelihood of readability issues for drivers, and increase the likelihood of a driver failing to travel to the sign posted speed limit. The likelihood of this risk may increase at night and / or adverse weather conditions. This may lead to vehicle crashes and injury to occupants of a vehicle(s). | As agreed with LPSC representative, Daracon proposes to install new speed limit signage as the existing sign is faded. | Completed on the 20 <sup>th</sup> March 2019. | | N/A |

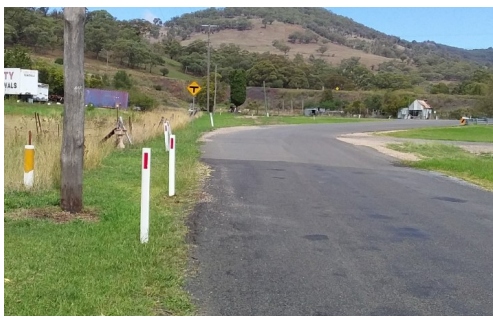
| RSA report identification number | Location / category | Description of risk to road safety | Specific actions Daracon commit to undertake | Completion date (if complete) with comments | Evidence of completion | If not complete, status update as at 30 <sup>th</sup> March 2020 (provided by Daracon to DPIE) |
|---|---|---|---|---|---|---|
| 10 | Main Street Approaching the Intersection with Ardglen Road Northbound and Southbound Roadside hazards | On Main Road approach to Ardglen Road, there is an existing power pole and fence posts within the clear zone. Errant vehicles at these locations may have a reduced ability to gain control of their vehicle and strike the power pole or fence post within the clear zone which may lead to rapid deceleration of the vehicle. This may be due to the combination of horizontal and / or vertical alignment of the road and / or drivers swerving to avoid striking an animal (i.e. animal carcass). The likelihood of this risk may increase at night and / or adverse weather conditions. This may result in vehicle crashes and injury to occupants of a vehicle(s), not limited to. | As agreed with LPSC representative, Daracon proposes to install delineation in the form of additional guideposts adjacent to the roadway to highlight the presence of the existing power pole. | Completed on the 26 <sup>th</sup> March 2019. | | N/A |

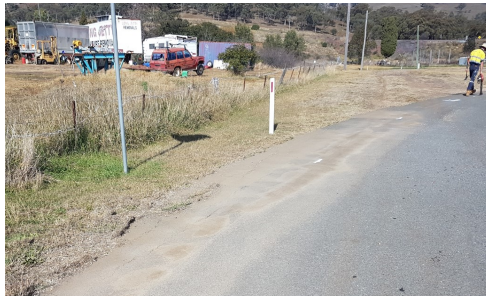
| RSA report identification number | Location / category | Description of risk to road safety | Specific actions Daracon commit to undertake | Completion date (if complete) with comments | Evidence of completion | If not complete, status update as at 30 <sup>th</sup> March 2020 (provided by Daracon to DPIE) |
|---|---|---|---|---|---|---|
| 11 | Main Street Approaching the Intersection with Ardglen Road Northbound and Southbound Pavement | Approximately 65m along Main Road from the intersection of Main Road and High Road, there is loose gravel on the outside of the horizontal curve. This may lead to reduced skid resistance for an errant vehicle. The likelihood of this risk may increase at night and / or adverse weather conditions. This may result in vehicle crashes and serious injury to occupants of a vehicle(s). | As agreed with LPSC representative, the loose gravel on the outside of the curve will be removed by appropriate means by Daracon. | Completed on the 3 <sup>rd</sup> April 2019 with street sweeper on site. Additional gravel removal occurred on the 11 <sup>th</sup> July 2019 before the line marking was installed. | | N/A |

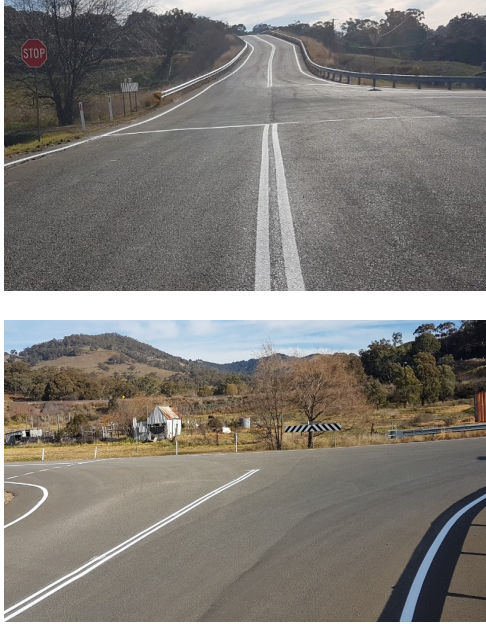
| RSA report identification number | Location / category | Description of risk to road safety | Specific actions Daracon commit to undertake | Completion date (if complete) with comments | Evidence of completion | If not complete, status update as at 30 <sup>th</sup> March 2020 (provided by Daracon to DPIE) |
|---|---|---|---|---|---|---|
| 12 | Main Street Intersection with High Street Delineation | At the intersection of Main Street and High Street, the existing delineation is faded. This may lead to readability issues for a driver and increase the likelihood of a vehicle failing to give way at the intersection. The likelihood of this risk may increase at night and / or adverse weather conditions. This may lead to vehicle crashes and injury to occupants of a vehicle(s). | As agreed with LPSC representative, Daracon proposes to refresh the existing line marking. | Completed on the 11 <sup>th</sup> July 2019. | | N/A |

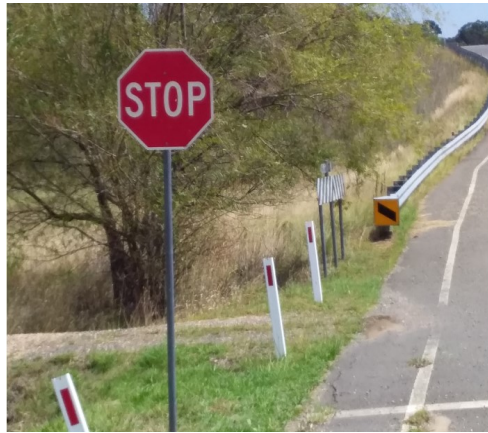
| RSA report identification number | Location / category | Description of risk to road safety | Specific actions Daracon commit to undertake | Completion date (if complete) with comments | Evidence of completion | If not complete, status update as at 30 <sup>th</sup> March 2020 (provided by Daracon to DPIE) |
|---|---|---|---|---|---|---|
| 13 | Main Street Intersection with High Street Westbound Traffic signs | Approaching the intersection of Main Street and High Street from the south eastern side traveling west there is a missing Stop sign. This may increase the likelihood of readability issues for drivers and lead to drivers failing to stop to oncoming vehicles. This may increase the likelihood of vehicle crashes, especially during adverse weather conditions. This could lead to crashes with other vehicles, thus may result in serious injury to occupants of a vehicle(s). | As agreed with LPSC representative, Daracon proposes to reinstate the existing stop sign. | Completed on the 20 <sup>th</sup> March 2019. | | N/A |

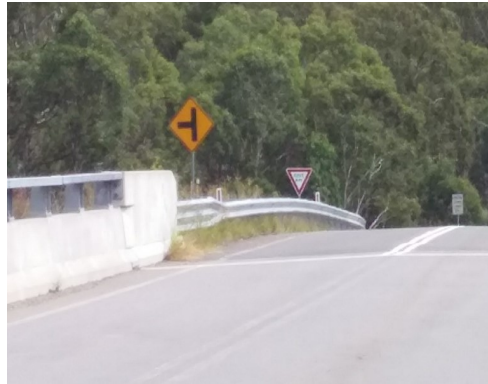
| RSA report identification number | Location / category | Description of risk to road safety | Specific actions Daracon commit to undertake | Completion date (if complete) with comments | Evidence of completion | If not complete, status update as at 30 <sup>th</sup> March 2020 (provided by Daracon to DPIE) |
|---|---|---|---|---|---|---|
| 14 | High Street Approach to St Stephen Street intersection Westbound Traffic signs | On the south eastern side of the intersection of High Street and St Stephen Street, the advanced warning of T-intersection signage is loose, which has caused the sign to point in the wrong direction. This may increase the likelihood of readability issues for drivers and lead to drivers failing to negotiate the intersection. This may increase the likelihood of vehicle crashes, especially during adverse weather conditions. This could lead to crashes with other vehicles, thus may result in serious injury to occupants of a vehicle(s). | As agreed with LPSC representative, Daracon proposes to reinstate the existing T intersection sign. | Completed on the 26 <sup>th</sup> March 2019. | | N/A |

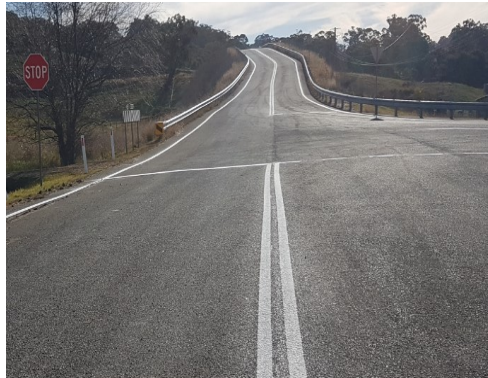
| RSA report identification number | Location / category | Description of risk to road safety | Specific actions Daracon commit to undertake | Completion date (if complete) with comments | Evidence of completion | If not complete, status update as at 30 <sup>th</sup> March 2020 (provided by Daracon to DPIE) |
|---|---|---|---|---|---|---|
| 15 | High street Rail overpass bridge Eastbound and Westbound Road alignment and cross section | Traveling west along High Street towards the rail overpass bridge, the travel lanes appear to narrow and there is a kink in the alignment of the road. The narrow travel lane widths may limit a driver's manoeuvrability and increase the likelihood of readability issues to oncoming vehicles. Narrow travel lane may also limit the available road width for wide vehicle loads and restrict vehicles in the opposing direction. This may result in drivers striking oncoming vehicles or safety barriers and lead to rapid deceleration of the vehicle. This may result in serious injury (not limited to) to occupants of a vehicle(s). | As agreed with LPSC representative, all existing line marking will be renewed if not completed recently by LPSC. An additional control that has been implemented is the self-imposed mandatory speed limit of 40kph from the New England Highway to the Quarry entrance for all trucks. Appropriate delineation already exists along the guardrail. | Self-imposed 40 kph speed limit imposed immediately. The line marking was completed on the 11 <sup>th</sup> July 2019. | | N/A |

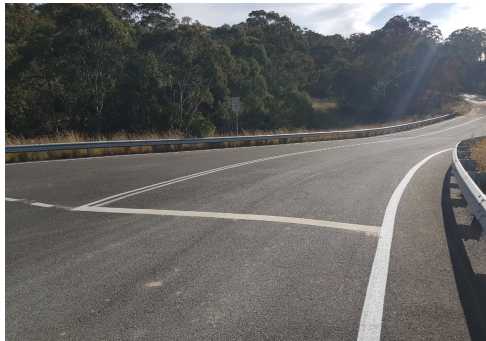
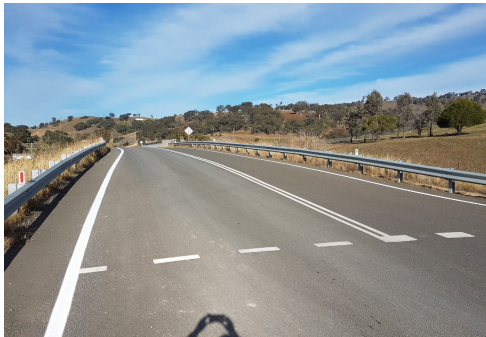
| RSA report identification number | Location / category | Description of risk to road safety | Specific actions Daracon commit to undertake | Completion date (if complete) with comments | Evidence of completion | If not complete, status update as at 30 <sup>th</sup> March 2020 (provided by Daracon to DPIE) |
|---|---|---|---|---|---|---|
| 16 | High Street Approach to St Stephen Street Intersection Eastbound and Westbound Delineation | <p>At the intersection of High Street and St Stephen Street, the existing delineated is faded. This may lead to readability issues for a driver and increase the likelihood of a vehicle failing to give way / stop at the intersection. The likelihood of this risk may increase at night and / or adverse weather conditions. This may lead to vehicle crashes and injury to occupants of a vehicle(s).</p> | As agreed with LPSC representative, all existing line marking will be renewed by Daracon if not completed recently by LPSC. | Completed on the 11 <sup>th</sup> July 2019. | | N/A |

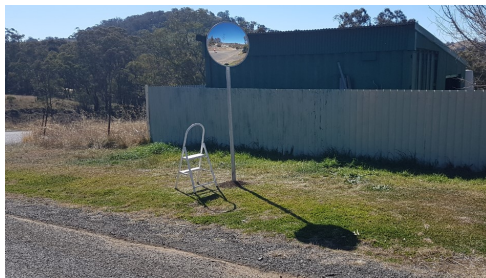
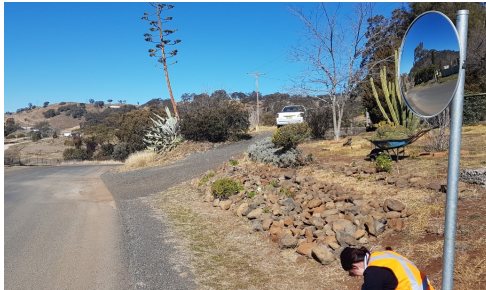
| RSA report identification number | Location / category | Description of risk to road safety | Specific actions Daracon commit to undertake | Completion date (if complete) with comments | Evidence of completion | If not complete, status update as at 30 <sup>th</sup> March 2020 (provided by Daracon to DPIE) |
|---|---|---|---|---|---|---|
| 17 | St Stephen Street Northbound and Southbound Road alignment and cross section | <p>The road carriageway width along St Stephens Street does not appear suitable for vehicles to pass (i.e. trucks passing other trucks and / or cars). The travel lane widths may limit a driver's manoeuvrability and increase the likelihood of readability issues to oncoming vehicles. Narrow travel lane may also limit the available road width for wide vehicle loads and restrict vehicles in the opposing direction. This may result in drivers striking oncoming vehicles or objects within the clear zone and lead to rapid deceleration of the vehicle. This may result in serious injury (not limited to) to occupants of a vehicle(s).</p> | As agreed with LPSC representative, Daracon will consult with the three residents along Warra and St Stephen Streets to discuss the potential installation of convex mirrors at strategic locations and will install as agreed. Daracon has also implemented a self-imposed mandatory speed limit of 40kph from the New England Highway to the Quarry entrance as well as a mandatory "call up" protocol for St Stephens and Warra St's as detailed in the TTMP. | <p>Complete with the self-imposed mandatory speed limit of 40kph from the New England Highway to the Quarry entrance for all trucks was imposed immediately. The call up protocol for St Stephens and Warra St's was also implemented immediately as detailed in the TTMP. The residents along Warra and St Stephens St were also consulted with and agreed that the installation of "convex mirrors" located in strategic locations would assist to mitigate the issues identified. The "convex mirrors" were installed on the 15<sup>th</sup> August 2019 as shown in the images.</p> | | N/A |

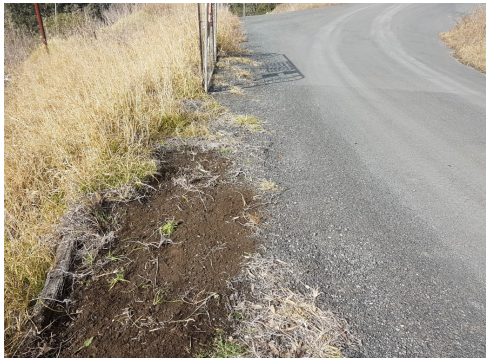
| RSA report identification number | Location / category | Description of risk to road safety | Specific actions Daracon commit to undertake | Completion date (if complete) with comments | Evidence of completion | If not complete, status update as at 30 <sup>th</sup> March 2020 (provided by Daracon to DPIE) |
|---|---|---|---|---|---|---|
| 20 | Warra Street Near the quarry entrance Southbound Pavement And Road alignment And cross section | Near the entrance to the quarry and part of Warra Road the existing pavement is deteriorated and shoulder show evidence of erosion. This may lead to soft shoulders and may be unstable for heavy vehicle to use if divers need to move their vehicle to avoid oncoming traffic. This may result in injury to occupants of a vehicle(s), not limited to. | As agreed with LPSC representative, Daracon proposes to investigate and repair the shoulder as described in the RSA. | Completed 20 <sup>th</sup> March 2019. | | N/A |

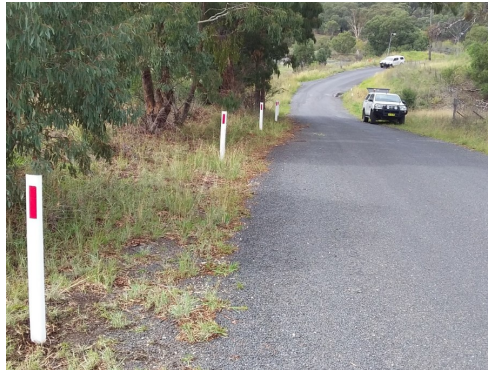
| RSA report identification number | Location / category | Description of risk to road safety | Specific actions Daracon commit to undertake | Completion date (if complete) with comments | Evidence of completion | If not complete, status update as at 30 <sup>th</sup> March 2020 (provided by Daracon to DPIE) |
|---|---|---|---|---|---|---|
| 21 | Warra Street Northbound and Southbound Roadside hazards | Along Warra Street the auditors observed trees within clear zone as well as narrow carriageway. Errant vehicles at these locations may have a reduced ability to gain control of their vehicle and strike the trees within the clear zone which may lead to rapid deceleration of the vehicle. This may be due to the narrow carriageway width of the road and / or drivers swerving to avoid striking oncoming vehicles. The likelihood of this risk may increase at night and / or adverse weather conditions. This may result in vehicle crashes and injury to occupants of a vehicle(s), not limited to. | As agreed with LPSC representative, Daracon proposes to install delineation in the form of additional guideposts adjacent to the roadway to highlight the presence of the trees. Daracon has implemented a self-imposed mandatory speed limit of 40kph from the New England Highway to the Quarry entrance as well as a mandatory "call up" protocol for St Stephens and Warra St's as detailed in the TTMP. | Completed on the 26 <sup>th</sup> March 2019. | | N/A |

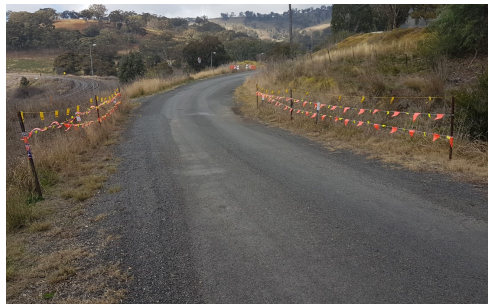
| RSA report identification number | Location / category | Description of risk to road safety | Specific actions Daracon commit to undertake | Completion date (if complete) with comments | Evidence of completion | If not complete, status update as at 30 <sup>th</sup> March 2020 (provided by Daracon to DPIE) |
|---|---|---|---|---|---|---|
| 22 | Warra Street Northbound and Southbound Roadside hazards | Approximately 50m from the entrance of the quarry there is an existing culvert headwall with drop-off within the clear zone. Errant vehicles at these locations may have a reduced ability to gain control of their vehicle impact with the existing headwall and / or surrounding objects within the clear zone. This may be due to the narrow carriageway width of the road and / or drivers swerving to avoid striking oncoming vehicles. The likelihood of this risk may increase at night and / or adverse weather conditions. This may result in vehicle crashes and serious injury to occupants of a vehicle(s). | As agreed with LPSC representative, Daracon proposes to install a temporary barrier (type F concrete or similar) to highlight the presence of the existing culvert and minimise the likelihood of interaction with the roadside hazard. Additionally, <b>LPSC have committed to investigating the option of extending the existing storm water pipe</b> to permit widening of the formation thus eliminating the roadside hazard. | The self-imposed mandatory speed limit of 40kph from the New England Highway to the Quarry entrance for all trucks was imposed immediately. The call up protocol for St Stephens and Warra St's was also implemented immediately as detailed in the TTMP. Temporary delineation was installed on the 1 <sup>st</sup> April 2019 as shown in the image. These are considered appropriate short term rectification measures due to the fact that this location exists beyond the section of Warra St that requires private vehicular access and only quarry traffic utilises this section of road. | | Longer term planning for additional works along Warra St are continuing in consultation with LPSC with final arrangements pending the proposed MOD #2 status. This matter was discussed and agreed with Warren Faulkner from LPSC on the 26 <sup>th</sup> February 2020. |

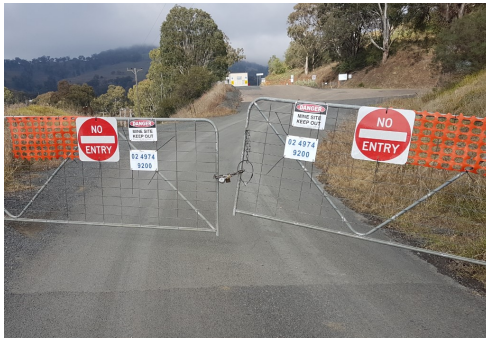
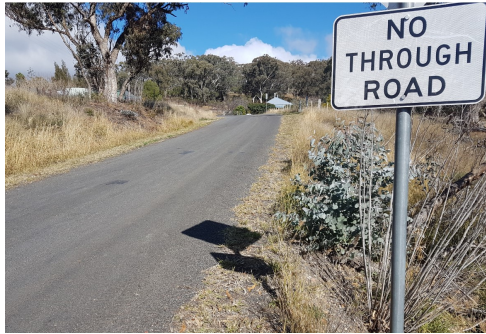
| RSA report identification number | Location / category | Description of risk to road safety | Specific actions Daracon commit to undertake | Completion date (if complete) with comments | Evidence of completion | If not complete, status update as at 30 <sup>th</sup> March 2020 (provided by Daracon to DPIE) |
|---|---|---|---|---|---|---|
| 23 | Warra Street Quarry entrance Northbound and Southbound Road alignment and cross section | At the site entry of the quarry, the entry appears narrow, lack of carriageway width for drivers to turn around as well as lack of restriction signage / no through road. This may lead to driver frustration and confusion which may contribute to driver error. The likelihood of this risk may increase at night and / or adverse weather conditions. This may result in vehicle crashes and serious injury to occupants of a vehicle(s). | As agreed with LPSC representative, Daracon has implemented a self-imposed mandatory speed limit of 40kph from the New England Highway to the Quarry entrance as well as a mandatory “call up” protocol for St Stephens and Warra St’s as detailed in the TTMP. | The self-imposed mandatory speed limit of 40kph from the New England Highway to the Quarry entrance for all trucks was imposed immediately. The call up protocol for St Stephens and Warra St’s was also implemented immediately as detailed in the TTMP. Additional “no entry” and “no through road” signage was installed on the 11 <sup>th</sup> July 2019. | | N/A |

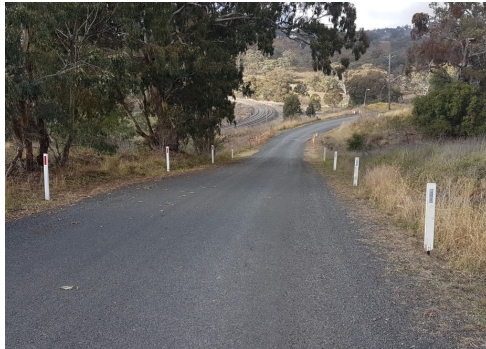
| RSA report identification number | Location / category | Description of risk to road safety | Specific actions Daracon commit to undertake | Completion date (if complete) with comments | Evidence of completion | If not complete, status update as at 30 <sup>th</sup> March 2020 (provided by Daracon to DPIE) |
|---|---|---|---|---|---|---|
| 24 | Warra Street Northbound and Southbound Delineation | It was noted that along Warra Street there is a lack of delineation. This may increase the likelihood of readability issues for drivers. The likelihood of this risk may increase at night and / or adverse weather conditions. This may result in vehicle crashes and injury to occupants of a vehicle(s). | As agreed with LPSC representative, Daracon proposes to install delineation in the form of additional guideposts adjacent to the roadway. | Completed on the 11 <sup>th</sup> July 2019. | | N/A |

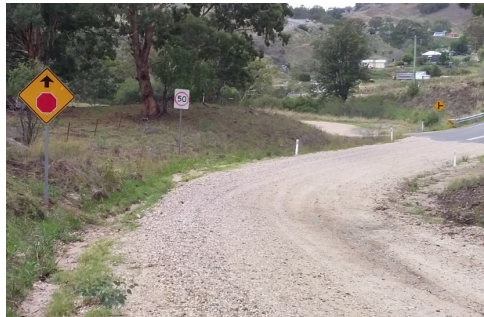
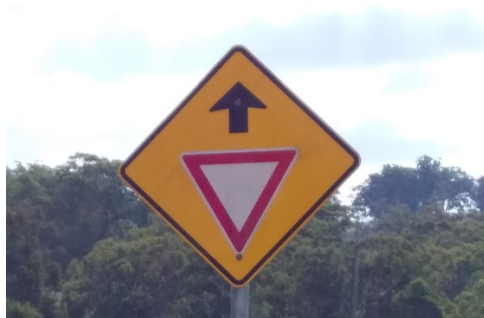
| RSA report identification number | Location / category | Description of risk to road safety | Specific actions Daracon commit to undertake | Completion date (if complete) with comments | Evidence of completion | If not complete, status update as at 30 <sup>th</sup> March 2020 (provided by Daracon to DPIE) |
|---|---|---|---|---|---|---|
| LPSC #1 | Either side of the rail overpass bridge | <p>The two 'T' intersections either side of the rail overpass bridge are not your normal 'T' intersections in that the approach roads to the top of the 'T' have right away, whereas the thru road normally has right of way. Whilst 'Give Way' and 'Stop Signs' along with line marking (that needs maintaining) exists, I think advance warning 'Give Way Sign Ahead' and 'Stop Sign Ahead' signs (W3-1B and W3-2B) should be considered to forewarn road users along High Street and Swinging Ridges Road as the thru road(s).</p> | <p>Daracon agree to install additional advance warning 'Give Way Sign Ahead' and 'Stop Sign Ahead' signs (W3-1B and W3-2B) to forewarn road users along High Street and Swinging Ridges Road as the thru road(s)</p> | <p>Completed on the 20<sup>th</sup> March 2019.</p> | | N/A |
