# ARDGLEN QUARRY

## 2020 Annual Environmental Management Report (AEMR)

PROJECT APPROVAL MP 06\_0264

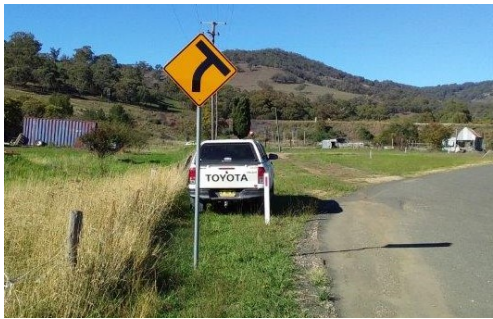
| RSA report identification number | Location / category | Description of risk to road safety | Specific actions Daracon commit to undertake | Completion date (if complete) with comments | Evidence of completion | If not complete, status update as at 30 <sup>th</sup> March 2020 (provided by Daracon to DPIE) |
|---|---|---|---|---|---|---|
| LPSC #3 | Main Street | The advance 'T' junction warning sign on Ardglan Road on approach to High Street does not depict the road alignment on approach to the intersection. The approach to the intersection has a horizontal curve between the Advanced intersection Warning Sign and the intersection. The sign should be changed to a Curved Intersection (W2-14B) sign. | Daracon agrees to change the advance 'T' junction warning sign on Ardglan Road on approach to High Street to a Curved Intersection (W2-14B) sign. | Completed on the 3 <sup>rd</sup> April 2019. | | N/A |

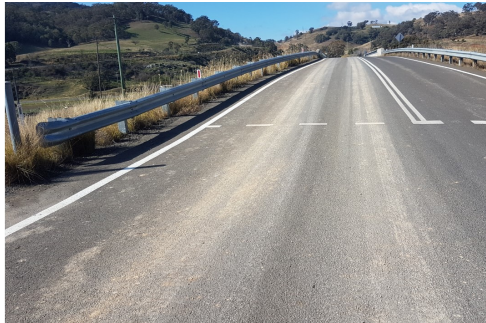
| RSA report identification number | Location / category | Description of risk to road safety | Specific actions Daracon commit to undertake | Completion date (if complete) with comments | Evidence of completion | If not complete, status update as at 30 <sup>th</sup> March 2020 (provided by Daracon to DPIE) |
|---|---|---|---|---|---|---|
| Other observation #2 | St Stephen Street and Main Street | There is a gap in the existing w-beam safety barrier for rail corridor access at the intersection of St Stephen Street and High Street. The auditors observed that the point of need for safety barrier may not protect an errant vehicle from the hazard at this location. | <p>Ardglen Quarry has been operating as a hard rock quarry for over 100 years and Buttai Gravel (Daracon) has owned and operated Ardglen Quarry since 2005 after purchasing the quarry from the State Rail Authority. Sometime following Daracon's purchase of the quarry, ARTC commenced work on the construction of the rail overpass bridge which was completed sometime before 2009 (and whilst the quarry was still operating).</p> <p>With respect to the design and construction of the new rail overpass bridge, access road and associated structures, Daracon were not involved in the process and had no influence over the design parameters associated with the safety barriers associated with the new bridge and access roads.</p> <p><b>However, Daracon and LPSC have recently renewed the line marking in this location which, combined with the additional signage and guideposts installed as well as the self-imposed mandatory speed limit of 40kph from the New England Highway to the Quarry entrance for all trucks, has significantly reduced the risk of an errant vehicle in this location.</b></p> | Completed on the 11 <sup>th</sup> July 2019. | <p>Note – The dirt present on the road surface (as shown in the above image) was the result of LPSC unsealed road maintenance occurring along Swinging Ridges Rd and was in no way associated with truck movements to or from Ardglen Quarry.</p> | N/A |
