**PRELIMINARY GEOTECHNICAL  
INVESTIGATION - PROPOSED  
COMMERCIAL DEVELOPMENT**

Bovis Lend Lease  
Corner of Olympic Boulevard and Herb Elliott  
Avenue, Sydney Olympic Park, Homebush Bay

GEOTLCOV23048AA-AH  
16 January 2007

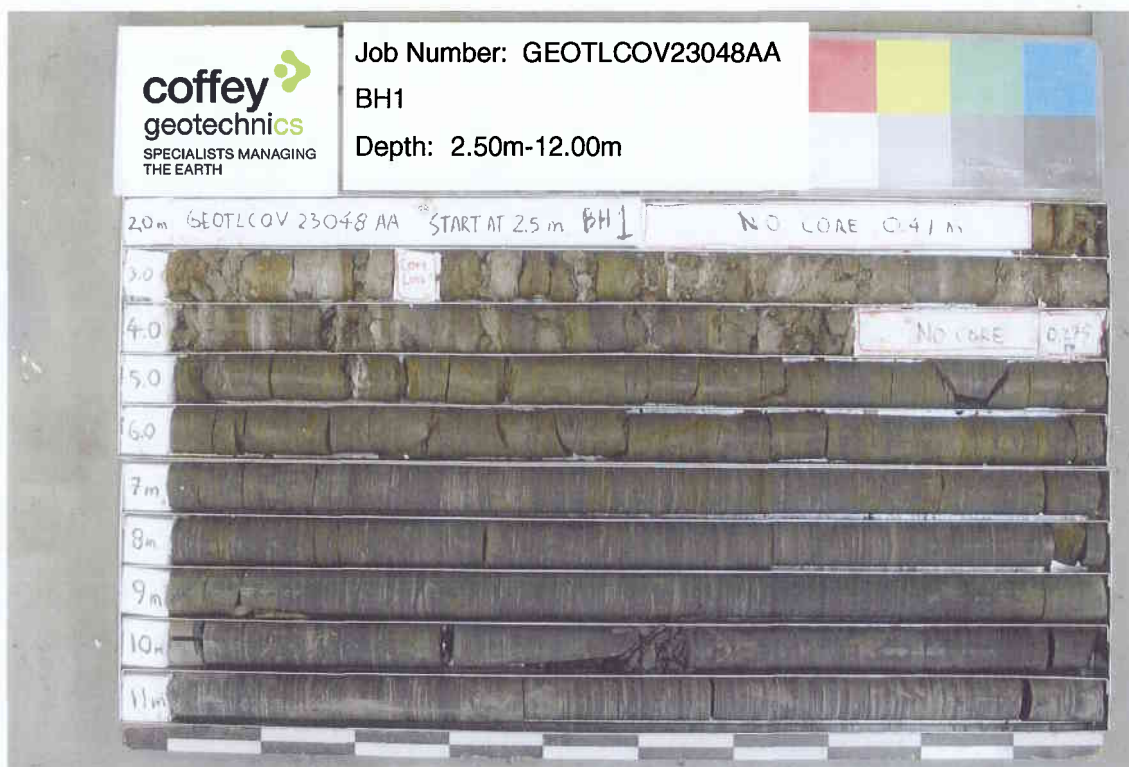
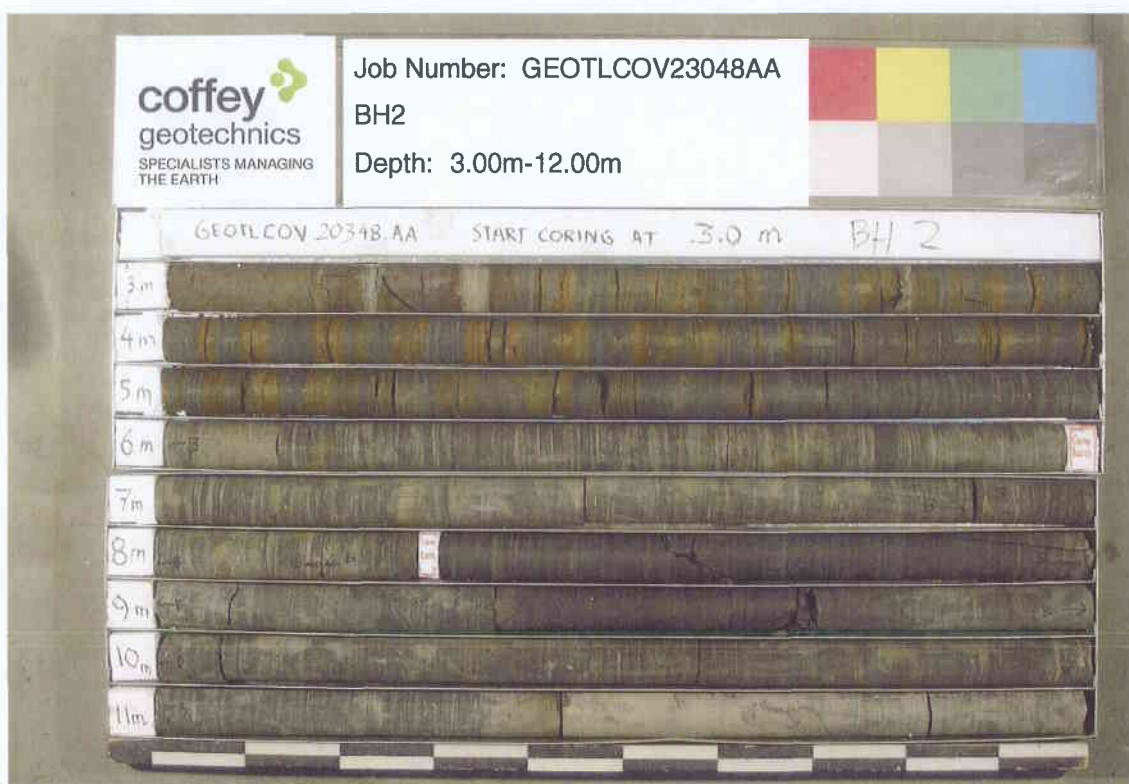
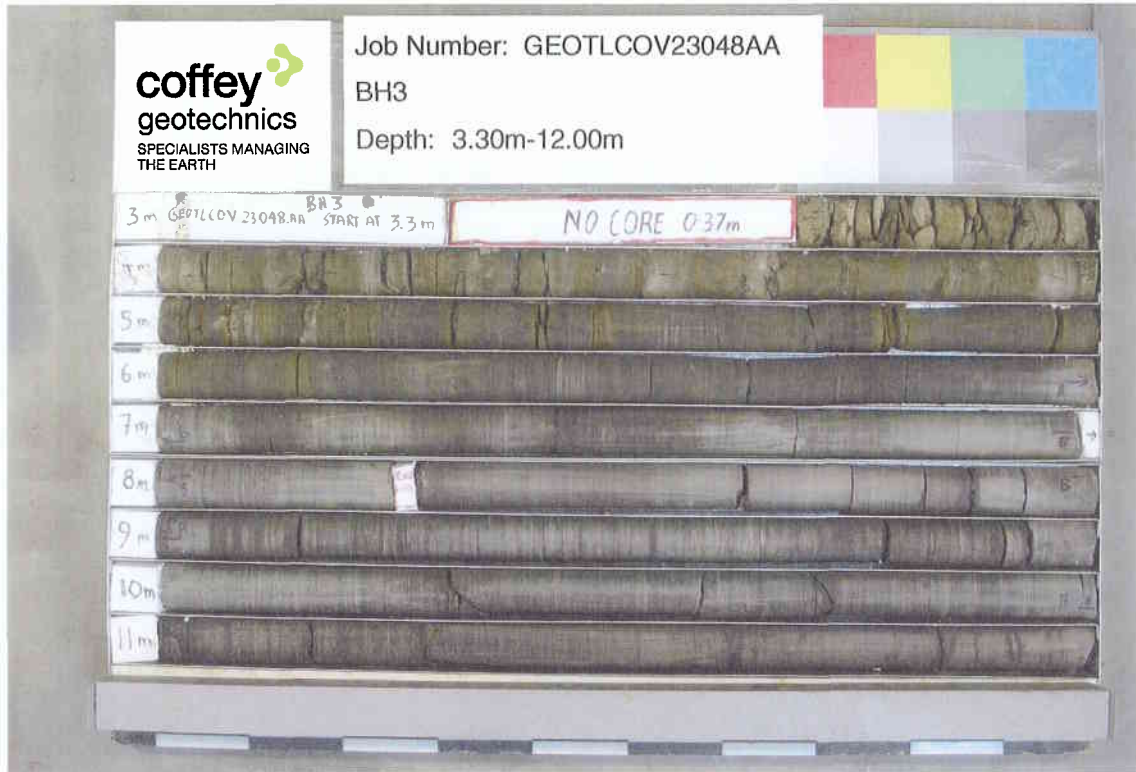
Appendix 1: Engineering Borehole Logs, Core Photographs and Explanation Sheets

Standard Penetration Testing was carried out at regular depth intervals as drilling progressed in soils to assessment strength and to obtaining samples for logging. The boreholes were drilled to the refusal depth of a V bit and thereafter continued using a tungsten carbide bit through soil and weathered rock. The less weathered rock was cored using a triple tube core barrel. Rock cores were photographed and are presented with the borehole logs.

Disturbed soil samples from Standard Penetration Testing and rock core samples were transported to our NATA registered laboratory. No soil testing was carried out. Representative rock core samples were designated for Point Load Strength Index (PLI) testing for estimates of rock strength. Colour photographs of the rock cores were taken and presented as part of the borehole logs in Appendix A.
