### SUPPLEMENTARY ABORIGINAL CULTURAL HERITAGE ASSESSMENT

***Proposed Coffs Harbour Water Treatment Plant,  
140 Upper Orara Road, Karangi, NSW mid-north coast***

***Supplementary Aboriginal cultural heritage assessment***

*June 2007*

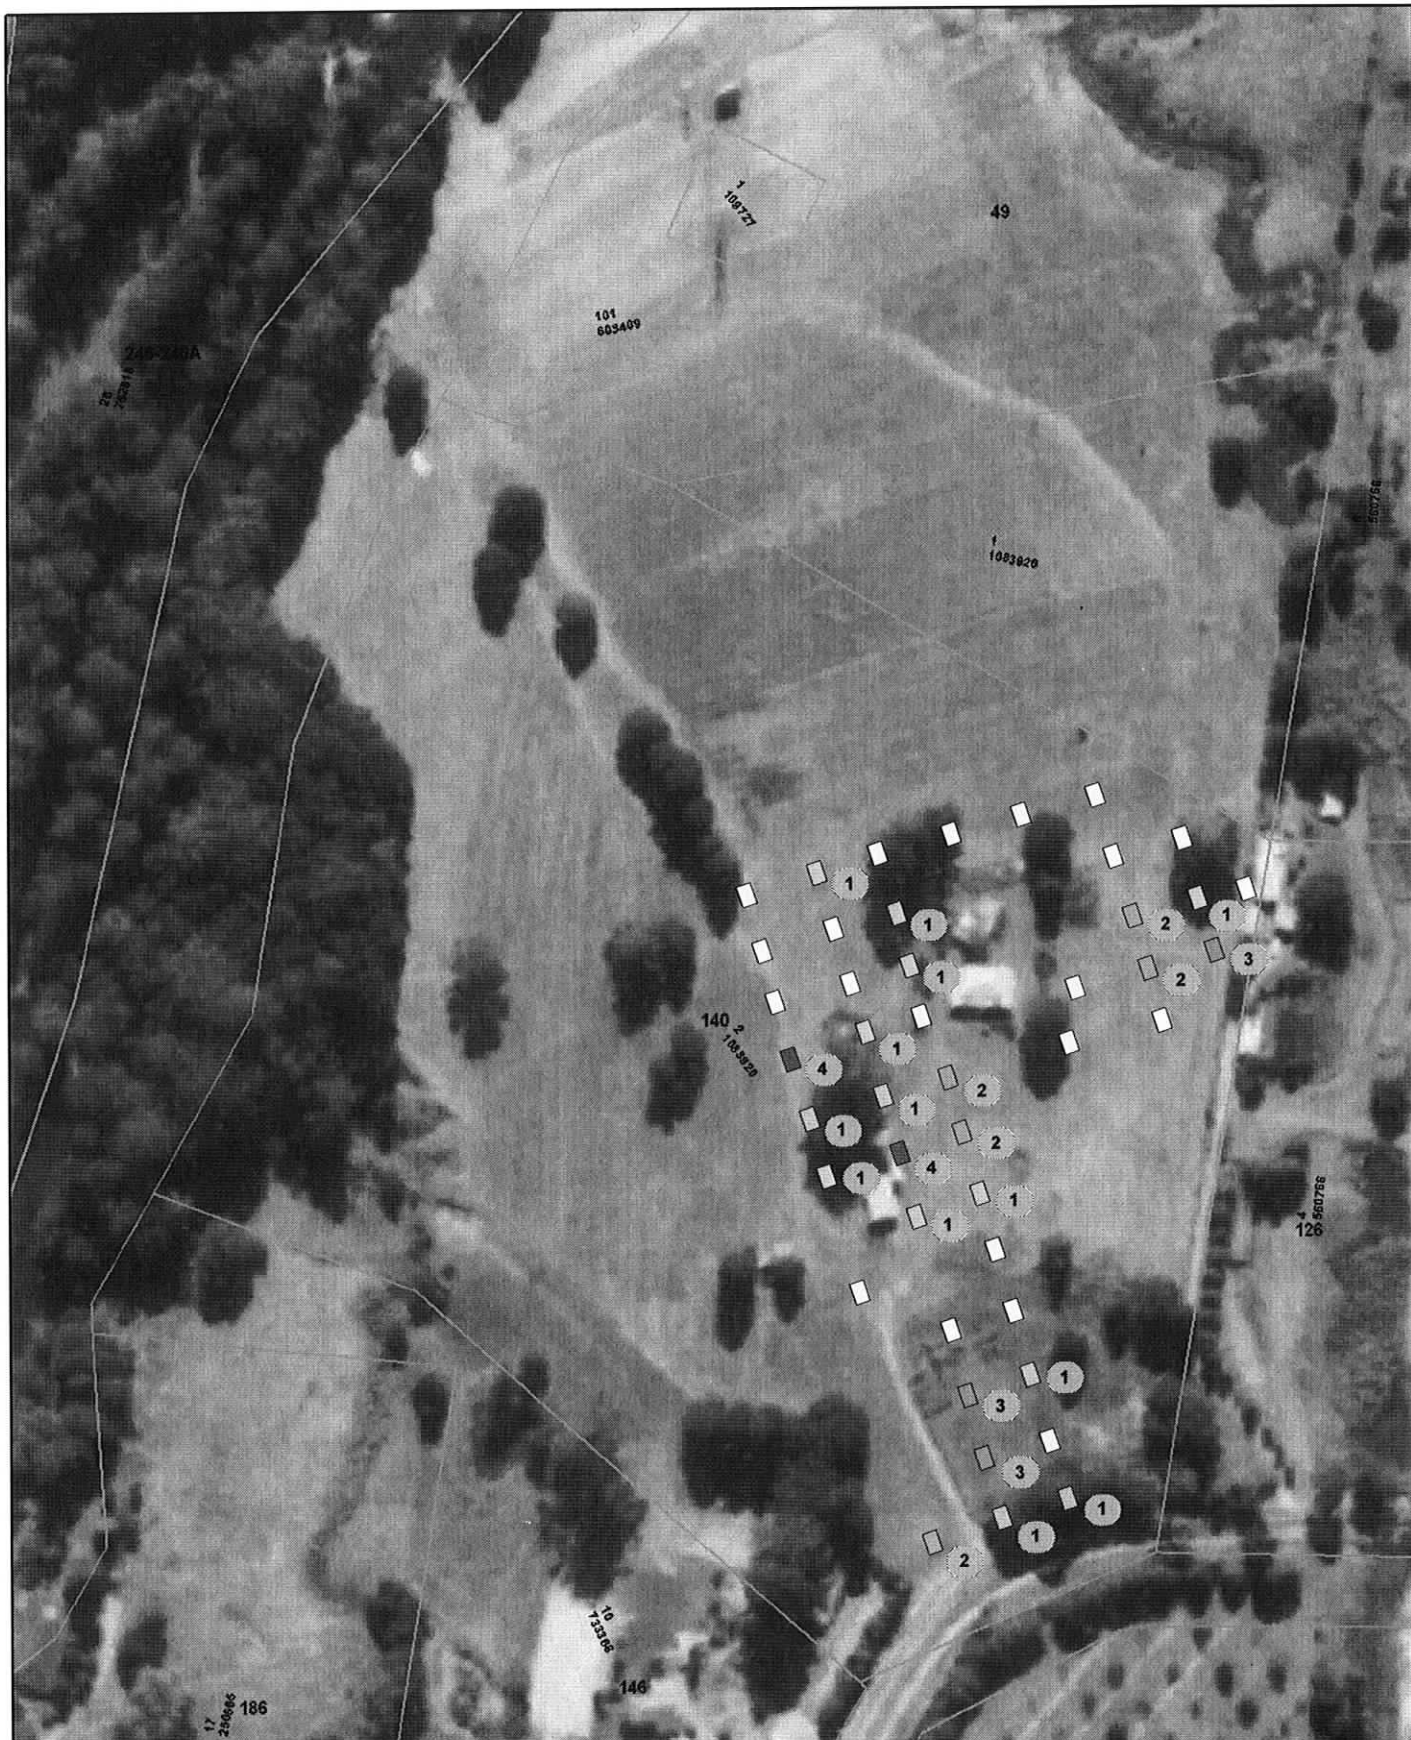
Figure 5. Number of stone artefacts recovered from test excavation pits

Subsurface artefacts were intercepted with highest frequency adjacent to Upper Orara Road, between the existing house and shed, and east of the house (Figure 5). These locations appear to have largely escaped the land levelling, cultivation, services installation and/or driveway/track construction modifications apparent elsewhere, but will have been similarly subject to the topsoil churning effects of tree root removal, cattle trampling and invertebrate bio-turbation. Although a loose level of horizontal spatial integrity has probably been maintained, there is little doubt that the artefact distribution has been substantially disturbed.

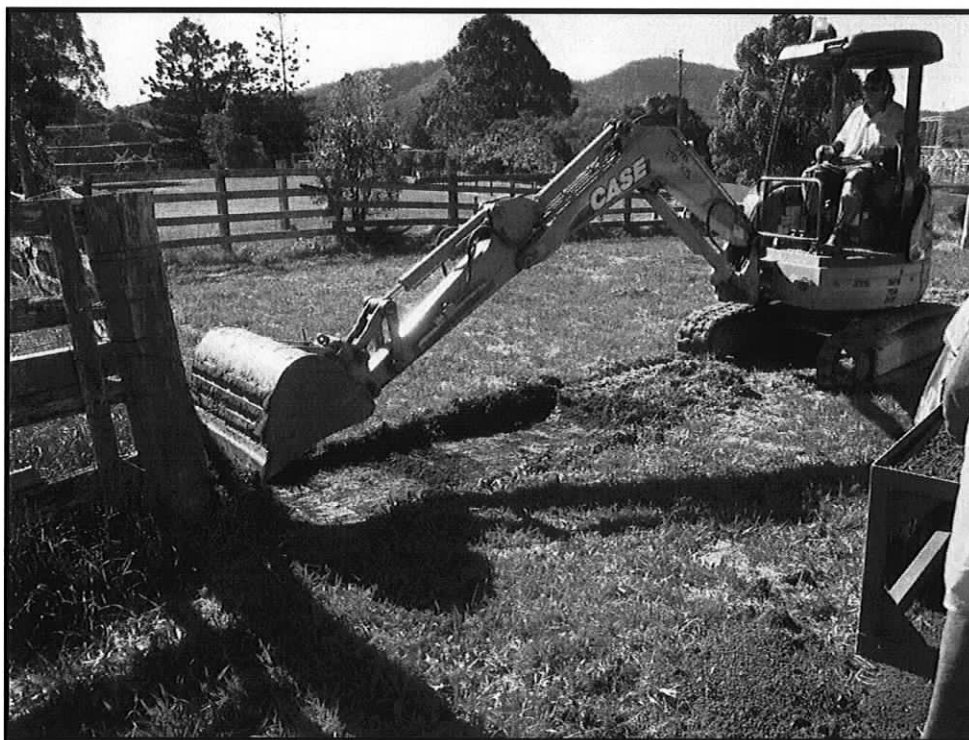
Plate 4. Typical excavation procedure (TP A2)

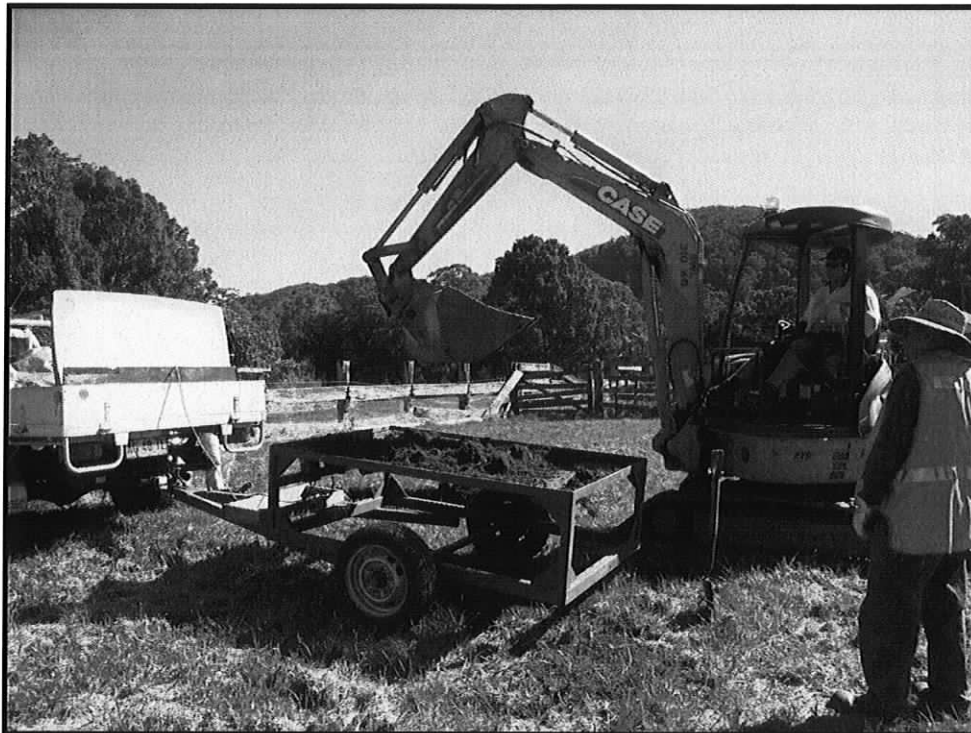
Plate 5. Excavated spoil placed directly on sieve (TP A3)

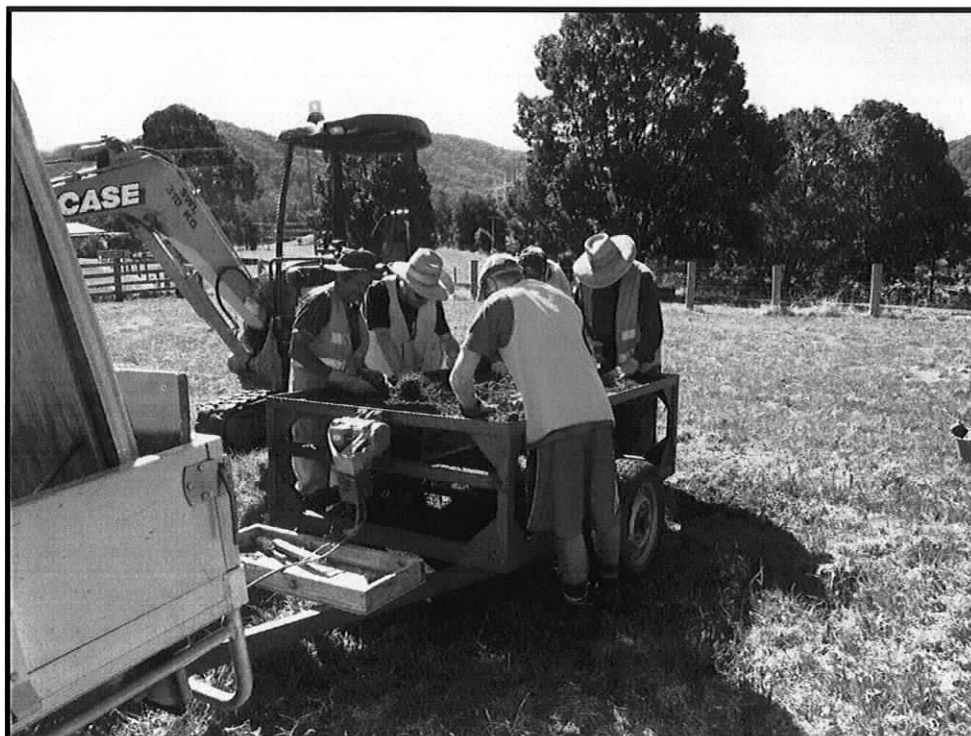
Plate 6. Typical sieving procedure. Sediment sieved and residue inspected by entire field team (TP A3)

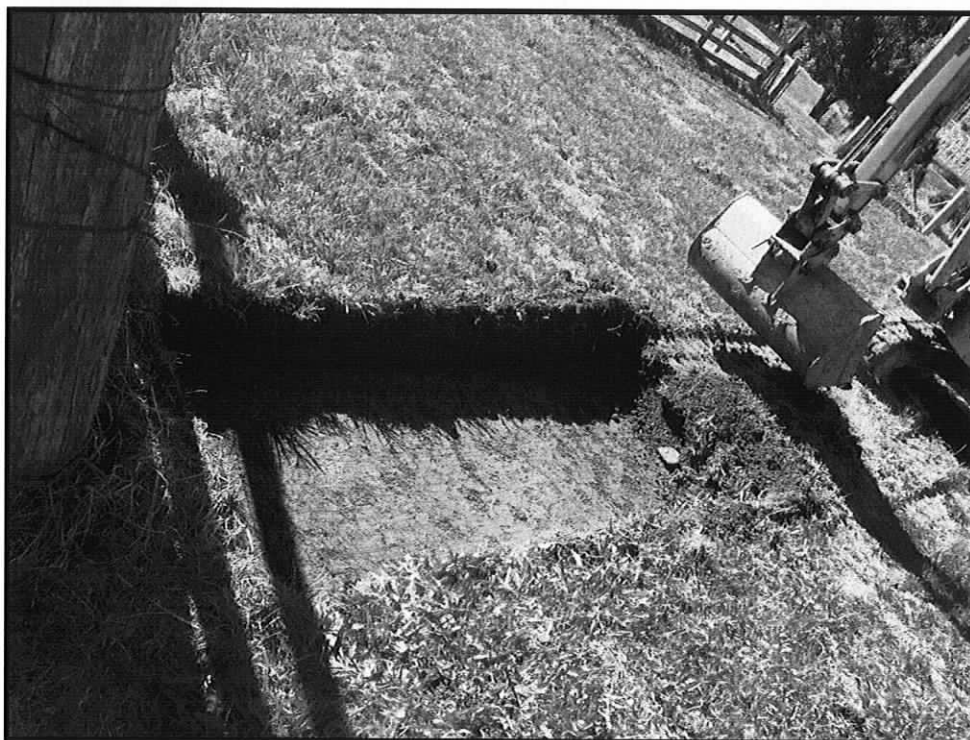
Plate 8. Typical test pit showing the basal clay unit (TP A2)

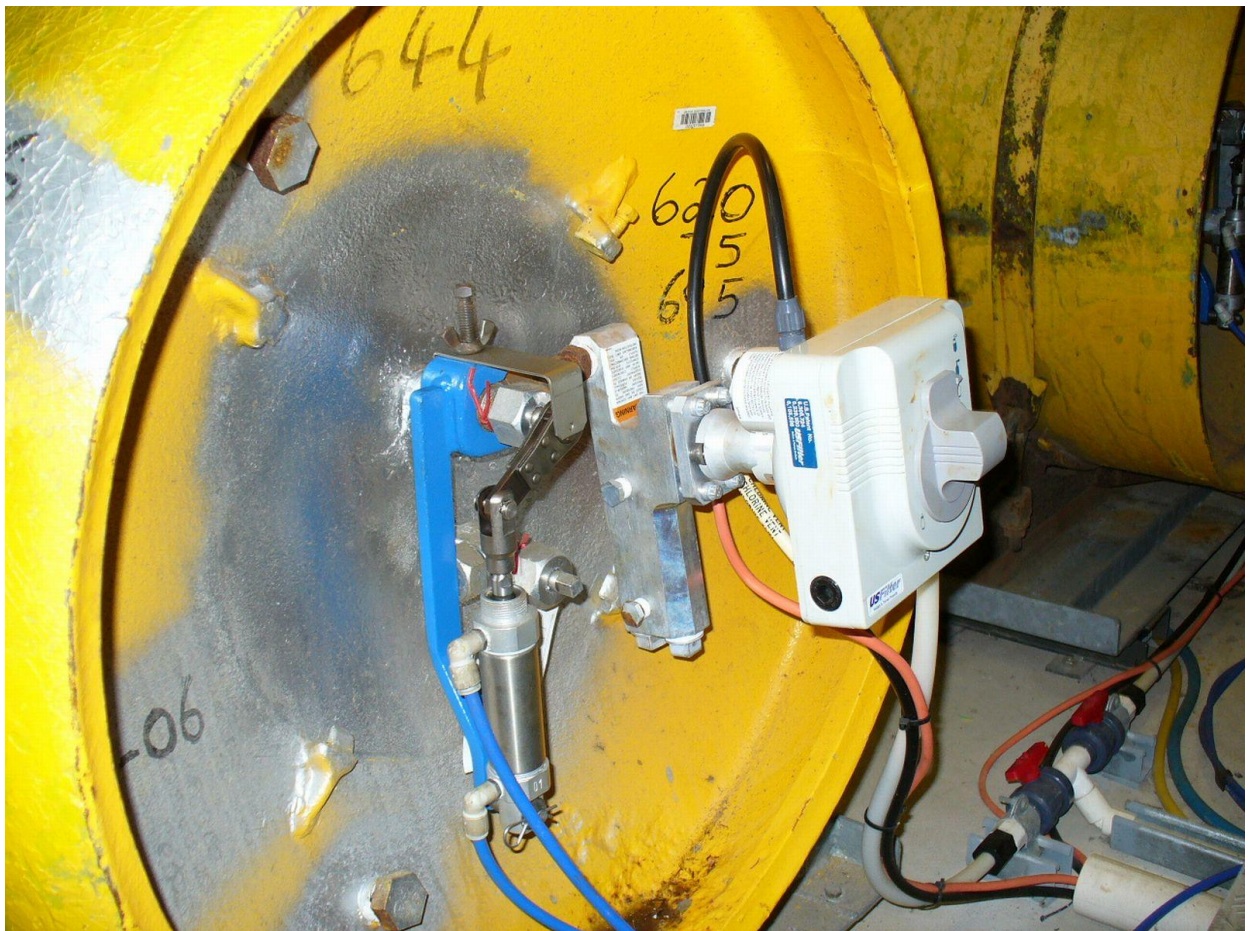
**Chlorine drum connection detail showing Chlorguard unit and vacuum regulator.**  
(Photo taken from Coffs Harbour City Council's Red Hill tank site chlorination plant)

The chlorination system is totally vacuum operated and does not use pigtails.
2. Valves 289-V-09 & 12 are vacuum regulating valves, which are mounted on the drum (immediately downstream of the Chlorguard units) to immediately reduce the pressurized gas to vacuum. These also serve as automatic switchover valves for drum changeover.
3. The drum isolating valves 289-V-08 & 11 are closed via the Chlorguard system if a chlorine leak is detected.
4. The vacuum regulator is mounted directly on the chlorine drum – immediately downstream of the aforementioned Chlorguard units.
5. Typo: The text should read 'air' not oxygen
6. Typo: One drum, limited by a 6 mm release rate for 60 minutes = 224 kg (not 187 kg) – 224 kg chlorine release was modelled.
