# **Sapphire to Woolgoolga Upgrade**

## **Environmental Review**

### **Material Re-use Strategy**

**May 2016  
Revision 0.8**

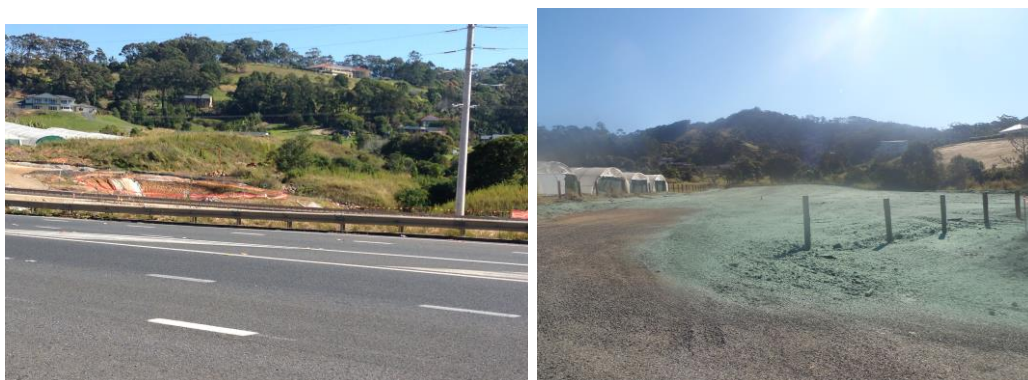
**Temporary stockpile condition (photo 1) and proposed permanent shape (photo 2) at SPW 1 (south)**

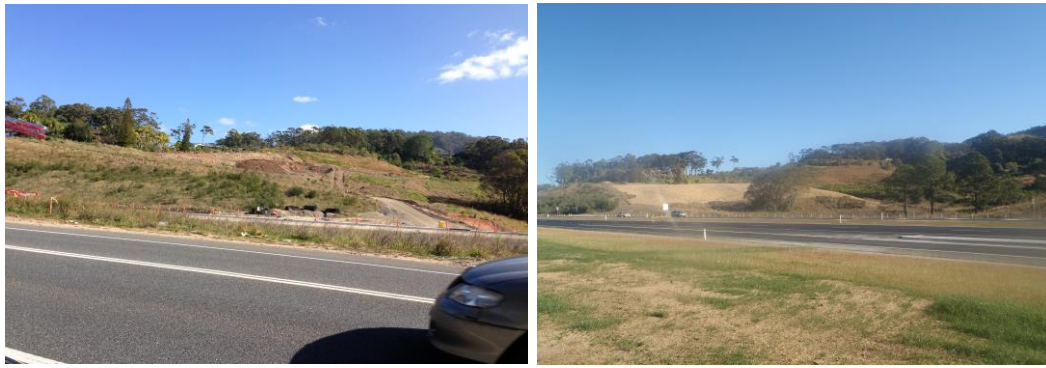
**Temporary stockpile condition (photo 1) and proposed permanent shape (photo 2) at SPW3**

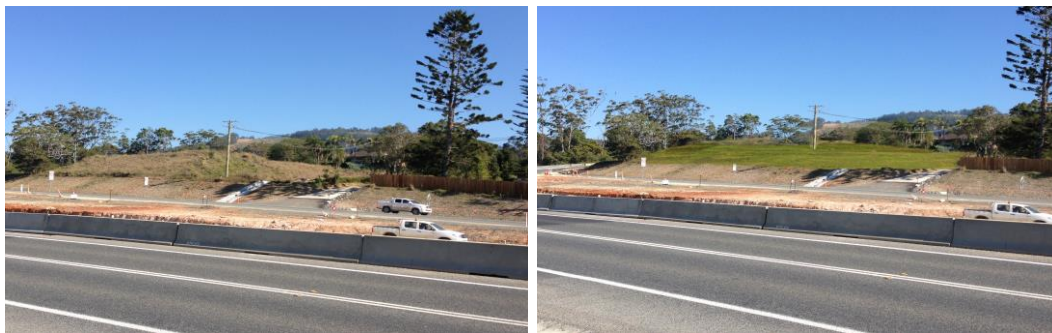
**Temporary stockpile condition (photo 1) and proposed permanent shape (photo 2) at SPW6**

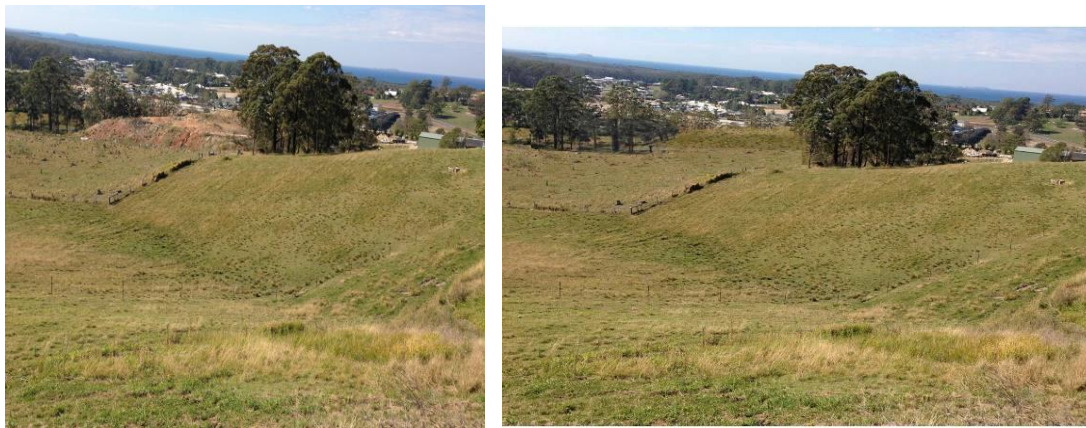
**Temporary stockpile condition (photo 1) and proposed permanent shape (photo 2) at SPW7**

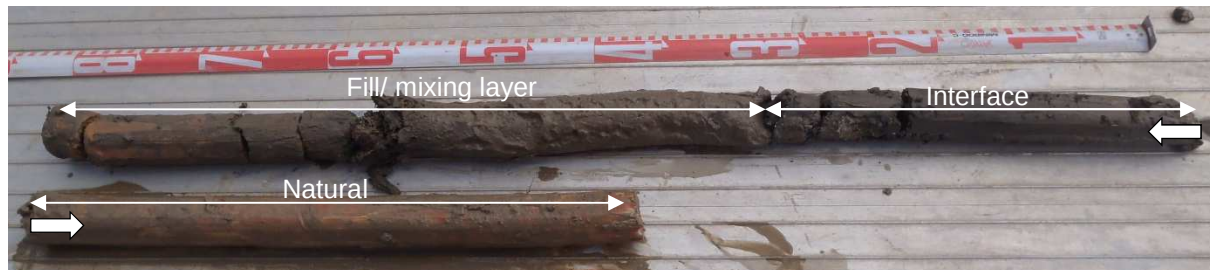
The arrows in the below photographs indicates highest to deepest point of borehole. Note: Sample recovery from SPT varies and depths shown are approximate.

Photograph 1, shows undisturbed sample recovered from BH7B: 7.5m to 8.4m.

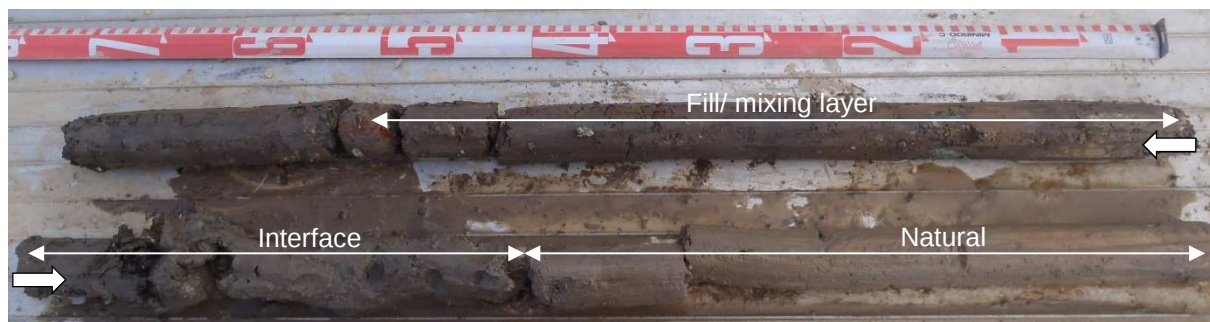
Photograph 2, shows undisturbed sample recovered from BH7C: 7.0m to 7.9m.

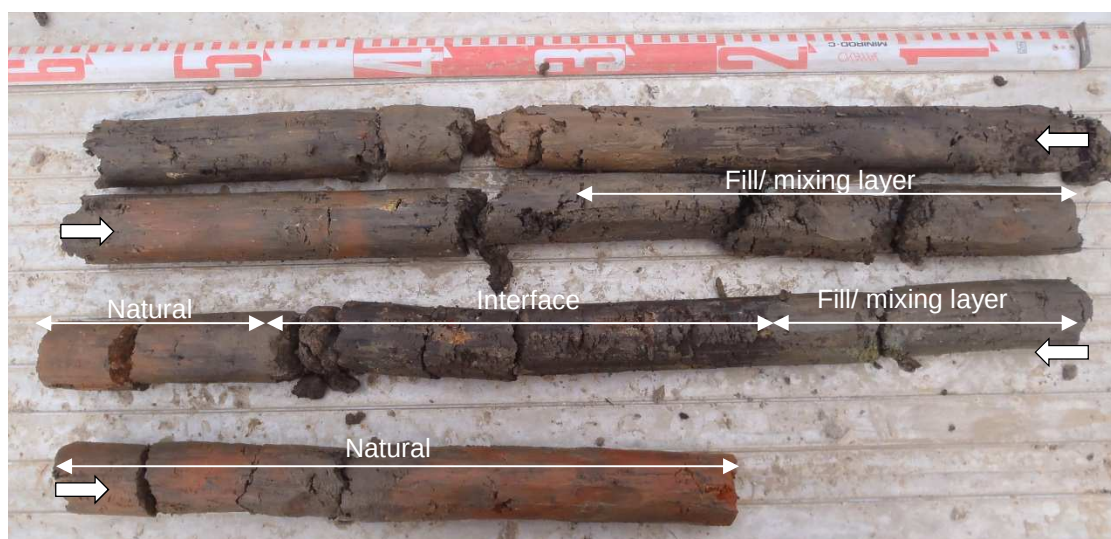
Photograph 5, shows undisturbed sample recovered from BH34B: 10m to 11.8m.
