2020 Cadia Valley Operations Rehabilitation Monitoring Report

for
Newcrest Mining Limited

Prepared by
DnA Environmental
May 2020

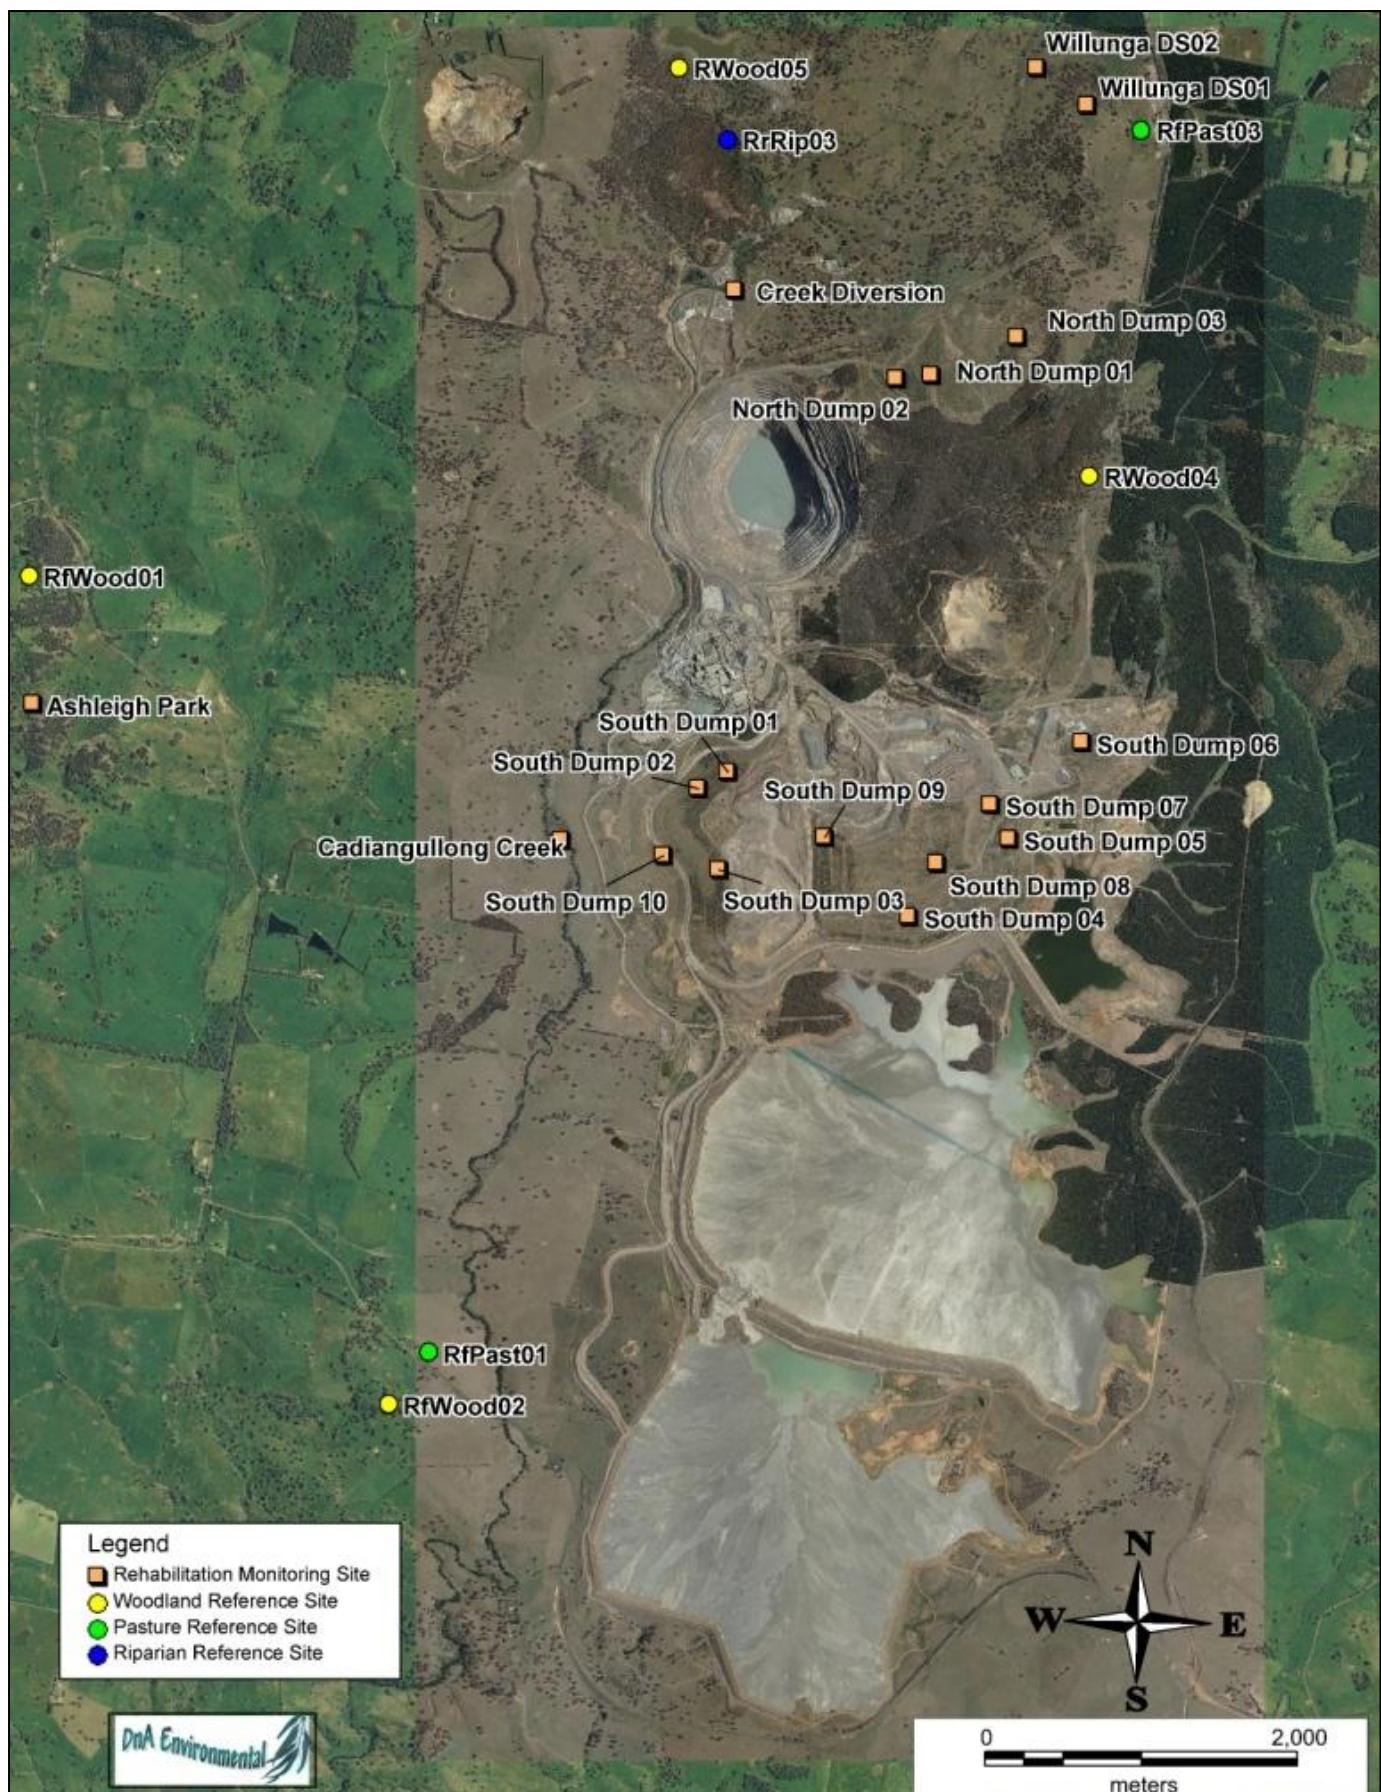
Figure 2-1. Map of the CVO monitoring sites.

Table 2-1 shows a summary of the monitoring sites assessed as part of the CVO monitoring program, including the general locality, year of establishment, community type and frequency of monitoring. Figure 2-1 shows the location of the reference and rehabilitation monitoring sites. GPS coordinates and other site specific information is provided in Appendix 1.

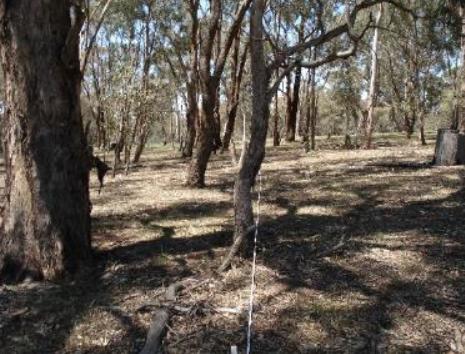
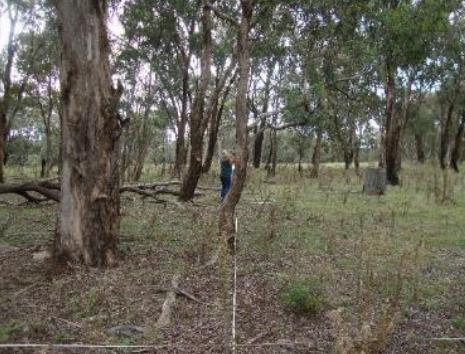
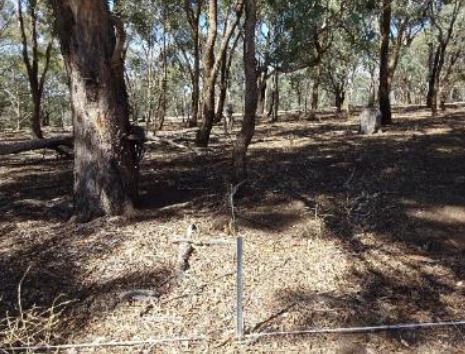
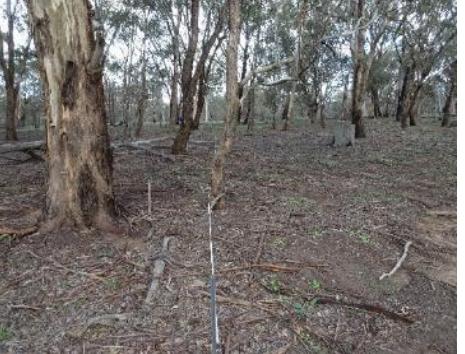
Site name	2008	2012	2016	2020
RfWood01: "Ashleigh Park"

Table 5-1. General description and permanent photo-point along the vegetation transect in the reference monitoring sites 2008 - 2020.

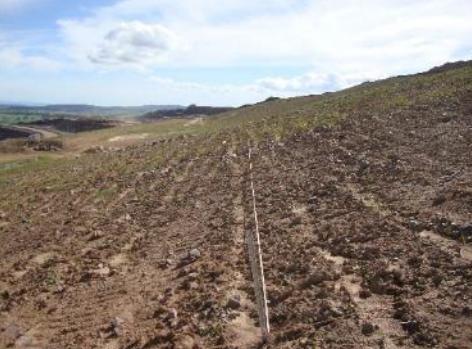
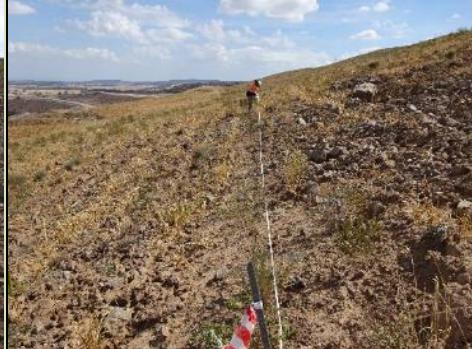
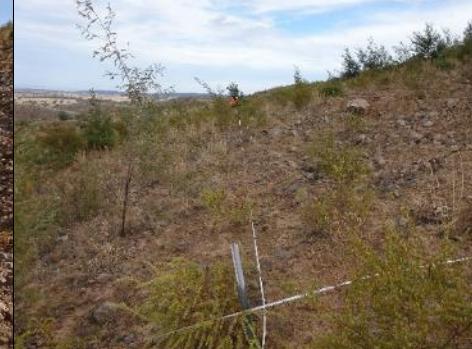
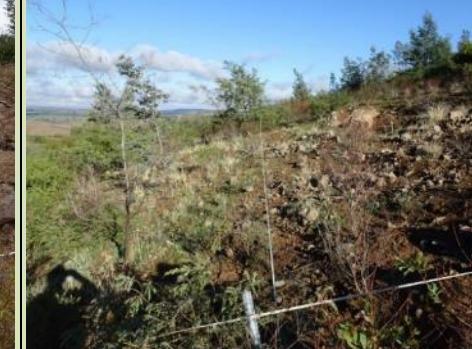
Site name	2014	2016	2018	2020
South Dump 04

Table 5-2 provides a photograph taken from the permanent monitoring point along the vegetation transect of rehabilitation sites established on the South and North Dumps from 2014 to 2020. North Dump 03 and South Dump 08 are relatively flat, while the remainder are on slopes. Sites South Dump 04 and 05 and North Dump 01, 02 and 03 were aerial seeded during November 2013 with a blend of native trees and shrubs and exotic pasture species. Sites on the North Dump were over sown with Japanese Millet while sites on the South Dump were over sown with Cereal Rye, Couch, Cocksfoot, Phalaris, Subterranean Clover, Perennial Ryegrass and the native grass *Bothriochloa macra* (Redgrass). In October 2015, sites South Dump 04 and 05 were cross ripped and re-seeded to reduce the compaction layer. Sites South Dump 07, 08 and 09 were also aerial sown in February 2015 with a mix of endemic native, shrubs and ground cover species. South Dump 10 was sown in February 2018. GPS co-ordinates and other site specific information of the rehabilitation sites are provided in Appendix 1.

Table 5-2. Permanent photo-point of the rehabilitation monitoring sites on the south and north dumps 2014 - 2020.

All of the rehabilitation sites established on the South Dump (South Dump 04 – South Dump 09) since 2014 have previously demonstrated significant increases in functional patch area. Despite the loss of many of the original troughs and banks due to erosive process over the first few years, there has typically been a concurrent increase in plant and litter covers. In 2017, prolonged dry conditions and increased grazing and disturbance by animals has resulted in a deterioration of functional patch area and stability in most of the rehabilitation sites, especially in South Dump 05, 07 and 09.

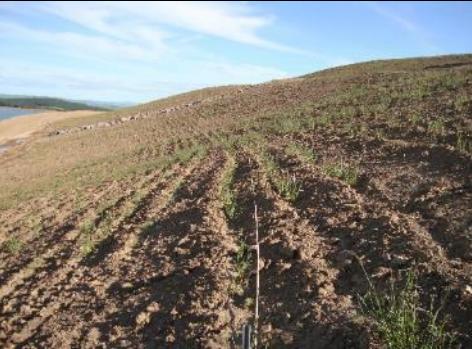
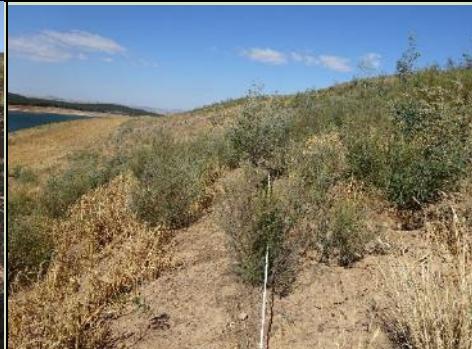
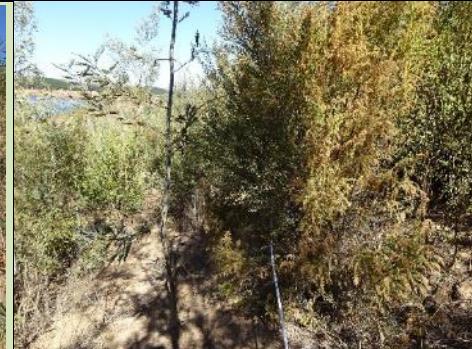
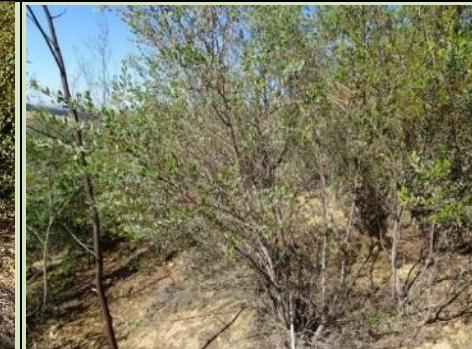
This year South Dump 05 continued to be subjected by heavy disturbance by macropods, while active rilling and sheet erosion created unstable conditions for the establishment of cryptogams and other ground cover vegetation in the steeper slopes of South Dump 04 and South Dump 09, and parts of South Dump 07. In the remaining rehabilitation sites, there tended to be an increase in litter and ground cover vegetation and in some sites, there has been an increase in shrub cover and/or cryptogams were relatively abundant. Rehabilitation sites South

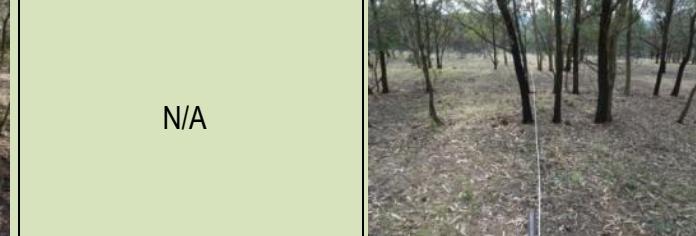
Willunga DS02: Woodland rehabilitation: Willunga property. Paddock adjacent to Ridgeway access road. It is a rocky knoll with native pastures that has been fenced off to restrict grazing. The area was direct seeded in 2005 and 2006, with sparse scattering of seedlings now present. Some tubestock were planted in the lower section of the monitoring area. The site is largely ungrazed and dominated by tall rank *Bothriochloa macra*, and there appeared to more weeds (Skeleton weed, dead Saffron Thistle and Blackberry). In 2012, the site remained ungrazed, but the large patches of Blackberries had been sprayed. There continued to a dense sward of native grasses with relatively few weeds. The trees and shrubs have continued to grow with a couple of individuals being affected by spray drift. Many small Blackberries were observed so follow up spraying will be essential. In 2013, macropods have kept the grass short and while the Blackberries had been sprayed will continue to require some follow up. In 2014 the site remained ungrazed and there were a scattering of small Blackberries. The site had not been recently grazed and had retained a moderate cover of native grasses and Skeleton weed was abundant. A few Blackberry canes remain and occasional Blackberry persist. While many acacias have died over the years the remaining trees have grown and appear healthy. There were few annual grasses present this year. In 2016 there was limited live ground cover and these were grazed very low by a combination of recent strategic stock grazing and macropods. In 2019, the area was being grazed by cattle but good ground cover was retained. There was some recent germination of annuals and reshooting of perennial ground covers. The surviving trees and shrubs had significantly grown, and the Acacias were suckering.
