### 3.0 Physical Assessment

#### 3.3.1 Slab Homestead

### 3.3.4 Slab Hut Homestead Condition

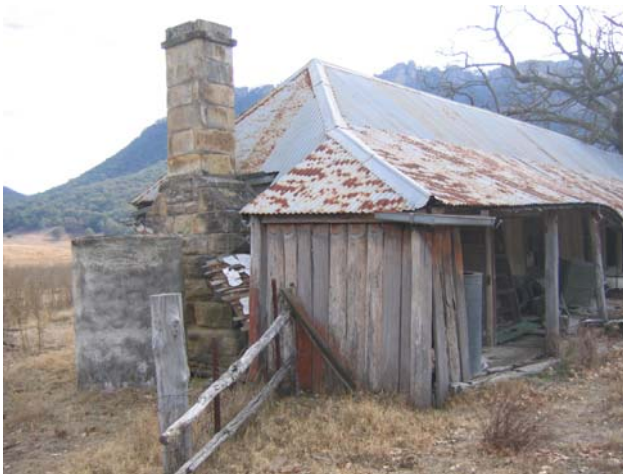
**Figure 3.5:** West Elevation of homestead showing Kitchen Chimney

Adjacent to the southern end of the north-south wing is an isolated fireplace with chimney of rough-hewn sandstone with corrugated iron capping (see Figures 3.5 and 3.8). To the north of fireplace is an assortment of construction material including timber planks and corrugated iron. This is the surviving remnant of the external kitchen.

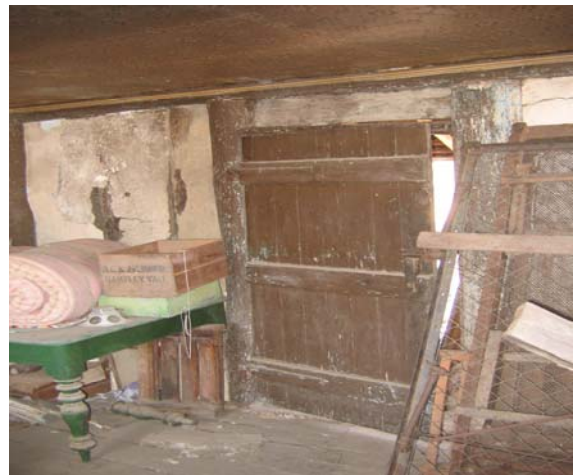
**Figure 3.12:** Detail of East Elevation of Slab Hut with verandah roof junction

The verandah (see Figures 3.12 and 3.13) appears to have been a later addition to the East Elevation. Timber verandah poles are rammed into the earth. The notched over beam is approximately 100mm to 200mm in depth. The verandah flooring is stone edged slab on rammed earth and gravel. The timber board dimensions are approx 60 x 130mm. The external ends are affected by wet rot. The southern end of the verandah has been in-filled to form a bathroom. The eastern wall of the bathroom has been removed. A bathtub remains in situ.

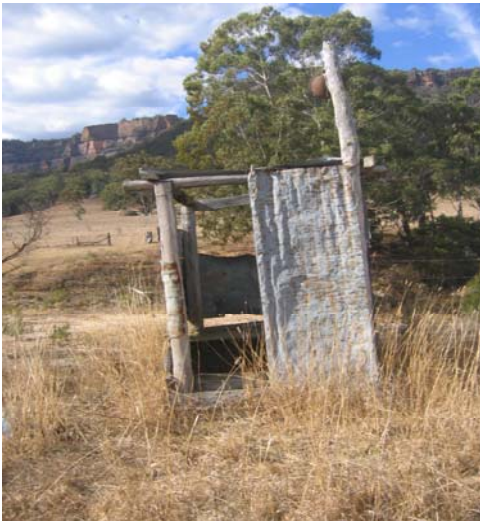
**Figure 3.15:** West Elevation of Privy

The privy is located to the east of the slab hut homestead and northeast of the Men's Quarters. The door opening to the pit toilet is oriented west, facing the house (see Figure 3.14). The privy is constructed of timber poles and is clad with corrugated metal sheeting. The floor of the privy is timber slabs and a timber seat is constructed over the pit. The corrugated iron cladding appears to be reused from other structures. Rust is found on sections of the cladding. Some cladding panels are missing, including the roof. Generally, the structure is in poor condition, although still functional.

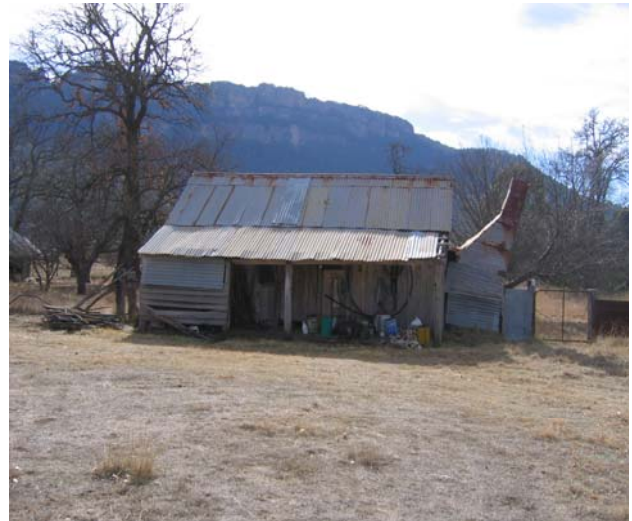
**Figure 3.16:** South Elevation of Men's Quarters

The two-room slab hut, known as the Men's Quarters, is located southeast of the slab hut homestead. The Men's Quarters has a verandah on the South Elevation (see Figure 3.15) and a metal chimney on the East Elevation. It is constructed using timber poles rammed into the earth. Vertical slabs are used to infill the four walls. Horizontal slabs are used in the construction of the gables (Figure 3.17). The slab hut has a gabled and pitched roof finished with corrugated metal sheeting. The verandah roof continues the roof line with a broken back pitch. A small annex room is located at the western end of the verandah. The annex is horizontal slab construction and a panel of corrugated metal sheeting, used where slabs have been lost.

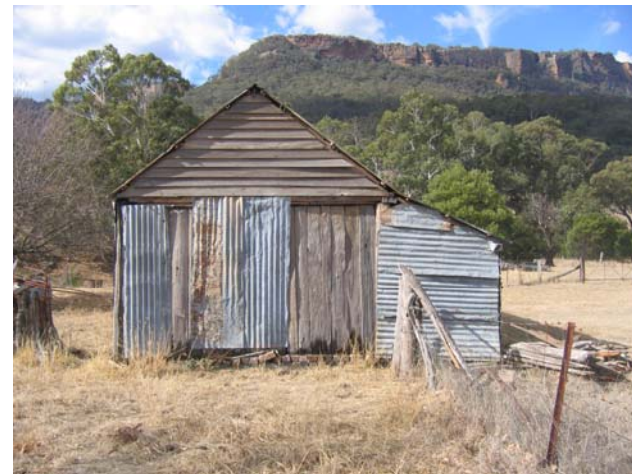
**Figure 3.18:** West Elevation of Men's Quarters

The building is in moderate condition. The chimney has partially collapsed. The slabs have begun to splay on the West Elevation (see Figure 3.16). Corrugated metal sheeting used as cladding where slabs have been removed.

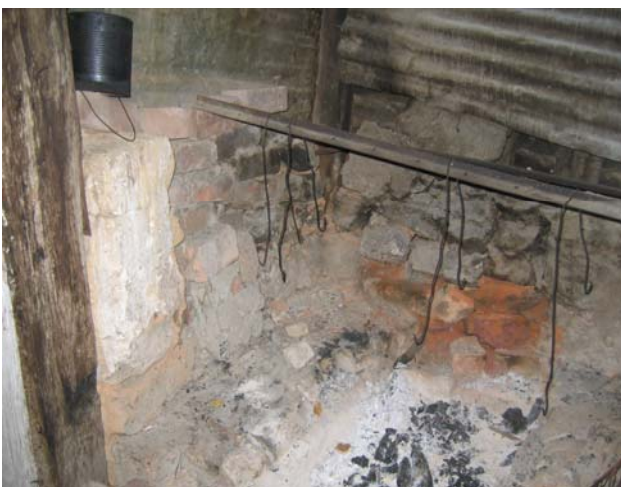
**Figure 3.19** Interior of Men's Quarters showing the Fireplace

Internally, the timber slabs and roof beams are exposed and unfinished. The flooring comprises exposed timber floor boards. There is evidence that the walls have been whitewashed. The internal dividing wall between the two rooms is constructed of short sawn timber planks. There are no windows. The fireplace is partially collapsed (see Figures 3.17 and 3.18).

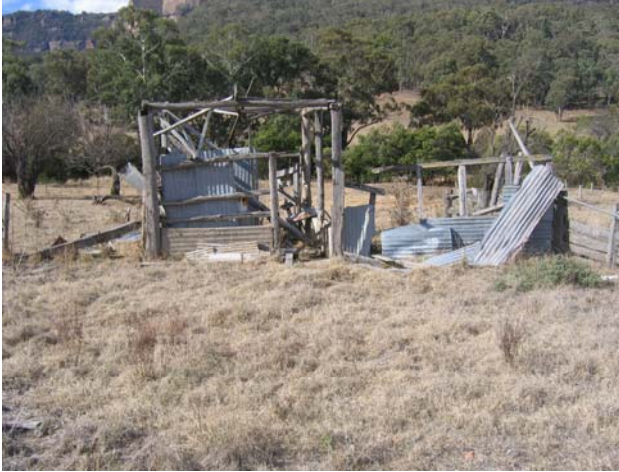
**Figure 3.21:** Remains of Slaughterhouse

The Slaughterhouse comprises a single-space structure. It is constructed of a timber frame (uncut logs, rough hewn and sawn planks). Sections of corrugated metal sheeting, fixed to the interior of the structure are used as cladding. Concrete upstands (between 400-500 mm in height) are constructed between the timber poles on the South, West and North Elevations. Internally, the floor is concrete and a drain is located adjacent to the entry doorway on the eastern façade. The building contains the discarded timbers, corrugated iron sheeting and some equipment associated with its former use. The building is unroofed although timber bracing indicates that a roof was formerly located on the structure. The structure is in poor condition.

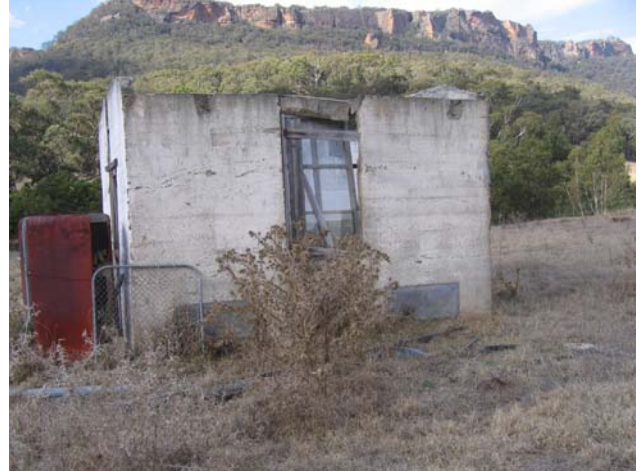
**Figure 3.22:** Western elevation of Meat House

The building has no roof, although the South and North Elevations indicate a shallow pitched and gabled roof existed. Cracking in the wall is evident from the roofline to the door and window openings.

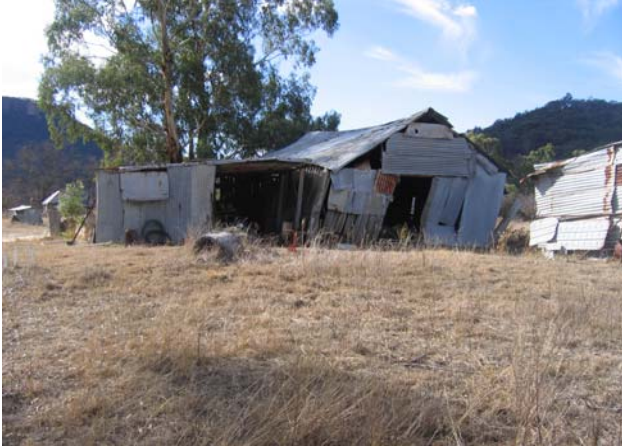
**Figure 3.27:** South Elevation of Shearing Shed

The western wing is in a moderate condition while the eastern wing is in a dilapidated state.

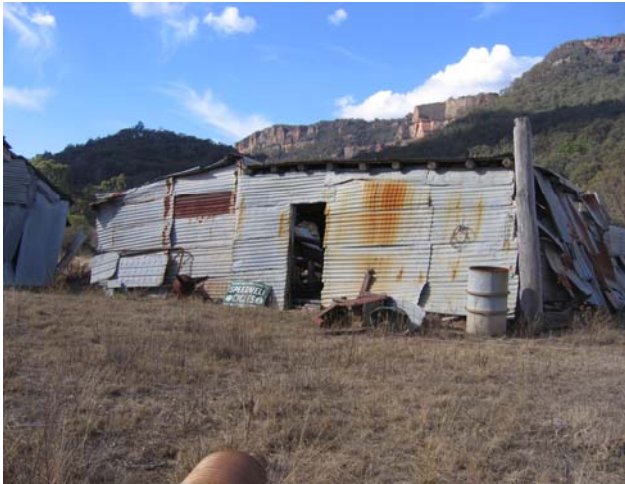
**Figure 3.33:** West Elevation of Barn

A timber framed barn clad in corrugated metal sheeting is located southeast of the shearing shed (see Figures 3.27 and 3.28). A covered driveway is attached to the barn. The barn has a mezzanine level accessed via a ladder. The flooring comprises rammed earth. Overall the building is in a poor condition in a state of collapse due to a severe windstorm.

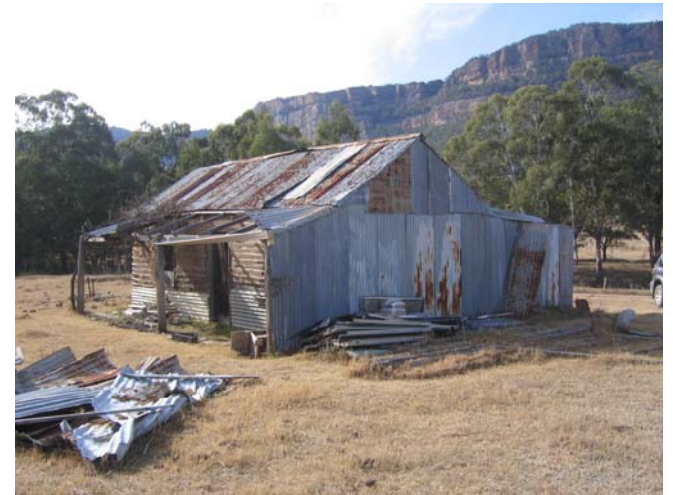
**Figure 3.36:** South and West Elevation of Timber Lathe and Mud Hut

A timber lathe and mud hut (see Figure 3.30 and 3.31) is located along the access road that leads to the Wolgan Homestead site. It is located on the western side of Wolgan River where the valley floor begins to open out from the foot of Donkey Mountain. The hut is a four-room residential building with central corridor. Door and verandah are located on the West Elevation. A door is located on the East Elevation. The building is constructed in timber lathe and mud construction on a timber frame. The South, West and part of the East Elevations are clad in corrugated metal sheeting. The walls are further reinforced with an internal layer of chicken wire. The roof is clad with corrugated metal sheeting.

The hut is in poor condition.

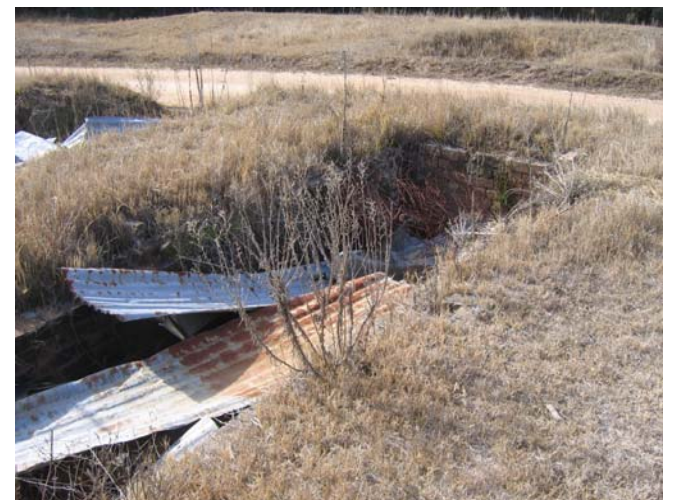
**Figure 3.38:** Charcoal pits located adjacent to Timber Lathe and Mud Hut

Located to the north of the hut in close proximity to the access road are two trenches. The walls of the first trench are constructed from brick (see Figure 3.32), while the second trench is constructed principally from concrete with the southern wall constructed from brick. It is understood that these trenches were constructed during the 1929 to early 1930s depression period and were used for charcoal burning.
