Inner West Marina

Parramatta River, Sydney

ENVIRONMENTAL ASSESSMENT

Estuary Hydrodynamics and Physical Sedimentary Environment

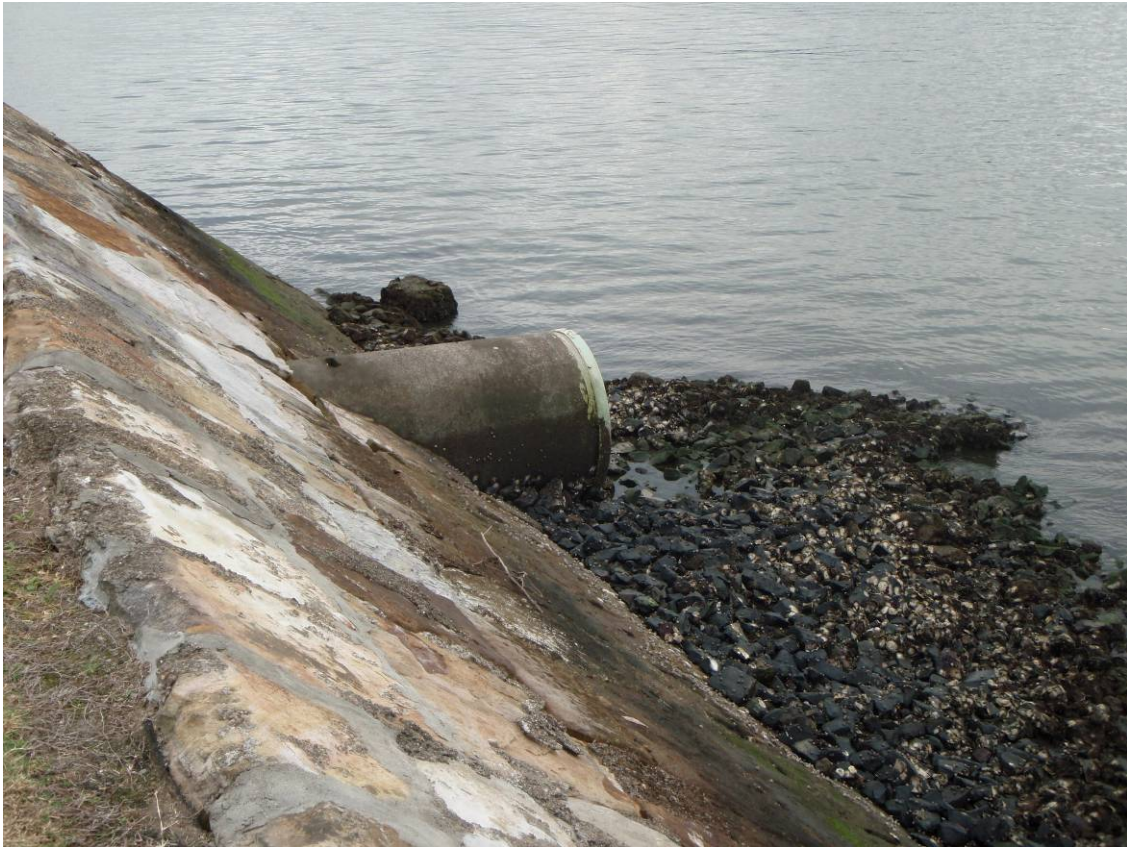
Photo 13

We observed seven stormwater outlets at the shoreline. These ranged in size from approximately 300Ø to 1650Ø, with both the smallest and the largest discharging at the same location behind the mangroves at the head of the bay. Two outlets occur at the beach in the SE corner (600Ø and 450Ø), and the remaining three along the western shoreline (approx 750 - 900Ø, not accessed; **Photo 13**).

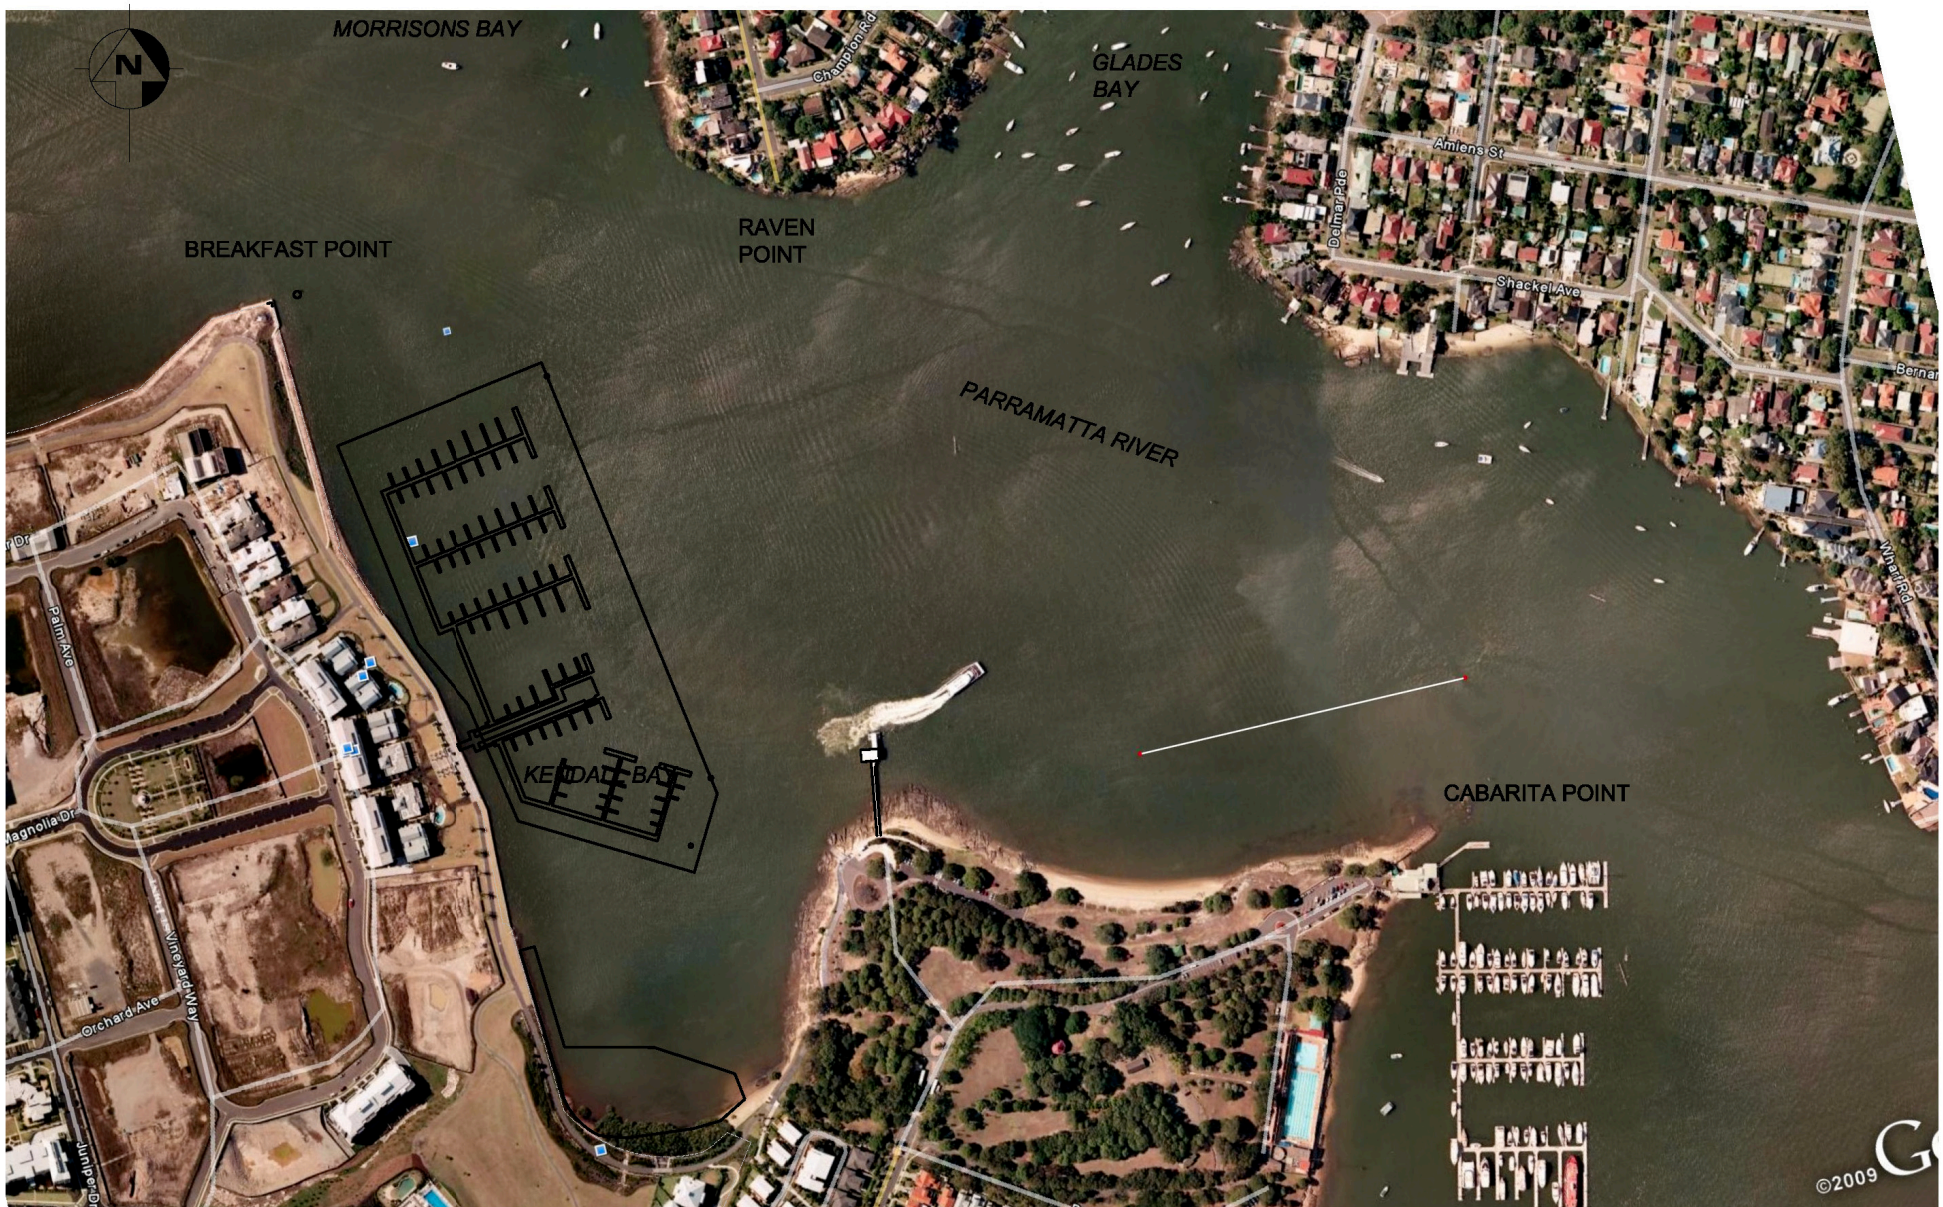
STUDY AREA

- 1. BASE PHOTO GOOGELE EARTH PRO 4/09
- 2. MARINA LAYOUT FROM TLB DA10 REC 8/7/09

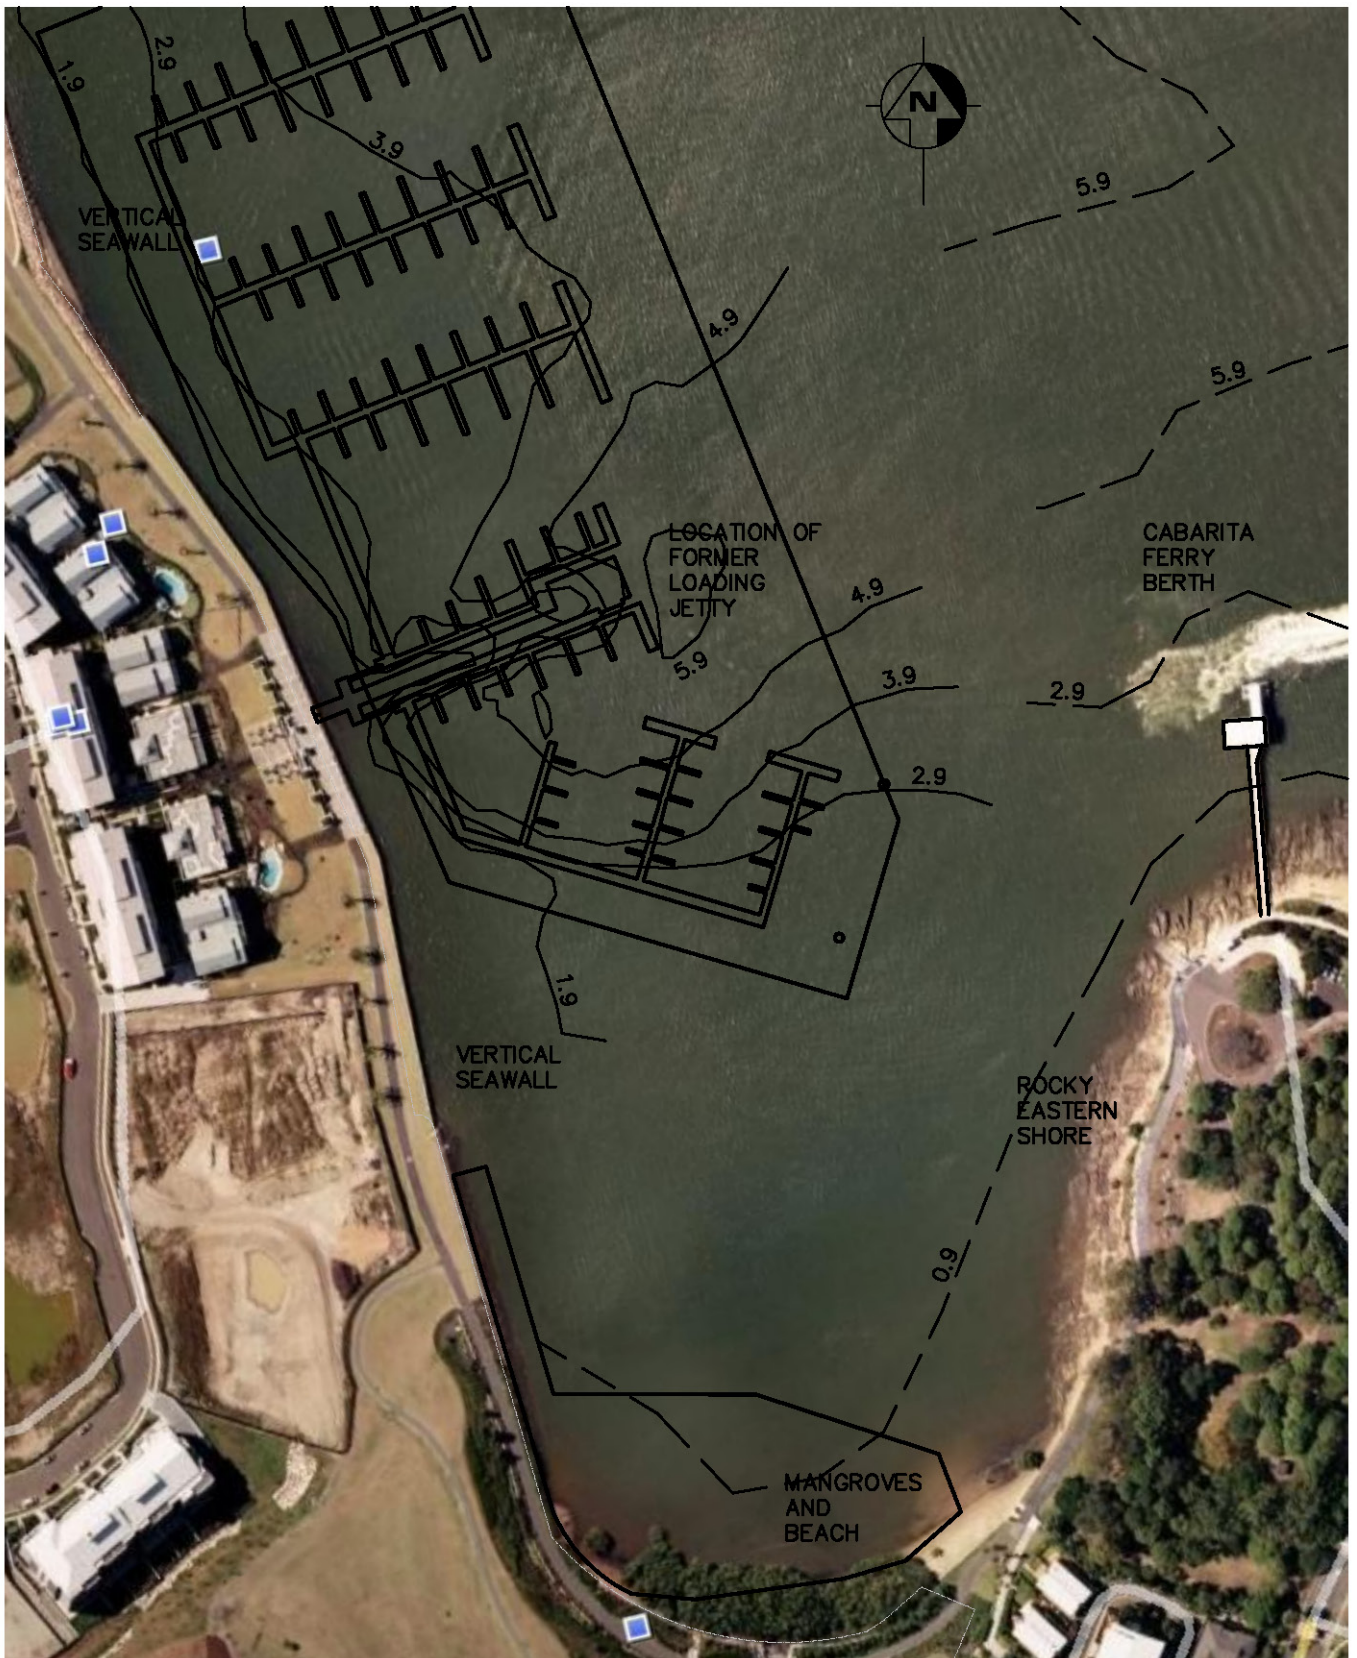
**BATHYMETRY AND
SHORELINE
MORPHOLOGY**

1. BASE PHOTO GOOGLE EARTH PRO 4/09
2. MARINA LAYOUT FROM TLB DAO3 REC 8/7/09
3. BATHYMETRY FROM HARVEY HYDROGRAPHIC SURVEYS (8/01) AND AUS 203. BED LEVELS IN METRES BELOW AHD. FULL LINE HARVEY, DASHED LINE AUS CHART.

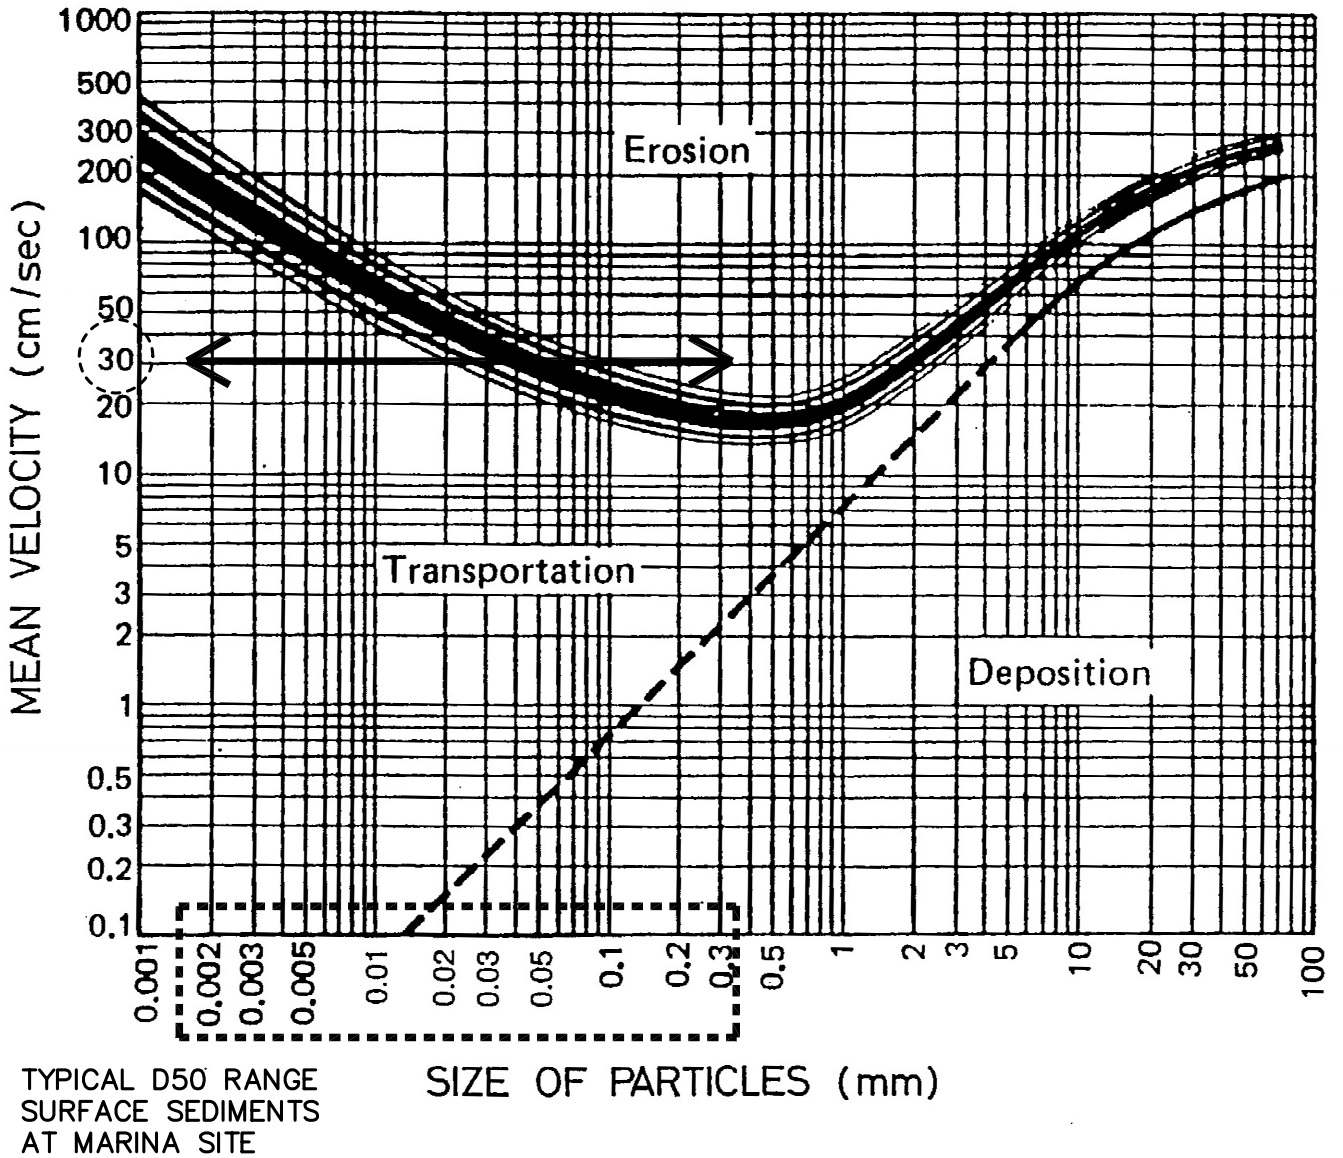
GENERALIZED RELATIONSHIP BETWEEN
AVERAGE CURRENT VELOCITY AND
SEDIMENTARY BEHAVIOUR

THRESHOLD VELOCITY OF
30 cm/s ADOPTED FOR
GENERAL CONSIDERATION
OF EROSION AT MARINA
SITE

SOURCE HJULSTROM (1939)

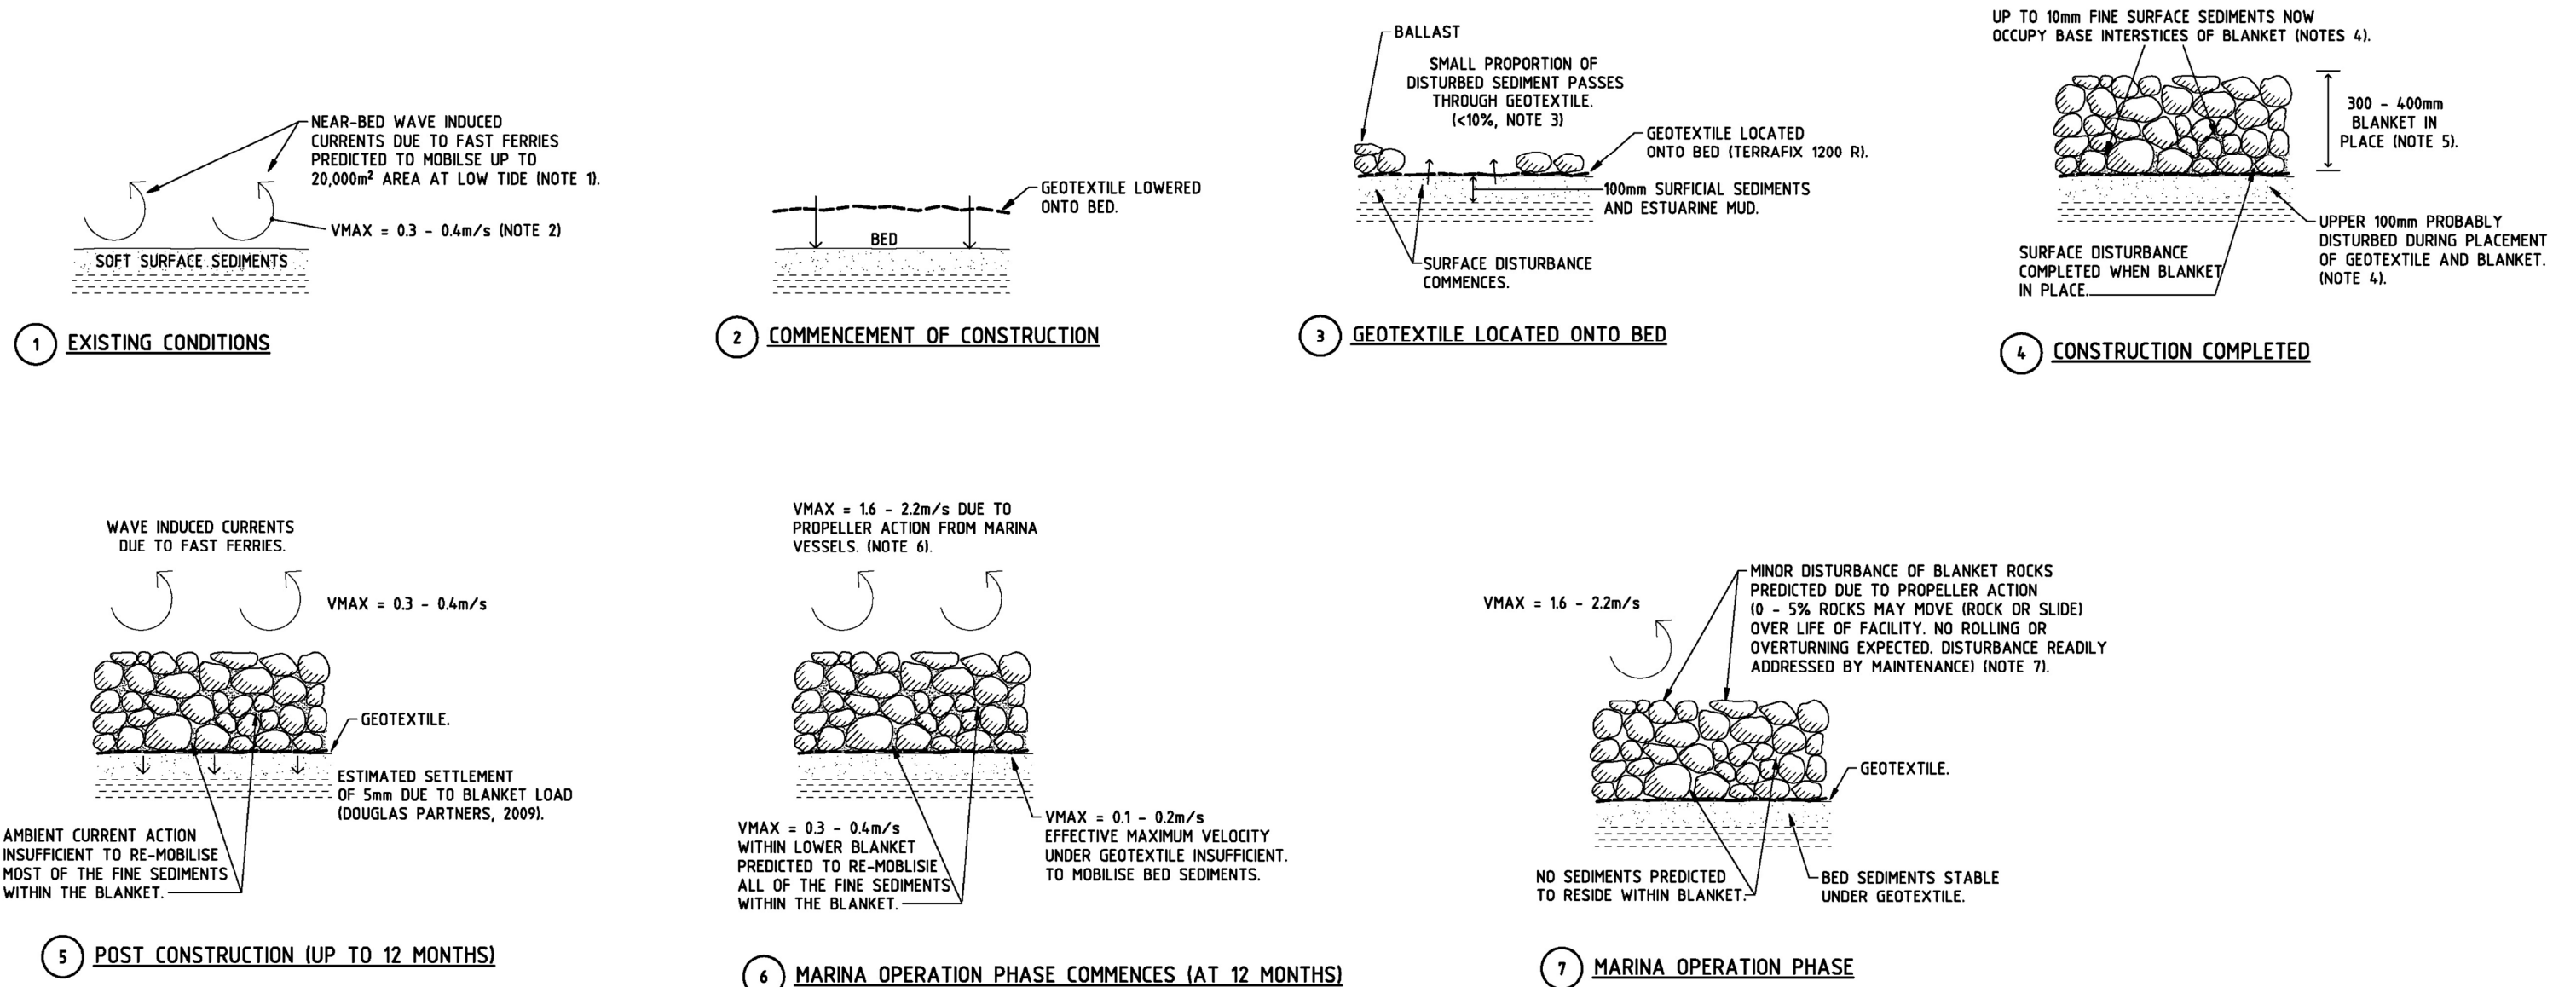
NOTE 1. 19,100m² AREA LOCATED IN DEPTHS <2.8m FOR SWL=RL-0.5m AHD EXPOSED TO NEAR-BED VMAX >0.3m/s (REFER TO APPENDIX E).

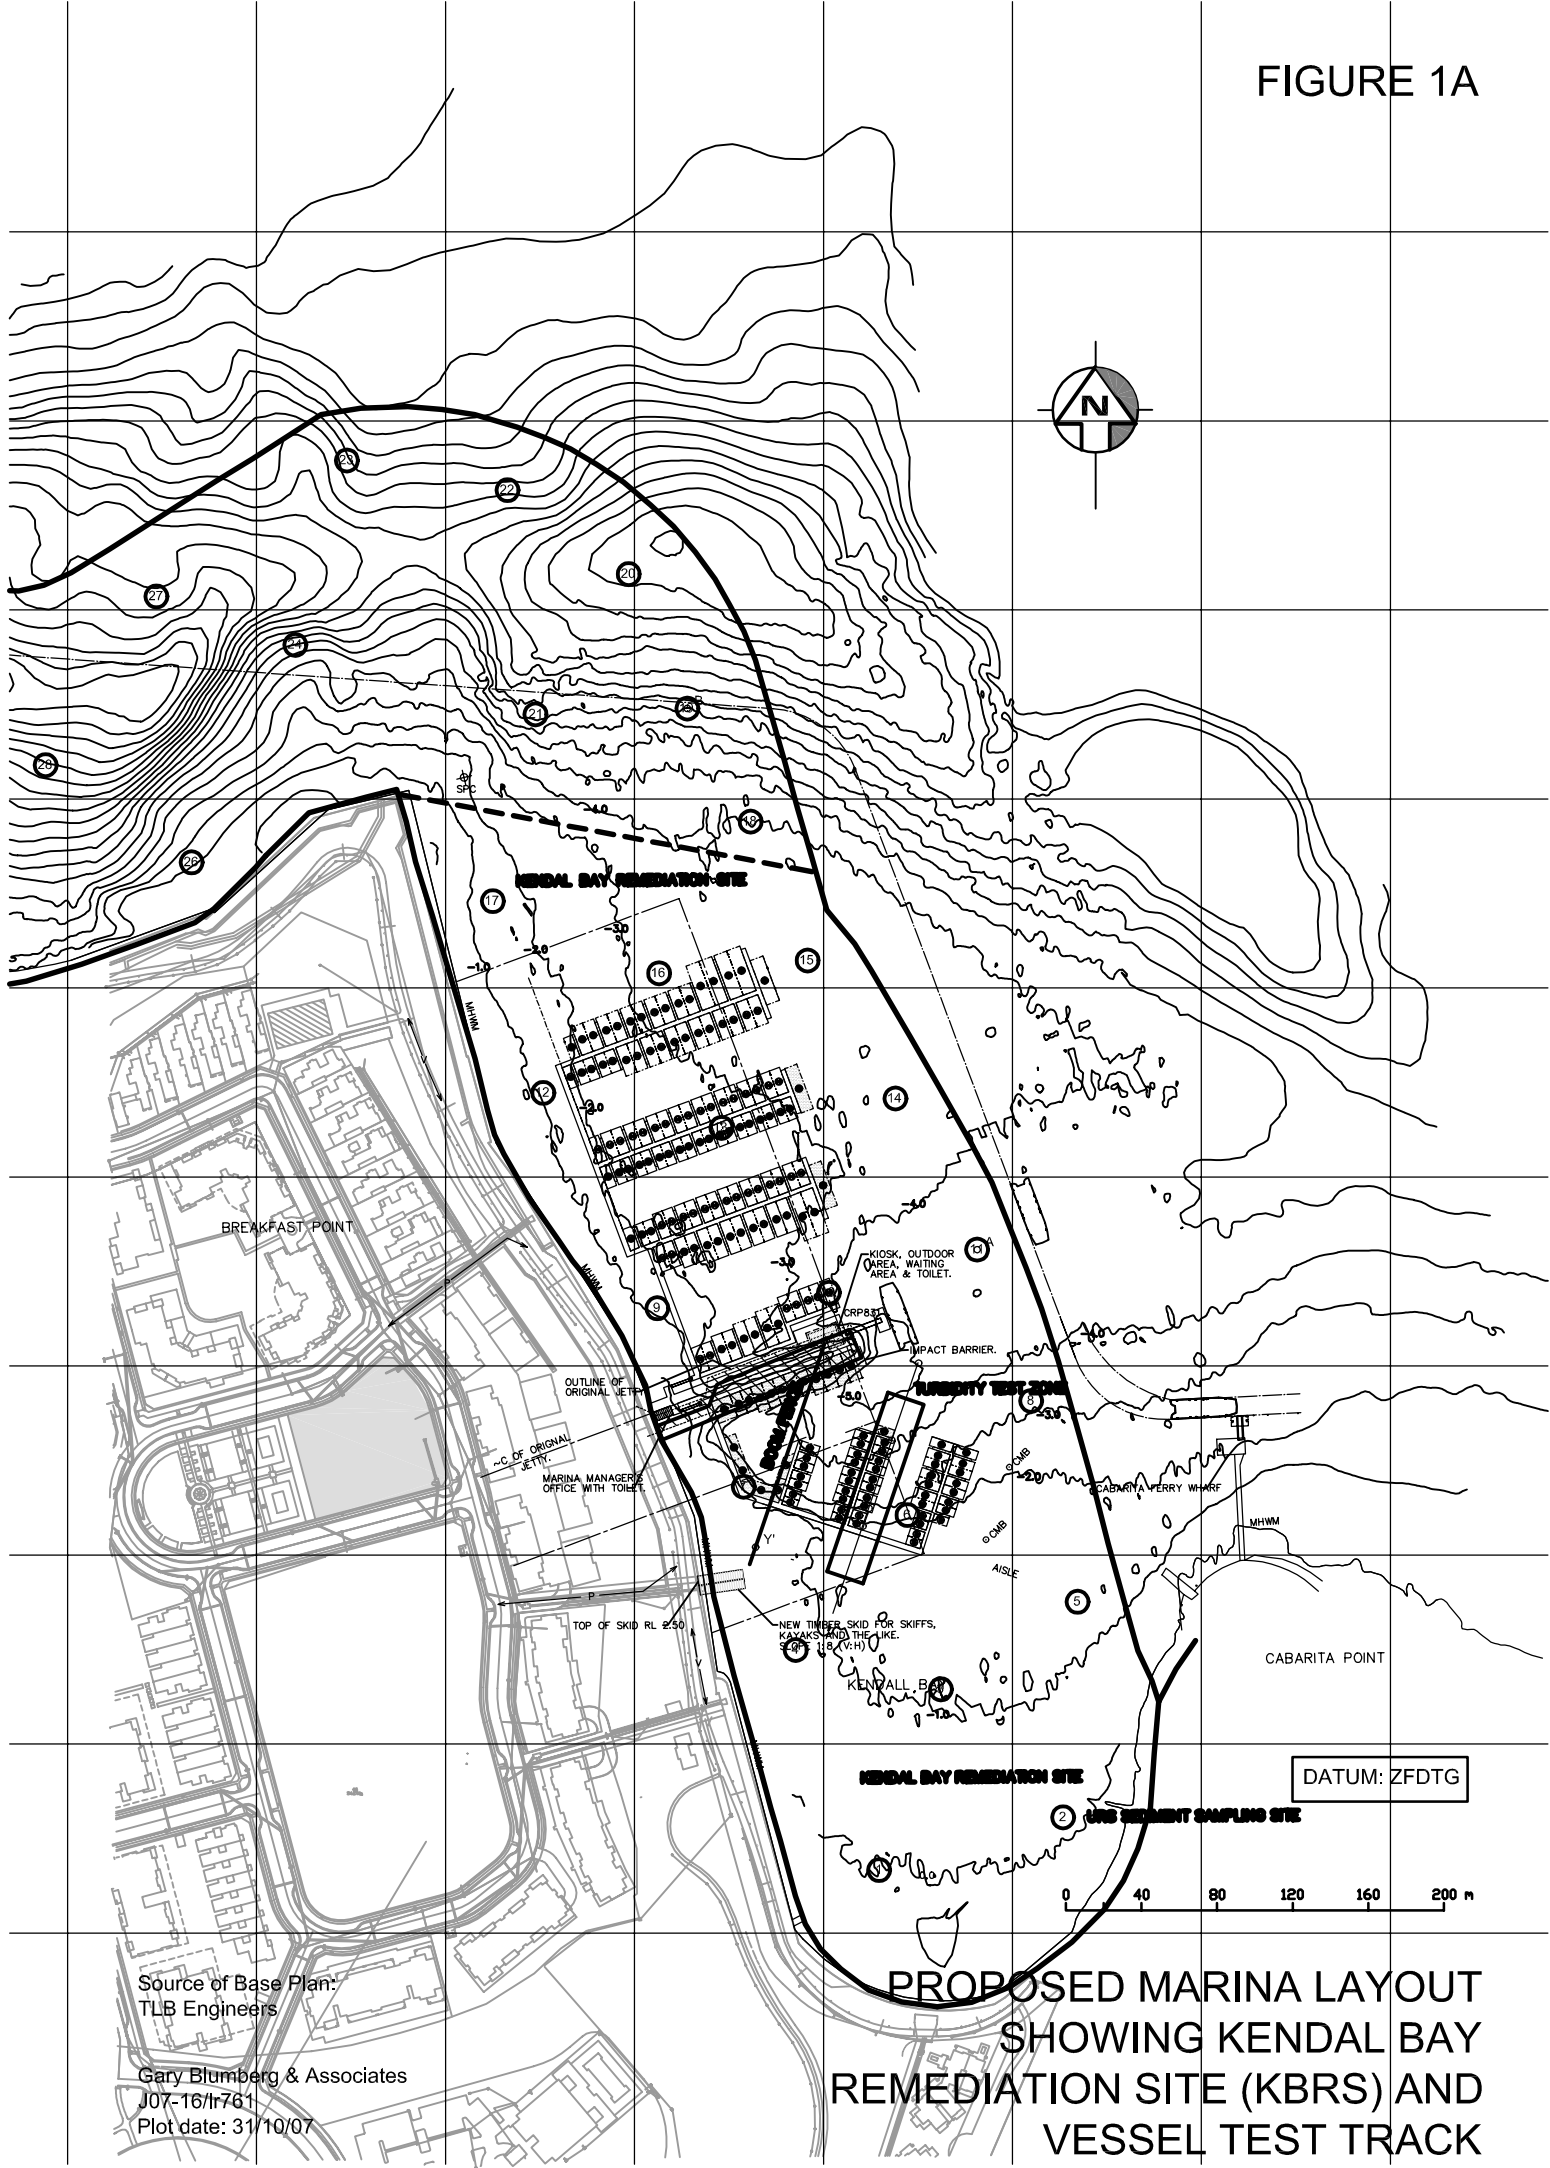
FIGURE 1A

**PROPOSED MARINA LAYOUT
SHOWING KENDAL BAY
REMEDICATION SITE (KBRS) AND
VESSEL TEST TRACK**

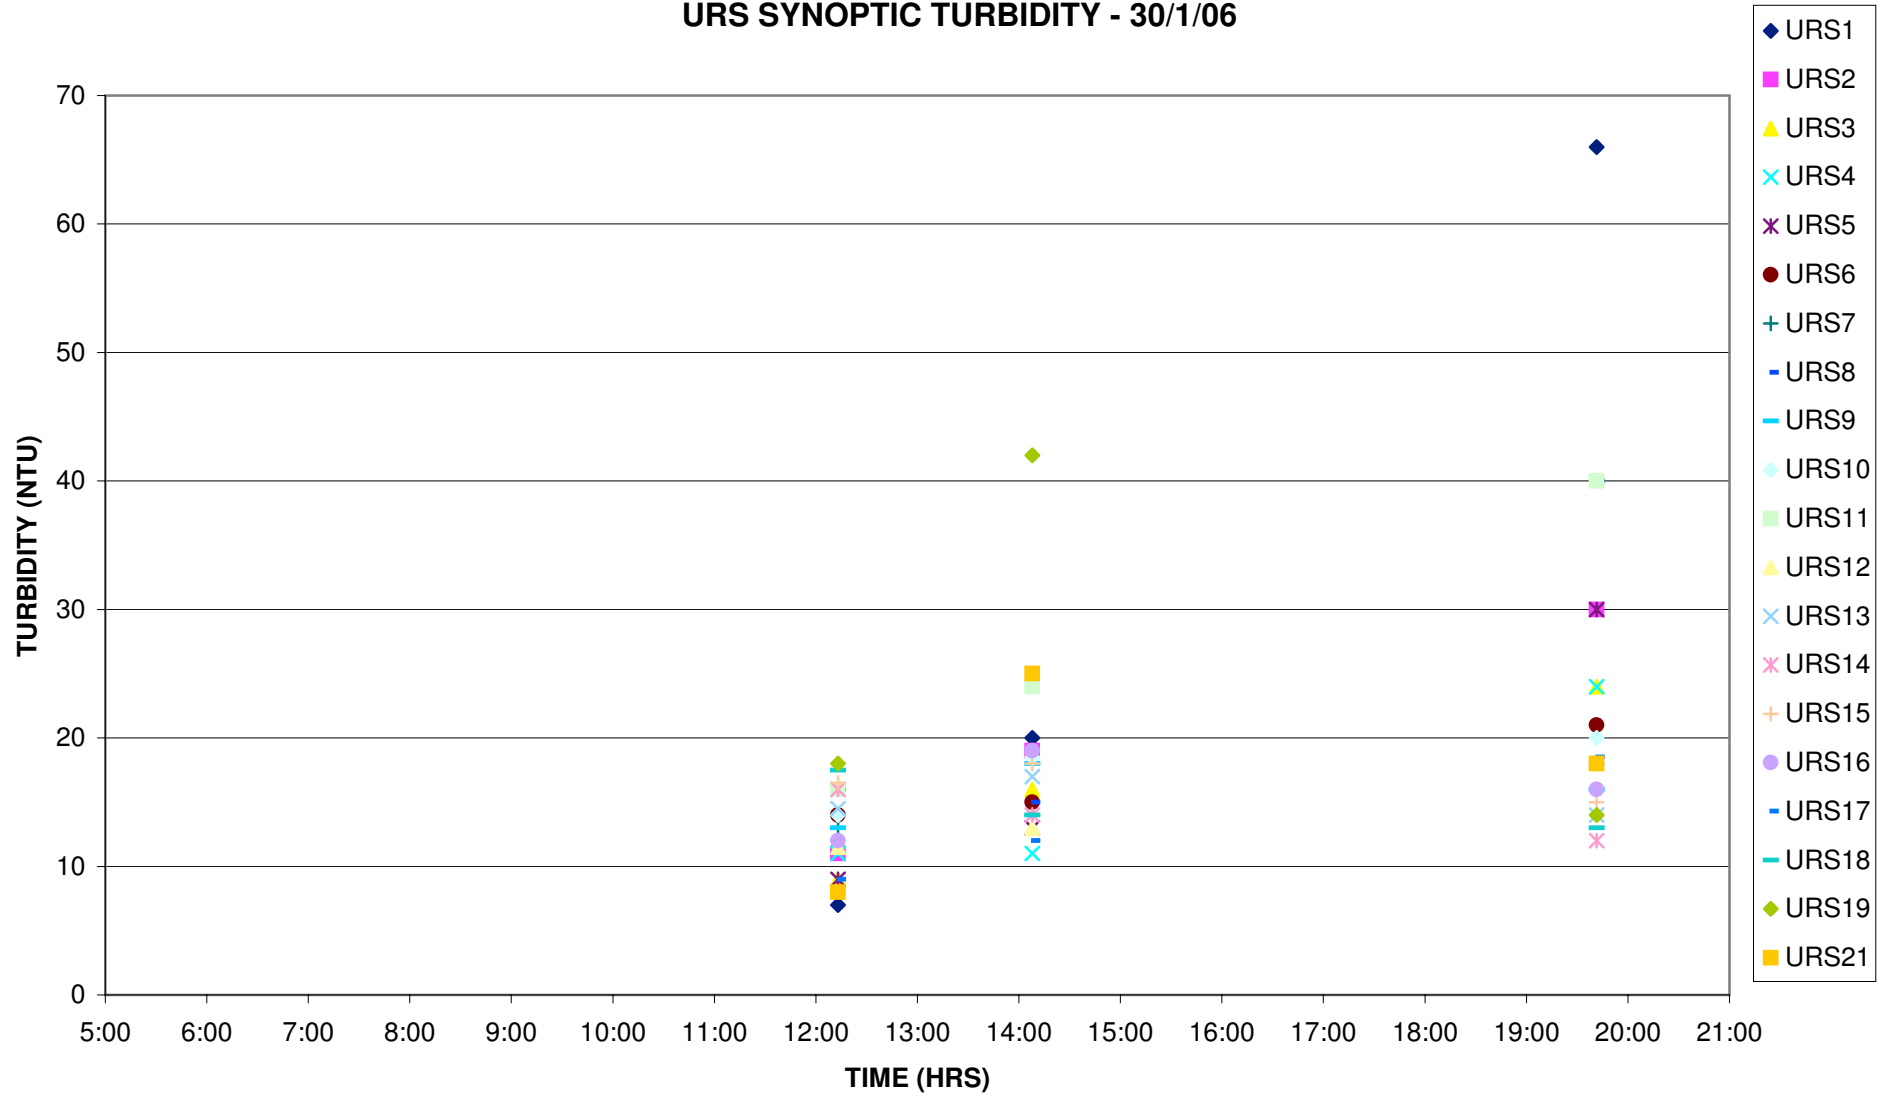
URS SYNOPTIC TURBIDITY - 30/1/06

URS used backscatterance (*proxy for turbidity*) and ADCP (*acoustic Doppler current profiling*) measurements to characterise potential sediment resuspension by tidal currents. They found a strong correlation between current velocity and turbidity during the ebb tide in the main channel off Kendall Bay. Here maximum tidal velocities of 0.7 m/s were recorded. Observing vertically uniform high turbidity through the water column, URS concluded that the source of the turbidity was advection from upstream rather than local resuspension. The strong tidal currents observed in the main channel do not extend to the shallow waters of Kendall Bay. URS determined that resuspension of surficial sediments due to tidal currents was unlikely in Kendall Bay due to the low current velocities (*URS, 2006*)

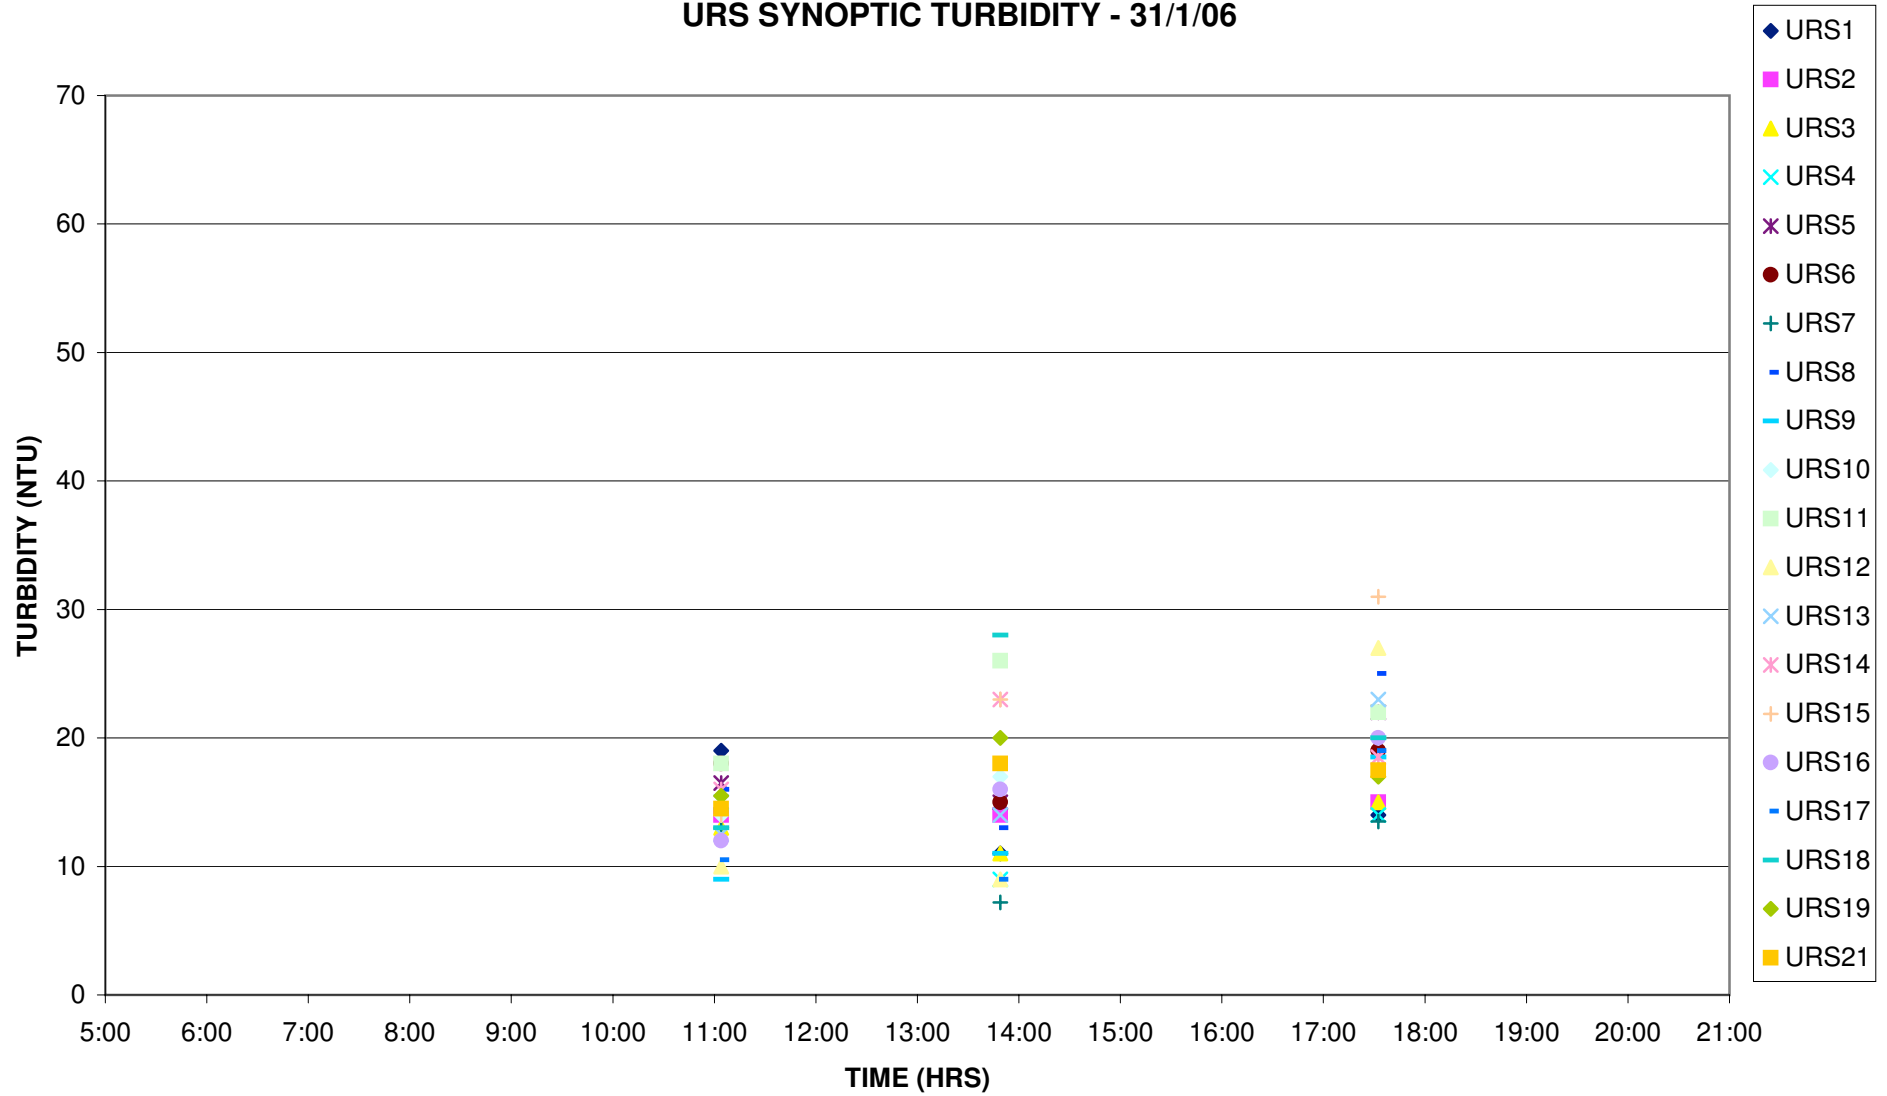
URS SYNOPTIC TURBIDITY - 31/1/06

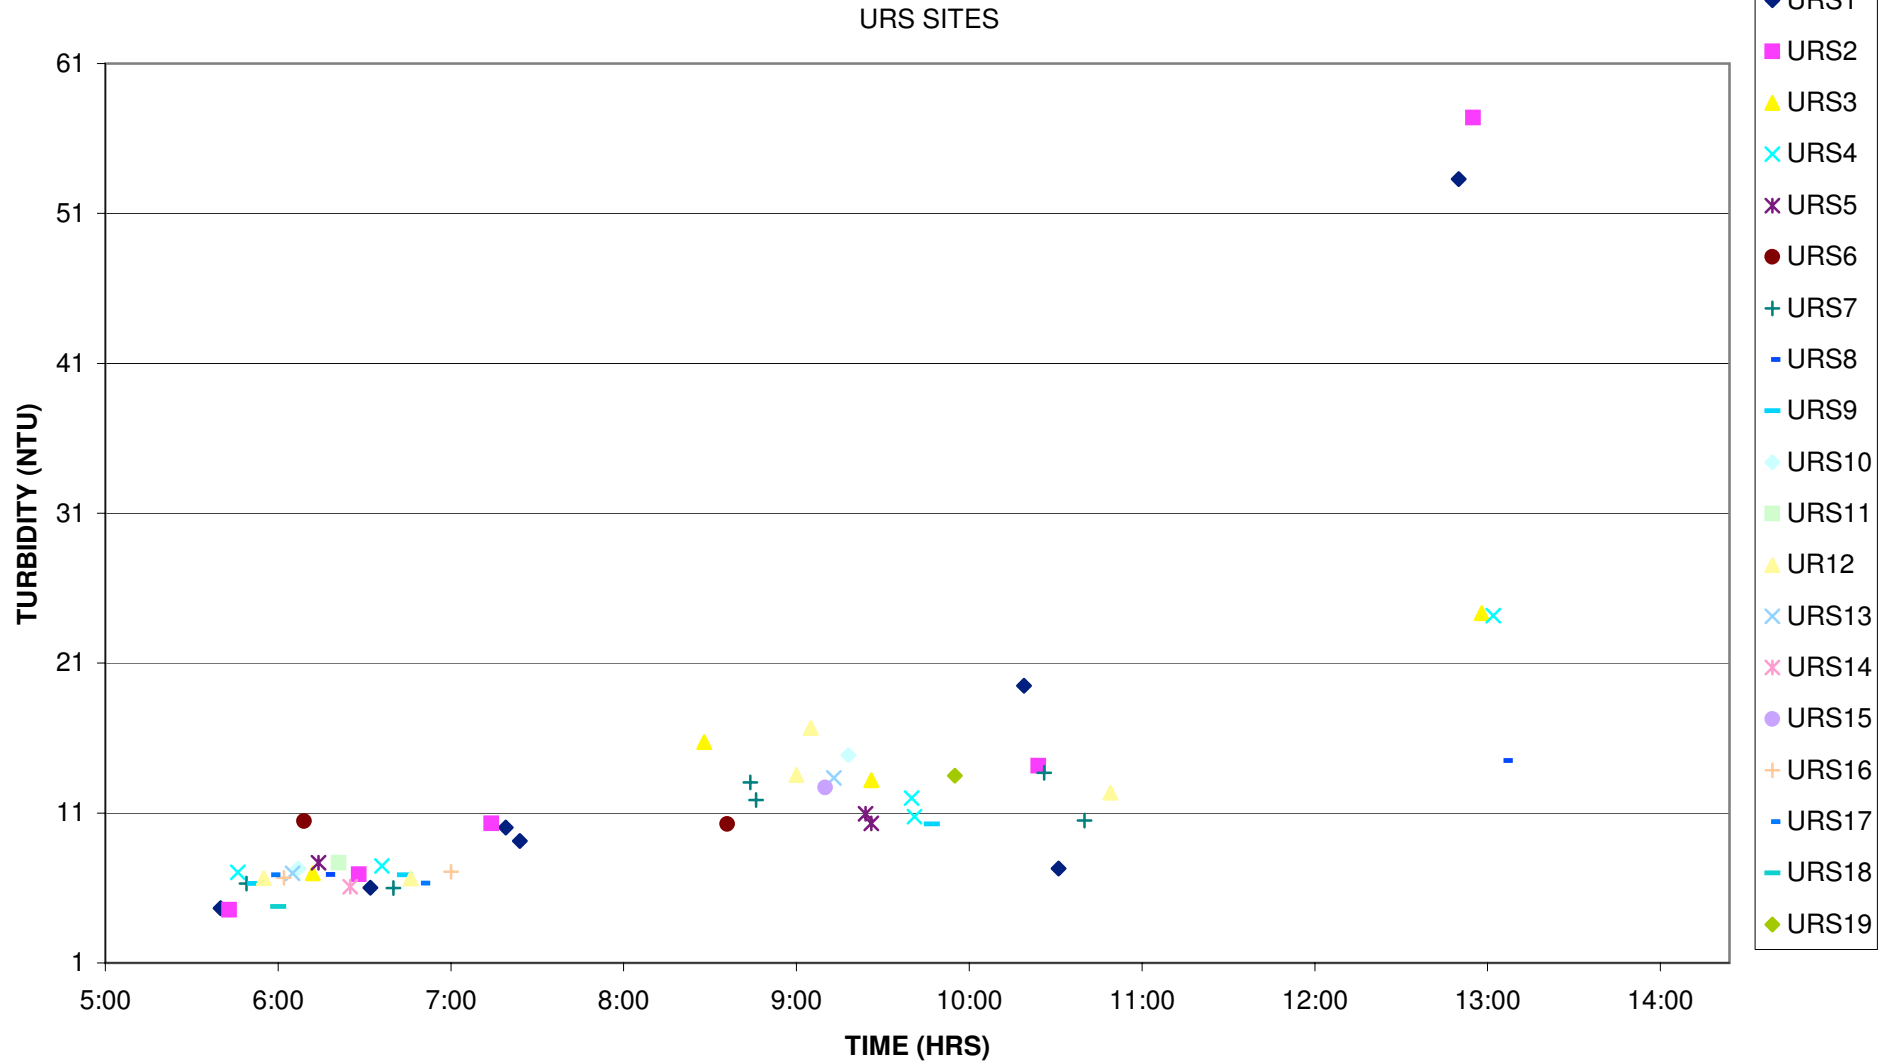
BACKGROUND TURBIDITY - 26/9/07

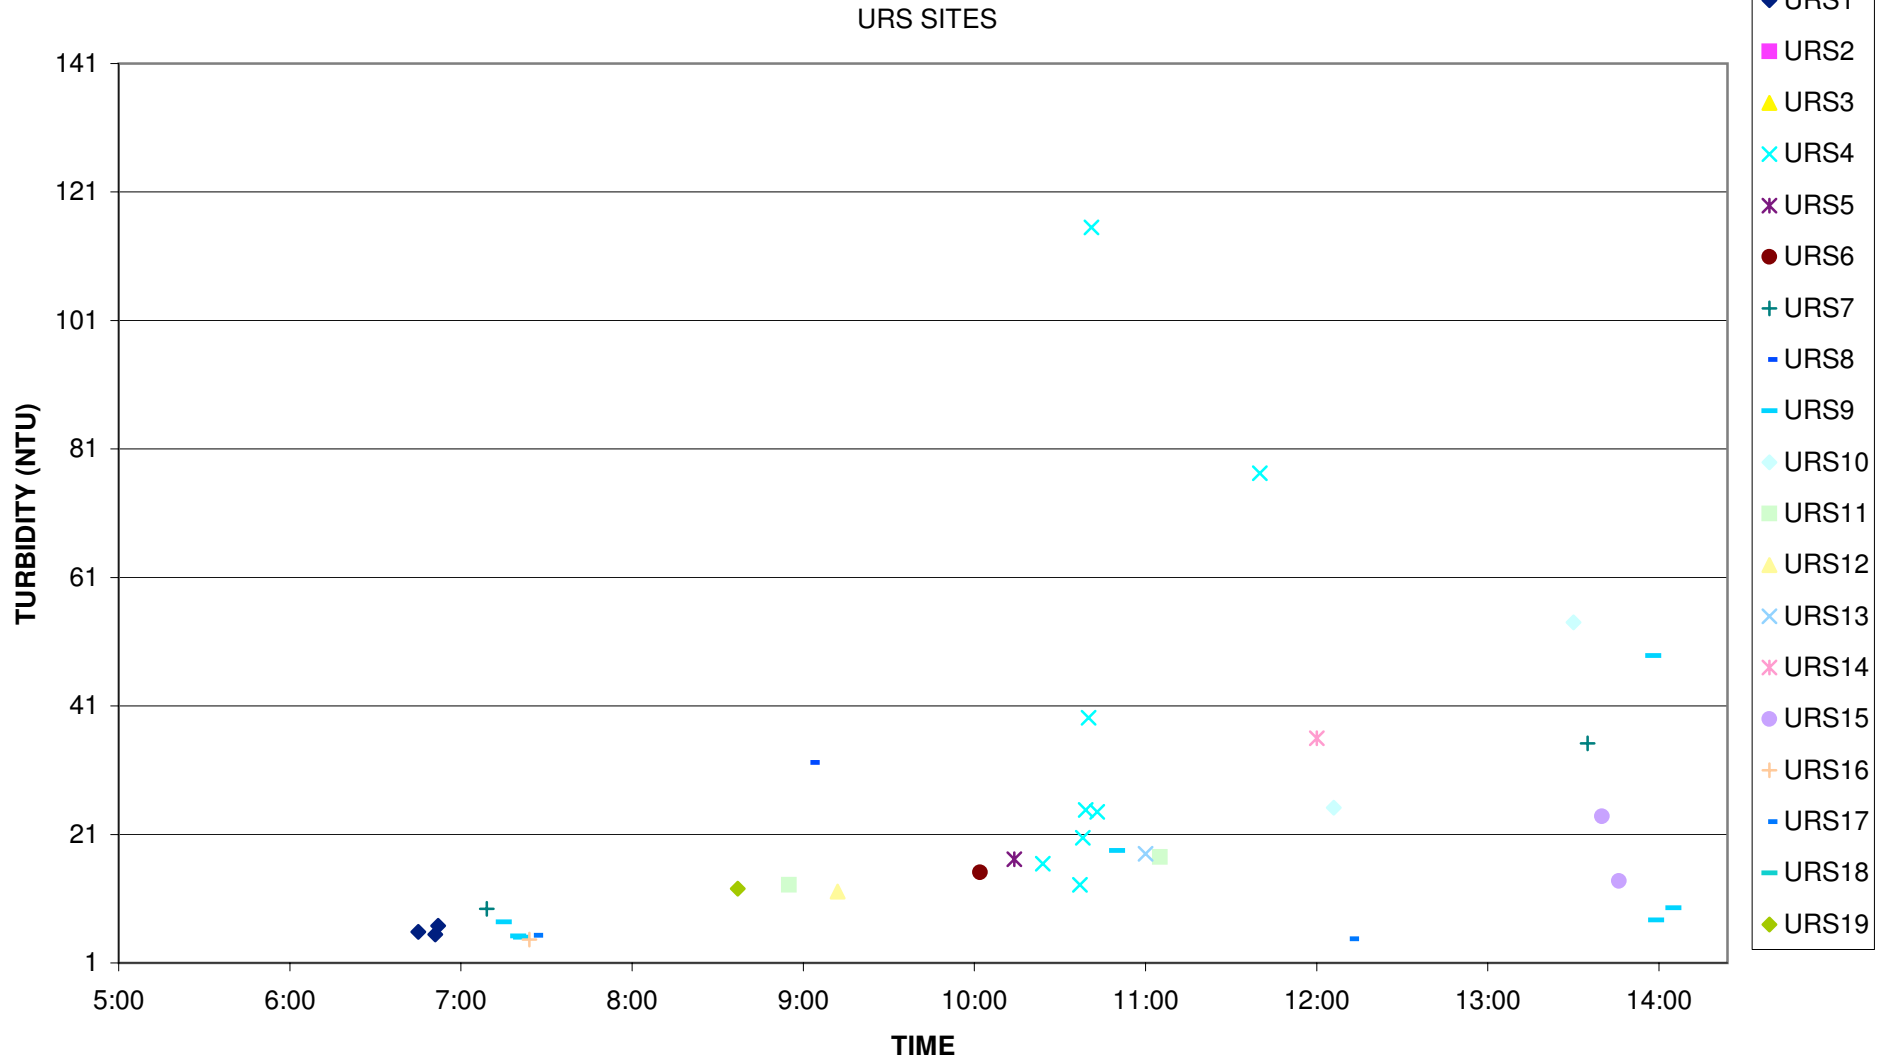
BACKGROUND TURBIDITY - 25/9/07
