Inner West Marina

Parramatta River, Sydney

ENVIRONMENTAL ASSESSMENT

Estuary Hydrodynamics and Physical Sedimentary Environment

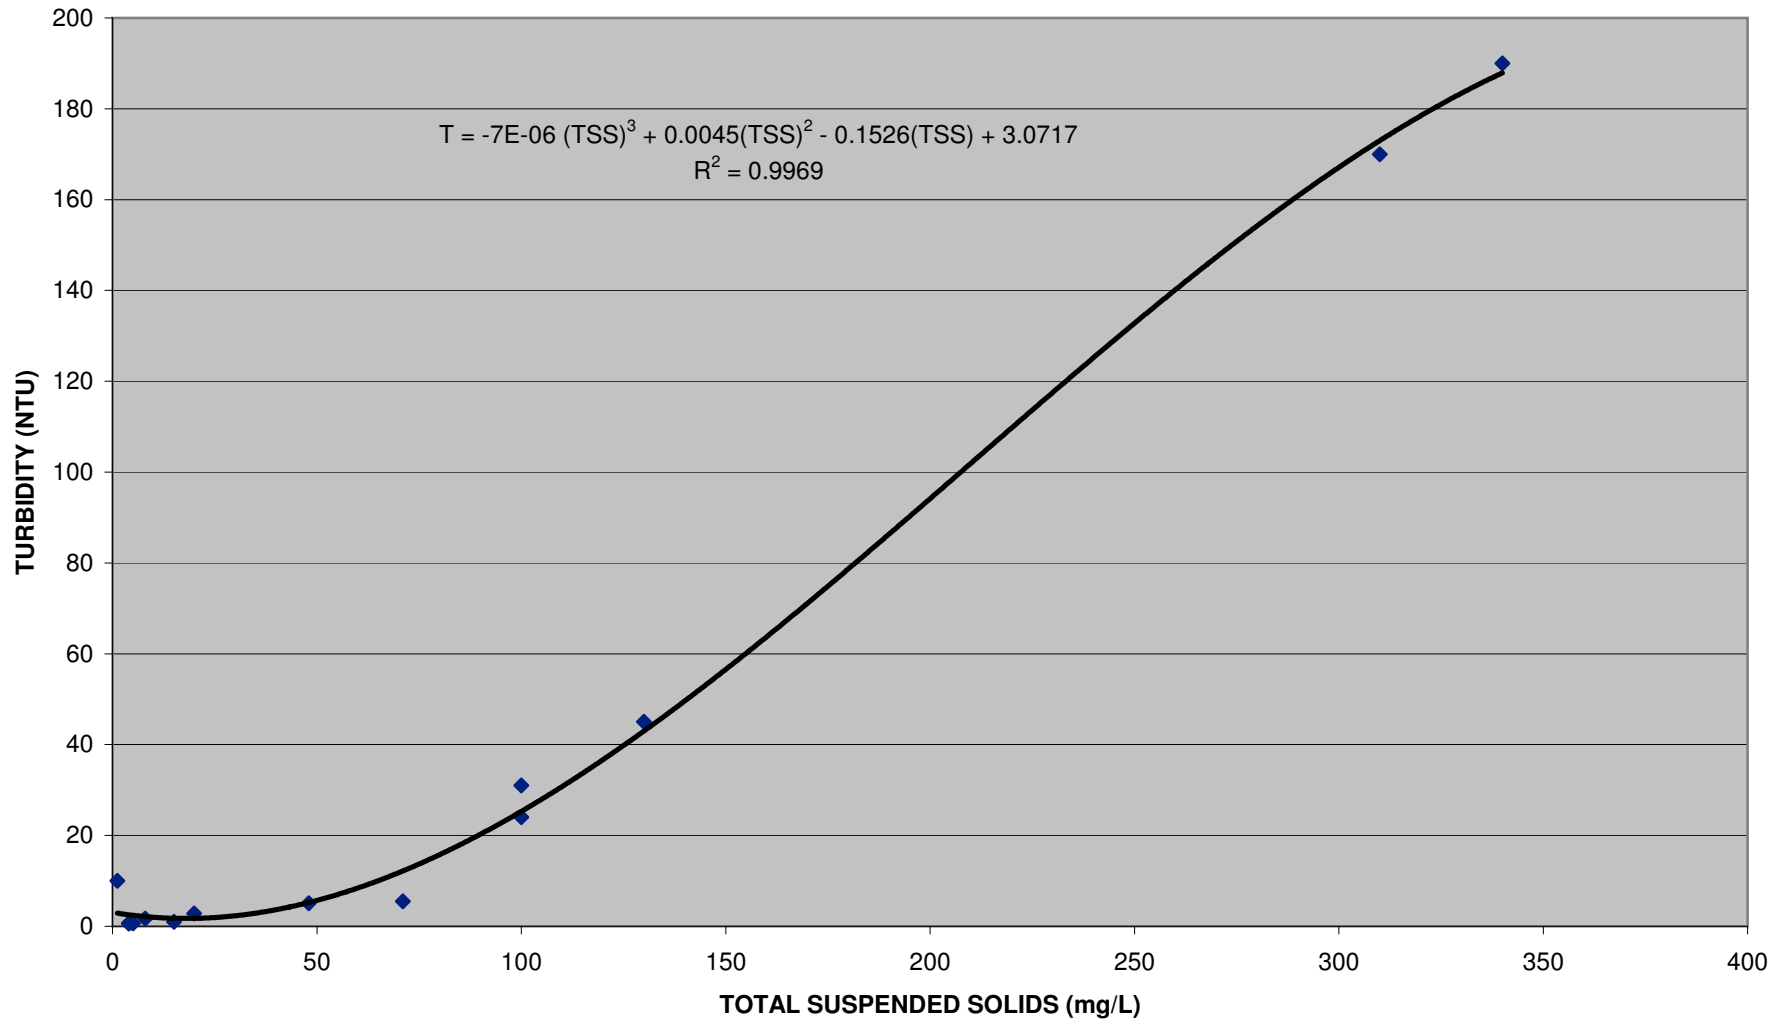
CORRELATION BETWEEN TURBIDITY AND TSS

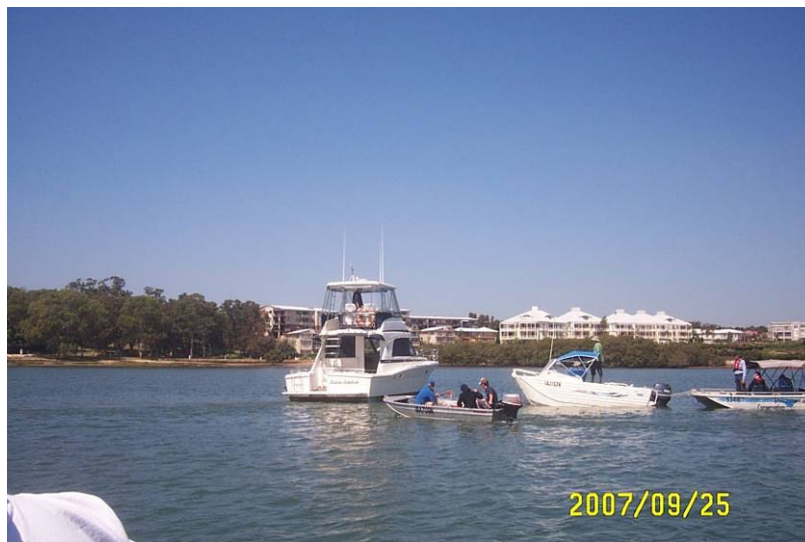
Erwin Benker and Peter Skeynes from DEC visited the site on Day 1 to observe the monitoring exercise (**Photo 2**).

TABLE 2		VESSELS USED FOR TURBIDITY INVESTIGATION			
Vessel Descriptor	Type / Name	Length	Draft	Machinery	% Boats in Marina which are the Same Size or Smaller
“Small” (Photos 2, 5 and 6)	Riviera Flybridge 37	11.3 m	1.0 m	Twin Cummins B370 diesel	20
“Medium” (Photos 9-15, 19, 21)	Riviera M430	14.3 m	0.8 m	300 hp Volvo Penta Turbo	71
“Large” (Photos 16 and 17)	MV Bennelong 80	24.4 m	2.0 – 2.2 m	2x220 hp Rolls Royce engines, 3:1 reduction; twin prop 1mØ approx	100

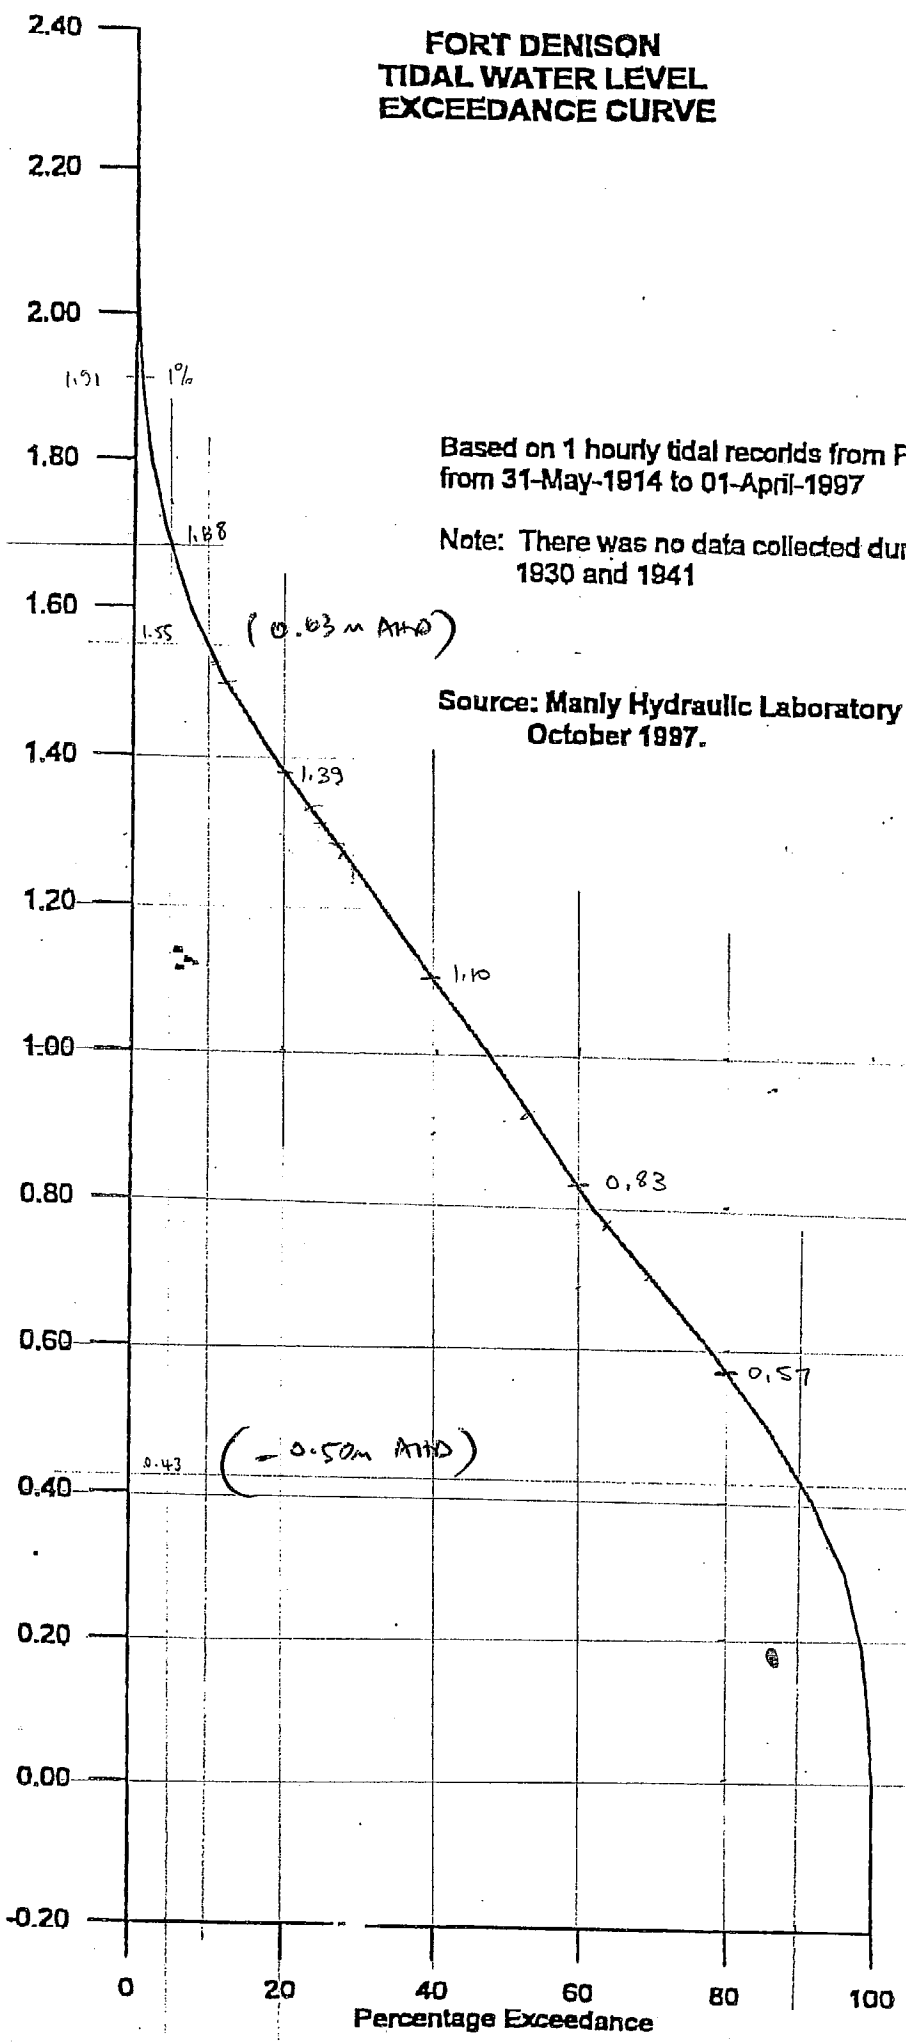
FORT DENISON TIDAL WATER LEVEL EXCEEDANCE CURVE

Tidal Level (Metres)
 Datum Zero of Fort Denison Tide Gauge

Based on 1 hourly tidal records from Fort Denison from 31-May-1914 to 01-April-1997

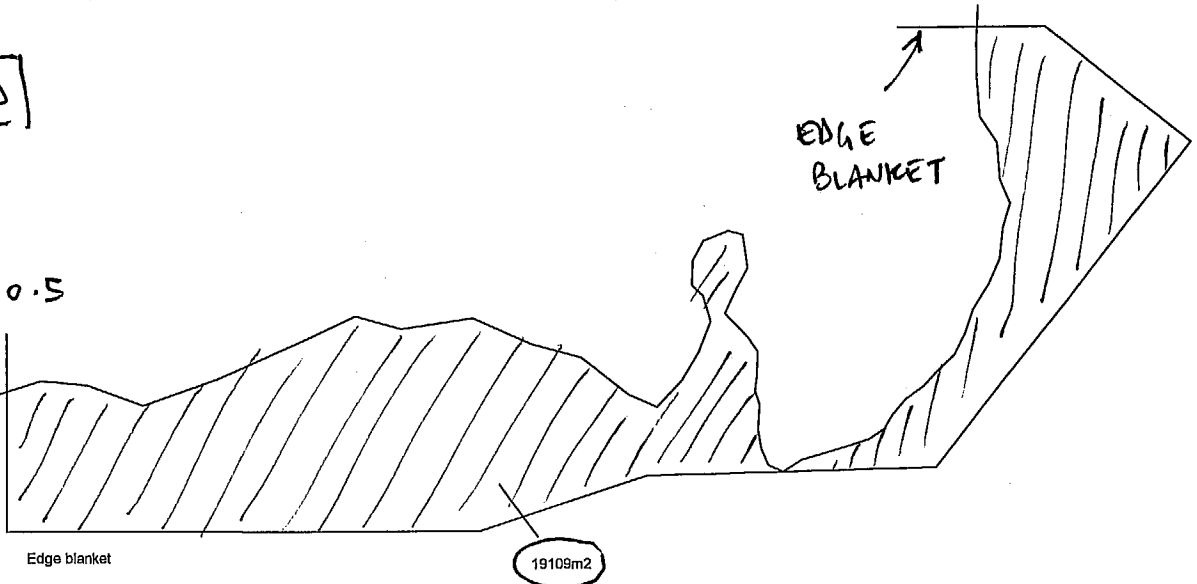
$4971 + 3322 = 8293 m^2$
 Every time a fast ferry passes
 at $WL = RL + 0.5$ AHD, $8293 m^2$ within
 the footprint of the proposed blanket
 would be stirred by wave induced
 currents $\geq 0.3 m/s$

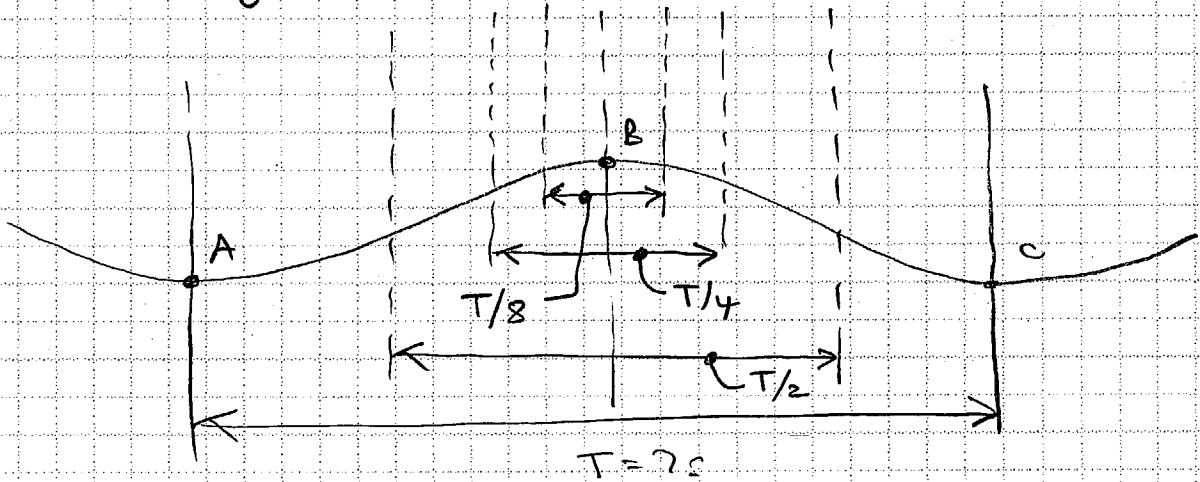
$|u_{max}|$ occurs under crests and troughs (A, B, C...)

It would be reasonable to assume that $|u_{max}|$ lasts for $T/8$ per wave passing. While u_{max} is theoretically an instantaneous measure, it would not change appreciably close to the crest and close to the trough.
