MJT:jlb
 Project 71235
 25 June 2009

**MARINA AT BREAKFAST POINT
 CONSOLIDATION SETTLEMENT AND WATER FLOW**

The Nerang River Training wall project was the first time **Australian made** thick nonwoven needlepunched geotextiles (**ELCOMAX[®]**) was installed on the Australian continent. Over 75000 m² of **ELCOMAX[®] 1200R** was used to replace a granular filter layer in a hostile marine environment. 2.5 to 5.0 tonne armour rock was placed directly onto the geotextile, which needed to be sufficiently robust to resist damage thereby ensuring long-term filter stability.

Use of geotextiles to overcome challenging conditions at the seawall project in Port of Brisbane

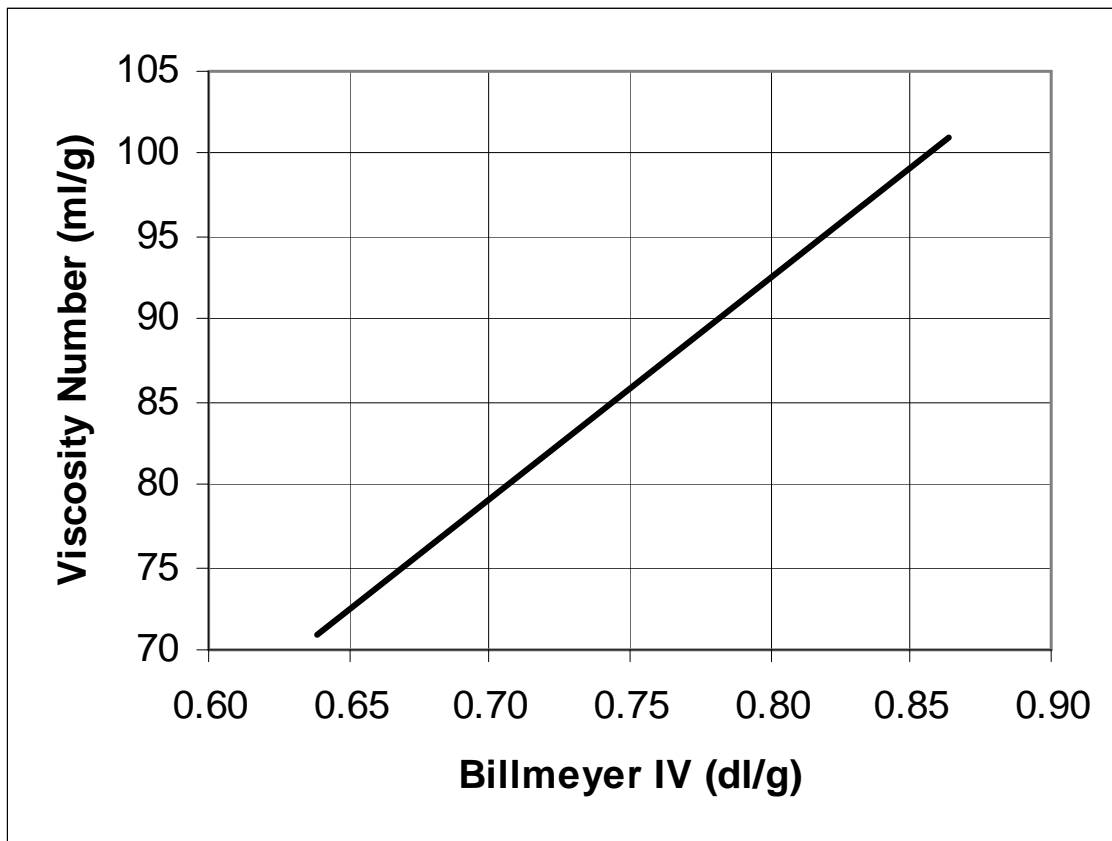
The following graph shows the trend of VN versus IV for PET, as calculated from this empirical correlation.

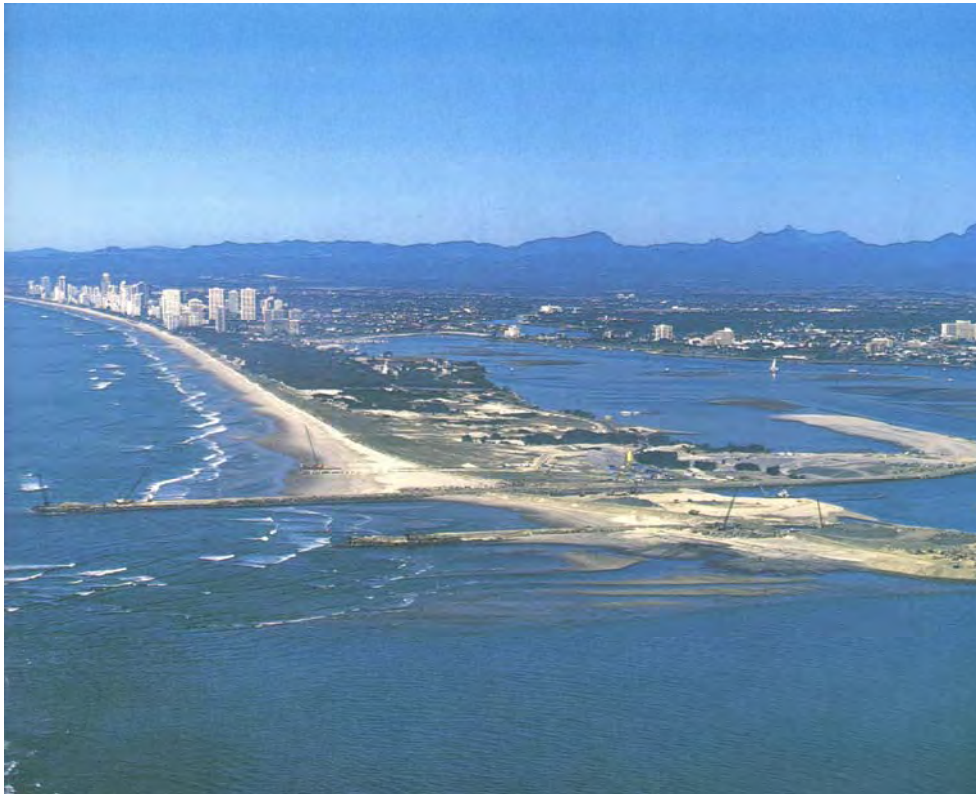
Training walls under construction 1985

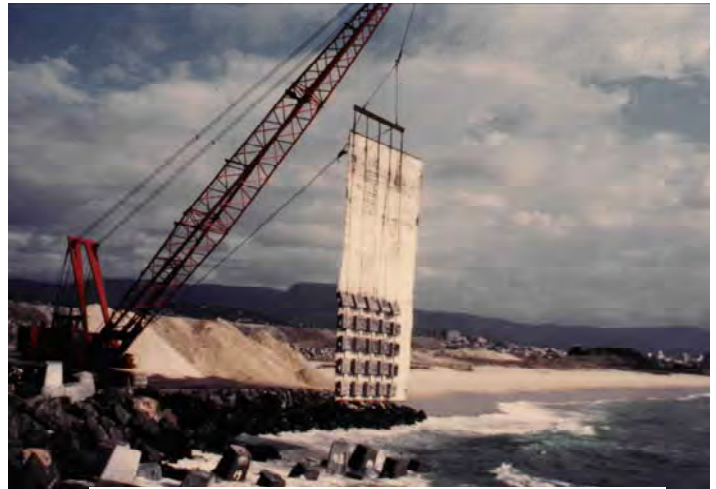
Installation of ELCOMAX® 1200R

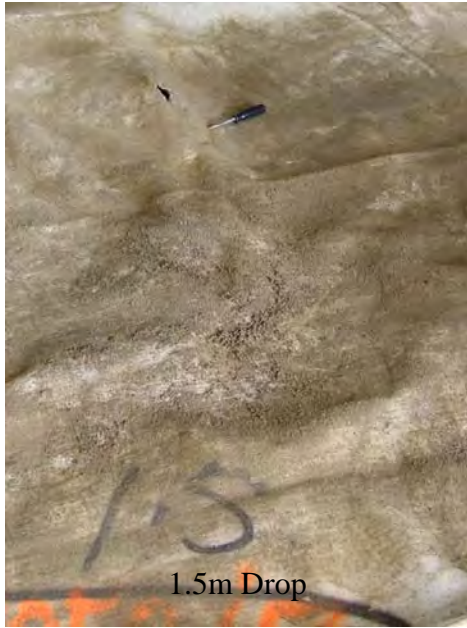
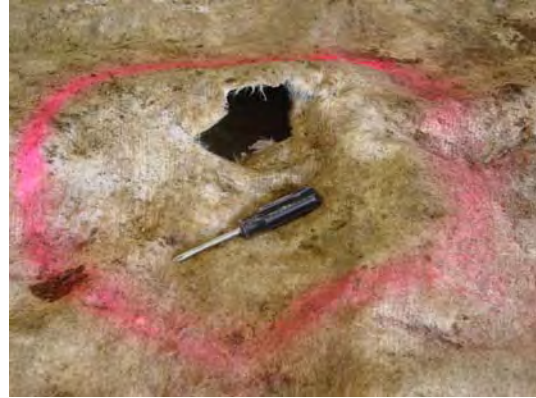
The 1050g/m² product was damaged during 1.5 and 3m drops, see examples below.

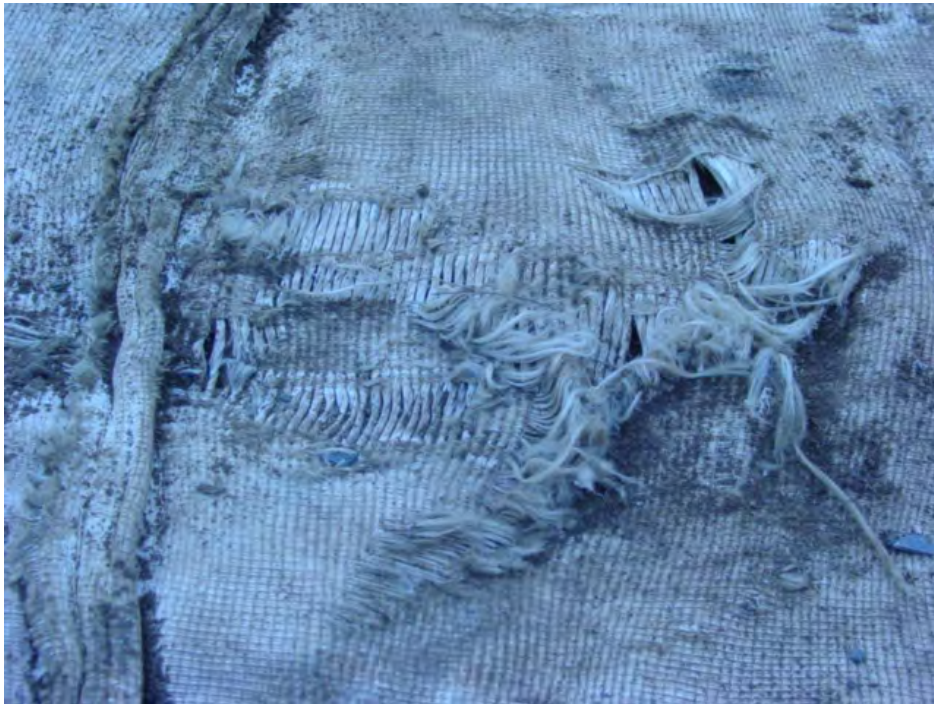
800Kn x 100kN woven geotextile – 1.5m drop height

An important factor to note when designing for survivability is that strength alone is not a good indication of survivability, the combination of strength, mass and elongation determines the survivability of the geotextile. For example the survivability of high strength low elongation geotextiles were analysed during the tests above and a 800kN x 100kN product with an elongation of <15% was severely damaged during 1.5m and 3m drops.

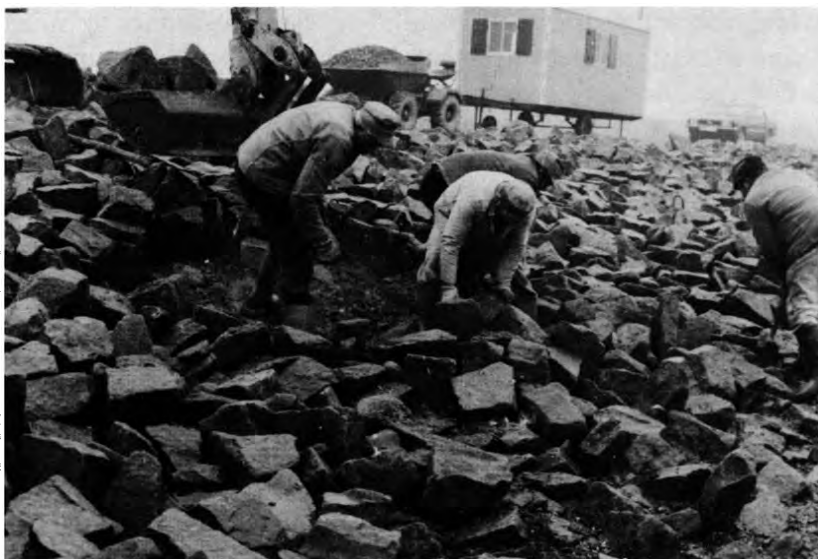
Fig. 5. Sampling operations at the seadike revetment.

Figure 5 gives an impression of the sampling operation on a seadike

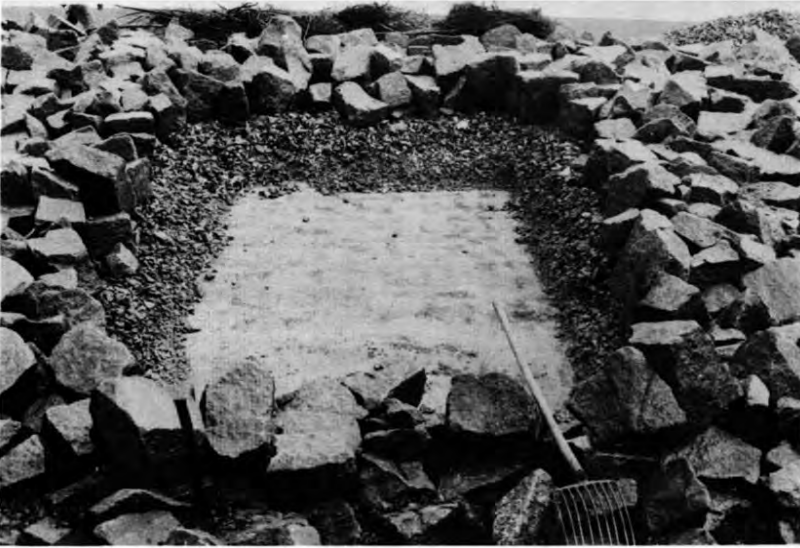
Fig. 6. Needle-punched nonwoven fabric after removing the revetment cover layers.

Additional investigations led to the conviction that the sand and mud particles in the coarse layers came mostly from the sea side of the construction and not from the bottom side. Some significant profile changes with a flatter slope of some revetment sections were perhaps caused by soil-liquefaction under wave impact but certainly not by a soil washout through the filter-fabrics.

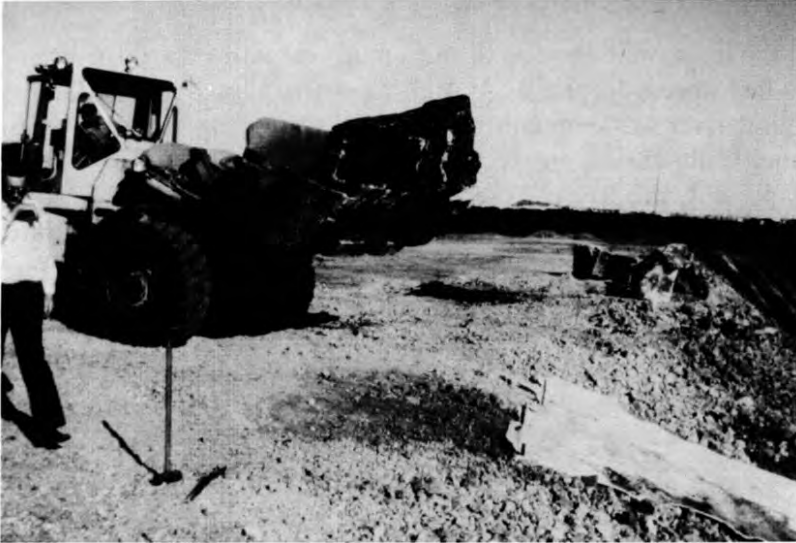
Fig. 13. Port Kembla Seawall, Australia: field tests on geotextile penetration resistance.

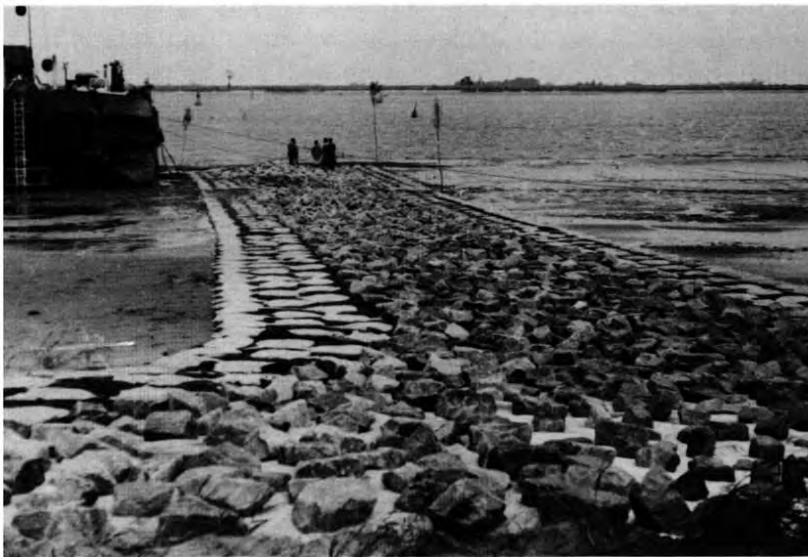
Fig. 16. Groin at the River Weser: under construction at tidal low water.

Figure 16 shows a groin under construction. The nonwoven geotextile and the scour protection mattress are installed. The geotextile is fixed on the seabed by a first layer of stones. The special concrete vessel is still anchoring after ballasting the mat at the site.

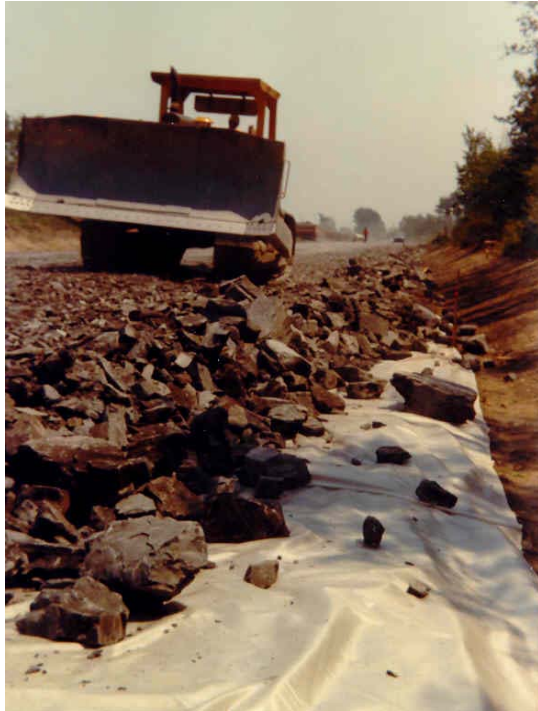
Figure-2: Photograph of attacked geotextile by aggressive cover soil

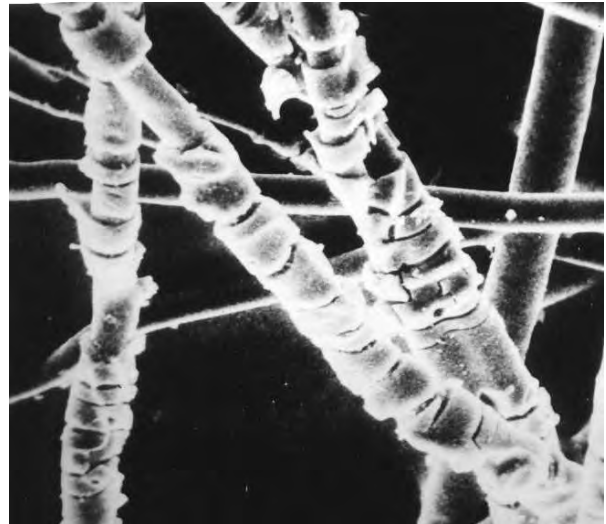
Figure-3 : Photograph of attacked geotextile by UV

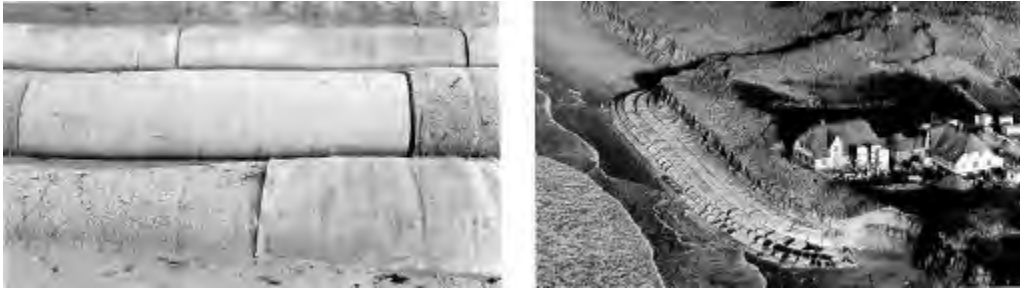
Figure 3: Protection of an artificial dune near Kampen (Island of Sylt, Germany) by a light geotextile revetment

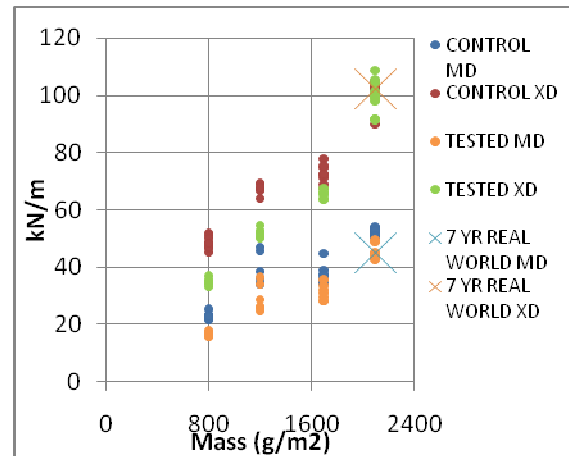
total damage to the product. In reviewing these results it is important to remember that the geotextile is damaged in two manners and as such we have taken the various forms of abrasion and the damage caused by sunlight exposure to be approximately equal in magnitude (that is any damage is attributed equally to UV and abrasion damage). The results from the various tests are shown below;

The results (above) show that the geotextile is damaged approximately equally in terms of strength loss when comparing a 7 year exposed product and the rotating drum test. There is however a larger degree of elongation loss which is largely attributed to the way ultraviolet light damages the polymers of the geotextile. The conditions of the 'real world' test are some of the most extreme a geotextile is likely to be placed and would it would be realistic to say that at least half of the damage was UV related. As a consequence it is reasonable to suggest that a geotextile subject to high levels of abrasion exclusively should be able match the rotating drum results after fifteen years and remain serviceable well after that.

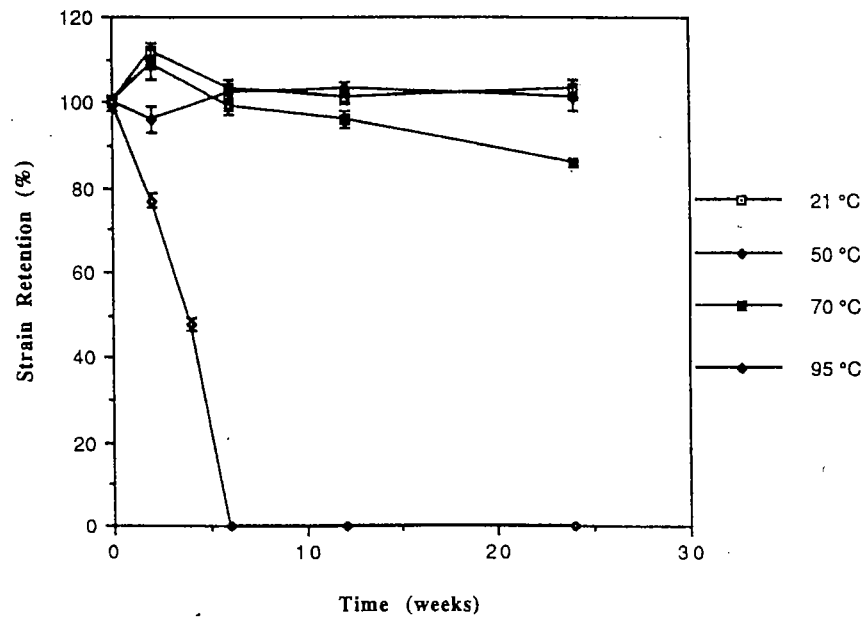
Fig. 5. Effect of pH 10 on PET/GT strain.
