**GEOTECHNICAL INVESTIGATION REPORT**

PROPOSED WOLLONGONG PRIVATE HOSPITAL  
360 – 364 CROWN STREET, WOLLONGONG NSW  
AA CROWN HOLDINGS PTY LTD  
REPORT ID: G10002TPG-R01F

**Date:** 29 March 2010

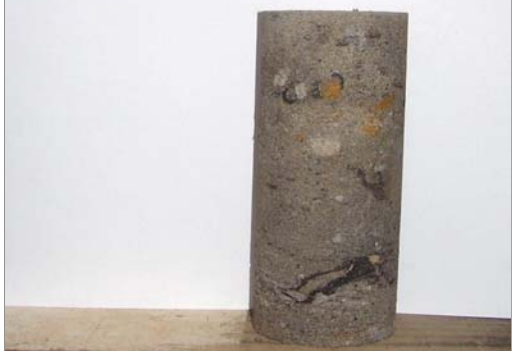
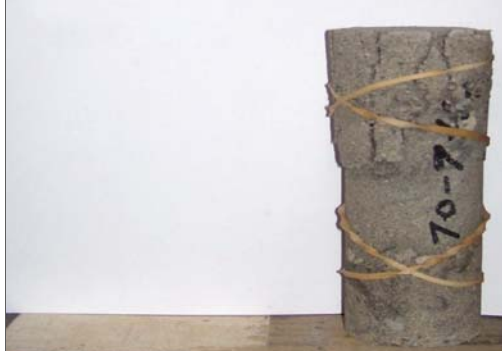
**BH 1**  
**7.0-7.16m**

GEE  
Wollongong Private Hospital  
Unconfined Compressive Strength  
Test Sample

GEE  
Wollongong Private Hospital  
Unconfined Compressive Strength  
After Test Sample

**U.C.S. (MPa) = 6.1**

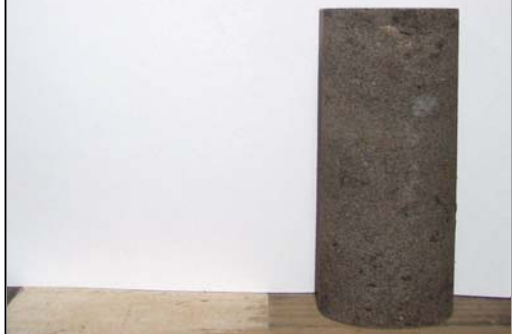
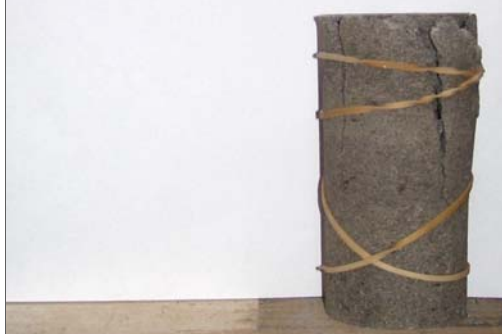
**BH 1**  
**11.0-11.16m**

GEE  
Wollongong Private Hospital  
Unconfined Compressive Strength  
Test Sample

GEE  
Wollongong Private Hospital  
Unconfined Compressive Strength  
After Test Sample

**U.C.S. (MPa) = 11.7**

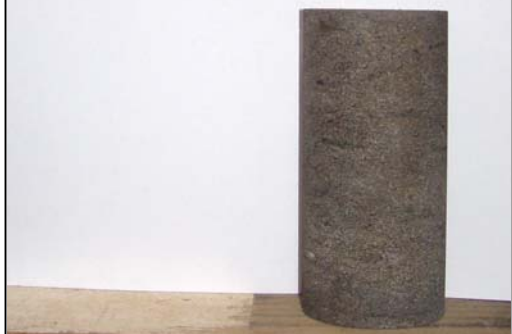
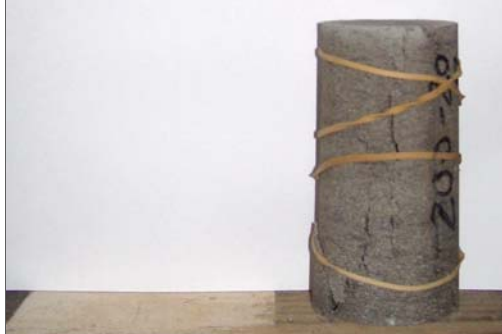
**BH 1**  
**20.0-20.17m**

GEE  
Wollongong Private Hospital  
Unconfined Compressive Strength  
Test Sample

GEE  
Wollongong Private Hospital  
Unconfined Compressive Strength  
After Test Sample

**U.C.S. (MPa) = 20.3**

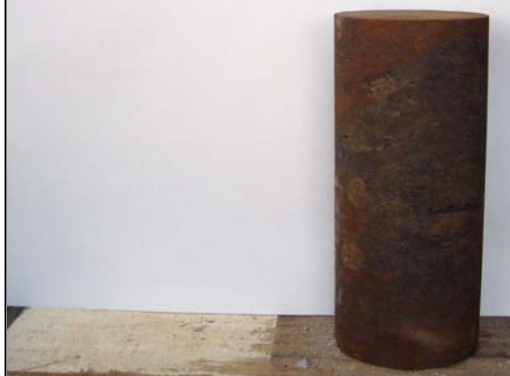
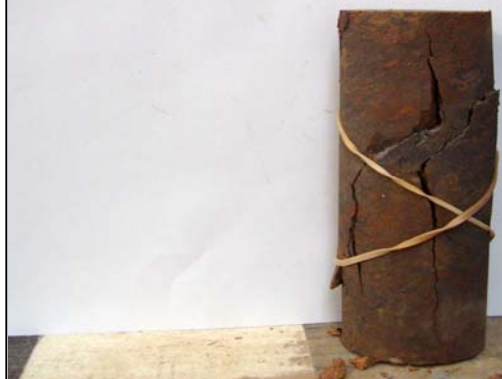
**BH 2**  
**6.28-6.48m**

GEE  
Wollongong Private Hospital  
Unconfined Compressive Strength  
Test Sample

GEE  
Wollongong Private Hospital  
Unconfined Compressive Strength  
After Test Sample

**U.C.S. (MPa) = 28.2**

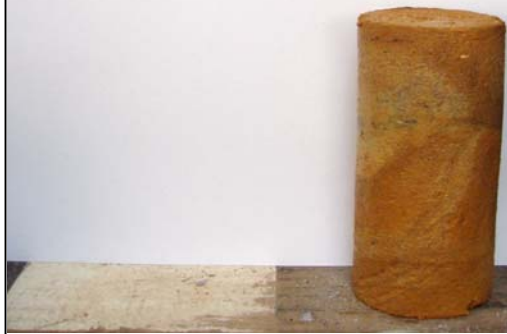
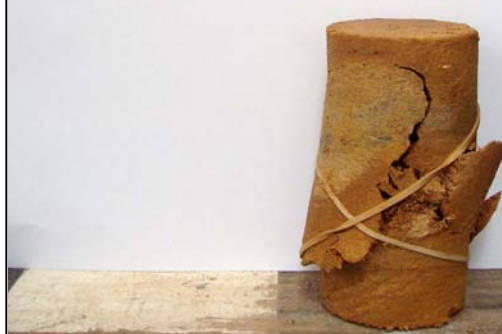
**BH 2**  
**9.05-9.19m**

**GEE**  
**Wollongong Private Hospital**  
**Unconfined Compressive Strength**  
**Test Sample**

**GEE**  
**Wollongong Private Hospital**  
**Unconfined Compressive Strength**  
**After Test Sample**

**U.C.S. (MPa) = 0.1**

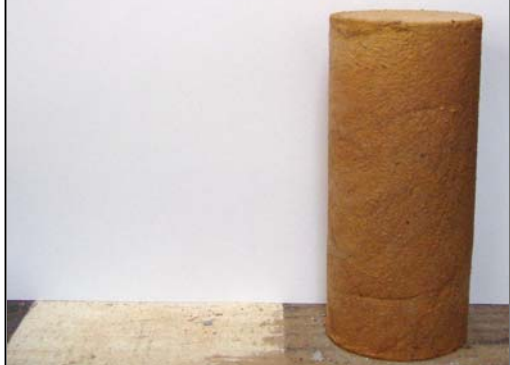
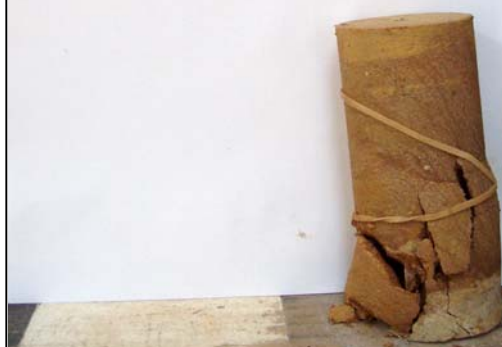
**BH 2**  
**13.27-13.42m**

GEE  
Wollongong Private Hospital  
Unconfined Compressive Strength  
Test Sample

GEE  
Wollongong Private Hospital  
Unconfined Compressive Strength  
After Test Sample

U.C.S. (MPa) = 2.0

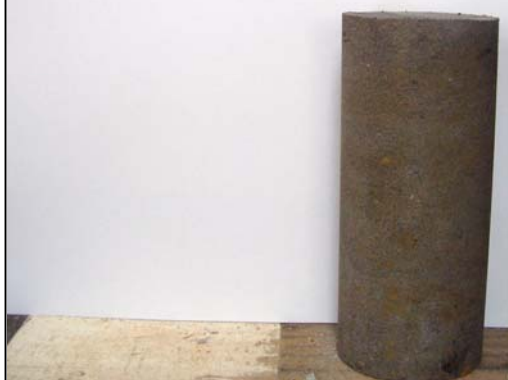
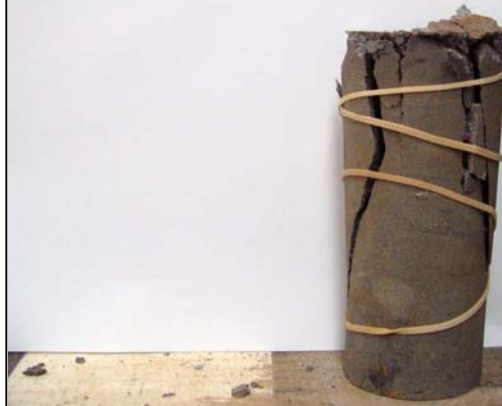
**BH 2**  
**19.00-19.22m**

GEE  
Wollongong Private Hospital  
Unconfined Compressive Strength  
Test Sample

GEE  
Wollongong Private Hospital  
Unconfined Compressive Strength  
After Test Sample

**U.C.S. (MPa) = 19.8**

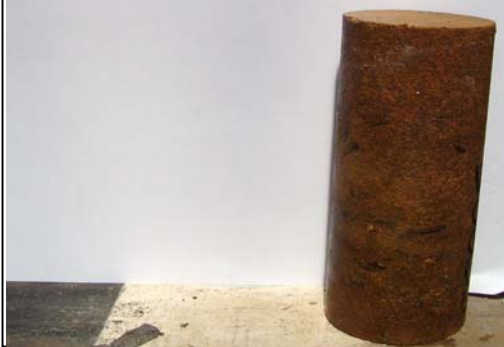
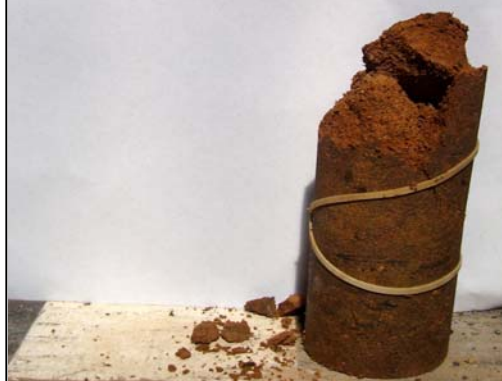
**BH 3**  
**3.5-3.72m**

GEE  
Wollongong Private Hospital  
Unconfined Compressive Strength  
Test Sample

GEE  
Wollongong Private Hospital  
Unconfined Compressive Strength  
After Test Sample

**U.C.S. (MPa) = 23.5**

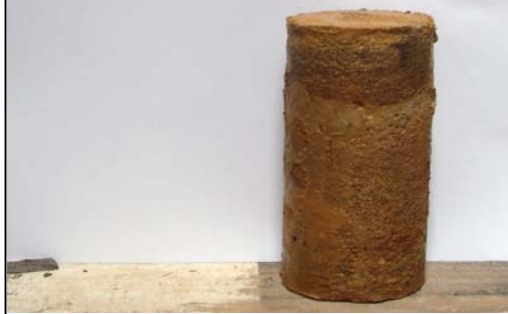
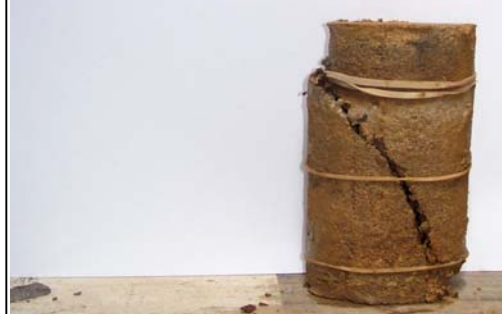
**BH 3**  
**5.0-5.20m**

GEE  
Wollongong Private Hospital  
Unconfined Compressive Strength  
Test Sample

GEE  
Wollongong Private Hospital  
Unconfined Compressive Strength  
After Test Sample

U.C.S. (MPa) = 0.5

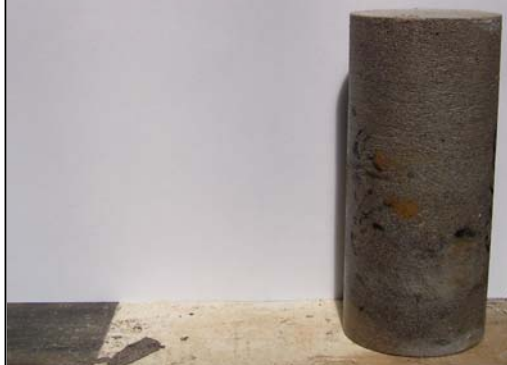
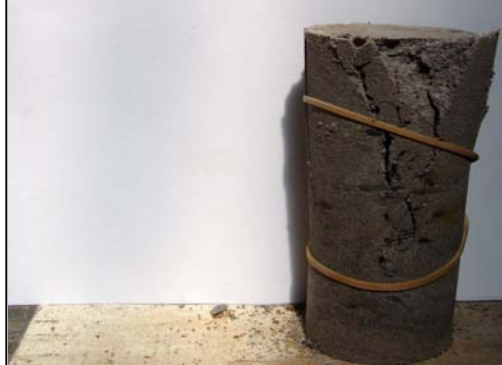
**BH 3**  
**8.0-8.25m**

GEE  
Wollongong Private Hospital  
Unconfined Compressive Strength  
Test Sample

GEE  
Wollongong Private Hospital  
Unconfined Compressive Strength  
After Test Sample

U.C.S. (MPa) = 9.1

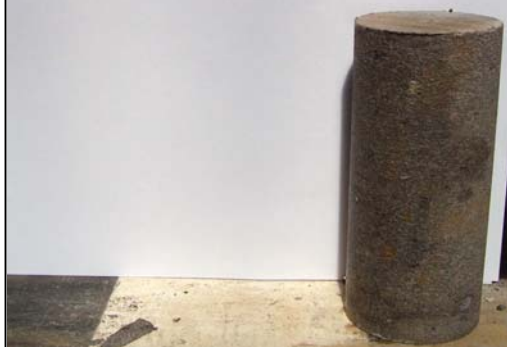
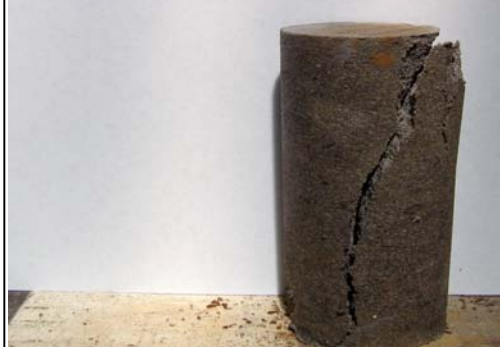
**BH 3**  
**13.78-14.0m**

GEE  
Wollongong Private Hospital  
Unconfined Compressive Strength  
Test Sample

GEE  
Wollongong Private Hospital  
Unconfined Compressive Strength  
After Test Sample

U.C.S. (MPa) = 8.2

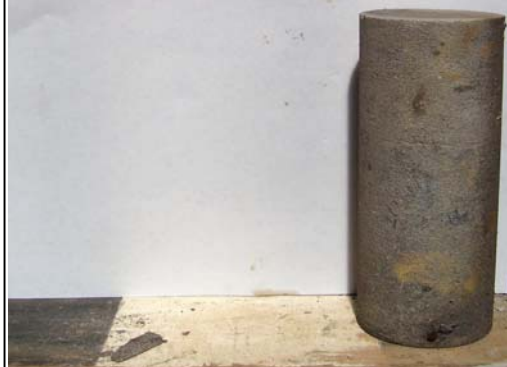
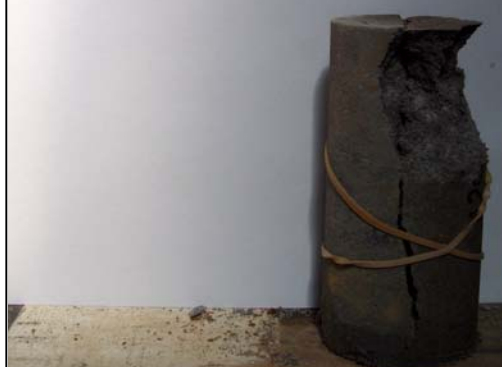
**BH 3**  
**16.45-16.62m**

GEE  
Wollongong Private Hospital  
Unconfined Compressive Strength  
Test Sample

GEE  
Wollongong Private Hospital  
Unconfined Compressive Strength  
After Test Sample

**U.C.S. (MPa) = 14.9**
