**BBK DEVELOPMENT CORPORATION**

**45 HEARNS LAKE ROAD WOOLGOOLGA  
COASTLINE HAZARD DEFINITION AND  
LAKE ENTRANCE PROCESSES**

**Issue No. 3  
OCTOBER 2004**

**Patterson Britton  
& Partners Pty Ltd**

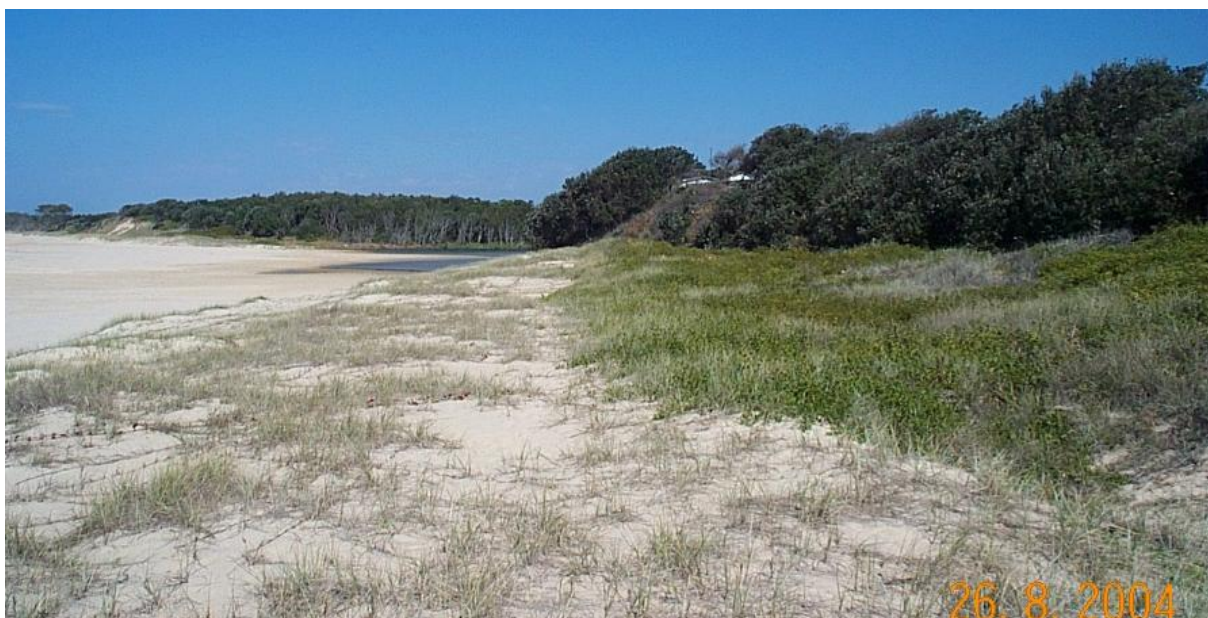
**Figure 1: Dune seaward of subject property, looking SSW towards Hearn's Lake**

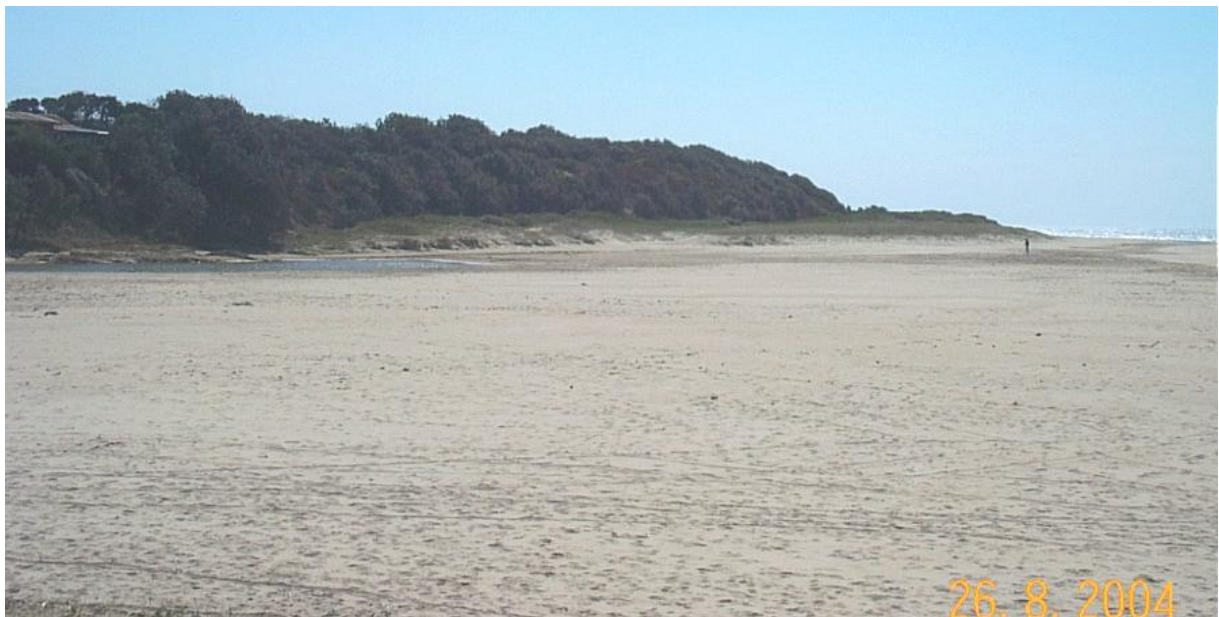
**Figure 2:** Dune seaward of subject property, looking north from Hearn's Lake

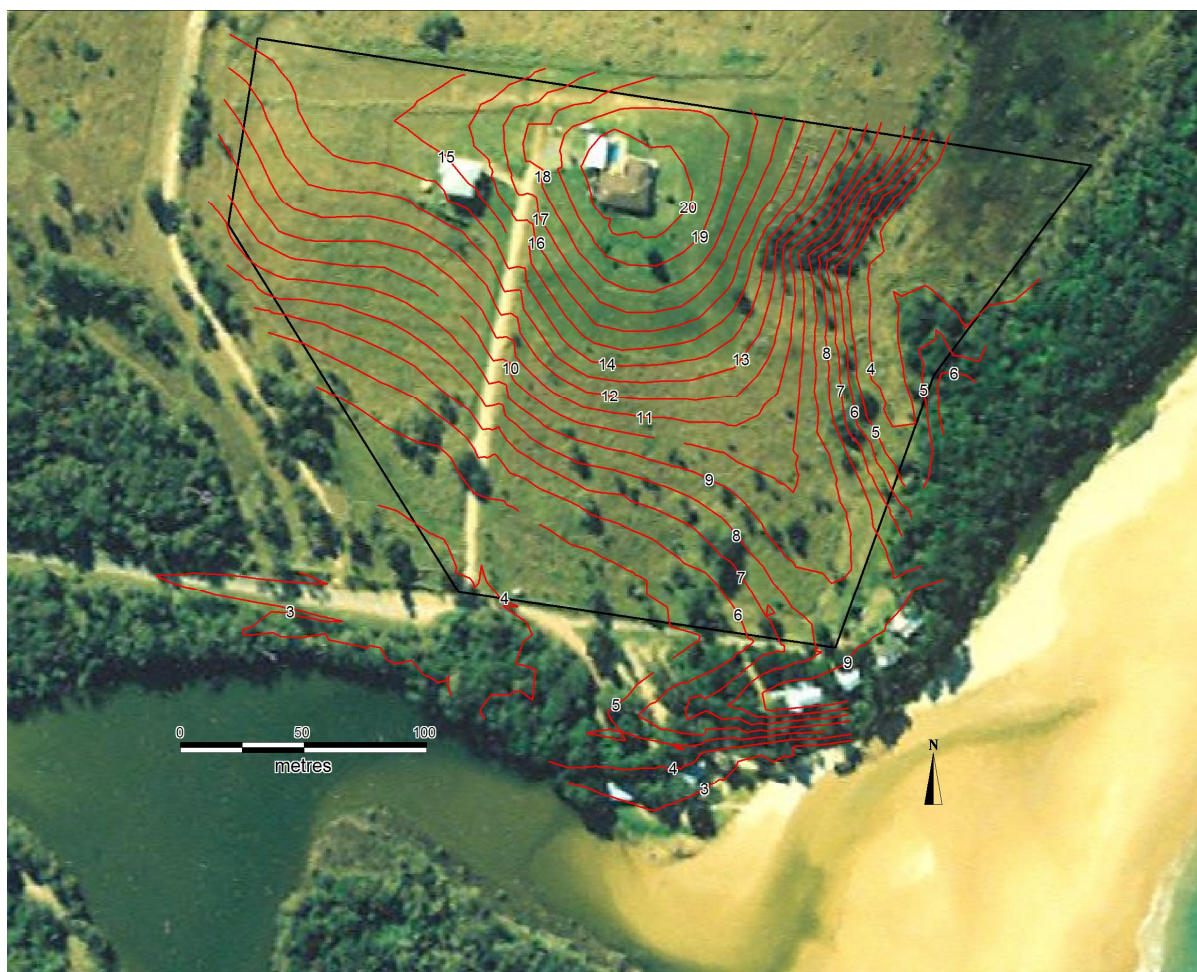
**Figure 3:** Elevations (m AHD) over and near subject property (1m contour interval)

<sup>5</sup> Note that the aerial photography shown in Figure 3 and Figure 4 was taken in June 2000, and was supplied by Coffs Harbour City Council. The subject property boundary shown was derived from cadastral information supplied by DIPNR.

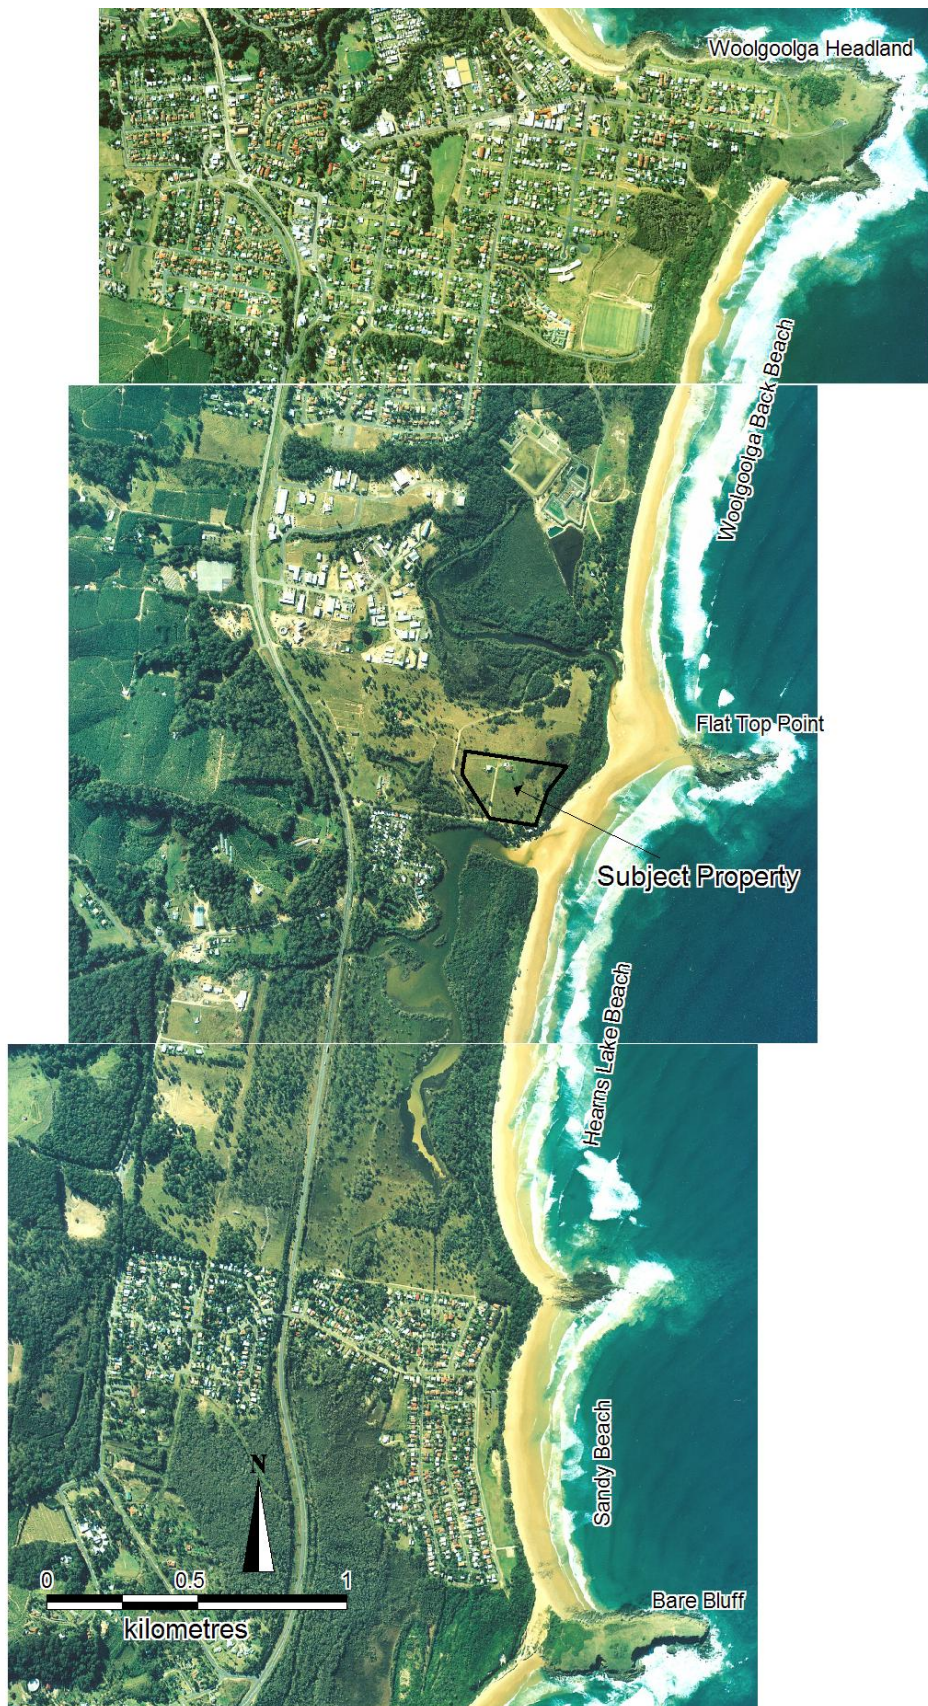
Figure 4: General view of Hearn's Lake Beach in relation to surrounding coastline

As shown in **Figure 4**, Hearn's Lake Beach faces approximately east and is about 2.0km long, extending between Flat Top Point in the north, and unnamed rocks forming the northern end of Sandy Beach<sup>6</sup> in the south. Sandy Beach extends south to the relatively prominent headland Bare Bluff, also facing east, and being about 1.1km long.

North of Flat Top Point, Woolgoolga Back Beach (as denoted by Short, 1993) extends to another relatively prominent headland, Woolgoolga Headland. The beach is about 2.0km long, and faces ESE. Flat Top Point is usually linked to the mainland via a sandy tombolo, as is evident in Figure 4.

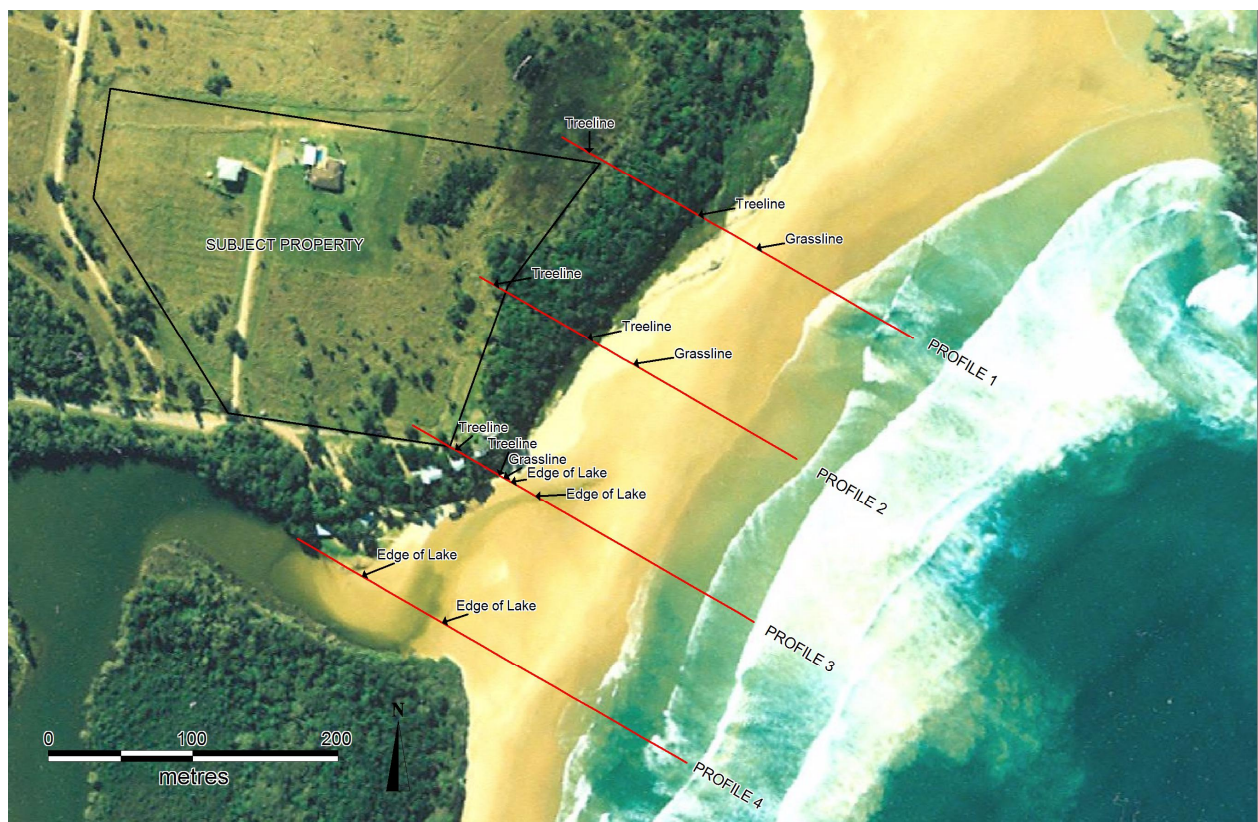
**Figure 7: Location of profiles obtained seaward of subject property in August 2004**

A survey of Hearn's Lake Beach was undertaken seaward of the subject property on 27 August 2004. The work was carried out by Reg Walters and Partners, Consulting Engineers, Surveyors and Planners. As part of this, four shore-normal beach profiles were obtained, as shown in **Figure 7**, overlaying aerial photography taken in June 2000 (refer Footnote 5, Page 3). The profiles were denoted as Profile 1 to Profile 4, proceeding from north to south. The location of features such as vegetation lines and lake edges were also noted, and are labelled in Figure 7.

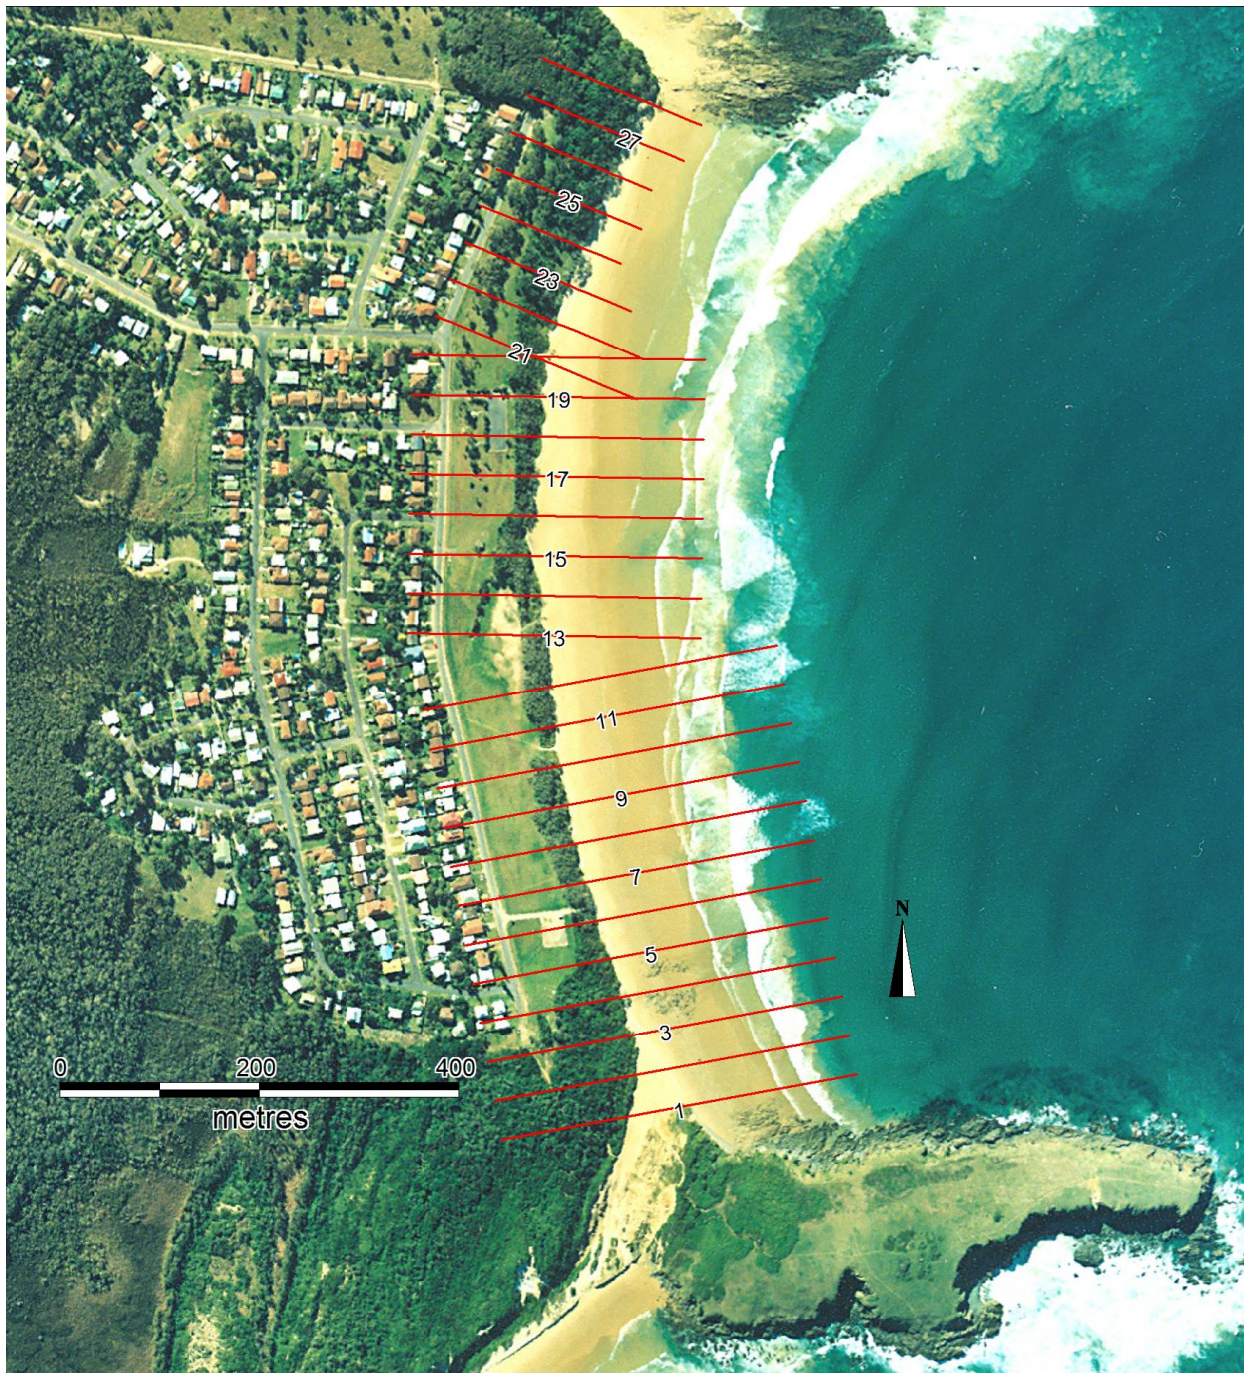
**Figure 9: Arrangement of photogrammetric profiles at Sandy Beach**

The photogrammetric profiles were arranged into 3 blocks, namely Blocks 1, 2 and 3 proceeding from south to north. There were 12 profiles in Block 1 and 8 profiles in each of Blocks 2 and 3. For the investigation reported herein, each profile was numbered from 1 to 28, with Profiles 1-12 in Block 1, Profiles 13-20 in Block 2, and Profiles 21-28 in Block 3. The arrangement of the profiles (based on the 1996 data extents and June 2000 aerial photography) is shown in **Figure 9**.
