### 5.6.2 Interpretation of Local Studies

### 5.6.3 Analysis of Vegetation Lines

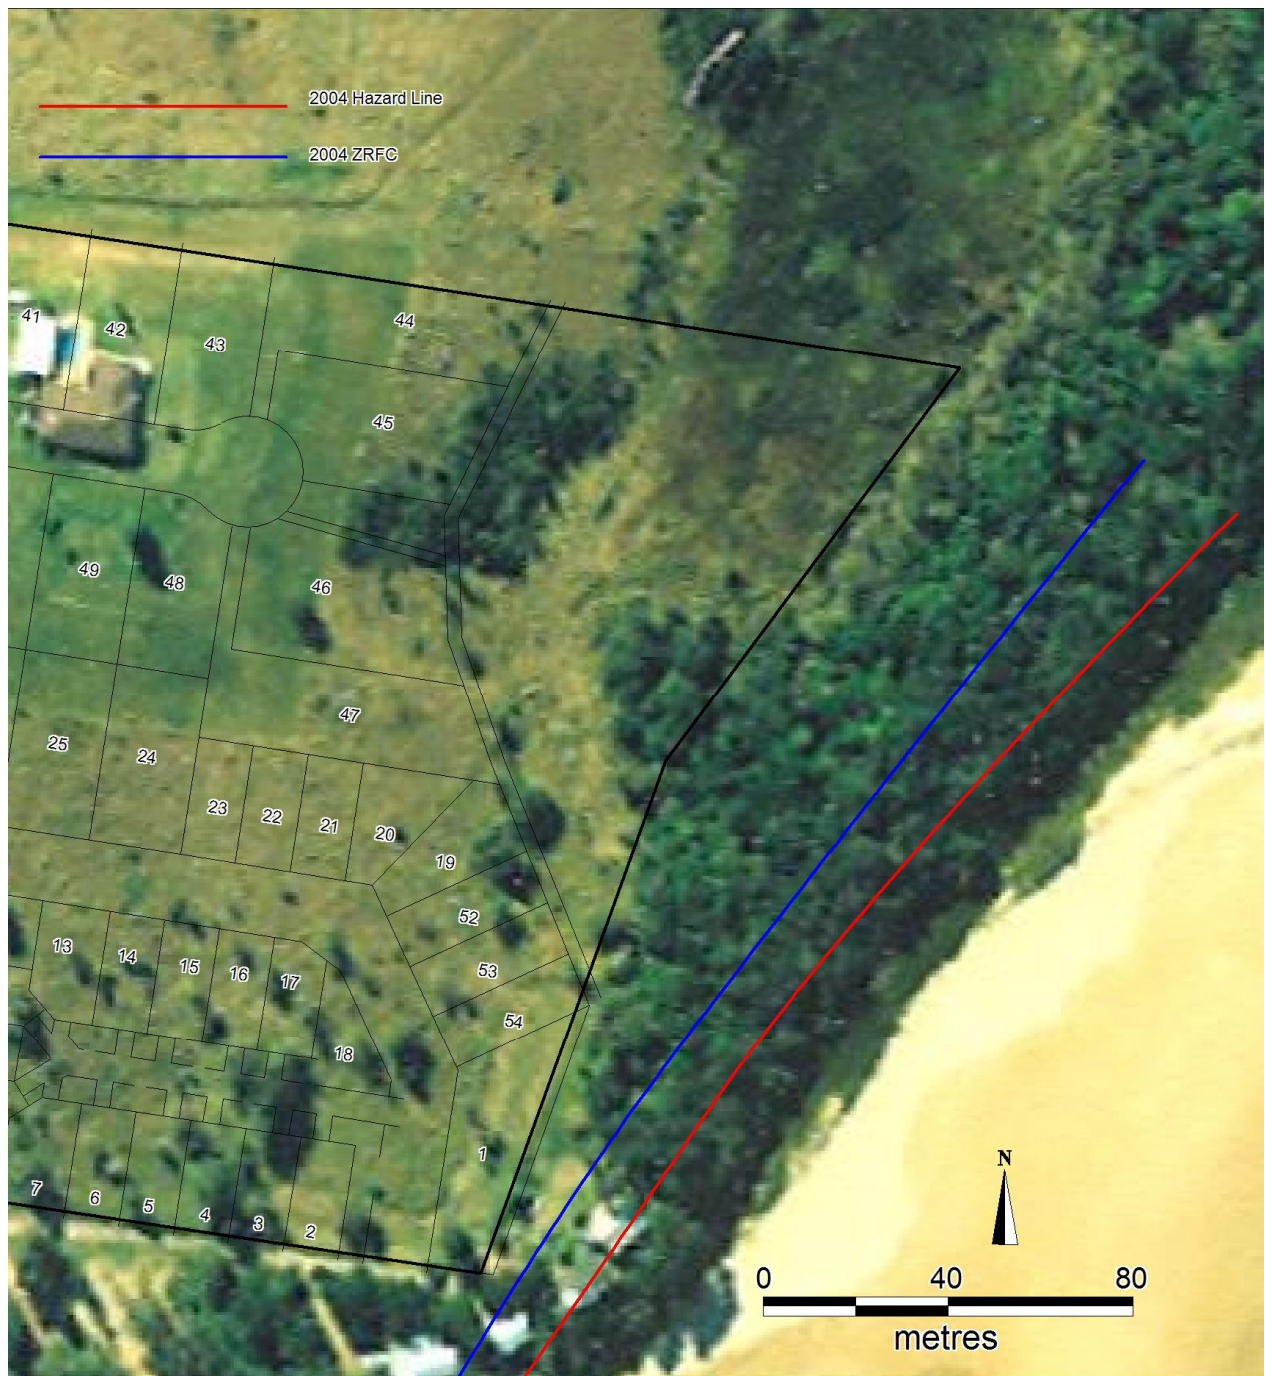
**Figure 31: 2004 Hazard Line and Zone of Reduced Foundation Capacity (ZRFC) for subject property**

The 2004 Hazard Line and ZRFC Line within the study area is shown in **Figure 31**, the 2054 Hazard Line and ZRFC Line is shown in **Figure 32**, and the 2104 Hazard Line and ZRFC Line is shown in **Figure 33**. These Figures include the proposed subdivision layout (as per the Reg Walters & Partners Drawing 03274-01, "Proposed Subdivision:- Lot 21 DP 714858, Hearn's (sic) Lake Road, Woolgoolga", 8 December 2003), with Lot numbers shown.

It is evident that the Hazard Line is seaward of the subject property for all planning periods. Therefore, from a coastal engineering perspective, the location of the proposed development is considered to be reasonable.

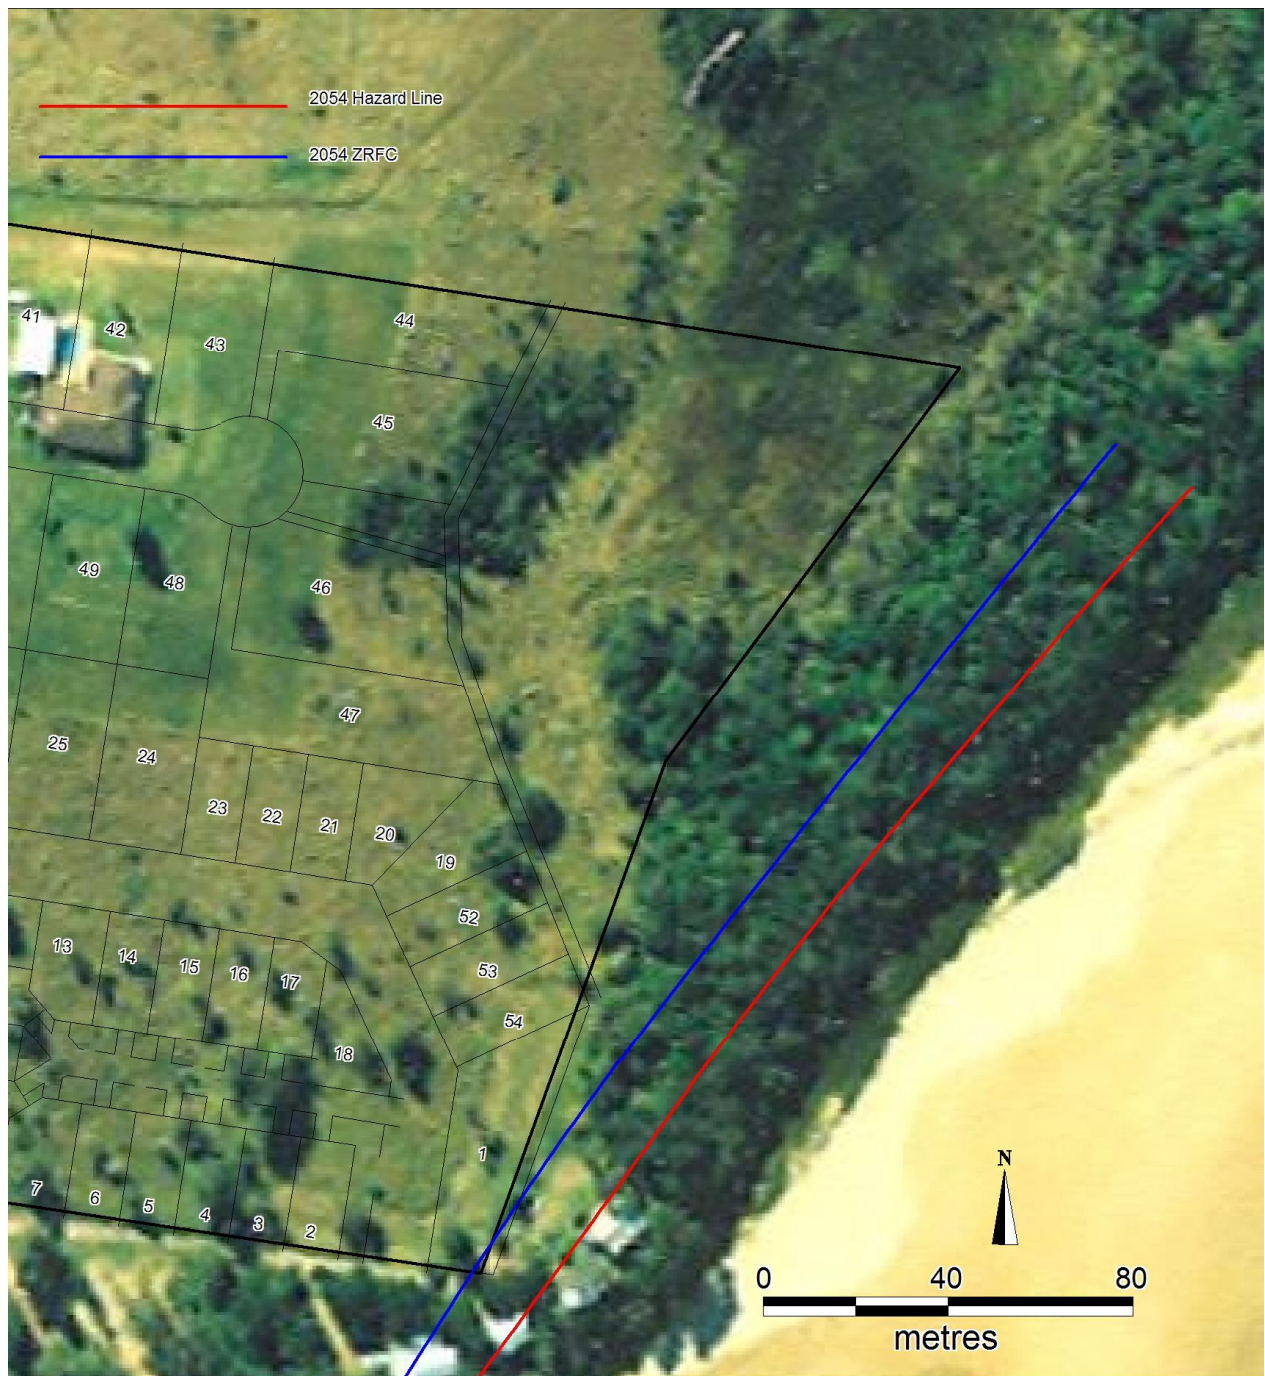
**Figure 32: 2054 Hazard Line and Zone of Reduced Foundation Capacity (ZRFC) for subject property**

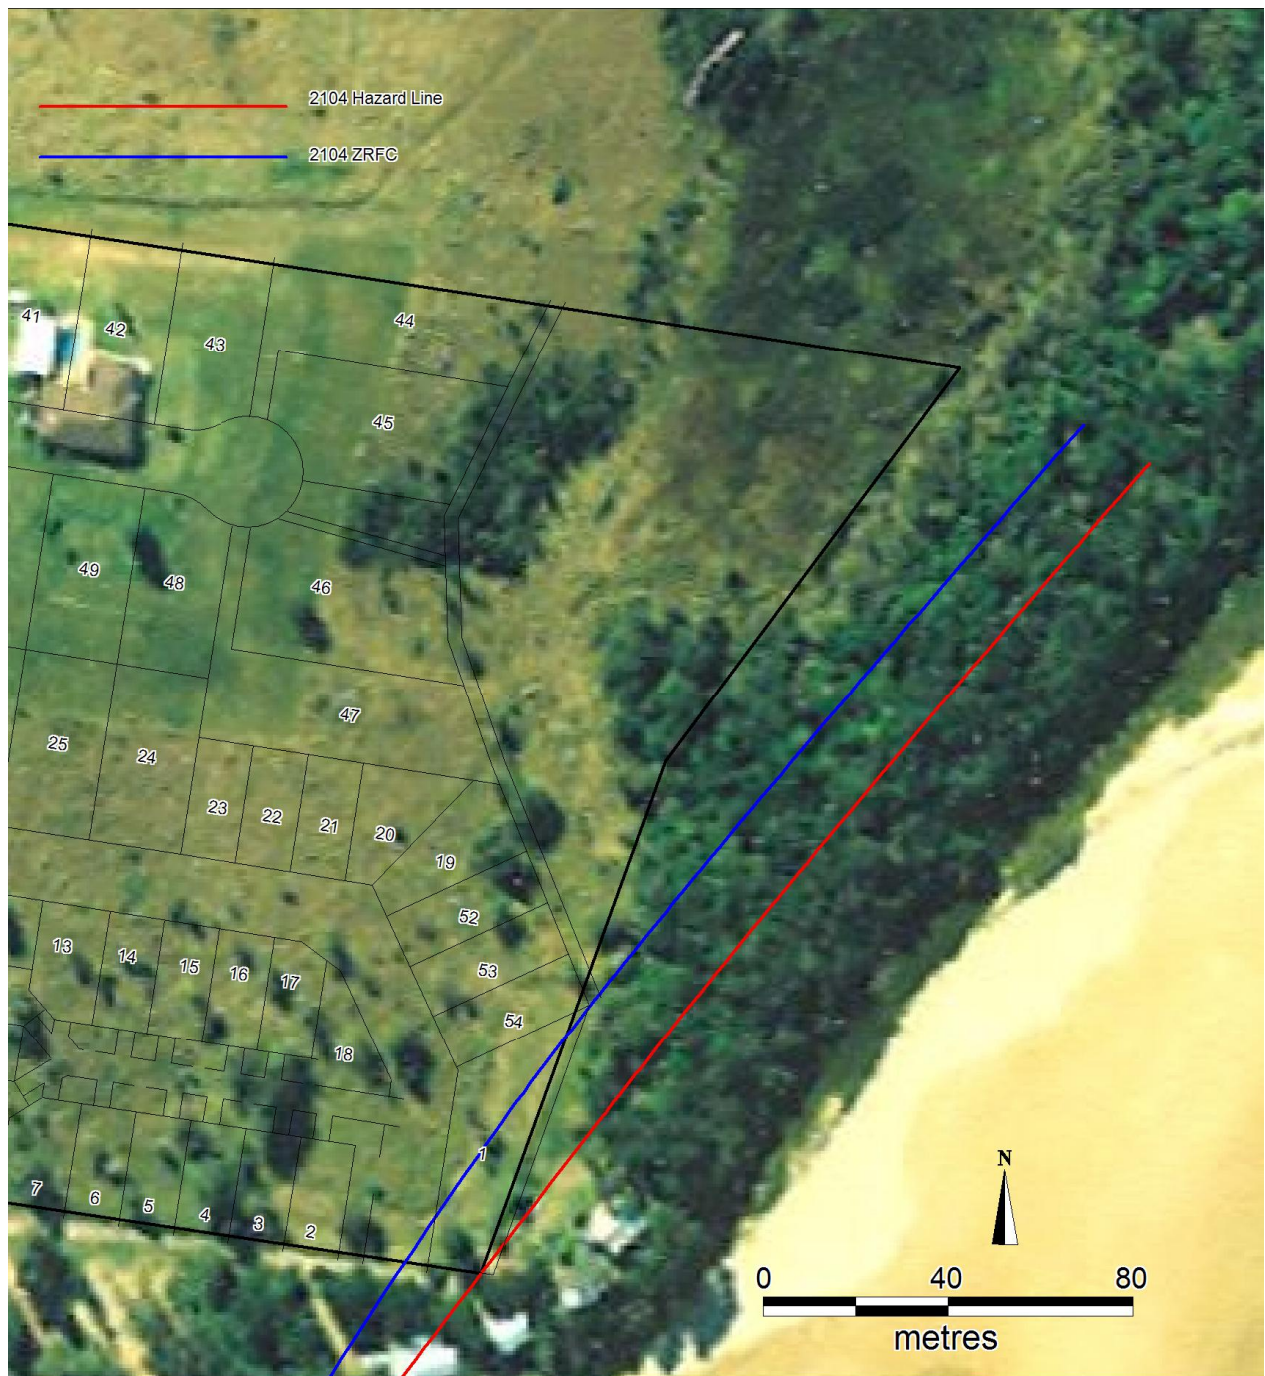
**Figure 33: 2104 Hazard Line and Zone of Reduced Foundation Capacity (ZRFC) for subject property**
