*GEOTECHNICAL ASSESSMENT FOR
PROPOSED RESIDENTIAL DEVELOPMENT
AT HEARNS LAKE - WOOLGOOLGA*

*GEOTECHNICAL ASSESSMENT FOR
PROPOSED RESIDENTIAL DEVELOPMENT
AT HEARNS LAKE, WOOLGOOLGA*

**LOCATION OF BOREHOLES
 AND IDENTIFICATION OF
 CONSTRAINT ZONES
 FOR GEOTECHNICAL ASSESSMENT**

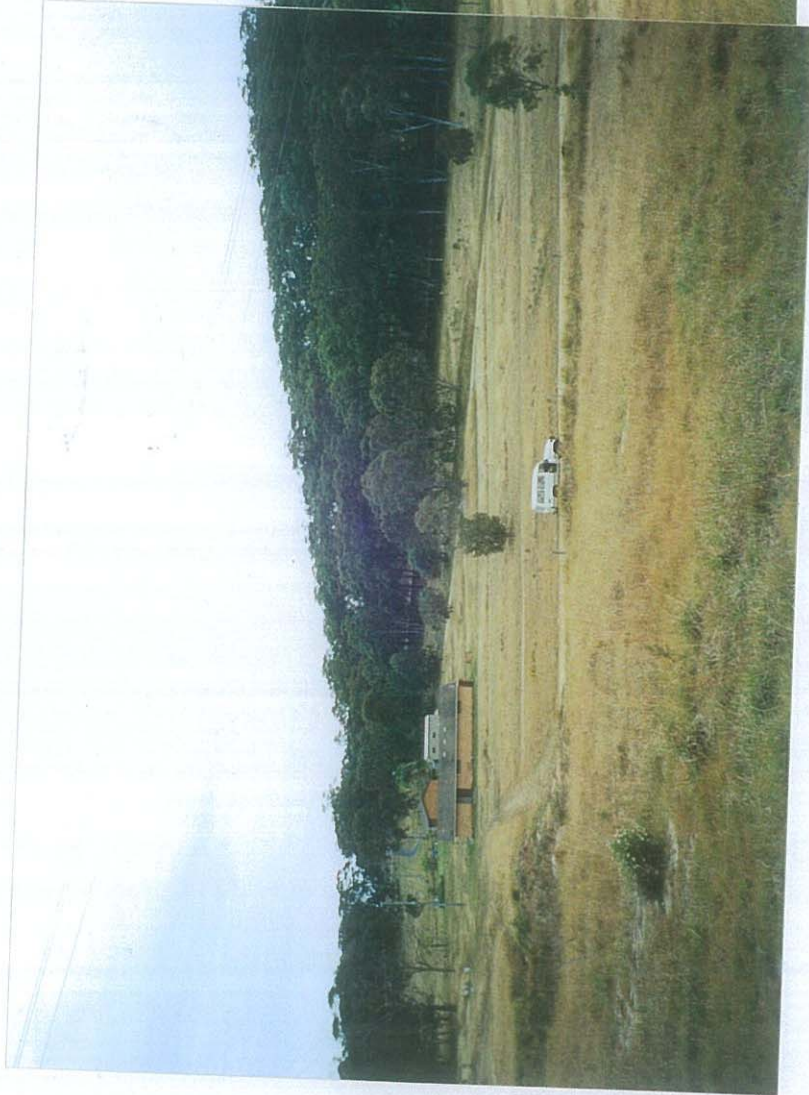
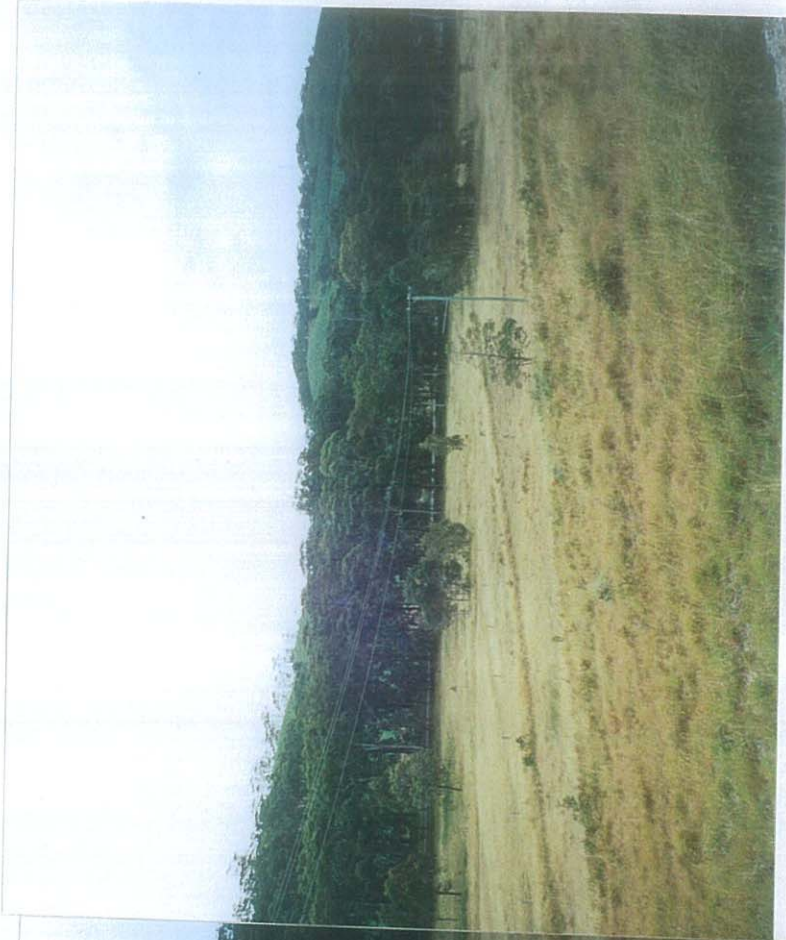
HEARNS LAKE DEVELOPMENT
ZONE D DRAINAGE

The run-off into this area is concentrated by two culverts under the Pacific Highway. One is located near the northern end and the other at the southern end of the boundary. Generally runoff from the Highway has also required the construction of a drain and levee running parallel to the Highway.

The former Caravan Park has attempted to control the runoff passing through this area with open drains.

Looking southwards across Lot 4. Pacific Highway in the rear treeline.

It will be necessary for the subdivisional development to replicate these drainage works with an appropriate stormwater system. Subsoil drainage along the 'nick' points (where there is a significant change of grade from the hillslope to the valley floor) will be required to intercept ground water discharging at the bottom of the hillslope during wet periods. Such drainage could be required as a separate system, or incorporated into the stormwater lines if appropriate.

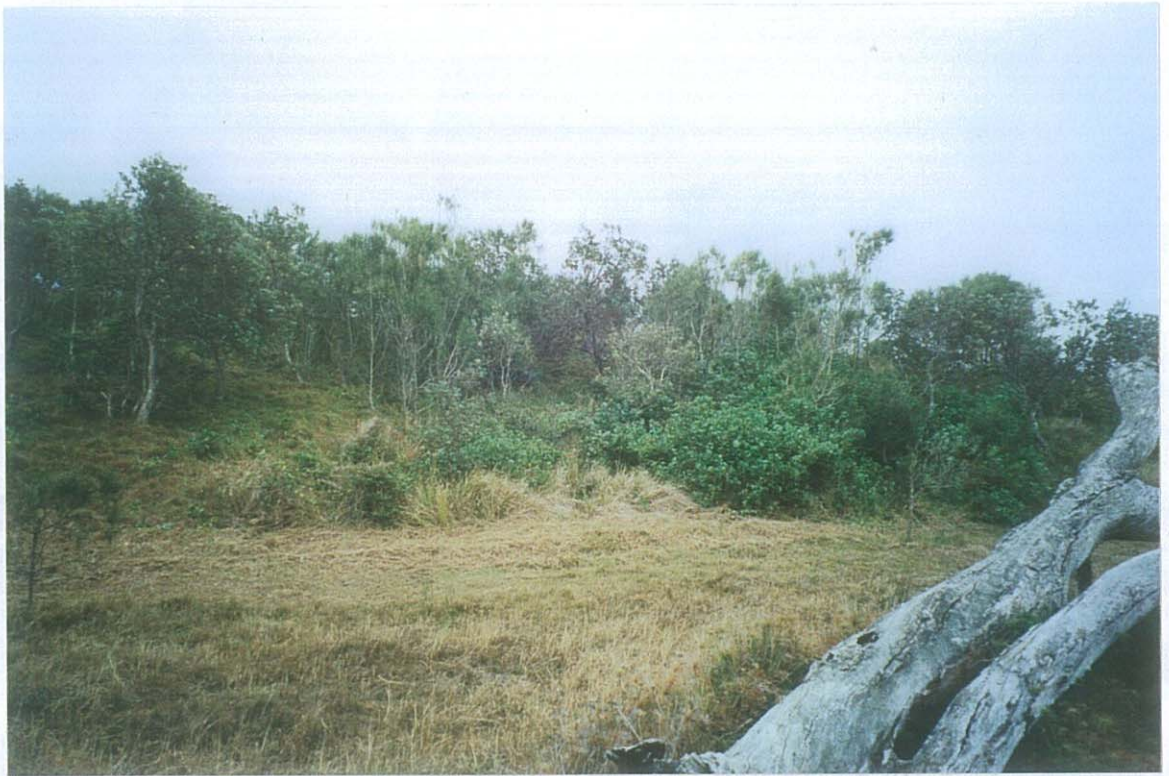
ZONE M MODERATE RISK STEEP LAND

In this area, there is evidence of slumping of the steep slope with the formation of two shallow gully lines in the weaker beds in the rock formation.

View looking westward into the northern end of the Zone
slumped slope in centre of photo.

This area is considered to have a moderate risk of slope instability and as a result, will require specific investigation of any particular proposed development.

Applying additional loading to the surface mantle must be avoided, and hence it is expected that all structural loads will be supported on deep foundations.

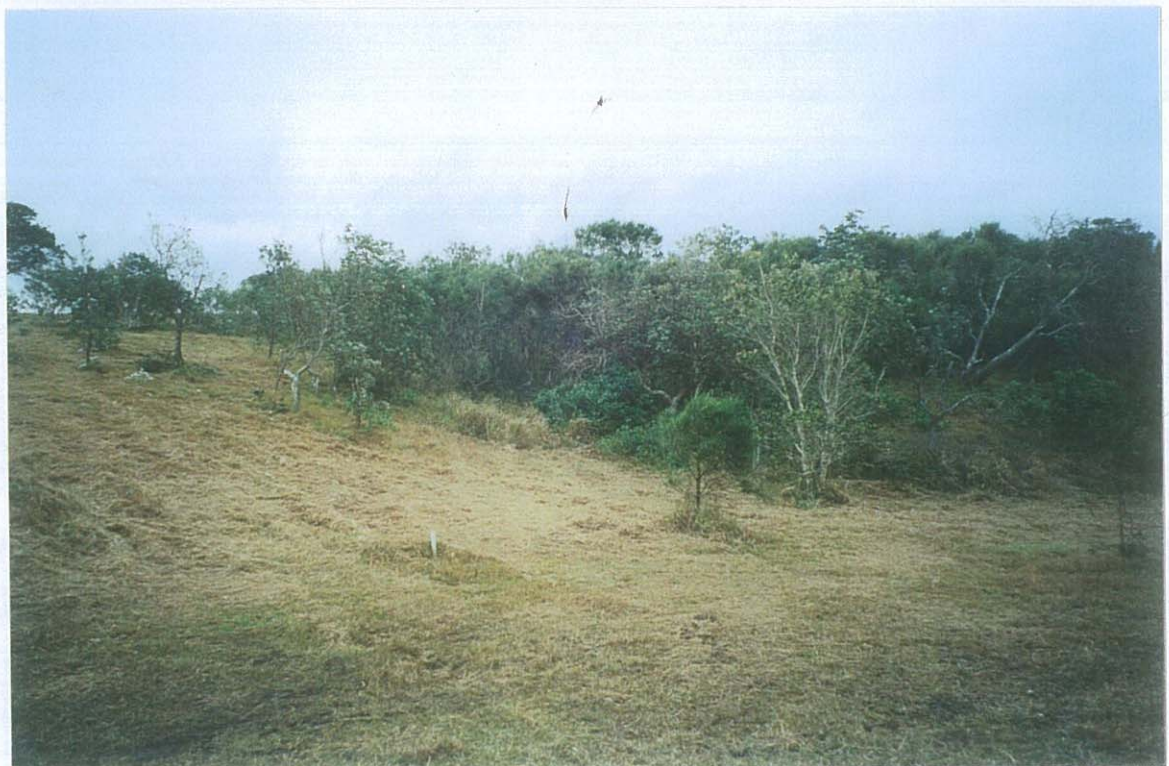
View looking westwards into the southern end of the Zone
steep erosion gully with slumping sides

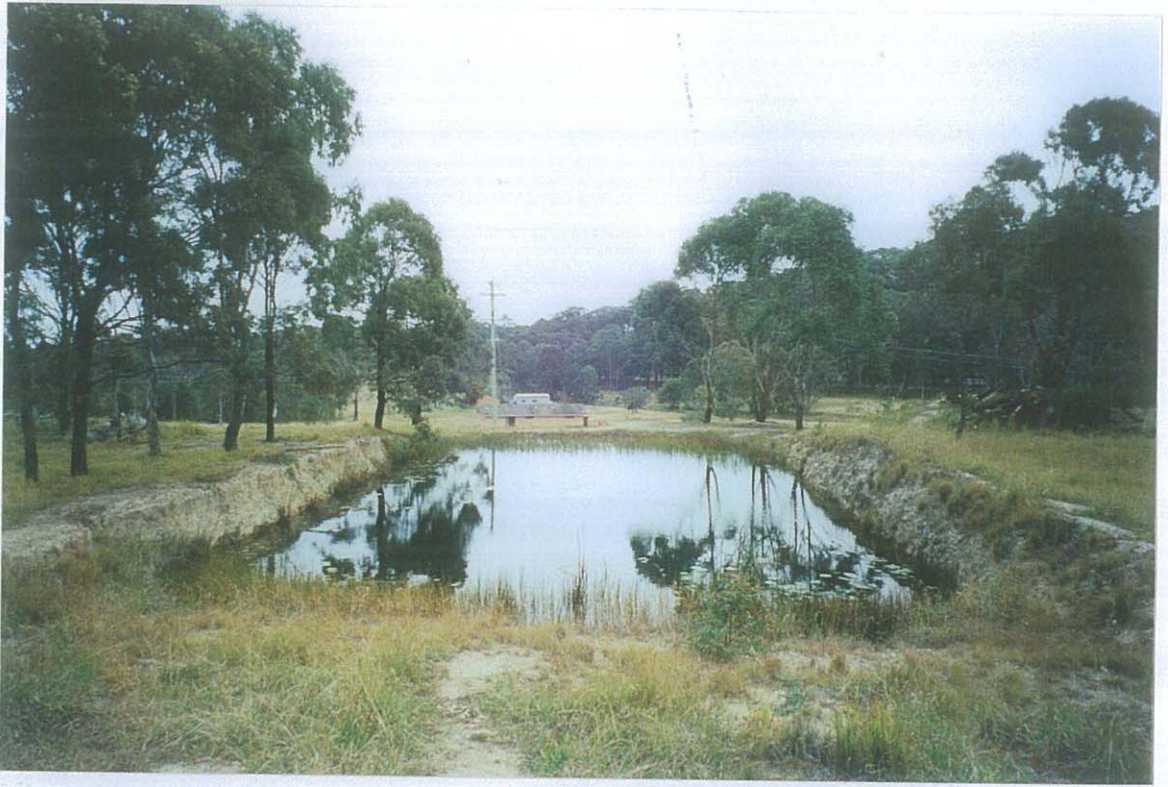
ZONE P EXISTING EXCAVATIONS

These areas, located on Lot 4, are excavations which have been dug out to various depths to create a water storage pond, effluent polishing ponds, rubbish dumps and aborted stormwater lines.

Water storage pond on main ridge top. Excavation at least 2½ m deep.

These areas should be identified by survey prior to any construction work commencing.

Suitable contract documentation and supervision of civil works for the development will be required to ensure that all unsuitable material is removed from the excavations and that suitable thoroughly compacted material is used to restore these excavations.

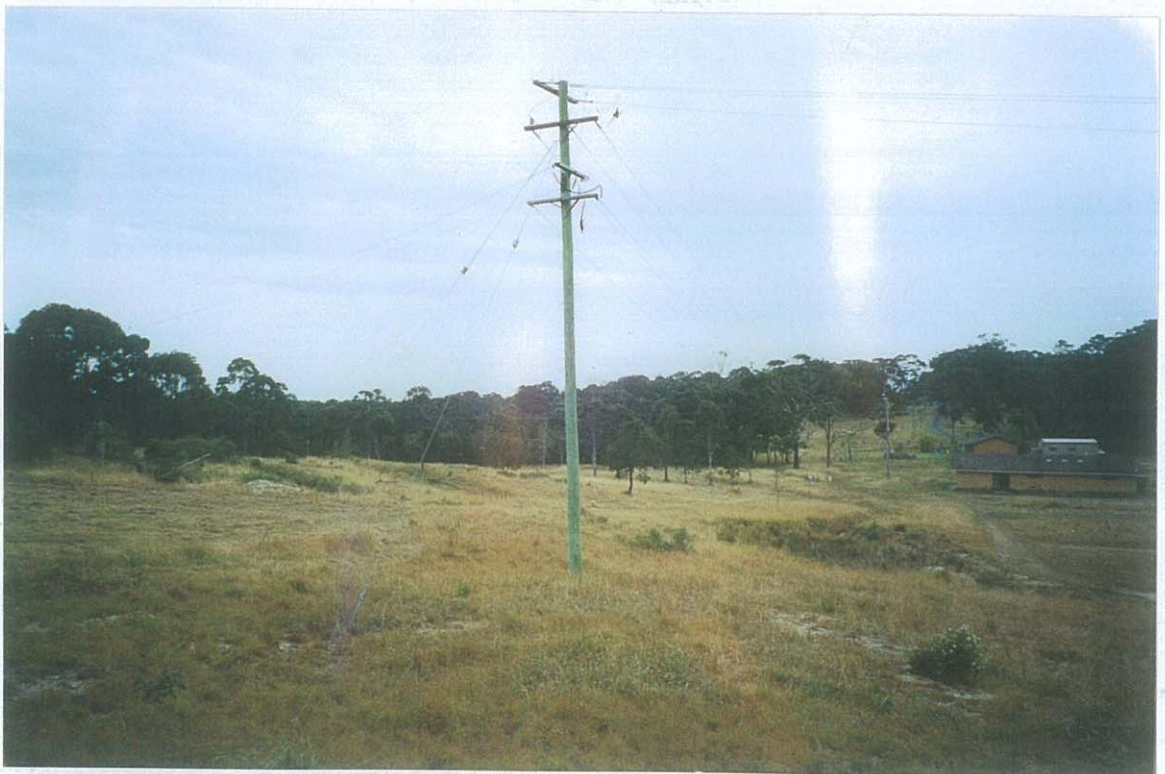
In addition, there are three overgrown ponds which were used as polishing ponds for the effluent from the Caravan park treatment works. These will also have to be cleaned out before reinstatement is undertaken.

Effluent polishing ponds on ridge line

Excavation for material and aborted stormwater line.

View looking southwards in lot 4.
