# Draft Stage 1 Remedial Action Plan for Barangaroo, Hickson Road, Sydney

Sydney Harbour Foreshore Authority

0065952RP02 Rev 03 Draft

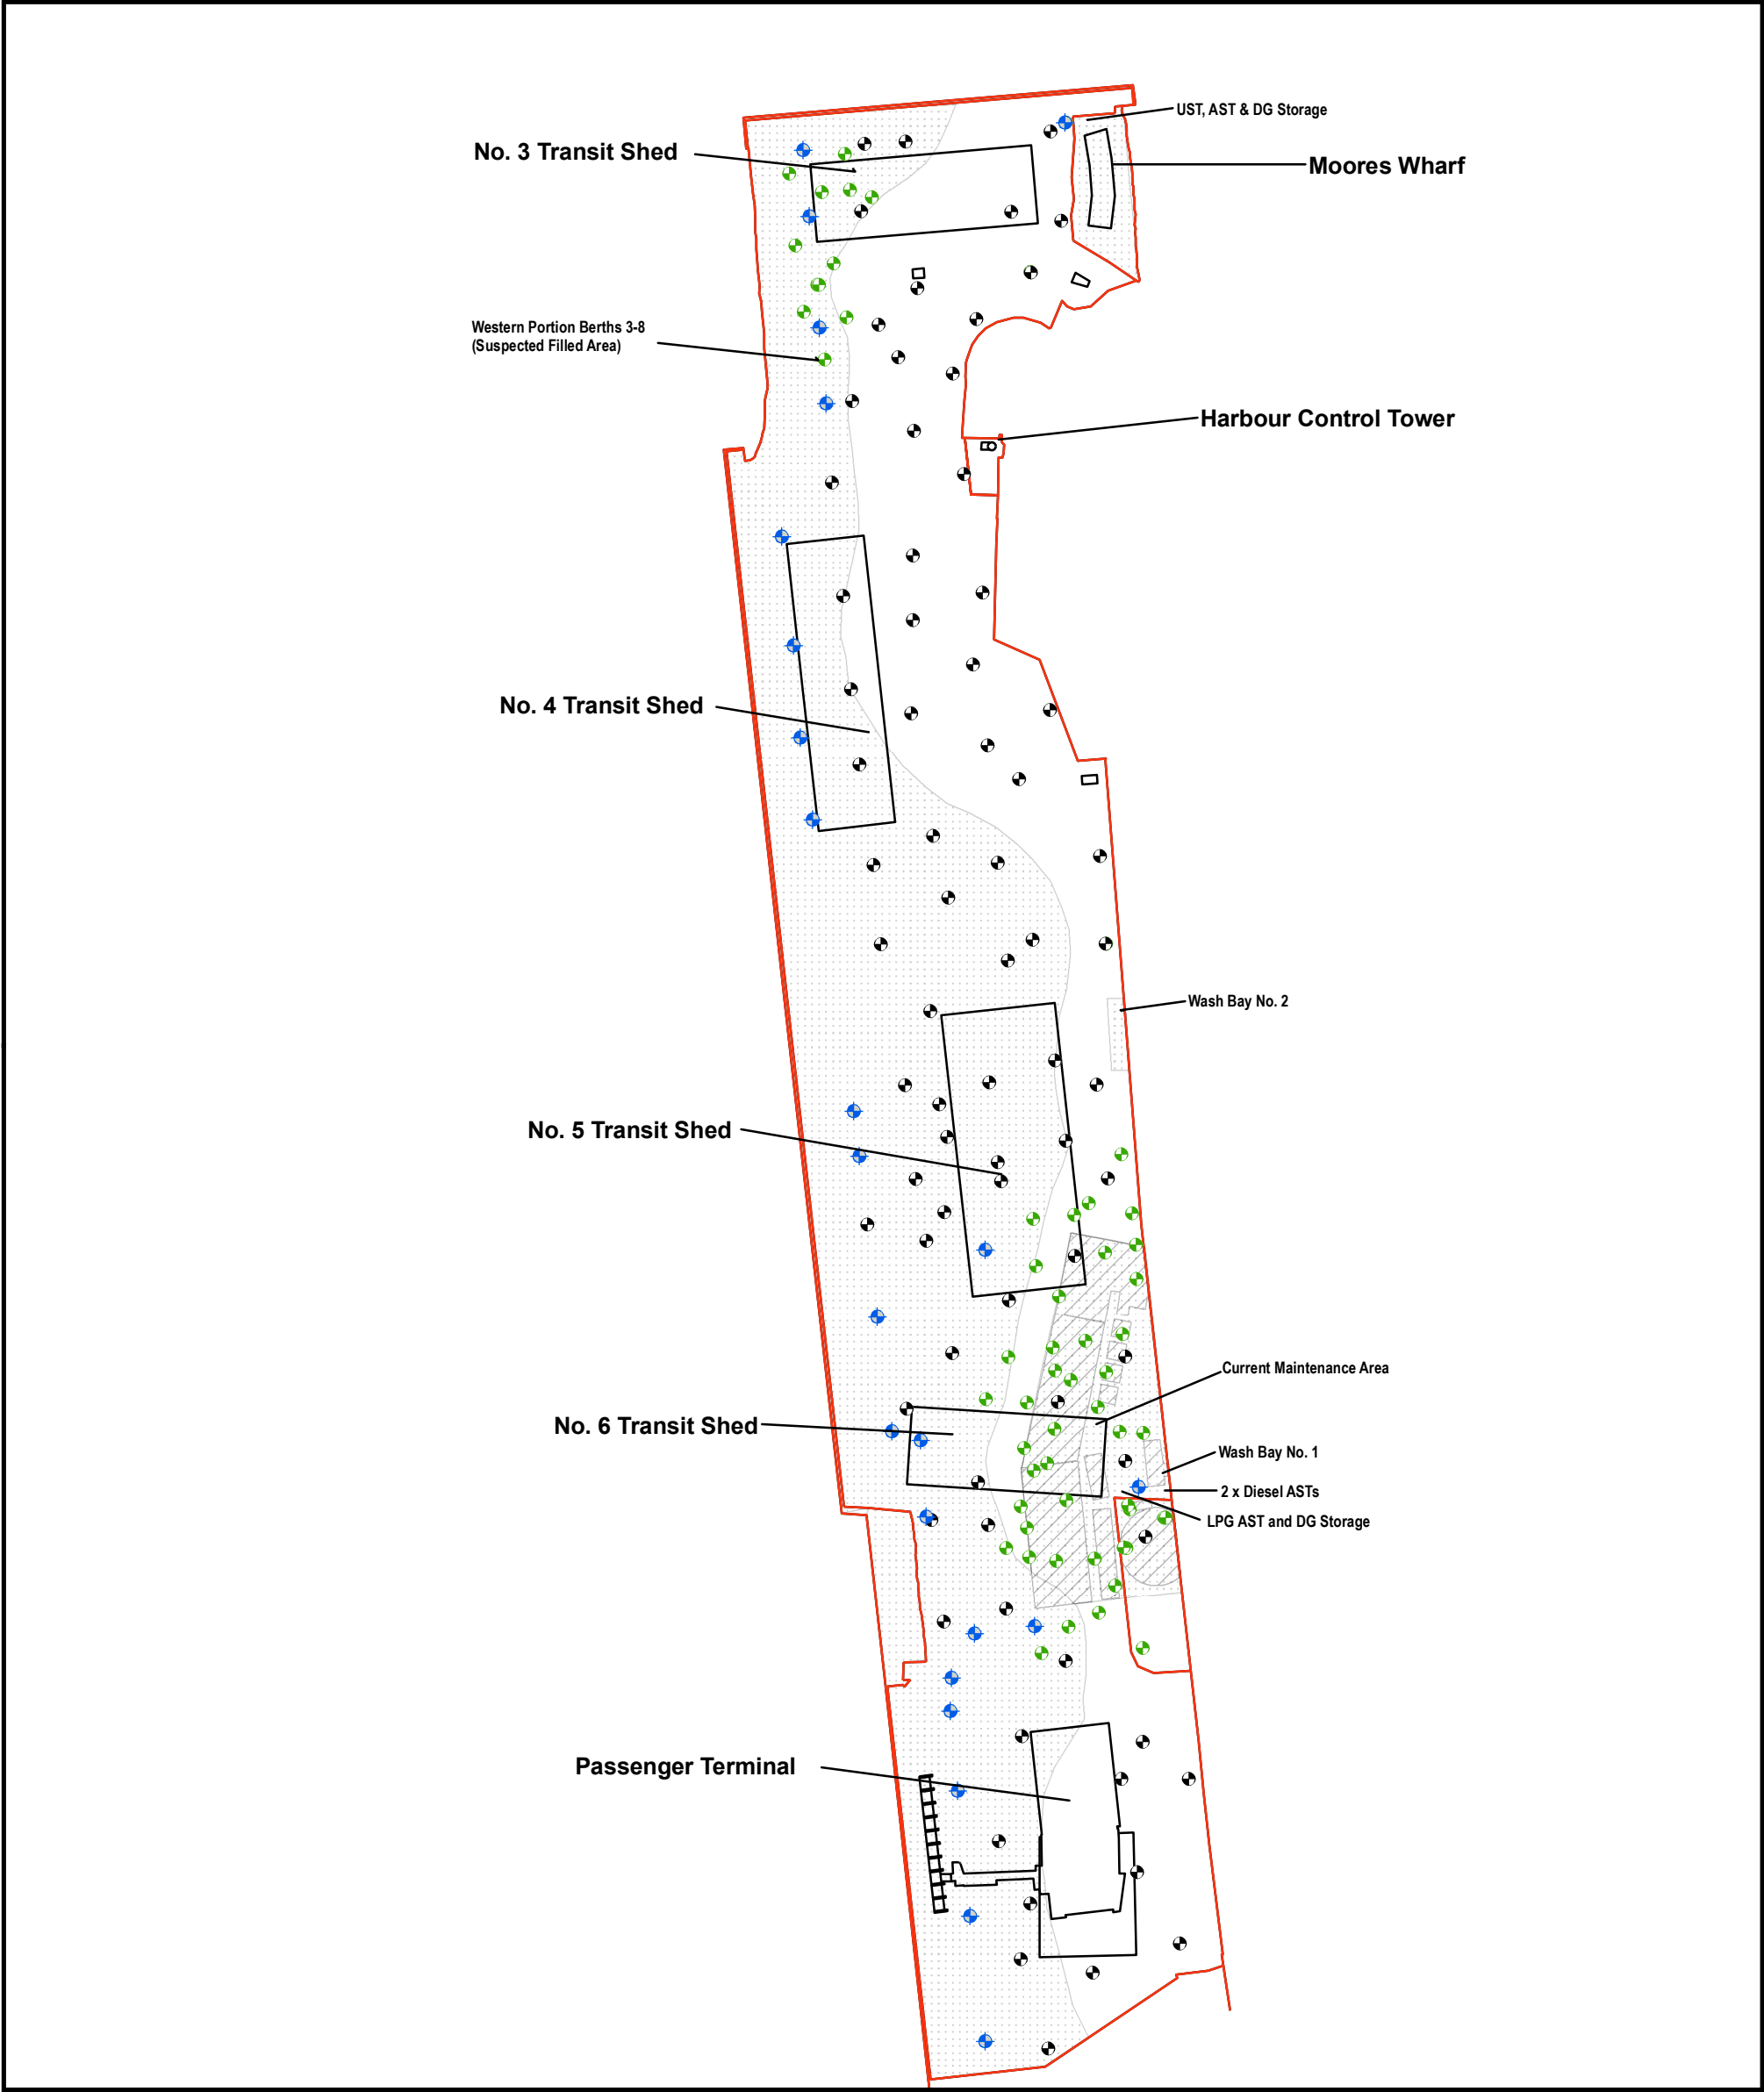
Following the most recent Site investigation works, ERM (2007) reported the analytical results for 347 primary soil samples collected from 153 boreholes. The locations of these sampling points are illustrated on *Figure 2 of Annex A*. It is noted that not all suspected areas of impact (including some gas works structures) could be sampled due to access restrictions and adverse drilling conditions. Samples were analysed by a NATA accredited laboratory for a suite of analytes, including inorganics (arsenic, cadmium, total chromium, copper, lead, mercury, nickel, zinc, sulphate and cyanide), total petroleum hydrocarbons (TPH), benzene, toluene, ethylbenzene, and xylenes (BTEX compounds), polycyclic aromatic hydrocarbons (PAHs), organochlorine pesticides (OCPs), organophosphorous pesticides (OPPs), total polychlorinated biphenyls (PCBs) and phenolic compounds.

The extent of the area to which this RAP applies is as described in *Section 2.1* and shown on *Figure 2* of *Annex A*. As noted in *Section 1.3*, temporally, this RAP applies only to the short term use of the site as the venue for a public event.

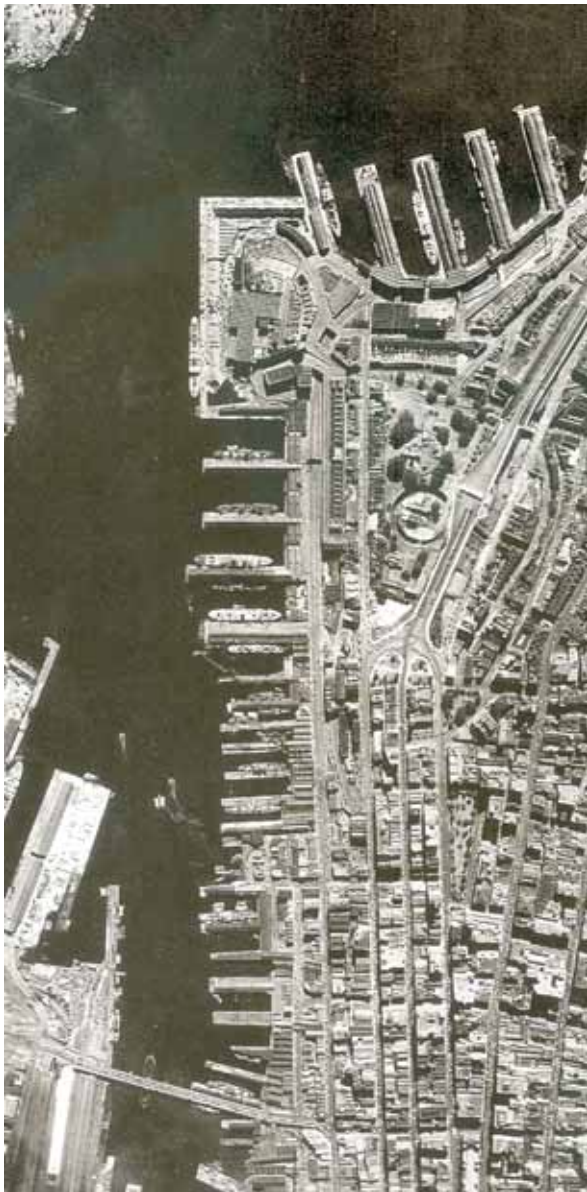
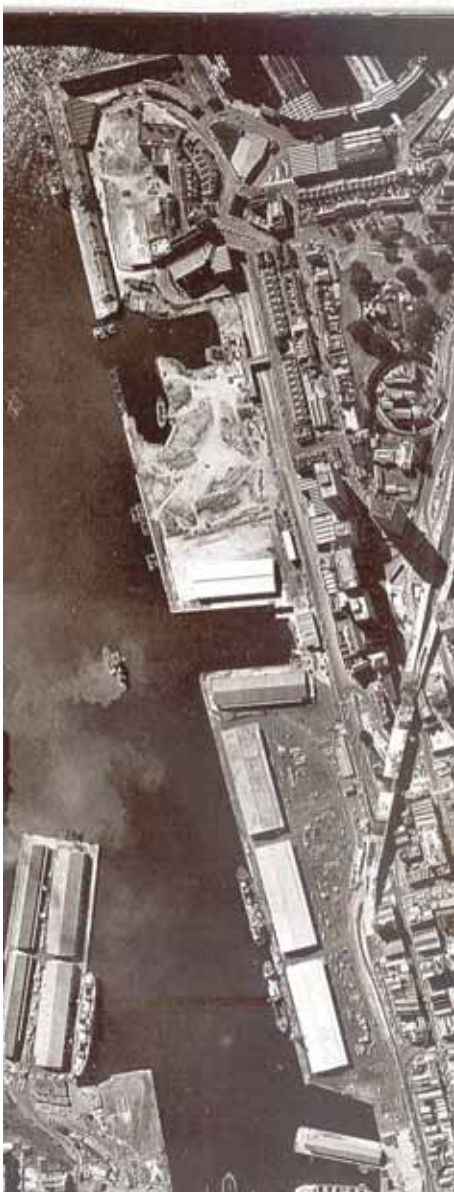
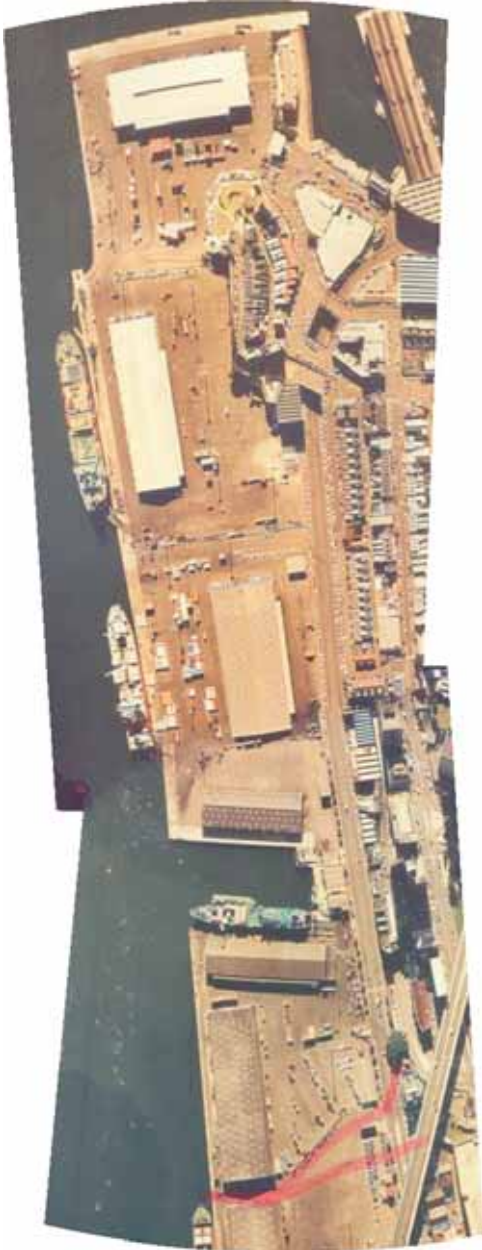
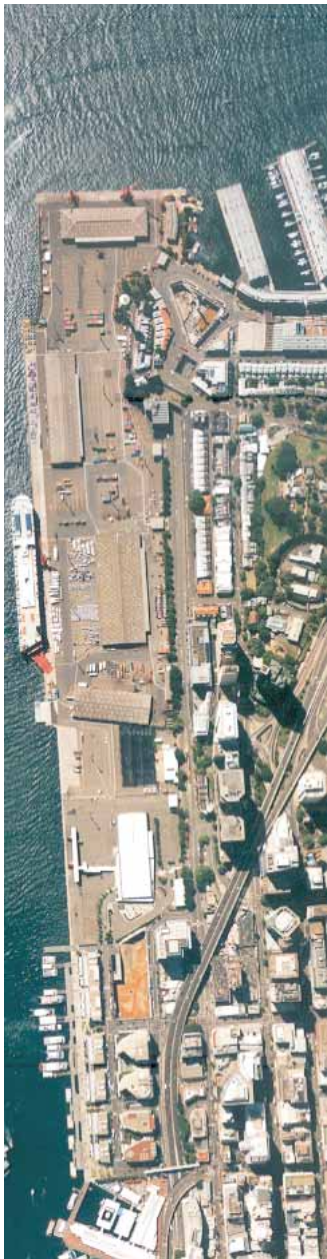
Figure 3  
Aerial Photos 1951 - 2004

Following a review of existing reports, land title searches and aerial photography (refer to *Figure 3 of Annex A*), the historical activities carried out at the Site can be summarised as follows:

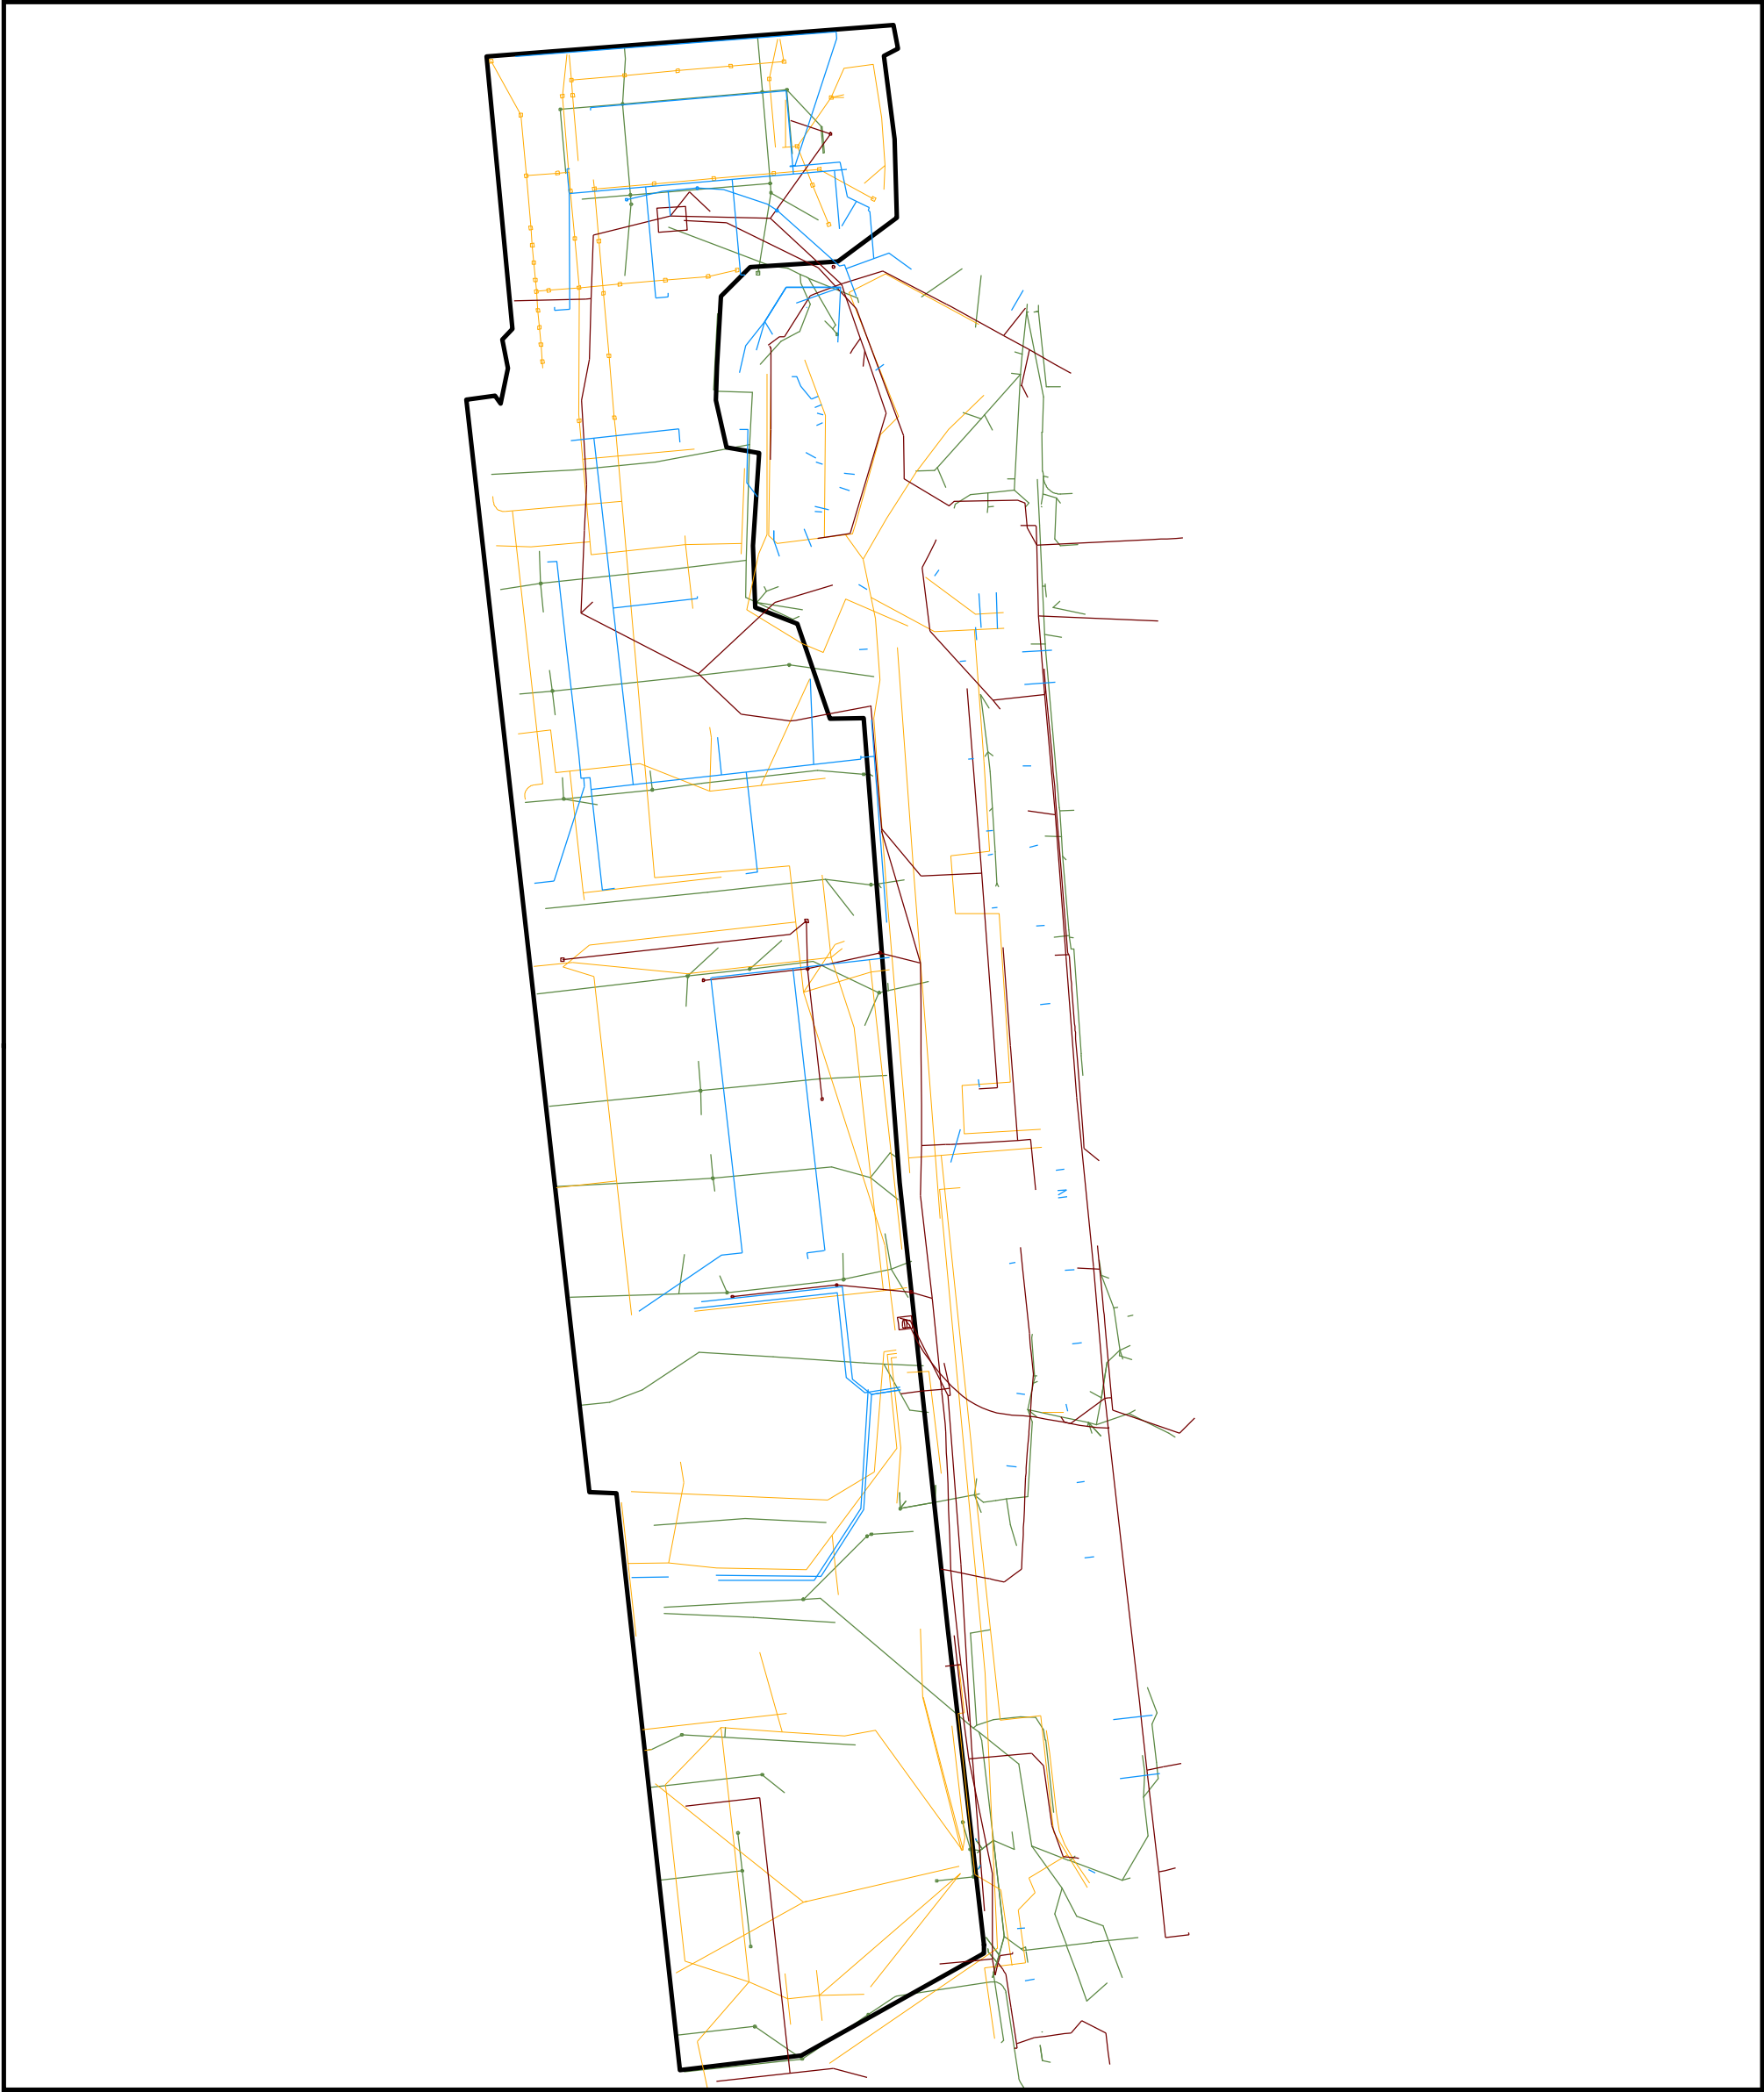
There are no permanent surface water bodies present on the site itself and stormwater is collected via a network of surface and below ground drains as indicated in the services diagram presented as *Figure 4 of Annex A*. The water quality in Sydney Harbour, and more particularly Darling Harbour, which is the closest surface water body to the site, is known to have been significantly degraded by industrial and urban activities within the catchment area. *“Darling Harbour has frequently been the most polluted of the Sydney Harbour sites monitored as part of the Harbourwatch Program. This was again the case in 2005–2006, with Darling Harbour frequently having elevated faecal coliform and enterococci levels. Swimming by the general public is not permitted in Darling Harbour.”*<sup>1</sup>

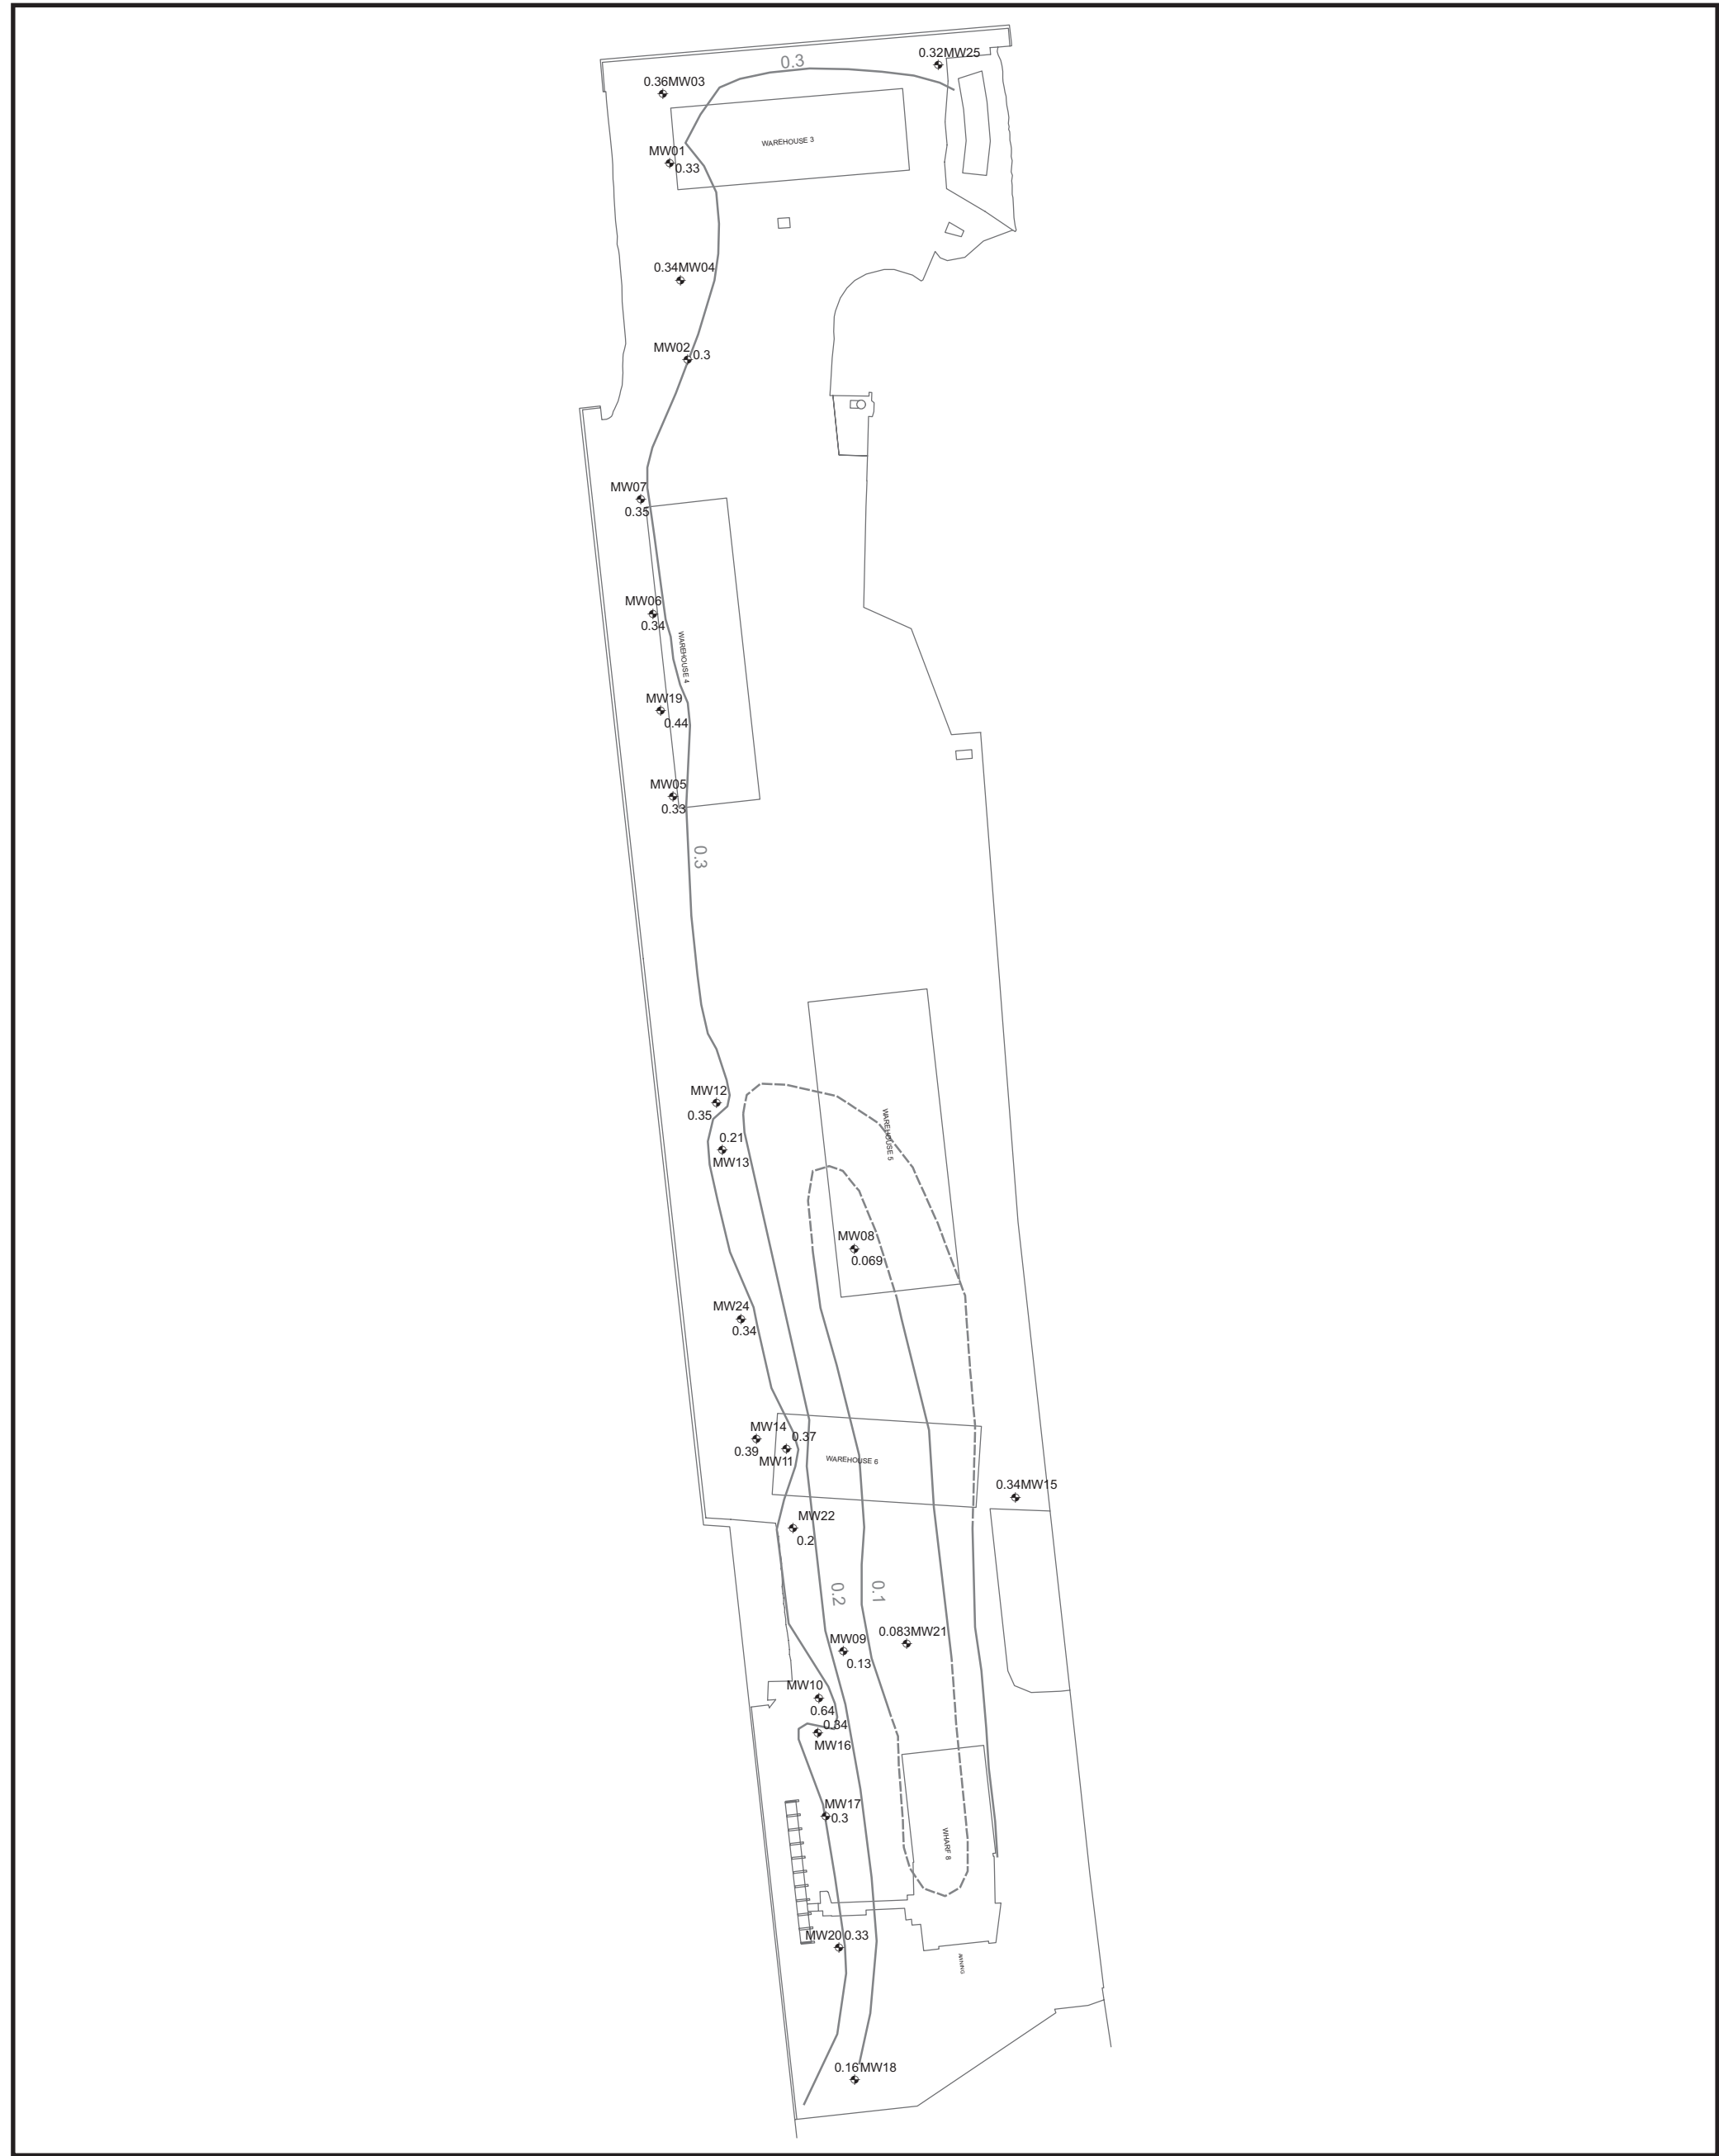
Although groundwater at the site would be anticipated to flow toward Sydney Harbour, the hydrogeological regime appears to be heavily influenced by tidal fluctuations and the dewatering activities on the eastern side of Hickson Road. This may provide some explanation for the variable groundwater elevations noted on site.
