# Preliminary Contaminated Site Investigation

Proposed Multi-unit Eco-tourism Development  
Lot 490 DP1095234, Casuarina Way Kingscliff NSW

**1 September 2009**

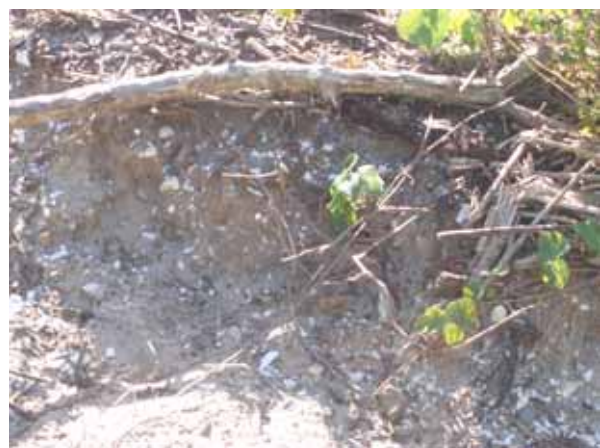
The site appears to be revegetated mainly by exotic species such as Bitou Bush and Lantana with much of the site impassable due to the lack of proper weed management and control. Sparsely dispersed stands of Casuarina and Banksia species are present amongst the exotics, particularly upon the extreme low lying areas to the south-west and the elevated sections of the north and north-east (bounding Casuarina Way).

**Plate 1.** Shell grit observed across the majority of the study area
