## **Salt Ash Sand Quarry**

### Annual Review 2022

ATB Morton Pty Ltd

March 2023

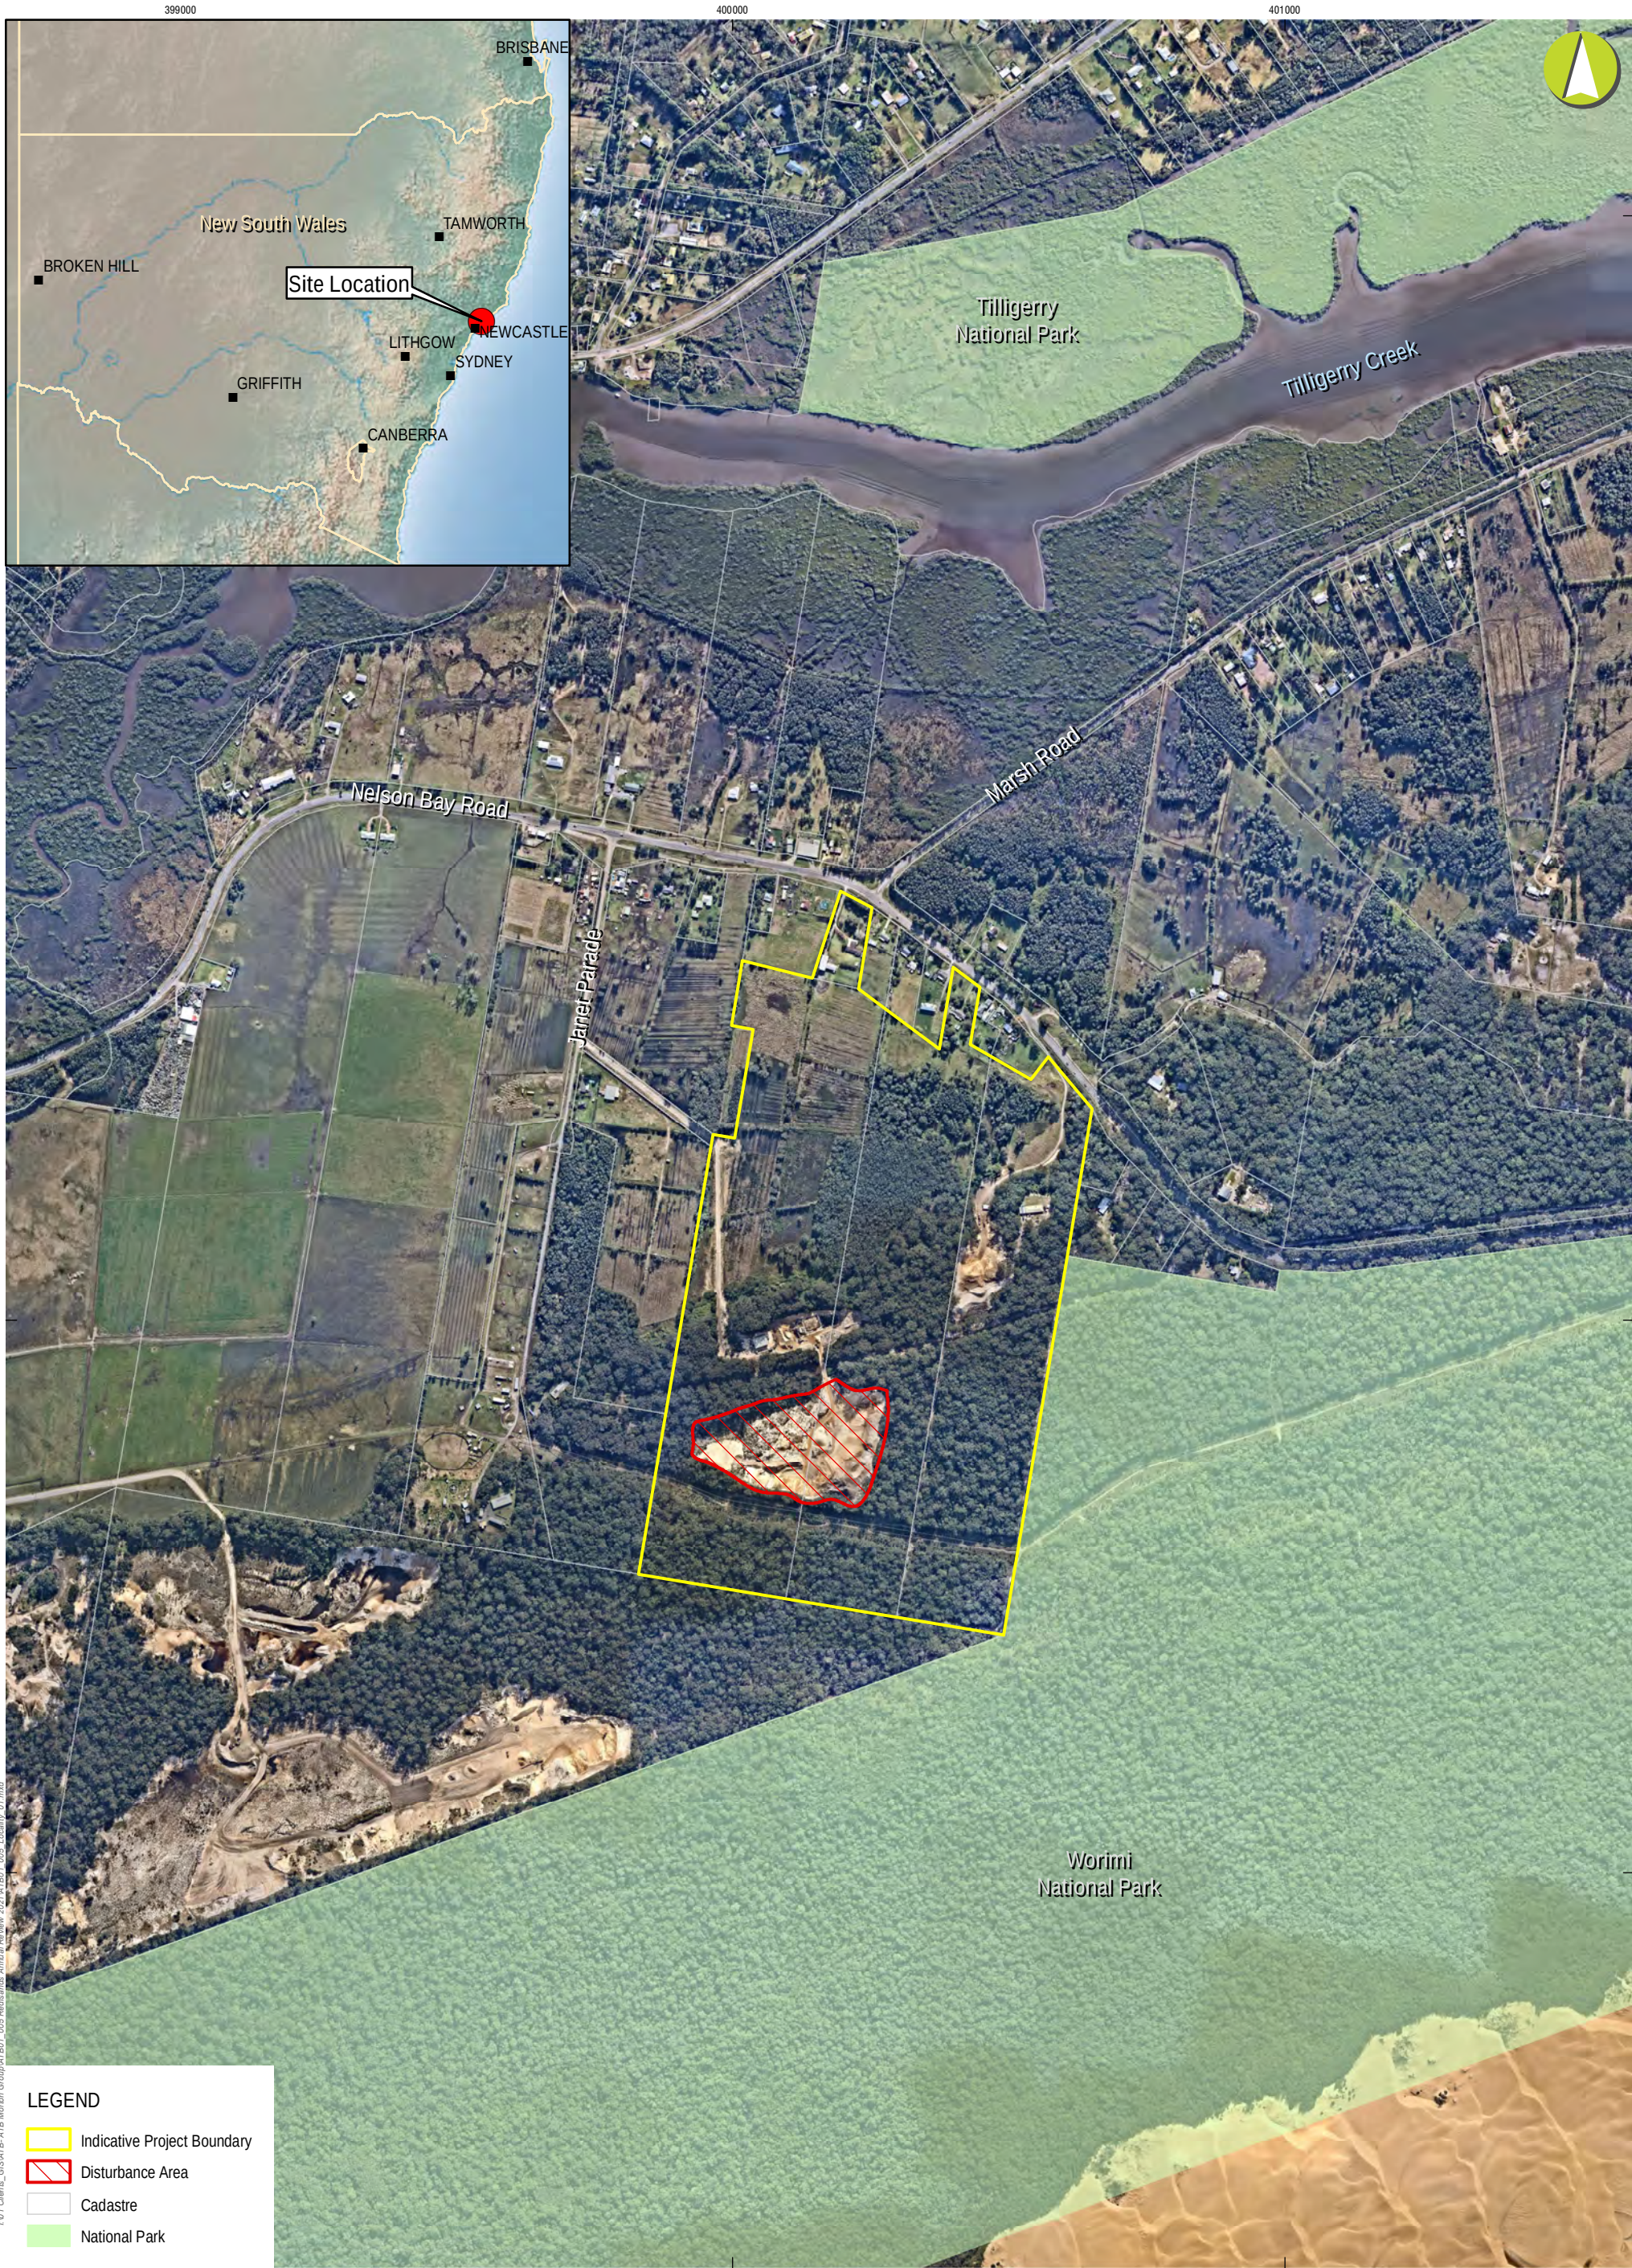
| FIGURE 2 – DISTURBANCE FOOTPRINT (IEMA, 2022)..... | 14 |

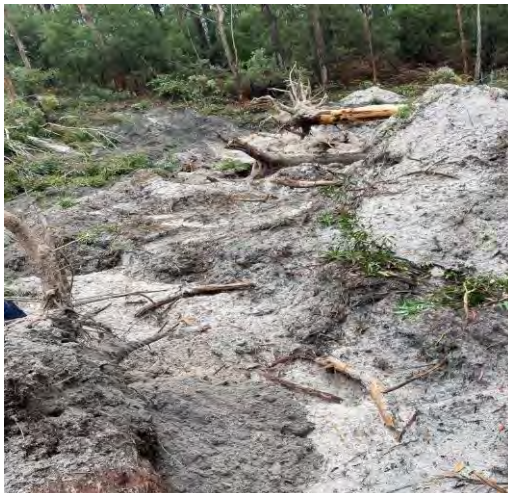
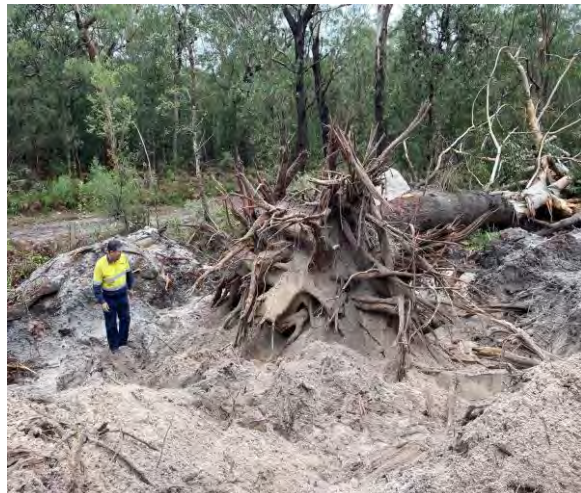
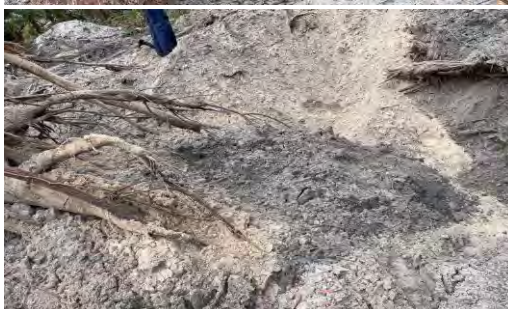
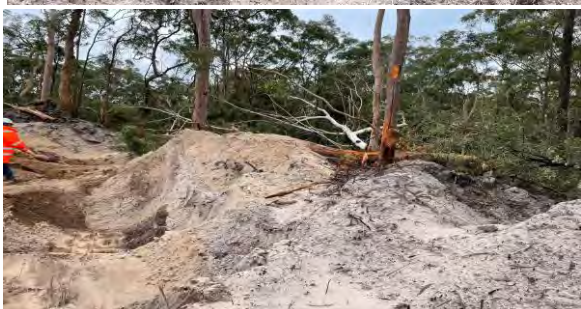
We also completed a walk over of the site which has been cleared of vegetation and remediation has begun including investigation of the overburden where cultural material may be identified in the remnant soils.

This process is being completed to follow current plans in place and to ensure protection of local Aboriginal Sites and collection of cultural material for further education and reburial of Worimi Aboriginal Objects. This inspection was completed by site officers' walking in transects over the area.

No cultural material was identified onsite during vegetation clearing or within the remnant/overburden soils.

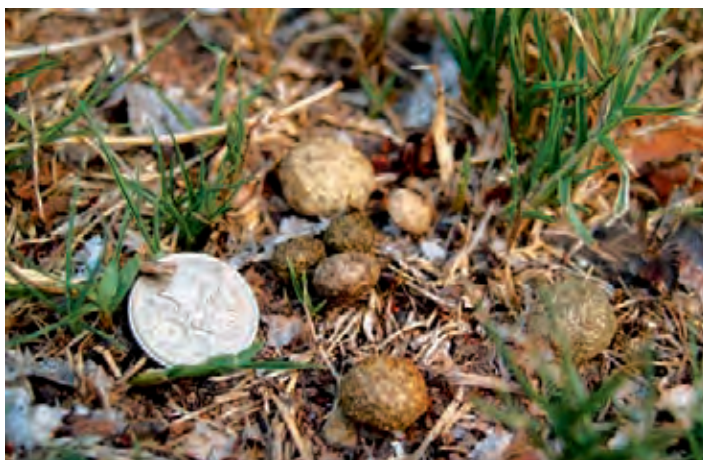
**FIGURE 1:** Typical small clump of rabbit pellets (faeces) in grassland.

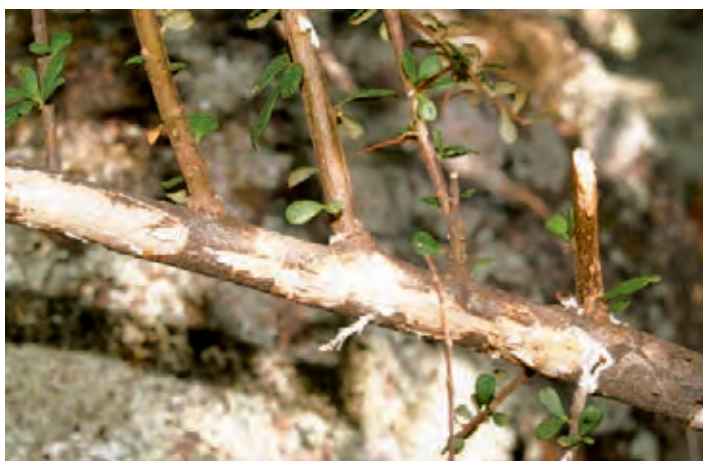
**FIGURE 2:** Rabbit damage showing stripping of bark and 45° ‘secateurs-like’ cuts through twigs.

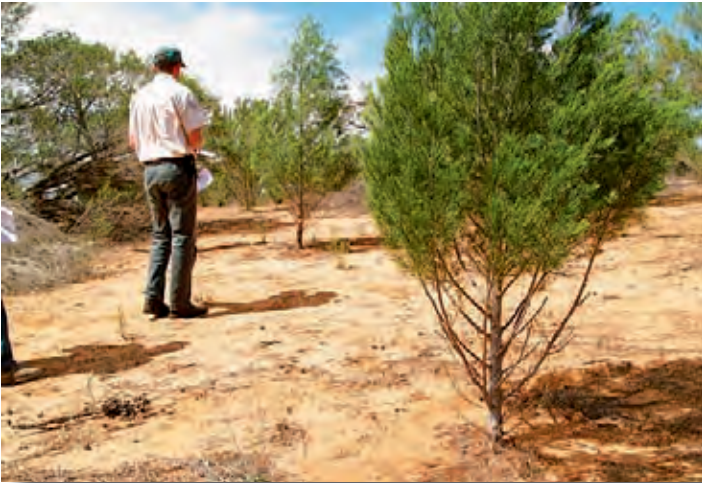
In some instances rabbits may have eaten all of the seedlings but the severity of grazing can still be ranked at '5' from the presence of a distinct 'browse-line' 500 millimetres above the ground on older saplings or mature shrubs with lower foliage within reach of the rabbits (see **Figure 3**).

**FIGURE 3: Absence of small seedlings and a distinct 'browse-line' 500 millimetres above the ground on older saplings indicates severe rabbit impact (Damage score = 5).**

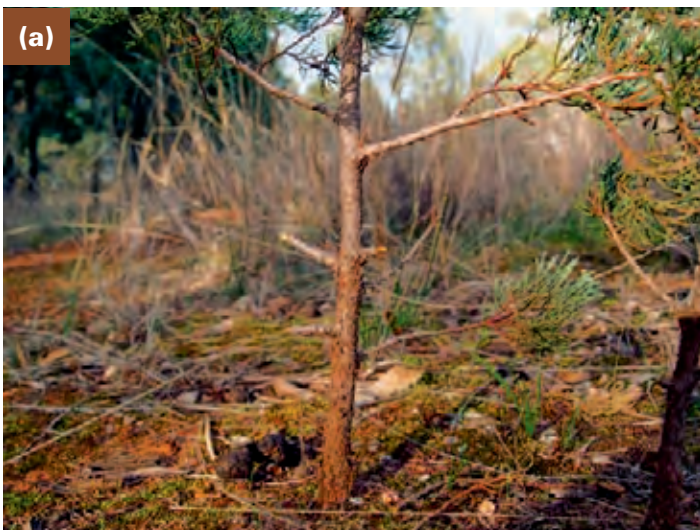
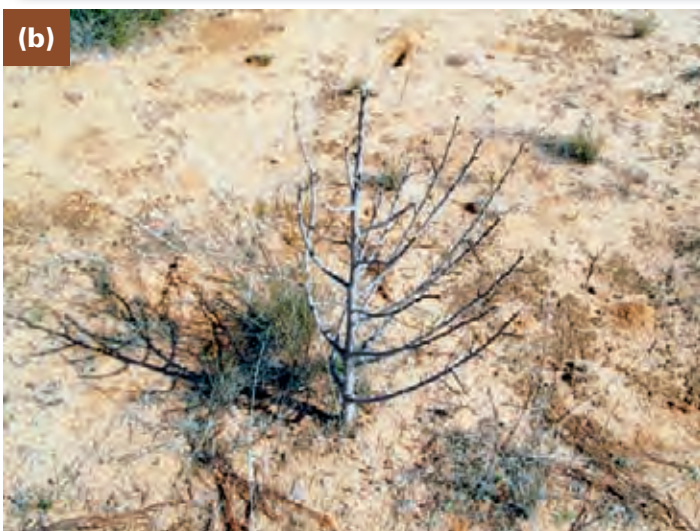
**FIGURE 4:** Native pines with: (a) little damage (score 1); or (b) complete defoliation (score 5).
