## **Salt Ash Sand Quarry**

### Annual Review 2023

ATB Morton Pty Ltd

March 2024

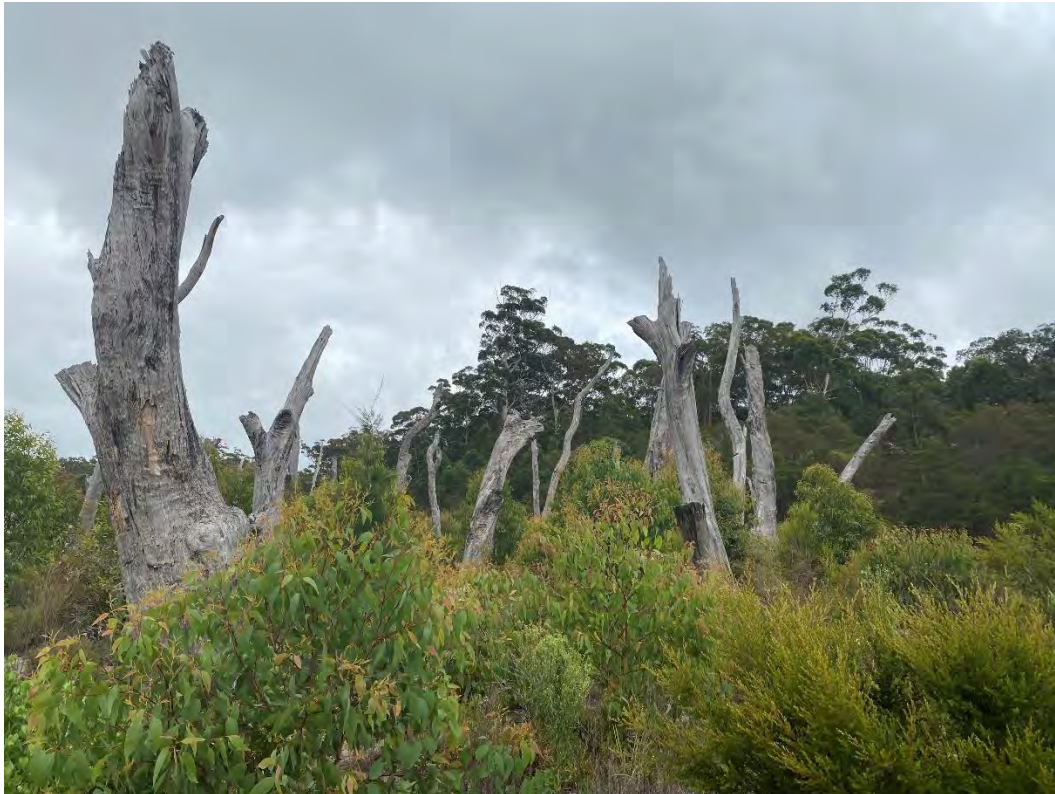
Photo 1: Healthy rehabilitation with hollow bearing trees.

*Note: Multiple hollow bearing trees are unsable and unsafe to monitor for site personel.*

Nest box monitoring was not conducted during the 2023 reporting period due to staff safety access. The nest boxes have been deemed unstable, and monitoring of the nest boxes is unsafe, see **Appendix H**.

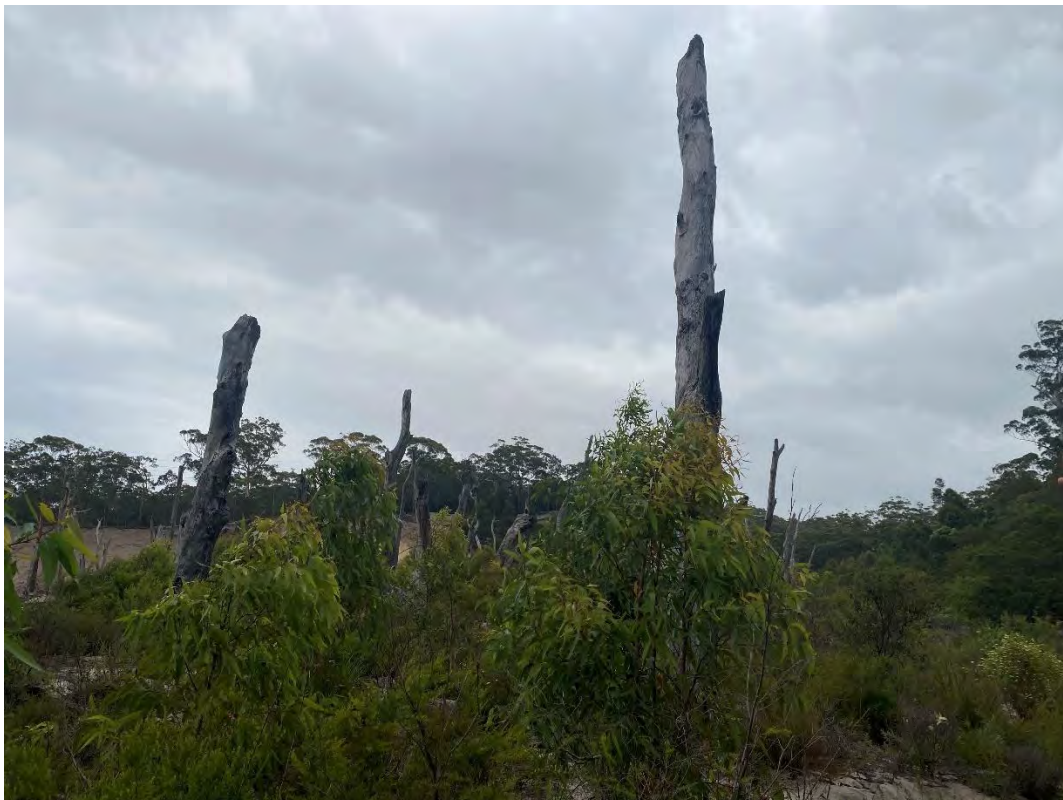
Photo 4: Rehabilitation showing large hollow bearing trees.

*Note: Multiple hollow bearing trees are unsable and unsafe to monitor for site personel.*

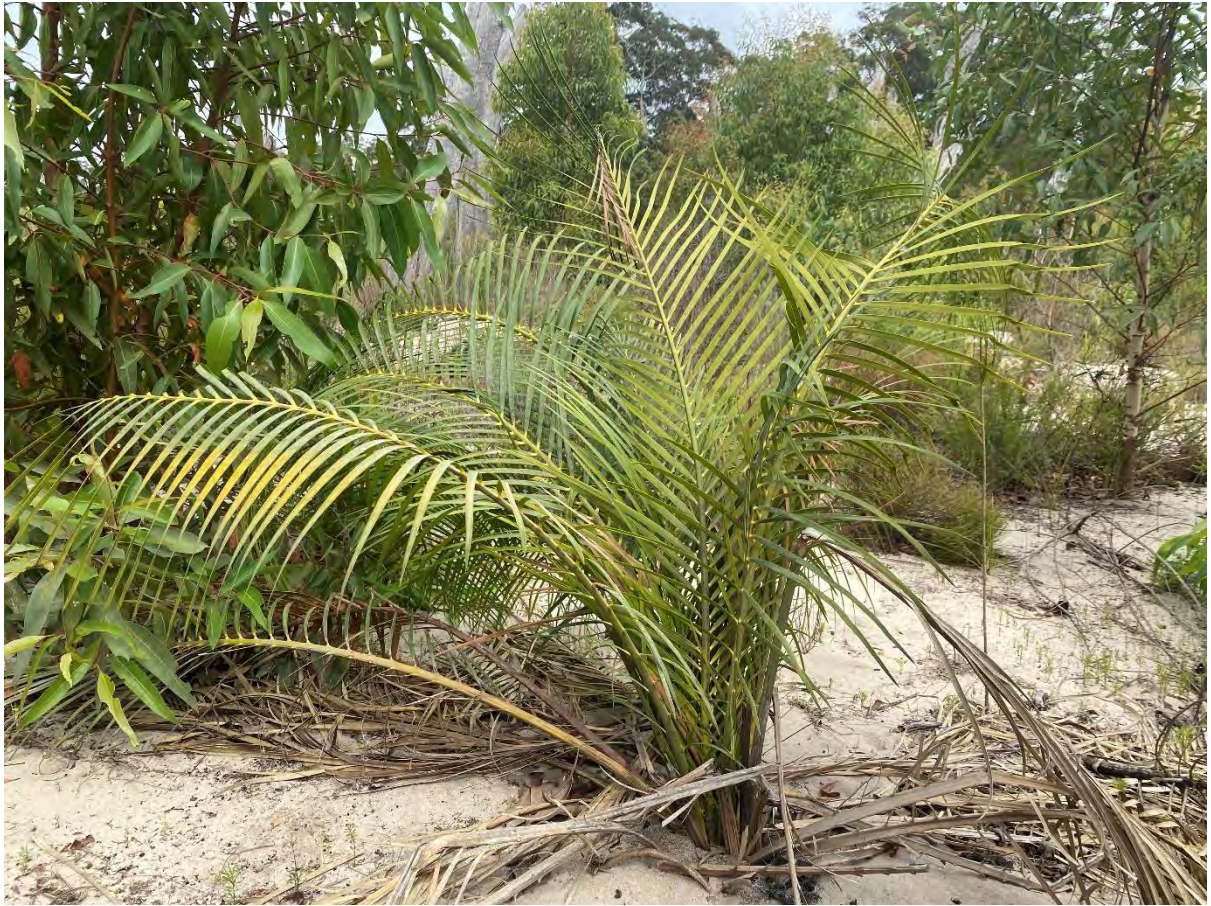
Photo 5: Active rehabilitation.
