APPENDIX D **Aboriginal due diligence advice – emergency storage tank, Cattai Creek carrier, Mile End Road, Rouse Hill, NSW**

**Re: Aboriginal Heritage Due Diligence Advice - Emergency Storage Tank, Cattai Creek Carrier,
Mile End Road, Rouse Hill NSW**

SYDNEY WATER EMERGENCY STORAGE TANK, CATTAI CREEK CARRIER: ABORIGINAL HERITAGE DUE DILIGENCE ADVICE

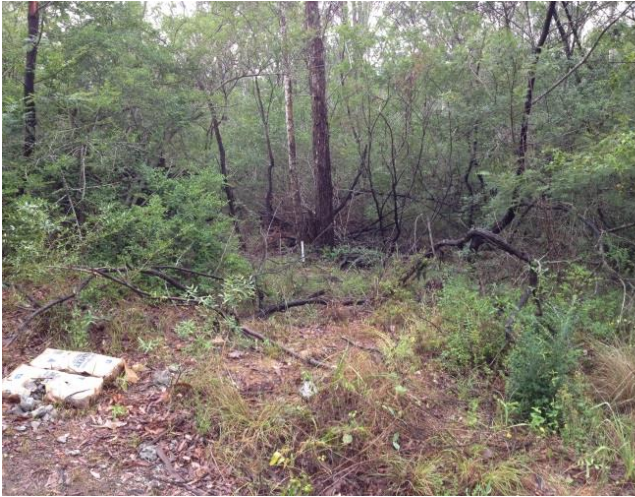
Figure 5 *Regrowth trees north of the road end*

The site inspection also confirmed that the local landscape has been cleared. Several areas are now populated by regrowth trees (**Figure 5**). The south of subject area has been levelled for the road and cycle path with evidence of earthworks also visible, including the construction a drainage channel (**Figure 6 - Figure 10**). There are no sandstone outcrops with art work visible or rock shelters located in the study area.

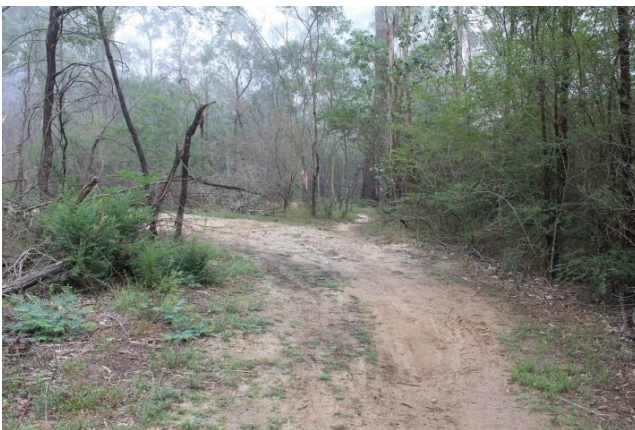
Figure 9 *Artefact scatter identified during site inspection on 7 March 2014 facing north*

Two Aboriginal objects were identified during the site visit; one yellow silcrete proximal flake and one red silcrete proximal flake. The objects had been exposed in a white-yellow sand body at the edge of a dirt walking track approximately 20m away from the proposed development footprint (**Figure 4**). The area where the objects were found is 90m south of Second Ponds Creek on a terrace flat area. There were no other objects identified in the sand body due to vegetation coverage that gave the ground surface low visibility, however, there is potential for this sand body to contain more Aboriginal objects (**Figure 11**).

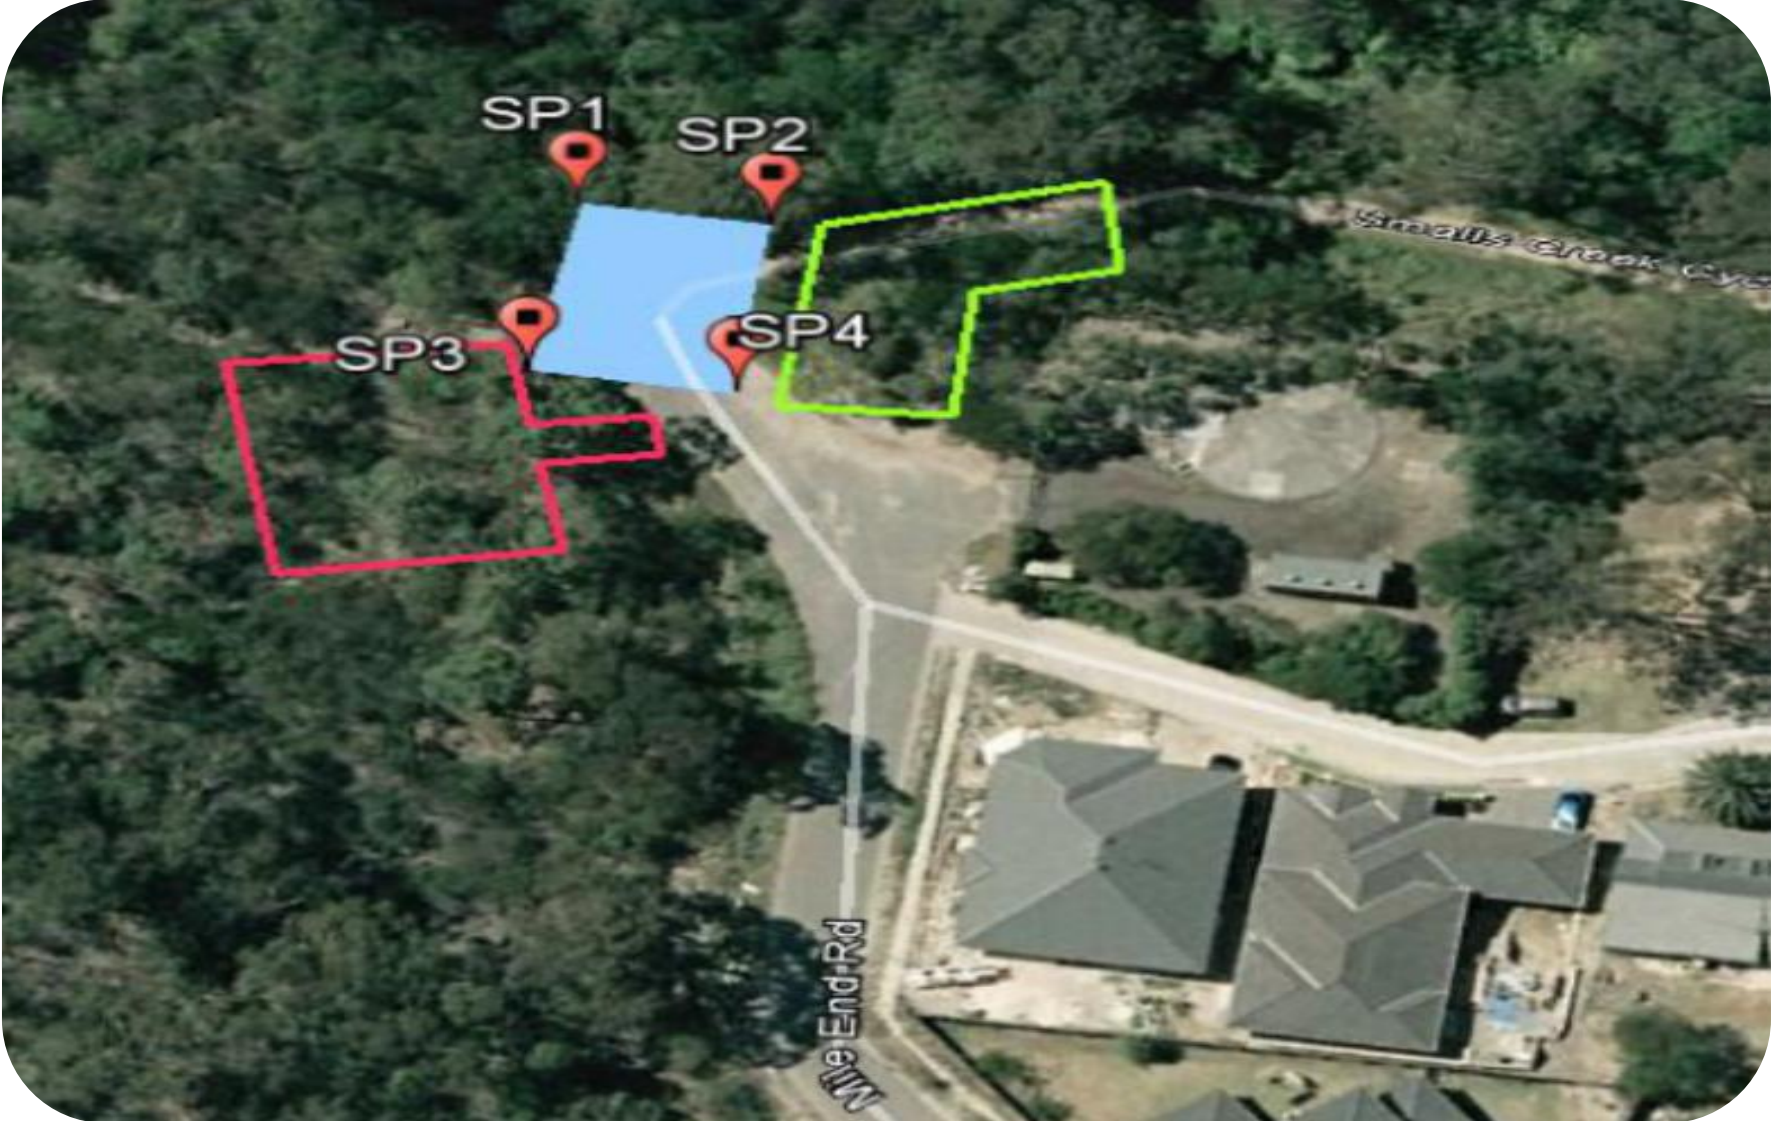
Construction overview

- Reinforced concrete in-ground tank
- Existing road will be reinstated
- The cycle-way will be reinstated and adjusted to the new street level
- Bollards and handrails will be installed for public safety
