# Riverina Oils and BioEnergy

Integrated Oilseed Processing Plant

Appendix H  
Groundwater Review

# Groundwater Review for Integrated Oilseed Processing and Biodiesel Plant

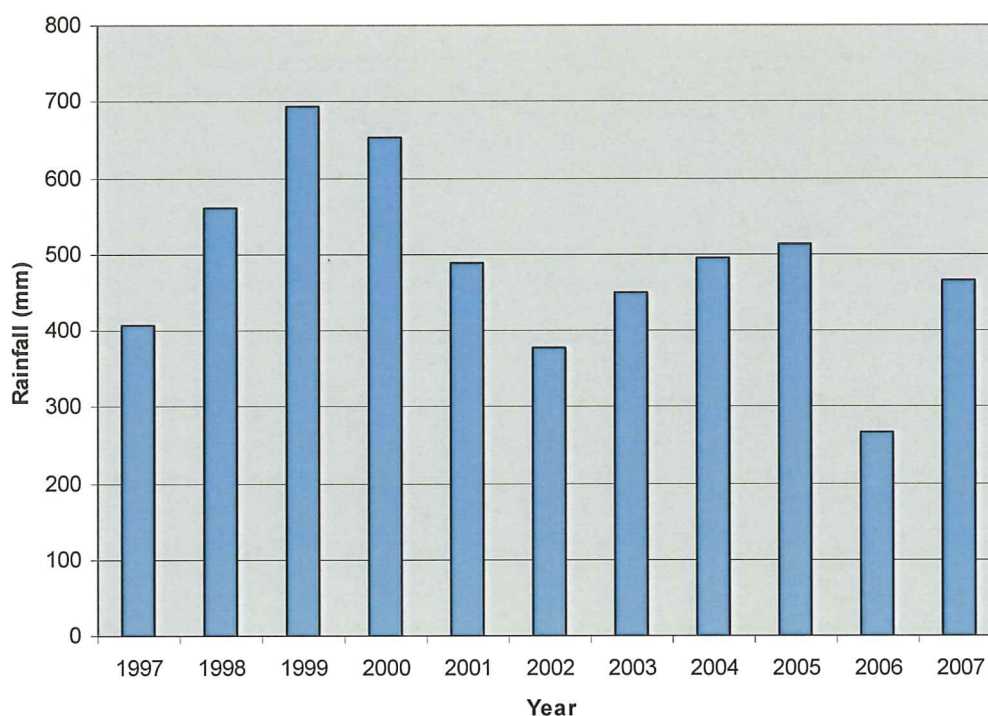
Figure 1: Graphical Representation of Annual Rainfall 1999 – 2006

Average monthly rainfall over the period 1997 to 2007 is presented in **Table 1** below.

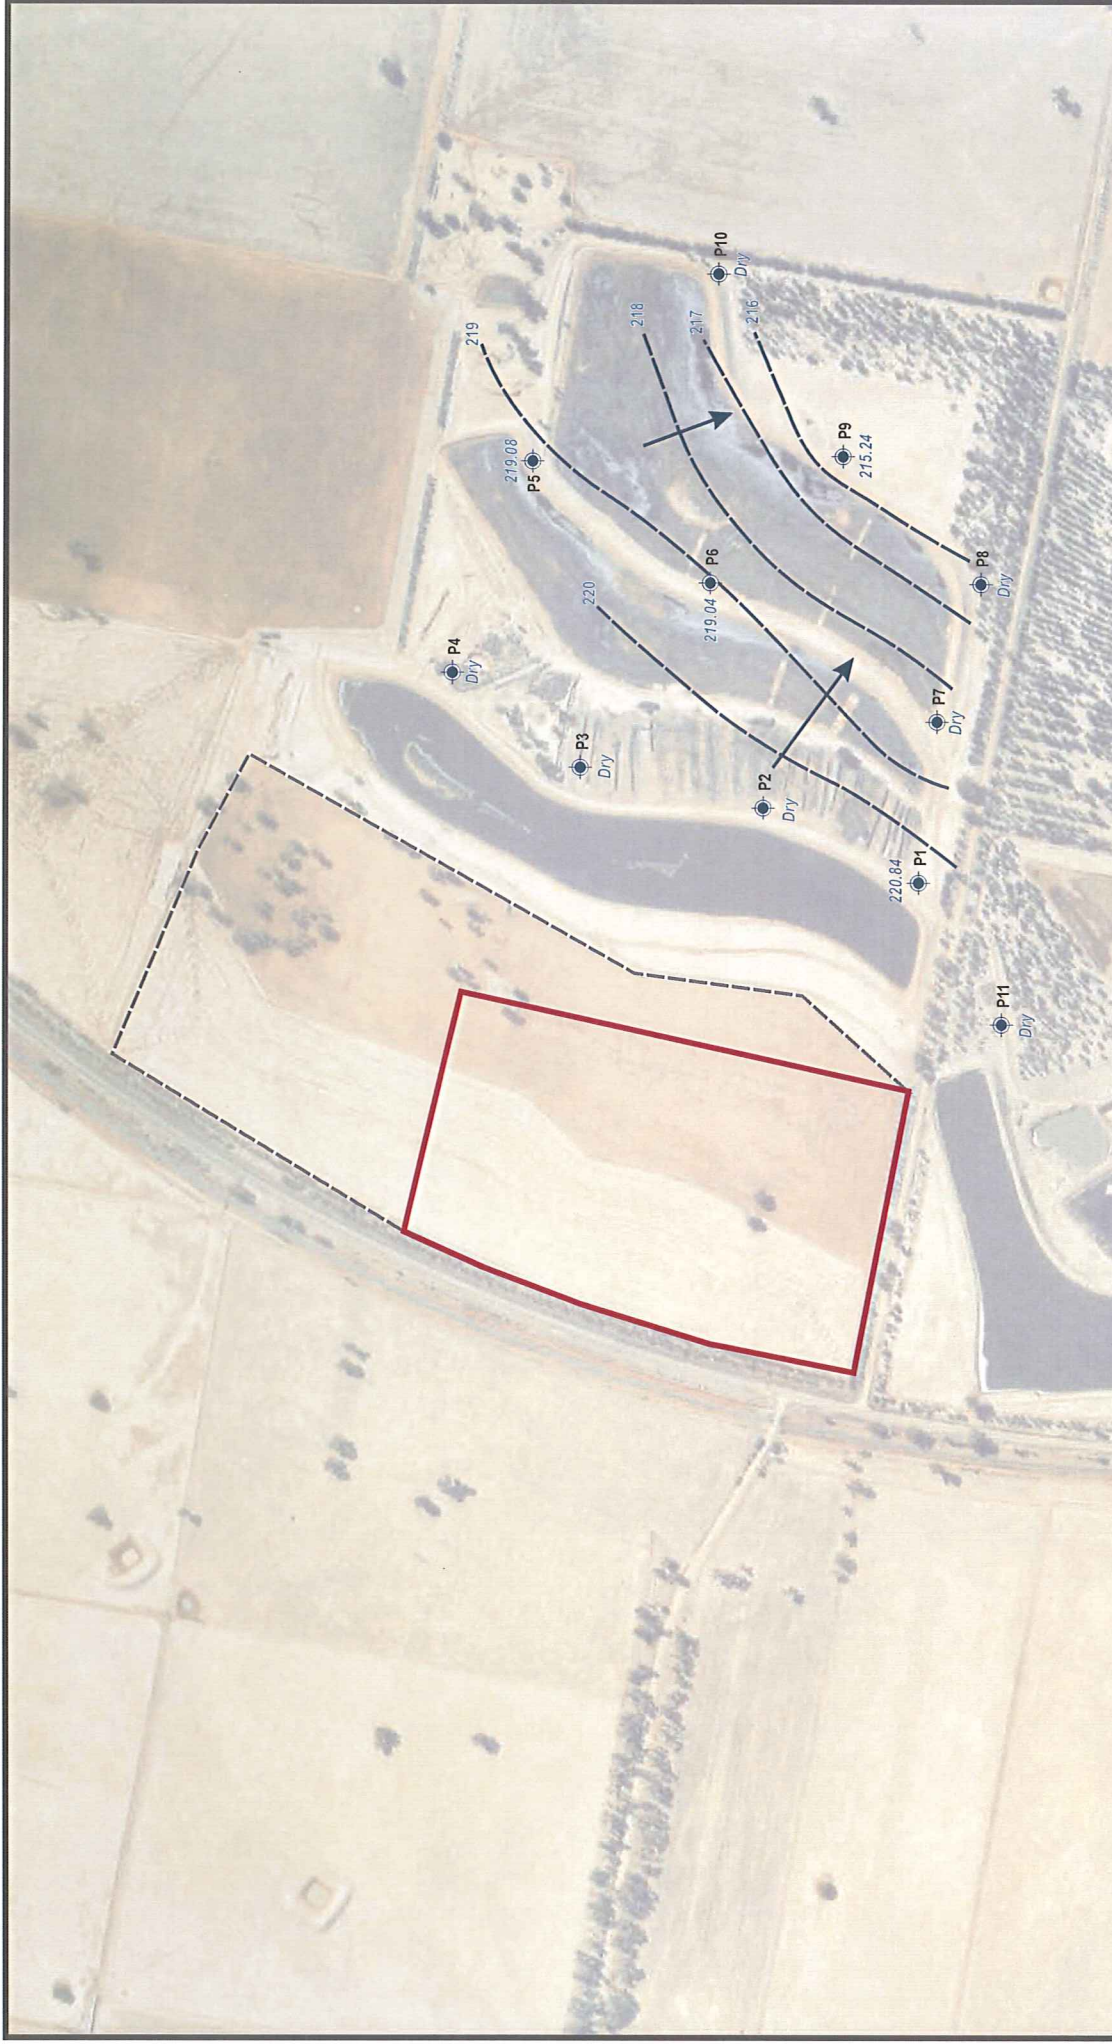
**Figure 3** Groundwater Standing Water Levels:  
Deep Aquifer Summer 07/01/2004  
Riverina Oils and Bio Energy Pty Ltd  
Groundwater Review  
Integrated Oilseed Processing and  
Biodiesel Plant

Approximate project footprint  
Property boundary  
Inferred groundwater contour (mAHd)  
Inferred groundwater flow direction  
Standing water level

Review of the available historical groundwater level data indicates that the previous use of the ponds caused little variation in deep groundwater flow direction. An assessment of the impact to shallow groundwater was unable to be undertaken due to limited historical data.

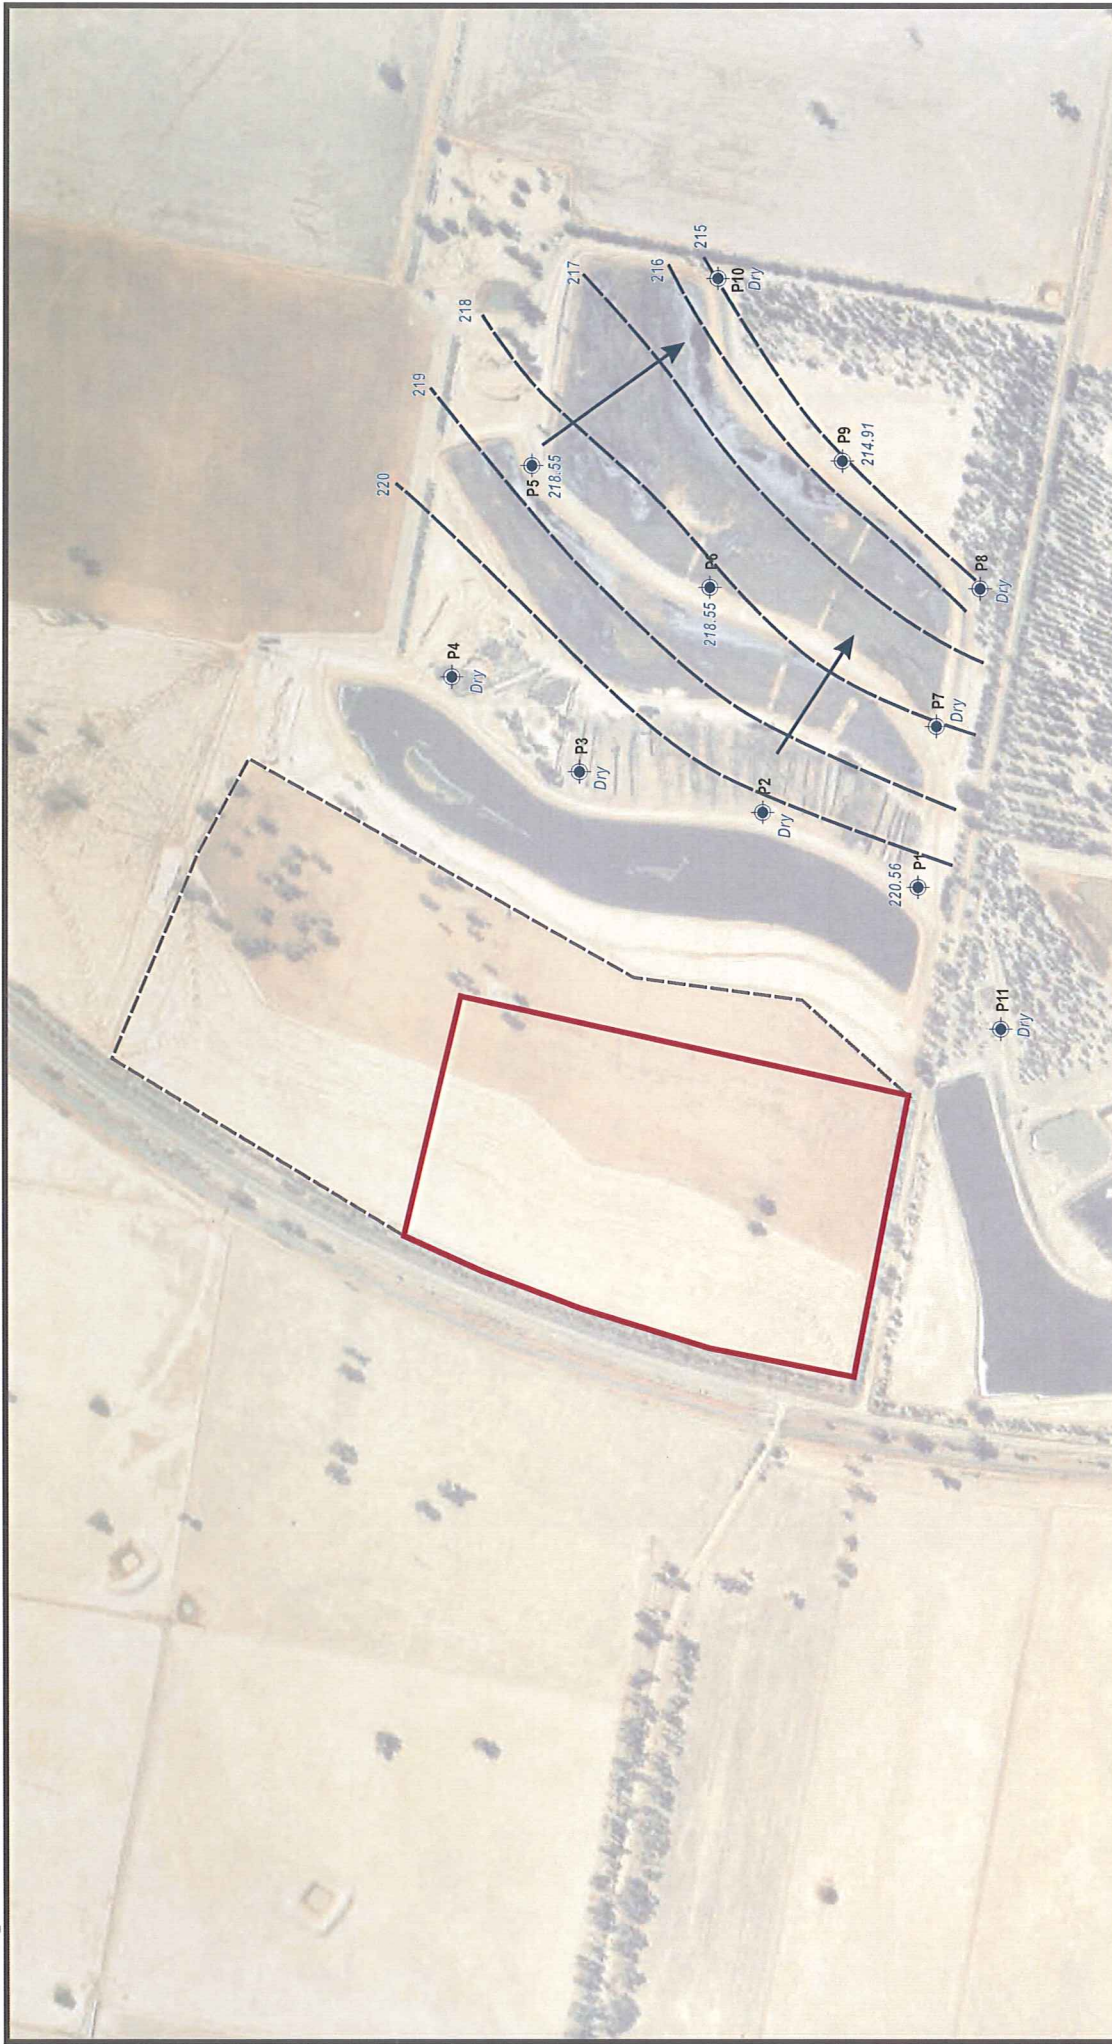
Note: P12 - P20b are located outside the study area

Approximate project footprint

Monitoring wells P1, P2, P3 P4, P5, P6, P7 and P11 are the closest wells to the subject site and evaporation pond proposed for use. Refer to **Figure 3 to 8** for location of these wells.

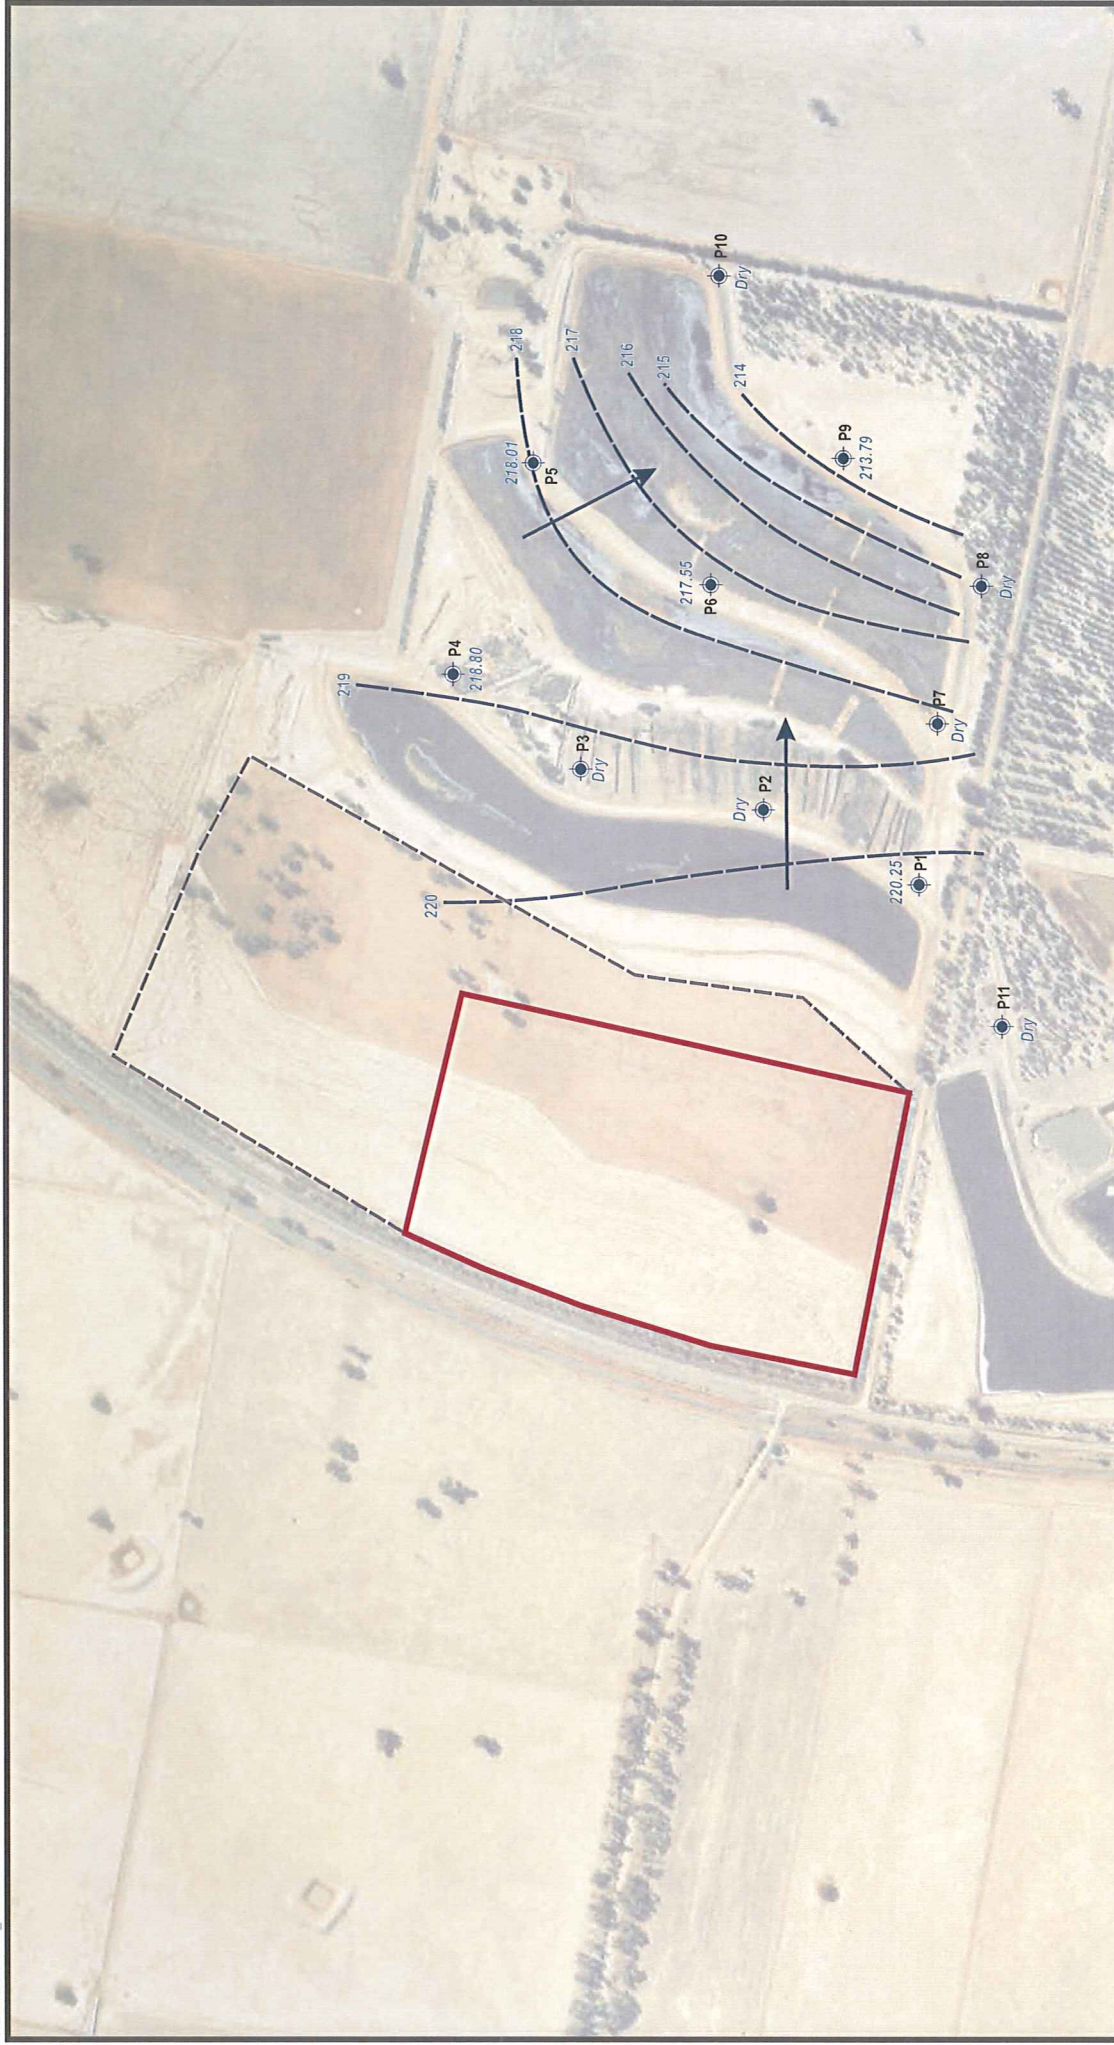
**Figure 5** Groundwater Standing Water Levels:  
Deep Aquifer Summer 05/01/2006

- Approximate project footprint
- - - Property boundary
- - - Inferred groundwater contour (mAHD)
- Inferred groundwater flow direction
- 215.24 Standing water level

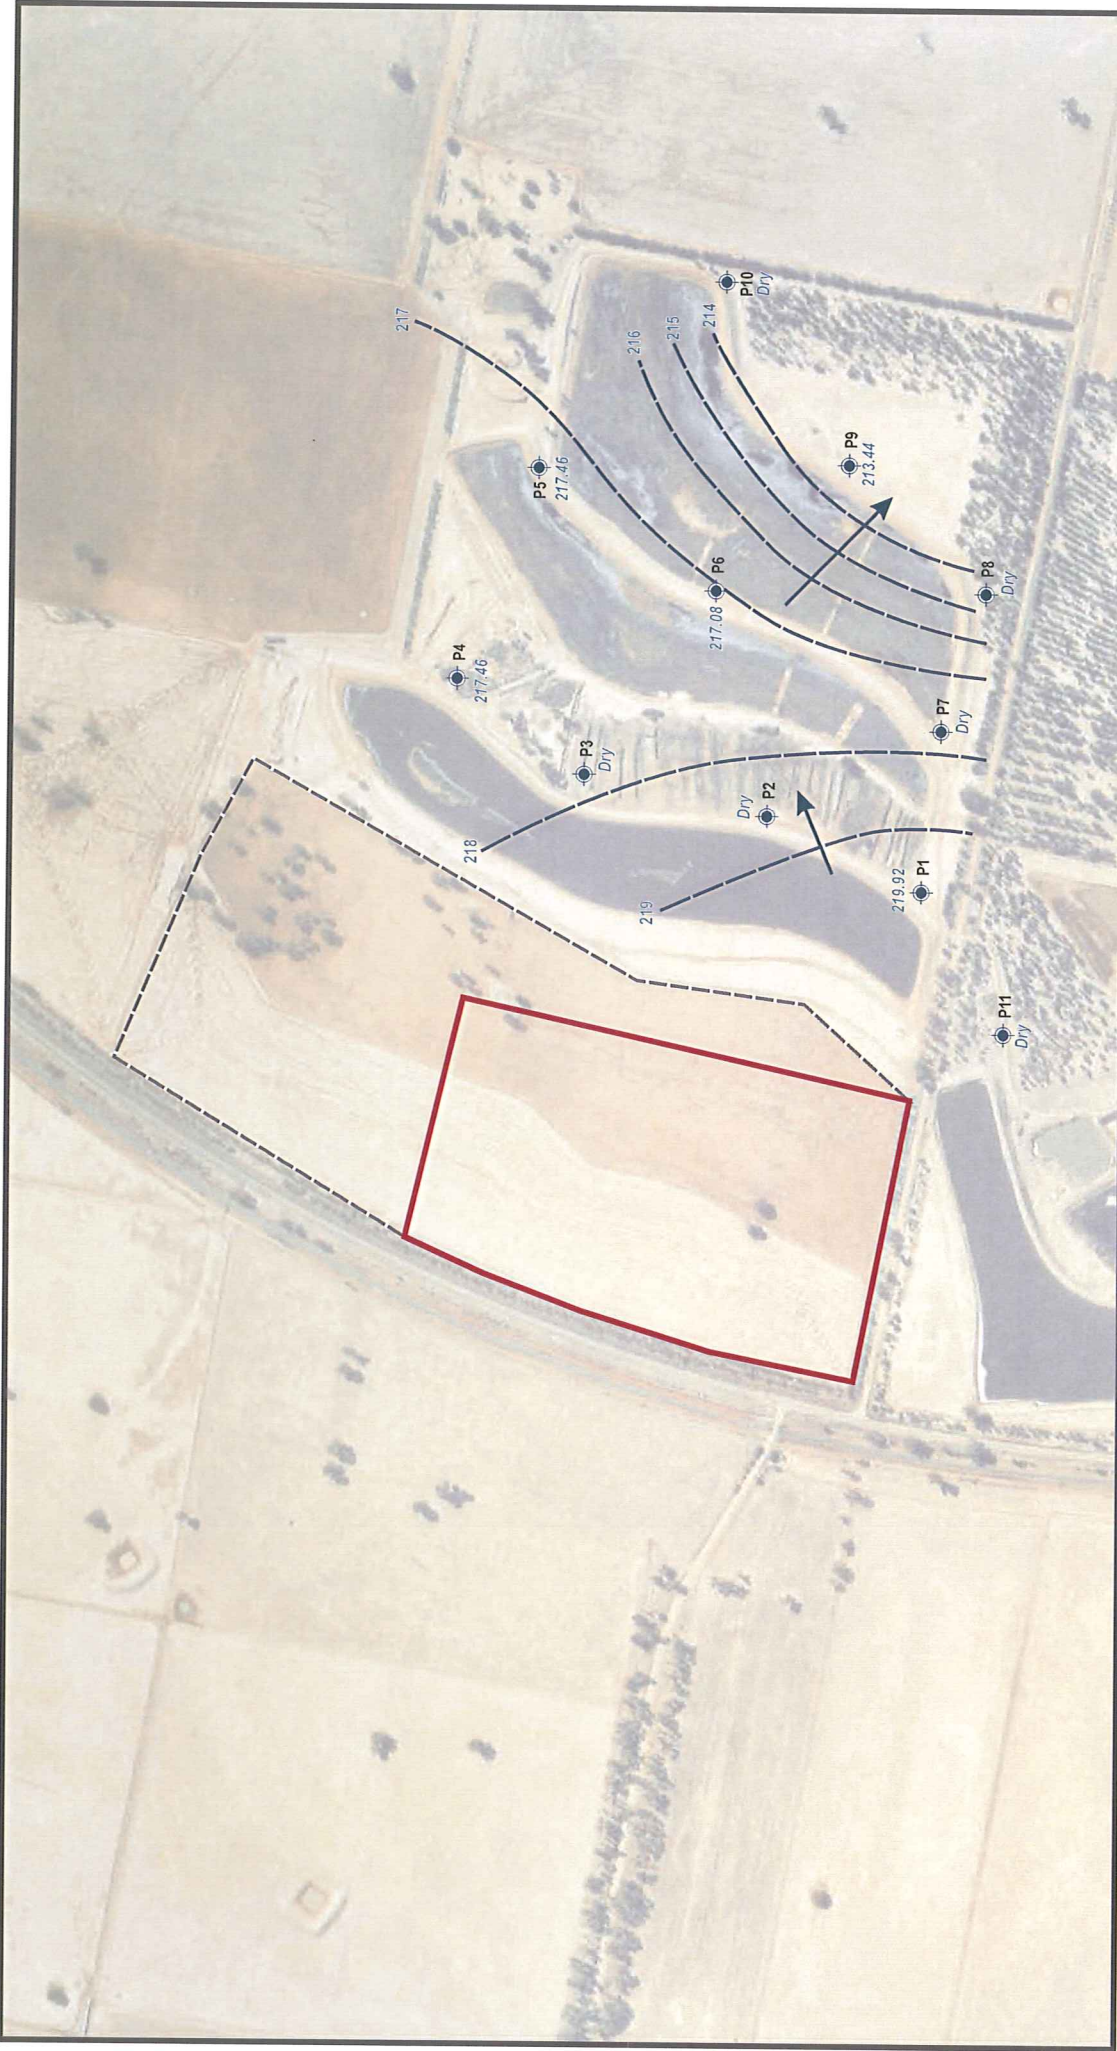
**Figure 6** Groundwater Standing Water Levels:  
Deep Aquifer Winter 12/07/2006  
Riverina Oils and Bio Energy Pty Ltd  
*Groundwater Review*  
Integrated Oilseed Processing and  
Biodiesel Plant

- Approximate project footprint
- - - Property boundary
- - - Inferred groundwater contour (mAHd)
- Inferred groundwater flow direction
- 215.24 Standing water level

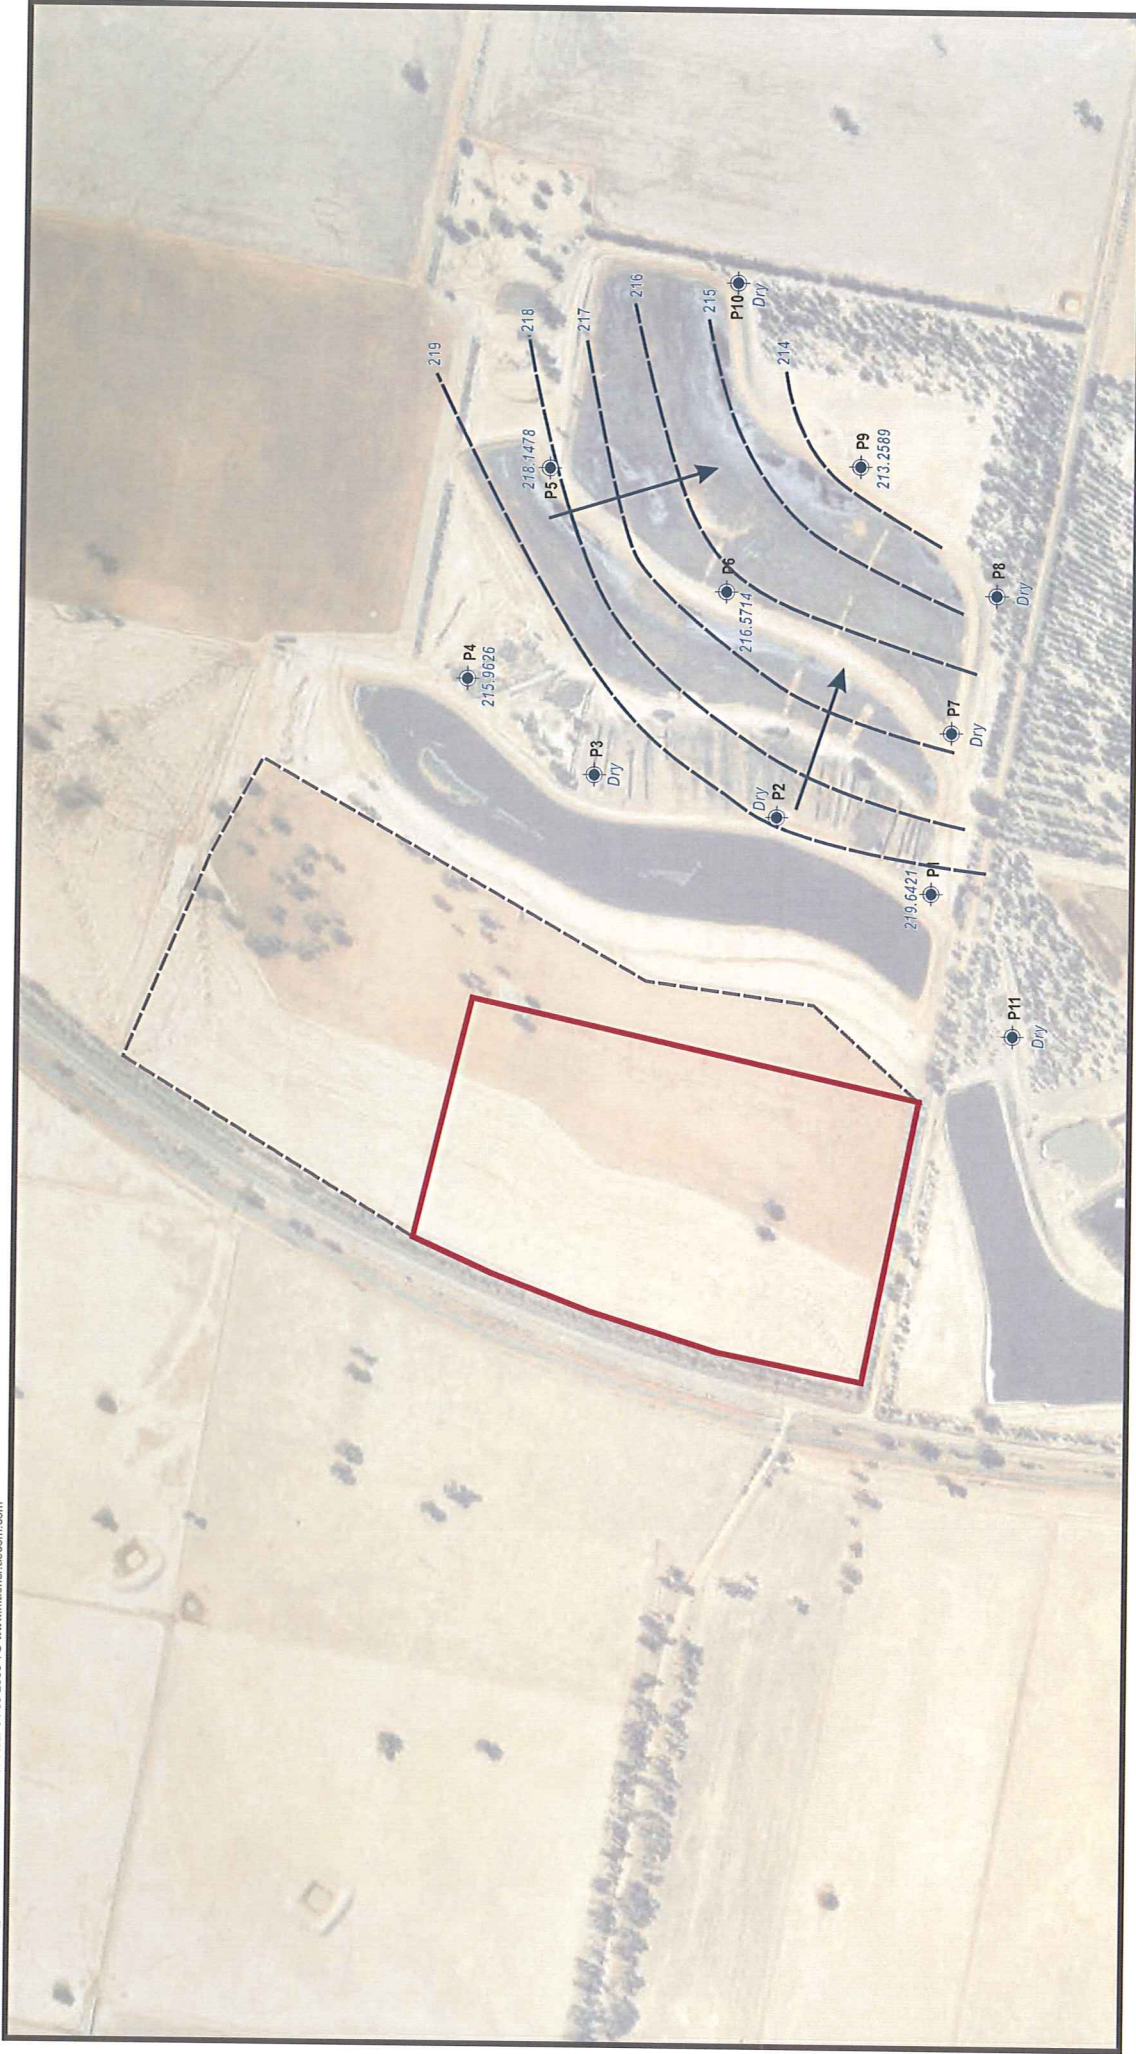
**Figure 7** Groundwater Standing Water Levels:  
 Deep Aquifer Summer 01/01/2007  
 Riverina Oils and Bio Energy Pty Ltd

— Approximate project footprint  
--- Property boundary  
--- Inferred groundwater contour (mAHD)  
→ Inferred groundwater flow direction  
215.24 Standing water level

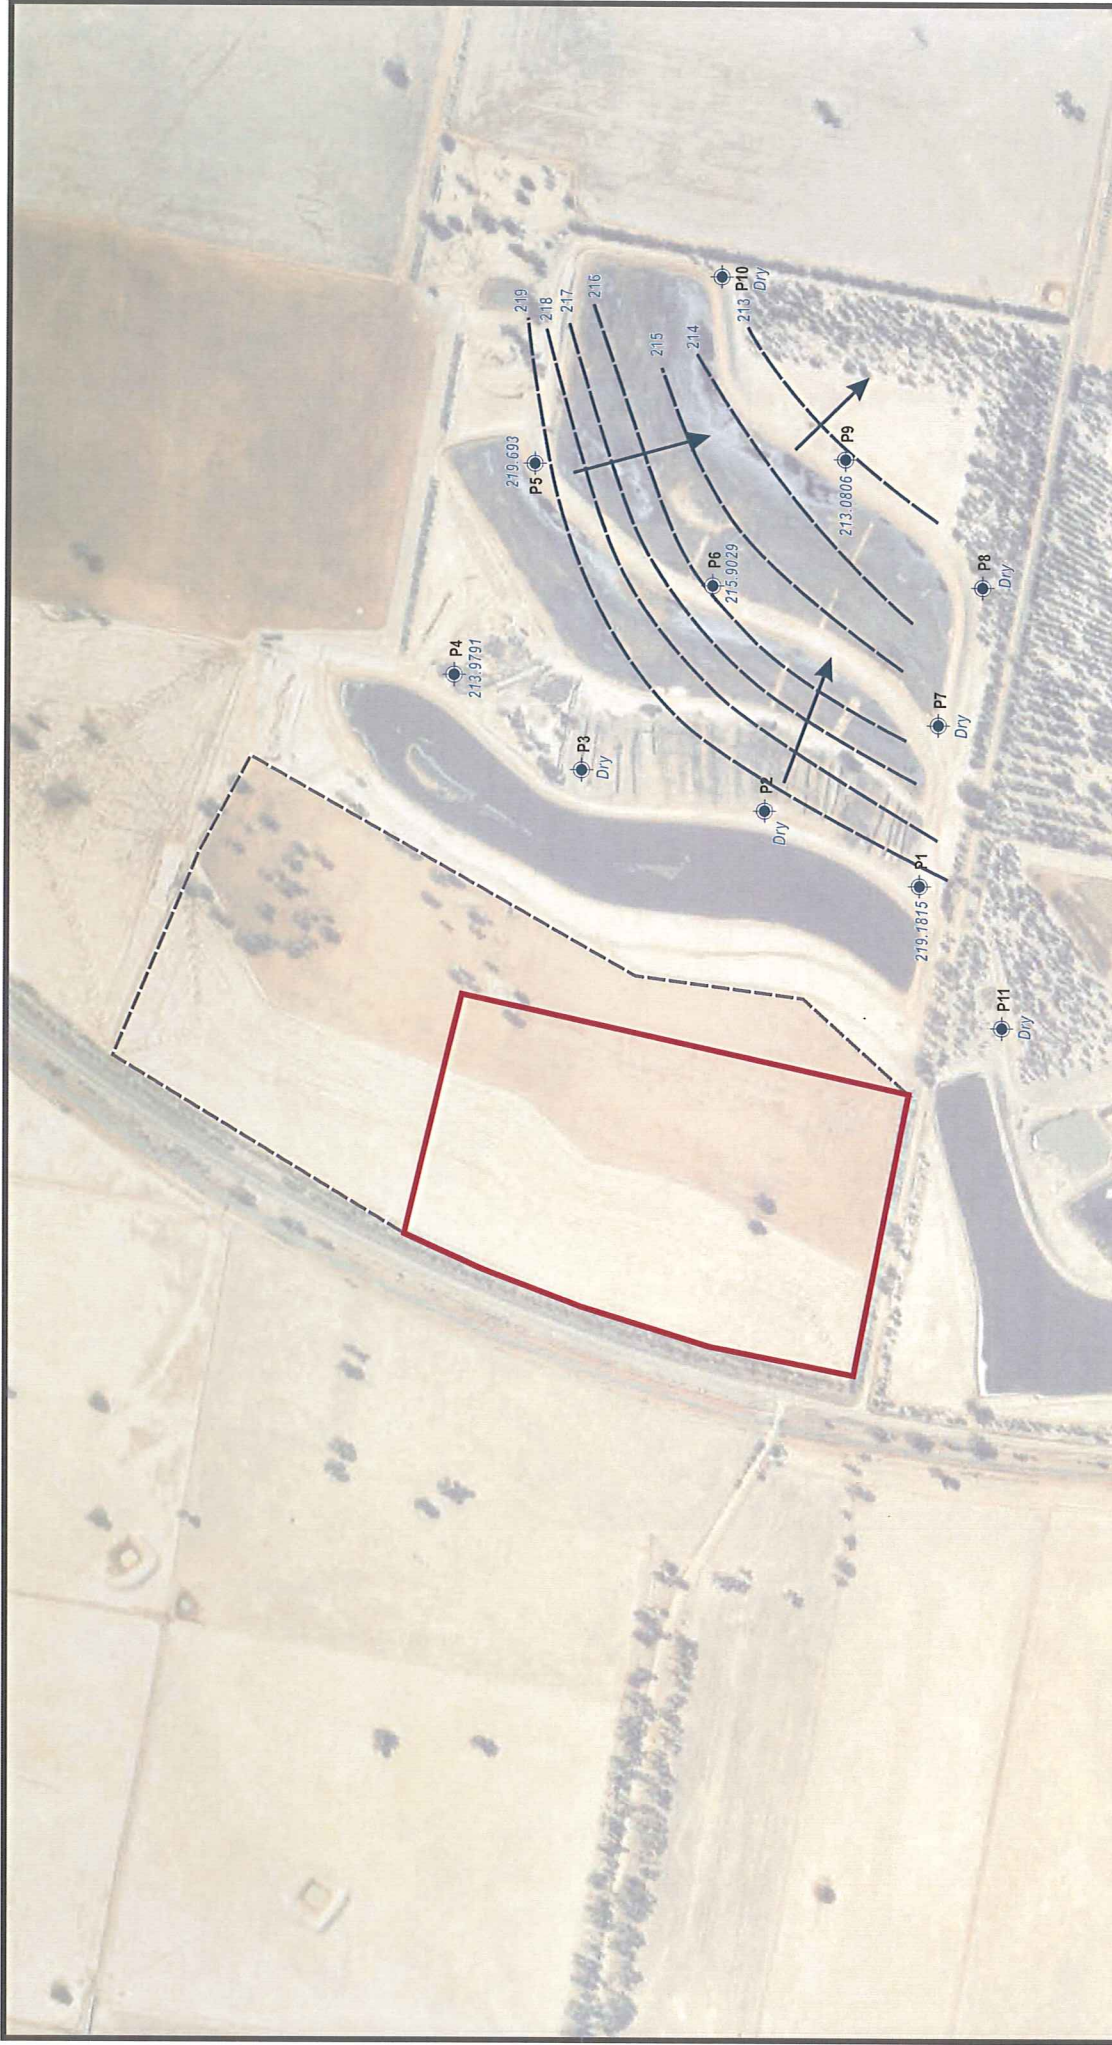
**Figure 8** Groundwater Standing Water Levels:  
Deep Aquifer Winter 03/07/2007

Approximate project footprint  
Property boundary  
Inferred groundwater contour (mAHd)  
Inferred groundwater flow direction  
Standing water level  
215.24

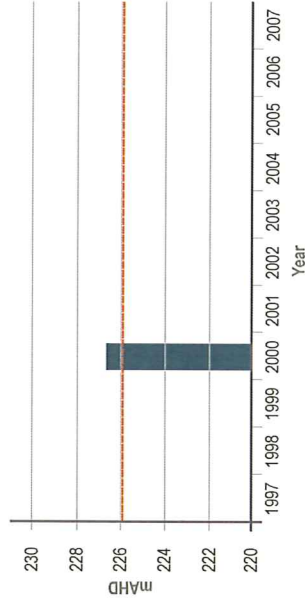
Figure 12 | Piezometer Hydrographs 10A - 12B

Maximum well depth

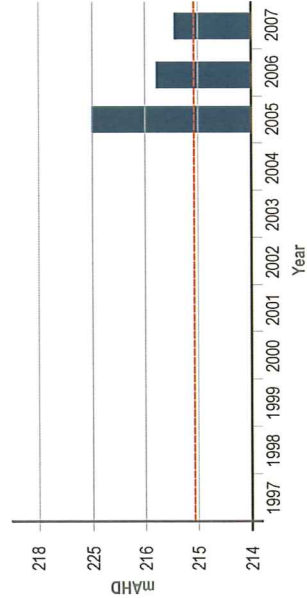
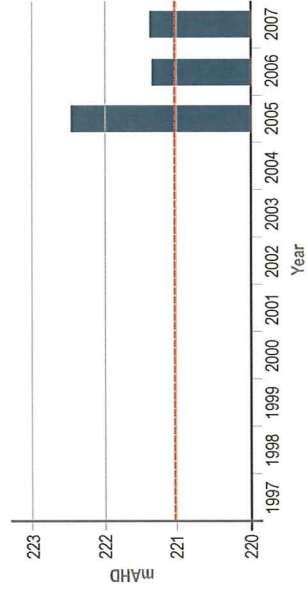
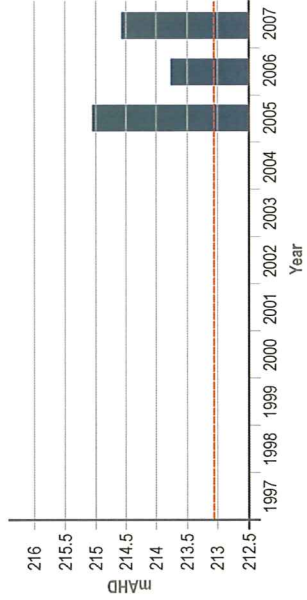
Figure 15 | Piezometer Hydrographs 19B - 20B

Maximum well depth
