3.0 Analysis of Evidence

634–726 Princes Highway, Tempe—Heritage Advice June 2007

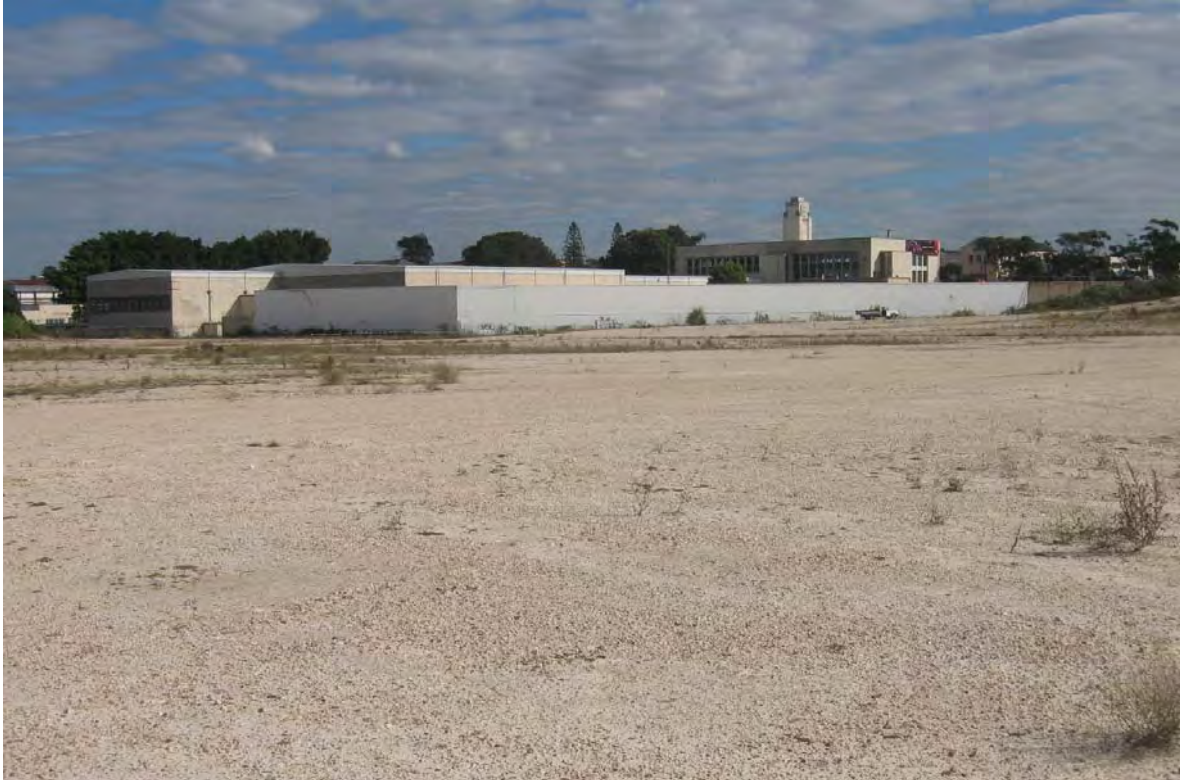
Figure 3.1 View to the west showing the large area of sandstone rubble fill located across the eastern half of the subject site. Note the c1959 constructed Penfolds Warehouse complex with its distinctive clock tower. The sandstone fill is likely to cap the fill of the quarry, associated with the former brickworks, which was located in this area of the site. (Source: GML 2008)

Extensive surface modification (including the introduction of fill deposits) and grading/excavation works have occurred. The eastern (at present undeveloped) half of the site consists of a large area of sandstone rubble fill (see Figure 3.1). This fill is likely to cap the St Peters Council tip that was in operation from c1942–1961 in the area of the site formerly occupied by the brickworks quarry. The extensive quarry would have removed any earlier archaeological remains.

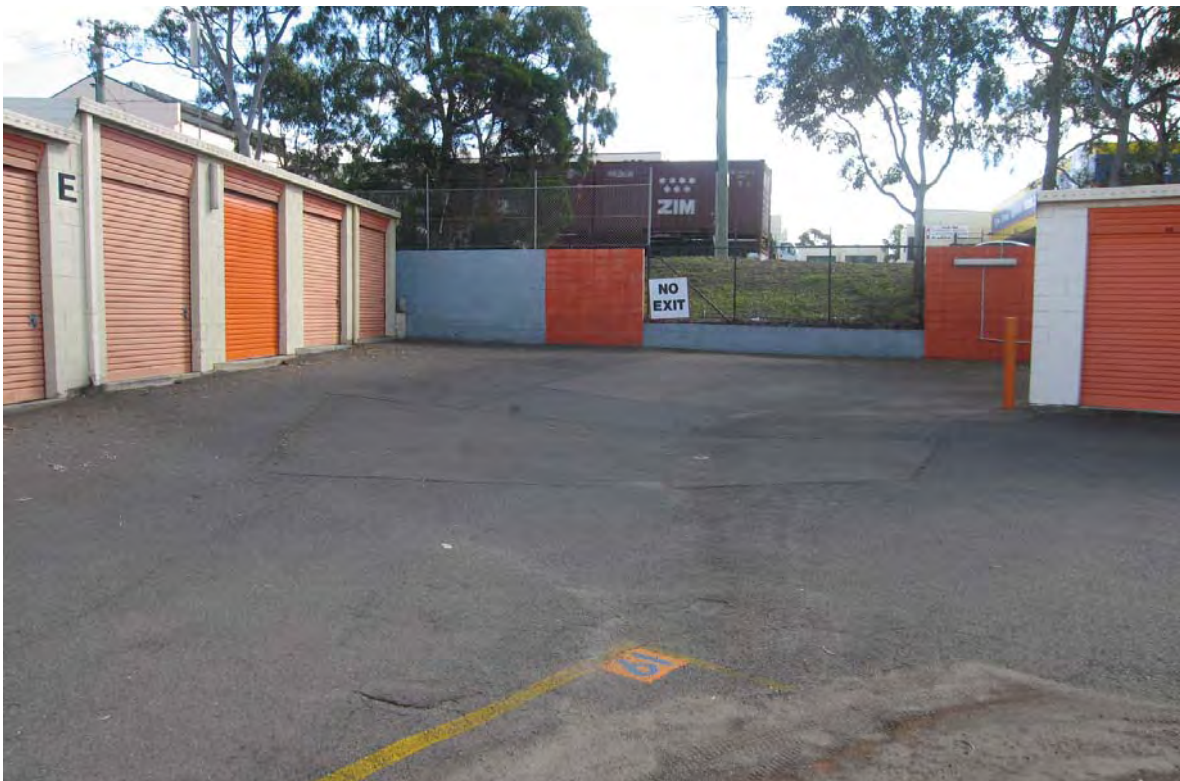
Figure 3.2 View to northwest of the north-western corner of the Kennards Storage Depot. Note the graded ground level of the depot compared to the level of the Princes Highway at the rear of the photograph. (Source: GML 2008)

The construction of the brickworks in the late nineteenth century on the area of the site now occupied by the Kennards Storage Depot is also likely to have extensively disturbed any earlier archaeological remains formerly located in this part of the site. The demolition of the brickworks and subsequent grading and preparation of the land prior to the construction of the Kennards Depot is likely to have disturbed evidence the brickworks, especially in the northwestern corner of the Kennards site where the ground level has been cut below the level of the Princes Highway (see Figure 3.2).

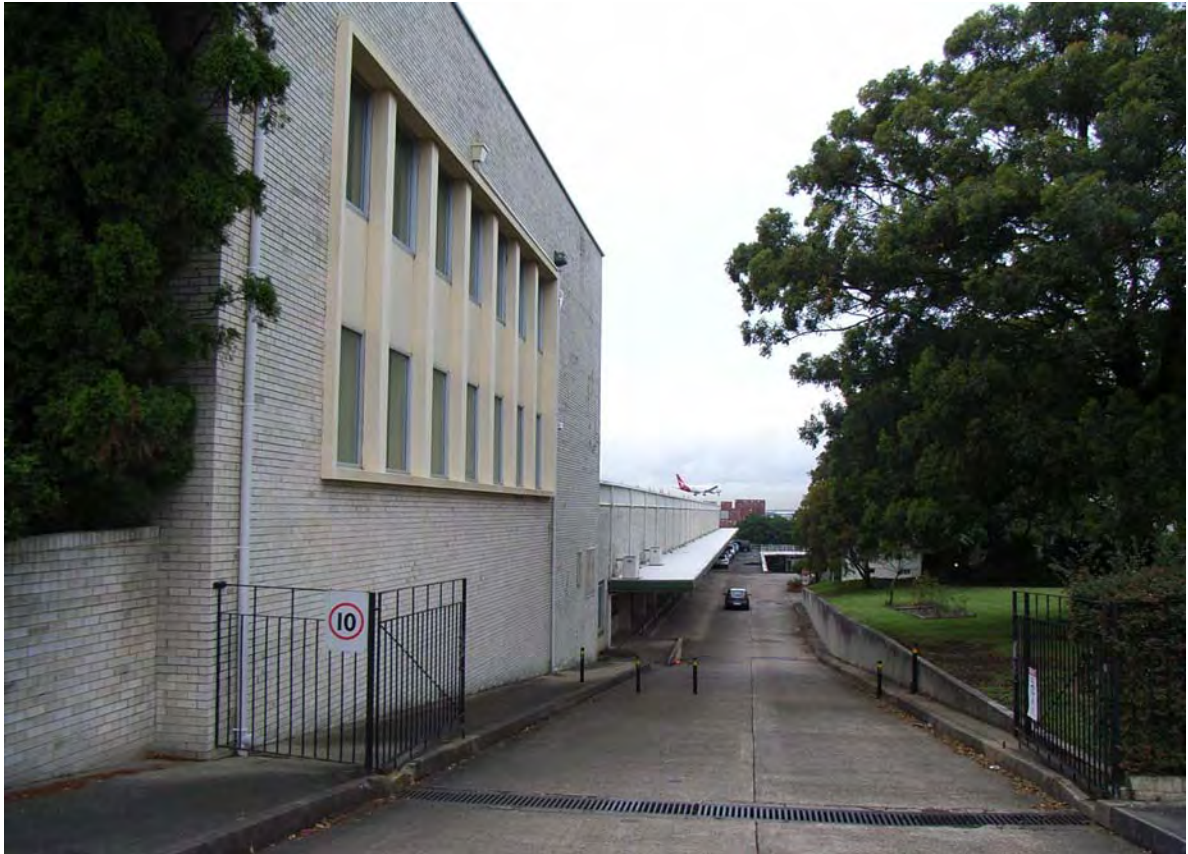
Figure 3.3 View to the southeast showing vehicular access along the south—side of the Penfolds warehouse complex. Note the difference in level between the access road and the landscaped area on the right of the photograph. (Source: GML 2008)

The construction of the Penfolds industrial factory buildings in the 1950s is likely to have resulted in extensive disturbance to any below-ground archaeological remains which may have been present. The building has basement levels and the ground surface around the building footprint has been extensively modified, including excavation around its curtilage to a depth of up to 2m to provide vehicular access around the building (see Figures 3.3 and 3.4).

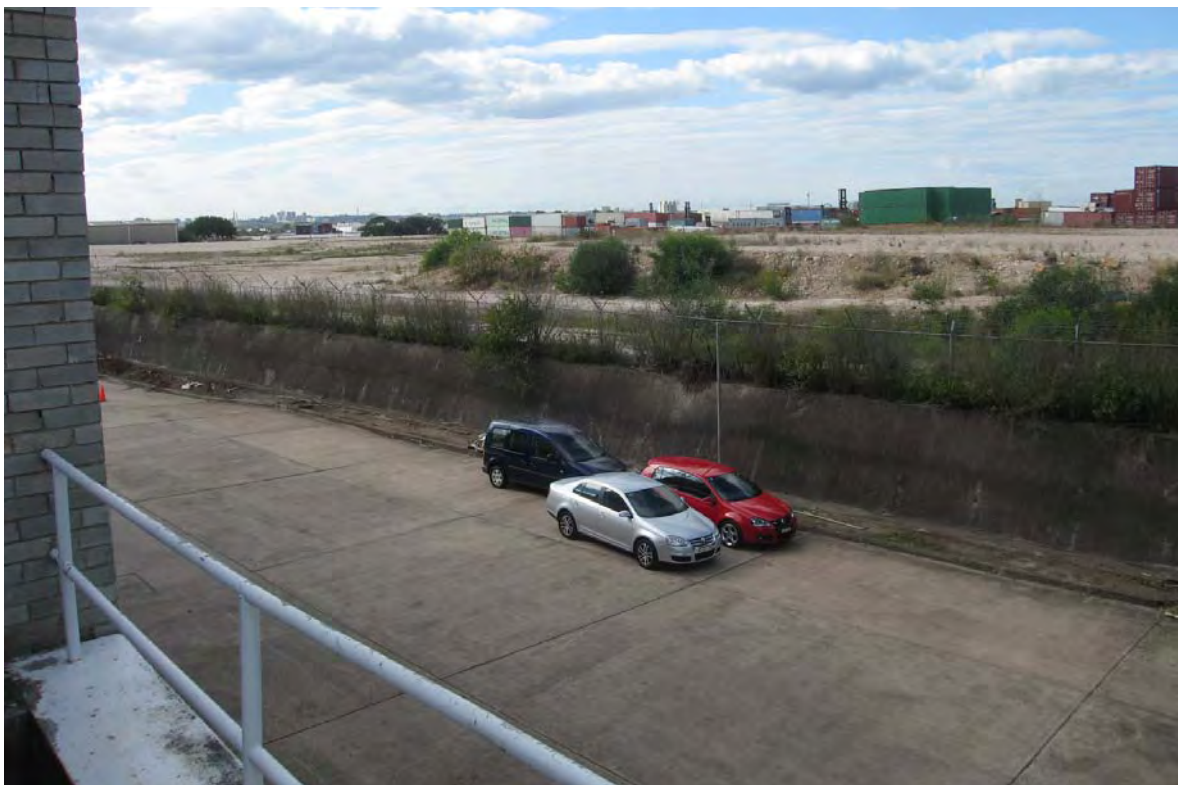
Figure 3.4 View to the southeast from the rear of the Penfolds warehouse complex. Note the change in levels between the access driveway to the rear of the warehouse building and the area of sandstone on the south-eastern portion of the site. (Source: GML 2008)

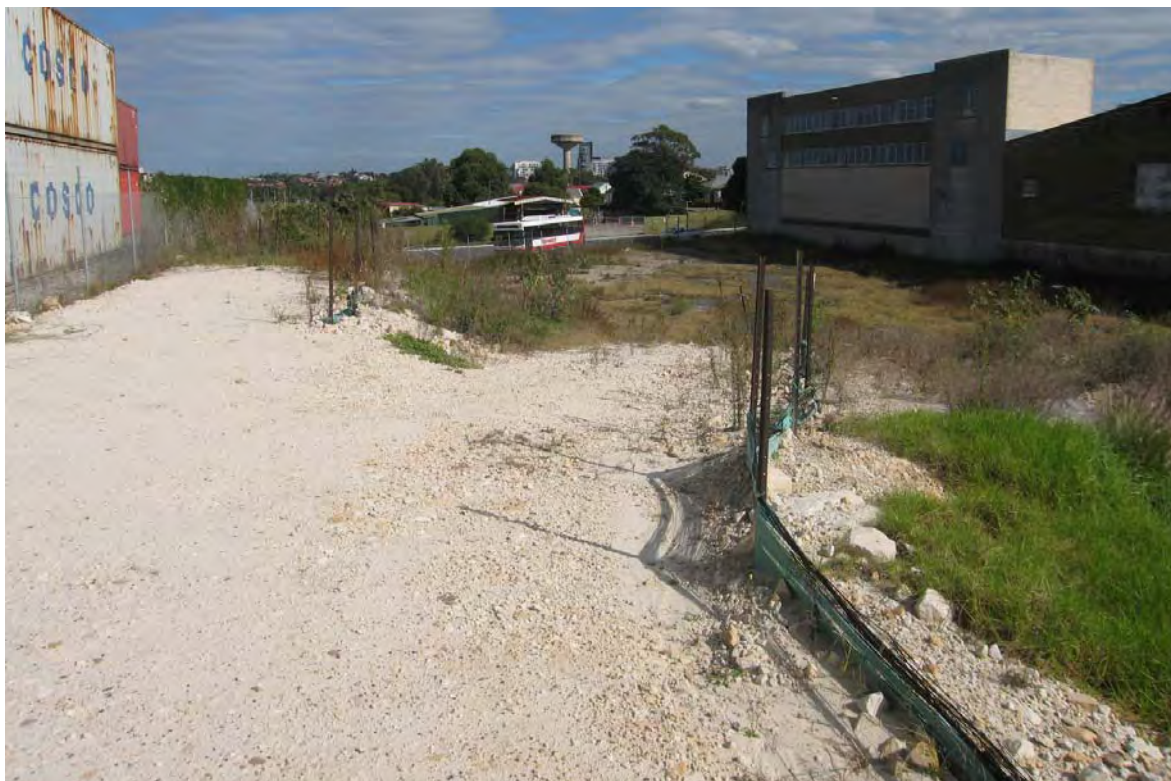
Figure 3.5 View to the southwest showing the sandstone fill in the south-western corner of the site. The remains of the stables and coach house associated with The Poffle are likely to be located beneath this fill. Note the location of Smith Street in the background. (Source: GML 2008)

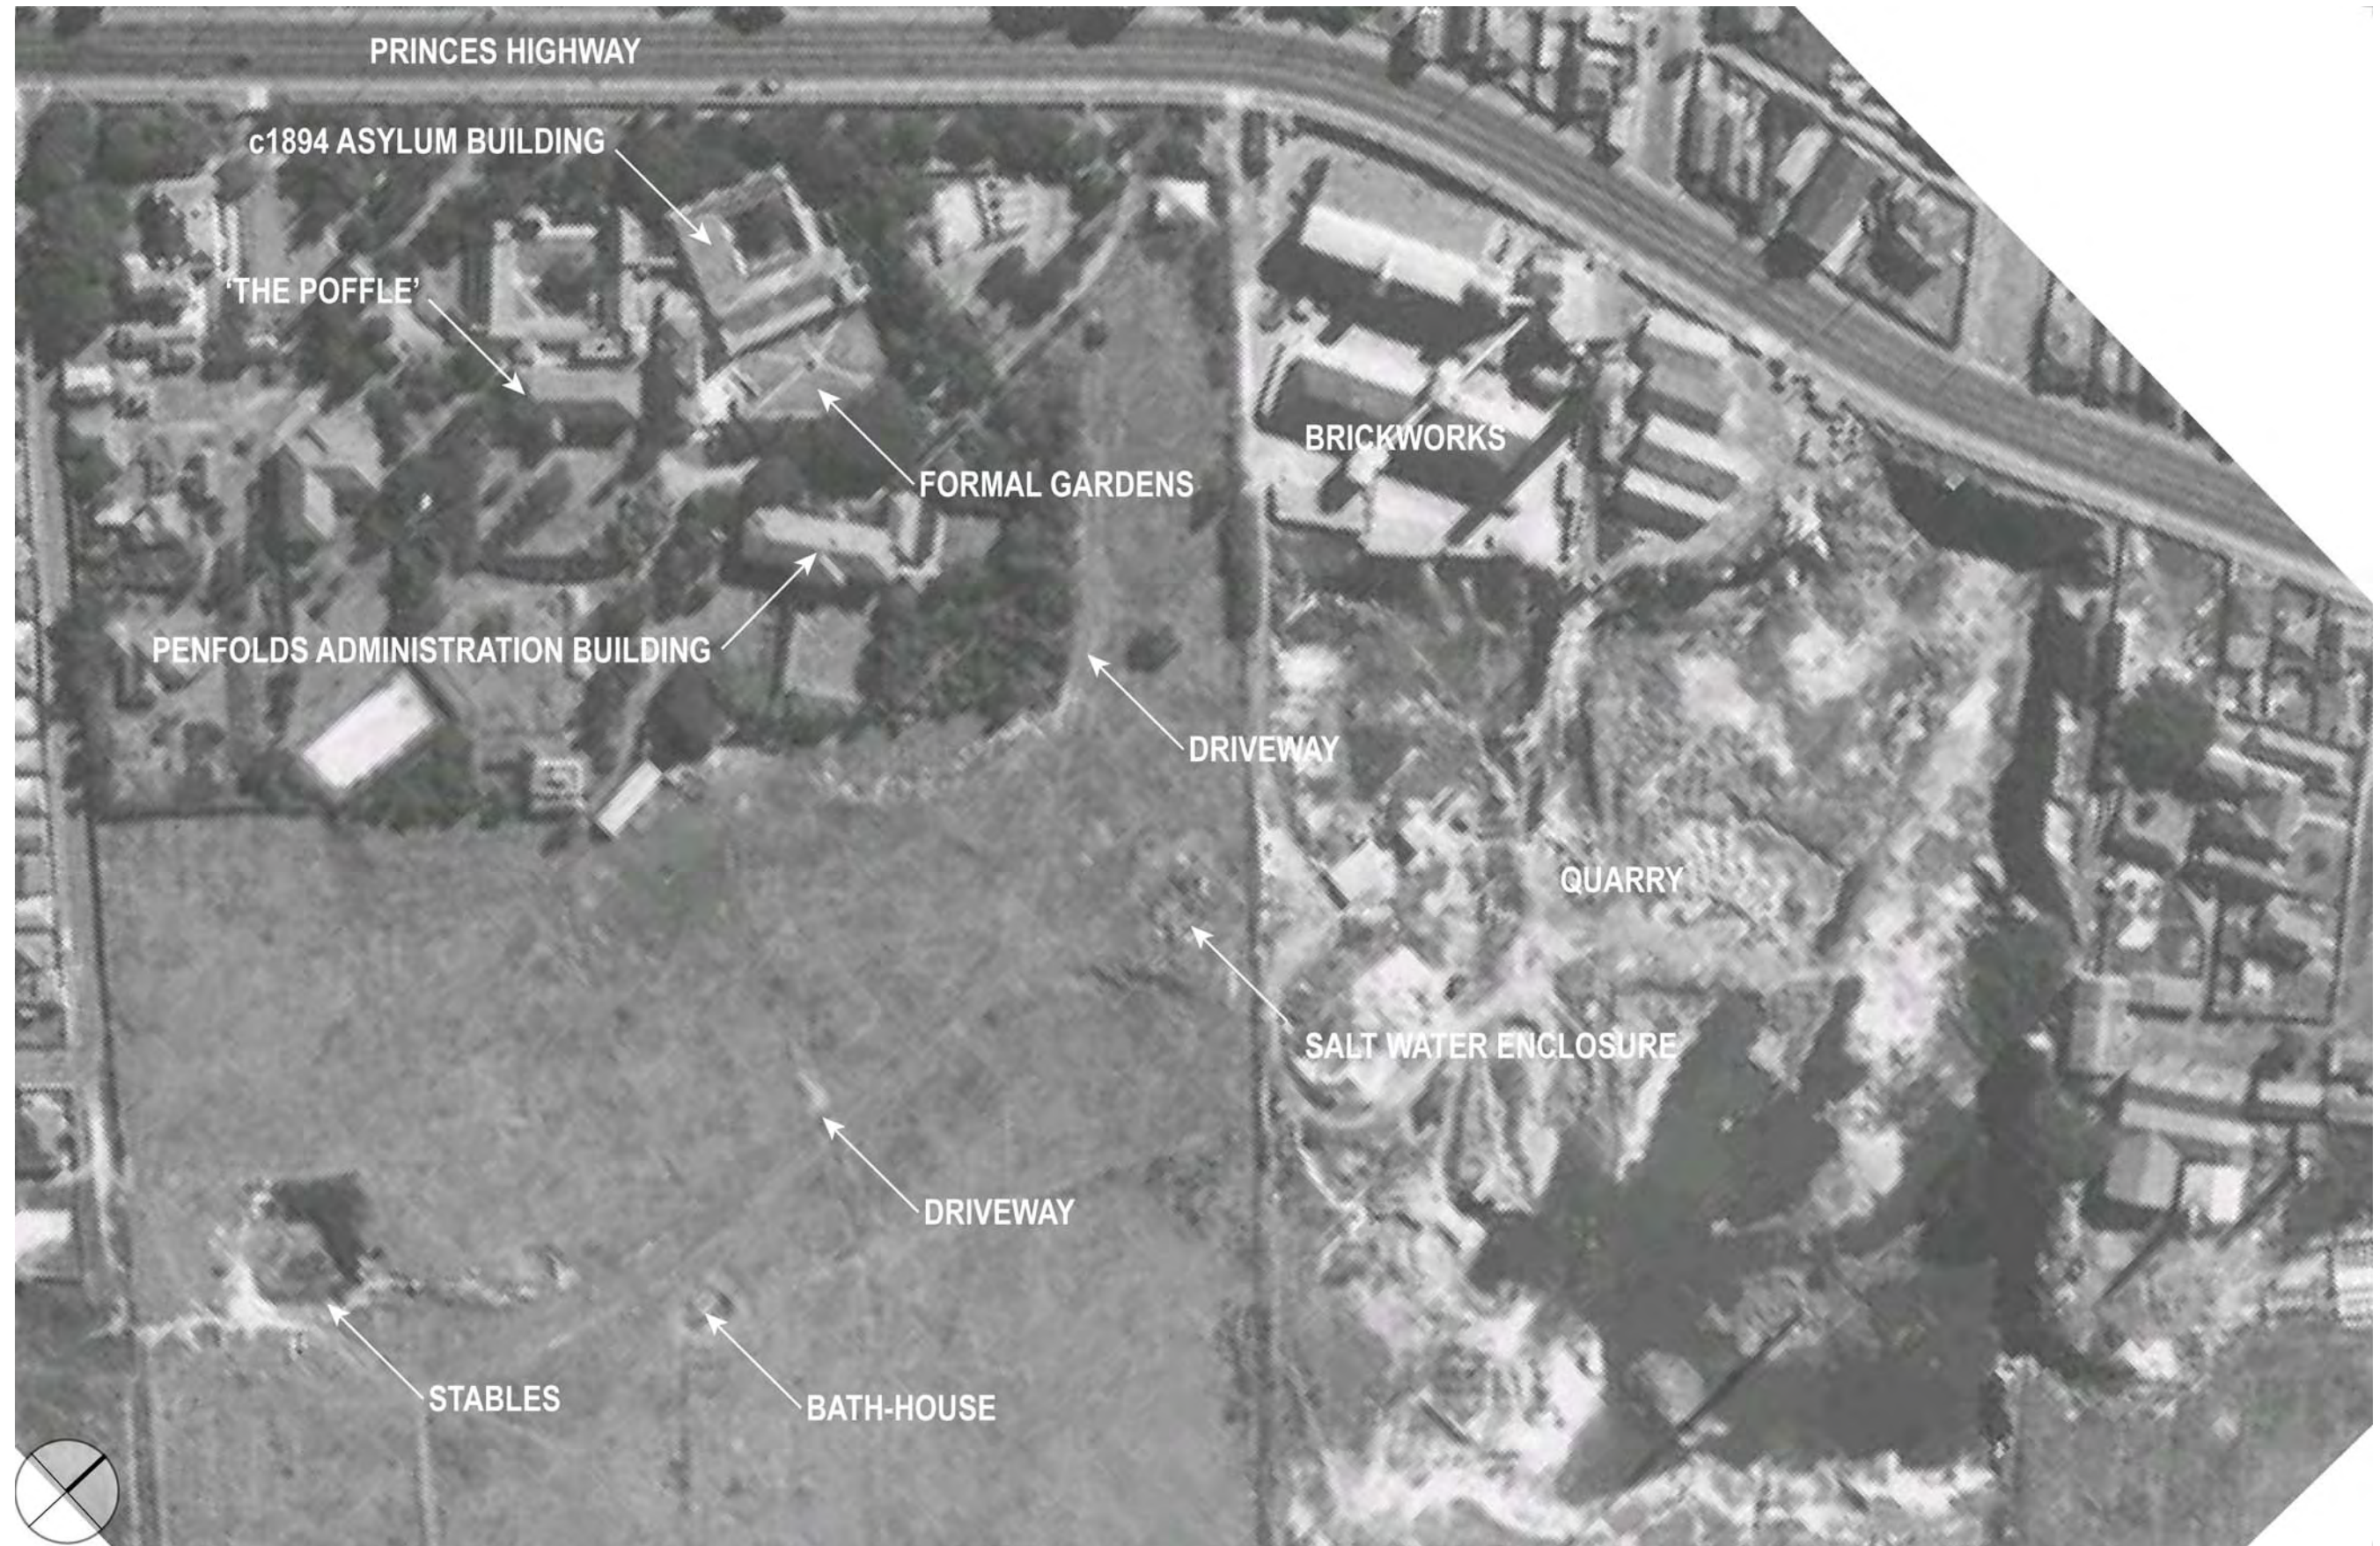
Figure 3.7 1943 aerial indicating the locations of early structures and features on the subject site. (Source: RTA)

Lesslie Duguid built his house, 'The Poffle', on his newly purchased estate in c1837. In 1856 The Poffle was converted into a collegiate school named Rugby until it was closed in 1865. Associated with The Poffle were a number of outbuildings (including a stables which later included a coach house and possibly a caretakers hut, a saltwater bathing house with associated drains, a gatehouse, a summer house and a freshwater enclosure with pumps), landscaped gardens, paths and carriageways (see Figures 2.1, 2.2 and 3.7).

- Evidence of the stables, coach house, possible caretaker's hut and salt water bath house with associated drains is likely to be located along the south-western—boundary of the study area beneath the sandstone rubble fill covering this area of the site (see Figures 3.7 and 3.8). The

- The freshwater enclosure with pumps is likely to have been located towards the rear of the extant Penfolds industrial factory building (see Figures 3.7 and 3.8). Although not beneath the footprint of this building, this feature is likely to have been disturbed by the extensive cut and fill activities which appear to have been undertaken across the rear portion of the site (see Figure 3.9). The results of the geotechnical investigation confirm that this portion of the site has been cut down into natural deposits (see Section 3.3.3).

c1930-built Penfolds administration building and the Princes Highway consists of up to 700mm of topsoil and fill material above natural deposits (see Section 3.3.3) and is thus likely to have sub-surface remains of the gardens shown on the 1943 aerial photograph (see Figures 3.7 and 3.8).

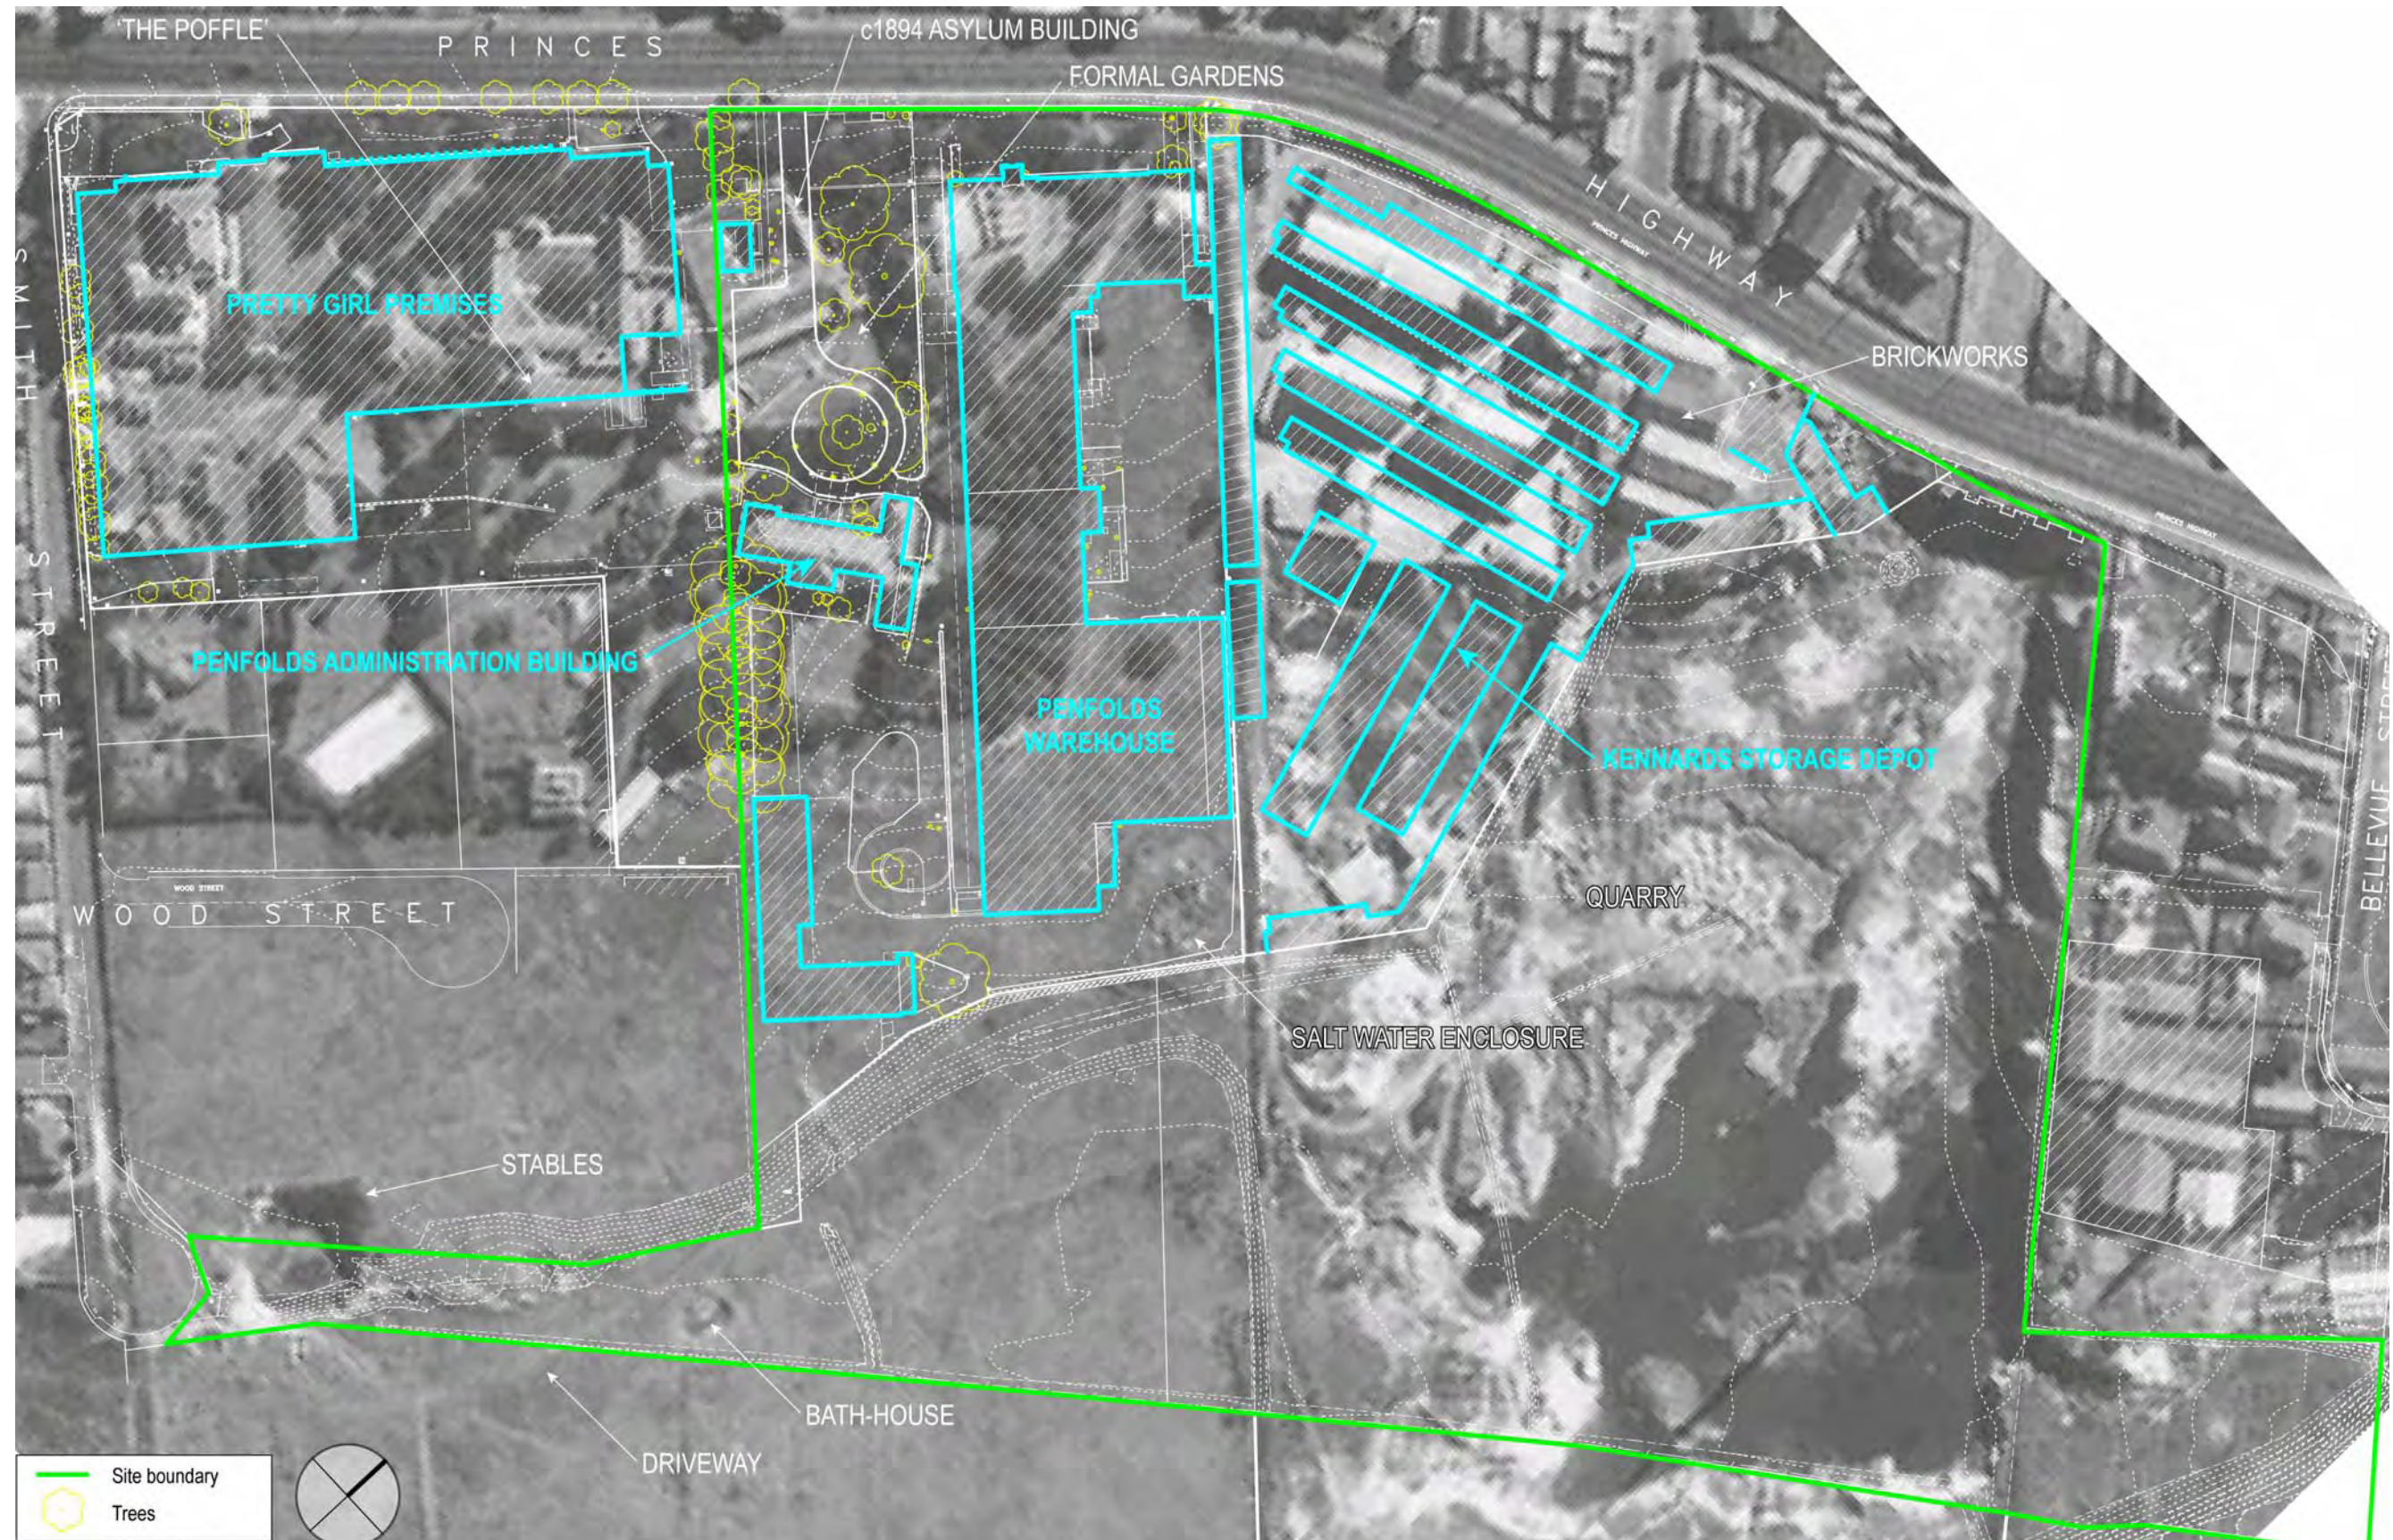
Figure 3.8 1943 aerial photograph overlain onto a current survey plan of the site illustrating locations of early structures and features within the study area. (Source of base plan: RTA)

The site of The Poffle is beneath the current Pretty Girl premises outside the area of study of this report (see Figure 3.8). The majority of the structures and features associated with The Poffle and Rugby School were also located outside the study area (beneath the Pretty Girl premises) or have been substantially impacted upon by the construction of the Penfolds industrial factory buildings in the 1950s. Figure 3.8 shows the 1943 aerial photograph overlain onto a current survey plan of the site illustrating the locations of the early structures. The buildings and features potentially within the study area and outside the footprints of the extant buildings include the stables, coach house and possible caretakers hut, the saltwater bath house and associated drains, the freshwater enclosure with pumps and various elements of landscaping, paths and driveways.

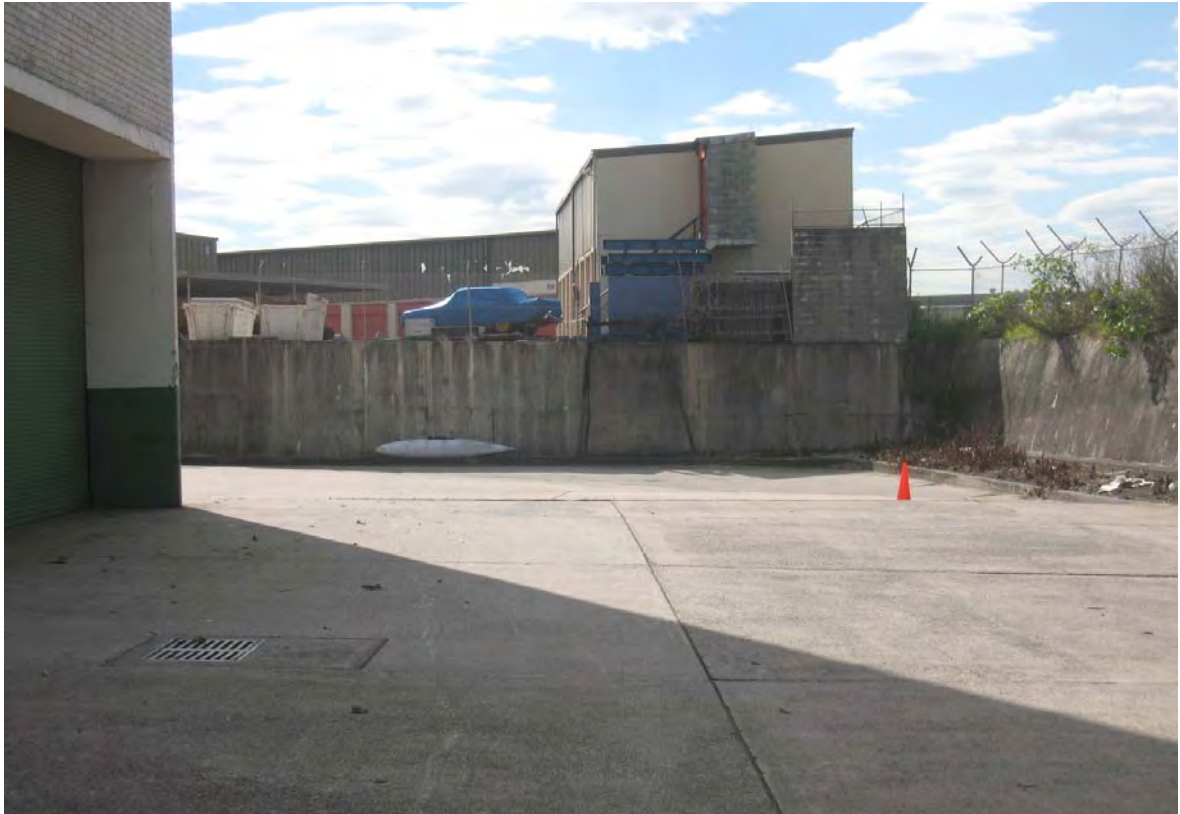
Figure 3.9 View to the east showing the eastern corner of the Penfolds warehouse complex, the freshwater enclosure with pumps associated with The Poffle is likely to have been located in this area. (Source: GML 2008)

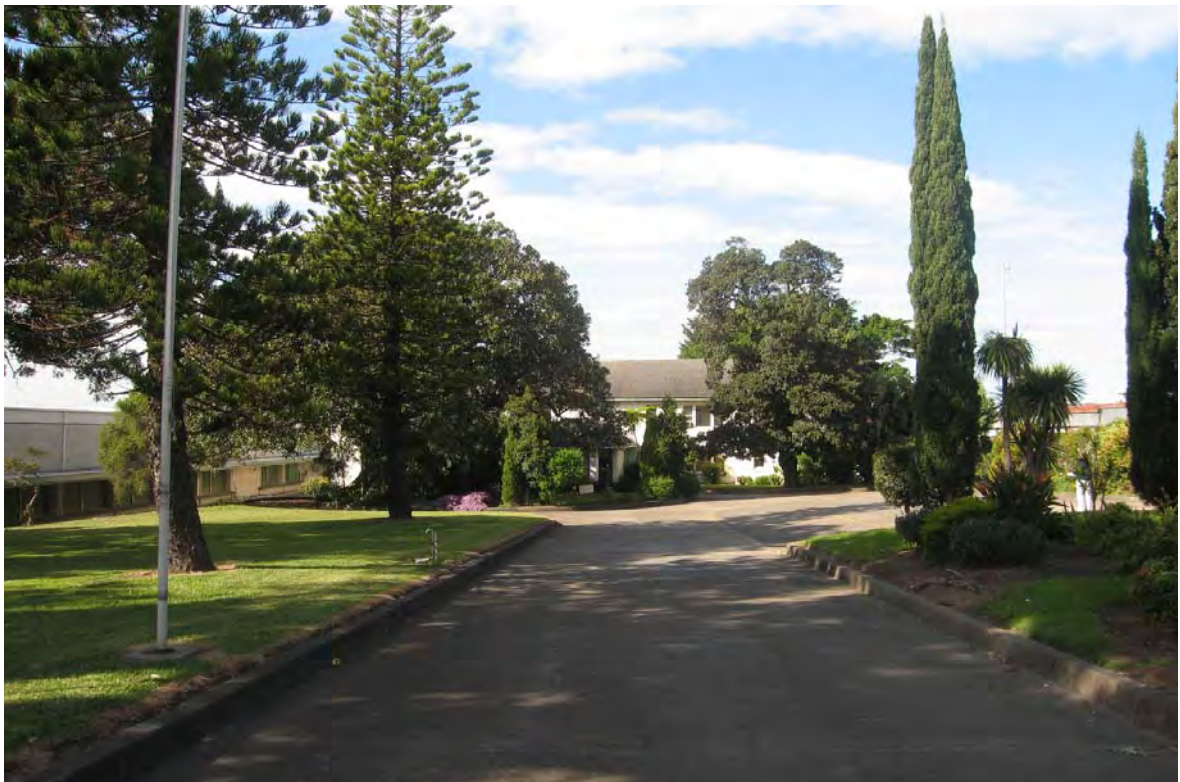
Figure 3.10 View to the southeast looking towards the c1930s-constructed Penfolds administration building showing the landscaped area in the northwest of the study area. The c1894 built extension and new wing of the Bayview Asylum is likely to have been located in this area. Note the Penfolds warehouse on the left of the photograph. (Source: GML 2008)

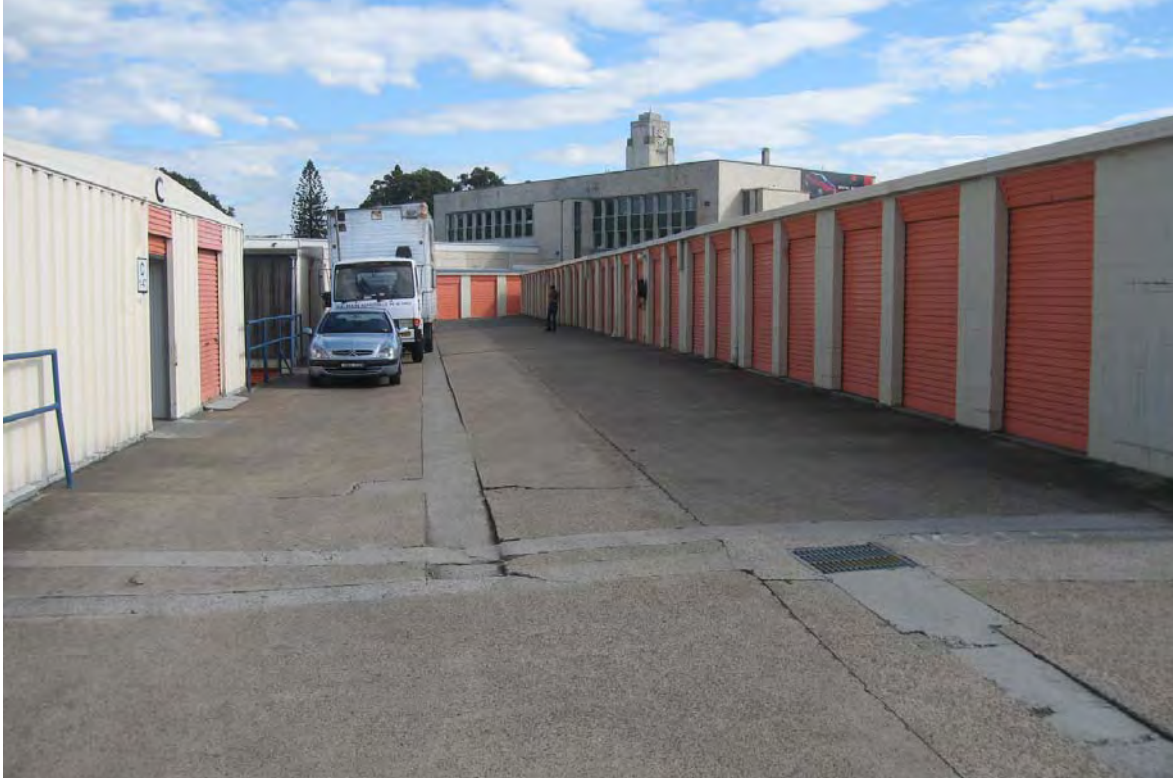
Figure 3.11 View to the west showing the Kennards Storage Depot. Note the level ground and location of service trenches. The distinctive tower of the Penfolds warehouse complex is at the rear of the photograph. (Source: GML 2008)

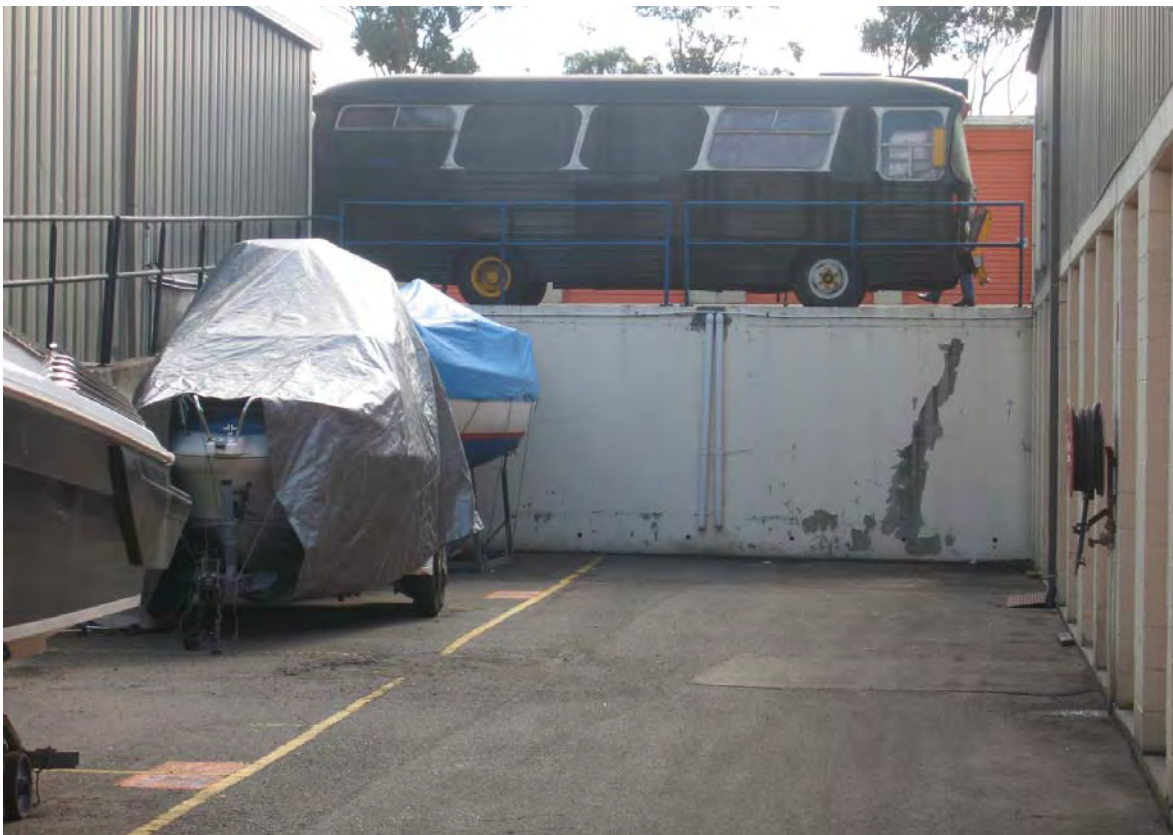
Figure 3.12 View to the north showing the step down in levels within the Kennards Storage Depot. The edge of the quarry associated with the former brickworks is likely to have been located in this area. (Source: GML 2008)
