**"RIPPON GRANGE"**  
**35 WATER STREET, WAHROONGA**

**CONSERVATION MANAGEMENT PLAN**

**ROD HOWARD & ASSOCIATES PTY LIMITED**

REVISION 'C': DECEMBER 2007 AND UPDATED MAY 2008  
as endorsed by the Heritage Council of New South Wales, 11 May 2008

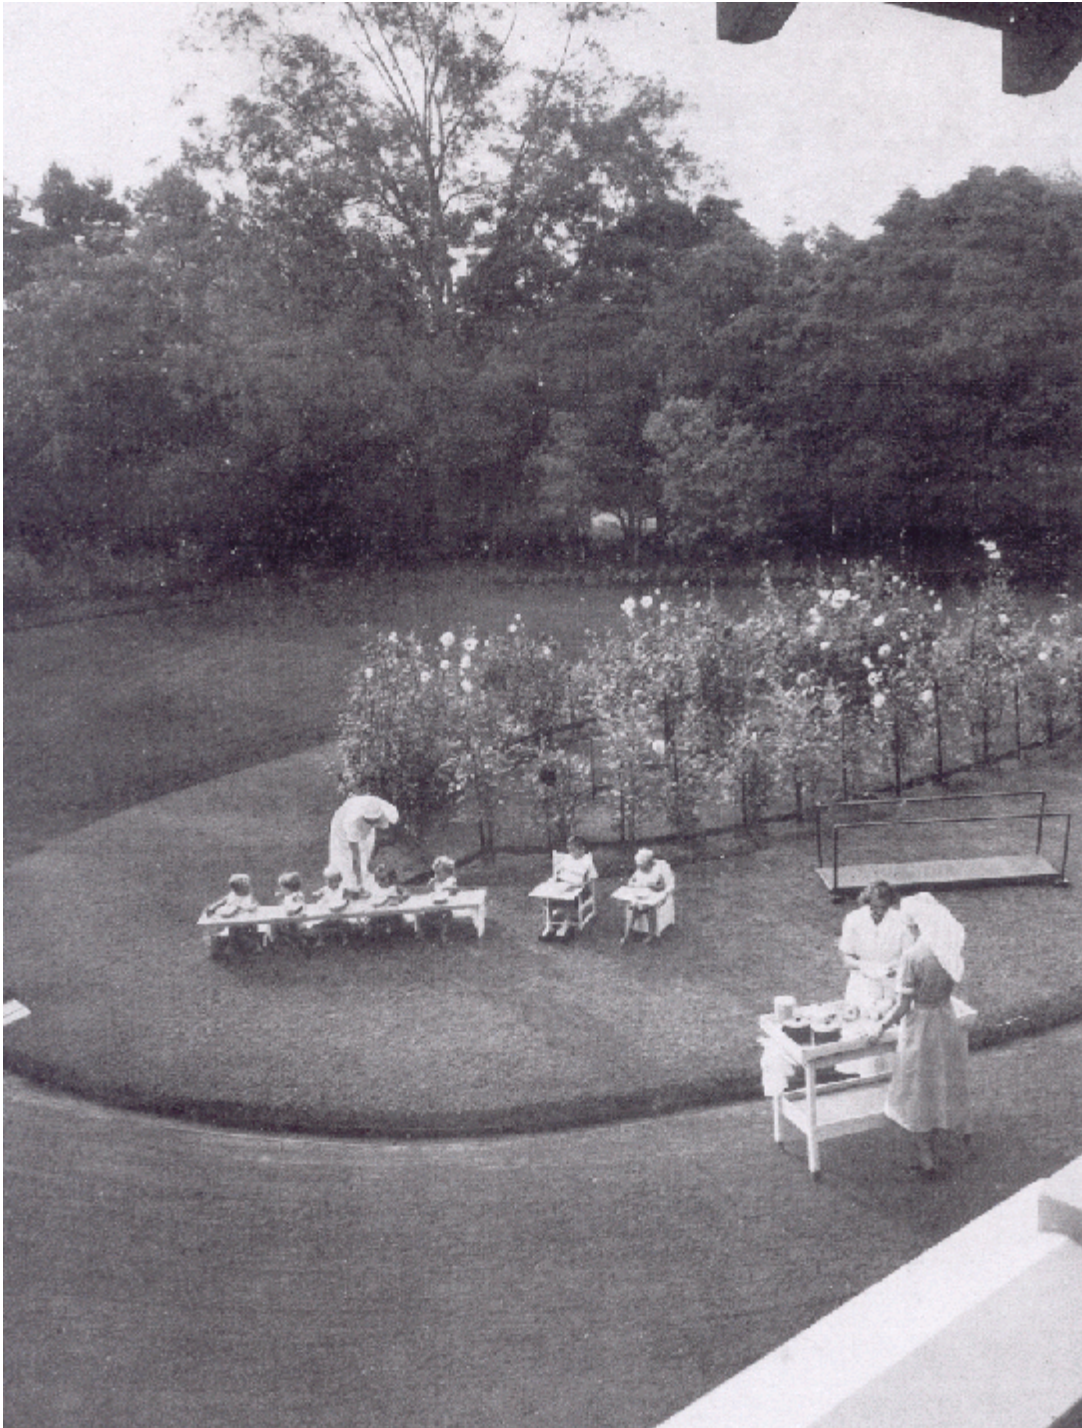
Figure 16: Carriage loop on the western side of “Rippon Grange”, early 1950s (*Seventy-Third Annual Report of the Royal Alexandra Hospital for Children, 1952-53, rear cover*)

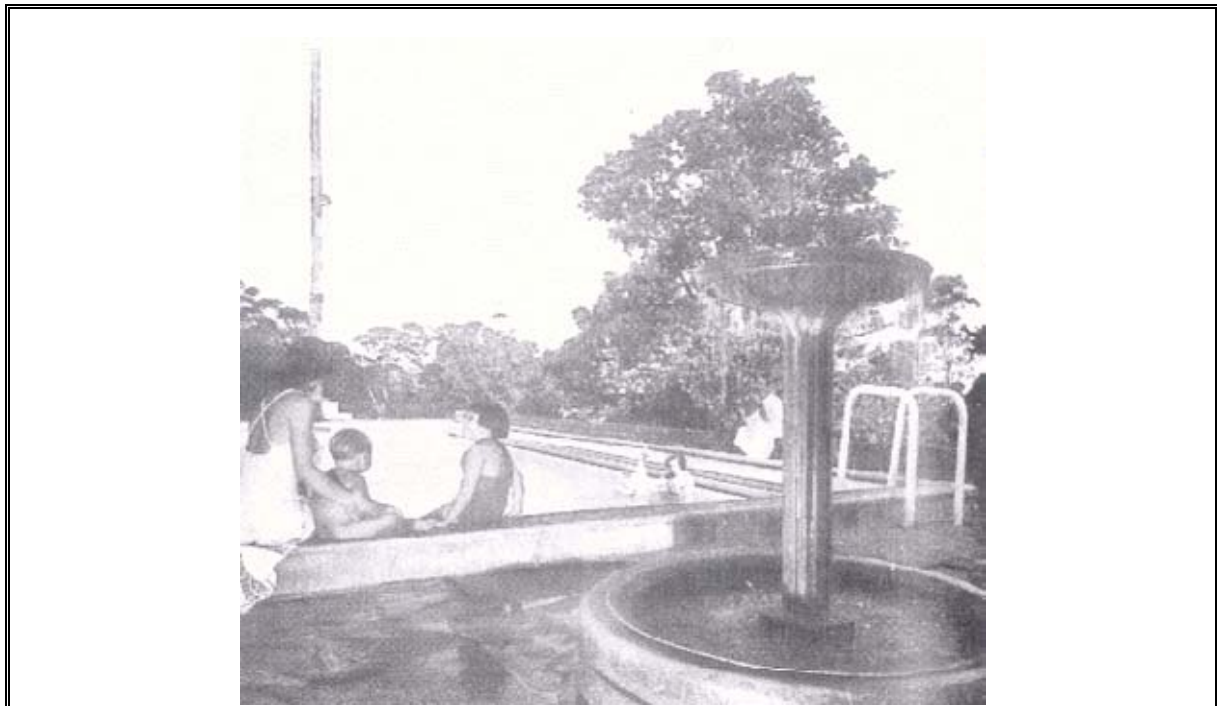
Figure 20: Swimming Pool with decorative fountain in foreground. The fountain no longer exists. (Seventy-Fifth Annual Report of the Royal Alexandra Hospital for Children, 1954-55 Inside front cover)

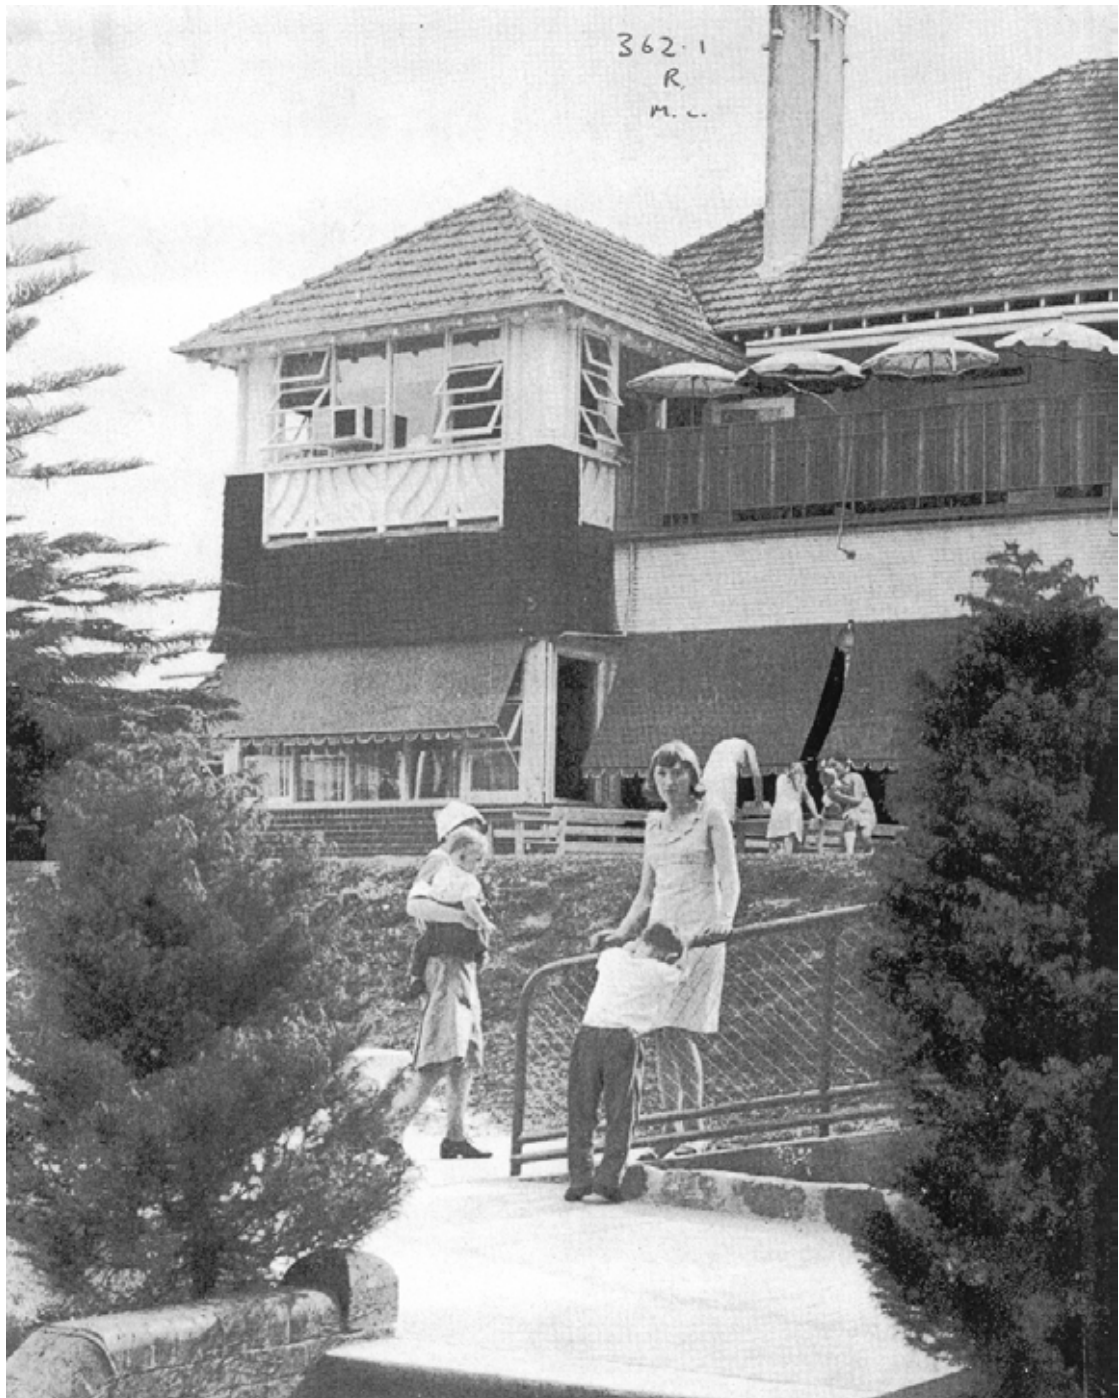
Figure 25: The south eastern corner of “Rippon Grange” prior to the addition of the 1970 ward block. The photograph was taken in the middle of the 1960's (*Eighty-Sixth Annual Report of the Royal Alexandra Hospital for Children, 1965-66, rear cover*).

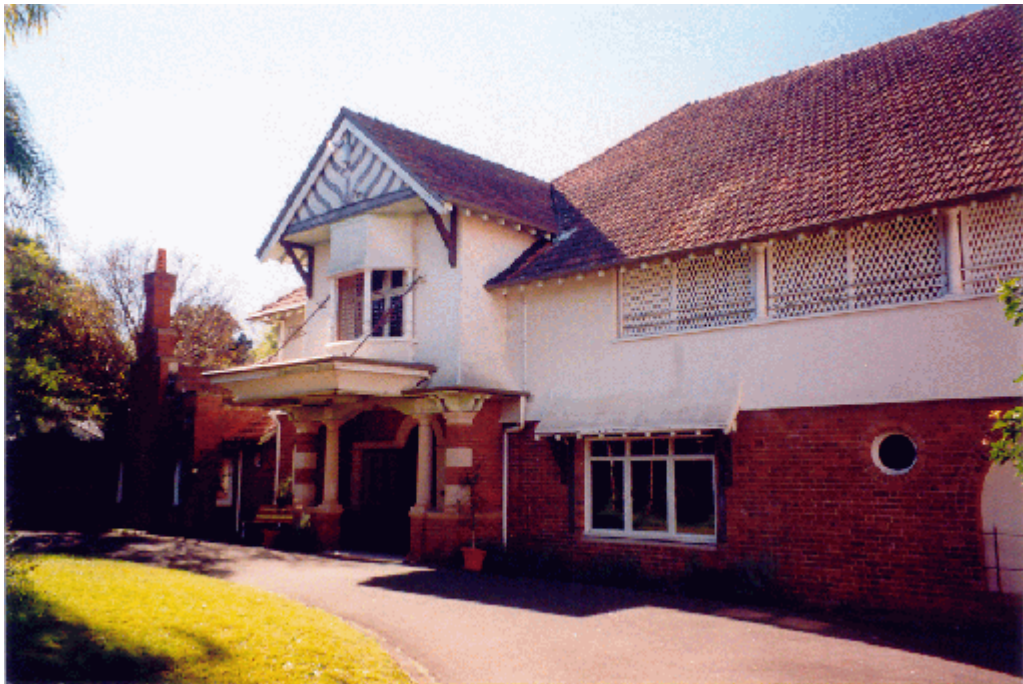
Figure 29: The western side of “Rippon Grange”. Although the exterior of the house has retained much of its early form and fabric, unsympathetic modifications include obscuring of verandahs and the replacement of timber shingle wall linings with a fire resistant plaster finish (Rod Howard Heritage Conservation Pty Ltd, October 2000).

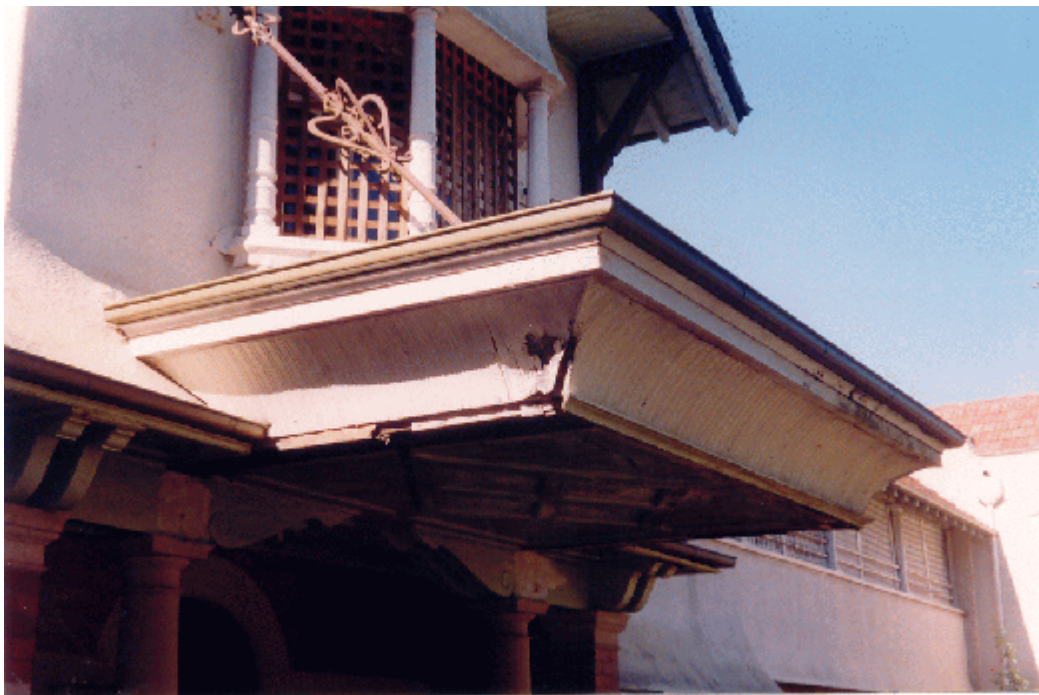
Figure 30: The canopy over the main entrance is deteriorating and has suffered the loss of important elements including the brackets that connect it to the columns on either side of the porch (Rod Howard Heritage Conservation Pty Ltd, October 2000).

- The distinctive suspended canopy protecting the main entrance. The fabric of the canopy is in poor condition and is deteriorating, whilst some joinery elements have been removed;
- The marble flooring of the entrance porch;
- The tiled verandah floor and marble margin of the eastern verandah (room G43);
- Roughcast wall linings at the first floor levels on the eastern side of the house;
- Timber joinery associated with the entrance porch;
- Remnants of leadlight glazing in windows associated with room G2;
- Terracotta roof tiles and exposed rafter ends;
- Chimneys;
- Timber window and door joinery;
- Tiled paving in the sunken service passage to the south of the main entrance to the house.

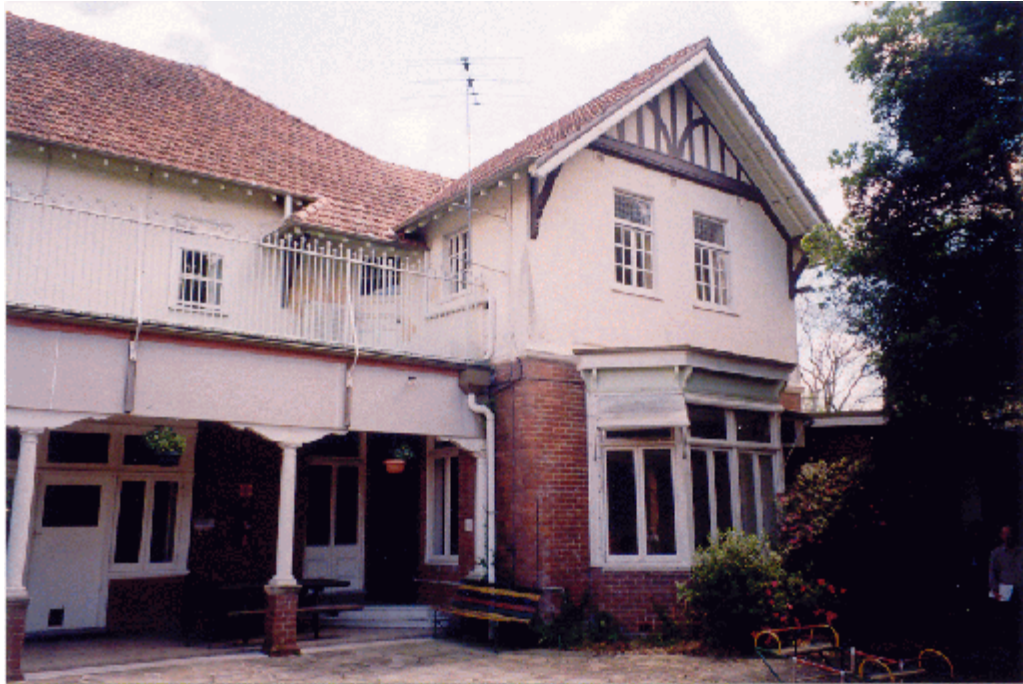
Figure 31: The eastern side of “Rippon Grange”. Modifications in this part of the house include the addition of lavatory facilities along the northern corner and replacement of early timber balustrades and shingle skirts associated with the first floor terrace with unsympathetic metal balustrading (Rod Howard Heritage Conservation Pty Ltd, October 2000).

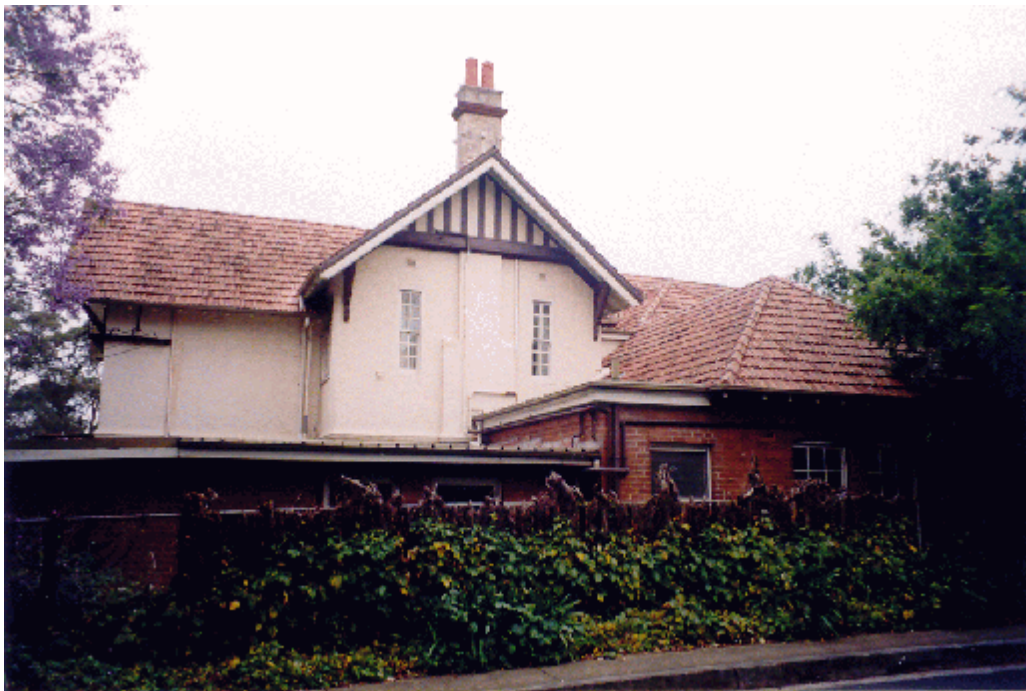
Figure 32: The northern side of “Rippon Grange”, with Howard Joseland’s addition of 1905 close to the street. Flat roofed additions dating from the 1950’s and 1960’s are also visible (Rod Howard Heritage Conservation Pty Ltd, October 2000).

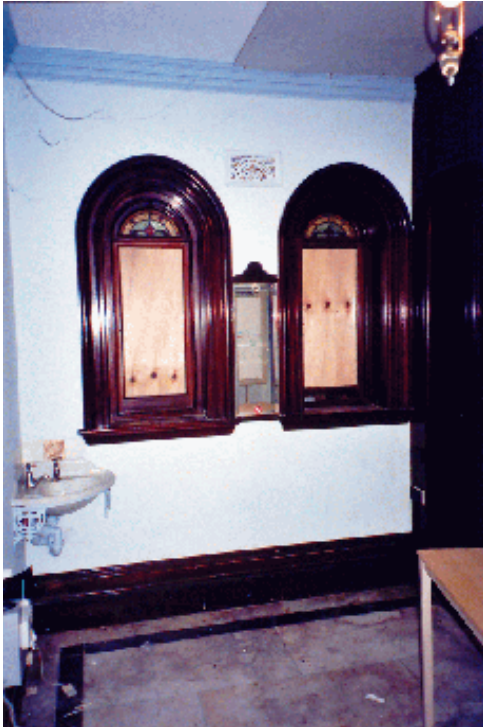
Figure 38: Western end of Room G2 (Rod Howard Heritage Conservation Pty Ltd, October 2000).

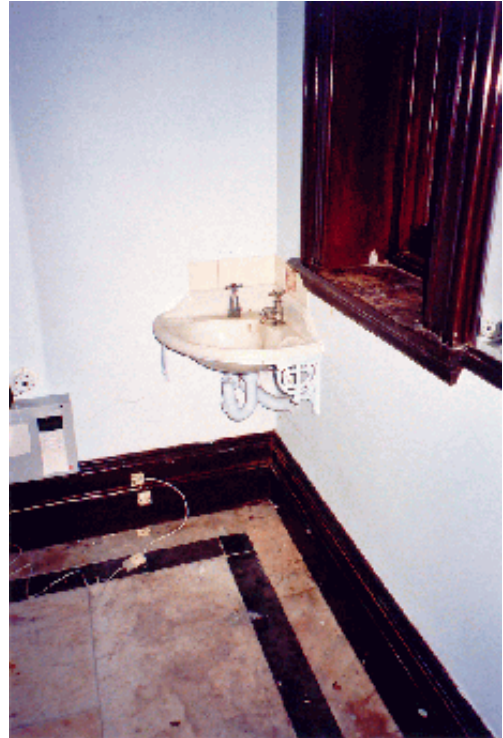
Figure 39: Flooring and lavatory basin in Room G2 (Rod Howard Heritage Conservation Pty Ltd, October 2000).

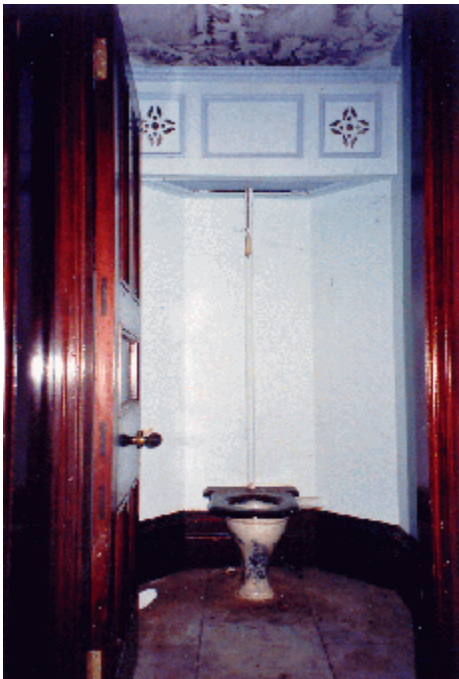
Figure 40: Water closet and cistern, Room G3 (Rod Howard Heritage Conservation Pty Ltd, October 2000).

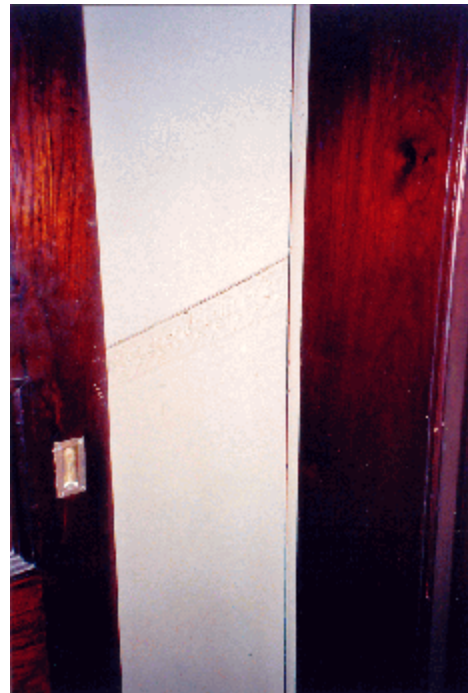
Figure 41: Early wall linings in the curved stair space off the south-western corner of Room G13 (Rod Howard Heritage Conservation Pty Ltd, October 2000).

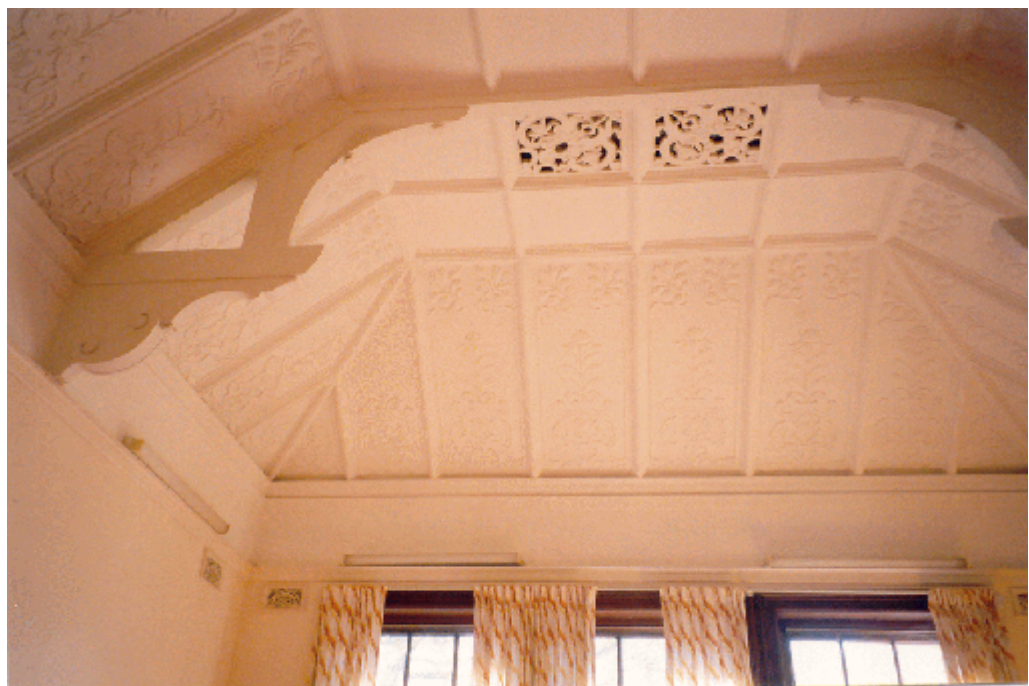
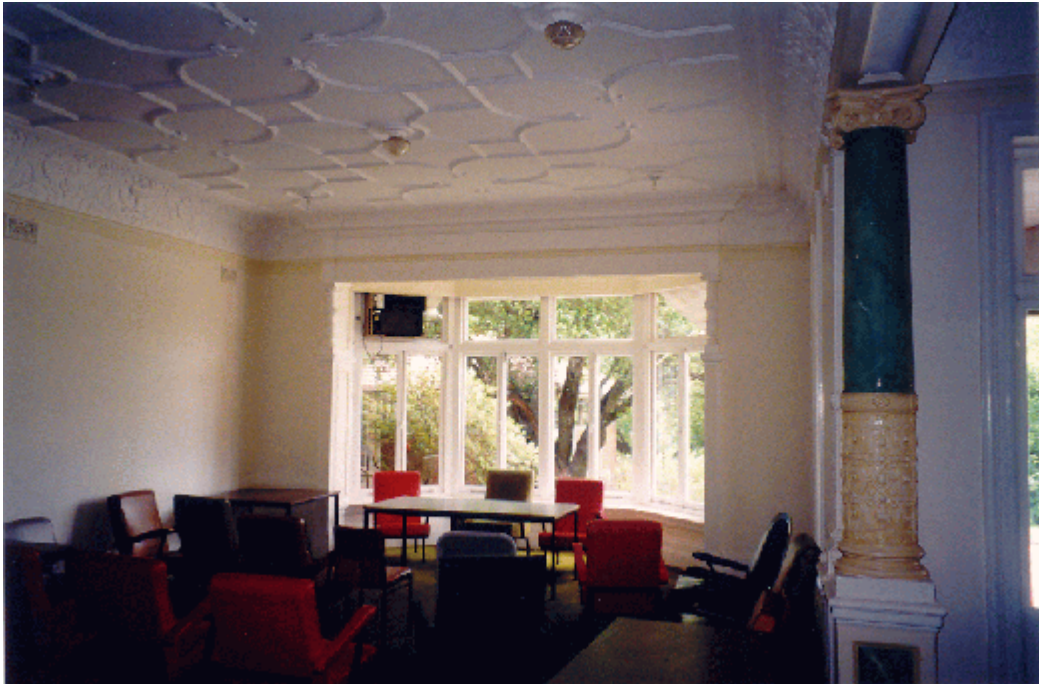
Figure 43: Room G12 is amongst the most important spaces within “Rippon Grange”, although it has been modified as a result of the conversion to hospital use. The quality of plaster ceilings, cornices and other decorative details is very high (Rod Howard Heritage Conservation Pty Ltd, October 2000).

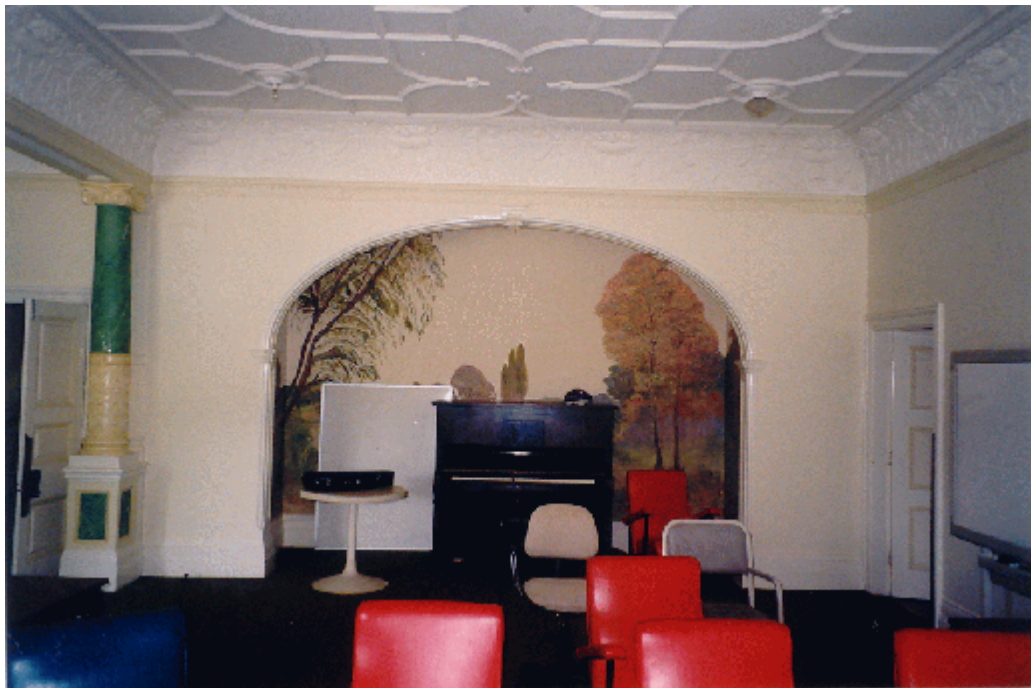
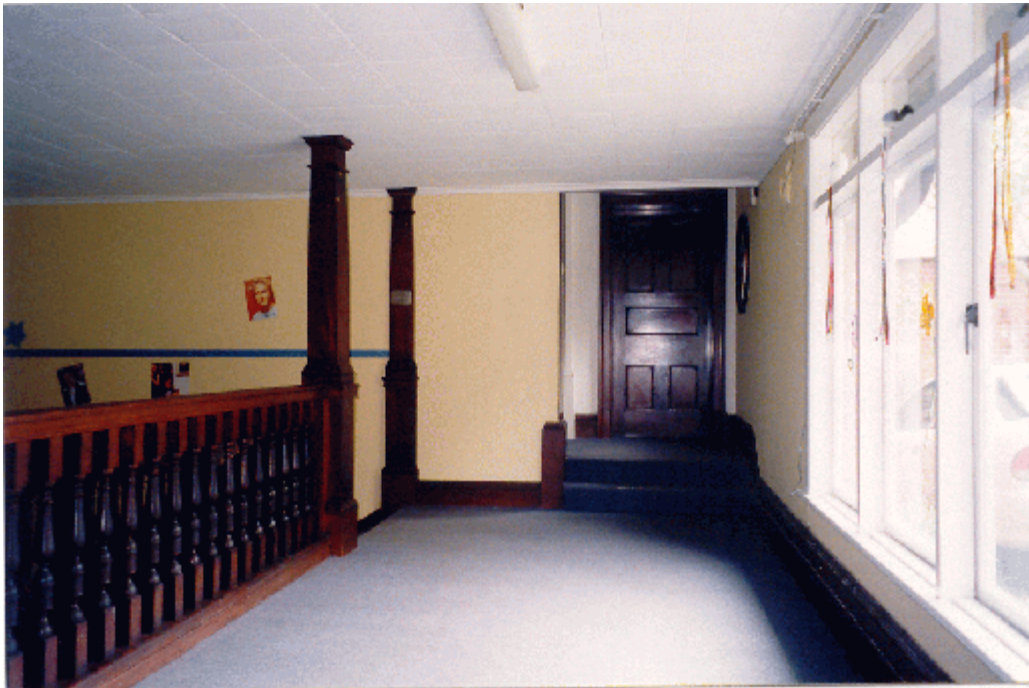
Figure 44: Room G13 is another of the important spaces in “Rippon Grange” because of its fabric, scale and configuration over two levels. The upper gallery leads to the main stair beyond the southern wall of the room. The space has been unsympathetically modified with a suspended ceiling and alterations to the original stair joinery, windows in the western wall and the fireplace (Rod Howard Heritage Conservation Pty Ltd, October 2000).

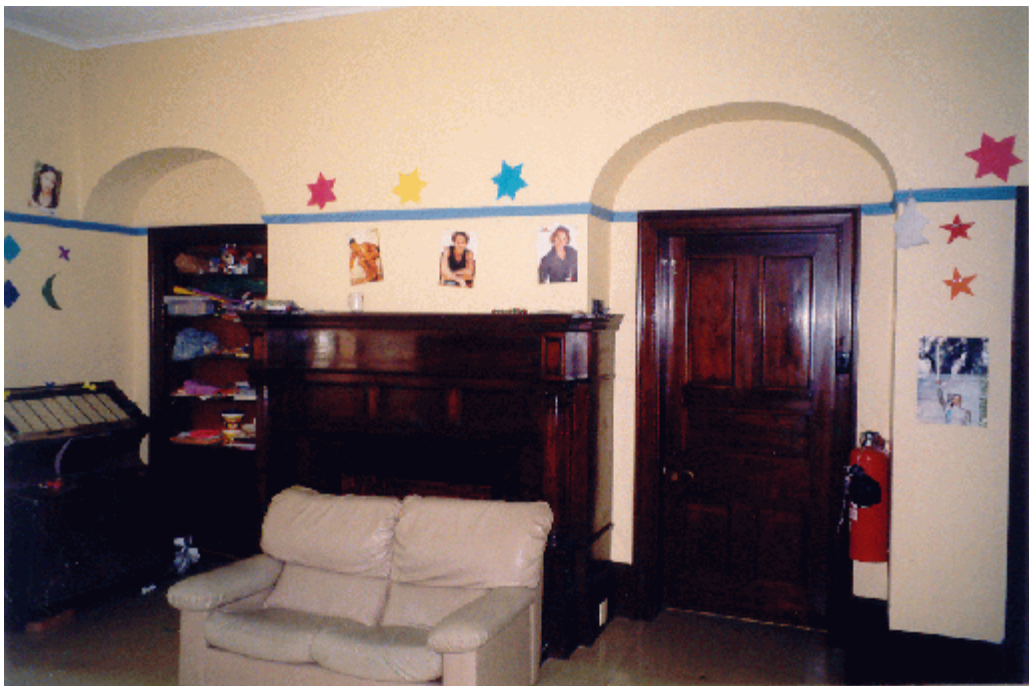
Figure 45: Early timber door and window joinery, eastern side of Room G14 (Rod Howard Heritage Conservation Pty Ltd, October 2000).

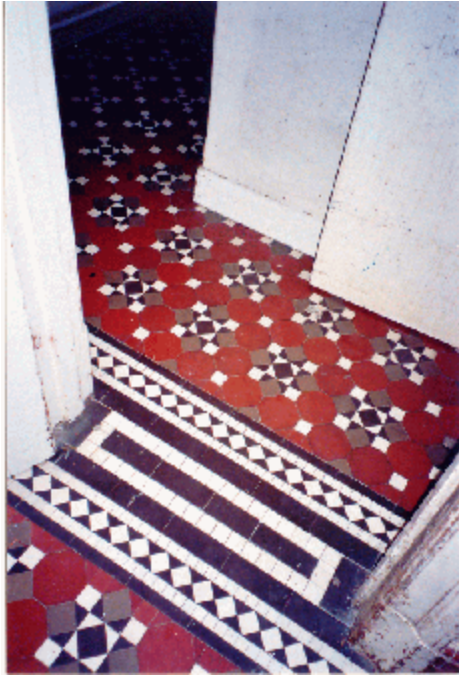
Figure 48: Tiling in Room G28, southern wall (Rod Howard Heritage Conservation Pty Ltd, October 2000).

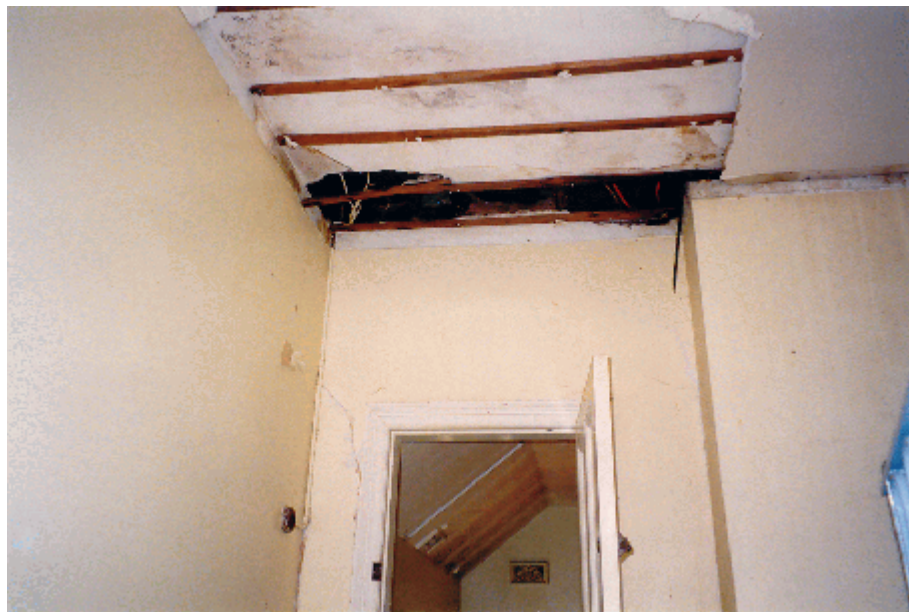
Figure 57: The fabric of Room F19 to F21 has deteriorated as a result of water penetration and other causes. Ceilings have collapsed in some places (Rod Howard Heritage Conservation Pty Ltd, October 2000).

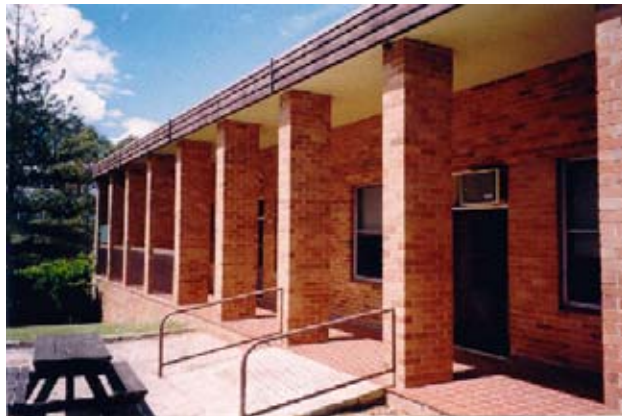
Figure 58: The unsympathetic ward block addition to “Rippon Grange”, circa 1970, is intrusive and crude in detail and proportion (Rod Howard Heritage Conservation Pty Ltd, October 2000).

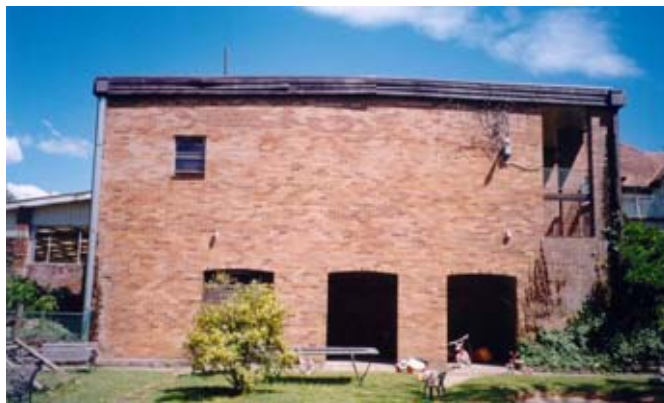
Figure 59: The ward block’s eastern side is even more devoid of architectural merit (Rod Howard Heritage Conservation Pty Ltd, October 2000).

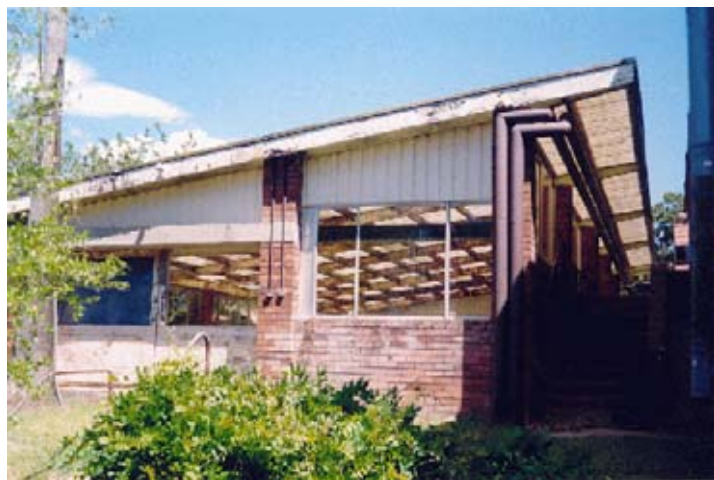
Figure 60: The enclosure around the swimming pool has deteriorated and it is in fair condition only. Although an important adjunct to the treatment of children, it is not in sympathy with the pool of nearby “Rippon Grange” (Rod Howard Heritage Conservation Pty Ltd, October 2000).

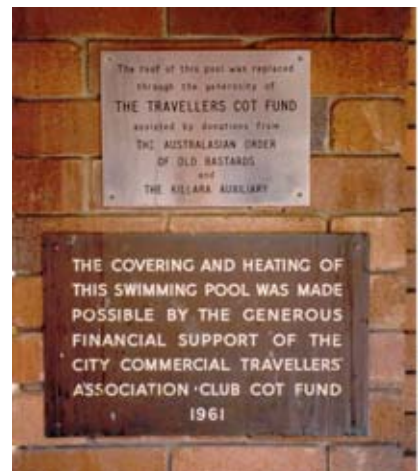
Figure 61: Commemorative plaques associated with enclosure of the Swimming Pool, recording the generosity of various community groups (Rod Howard Heritage Conservation Pty Ltd, October 2000).

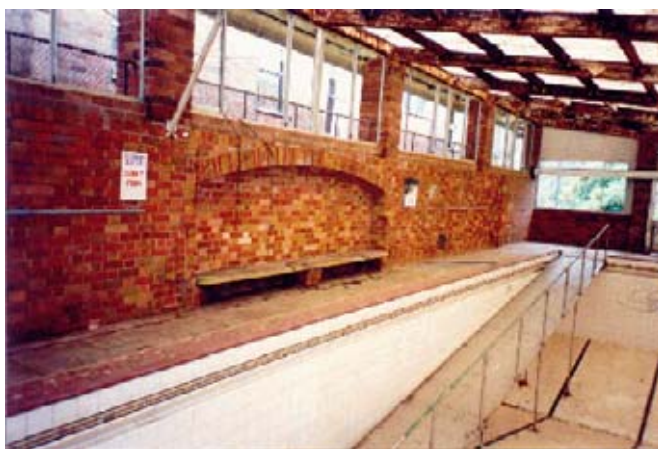
Figure 62: Early brick wall on the northern side of the Swimming Pool (Rod Howard Heritage Conservation Pty Ltd, October 2000).

The swimming pool located on the southern side of “Rippon Grange” was built circa 1936. It is rectangular in shape and surrounded by a tiled upstand and concrete paving. A wall constructed of coloured textured bricks is located on its northern side. It incorporates a shallow arched opening and decorative brick piers, some of which have been damaged and others removed. Original ceramic tiling has survived within the pool itself and on the horizontal surface of the upstand. Other tiles appear to have been installed after the advent of the Hospital. The brick and steel framed enclosure lined with translucent material was erected around 1960. The steelwork is in relatively poor condition. Plaques commemorating its construction are located on a brick pier adjacent to the pool.

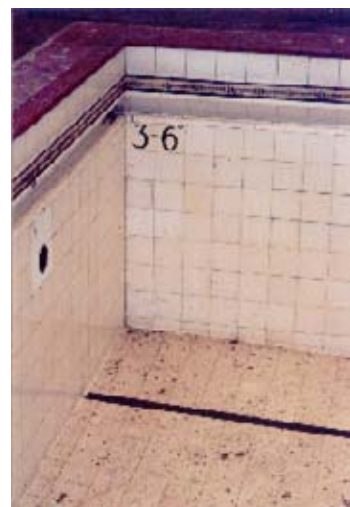
Figure 63: Tiling within the Swimming Pool (Rod Howard Heritage Conservation Pty Ltd, October 2000).

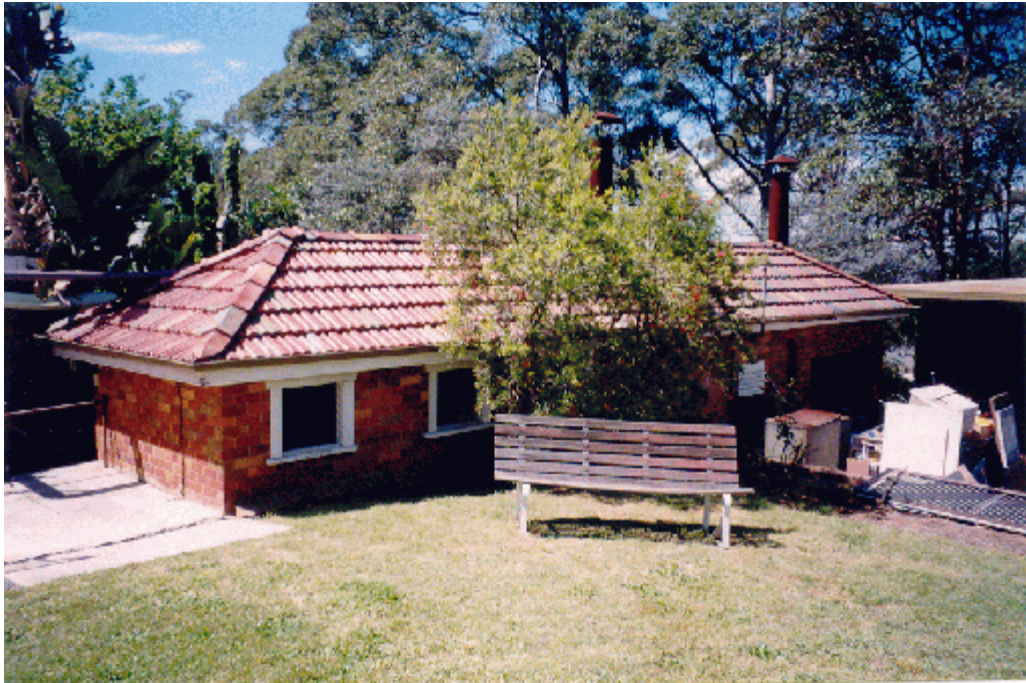
Figure 64: The pool shed originally dates to the mid 1930s. It has been extended twice, but the roof tiling is consistent for its entire length (Rod Howard Heritage Conservation Pty Ltd, October 2000).

This small brick building is located to the south of the swimming pool. It has a hipped roof covered with colour blended terracotta tiles. The different tones and textures of the brickwork visible on the exterior of the building provide evidence that it was extended in two stages – the original portion, which contains ablutions facilities that have been refurbished within the past thirty years, is at the northern end of the building and was constructed in the mid 1930s when the Swimming Pool was installed. The textured bricks in this section are similar to those in the wall on the northern side.

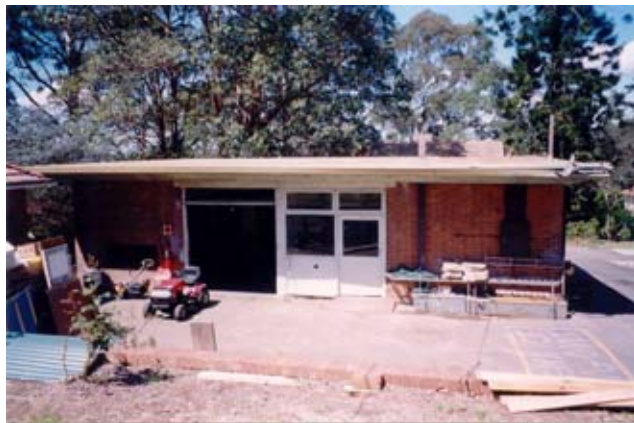
Figure 65: Although the Garage is amongst the earliest buildings on the site, it has been extensively altered over the years. The original gabled roof form has been replaced by this unsympathetic flat roof (Rod Howard Heritage Conservation Pty Ltd, October 2000).

The Garage was built prior to 1922 and has been modified several times since the 1950s, if not before. Photographs taken during the 1950s and earlier show the building to have had a gabled roof, but this has been replaced by a flat roof covered by metal linings and wide board lined eaves. Decorative joinery around some window openings suggests that the building may have been constructed at the same time as "Rippon Grange", although many windows have been subsequently modified. It is possible that it was originally built as a stable. External walls are constructed of face brick, which is deteriorating in some parts of the building as a result of dampness and erosion of mortar in joints. A concrete lintel spans the wide openings on the northern side of the building and wide doors have been installed within them. The reveals of these openings are distinguished by bricks that are curved in profile. Conduits and pipes have been crudely placed on some wall surfaces. There is a small skillion roofed addition on the southern side of the building.

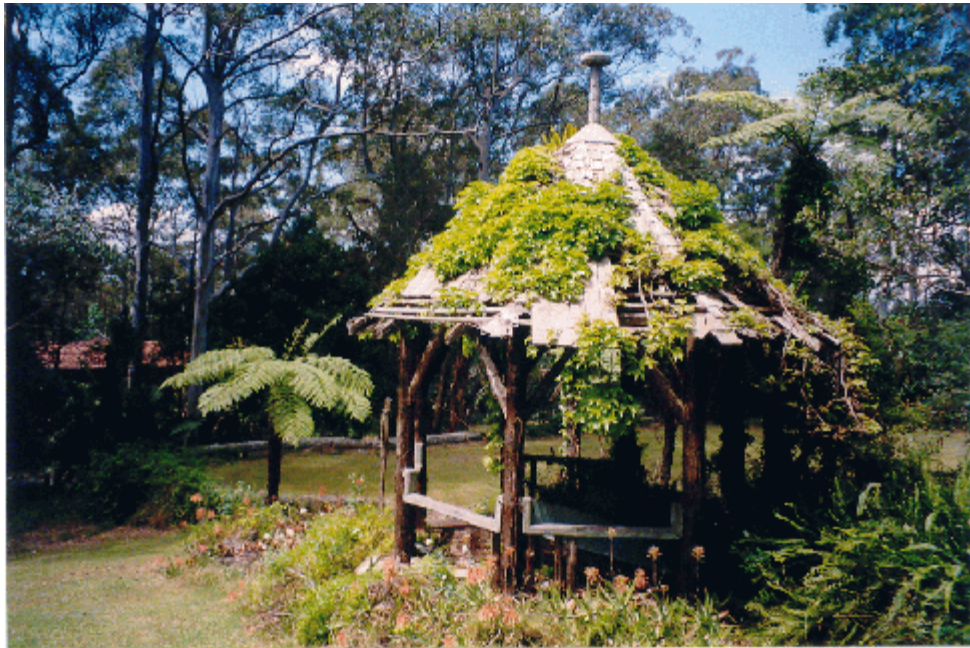
Figure 67: The Summerhouse, on the northern side of the former croquet lawn, was a charming structure that skilfully combined found timber elements with joinery items. It had deteriorated due to a lack of maintenance and the deleterious effects of vegetation that had grown over it (Rod Howard Heritage Conservation Pty Ltd, October 2000).

The Summerhouse was octagonal in plan and had been skilfully constructed with undressed timber posts and brackets contrasting with carefully shaped rails supported off undressed timber balustrades. The roof was covered with timber shingles and culminated in a tall turned finial. It contained the remains of two timber benches, of which a relatively large amount of fabric was still evident.

The Summerhouse collapsed at some time after 2001 as a result of invasive vegetation (although Cazneaux photographs show that vines and plants had covered the roof of the structure during the 1920s) and ongoing neglect.

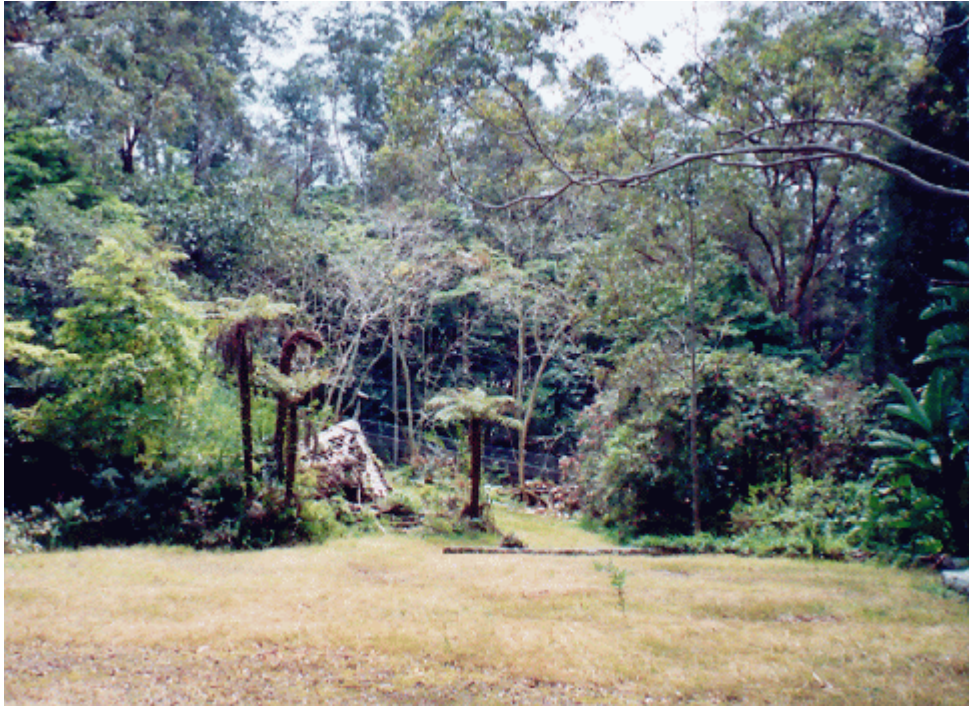
Figure 68: The Summerhouse has since collapsed (Rod Howard & Associates, 2006).

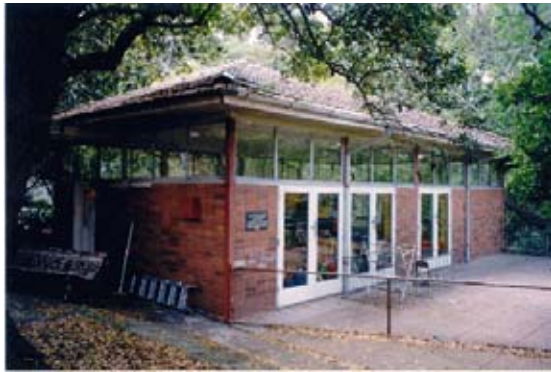
Figure 69: The playroom/classroom building is the most architecturally successful building constructed in association with the John Williams Memorial Hospital (Rod Howard Heritage Conservation Pty Ltd, October 2000).

The Playroom/Classroom is located to the east of “Rippon Grange” on the northern side of the site and close to Water Street. It is sited over a part of the early terraced garden area and is a single storey building with aluminium framed windows, face brickwork laid in stack bond between structural steel columns and a concrete floor slab. The tiled roof is hipped and features wide eave overhangs. Continuous high windows are located beneath the eaves. The southern wall of the building is glazed from floor to ceiling level, while the three pairs of timber framed French doors open onto a concrete paved terrace on the southern side of the building. There is dry rot in the roofing timbers at the eaves, especially at the south eastern corner of the building – the eaves are sagging in this location. Internally the building is a large unencumbered space with finishes that are simple – cement rendered walls and a flush finished fibrous plaster ceiling – and largely unaltered since the building was completed in 1959.

The building is suffering from the effects of vandalism.

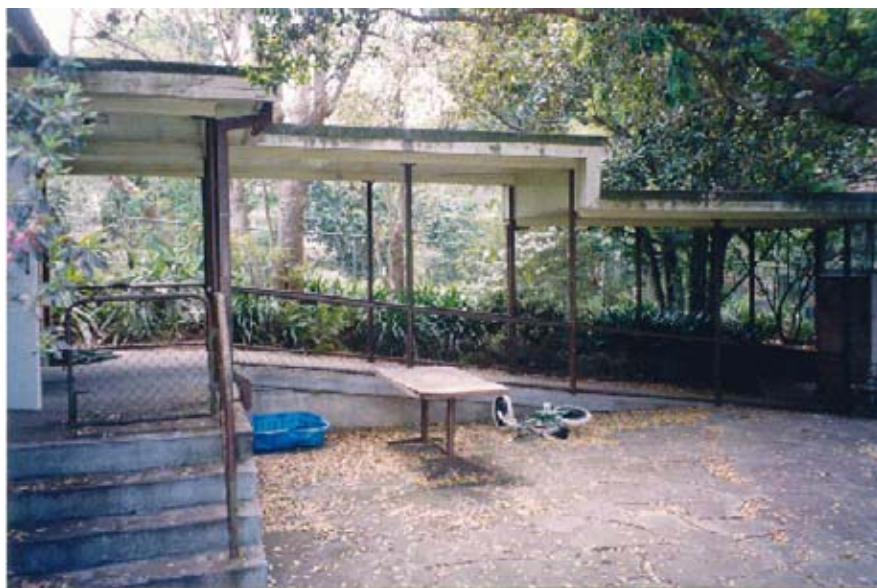
Figure 71: The covered way, constructed some six years later than the Playroom/Classroom, is rather more intrusive (Rod Howard Heritage Conservation Pty Ltd, October 2000).

The covered way connects the Playroom/Classroom block to “Rippon Grange” and is part of a small addition made to the house in 1966. It was designed in the office of Leighton Irwin & Company. It consists of a concrete ramp which falls to accommodate the change in level between the two buildings, protected by a flat metal roof supported off steel pipe columns. The underside of the roof structure, which steps down in three sections, is lined with fibro or a similar material. Steel pipe handrails with chain wire balustrades have been installed on either side of the ramp between the columns.

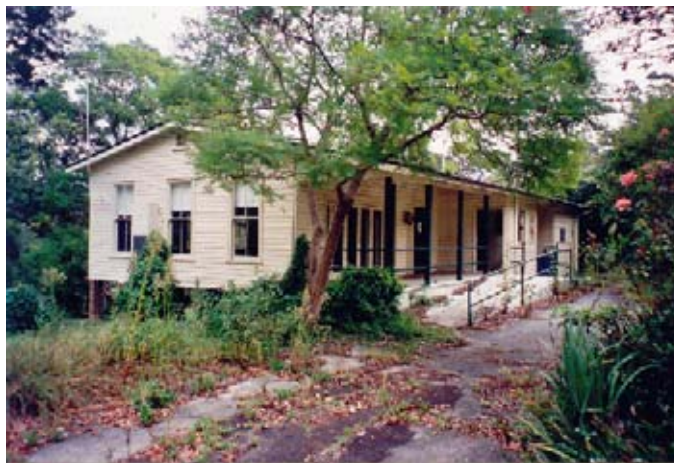
Figure 72: The Classroom Block was built in two stages. The eastern section was designed in 1954, while the western section was designed six years later. This provides evidence of the growth of the John Williams Memorial Hospital during its first decade of operation (Rod Howard Heritage Conservation Pty Ltd, October 2000).

The Classroom Block was constructed in two stages between 1954 and 1960 – the second stage is located at the western end of the building. It is a single storey building with timber framed walls lined externally with rusticated timber weather boards and has a shallow pitched gabled roof covered with corrugated iron and a verandah along the northern side. Rainwater goods are relatively recent fabric and are made of p.v.c. Tall windows with low sill and double hung timber framed sashes provide ample light and air into the building. The building is supported off brick piers, and because of the fall across the site there is sufficient space to stand and to store large objects beneath it.

Internally walls are lined with fibrous plaster or a similar material above a low dado finished with vertical timber boards. Ceilings are also lined with fibrous plaster or similar material and joints are covered with timber battens. There is a small kitchen and office adjacent to the main classroom.

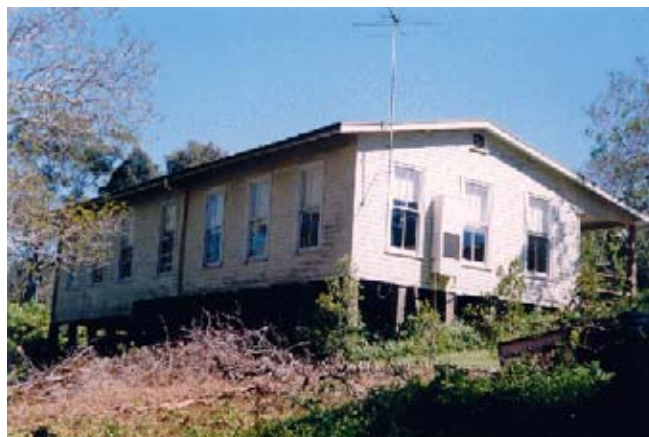
Figure 73: Killara Cottage. Photograph taken in March 2006 showing serious deterioration (Rod Howard & Associates).

Killara Cottage is a small playhouse that was built around 1964. It is in the form of a miniature dwelling, and is L-shaped in plan. It has a hipped roof covered in terracotta tiles, while the external walls are lined with timber weather boards. The windows are double hung timber framed sashes. The building contains two rooms and a small area fitted out as a kitchen, and has been painted in bright bands of colour. However, its physical condition is very poor. A portion of the roof has collapsed and there is evidence of termite infestation in roof and wall joinery.

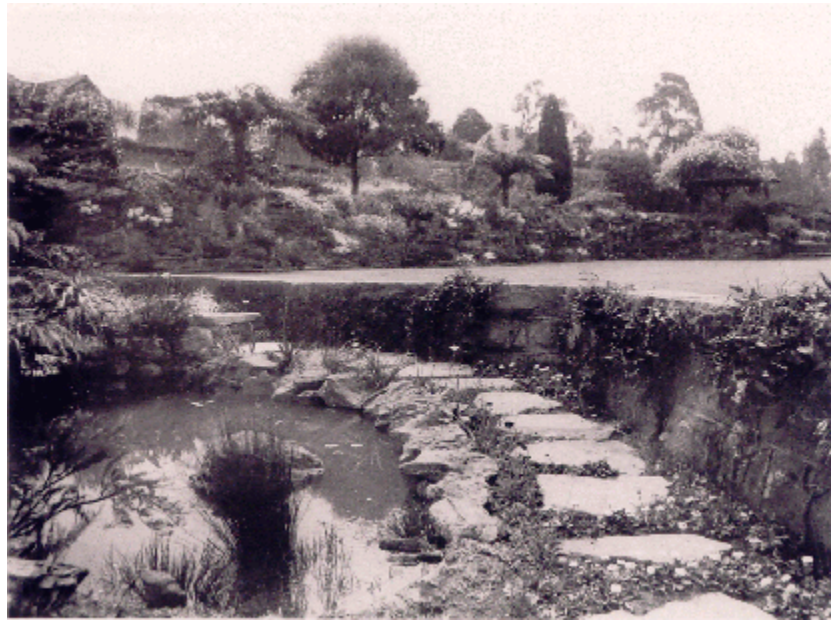
Figure 76: This photograph shows part of the elaborate fish pond abutting the southern wall of the croquet lawn at “Rippon Grange”. Note in the background the significant stone retaining wall separating the croquet lawn from the tennis court and the adjoining quaint summer house: “An unconventional garden pool at ‘Rippon Grange’, Wahroonga, N.S.W. The pool is sunk below the surface of a spacious lawn and surrounded by large flagstones, between which grow marigolds, daisies and Iceland poppies” (*The Home*, 1 February 1928, p.34).

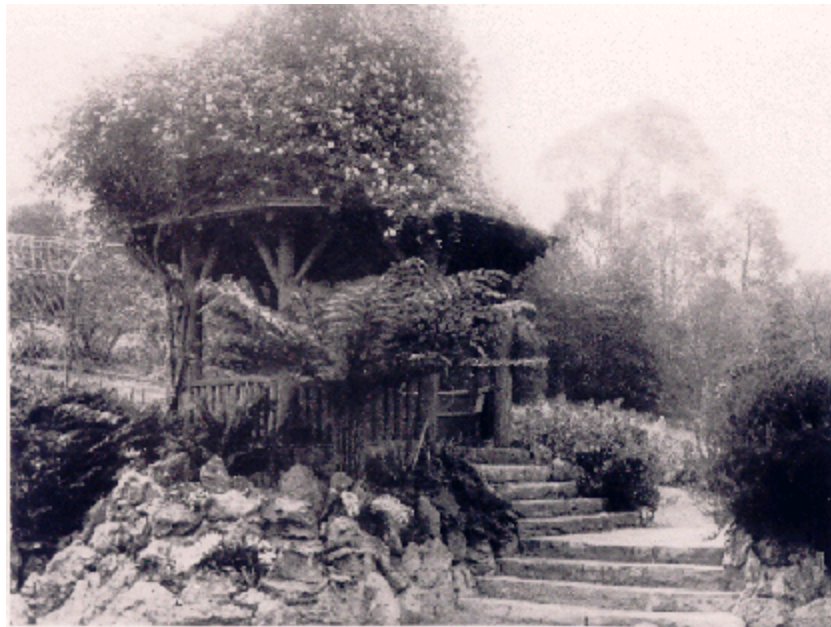
Figure 77: The secluded rustic Summer house, picturesquely perched above the expansive croquet lawn at the east of the property. Both the shelter and the wire trellis in the left background of the photograph are present on the site today: “Here the garden house and the garden are pleasantly blended. Treated with some regard to form the little rustic building fits admirably into a picturesque situation. There is a nice feeling of woody texture imparted by the log supports. At ‘Rippon Grange’, Wahroonga, N.S.W.” (*The Home*, 1 August 1928, p.28).

This structure, built pre-1934 to serve as a viewing shelter for the croquet lawn, collapsed recently, having been weighed down by vegetative overgrowth. The original rustic charm of the timber summerhouse is apparent in a 1928 photograph, as is the sinuous sandstone stairway that leads down to the croquet lawn. It is possible that what remains is not the original structure, and that it was renewed, perhaps in the 1930s.
