**"RIPPON GRANGE"**  
**35 WATER STREET, WAHROONGA**

**CONSERVATION MANAGEMENT PLAN**

**ROD HOWARD & ASSOCIATES PTY LIMITED**

REVISION 'C': DECEMBER 2007 AND UPDATED MAY 2008  
as endorsed by the Heritage Council of New South Wales, 11 May 2008

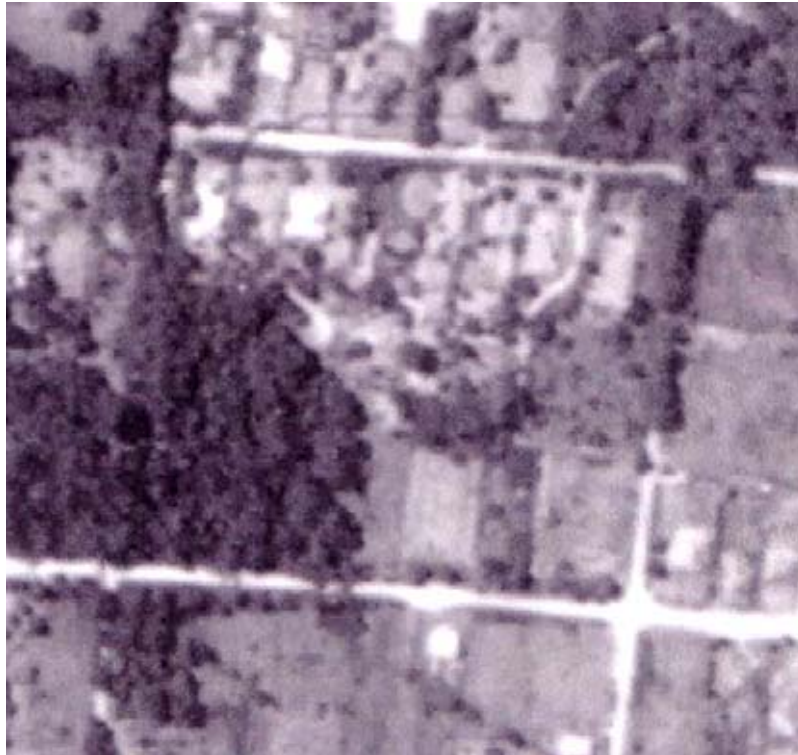
Figure 78: Portion of an aerial photograph of “Rippon Grange” from March 1930. During this period, the gravel drive between the tennis court and the croquet lawn can still be seen connecting to Water Street and the avenue of Eucalyptus along Young Street is already dominant.

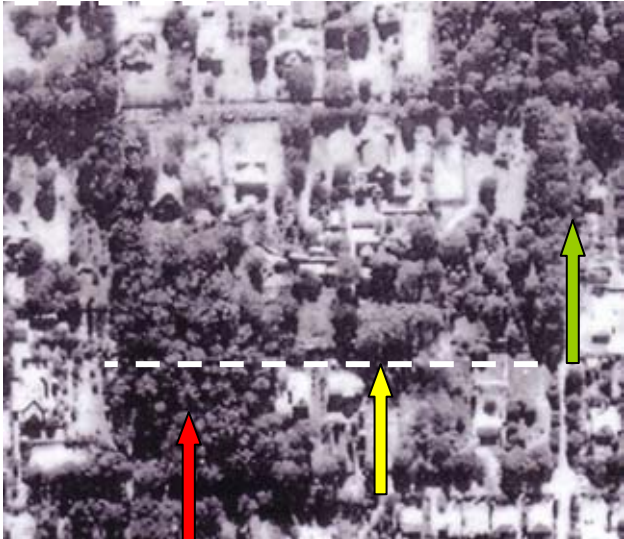
| <p>Figure 91: 1930</p> <p>Red arrow indicates tree cover on southern parts of the Sargood subdivision (Lots 8 to 10);</p> <p>Yellow arrow indicates trees in the central section of the southern boundary;</p> <p>Green arrow indicates cultural planting along Young Street.</p> | <p>Figure 92: 1951</p> <p>Red arrow indicates tree cover on southern parts of the Sargood subdivision (Lots 8 and 9);</p> <p>Yellow arrow: trees in the central section of the southern boundary;</p> <p>Green arrow indicates cultural planting along Young Street.</p> |

“Rippon Grange” suggested that these had either been spared, or had regenerated some decades previously, to have become as substantial as they appeared in 1930. An examination of the 1951 aerial photograph confirms that the Blue Gums in this area had increased in density and size since 1930 (see Figure 91 and Figure 92 below). The photograph indicates that the trees in the mid section of the southern boundary were still present and substantial, and also that the remnant of the Blue Gum High Forest was still present on lots 8 and 9 to the west. The planted trees along the Young St. boundary had become larger, as have the regenerated trees in the ‘bushland’ between them and the retaining wall of the croquet lawn.

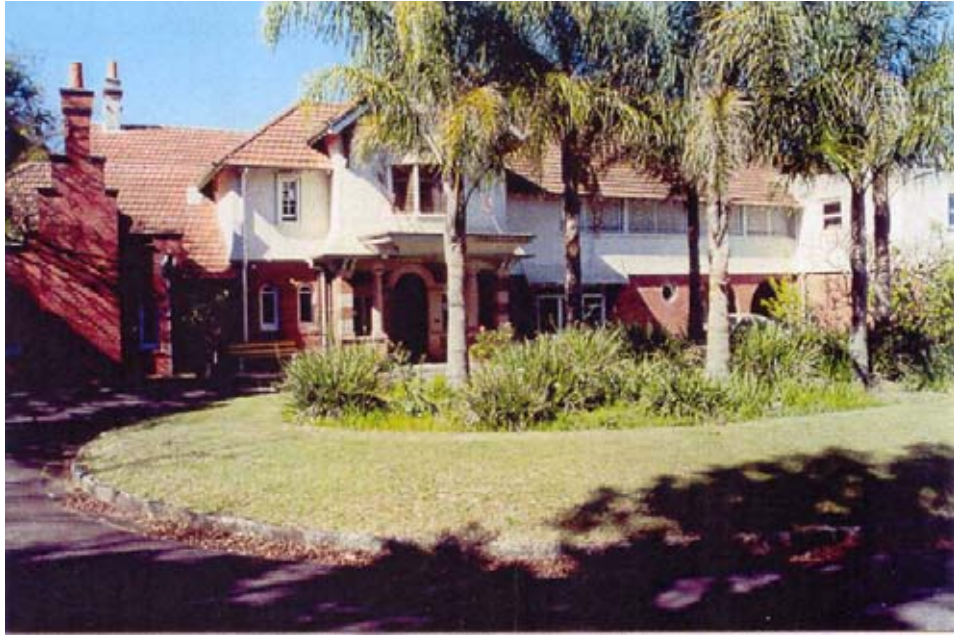
Figure 93: The carriage loop outside the western facade of the mansion. The present bitumen road surface was laid at a higher level than the original driveway servicing the main entry. The palms in this photographs are not original planting (Mayne-Wilson & Associates, August 2000).

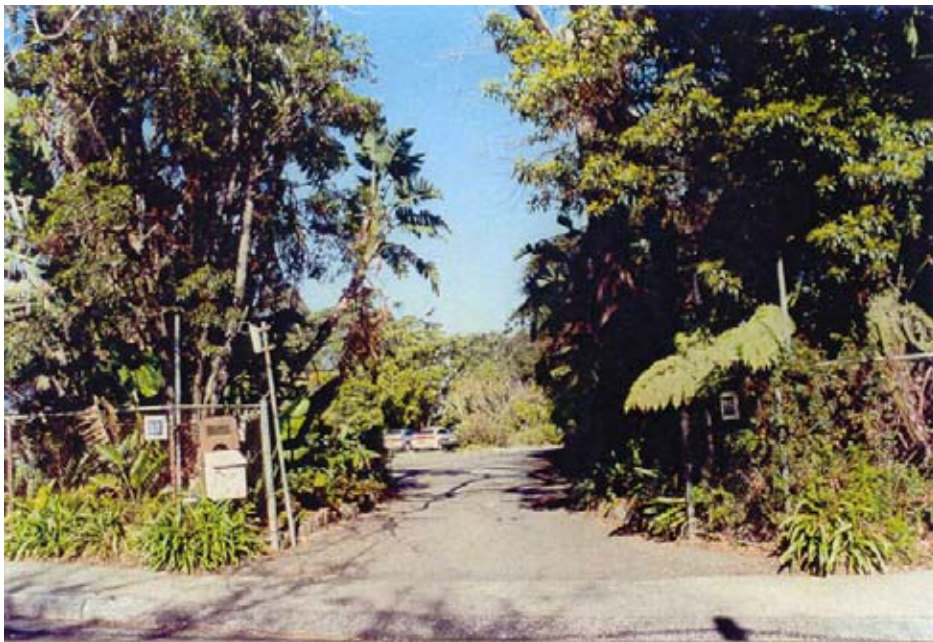
Figure 94: The main entry to “Rippon Grange” from Water Street (Mayne-Wilson & Associates, August 2000).

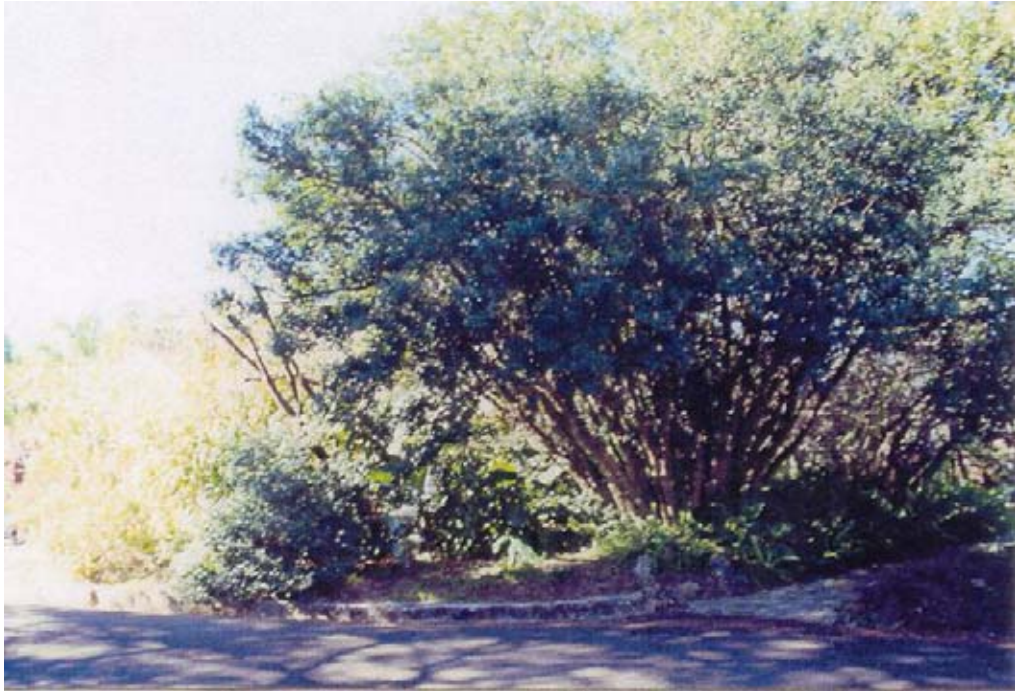
Figure 95: View looking north-east, from the driveway off the carriage loop, towards the mansion. The tree in the foreground is an Arbutus, flanked on its far edge by a large Magnolia. The path in the right foreground leads towards a conservatory, now concealed by dense creeping fig, with an abutting secluded ‘garden room’ (Mayne-Wilson & Associates, August 2000).

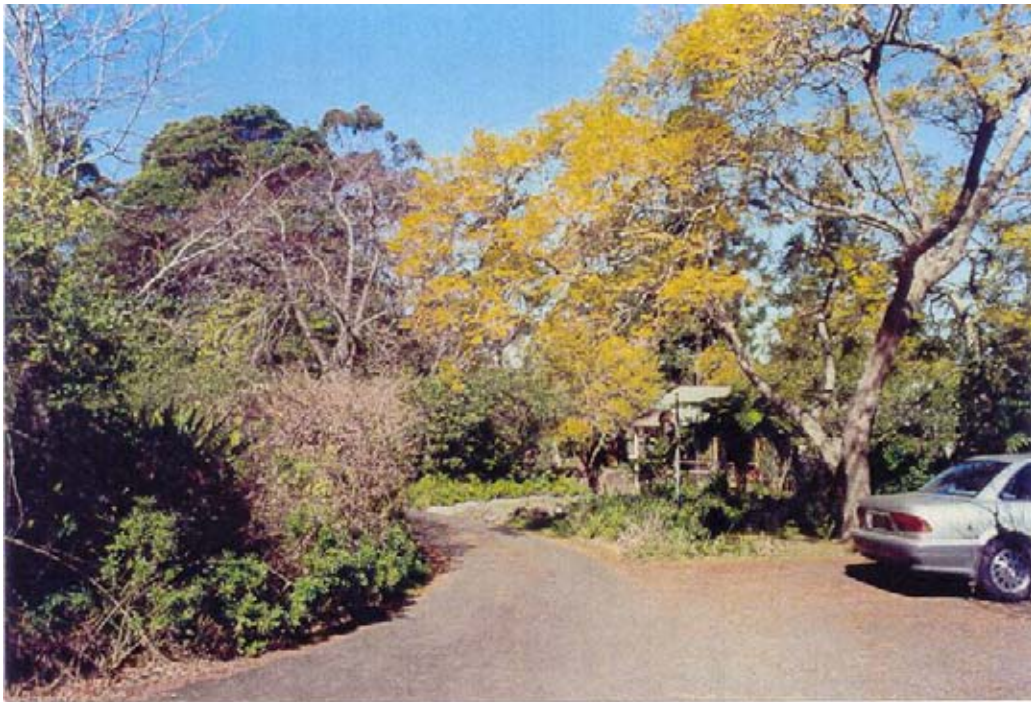
Figure 96: The arc of the driveway to the south of the entry carriage loop. The Jacaranda in the right foreground is an early site planting. The conservatory and its adjoining gardens are on the far left, raised above the driveway by a couple of metres (Mayne-Wilson & Associates, August 2000).

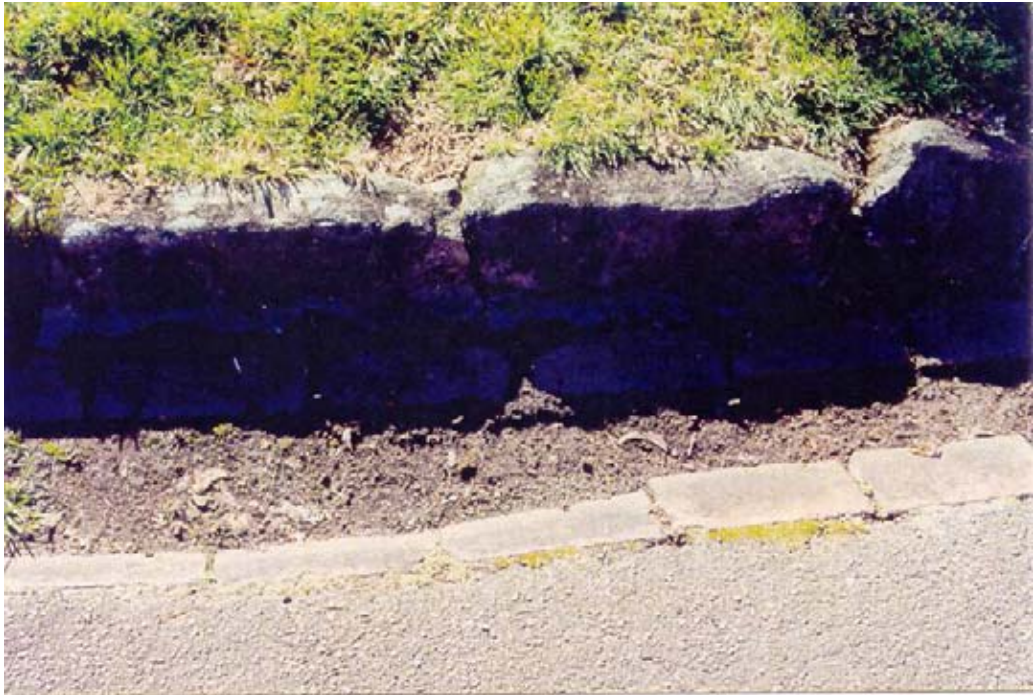
Figure 97: Detail of the kerbing and guttering along the edges of the carriage loop outside the western facade of the mansion. Such sandstone block gutters and brick spoon drains are commonly found on the edges of many of the driveways around the site (Mayne-Wilson & Associates, August 2000).

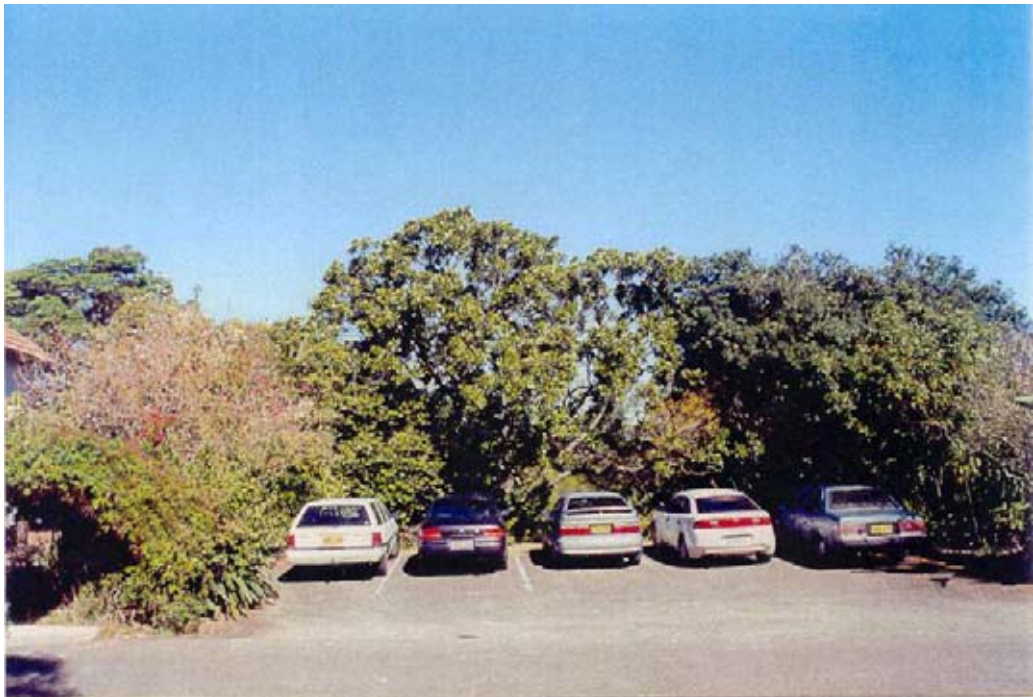
Figure 98: The parking area created at the southern edge of the carriage loop outside the main entry to the mansion abuts several original plantings, including a Magnolia, Camellias and poinsettias. The Magnolia is the largest specimen, in the middle of the photograph (Mayne-Wilson & Associates, August 2000).

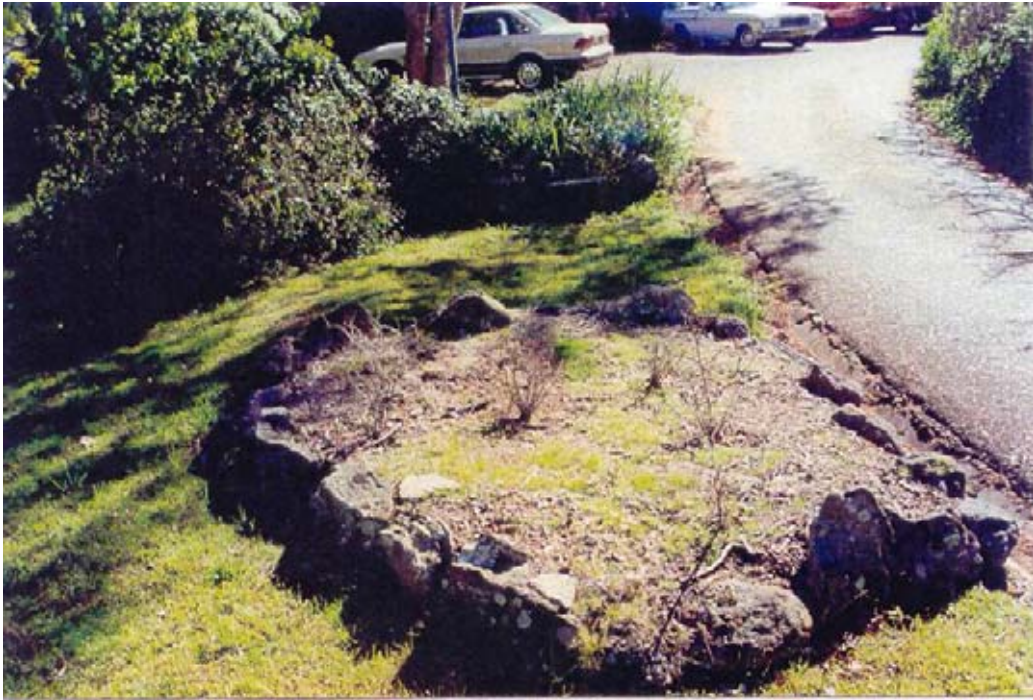
Figure 99: One of the several sandstone planting beds still visible in the lawn below and across the driveway from the conservatory. This feature was part of what was originally termed the ‘potting shed’, comprised of several sandstone-edged beds and a potting shed (Mayne-Wilson & Associates, August 2000).

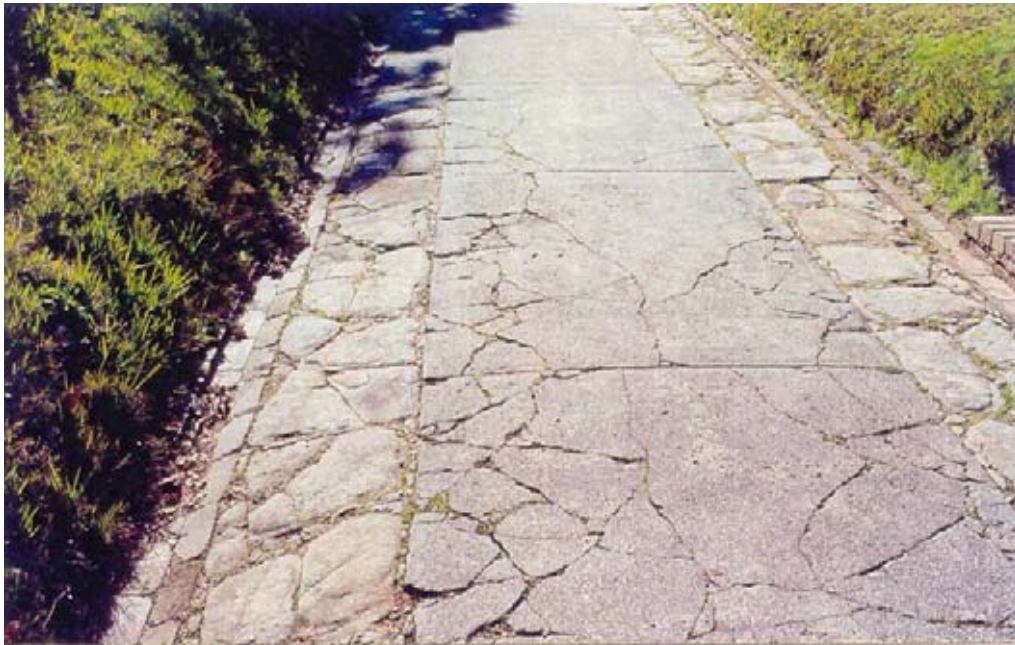
Figure 100: The concrete and sandstone driveway leading from the southern side of the mansion past the conservatory and ‘potting shed’. This may have originally been a service driveway to the kitchen area of the house. Note the brick spoon drains on either side of the driveway (Mayne-Wilson & Associates, August 2000).

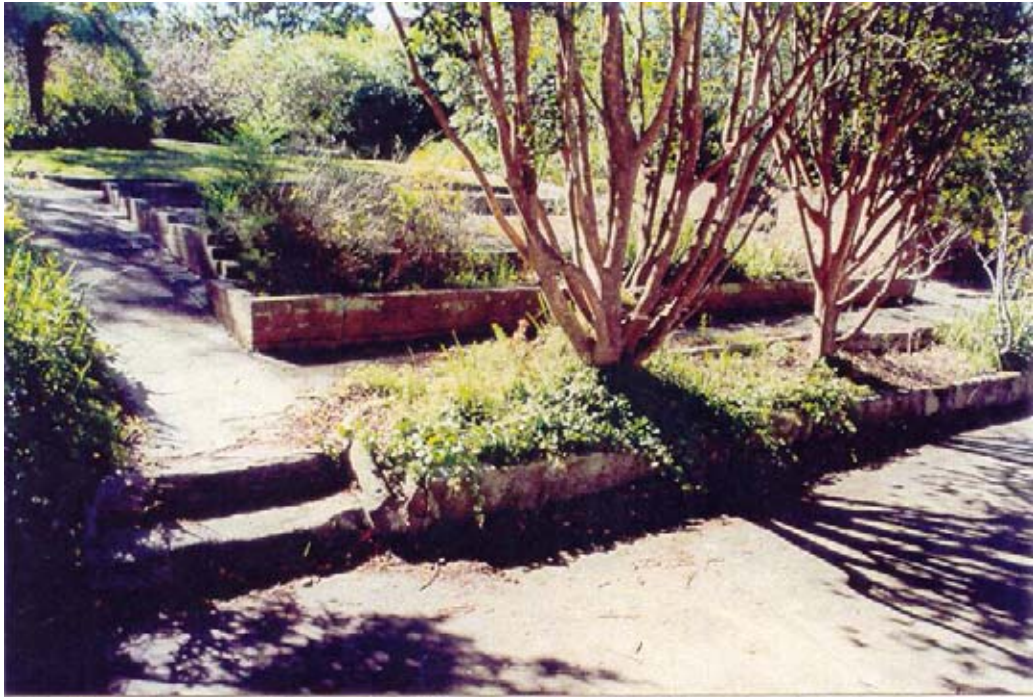
Figure 101: The southern edge of the original ‘potting garden’. The sandstone steps and bed walls in the foreground are original features of the garden layout. The Crepe Myrtles are more recent (Mayne-Wilson & Associates, August 2000).

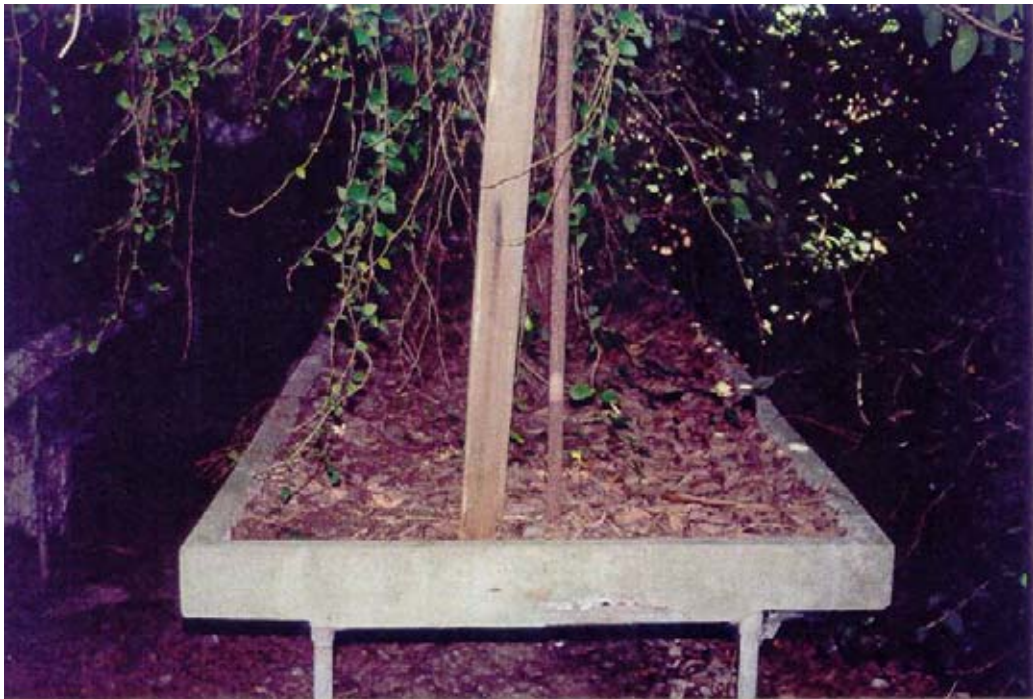
Figure 102: An internal view of the conservatory structure, to the south-west of the mansion. Detail of its original external structure is not available, due to the fig coverage (Mayne-Wilson & Associates, August 2000).

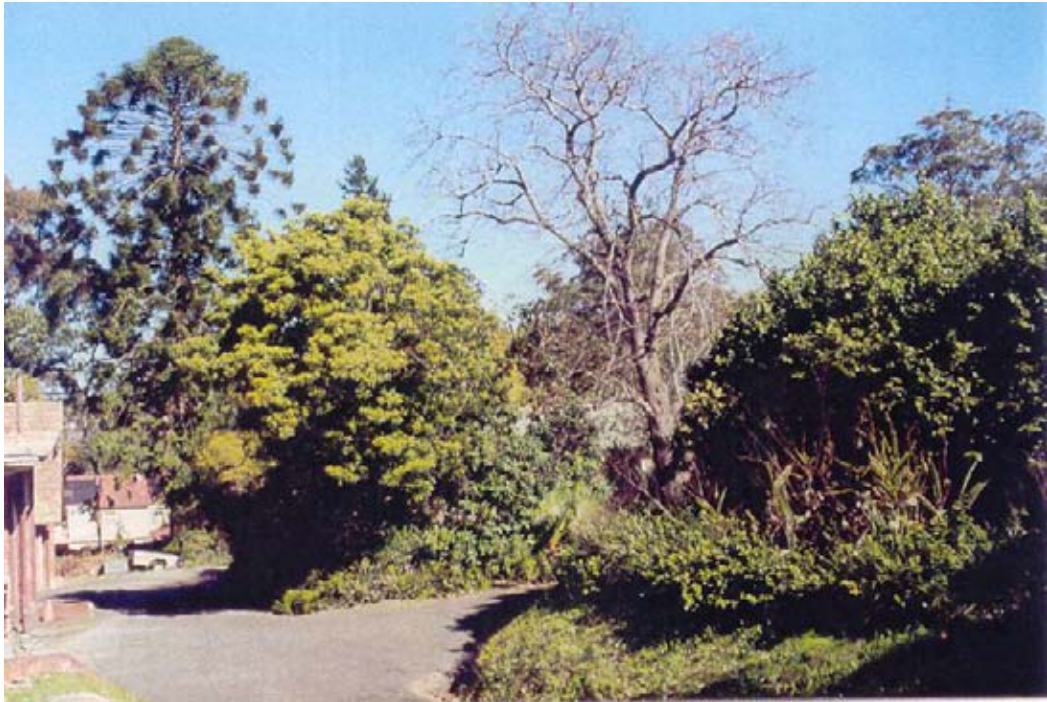
Figure 103: Looking south from the lawn forecourt outside the southern facade of the mansion. The conservatory, concealed by a creeping fig, is on the far right of the view. The driveway arm disappearing to the right of the photograph leads up to the carriage loop and Water Street. Note the dominant Bunya Pine (Mayne-Wilson & Associates, August 2000).

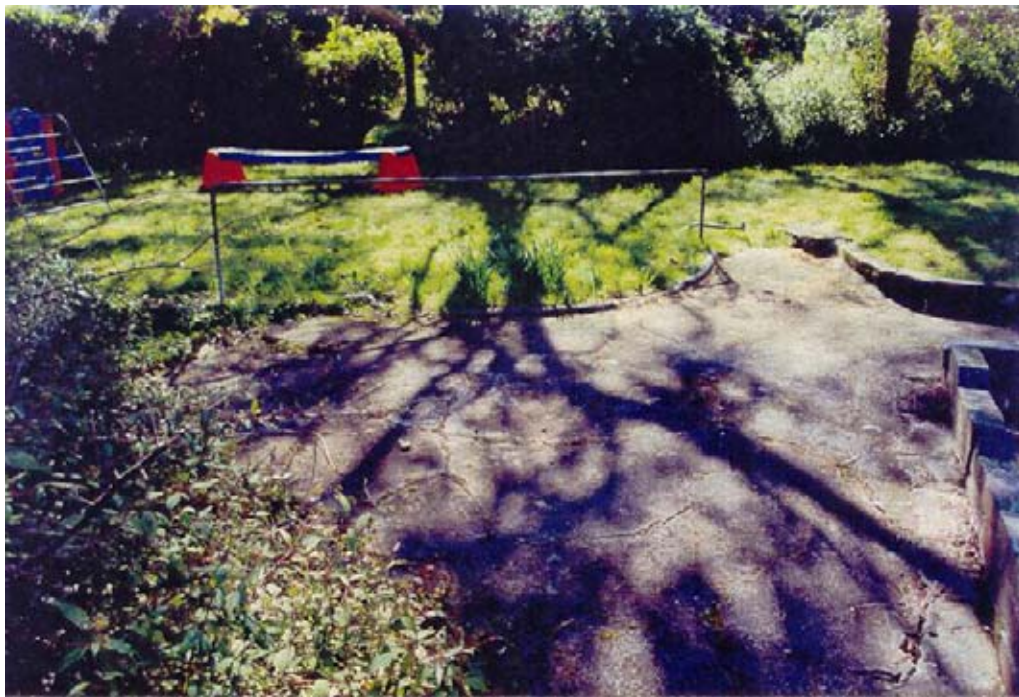
Figure 104: The western section of the original ‘potting garden’, now on the boundary of the property. The sandstone edging and crazy-paved paths are original elements of the garden layout (Mayne-Wilson & Associates, August 2000).

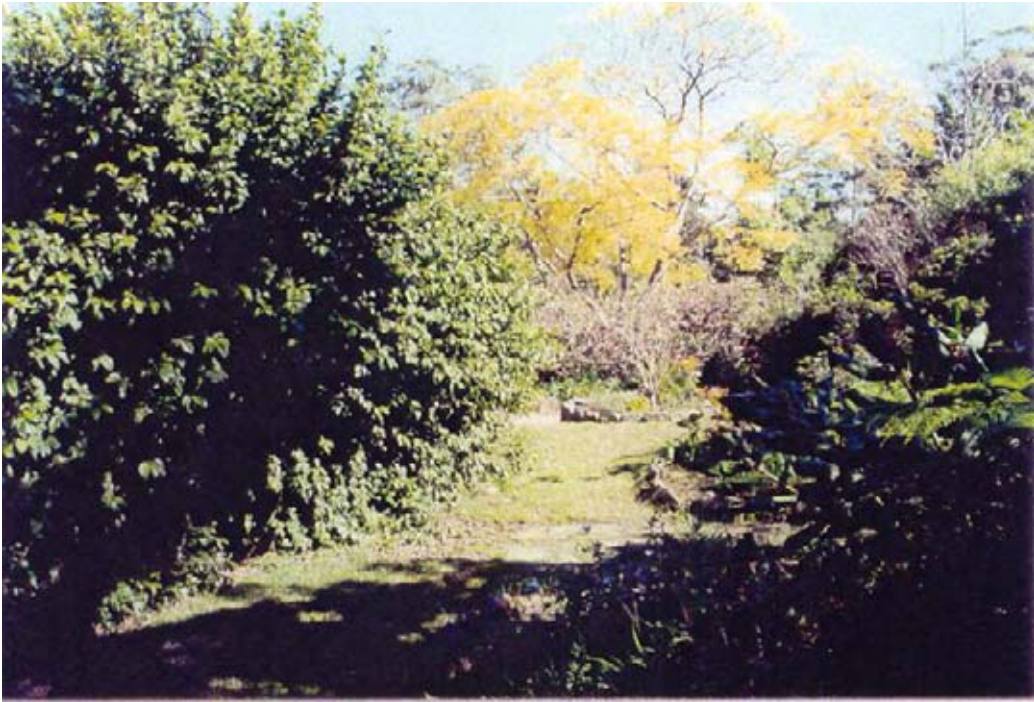
Figure 105: The ‘garden room’ outside the conservatory. Small sandstone-edged planting beds, similar to those found in the ‘potting garden’ border a lawn area. The conservatory is on the far left of the view (Mayne-Wilson & Associates, August 2000).

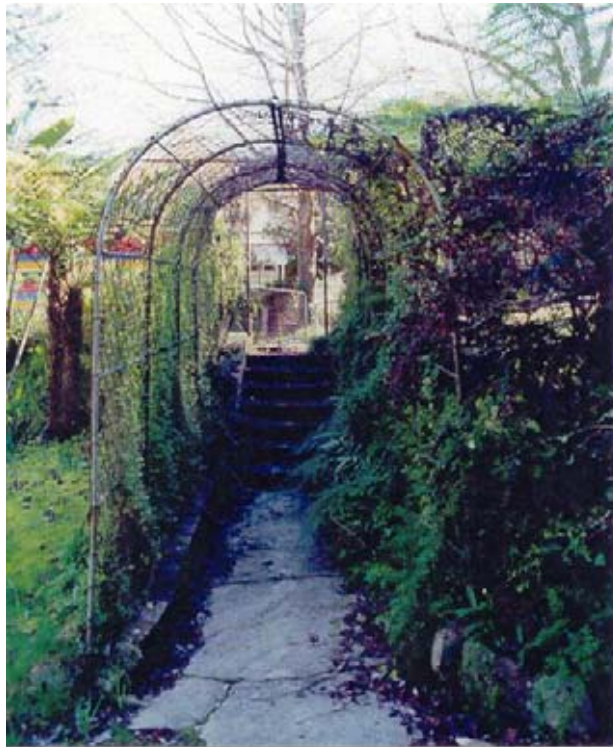
Figure 116: View looking west through the western-most of the two garden arbours leading towards the croquet lawn from the mansion (Mayne-Wilson & Associates, August 2000).

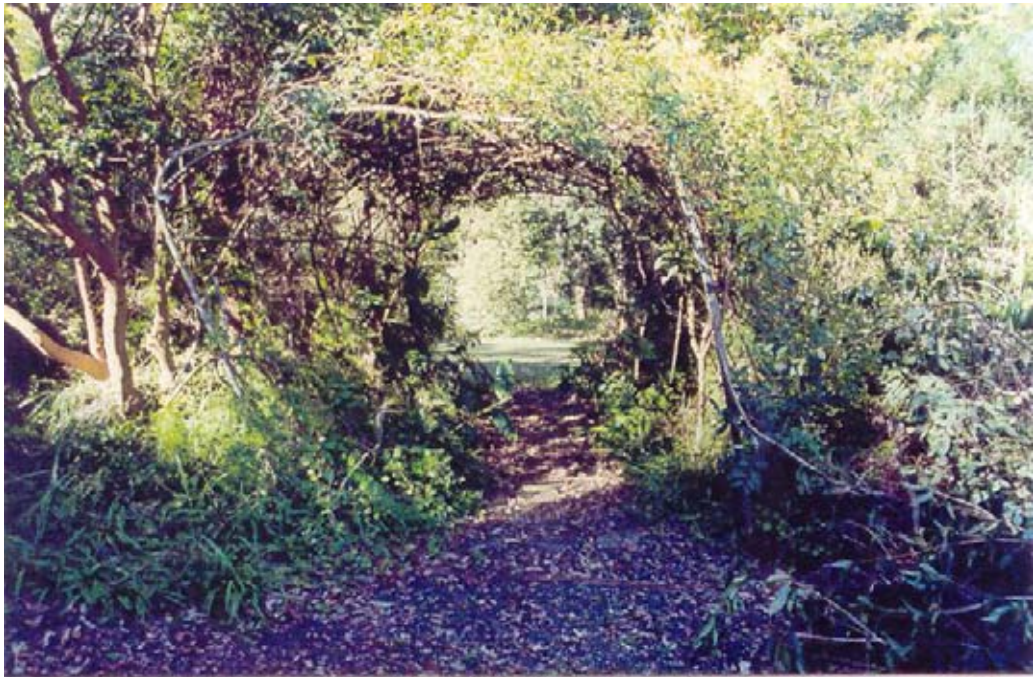
Figure 117: View looking east through the eastern-most of two garden arbours leading towards the croquet lawn from the mansion (Mayne-Wilson & Associates, August 2000).

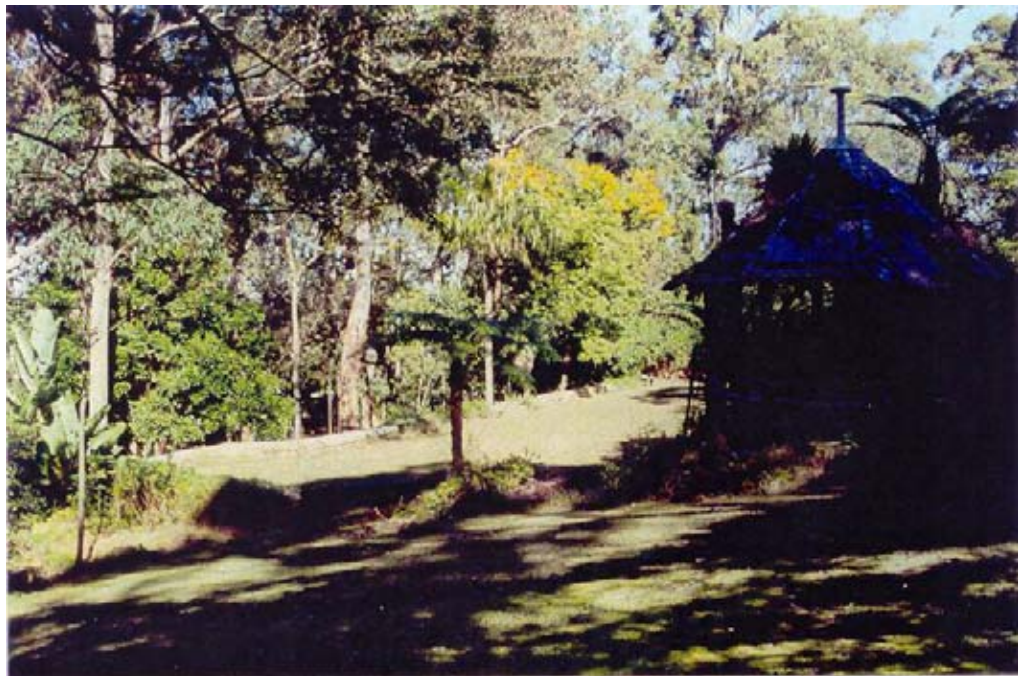
Figure 120: View looking south-east to the croquet lawn from the area to the north of the dilapidated Summer house built next to it (Mayne-Wilson & Associates, August 2000).

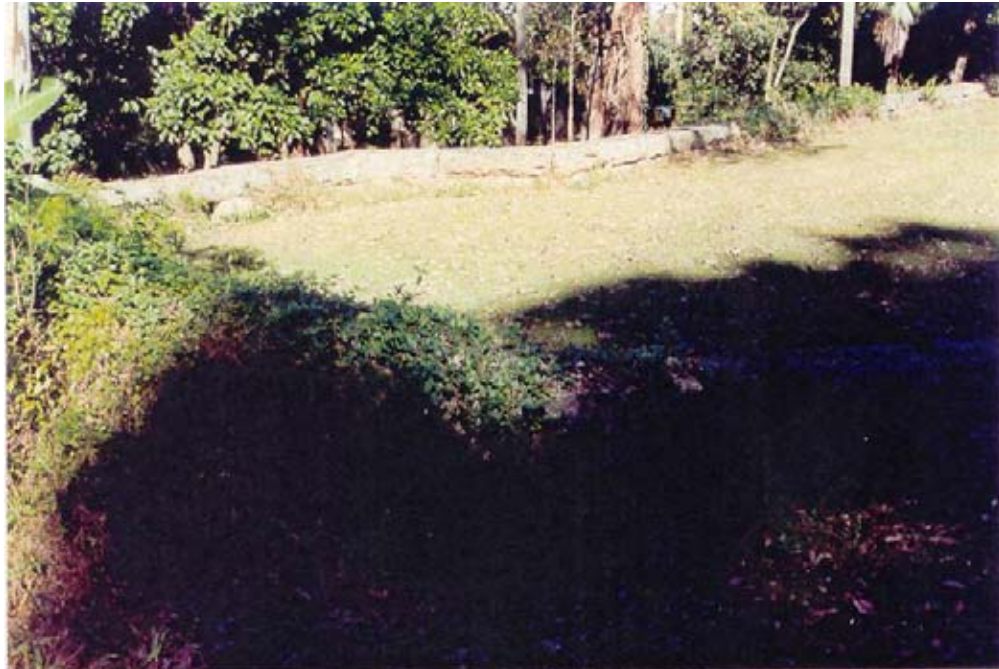
Figure 122: The north-east corner of the croquet lawn. The sandstone wall that retains the field on its eastern side extends above the level of the lawn by approximately 400 mm, as seen in the background of the view (Mayne-Wilson & Associates, August 2000).

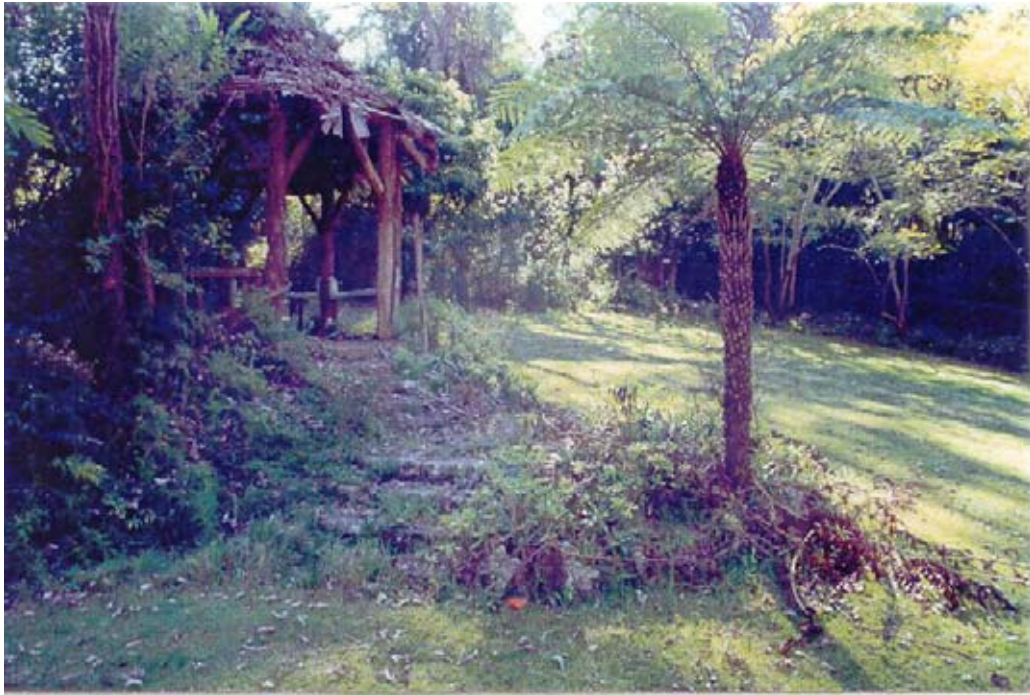
Figure 123: The ‘summer house’ adjoining the croquet lawn, seen from the south. This structure is thought to have been built after 1922 and was definitely in place by 1928 (Mayne-Wilson & Associates, August 2000).

This structure, built pre-1934 to serve as a viewing shelter for the croquet lawn, collapsed recently, having been weighed down by vegetative overgrowth. The original rustic charm of the timber summerhouse is apparent in a 1928 photograph, as is the sinuous sandstone stairway that leads down to the croquet lawn. It is possible that what remains is not the original structure, and that it was renewed, perhaps in the 1930s.

Once a charming, rustic feature with timber frame and conical, thatched roof, this has collapsed. Its precise date of construction is not known, but it appears likely to have been built in the 1920s.

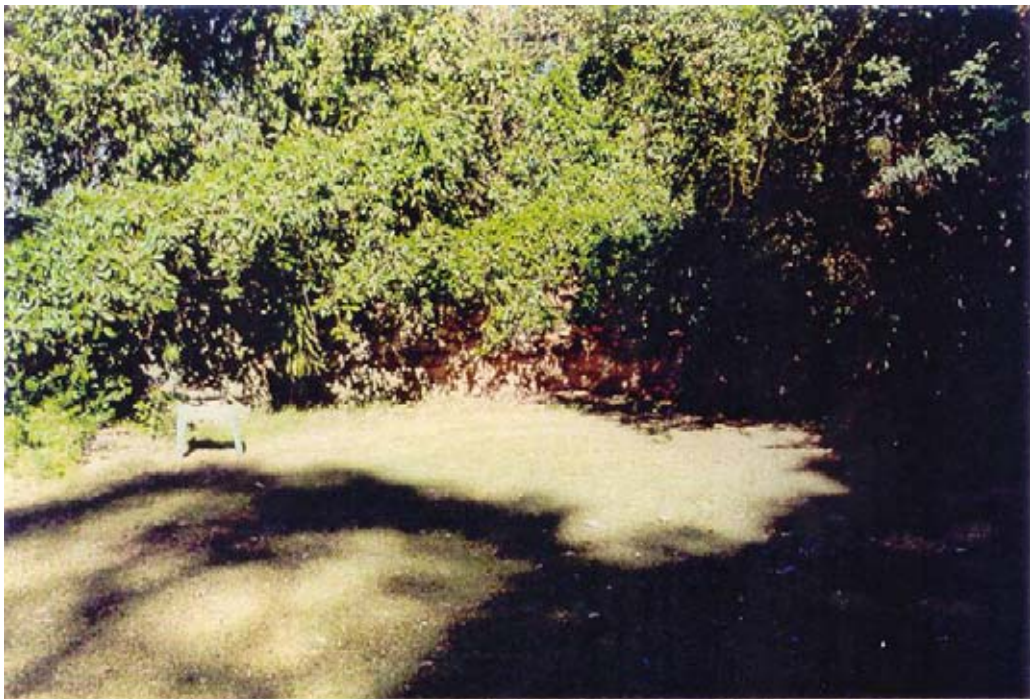
Figure 124: The south-east corner of the croquet lawn, where a higher sandstone wall and a long, arched sandstone seat provided a sheltered sunny location for spectators. The “grotto” in this part of the site is thought to date to the 1970s, as suggested by its construction (Mayne-Wilson & Associates, August 2000).

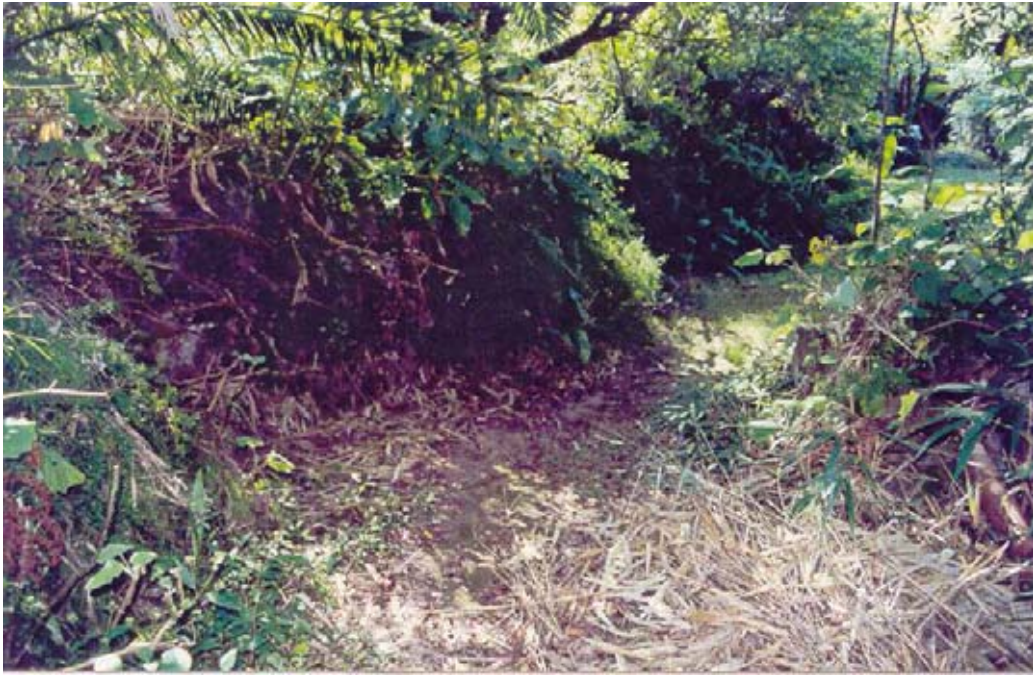
Figure 125: The southern entry and exit from the croquet lawn was marked by roughly constructed large-bouldered sandstone walls, the upper one of which (on the left) is partly remaining. They are both now concealed by vegetation overgrowth (Mayne-Wilson & Associates, August 2000).

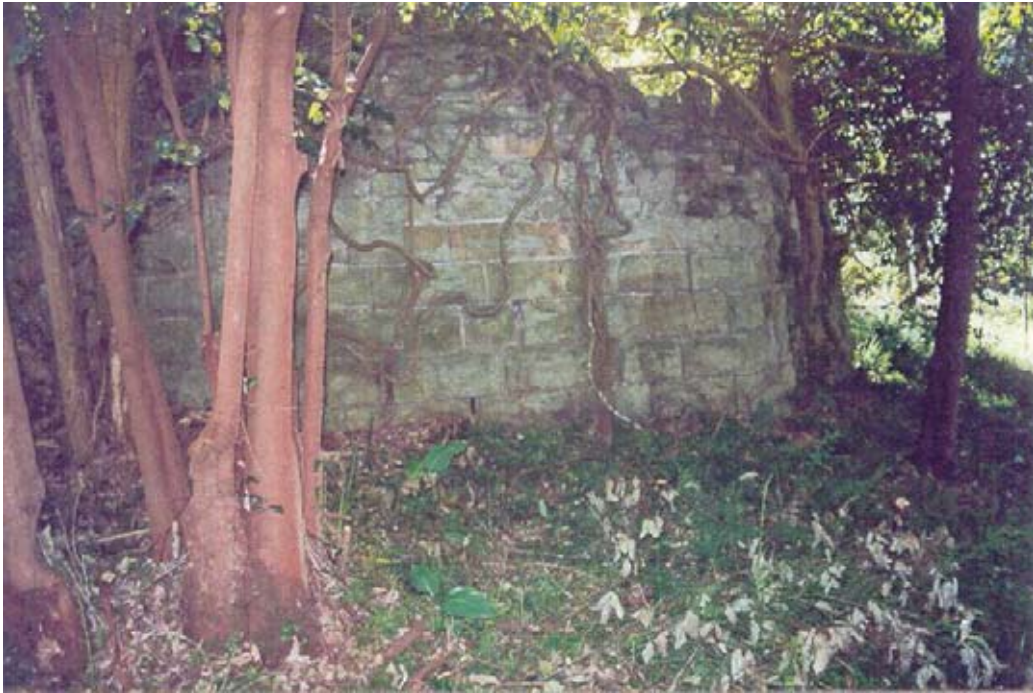
Figure 127: The southern face of the retaining wall supporting the croquet lawn. This section of the retaining wall is much higher than at the northern end of the field, due to the fall in ground level along the base of the wall (Mayne-Wilson & Associates, August 2000).

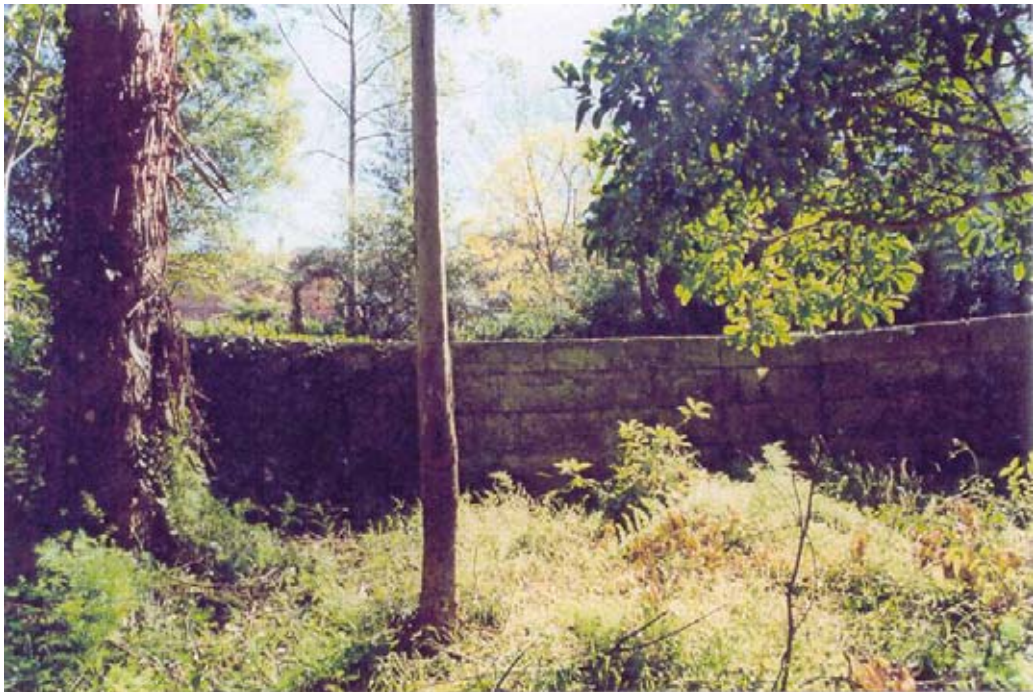
Figure 128: The eastern wall of the croquet lawn, closer to the northern end of the field. Glimpses of the mansion's roof are visible in the background of the photograph (Mayne-Wilson & Associates, August 2000).

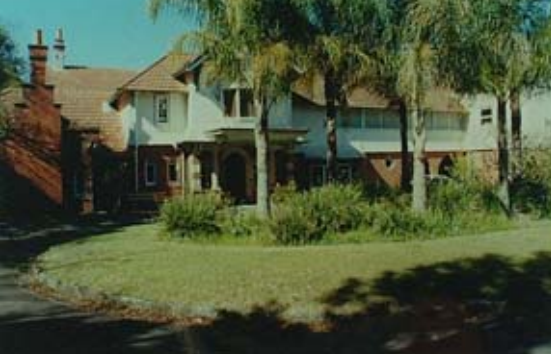
| No. | Item and Location /<br>Description of Historic<br>Elements | Photograph of Item | Heritage rating,<br>comment and/or heritage<br>recommendations |
|---|---|---|---|
| 1. | <p><b>Entry carriage loop</b><br/>(north-west sector)</p> <p>After the 1922 subdivision excised the original entrance to the property, this loop of the original carriage drive was merged with the new entrance to the front of the house.</p> | | <p><b>Rating: High</b></p> <p>Should be conserved and maintained, including the original brick drain edging. The palms are not significant and could be removed.</p> |

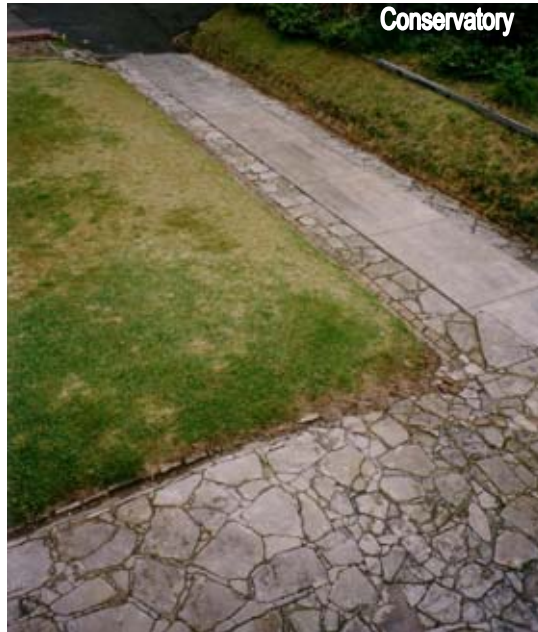
3. **Concrete driveway to garage & stables** (*central sector*)

This section once provided vehicular access from the main driveway to the service rooms & kitchen of the residence. It also provided pedestrian access from the carriage loop to the garage and stables via a wire arbor (see yellow arrow on item 2 above). This access way is now seldom used.

**Rating: Moderate**

In the event that it is retained, its configuration and crazy paved edging should be maintained. As its condition has deteriorated over the decades, it should be repaired, but only with similar materials.

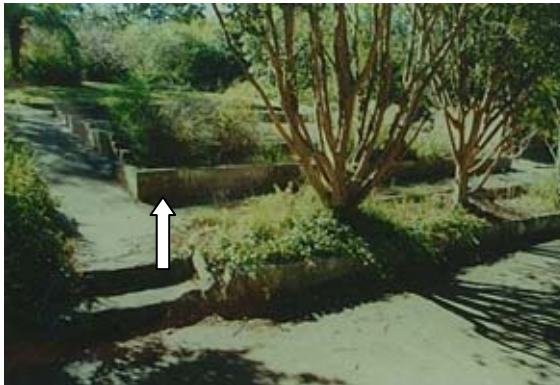
In the first four decades of the 20<sup>th</sup> century there were successive potting sheds and glasshouses in this area for the propagation of plants for the ornamental and vegetable gardens, demonstrating early attempts at self-sufficiency. As the picture opposite shows, only the bases of some of these structures remain (arrowed).

**Rating: A Little**

While the remnant footings could be retained for interpretative purposes, none of the original superstructures are left, so it is hardly worth doing so. Their location is already identified on site plans of 1934, 1937 and 1954.

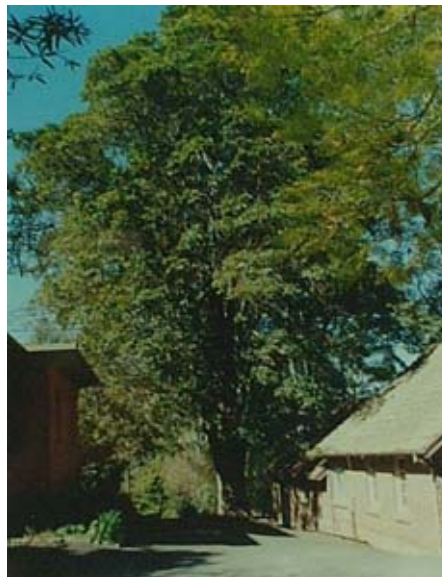
5. **Pair of old Brush Box trees** (*central sector*)

These huge trees appear to be quite early plantings on the site, flanking the central driveway down to the southern sector.

**Rating: High**

Should be conserved and maintained by a skilled arborist.

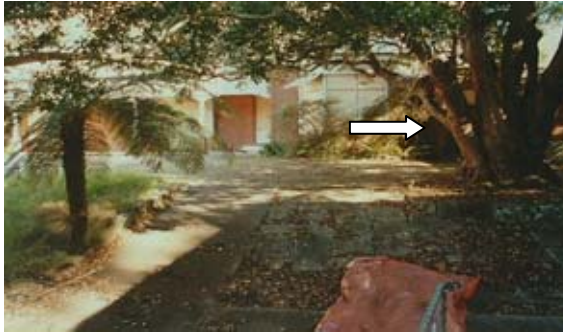
This was substantially altered by the construction of the 1960s hospital wing but the space is important as the main forecourt to the house.

It appears that the ground level of this terrace it has been raised about 300mm since 1960.

**Rating: High**

The paving and stone retaining wall should be removed and the terrace reinstated as closely as possible to the original layout, with lawn batter slopes of buffalo grass, as shown in the old black & white image below.

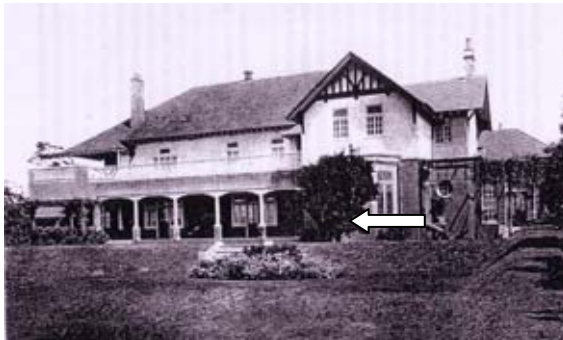
Note the Irish Strawberry tree (arrowed) in front of the bay window, right of centre.

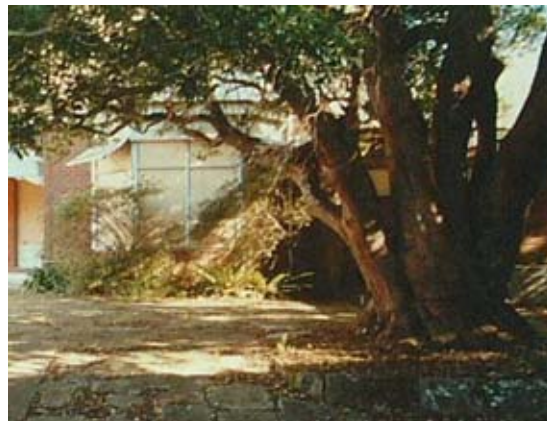
6a **Irish Strawberry Tree**

An original cultural planting in front of the Bay window (see black & white image below), this still exists in reasonably good condition.

**Rating: Moderate**

Should be conserved and maintained by a skilled arborist.

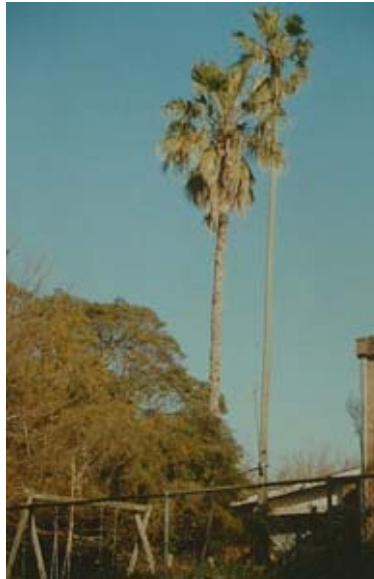
9. **Two mature palms, middle terrace** (central sector, south end)

These two Cabbage Tree Palms are not of the same age, the shorter one being planted in the late 1930s. The older one c.1900 is a typical federation period planting. They flank the view to the house from the croquet lawn and gravel drive.

**Rating: High**

Should be conserved and maintained by a skilled arborist.

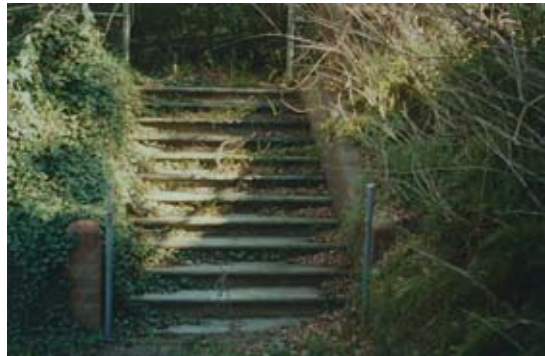
(central eastern sector)

This staircase, with slate treads, appears to have been re-built to a greater height, combining treads from the original upper staircase with those of this one. This was necessary to accommodate the fill laid over the middle terrace (see items 7 & 8 above).

**Rating: Moderate as is,  
High if restored**

The upper, dark slate treads should be lifted and used to restore the upper to middle level staircase (see item 7 above), and the pale slate used for the mid-terrace-to-tennis-court-level staircase, which will need to be reduced in height.

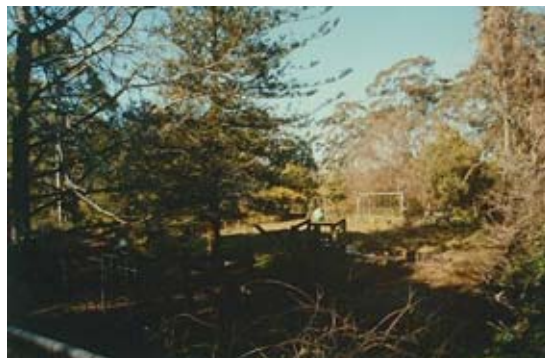
(central eastern sector)

This court has existed from early in the life of the estate, reflecting the popularity of the game for domestic recreation in the early decades of the 20<sup>th</sup> century.

**Rating: High**

All later elements such as children's playground equipment and tree plantings should be removed, and the court reinstated as closely as possible to the original layout.

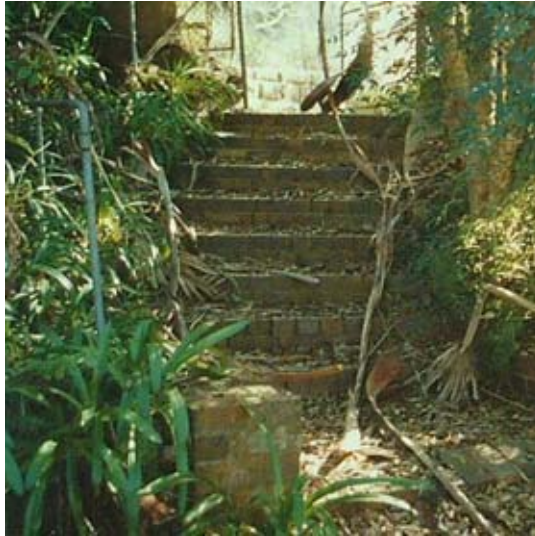
*(central eastern sector)*

These stairs are early ones, leading from the southern end of the tennis court to the pathways through the lawns and gardens south of the house. Their present configuration, however, reflects adjustments made when changes in level were made to the middle terrace when the swimming pool and hospital wing were added between 1935 and 1960

**Rating : High**

Should be retained, repaired and conserved. Adjustments may need to be made when the middle level terrace is restored and the hospital wing removed.

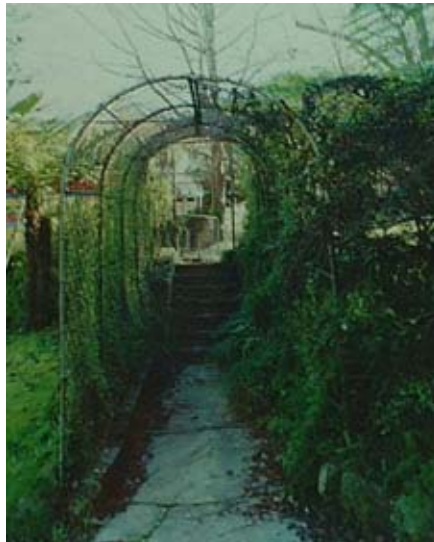
*(central north-east sector)*

This wire arch covers the stairs from the tennis court to the strip garden and early gravel drive below it. It was a typical feature of interwar gardens.

**Rating: Moderate**

Should be repaired, conserved and maintained. If too rusted and decrepit, it should be replaced by another arbor of very similar character and materials

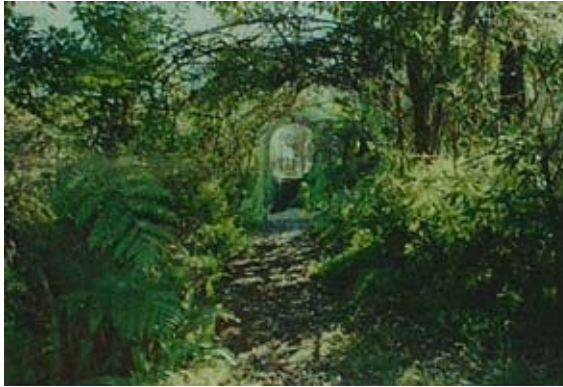
*(lower north-east sector)*

This leads from the early gravel drive (item 14) along the curving pathway to the summerhouse and croquet court. It is in poor condition.

**Rating: A Little**

Should be replaced by another arbor of similar character and material, to guide persons along the pathway to the croquet lawn.
