**"RIPPON GRANGE"**  
**35 WATER STREET, WAHROONGA**

**CONSERVATION MANAGEMENT PLAN**

**ROD HOWARD & ASSOCIATES PTY LIMITED**

REVISION 'C': DECEMBER 2007 AND UPDATED MAY 2008  
as endorsed by the Heritage Council of New South Wales, 11 May 2008

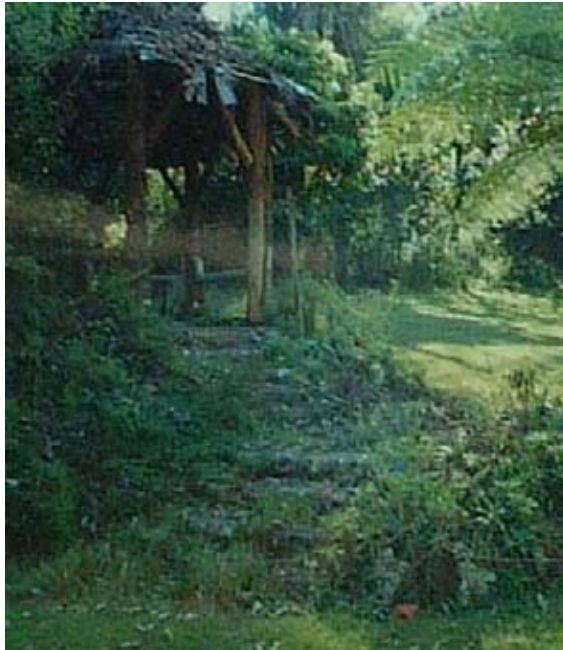
16. **Sandstone steps and pathway to summer house and croquet lawn**  
*(lower, eastern sector)*

Typical federation period curving pathway to summer house and on via sandstone steps down to croquet lawn.

**Rating: Moderate**

Should be restored, conserved and maintained.

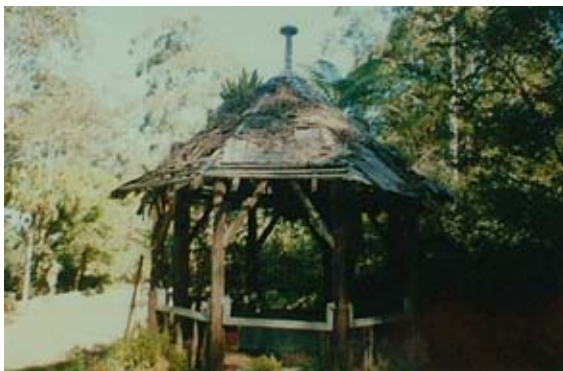
*(lower, eastern sector)*

Once a charming, rustic feature with timber frame and conical, thatched roof, this has collapsed. Its precise date of construction is not known, but it appears likely to have been built in the 1920s.

**Rating: Moderate,**

Excellent summer house (rusticated) in very poor repair.

As stated elsewhere in the Conservation Management Plan, the summerhouse has deteriorated to the extent that the structure has totally collapsed. However, deteriorated building fabric remains in place, providing evidence of the original design to guide restoration of sound early fabric and reconstruction of damaged elements.

Loose fabric should be stored on site so that it can be restored or used as a basis for reconstruction of the missing fabric.

- The summerhouse should be reconstructed in or close to its existing location and conserved so that its heritage significance can be regained;
- The building has collapsed as a result of poor maintenance and neglect. Loose fabric should be stored safely on site so that it can be restored or used as a basis for the reconstruction of missing fabric.

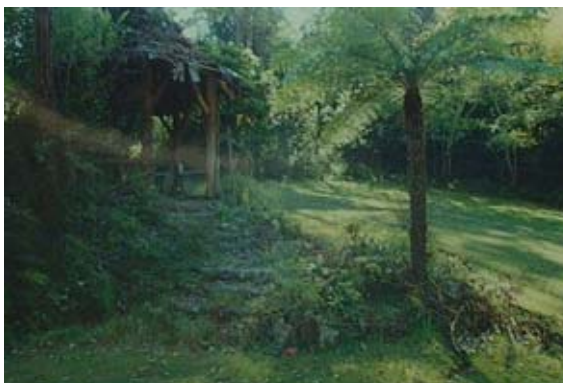
*(lower, eastern sector)*

These tree ferns became an integral part of the group composition with the summer house, perhaps inspired by that at *Rippon Lea* in Melbourne.

**Rating: A little**

Should be conserved and maintained by a skilled arborist.

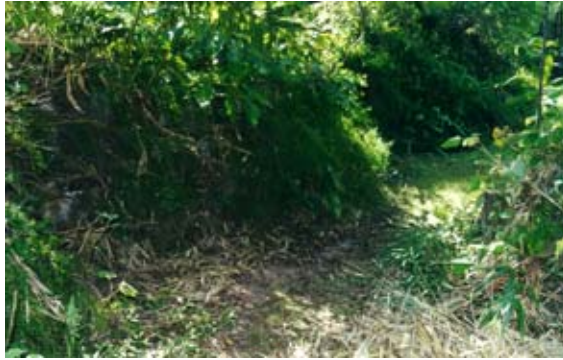
*(lower, eastern sector)*

This substantial rock boulder wall was originally an elaborate rockery (see late 1930s image in historical section above). It served to retain the slope between the gravel drive above and the croquet lawn below. It is now much overgrown.

**Rating: Moderate**

This should be repaired, conserved and maintained, and the vegetation in front of and within it removed.

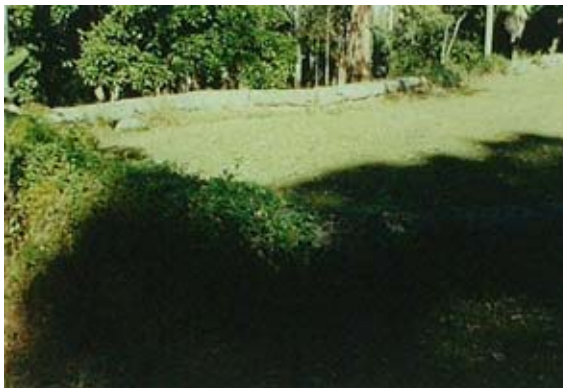
This is the lowest of the three major lawn terraces to the east of, and downslope from, the house.

It demonstrates another important recreation facility introduced by the Braddock family.

**Rating: High**

This should be cleared of any regrowth trees or shrubs, and the lawn surface restored. If not used for croquet, it should be retained as a grassed open space.

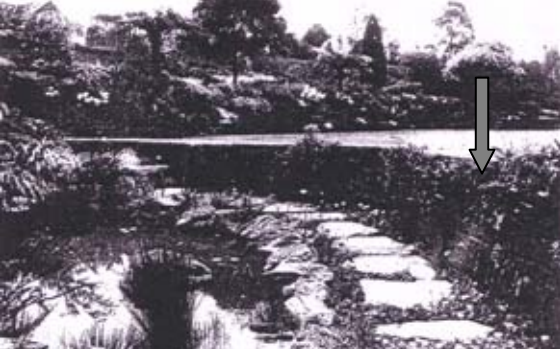
| 22. | <p><b>Former fish ponds</b><br/>(central, lower eastern sector)</p> <p>These have been completely covered over and have now become an archaeological item. This 1928 photograph opposite demonstrates their original character. They were an unusual adjunct and appear to have been installed after 1922 by the Braddock family.</p> | | <p><b>Rating: Formerly Moderate, now A Little</b></p> <p>They could be excavated, or remain covered, depending on the proposed future use of this area. If a water feature is desired within the future landscaping plan, it could be based on this site and its component elements.</p> |

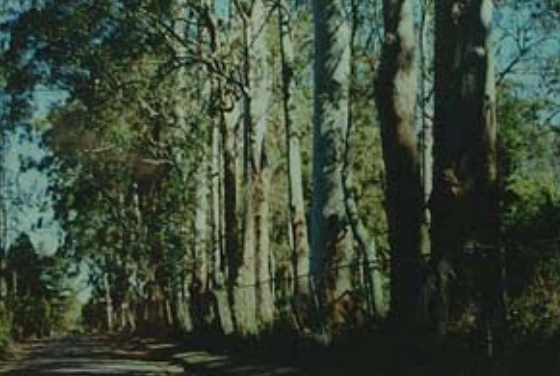
| 24a | <p><b>Blue Gums along Young St.</b><br/>(eastern boundary)</p> <p>The row of Blue Gums along the Young St. boundary are deliberate cultural plantings, probably of the 1920s, but some trees are either remnant or regenerated endemic specimens from the original Blue Gum High Forest.</p> | | <p><b>Rating: Moderate to High</b></p> <p>Mature, endemic species should be conserved and maintained by a skilled arborist. Plants belonging to the Blue Gum High Forest community which have regenerated there should be retained.</p> <p>Introduced species need not be retained, although some would have amenity and/or asset value.</p> |

and the line of Blue Gums along the Young Street site boundary, have some heritage value, and should be conserved. Firm controls would be needed to ensure their preservation, and conditions imposed to ensure that building envelopes did not come within distances from their trunks recommended by a consulting arborist.

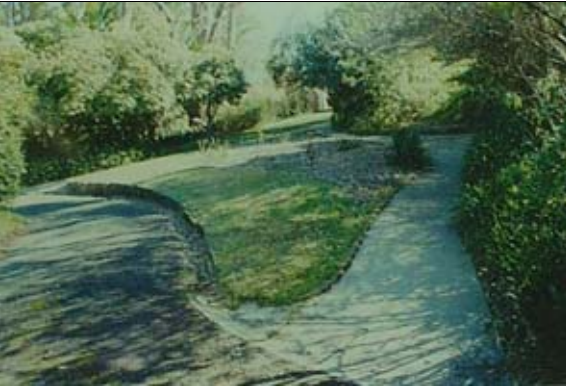
| 25. | <p><b>Central lawns and gardens – central sector</b></p> <p>These contained shrub and rose beds set in lawns, and demonstrate an integral part of the garden, possibly Federation.</p> <p>Note the raised stone edging and brick spoon drains which are typical of late Federation period gardens</p> | | <p><b>Rating: Moderate</b></p> <p>Now much overgrown, this area should be selectively cleared of inappropriate plantings and self-seeded plants, but valuable old shrubs should be retained and the lawn and rose bed reinstated.</p> |

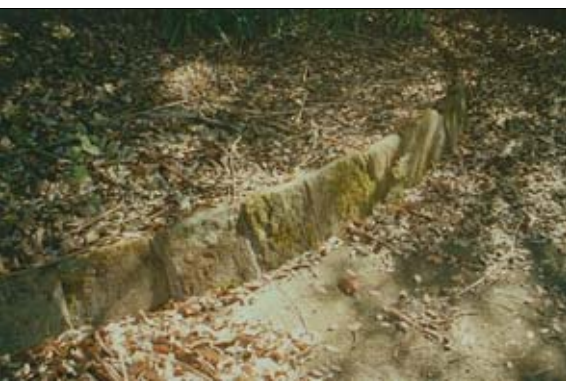
| 26. | <p><b>Stone pathways and garden bed edging (central sector)</b></p> <p>Many of these are made of sandstone slabs, probably exfoliated sheets from outcrops in the bush, some used as pavers, and some laid on edge to contain soil within garden beds.</p> <p>They are typical elements that accompanied the arts and crafts style of some federation houses.</p> | | <p><b>Rating: Moderate</b></p> <p>Should be repaired, conserved and maintained, using same materials as the original.</p> |

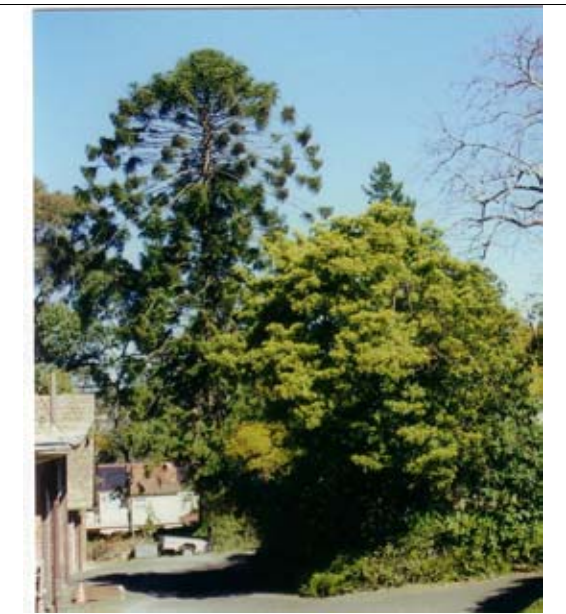
| 28. | <p><b>Bunya Pine (south-western sector)</b></p> <p>A typical late 19<sup>th</sup>–early 20<sup>th</sup> century planting, demonstrating planting tastes of the period. As it does not appear in the background of early photographs, it may have been planted in the late 1920s.</p> <p>(The Golden Cypress in the right foreground was removed after this photograph was taken in 2000.)</p> | | <p><b>Rating: High</b></p> <p>Should be conserved and maintained by a skilled arborist. No construction should occur within a radius of 7m from its trunk.</p> |

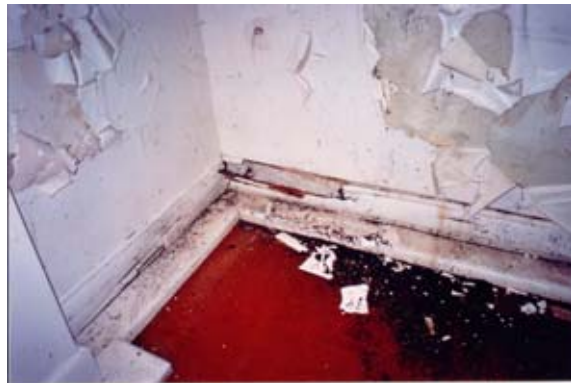
Figure 139: Deteriorating skirting joinery, north-western corner of Room G4 (Rod Howard & Associates, 2006).

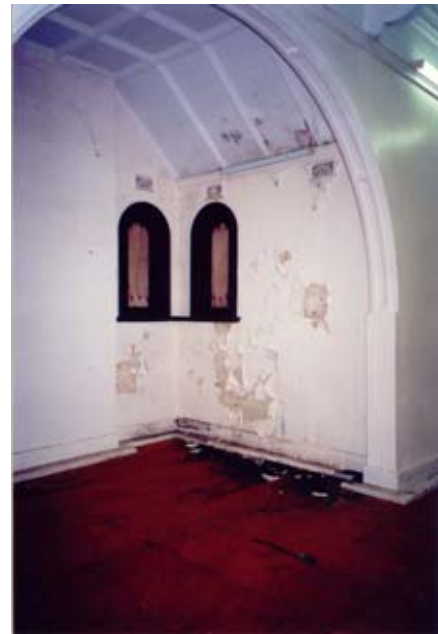
Figure 140: Damaged skirtings and wall surfaces in the north-western corner of Room G4 (Rod Howard & Associates, 2006).

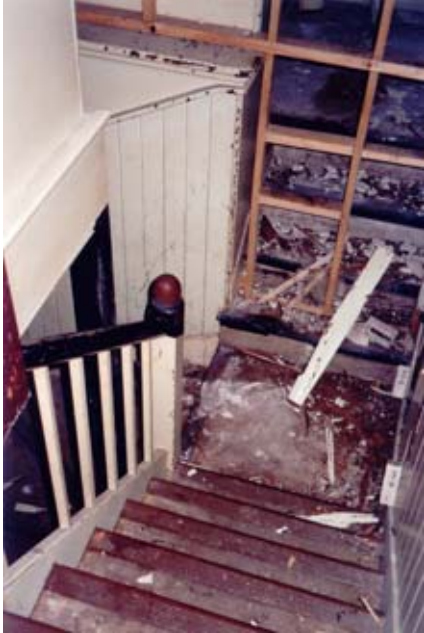
Figure 141: Badly damaged fabric associated with spaces adjacent to the stair at the southern end of “Rippon Grange” (Rod Howard & Associates, 2006).

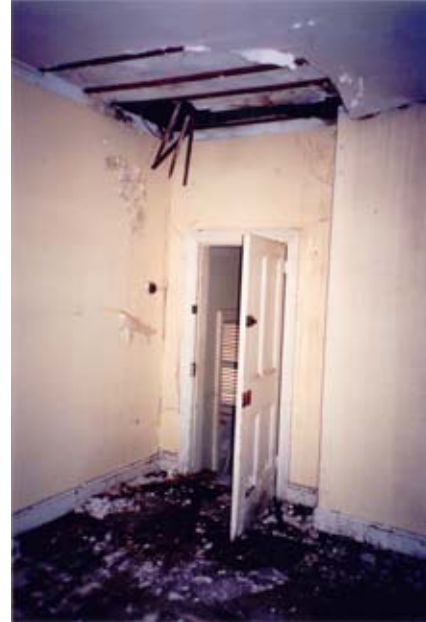
Figure 142: Damaged ceiling fabric, Room F19 (Rod Howard & Associates, 2006).

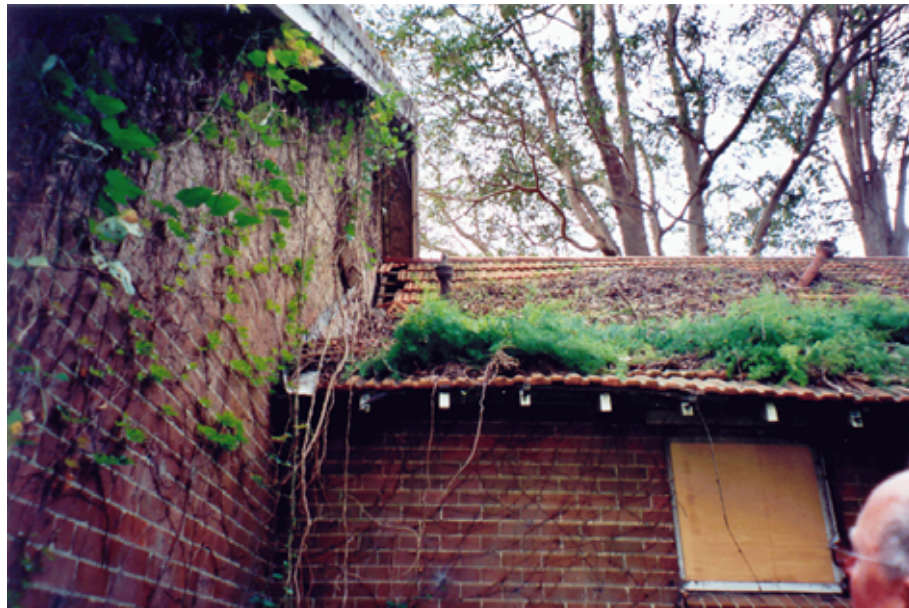
Figure 143: Collapsed section of roof on the south-eastern side of the former Stable (Rod Howard & Associates, 2006).

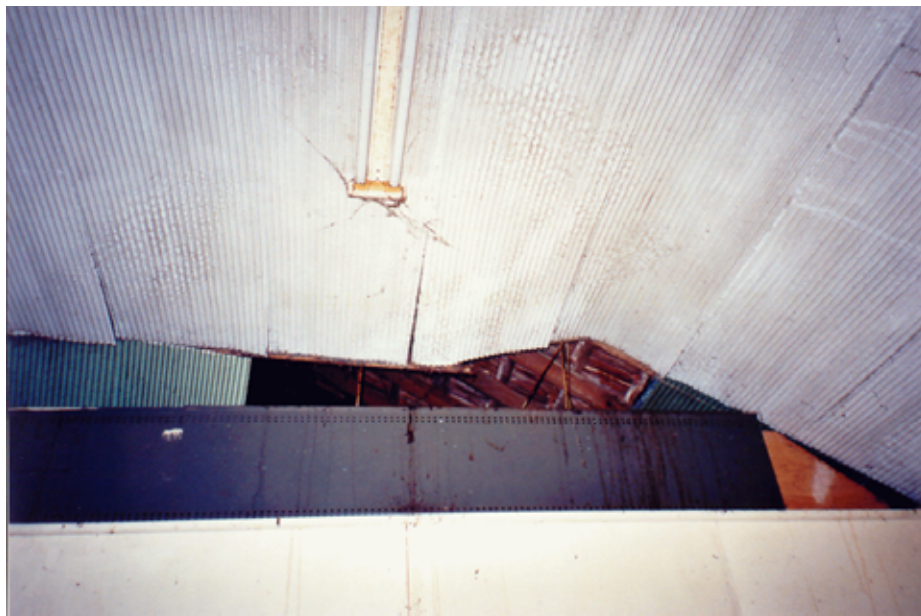
Figure 144: Condition of ceiling linings within the former Stable (Rod Howard & Associates, 2006).

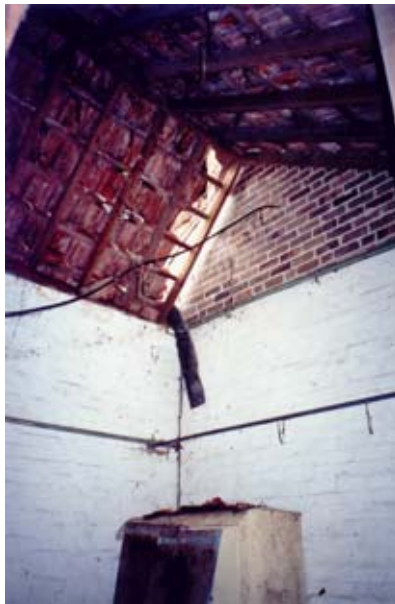
Figure 145: Deterioration of portion of roof within the former Stable (Rod Howard & Associates, 2006).

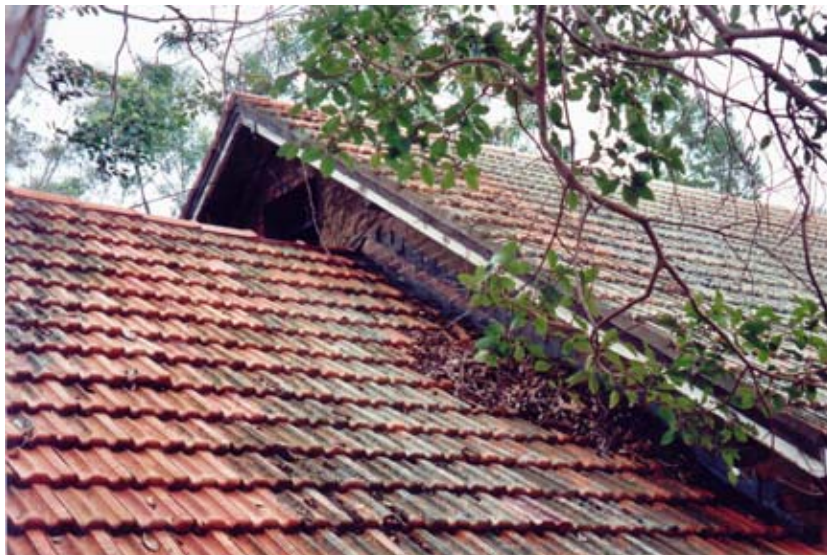
Figure 146: The gap between flashings and lower roof indicate the extent to which the roof has dropped (Rod Howard & Associates, 2006).

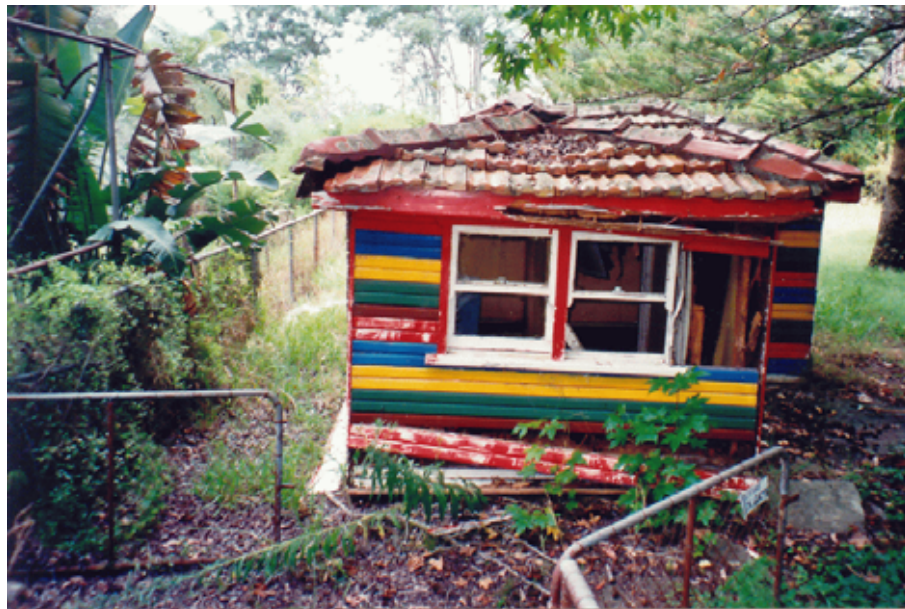
Killara Cottage is in very poor condition, with the northern section of its roof progressively collapsing and its walls demonstrating a sizable amount of termite infestation.

Figure 147: Killara Cottage (Rod Howard & Associates, 2006).
